# ACCELERATED CAVITATION DAMAGE OF STEELS AND SUPERALLOYS IN LIQUID METALS

*by Stanley G. Young and James R. Johnston*

*Lewis Research Center*

NASA TN D-5740

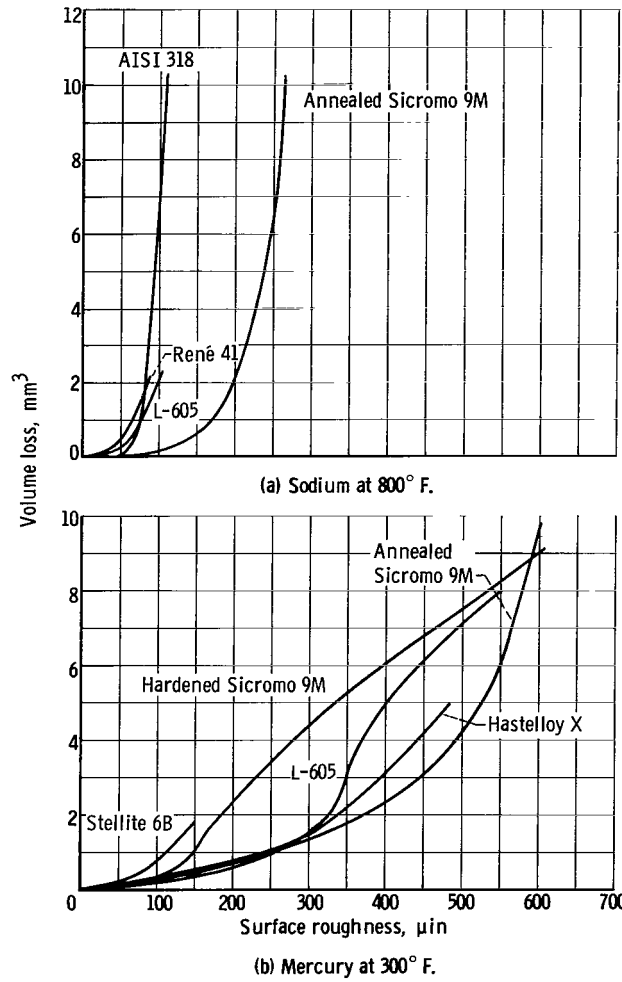
Figure 8. - Relation between volume loss and surface roughness.

times (fig. 8) indicates that, in the case of specimens damaged in sodium, the surface roughness tends to approach constant values with increasing volume loss. These constant values of surface roughness correspond to the steady-state volume loss rates illustrated in figure 6(a).

In the case of specimens damaged in mercury, however, the surface roughness, in general, tends to increase with increasing volume loss and does not appear to approach constant values as might be expected from the appearance of the volume loss rate curves for mercury (fig. 6(b)). These results suggest that the mechanism of cavitation attack by mercury may be quite different from that by sodium. Additional evidence to this effect will be shown in the next section. Briefly, damage to materials in sodium is evidenced by a general attrition of the surface, which is shown by the relatively fine-textured surface that erodes uniformly. Damage due to cavitation in mercury is evidenced by the formation and continual deepening of wide craters.

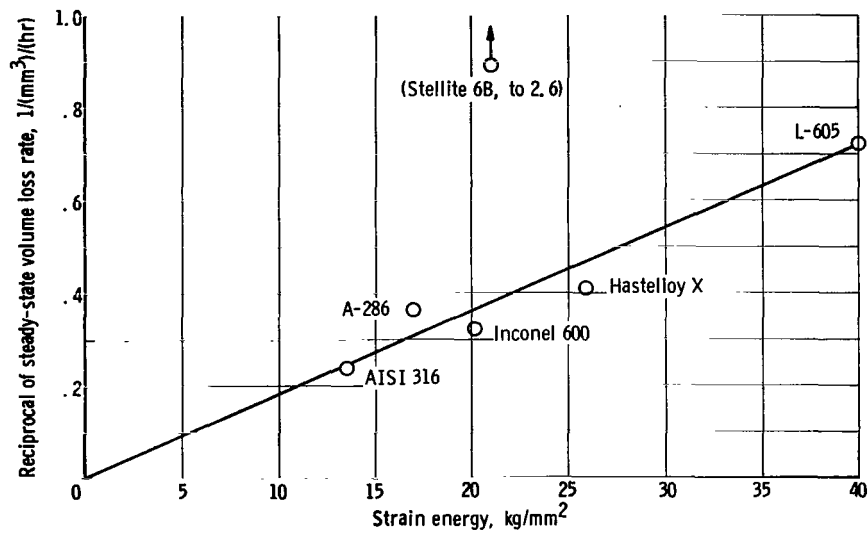
Figure 14. - Relation of cavitation damage in sodium with strain energy parameter.

The necessary properties for calculating the strain energy of materials at 800<sup>0</sup> F are given in table V; figure 14 shows the relation between strain energy and the reciprocal of the steady-state volume loss rate of materials subjected to cavitation damage in sodium. The steady-state volume loss rate values were obtained from figure 6(a) at 4 hours. Although the volume loss rate curves indicate that Stellite 6B, and perhaps L-605, may not yet have reached a steady-state condition after 4 hours, the values for this test time were used as approximations of the steady-state rates.

It is evident from the figure that all the data do not fall close to a correlating line. The data point for the material that performed most favorably, Stellite 6B, is very far removed from the data of the other materials. Even if the steady-state damage rate of Stellite 6B should be higher than that assumed (as it may be with longer test time), it is quite certain that the reciprocal of the volume loss would not be displaced by the approximately one order of magnitude needed to make this data point fall into line. Thus, the use of this particular correlating parameter would have resulted in omitting from consideration one of the most favorable cavitation damage resistant materials.
