SUMMARY OF OBSERVED RESULTS
WHEN CHILLING THE M-1 FUEL TURBOPUMP
TO LIQUID HYDROGEN TEMPERATURE

By
J. A. Ritter

AEROJET-GENERAL CORPORATION

3 June 1966

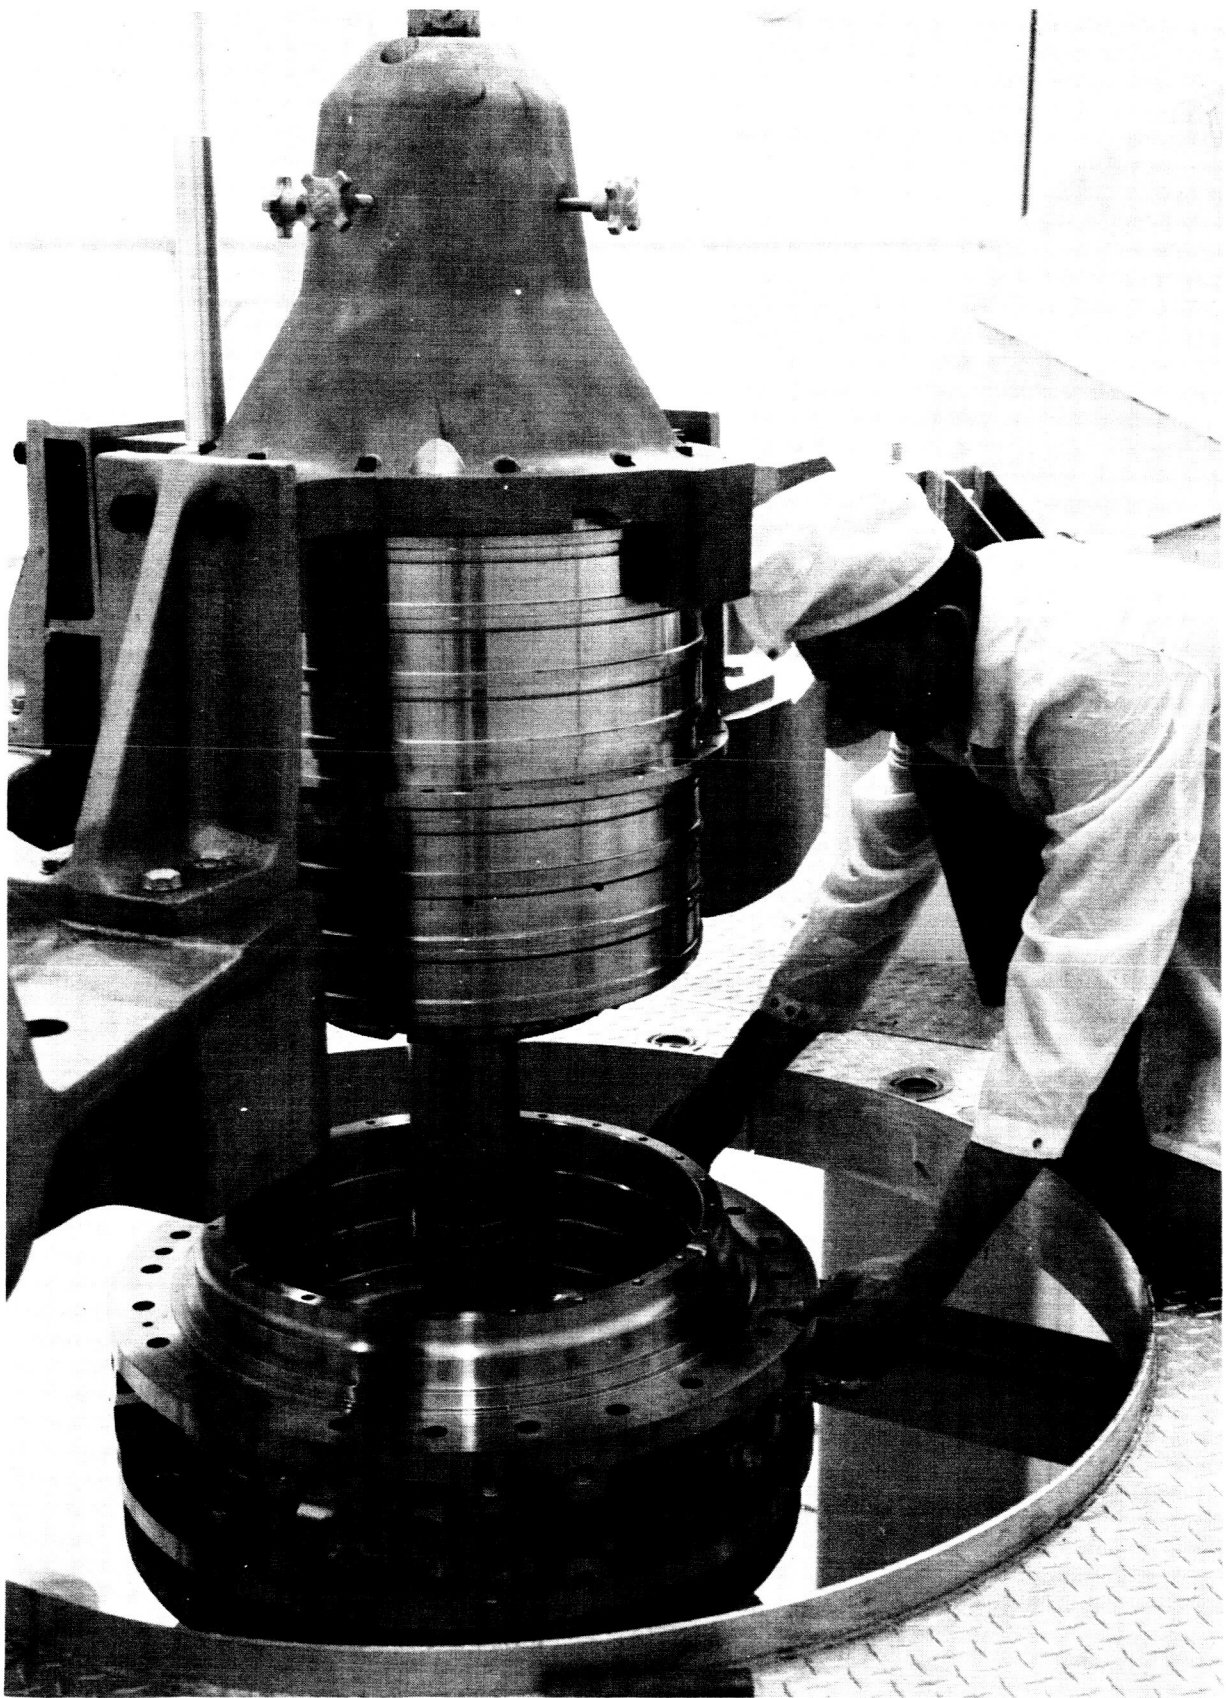
Figure 16

Assembly of Pump Rotor and Stator Assemblies Into the Mainstage Housing

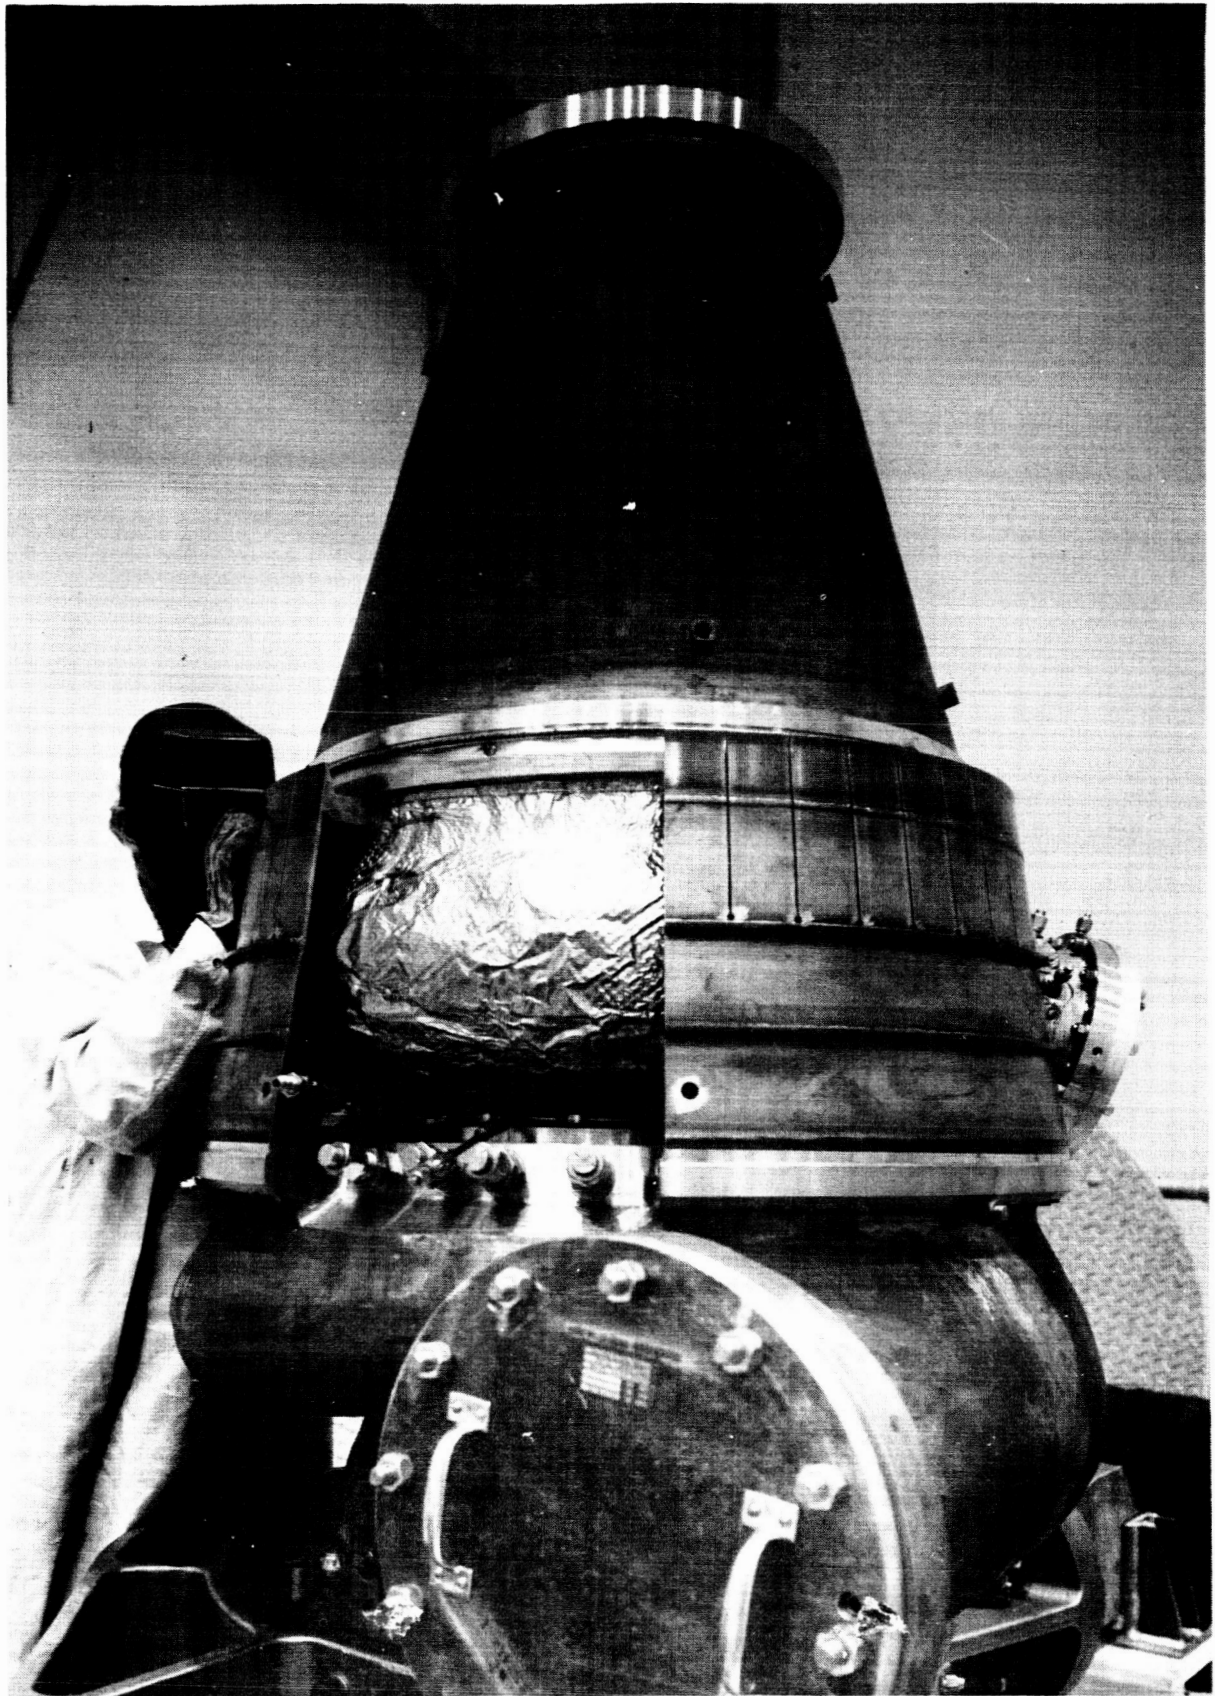
Figure 28

Turbine Exhaust Cone Installed on Model I Fuel Turbopump
