NASA CR-506

**ELECTRODE PHENOMENA IN HIGH ENERGY  
DENSITY DISCHARGES AS APPLIED TO  
PLASMA ACCELERATION PROBLEMS**

*by Helmut Poppa*

*Prepared by*  
**GENERAL DYNAMICS CORPORATION**  
San Diego, Calif.

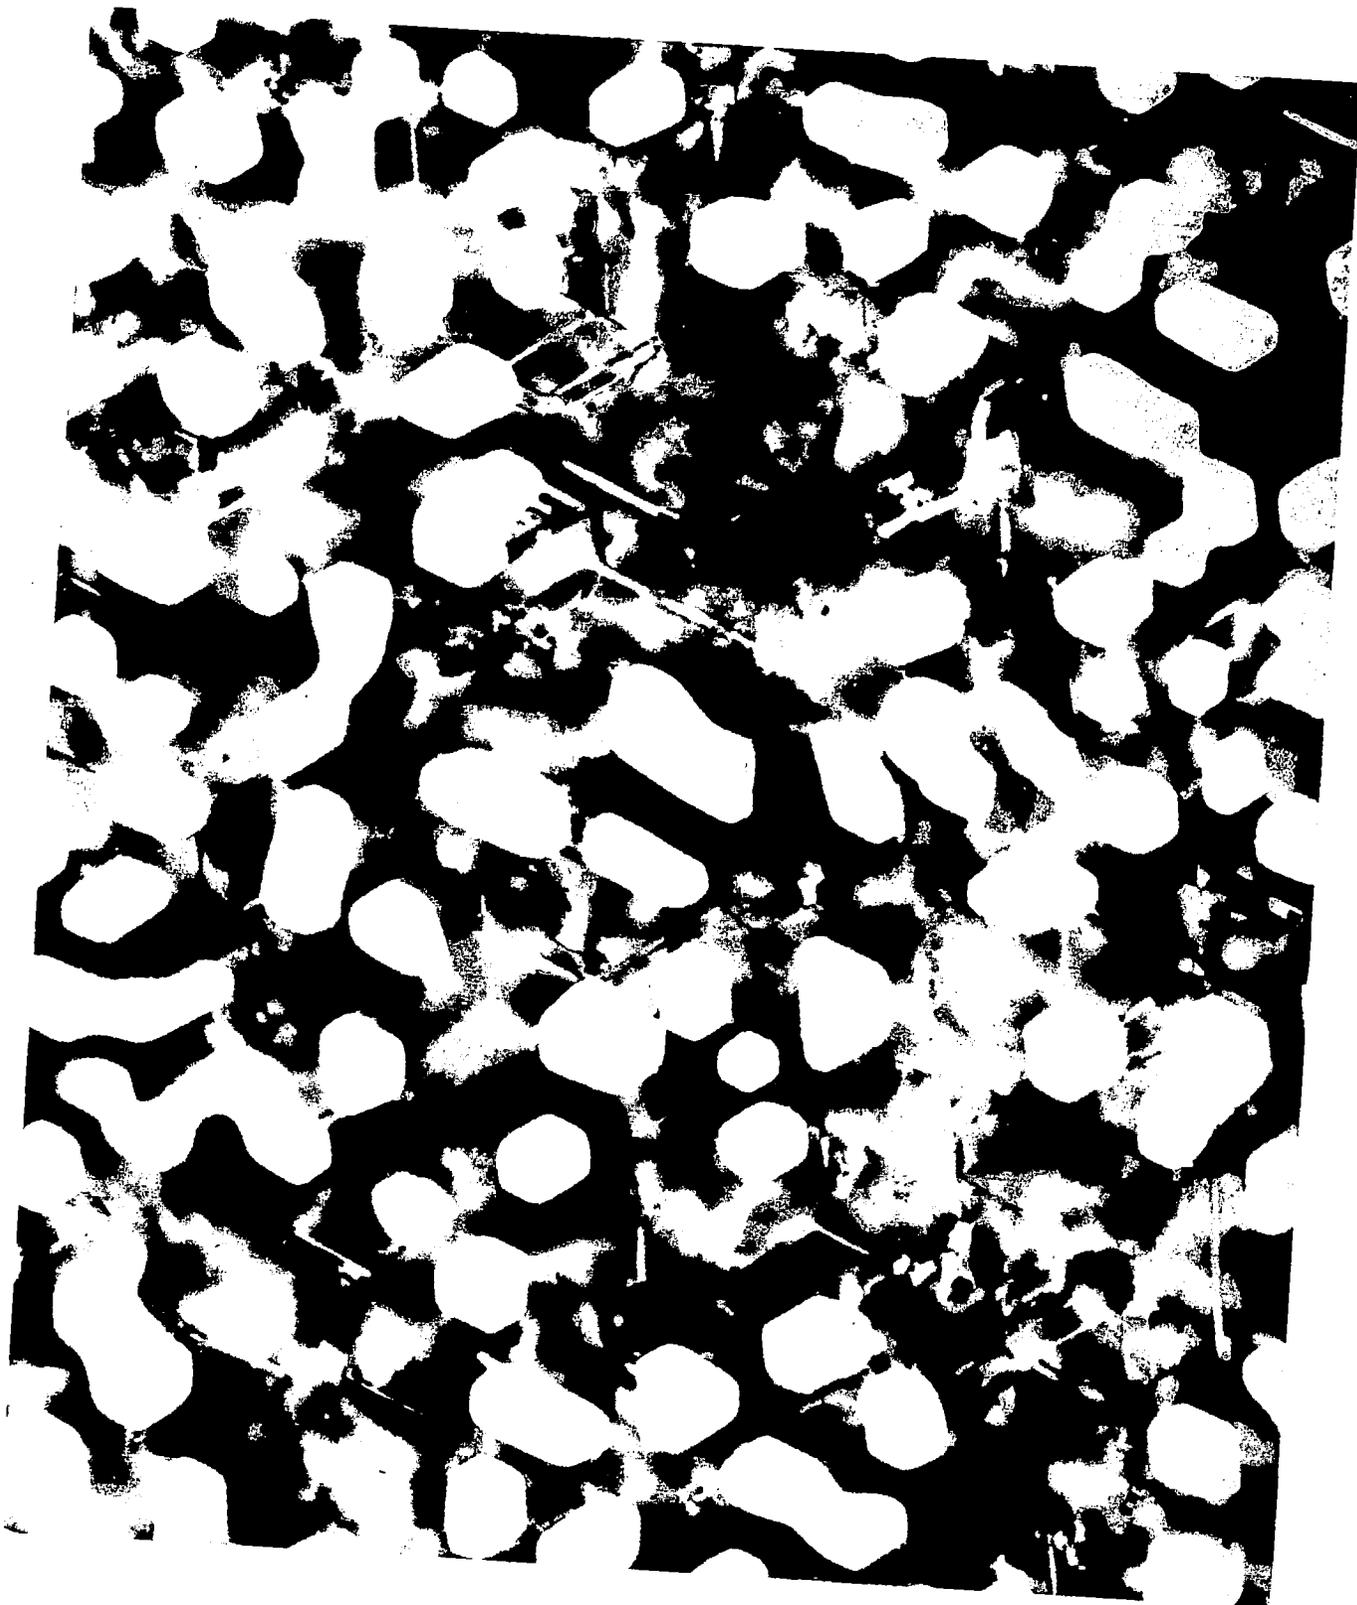
In target areas where the impinging  $\text{Ar}^+$  ion flux was higher the structure of the Au targets is quite different (Figure 5). Resulting from the high irradiation dose in these areas, holes are etched into the target. The three-fold (for (111) orientation) or four-fold (for (100) orientation) symmetry of these holes is directly related to the crystallographic structure of the target film. It can also be noted that the predominant lattice defects visible in these micrographs, namely microtwins, stacking faults, and coherent twin boundaries extend along directions which are parallel to the edges of the holes. This behavior shall be explained later in terms of preferred nucleation of argon interstitials at lattice defects.

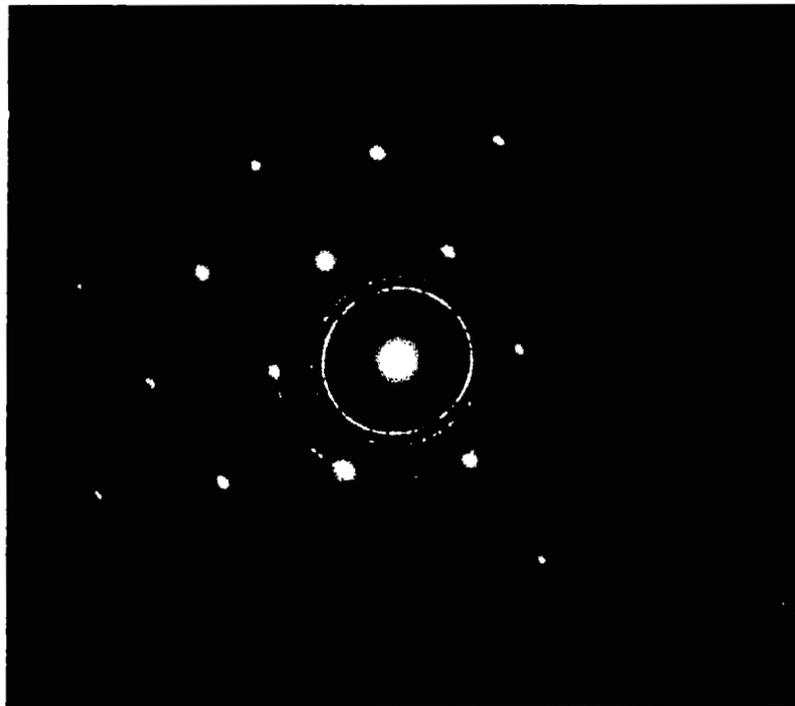
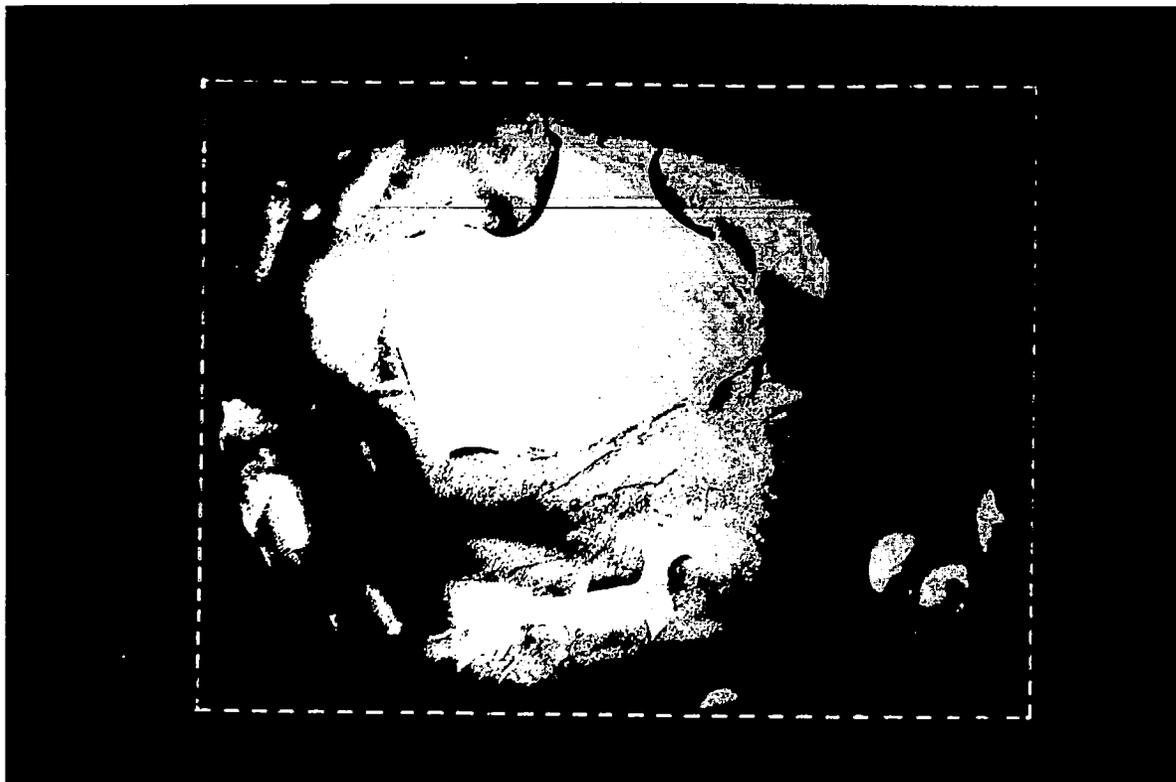
Figure 18 shows the results of the selected area electron microscope tests, confirming our expectations and previous results: local melting does take place in microscopically small cathode spot areas. A thinned area surrounding a hole in the single crystal cathode film can be seen in Figure 18a; the corresponding electron diffraction pattern with well defined Debye-Scherrer rings superimposed upon the original (111) spot pattern is Figure 18b. Figures 18c and 18d illustrate the same fact with one exception: the thinned area has not yet broken through the cathode film completely. A very thin amorphous film of low sputtering yield (well known from other experiments, and probably formed at the gold-silver interface during preparation procedures) remains, spanning the hole in the gold film. A fine polycrystalline gold film (Figure 18d) with a definite island structure (similar to the structure of incomplete evaporated metal films) can be distinguished on the amorphous film (Figure 18d). It seems plausible assuming that the fine structured gold film in the hole stems from recondensing cathode material and can be viewed as direct evidence for high thermal loads in the cathode spot regions, causing evaporation of cathode material.
