Technical Report No. 32-1023 Surveyor I Mission Report

Part I. Mission Description and Performance

JET PROPULSION LABORATORY CALIFORNIA INSTITUTE OF TECHNOLOGY PASADENA, CALIFORNIA

August 31, 1966

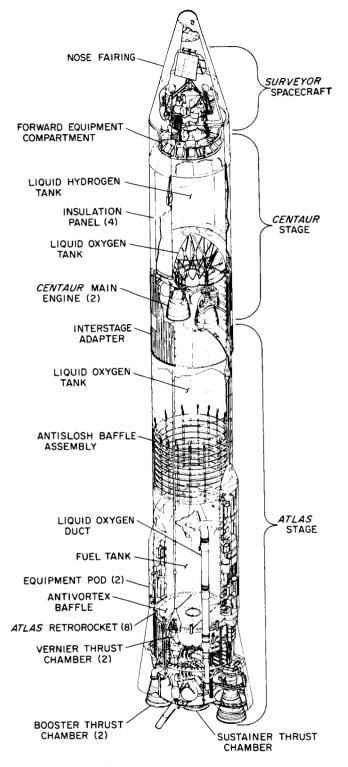
Fig. III-1. Atlas/Centaur/Surveyor space vehicle configuration

The first stage of the Atlas/Centaur vehicle is a modified version of the Atlas D used on many previous NASA and Air Force missions such as Ranger, Mariner and OGO. The Atlas propulsion system burns RP-1 kerosene and liquid oxygen in each of its five engines to provide a total liftoff thrust of approximately 388,000 lb. The individual sea-level thrust ratings of the engines are: two booster engines at 165,000 lb each; one sustainer engine at 57,000 lb; and two vernier engines at 670 lb each. The Atlas can be considered a 11/2-stage vehicle because the "booster section," weighing 6000 lb and consisting of the two booster engines together with the booster turbo pumps and other equipment located in the aft section, is jettisoned after about 2.5 min of flight. The sustainer and vernier engines continue to burn until propellant depletion. A mercury manometer propellant utilization system is used to control mixture ratio for the purpose of minimizing propellant residuals at Atlas burnout.

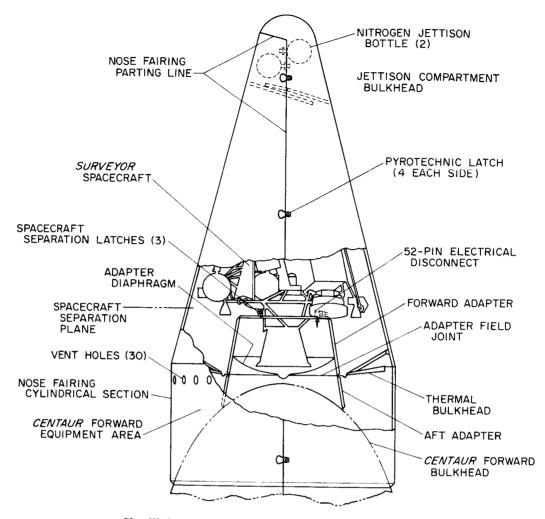
Fig. III-2. Surveyor/Centaur interface configuration

The general arrangement of the Surveyor/Centaur interface is illustrated in Fig. III-2. The spacecraft is completely encapsulated within a nose fairing/adapter system in the final assembly bay of the Explosive Safe Facility prior to being moved to the launch pad. This encapsulation provides protection for the spacecraft from the environment before launch as well as from aerodynamic loads during ascent.

The spacecraft is first attached to the forward section of a two-piece, conical adapter system of aluminum sheet and stringer design by means of three latch mechanisms, each containing a dual-squib pin puller. The following equipment is located on the forward adapter: three separation spring assemblies each containing a linear potentiometer for monitoring separation; a 52-pin electrical connector with a pyrotechnic separation mechanism; three pedestals for the spacecraft-mounted separation sensing and arming devices; a shaped-charge destruct assembly directed toward the spacecraft retromotor; an accelerometer for monitoring lateral vibration at the separation

plane; and a diaphragm to provide a thermal seal and to prevent contamination from passing to the spacecraft compartment from the *Centaur* forward equipment compartment.

Special distribution ducts are built into the nose fairing and forward adapter to provide air conditioning of the spacecraft cavity after encapsulation and until liftoff. Seals are provided at the joints to prevent shroud leakage except out through vent holes in the cylindrical section.

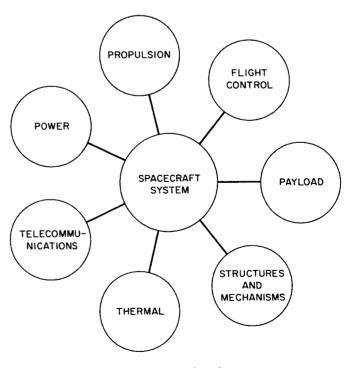
Fig. IV-1. Spacecraft subsystems

The peripheral areas shown in Fig. IV-1 represent all of the subsystems essential to the operation of the *Surveyor* spacecraft. These areas are discussed in subsequent sections. The *Surveyor I* spacecraft is an engineering test model equipped with all subsystems necessary for a soft-landing on the moon. It carries a survey television system and engineering instrumentation, including temperature sensors, strain gages, accelerometers, and position-indicating devices. The spacecraft coordinate system is an orthogonal, right-hand Cartesian coordinate system. The physical configuration of the spacecraft is shown in Fig. IV-2 and in Appendix B. A simplified functional block diagram of the spacecraft system is shown in Fig. IV-3.

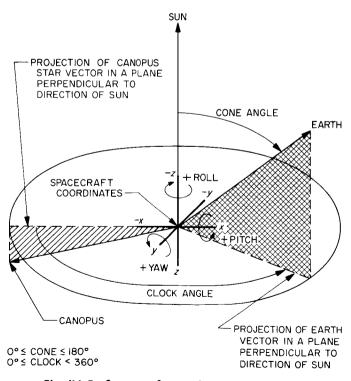
Fig. IV-5. Spacecraft coordinates relative to celestial references

Attitude control of the spacecraft is accomplished by the flight control function. The spacecraft detects attitude by celestial, inertial, and radar sensors. The sensor outputs are processed to create thrust commands to orient and stabilize the spacecraft during transit and to provide trajectory correction and establish vernier descent control for soft-landing the spacecraft on the lunar surface. Fig. IV-5 shows the spacecraft motion about its coordinate axes relative to the celestial references. The cone angle of the earth is the angle between the sun vector and the earth vector as seen from the spacecraft. The clock angle of the earth is measured in a plane perpendicular to the sun vector from the projection of the star Canopus vector to the projection of the earth vector in the plane. The spacecraft coordinate system may be related to the cone and clock angles coordinate system, provided sun and Canopus lock-on has been achieved. Note that the spacecraft minus Z-axis is directed toward the sun and the minus X-axis is coincident with the

The celestial references (Fig. IV-5), the sun and the star Canopus, are acquired and maintained automatically after the spacecraft separates from the *Centaur* stage and after automatic deployment of the solar panel. The sun is first acquired by the automatic sun sensor during an automatically commanded spacecraft roll maneuver. The 10-deg wide \times 196-deg fan-shaped field of view of the automatic sun sensor includes the Z axis and is centered

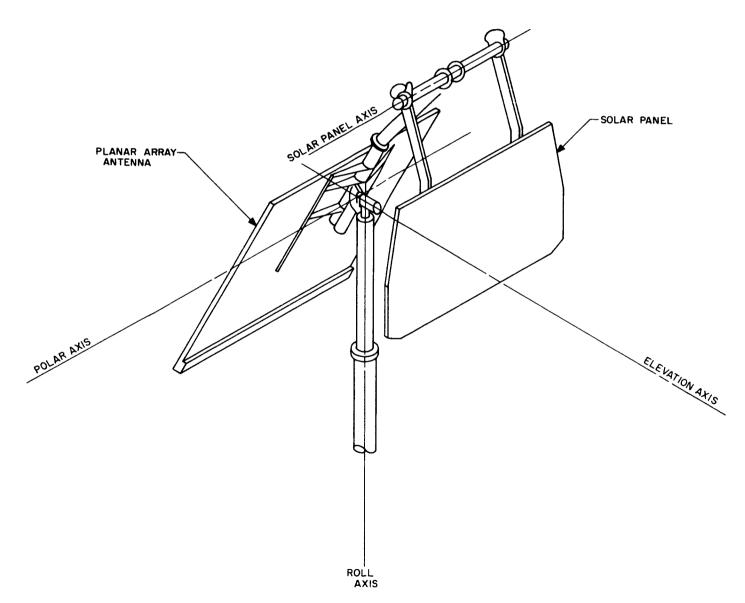
Fig. IV-15. Antenna/solar panel configuration

The solar axis is locked in a vertical position for stowage in the nose shroud. After launch, the solar panel is positioned parallel to the spacecraft X axis. The A/SPP remains locked in this position until after touchdown, at which time the roll, solar, and elevation axes are released. Potentiometers on each axis are read to indicate A/SPP orientation. Each command from earth gives $\frac{1}{8}$ degree of rotation in the roll, solar, and elevation axes and $\frac{1}{6}$ degree in the polar axis.

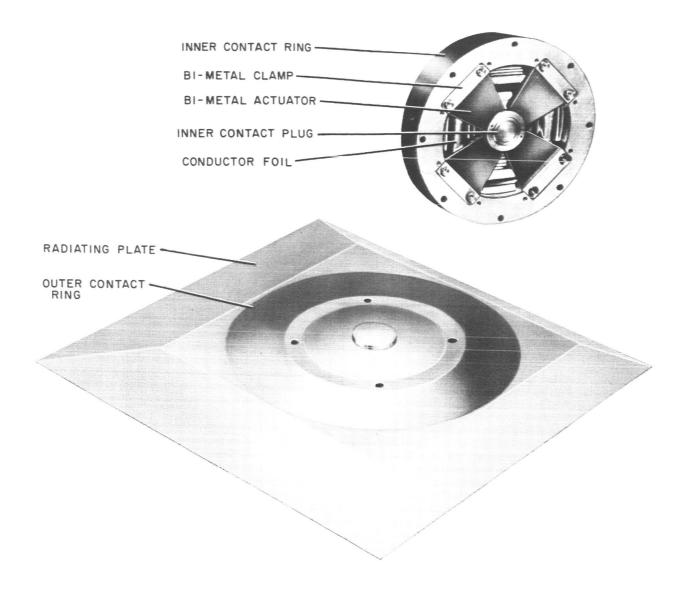
Fig. IV-16. Thermal switch

The thermal switches kept the electronics at or below the maximum temperature at all times during the lunar day, and therefore all switches were closed and had the proper conduction. However, a problem developed with the switches during the lunar night cycle. The switches were designed to open when the electronics module temperatures started to go below 65° F in Compartment A and below 50° F in Compartment B. Two switches in Compartment A did not open until the compartment reached 0° F. Two, or possibly three, of the Compartment B switches remained closed until after the last engineering interrogation, so it is not known at precisely what temperatures they opened, or whether they did open.

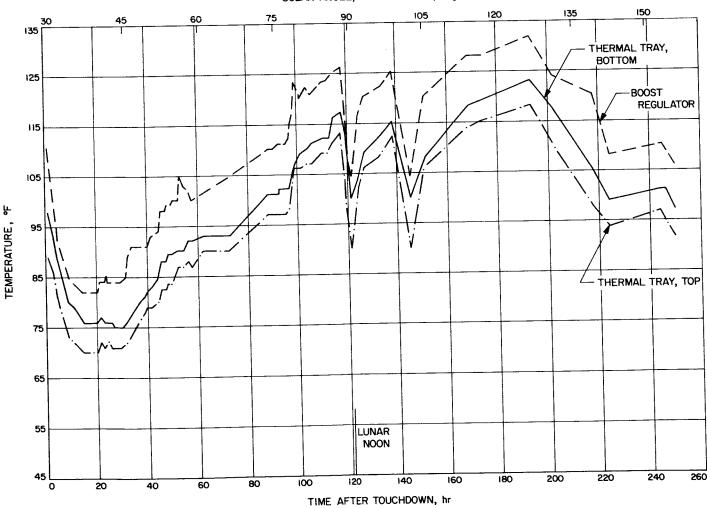
Fig. IV-19. Lunar temperatures, Compartment B

IV-18 and IV-19. Compartment thermal performance was greatly enhanced by planar array/solar panel shadowing for a good part of the lunar day, as shown in Fig. IV-4. Temperatures on the transmitters, battery charge regulator (BCR), and main battery were well within design temperature limits. TV thermal performance was nominal. Temperatures on the fuel and oxidizer tanks were well below the danger point. The temperature of the engines was high enough to cause seal degradation, although no damage to the spacecraft occurred. Lunar temperature histories for Vernier Engine No. 1, Fuel Tank No. 1, Solar Panel, Transmitter A, and TV survey camera electronics are shown graphically in Appendix C.

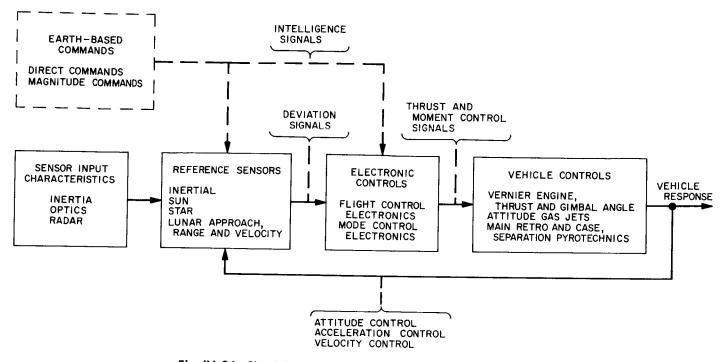
Fig. IV-34. Simplified flight control functional block diagram

The flight control subsystem (FCS) controls the spacecraft velocity and attitude during transit from the time of spacecraft separation from the *Centaur* vehicle to spacecraft touchdown on the lunar surface. The basic functions performed by the FCS include:

- 1. Attitude stabilization and orientation during transit.
- 2. Midcourse trajectory correction based on radio command data.
- 3. Retro pyrotechnic and vernier descent control for soft-landing the spacecraft.

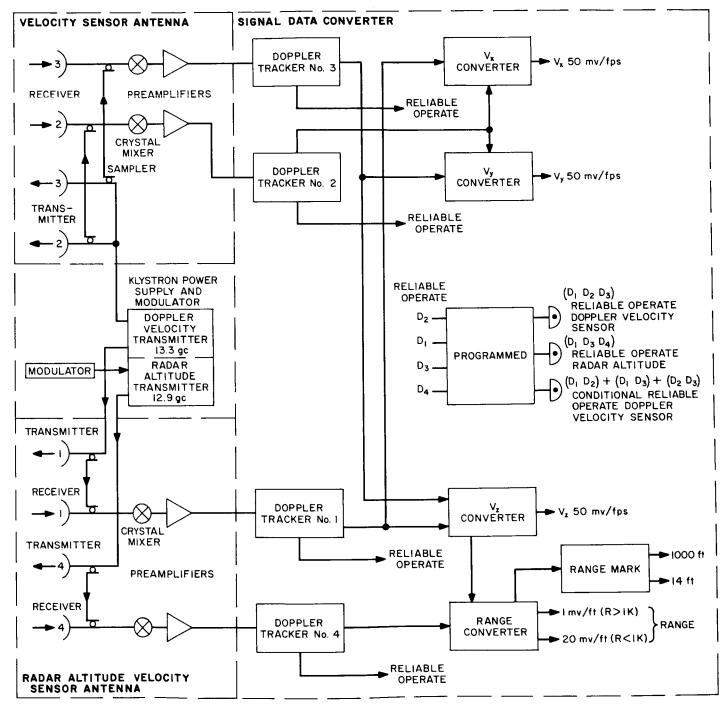
Fig. IV-35. Simplified RADVS functional block diagram

The D1 through D3 trackers in the signal data converter are similar in their operation. Each provides an output which is 600 kc plus the doppler frequency for approaching doppler shifts. If no doppler signal is present, the tracker will operate in search mode, scanning frequencies between 82 kc and 800 cps before retro burnout, or between 22 kc and 800 cps after retro burnout. When a doppler shift is obtained, the tracker will

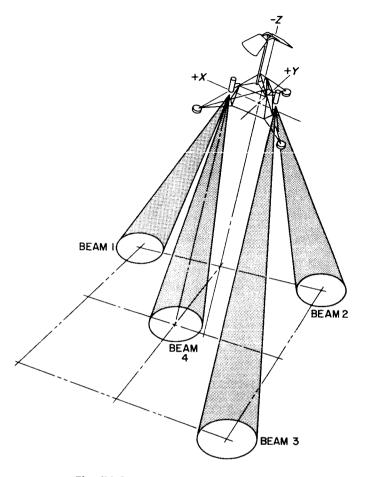
Fig. IV-36. RADVS beam orientation

operate as described above and initiate a lock-on signal. The tracker also determines amplitude of the reflected signal and routes this information to the signal processing electronics for telemetry.

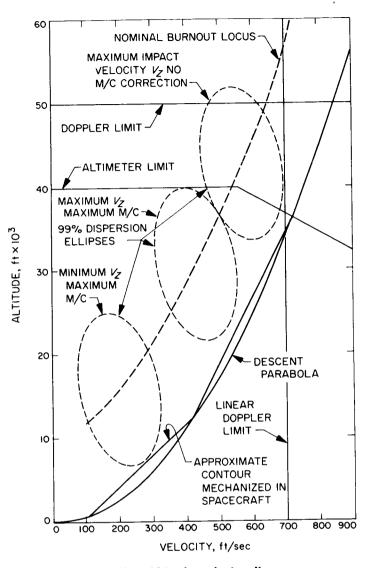
Fig. IV-37. Altitude-velocity diagram

Constraints on the allowable burnout region are imposed by the doppler radar and the altimeter. Linear operation of the doppler velocity sensor is expected for

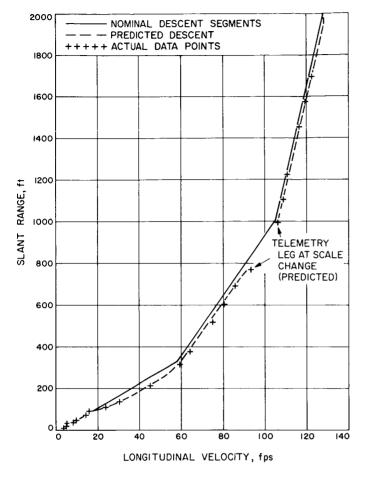
Fig. IV-39. Mission A descent profile, below 2000 ft

The altitude at engine cutoff and the touchdown velocity were investigated. Using the time between the 14-ft mark and touchdown, the spacecraft velocity gain at touchdown was 1.5×5.3 (lunar $g \approx 5.3$ ft/sec²) or approximately 8.0 ft/sec.

Just prior to engine cutoff (14 ft mark) the spacecraft was commanded to about 4 ft/sec. The touchdown velocity was thereby estimated at 11.97 ft/sec maximum. The altitude at vernier engine cutoff therefore appeared to be 12 ft rather than 14 ft.

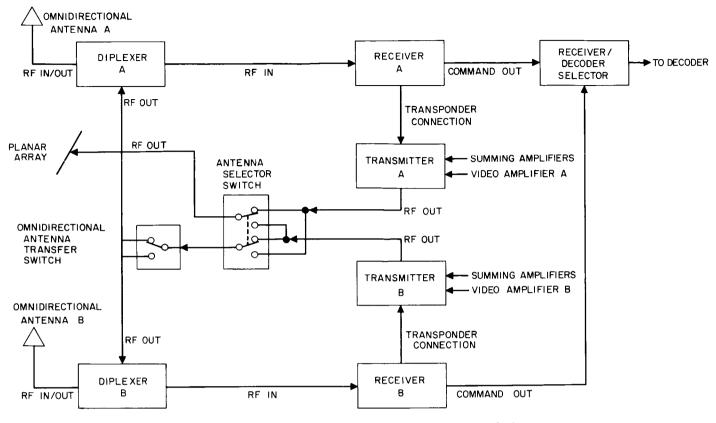
Fig. IV-45. Simplified telecommunication functional block diagram

Highly accurate tracking of the spacecraft requires transponders that permit two-way coherent doppler shift measurements. In this mode, a transmitter is phase-locked

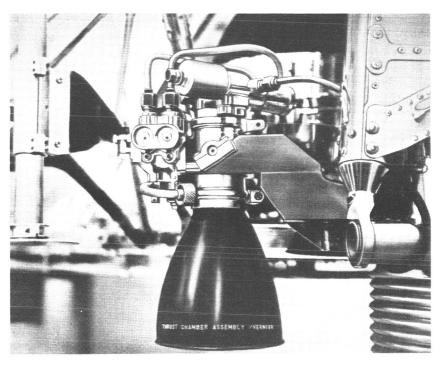
Fig. IV-52. Vernier engine thrust chamber

The thrust chambers (Fig. IV-52) are located near the hinge points of the three landing legs on the bottom of the main spaceframe. The moment arm of each engine is about 38 in. Engine No. 1 can be rotated $\pm 6 \text{ deg}$ about an axis in the spacecraft X-Y plane for spacecraft roll control. Engine 1 roll actuator is unlocked after boost. Engines Nos. 2 and 3 are not movable. The thrust of each engine (which is monitored by strain gages installed on each engine mounting bracket) can be throttled over a range of 30 to 104 lb. The specific impulse varies with engine thrust.

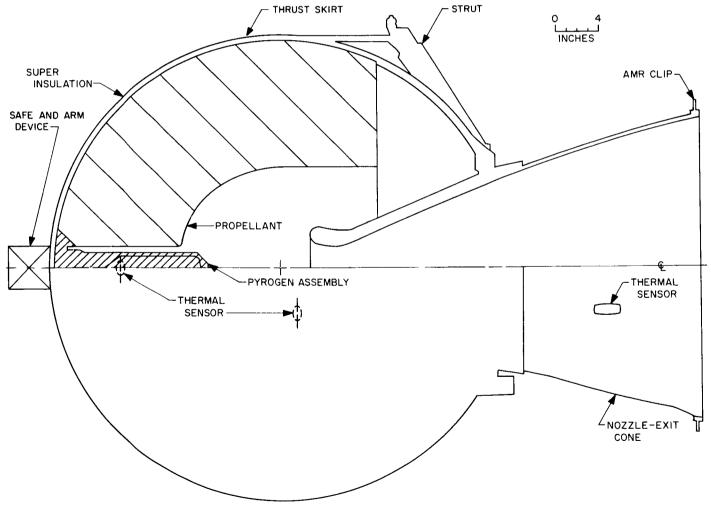
Fig. IV-53. Retrorocket engine

The main retrorocket, which performs the major portion of the deceleration of the spacecraft during lunar landing maneuver, is a spherical, solid-propellant unit with a partially submerged nozzle to minimize overall length (Fig. IV-53). The engine utilizes a carboxyl-terminated polyhydrocarbon composite-type propellant and conventional grain geometry.

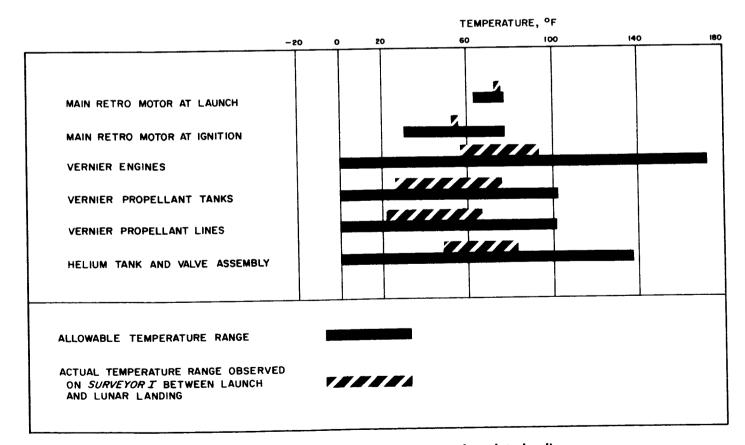
Fig. IV-54. Propulsion system temperatures, launch to landing

The vernier engines cooled to their steady-state temperatures within 5 hr after the midcourse correction.

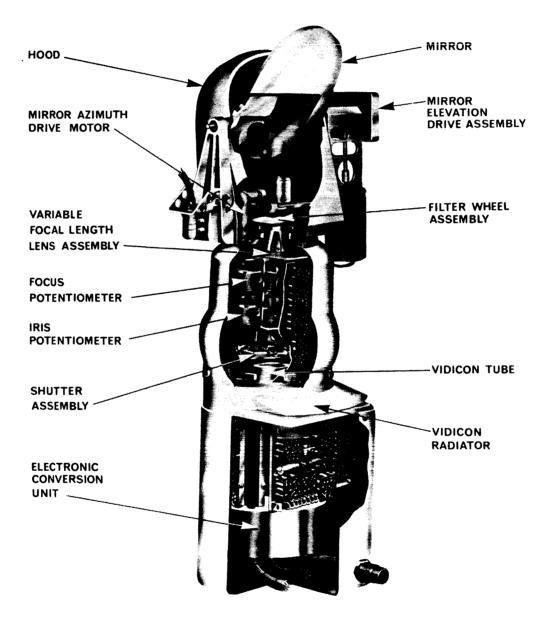
Fig. IV-59. Survey TV camera

The mirror assembly is comprised of a 10.5×15 cm elliptical mirror supported at its minor axis by trunnions. This mirror is formed by a vacuum-depositing an aluminum surface on a beryllium blank, followed by a deposition of Kanogen with an overcoat of silicon monoxide.

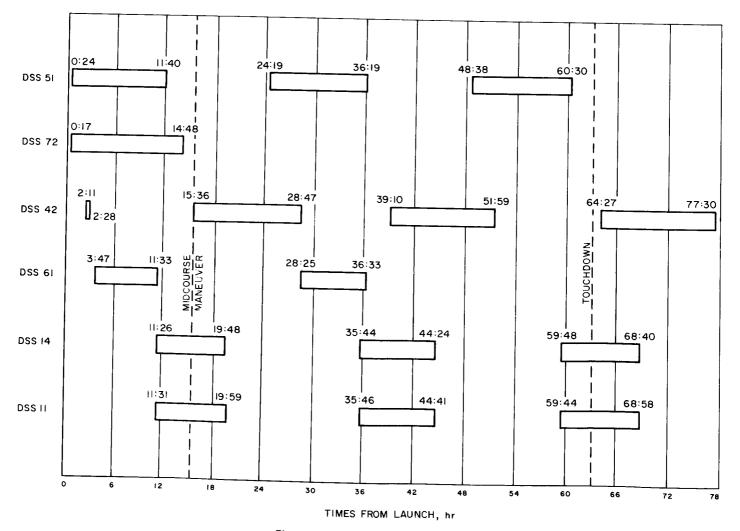
Fig. V-9. Station view periods

Figure V-9 is a profile of the DSIF mission activity up to lunar touchdown. This figure contains the periods

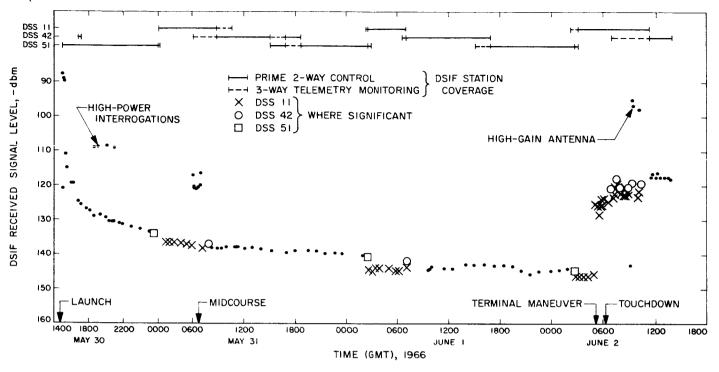
Fig. V-10. DSS-received signal level

each station tracked the spacecraft plotted against time in hours.

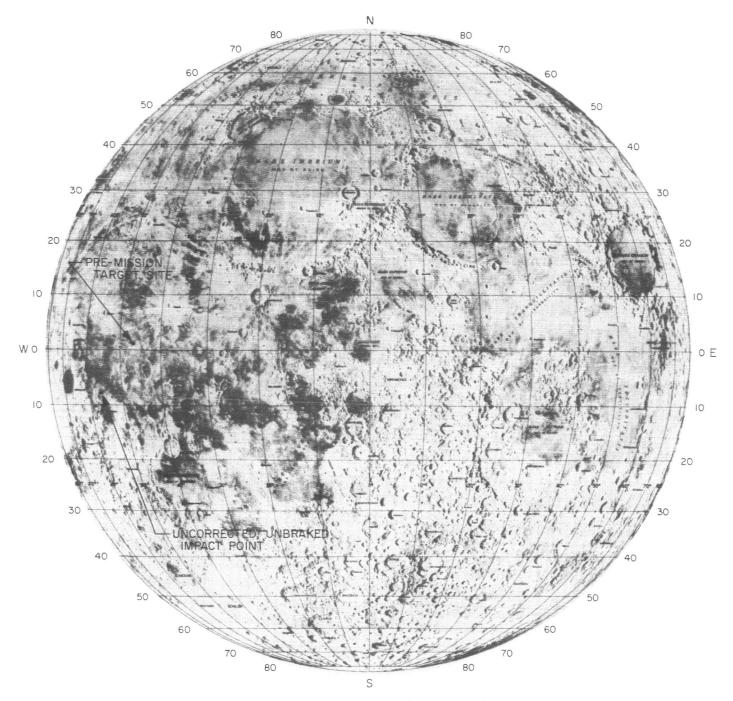
Fig. VII-4. Surveyor I program target and uncorrected impact points

The proximity of the uncorrected, unbraked impact point (-11.425 deg latitude, 305.853 deg longitude) and the original aim point (-3.25 deg latitude, 316.17 deg)
