NASA TECH BRIEF

Chemical Milling Solution Reveals Stress Corrosion Cracks in Titanium Alloy

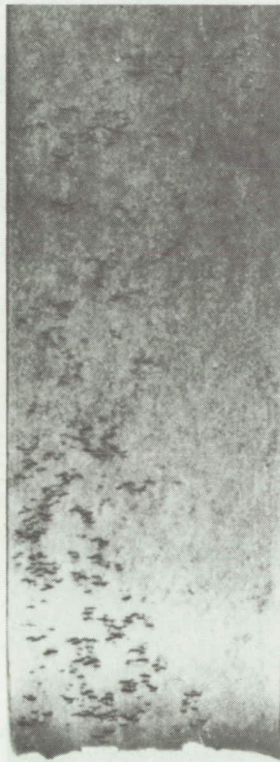
Untreated

The photograph illustrates stress corrosion cracks in a Ti-8Al-1Mo-1V titanium alloy which has been treated with the solution.
