# NATIONAL BUREAU OF STANDARDS REPORT

THE MECHANISMS OF STRESS CORROSION OF THE TITANIUM ALLOY Ti 8-1-1  
EXPOSED TO SALT ENVIRONMENTS AT ELEVATED TEMPERATURES

Headquarters  
National Aeronautics and Space Administration  
Requisition No. PR10-2081  
May 4, 1964  
Contract No. R-130

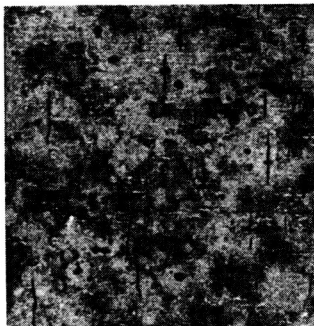
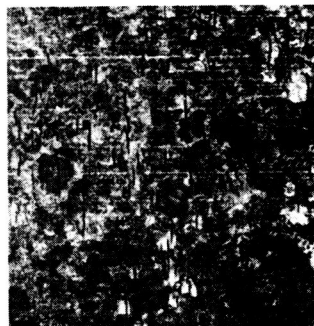
Fig. 1. Surfaces of four point loaded (80 Ksi) bend specimens which were coated with representative I and II group chlorides and exposed at 800°F for 280 days. Varying cracking severity is shown after surfaces were cleaned with an acid pickle. X 7

control. The severity of cracking decreased in the order  $\text{BaCl}_2$ ,  $\text{KCl}$ ,  $\text{CaCl}_2$ ,  $\text{CsCl}$ ,  $\text{SrCl}_2$  (see Fig. 1). Cracks were associated with pits in specimens coated with  $\text{KCl}$  and  $\text{SrCl}_2$ . No trends that might be expected on the basis of chemical periodicity were found.

2. Cracking of the bent beam specimens was produced using a number of chlorides. In decreasing order of severity, those investigated were:  $\text{BaCl}_2$ , KCl,  $\text{CaCl}_2$ , CsCl and  $\text{SrCl}_2$ .

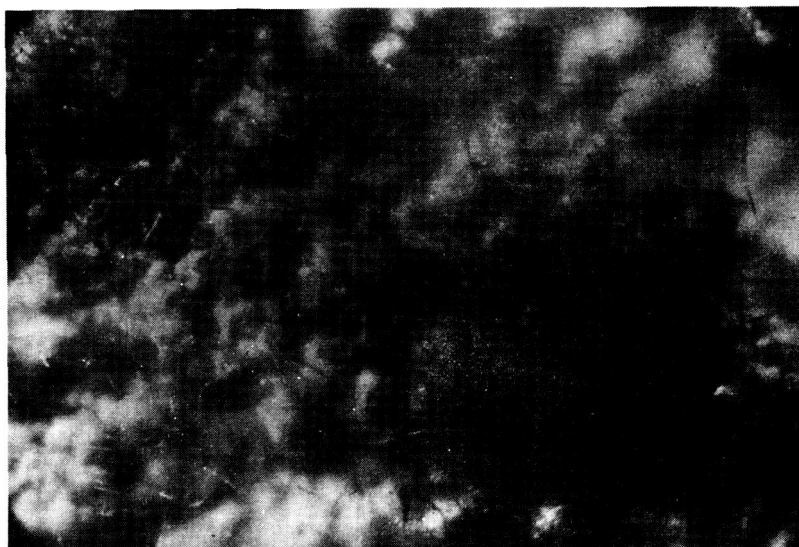
Fig. 4. Surface of sheet specimen with NaCl corrodent after exposure in oxygen atmosphere at 800°F for 30 days. Whiskers are either primarily NaCl (white) or rutile (black). Print from 35mm color slide. X 95

In addition to looking at the corrosion products formed in the presence of chlorides, a sheet specimen was heated in oxygen for 30 days. A subsequent microscopic examination showed it to be coated with light and dark whiskers, Fig. 4. The light whiskers were NaCl, the dark, rutile. The whiskers suggest that some NaCl existed in the vapor state. NaCl is reported to have a vapor pressure of 2.4 Torr at 1376°F. It is suggested that the black whiskers resulted from the diffusion of the rutile into the NaCl whiskers.
