NASA CR-752

**A PROGRAM OF HIGH ANGULAR
RESOLUTION STUDIES OF
CELESTIAL X-RAY SOURCES**

Prepared by
AMERICAN SCIENCE AND ENGINEERING, INC.
Cambridge, Mass.
for

This document is the final report on NASA contract NASW-1505. This contract is part of a continuing program of X-ray astronomy by AS&E and calls for the design, fabrication and flight of an instrumented payload from an Aerobee rocket and preliminary analysis of the resulting data.

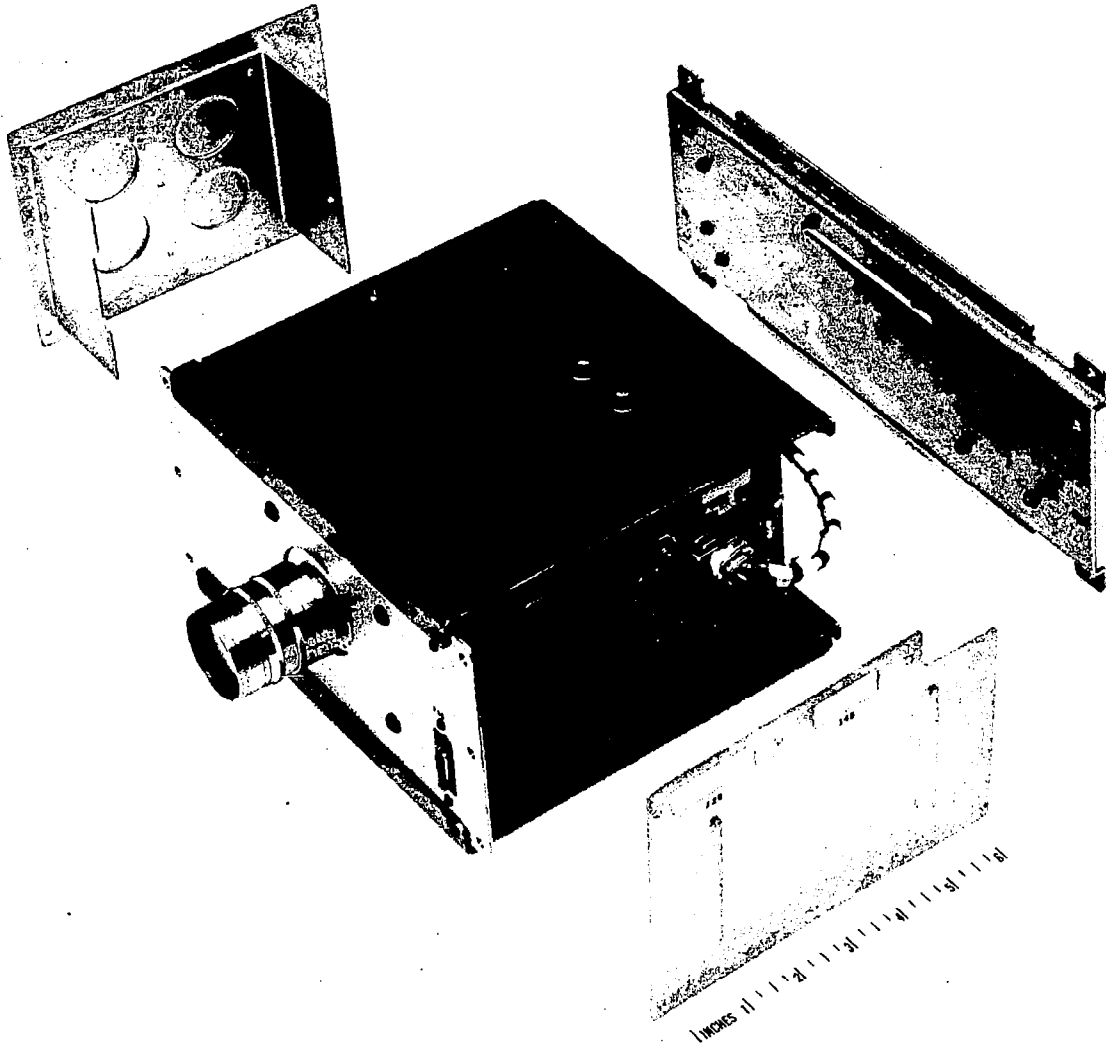
The camera which had been flown previously, and performed to expectations, was a 16 mm Milliken Model DBM-3C, with an Angenieux f/.95, 25 mm focal length lens. This lens was used to increase both the field of view and the exposure density. Figure 1 is a picture of the camera and associated hardware.

ASPECT CAMERA ASSEMBLY

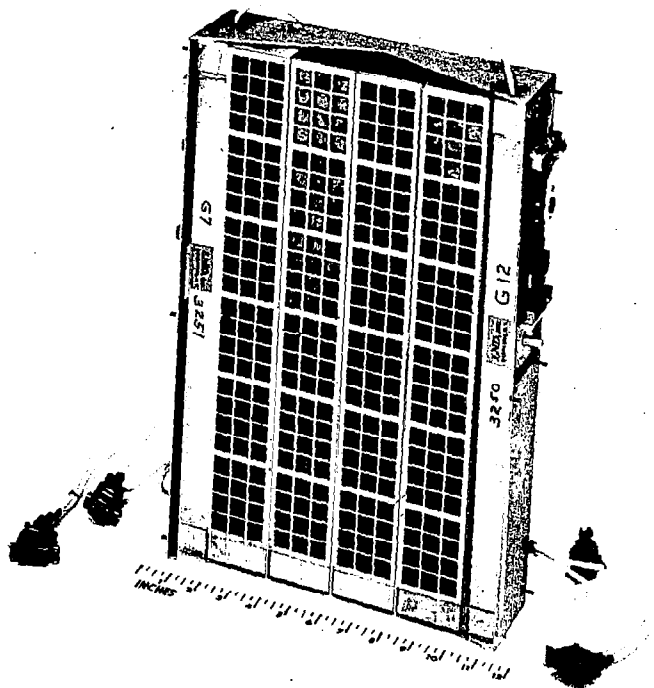
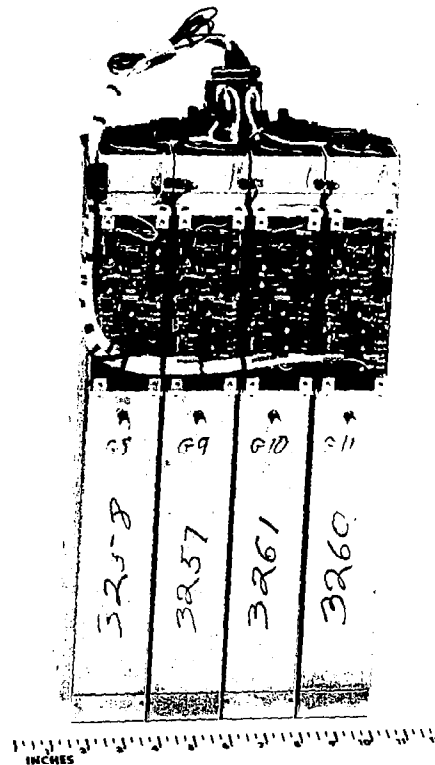
Two types of proportional counters were used on this flight. Of the twenty counters flown, eight had 2 mil Beryllium windows and 12 had no windows. The Beryllium window (active) counters were filled with P10 (90% Argon and 10% Methane) and had overall dimensions 16" x 2" x 2" with an effective window area of 14.81 x 1.75". The windowless (guard) counters were filled with Xenon and had overall dimensions of 16" x 2" x 1". The counters were set up in two banks with 4 active counters in front, enclosed by 6 guard counters on 3 sides in each bank. Figure 2 shows the layout of an active counter bank with a guard counter on each side. Figure 2 also shows the layout of the remaining guard counters which are mounted directly behind the active counters. Location of the preamp for each proportional counter can also be seen.

FRONT COUNTER ASSEMBLY

BACK COUNTER ASSEMBLY

PROPORTIONAL COUNTER ASSEMBLIES

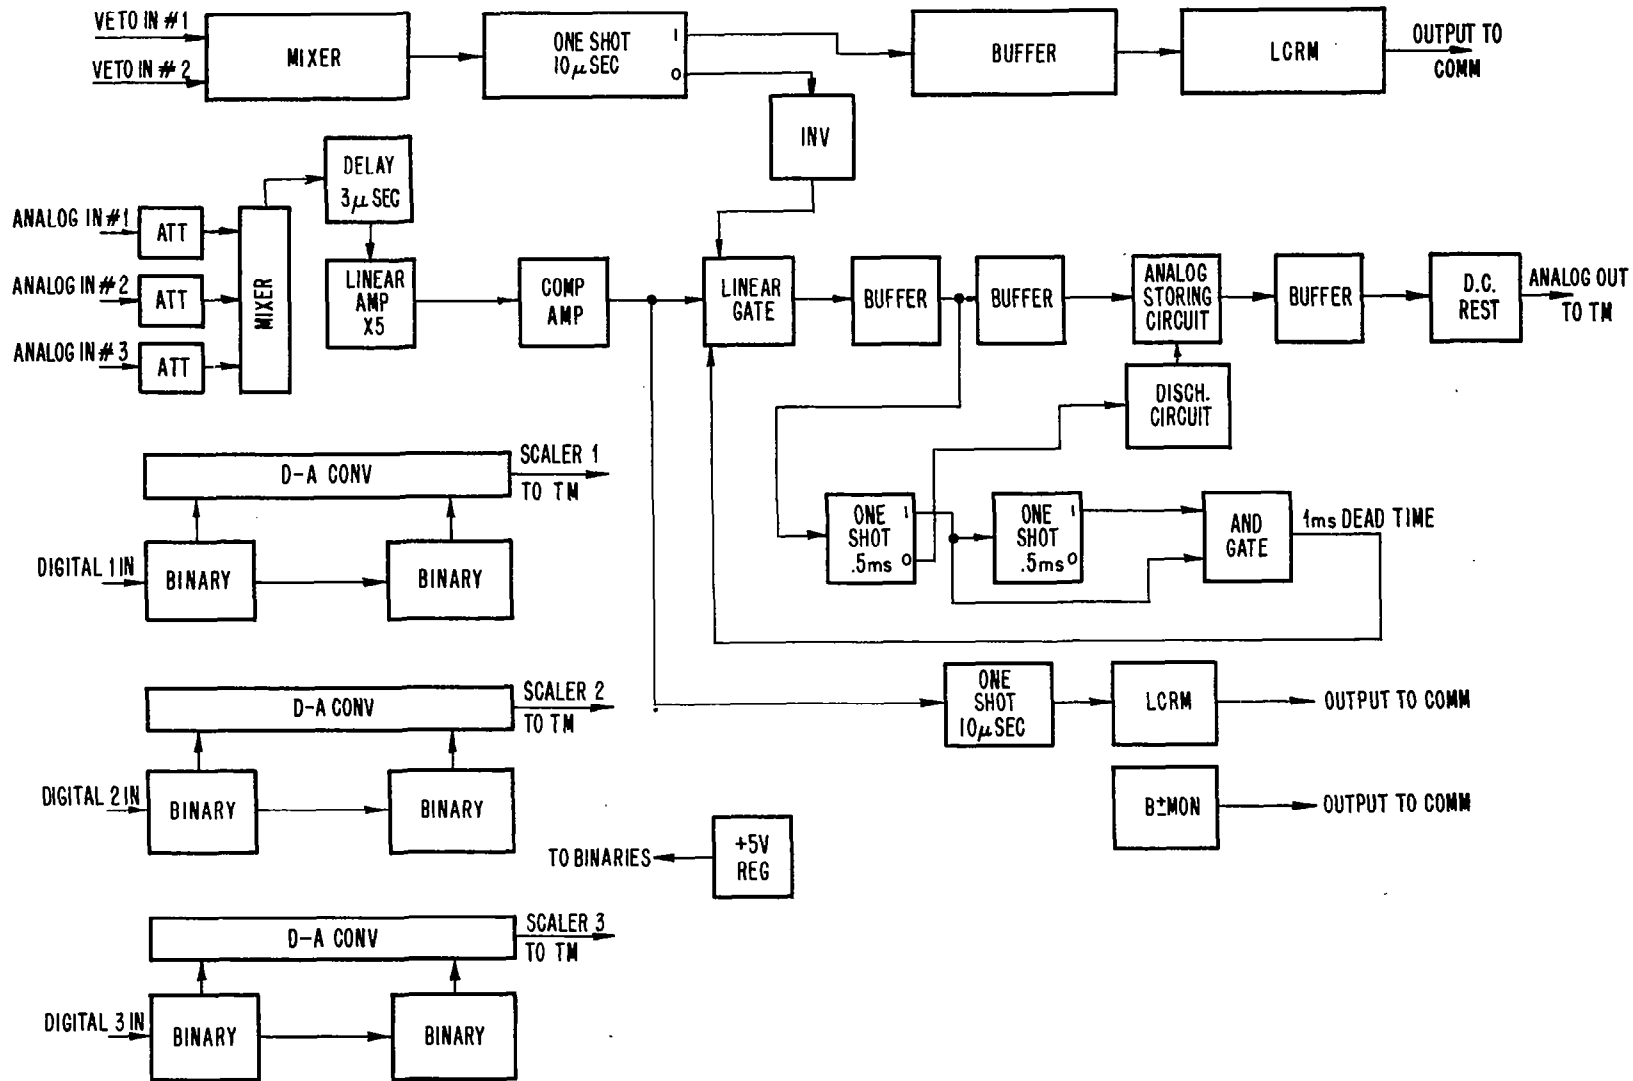
Figure 3

The layout of the TM information was such that the PHAb consisted of counters 2 and 4 on the top and PHAc consisted of counters 5 and 7 on the bottom bank on transmitter #1. Transmitter #2 had PHAa which was fed by counters 1 and 3 on the top and PHAd which was fed by counters 6 and 8

PROPORTIONAL COUNTER LOGIC

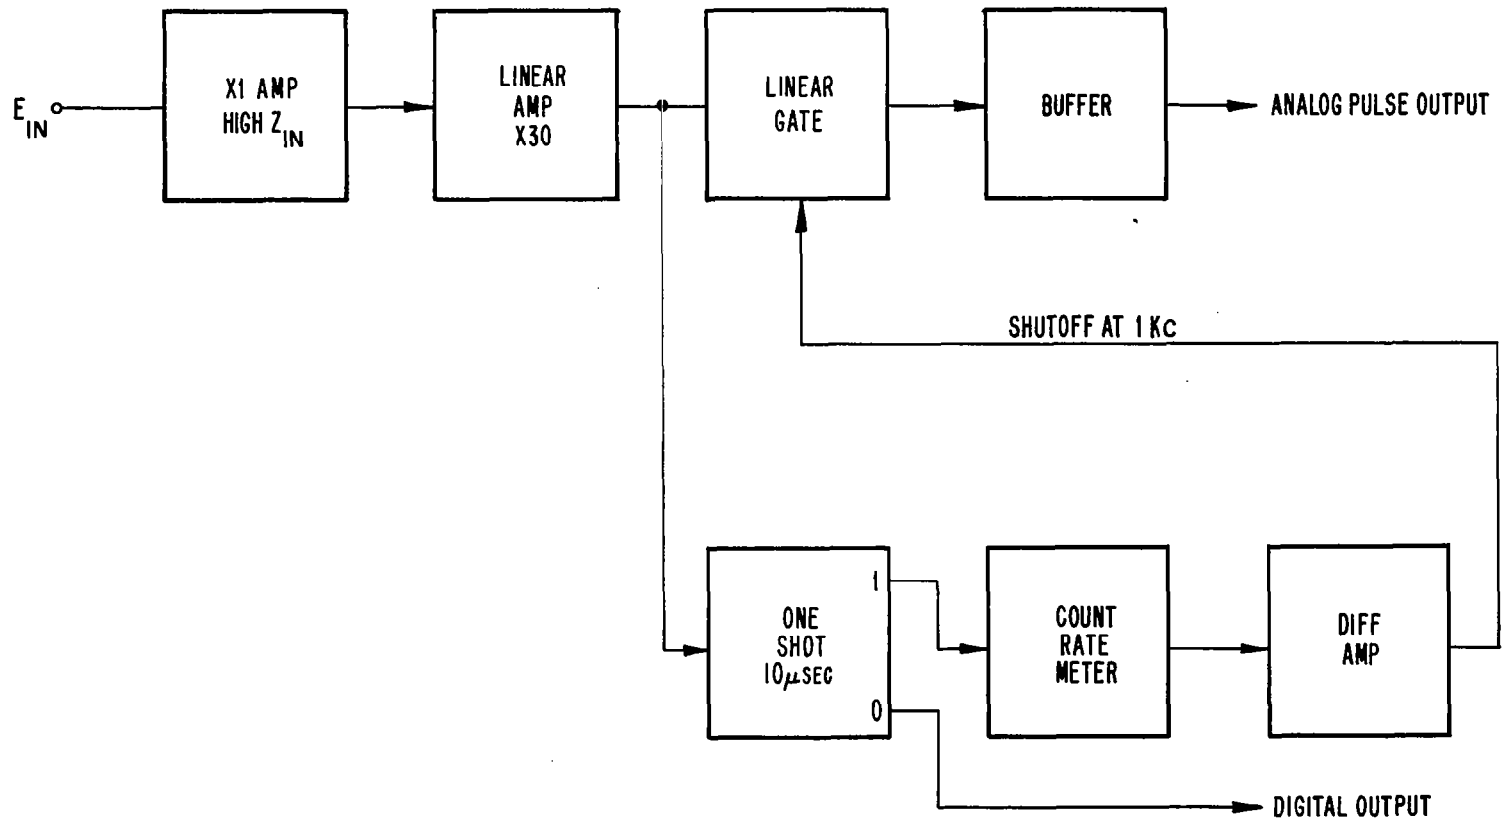
Any cosmic ray event which was able to penetrate the active counters and reach the guard counters would produce a veto signal which would block out the corresponding signals generated in the active counters. A 3M's delay line was added to the logic circuitry to compensate for any delays which might occur in the development of the veto signal in the guard counters. Figure 3 is a block diagram of the proportional counter logic used. Digital information was supplied by each active counter and two active counters were combined for the pulse height information. Two scalers, one pulse height analog channel and two log count rate meter outputs were supplied by each of four separate logic circuits. Figure 4 is a block diagram of the preamp circuit used for each of the counters.

PROPORTIONAL COUNTER PREAMP

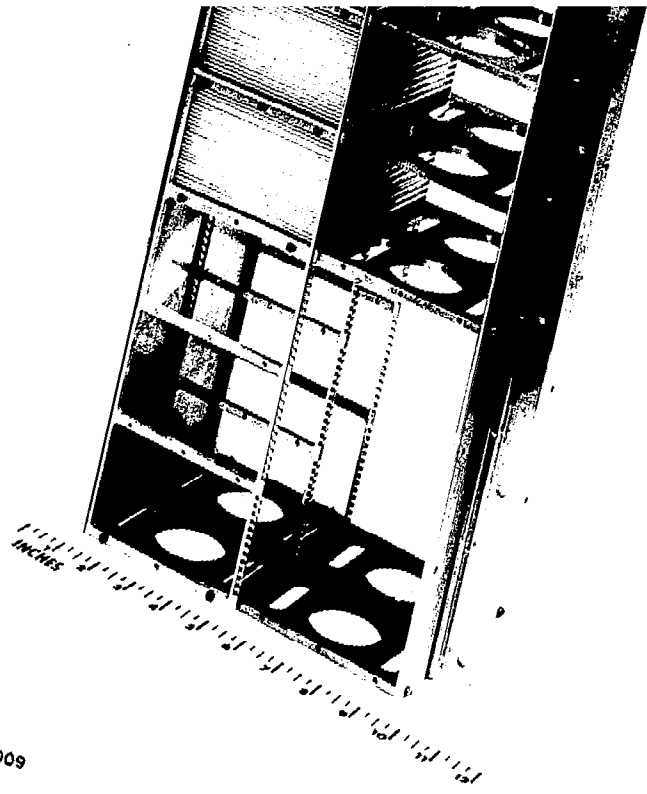
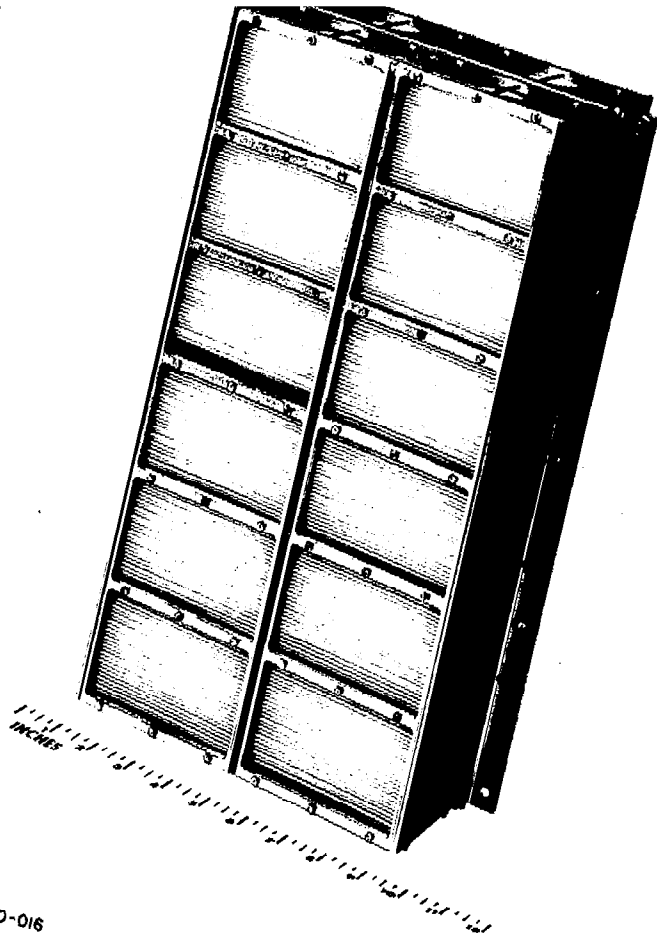
Figure 5
10

Two slat-type collimators, one in front of each bank of counters, were used to limit the acceptance directions of the X-rays. The overall dimension of each collimator bank was 15" x 8-1/2" x 5-1/2". The slats were .002" thick latex rubber, 2-1/2" long. The latex rubber was circular and stretched across 2 rods, 4" apart. Spacing between slats was .086". Slats were mounted 2 deep with the field of view perpendicular to the thrust axis. There were a total of 312 slats per collimator. Figure 5 shows a partially and fully assembled collimator. Figure 6 shows the sides of the completely assembled payload and Figure 7 shows the location of some of the subassemblies.

PARTIAL BANK ASSEMBLY

FULL BANK ASSEMBLY

SLAT TYPE COLLIMATOR

The X-ray collimator consisted of a series of slats measuring .087" by 5" x 4" (2 adjoining 2-1/2" x 2-1/2"). It was constructed of 2 mil latex rubber. The resultant field of view was $1^{\circ} \times 19^{\circ}$ (full width at half maximum). Transmission of a large area collimated beam of X-rays through the collimator as a function of the angle between the X-ray beam and the collimator is shown in Figure 10. An addition to the central maximum two side lobes are seen. These result from a slight gap between the two 2-1/2" slats of the 5" sides. While this effect was not desired, it represents less than 10% of the maximum flux transmitted and is not a major source of difficulty.

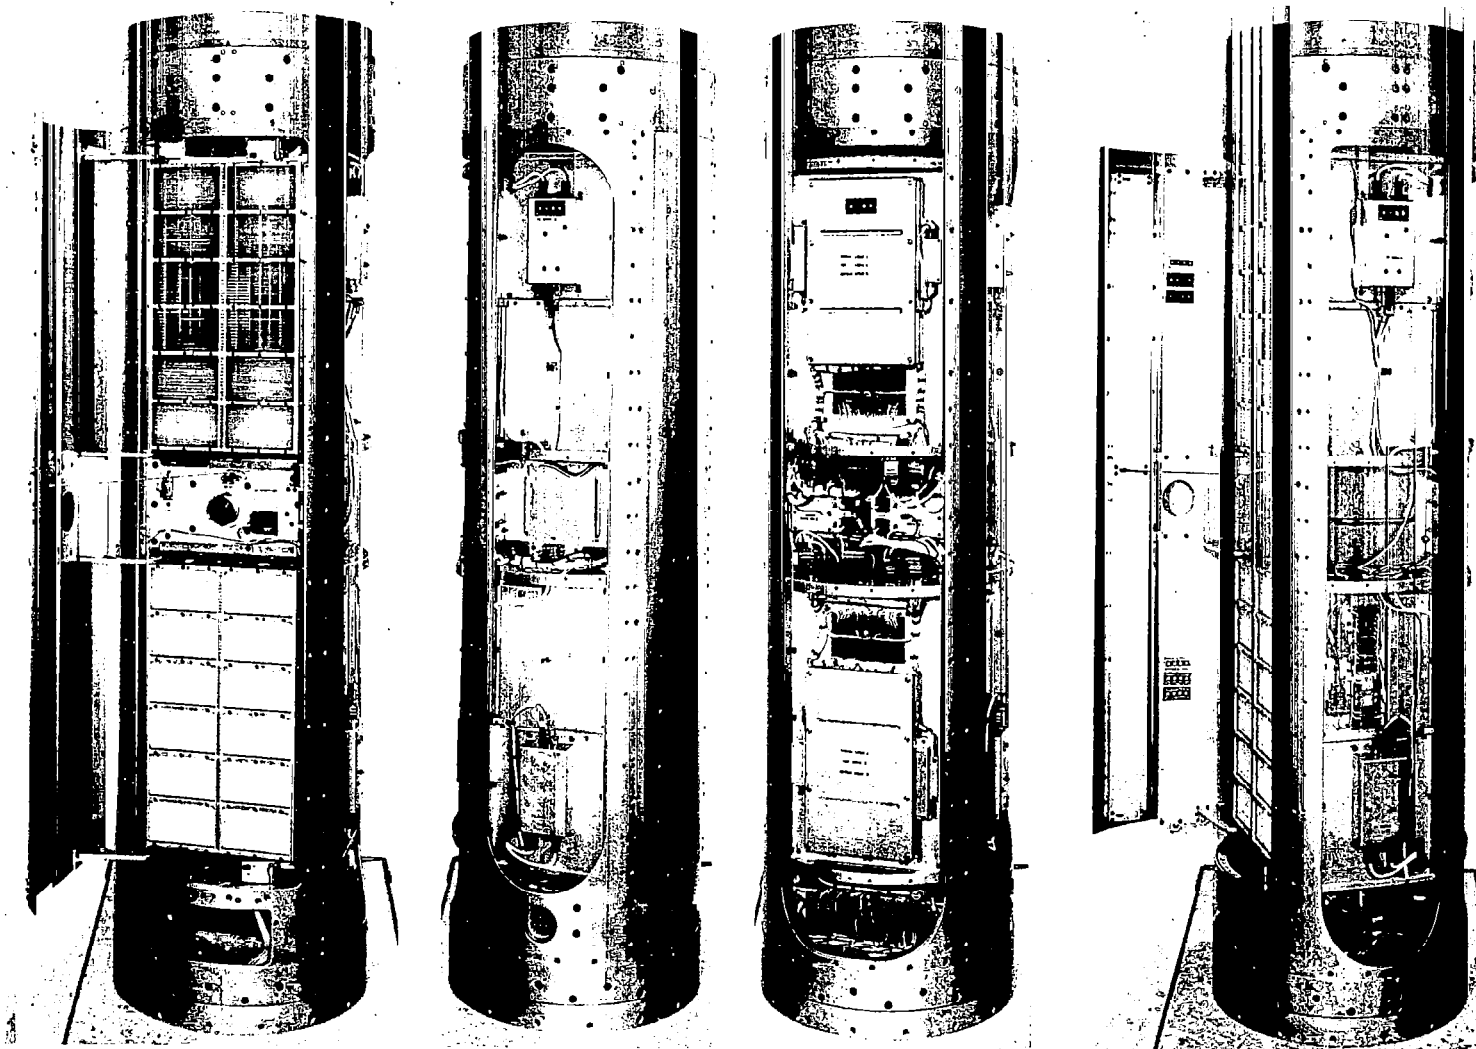
Figure 6

VIEWS OF ASSEMBLED PAYLOAD

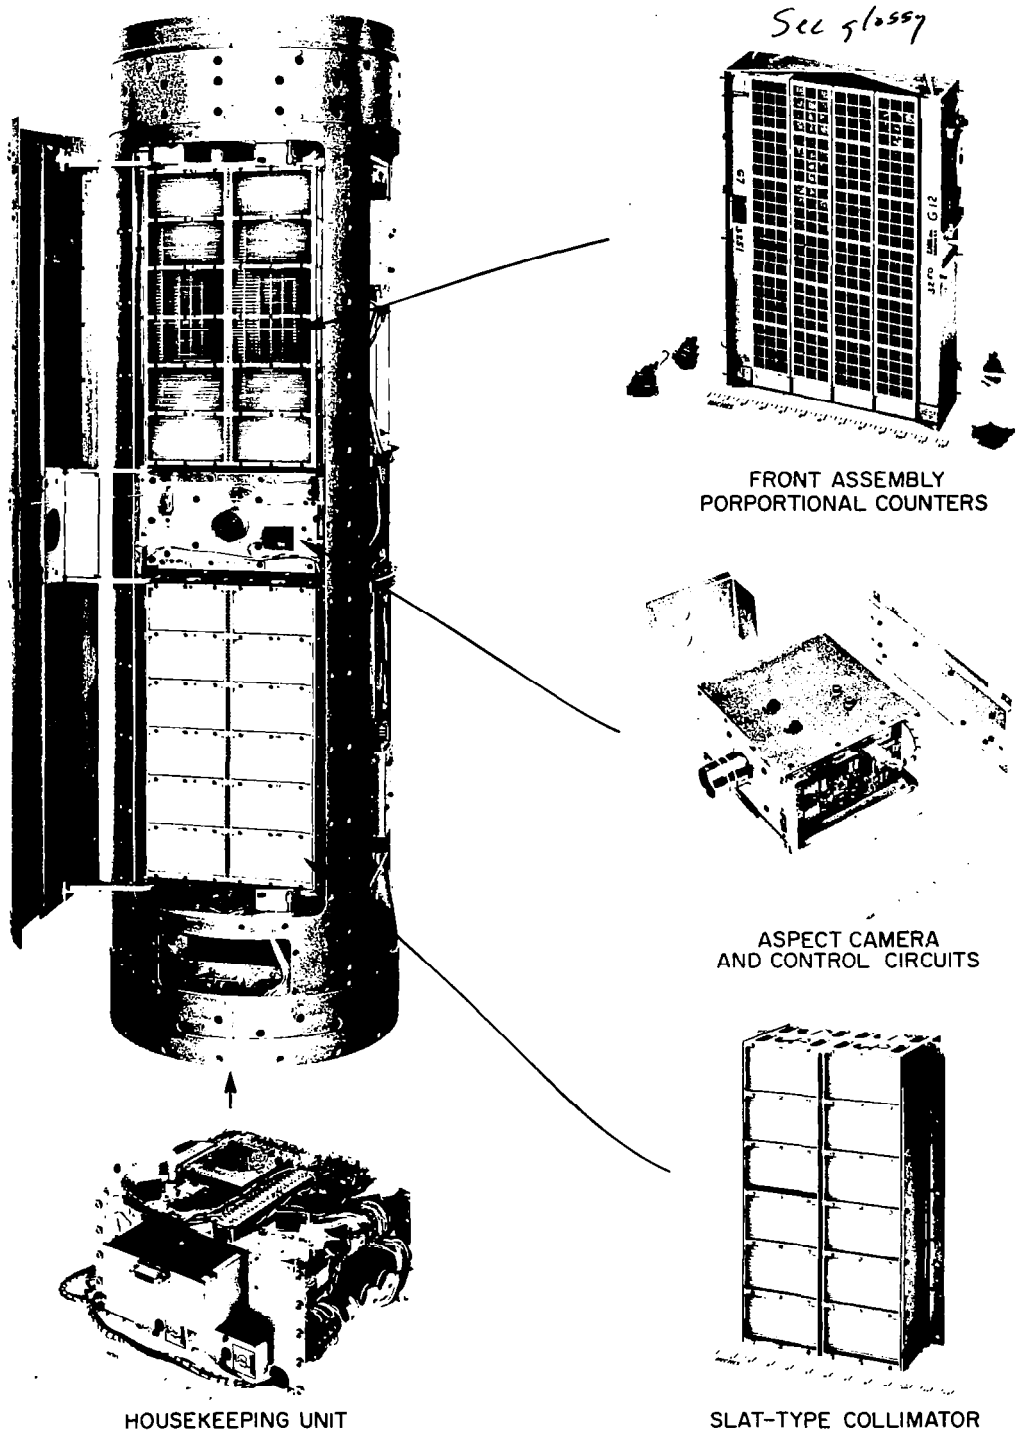
Figure 7

ASSEMBLED PAYLOAD

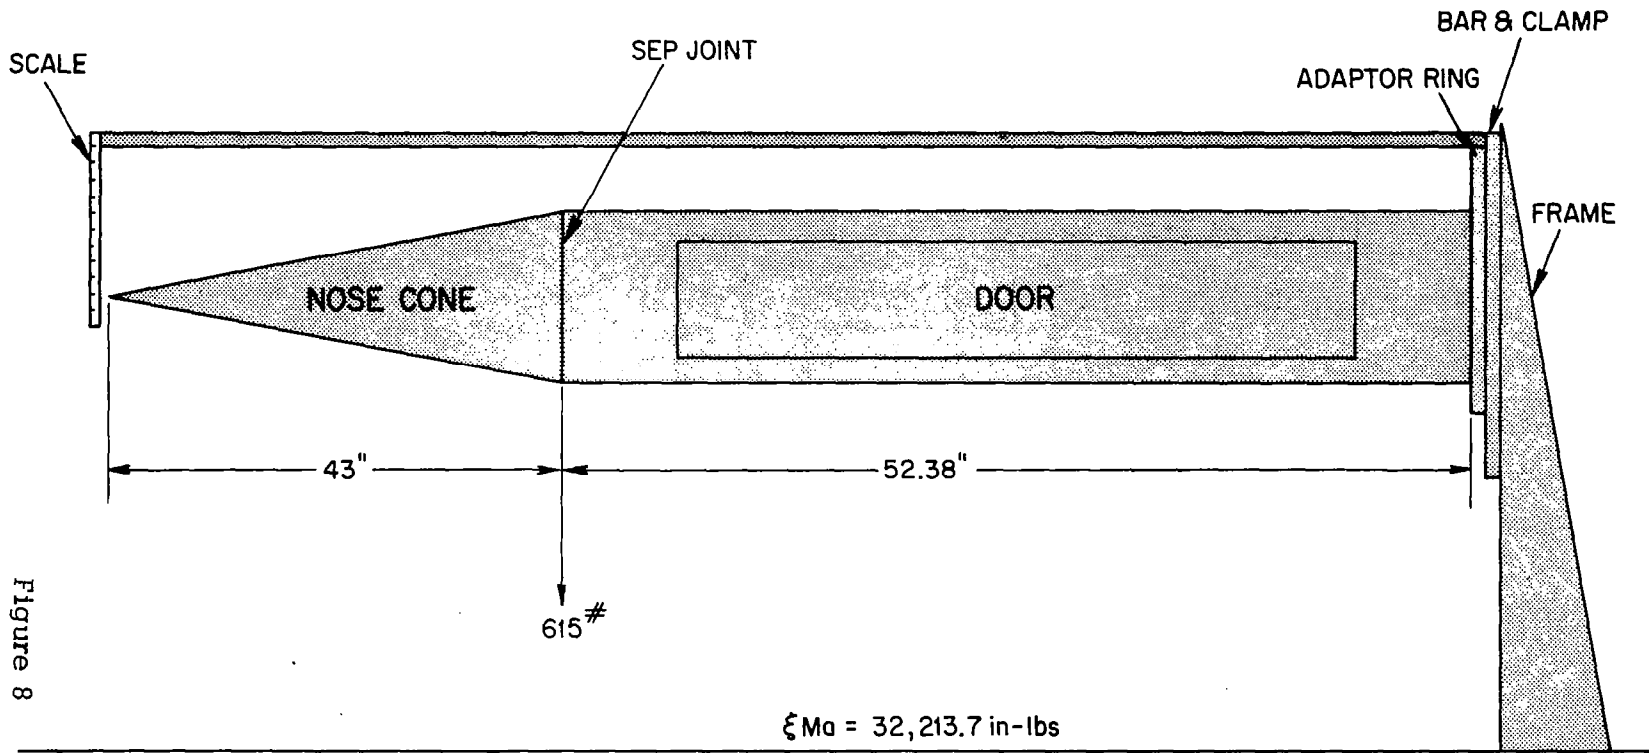
Figure 8
21

At the request of NASA/GSFC a static load test was performed at AS&E after return from the integration tests. The test was run with the load as shown in Figure 8. Total deflection was .118 in. Permanent set, if any, was less than .02 in. Figure 9 shows the static load test

4.149 CG NASA AEROBEE LOAD TEST

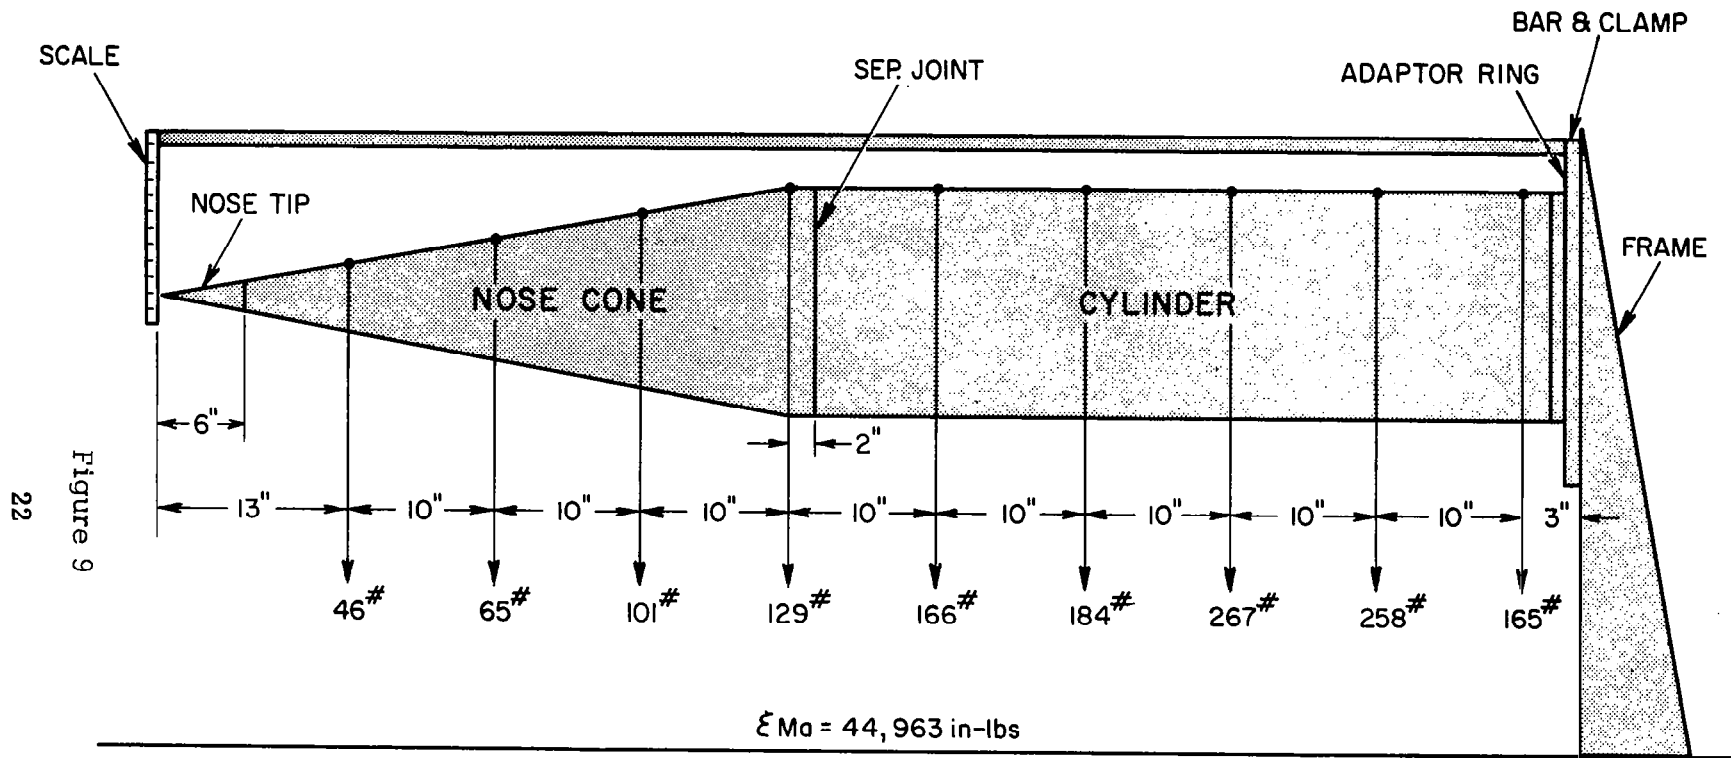
4.148 CG NASA ROCKET BENDING MOMENT TEST

performed on this same cylinder prior to flight of 4.148 CG. Deflection and permanent set were well within prescribed limits.

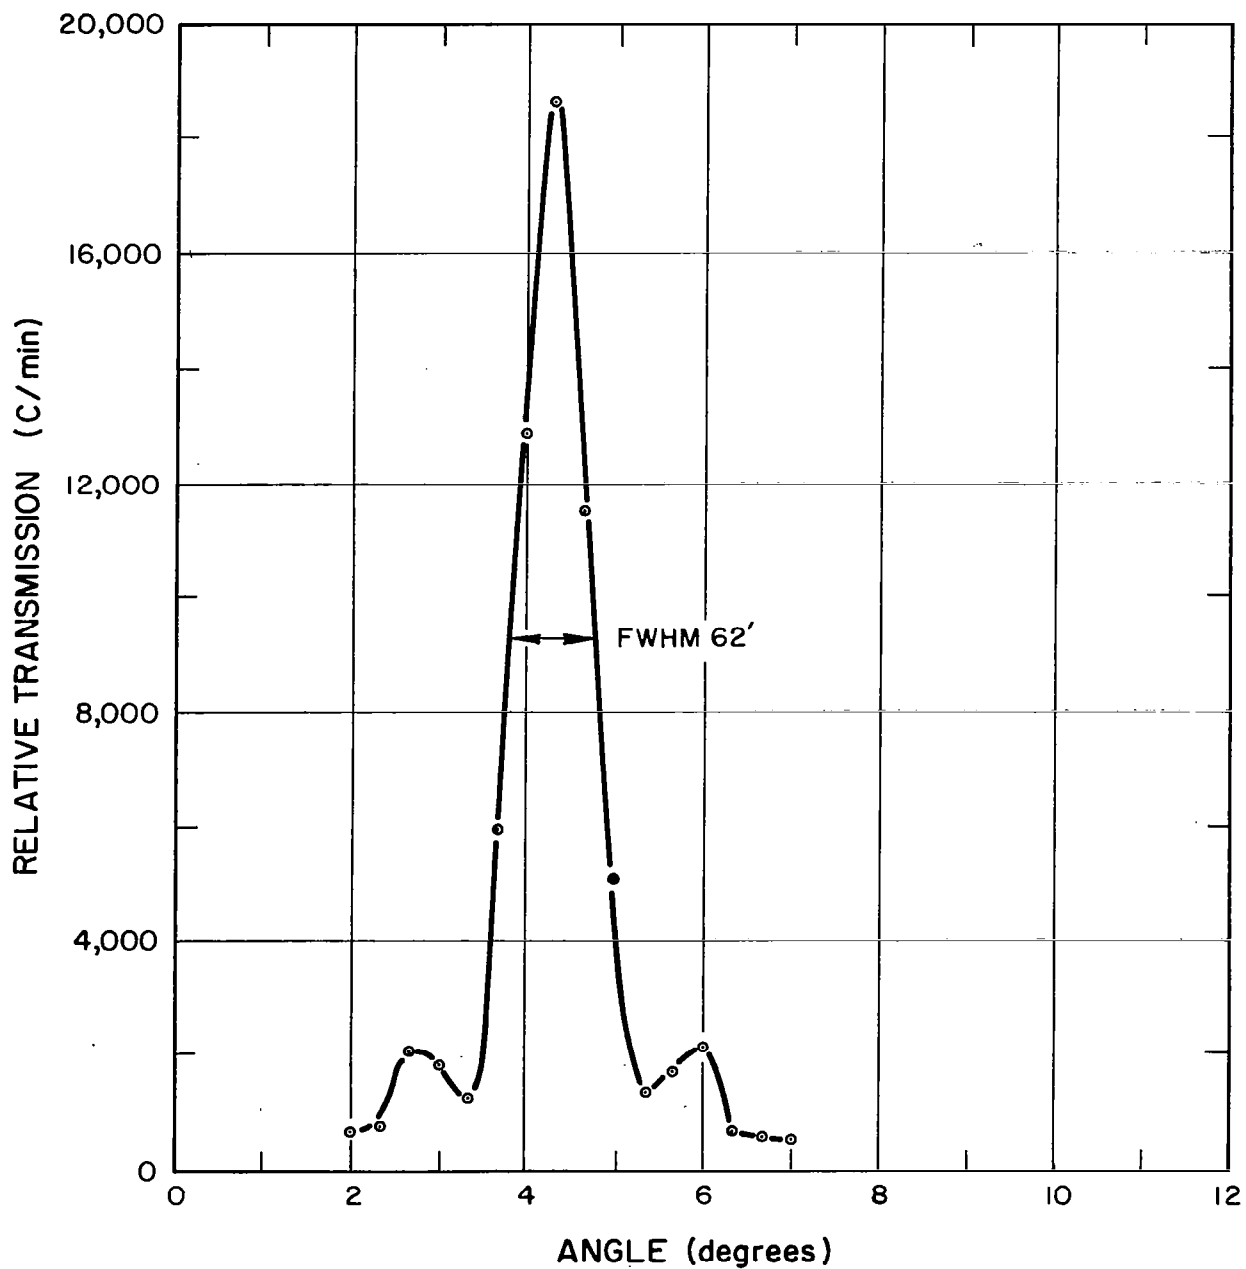
Figure 10

RESPONSE OF COLLIMATOR TO COLLIMATED X-RAY BEAM

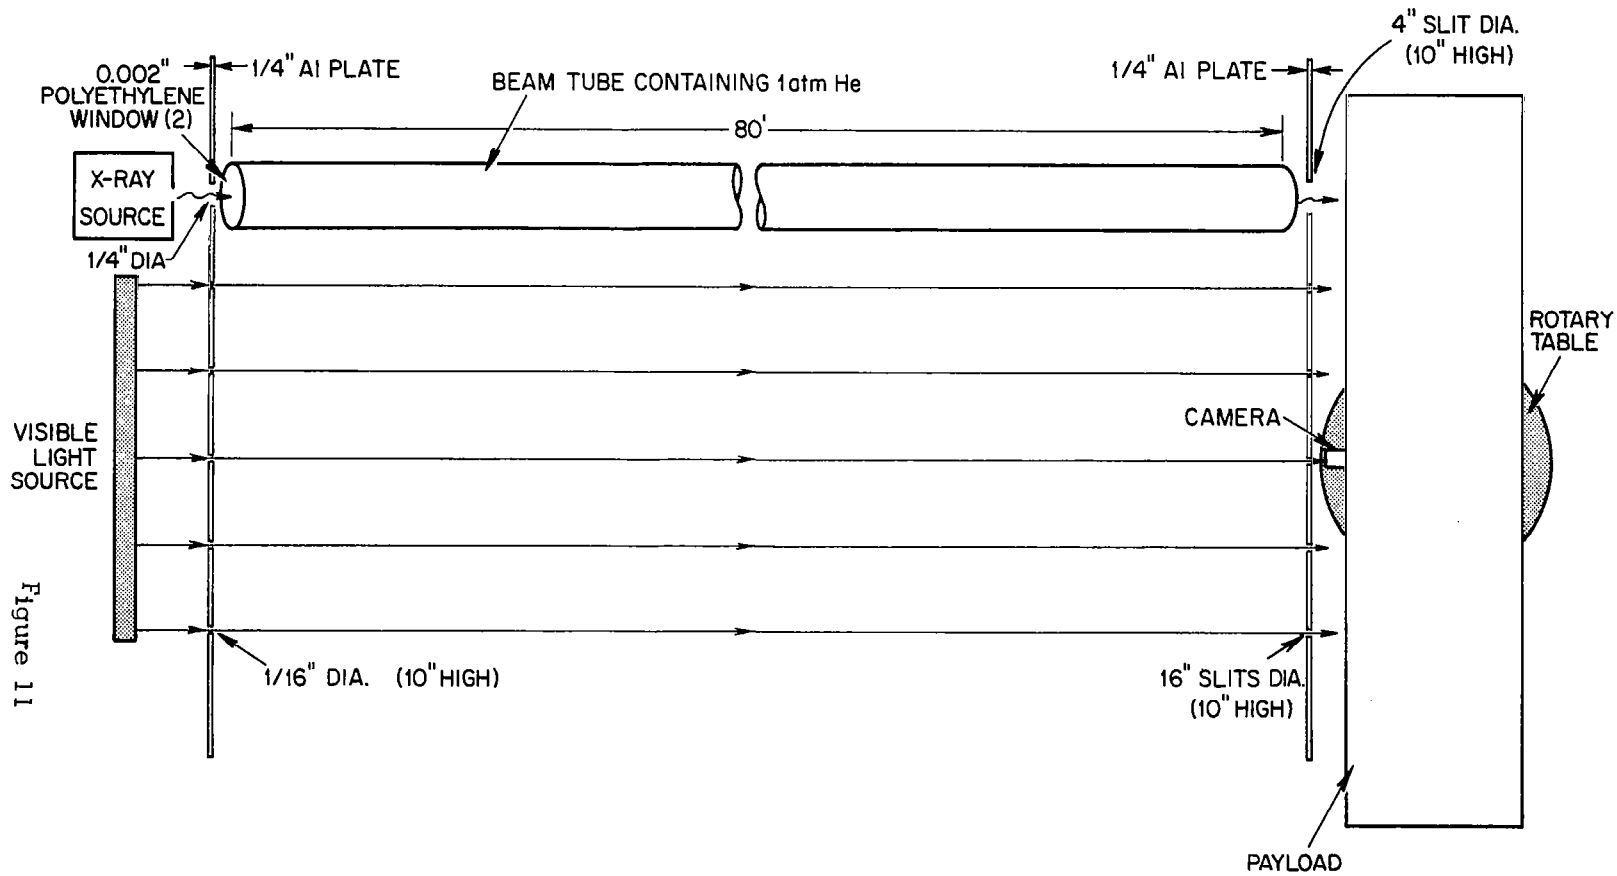
Figure 11

MEASUREMENT OF CAMERA-COLLIMATOR ALIGNMENT

Collimator plate #1 consisted of a series of holes ($1/4$ " dia for X-ray, $1/16$ " dia for visible light), spaced 3" apart. Collimator plate #2 was a series of slits 10" high whose spacing matched that of plate #1. It contained a 4" opening for the X-rays and several $1/16$ " openings for the light.

The X-ray and light sources were removed 80' from the payload. Consequently, the X-ray beam was collimated to 17 arc min. by the 4" opening and the light beams were collimated to less than $1/2$ arc min. Several passes were needed to sample the entire 32" of collimator length. As the low energy X-ray flux would be utterly attenuated by 80' of air, a beam tube containing 1 atmosphere of helium was used between the plates as the means of transmitting the X-rays.

The rigidity of the payload was such that the alignment of the aspect camera and X-ray collimator would be maintained throughout the launch and duration of the flight. However, it was essential to measure the alignment of these two in the laboratory prior to flight. By knowing the alignment, the location of an X-ray source could be determined from the observance of a counting rate peak at a certain time and the aspect photographs. This was achieved by setting up an "X-ray" star in the laboratory. Several light beams and an X-ray beam were made parallel to each other by collimating each through the same two rigid plates. The entire payload was set upon a rotary table with both the aspect camera and X-ray detectors in operation, as shown in Figure 11. The payload is positioned such that the camera views one of the light beams. As the rotary table is turned, a maximum is observed in the counting rate. At exactly that point a photograph is taken. Inspection of the photograph reveals where on the photograph the X-ray star will appear. The camera registration was sufficiently precise, such that the sprocket holes of the

film could be used as a reference. This technique enabled us to establish the alignment to within about 2 arc minutes.

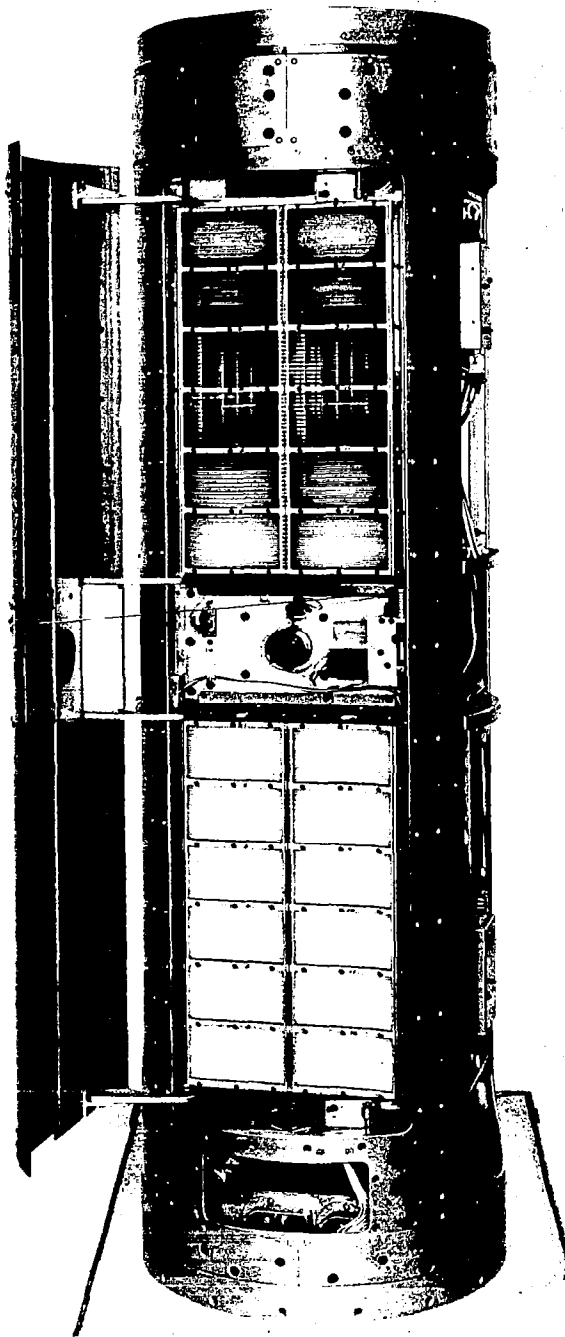
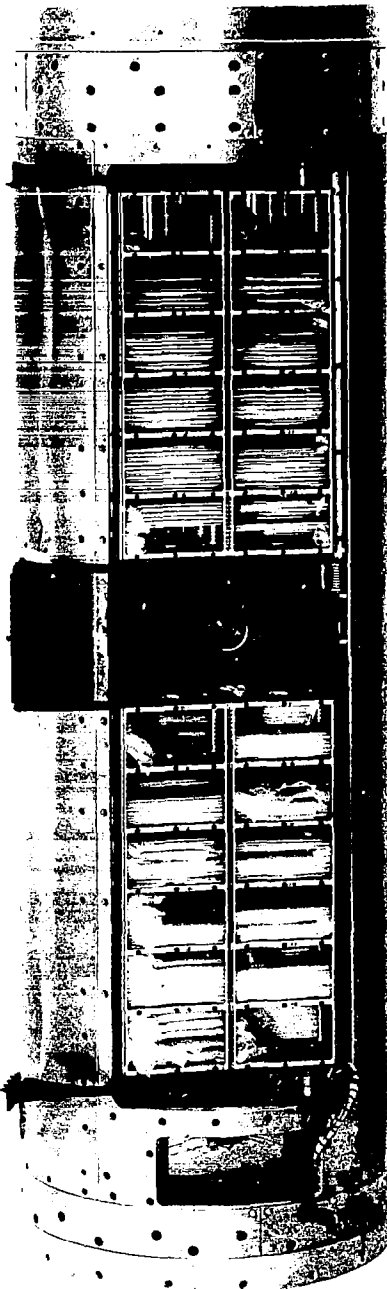
1. The door had been ripped off.
2. The 6" nose tip had been broken off.
3. A number of severe dents, in the nose cone, the top support ring, and on the panels.

Immediate conclusions were that the door might not have closed and was ripped off. However, after further investigations, examination of the flight film, and tests at AS&E, conclusions point to the fact that the door did close but was later ripped off, due to lifting at the upper

and lower door corners and pulling the support cable off the reel. Figure 12 shows a picture of the recovered payload and the payload prior to leaving AS&E. The black areas on the camera and hinges on the recovered payload were painted prior to launch to eliminate light reflections.

AEROBEE PAYLOAD FOR X-RAY OBSERVATIONS FLOWN ON VEHICLE 4.149, Oct. 1966

BEFORE FLIGHT

AFTER FLIGHT

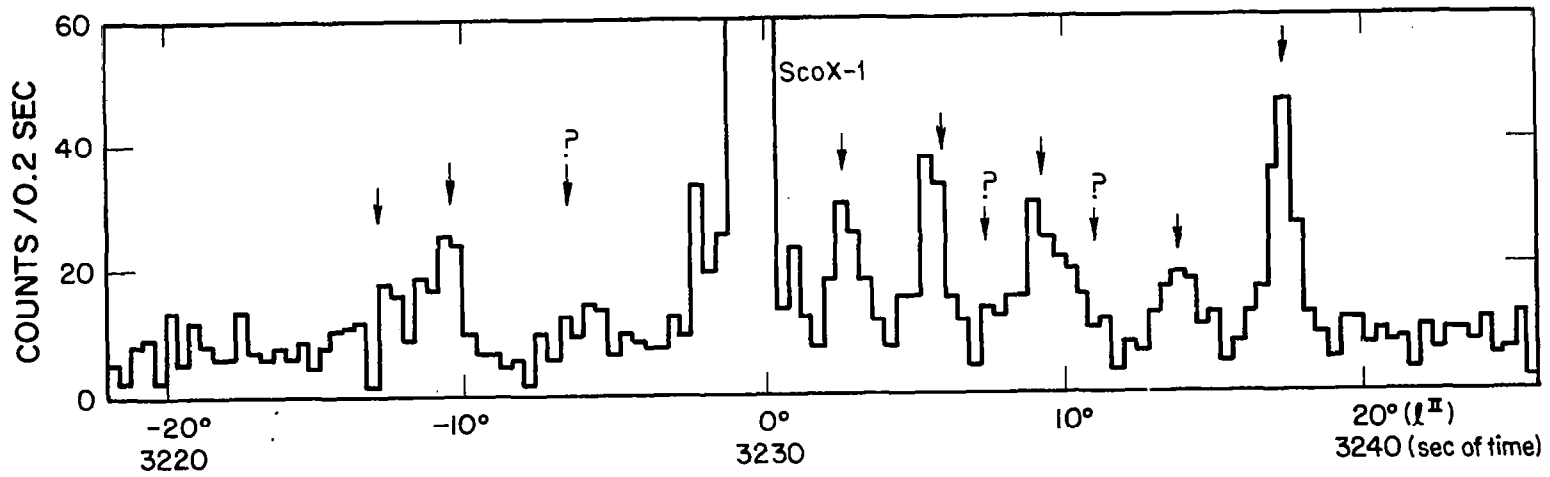
31
Figure 13

A portion of the telemetry data is shown in Figure 13. Several peaks above background are evident corresponding to celestial X-ray sources. Two aspect photographs of the target areas are shown in Figure 14. The first of these is of the stars of the galactic center region; the second of some of the stars in the constellation of Cygnus.

DISTRIBUTION OF COUNTS ALONG GALACTIC EQUATOR
