NASA CONTRACTOR
REPORT

LUNAR ORBITER III

PHOTOGRAPHY

THE BOEING COMPANY

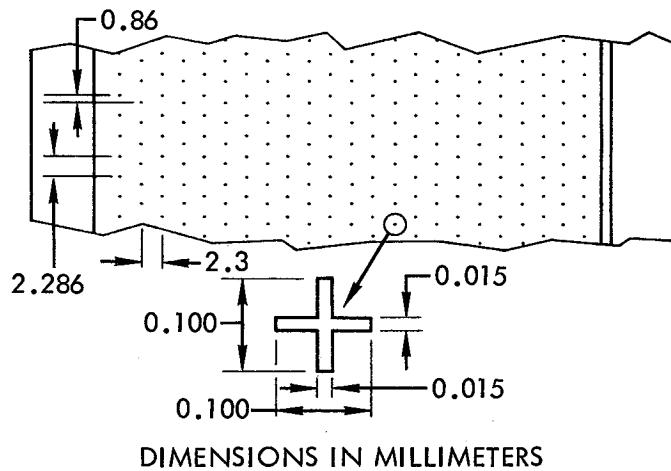
Figure 1-1: Pre-exposed Reseau Mark Placement and Detail of Cross

A pre-exposed pattern of reseau marks was placed on the spacecraft film for Mission II to provide a means for determination and correction of image distortions introduced by the system subsequent to the optical imaging on the spacecraft film. The pattern of the reseau marks was changed for Mission III to provide a closer pattern to improve measurement capability. The pattern used for Mission III is illustrated in Figure 1-1. The placement ensures that two lines of reseau marks will appear along the length of each framelet.

It will also be noted that the width of the lines forming the cross (0.015 mm on the spacecraft film) is equivalent to approximately 1.5 meters on the ground in telephoto pictures where the distance from the camera is about

graphs. The reseau pattern used for Mission III is illustrated in Figure 1-1. The newer pattern, having 23 marks arranged in two lines per framelet instead of a single nine-mark pattern used on Mission II, provides a means for more detailed and more reliable distortion detection and correction.

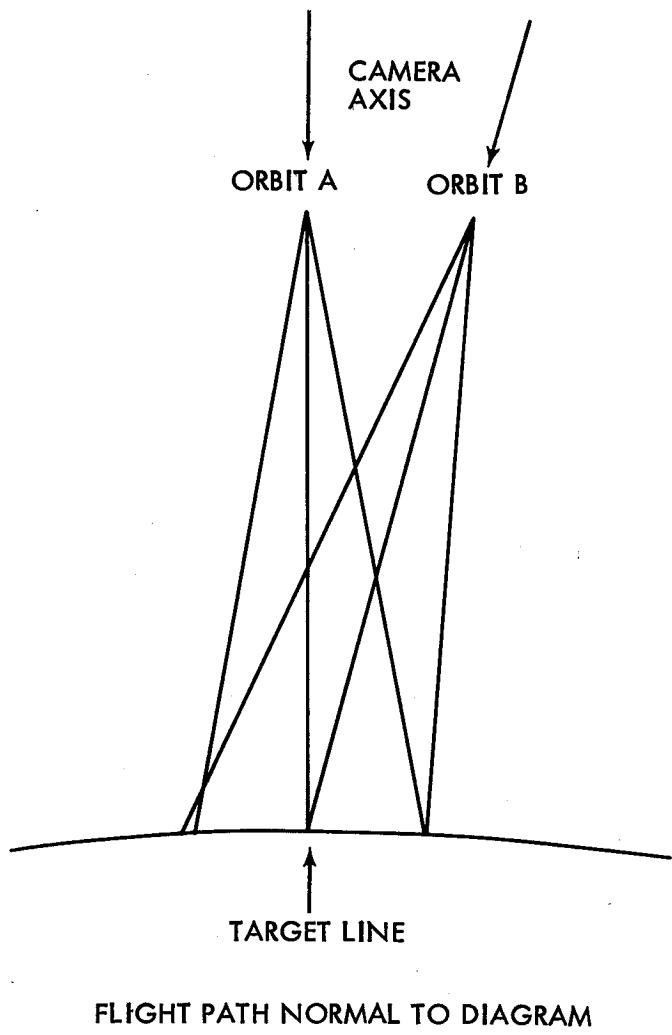
Figure 3-1: Camera Orientation for Convergent Telephoto Stereo

Because of the success of the above experiment, six of the 12 primary sites were selected for convergent telephoto stereo coverage. The remaining sites were planned for near-vertical photography or with cross-track tilt of the camera axis required for coverage from the nearest orbit. Where convergent stereo photography was used for a primary site, one sequence of photographs was taken

with the camera axis near vertical to obtain maximum resolution of the area. The camera axis was tilted on the other pass the amount necessary for coincident coverage. This is illustrated in Figure 3-1. While this technique increased the degradation of resolution caused by the greater tilt for one sequence, such resolution penalty was offset by retaining maximum resolution of the area by the near-vertical coverage. This was the general scheme. In practice, the tilt of the two sequences was determined for the location of the desired site center with respect to the two orbital tracks.

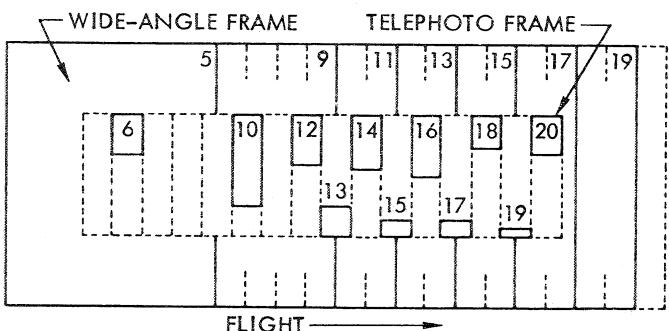
Figure 3-6: Priority Readout of Site IIIP-1

Note: Solid line outlines frames (or portions) read out.
Dashed lines outline frames photographed but not read out.

tions could not be carried out. To provide the basic information on these frames, the data from the site prediction EVAL is shown for Site IIIP-1 in the table of supporting data (Table 4-8). It should be noted that the listed frame corner coordinates are less reliable than for other sites because of the time uncertainty.

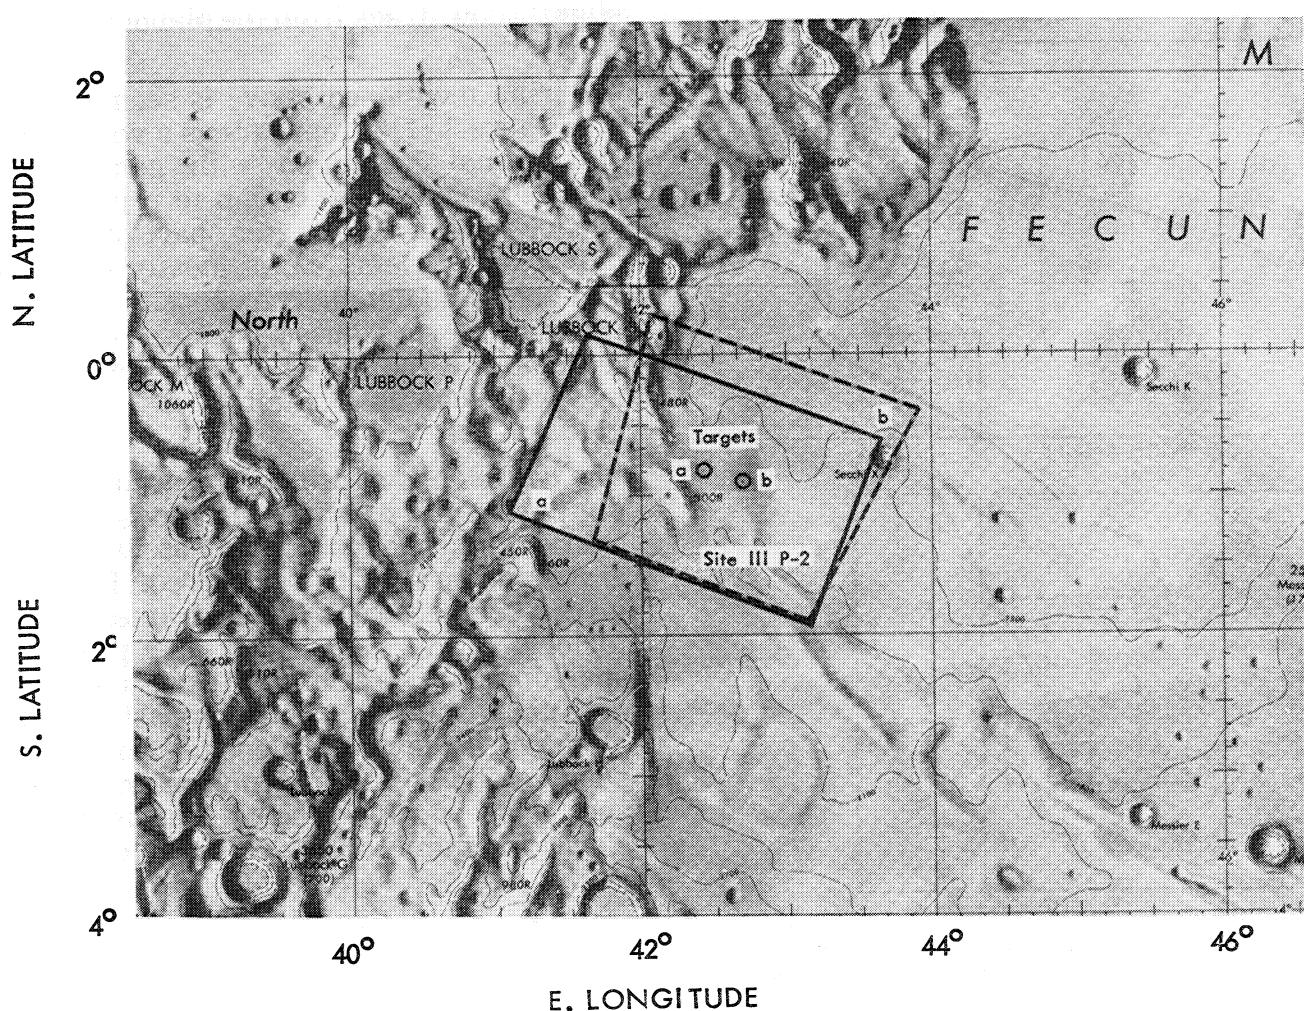
Figure 3-7: Coverage of Site IIIP-2; Inflight Prediction EVAL Computation

Site IIIP-2 is located at the western edge of Mare Fecunditatis and includes a portion of the upland terrain separating Mare Fecunditatis and Mare Tranquillitatis. The site lies almost entirely within the area of Mission I Site I-1.

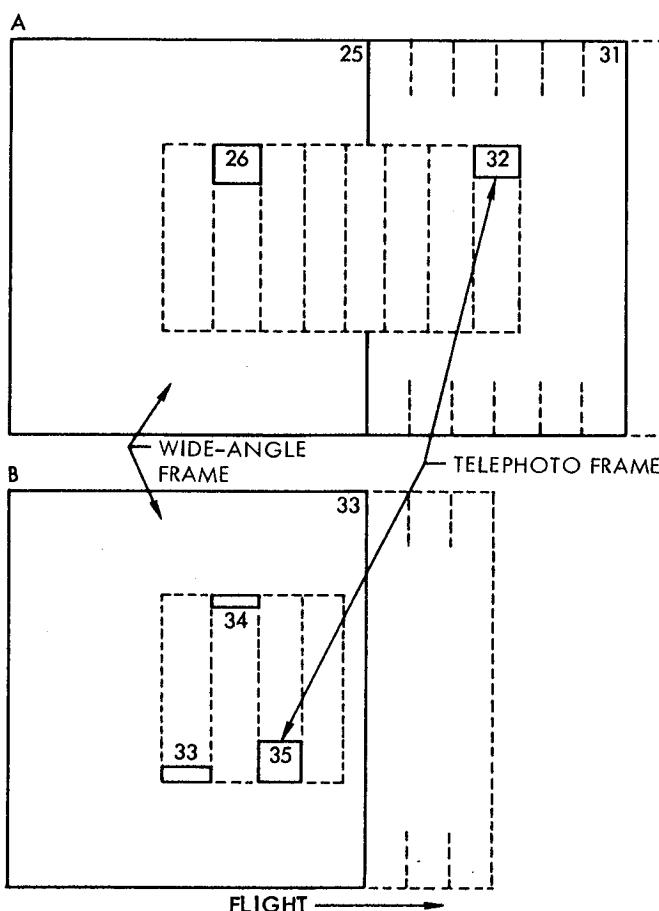
Figure 3-8: Priority Readout of Site IIIP-2

Note: Solid line outlines frames (or portions) readout.
Dashed lines outline frames photographed but not readout.

Evaluation of photography for this site was limited to the relatively small amount of coverage obtained by priority readout. As indicated by Figure 3-8, three of the wide-angle frames and parts of five of the telephoto frames were read out and reconstructed. Examination of these photographs indicates that they are underexposed or slightly underexposed. Despite the denser images, as seen on film positives, craters spanning as few as three scan lines can be detected in the central parts of the wide-angle frames. On-axis resolution for the telephoto frames cannot be established since no center sections were included in the partial readouts received from the spacecraft. Some detail is lost in the end framelets of the telephoto frames because of high image densities.

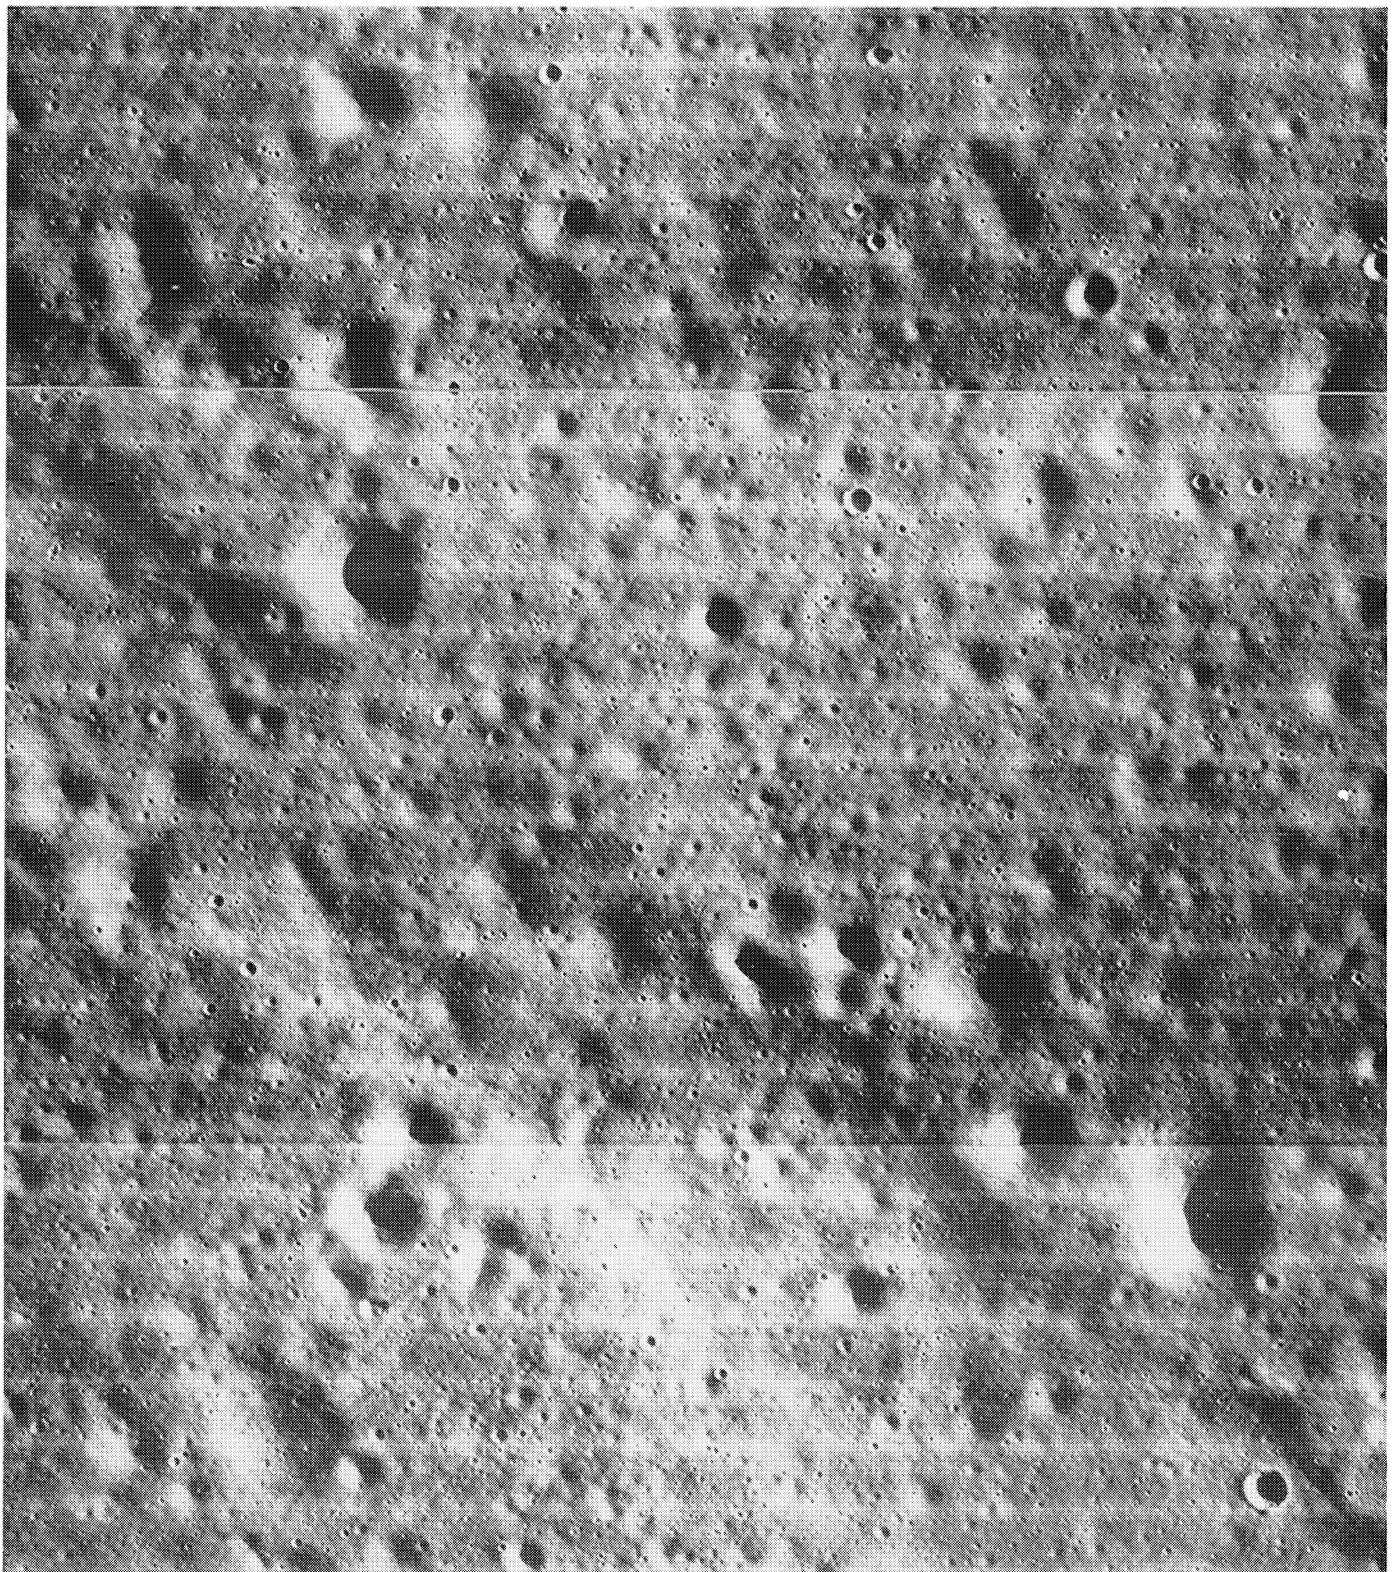
Figure 3-11: Portion of Telephoto Frame 40. Site IIIP-3

The rille mentioned above is seen in Frame 40 (Figure 3-11). It appears as a very shallow longitudinal formation with gentle slopes generally not steep enough to produce hard shadow. The large crater, part of which is included in Frame 42, is mostly in shadow and shows no detail. The opposite sunlit interior is overexposed because of the high luminance. The more nearly level areas, however, show good detail.

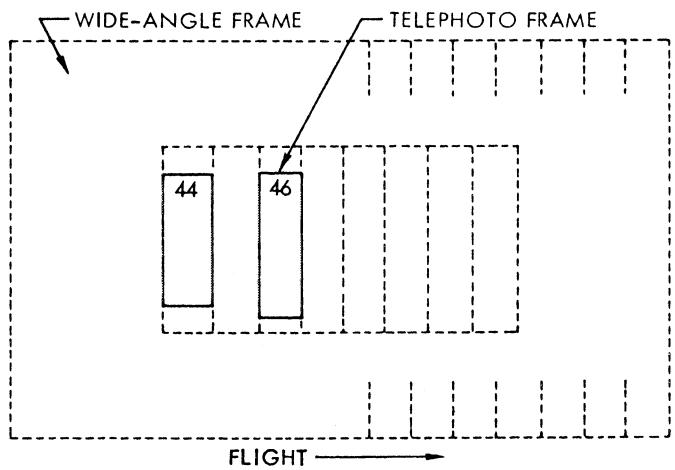
Figure 3-13: Priority Readout of Site IIIP-4

Note: Solid line outlines frames (or portions) readout.
Dashed lines outline frames photographed but not readout.

of eight frames taken in the fast mode with a shutter speed of 0.02 second. These photographs were not included in final readout, thus only those read out in priority mode were recovered. The frames read out are diagrammed in Figure 3-13.

The two partial telephoto frames read out for Site IIIP-4 included the center framelets but not all the end framelets. Priority readout also included one end framelet of Wide-Angle Frame 50. Average luminance for this site appeared to be somewhat less than expected for the conditions existing at the time of photography. As seen on positives, such as GRE film, these photographs have relatively high average image densities, with

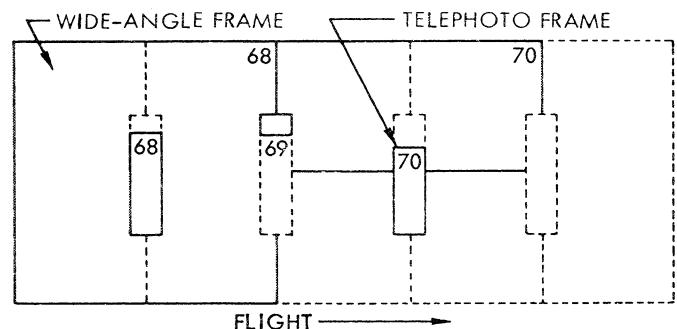
Figure 3-17: Priority Readout of Site IIIP-6

Note: Solid line outlines frames (or portions) readout.
Dashed lines outline frames photographed but not readout.

photographs of the site were read out in the priority mode only, as diagrammed in Figure 3-17.
