RESEARCH AND DEVELOPMENT FOR FABRICATING A BERYLLIUM  
AND BERYLLIUM-TITANIUM COMPOSITE PANEL (Final Report, Vol. II)

Prepared under Contract No. NAS 8-20534 by  
THE BOEING COMPANY

NASA-GEORGE C. MARSHALL SPACE FLIGHT  
Huntsville, Alabama

April 1968

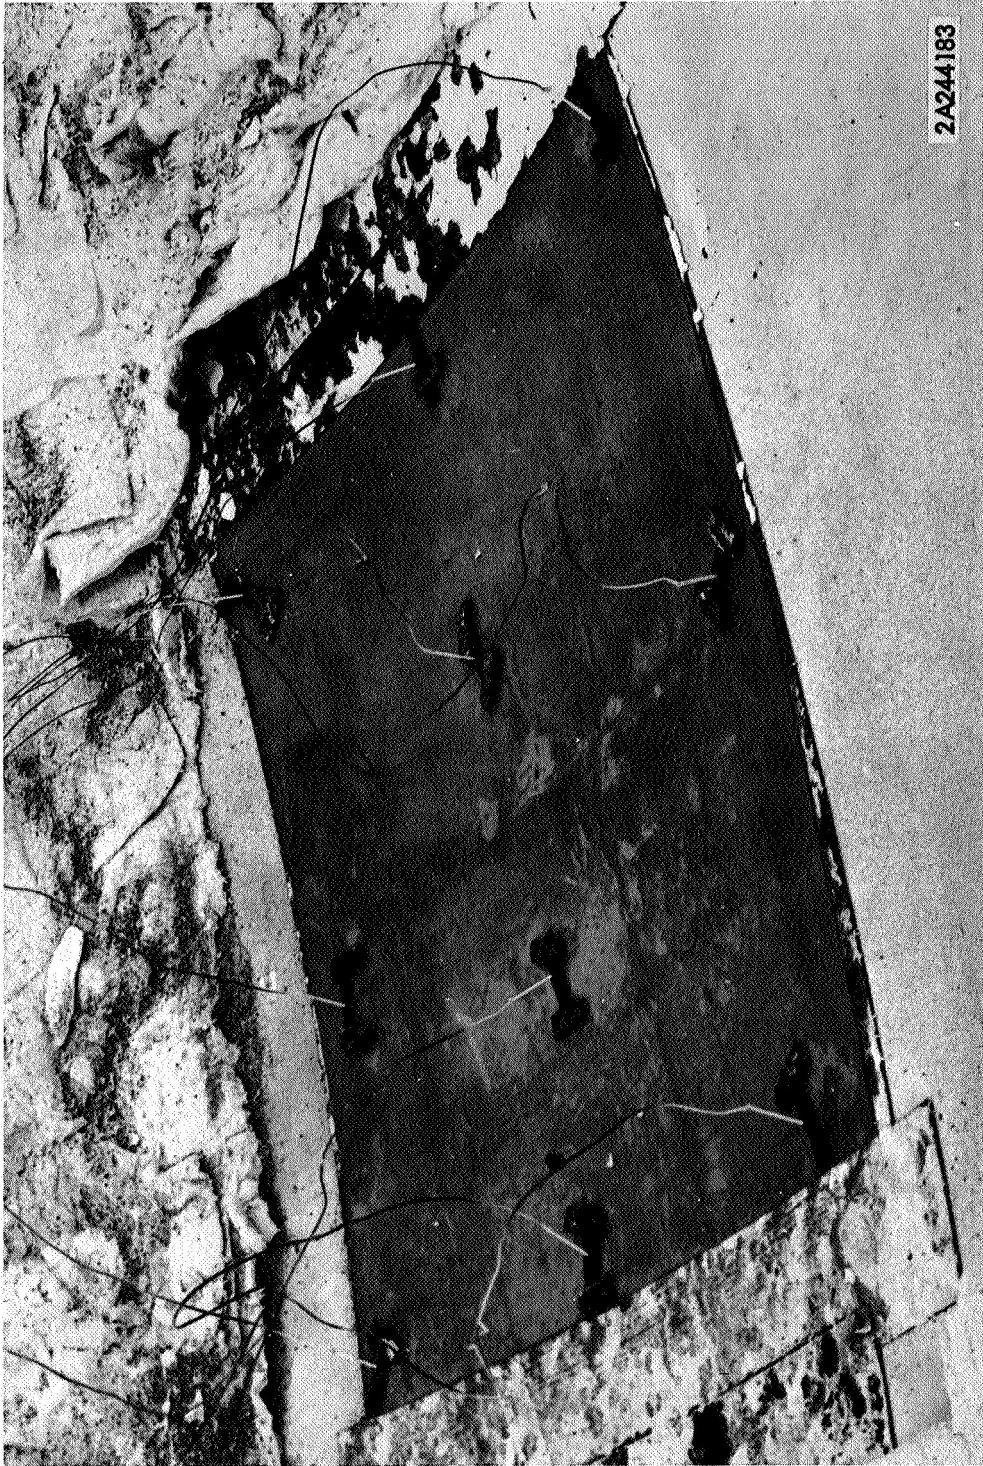
FIGURE 1  
FORMED BERYLLIUM PART IN DIE

The formed beryllium is shown in Figure 1 before removing from the forming die. This view shows the thermocouple locations. The thermocouple readings and the heating cycle are shown graphically in Figure 2.

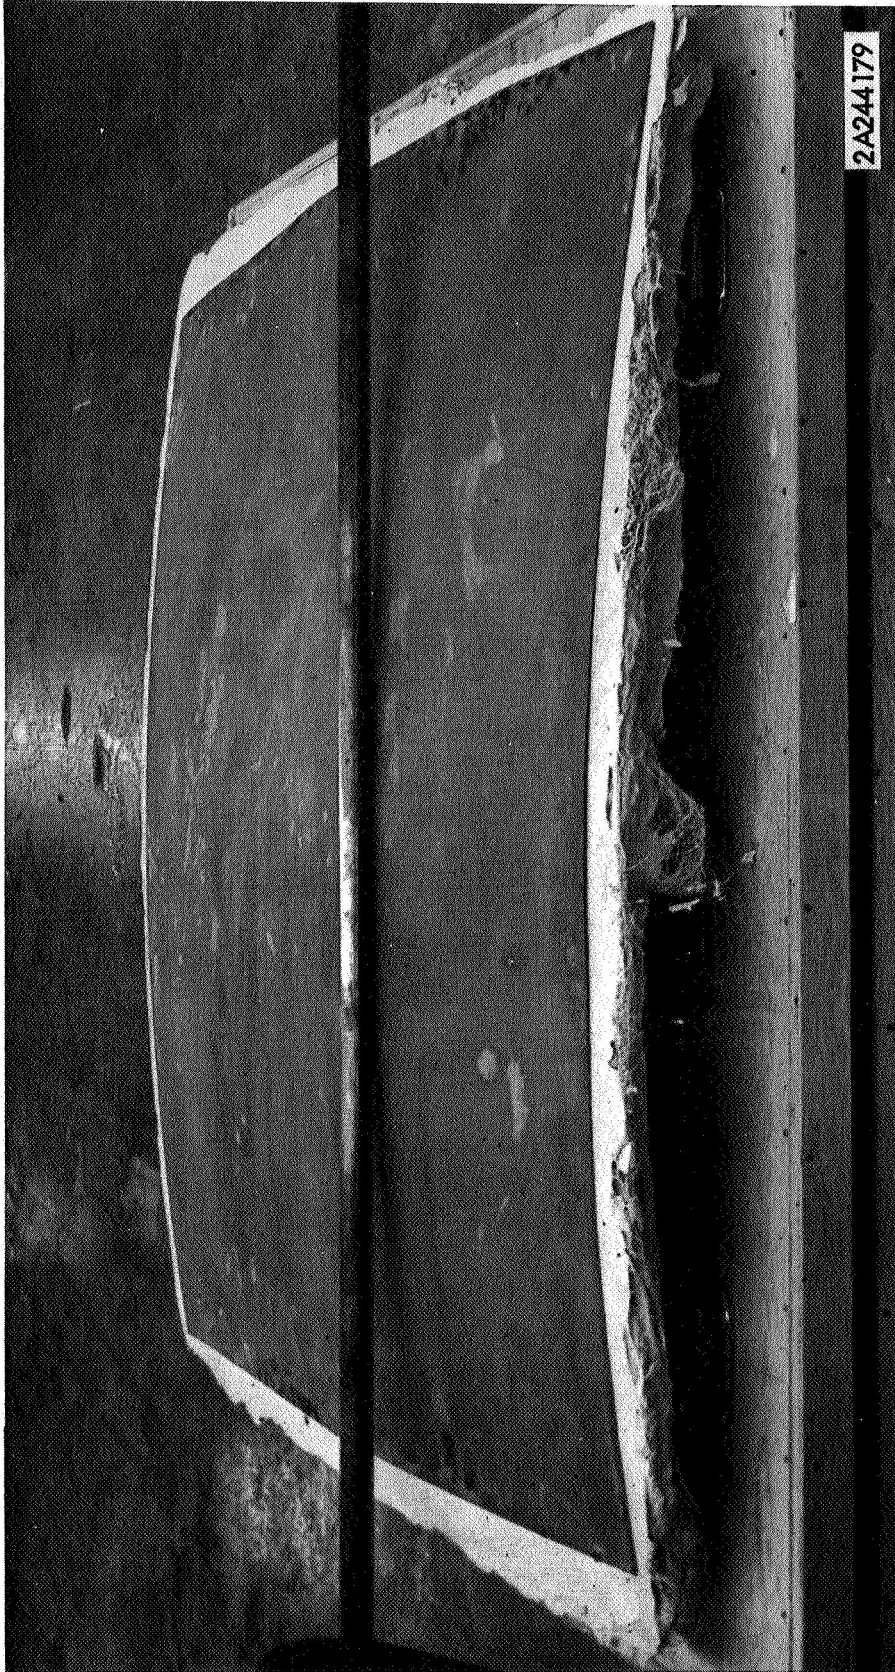
FIGURE 3  
FORMED BERYLLIUM PANEL 0.025 BY 46.0 BY 41.0 INCHES

All targets in the forming cycle were met. Visual inspection showed the part appeared to be net to the die (Figure 3). With the part on the checking fixture the edges were net and the center was raised slightly. From this visual inspection the hot vacuum forming of Y-12 beryllium was most successful.

Inspection verified that after forming the "oil cans" were removed and only a wrinkle 0.10 inches deep by 1.0-inch wide by 14.0 inches long remained. Post-analysis is that this wrinkle may be removed if a longer soak at 1300°F and full vacuum were used.

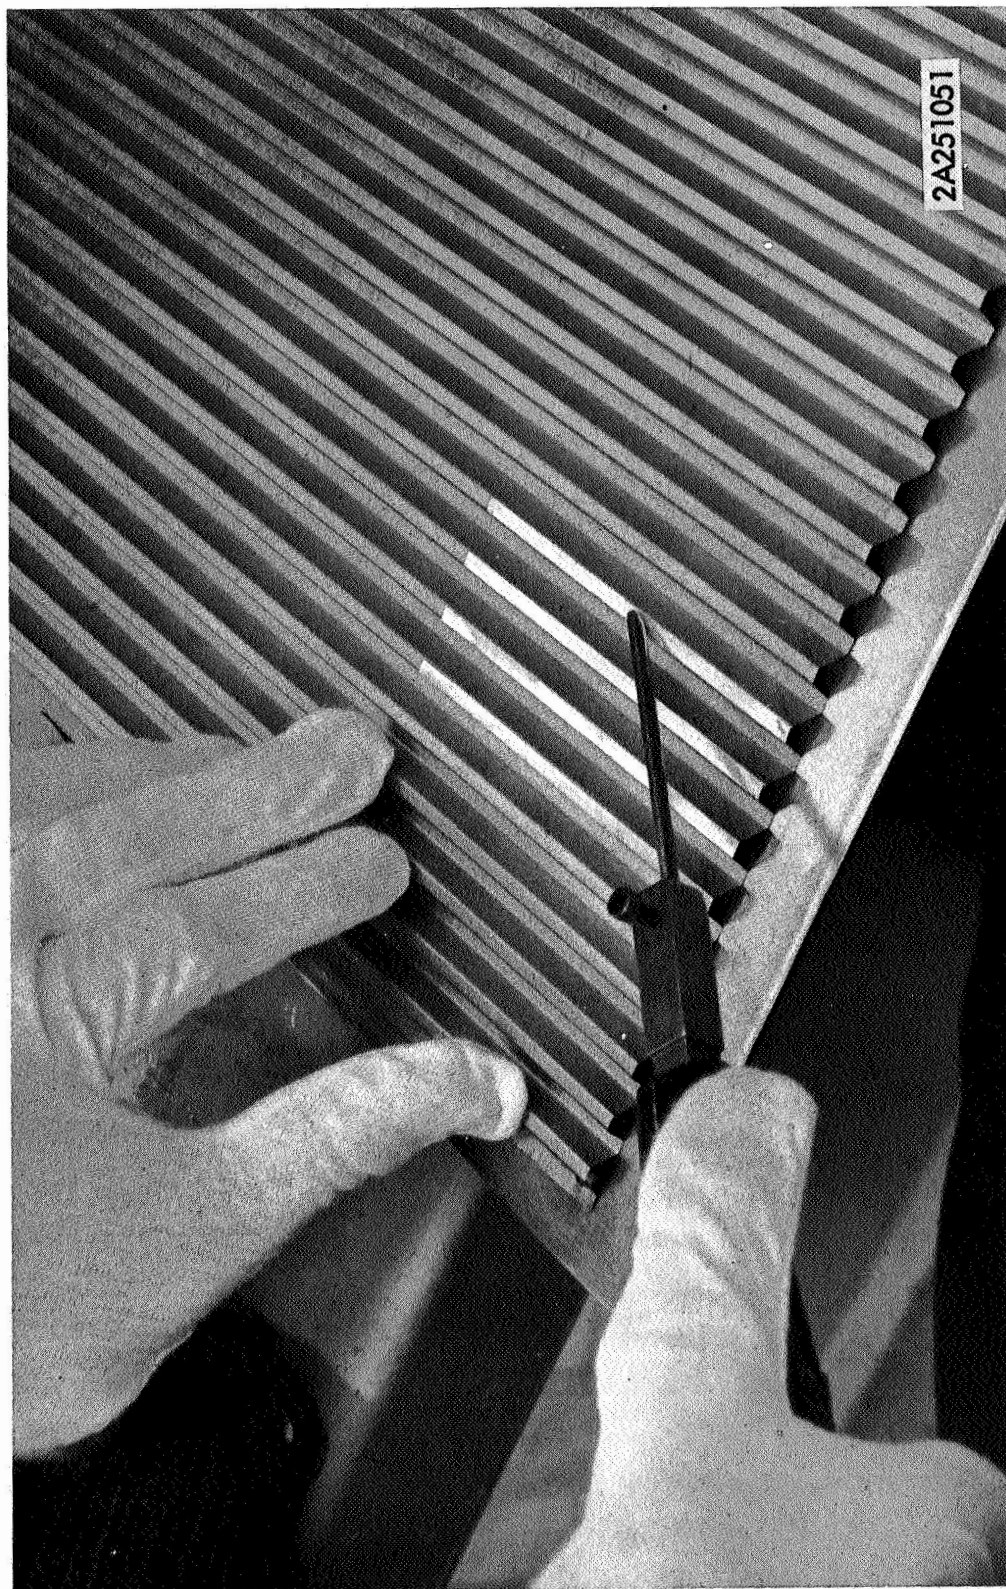
FIGURE 12  
RESISTANCE SPOT TACKING OF BRAZE ALLOY TO BERYLLIUM CORE

A condensor discharge spot welding machine was used to spot tack the braze alloy foil to the beryllium core (Figure 12). Ag-1Li 0.002-inch foil was cut into 0.12-inch wide strips and tack brazed to the 0.075-inch flats on the corrugations.
