POST-TEST ANALYSIS OF GENERANT TANK, PART NO. 9116270-H

JET PROPULSION LABORATORY
CALIFORNIA INSTITUTE OF TECHNOLOGY
PASADENA, CALIFORNIA 91103

April 15, 1968

A post-test analysis has been made of the prototype spacecraft generant tank, Part No. 9116270-H, which had been subjected to intermittent testing with hydrazine and gaseous nitrogen at internal pressures up to 1500 psi and temperatures of less than 150⁰F.

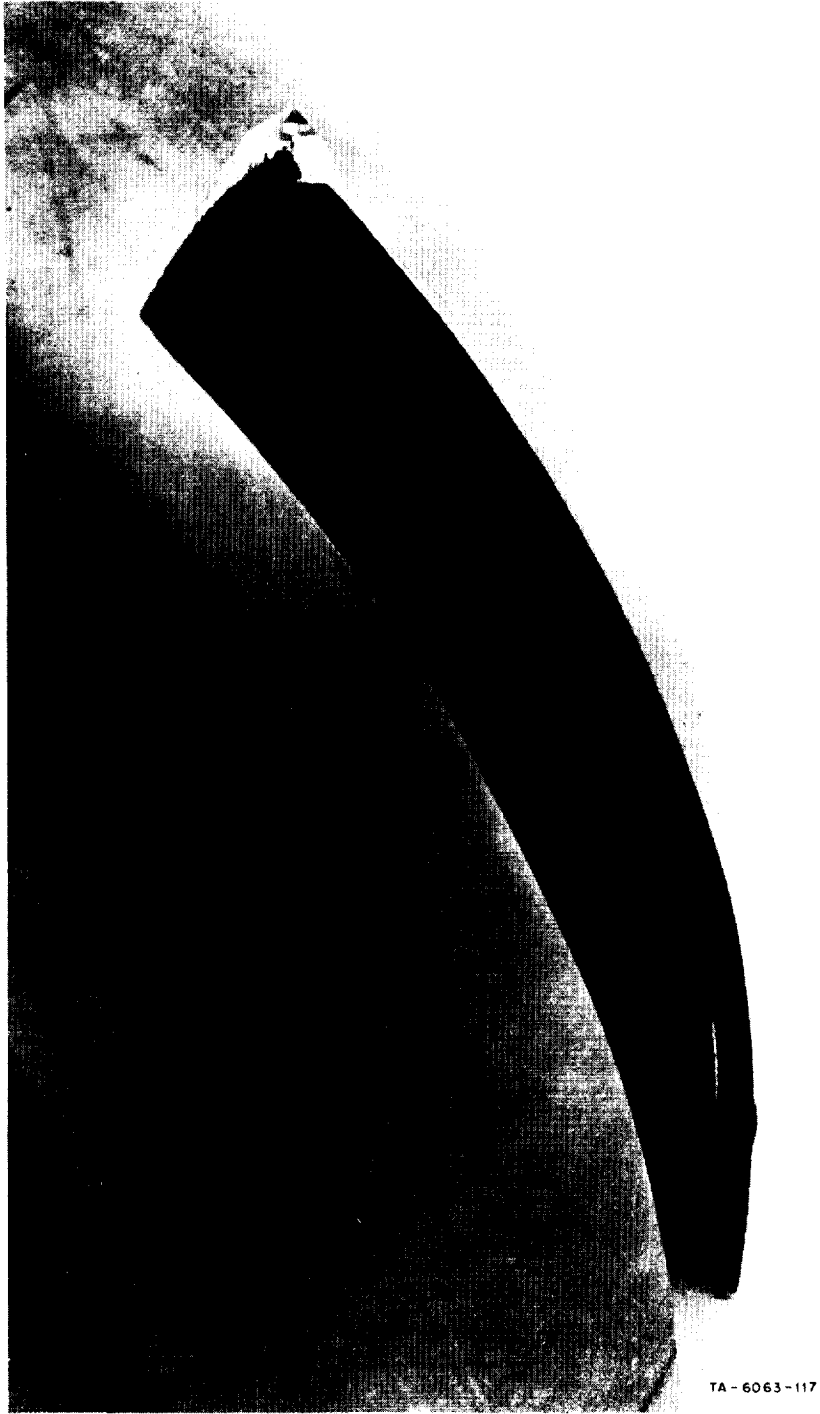
FIG. 3 VIEW OF TANK ASSEMBLY AT GIRTH WELD

The sub-assembly submitted to SRI was a 6Al-4V titanium hemisphere (17-inch diameter) in annealed condition containing a bonded diaphragm-type expulsion bladder made of ethylene-propylene co-polymer (Stillman Rubber Company, No. SR722-70). Figures 1 and 2 are photographs of the sub-assembly as received at SRI; the areas cut away were removed by JPL. The internal view (Figure 2) shows the side of the diaphragm which was exposed to nitrogen. The series of spots seen about the rim of the hemisphere in Figure 2 are the remains of temperature-sensitive tapes used to indicate welding temperatures during fabrication. A detail of the girth-weld and bonding of the diaphragm to the titanium hemisphere is shown in Figure 3.

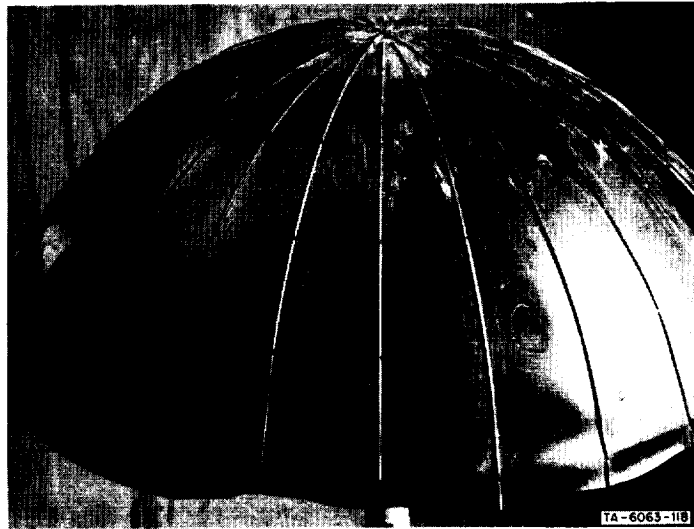
FIG. 4 PHOTOGRAPH OF THE EPR DIAPHRAGM (Hydrazine-Side) CUT AWAY FROM THE TITANIUM HEMISPHERE

The EPR diaphragm-type bladder was cut away from the titanium hemisphere along the girth weld line with a razor edge; care was taken to cut the elastomer close to the seam without scarring the titanium surface. A photograph of the side of the diaphragm which had been exposed to hydrazine is shown in Figure 4. Deposits of dark-colored material were found on the inner walls of the titanium hemisphere (shown in Figure 5) as distinct lines related to the rest-positions of the ribbed portions of the diaphragm and as occasional spots in-between the rib marks. This suggests that the hydrazine had leached colored substances out of the ethylene-propylene diaphragm.

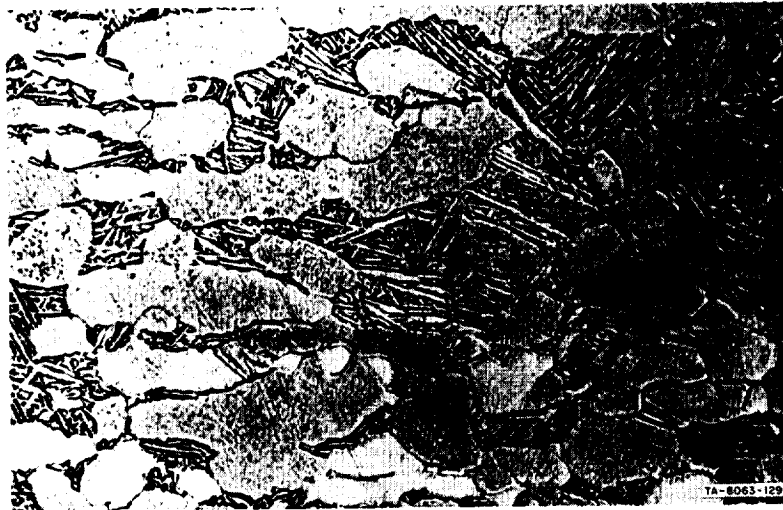
FIG. 13 PHOTOMICROGRAPH OF TRANSVERSE CROSS-SECTION OF HEMISPHERE AWAY FROM THE WELD AREA; MAGNIFICATION, 250X. (Etchant, 1 HF, 4 HNO₃, 95 H₂O, swab 10 seconds)

FIG. 14 PHOTOMICROGRAPH OF TRANSVERSE CROSS-SECTION OF HEMISPHERE AWAY FROM THE WELD AREA; MAGNIFICATION, 1000X

Photomicrographs of the structure in the transverse section in the parent metal away from the weld area are shown in Figures 13 and 14, and those of the longitudinal section in Figures 15 and 16. Comparison of the photomicrographs in Figures 13 and 15 indicates that there is a tendency to preferred orientation of the grains along the longitudinal axis of the hemisphere. Observation of the parent metal indicates that it has a highly desirable microstructure with a well-dispersed alpha phase. The grain size averages between 15 to 20 microns.

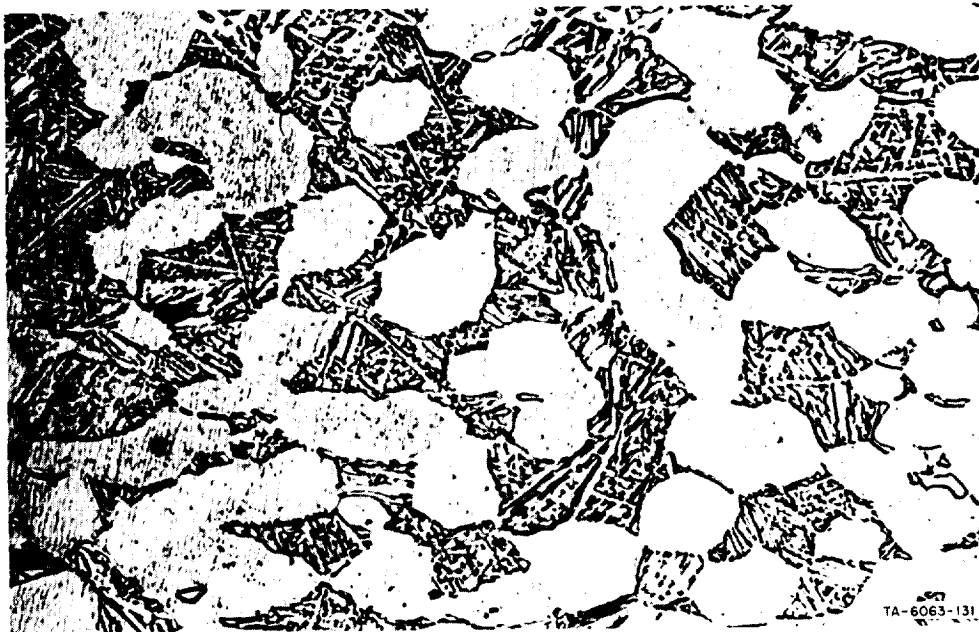
FIG. 15 PHOTOMICROGRAPH OF LONGITUDINAL CROSS-SECTION AWAY FROM THE WELD AREA; MAGNIFICATION, 250X (Etchant : 1 HF, 4 HNO₃, 95 H₂O swab 10 seconds)

FIG. 16 PHOTOMICROGRAPH OF LONGITUDINAL CROSS-SECTION AWAY FROM THE WELD AREA; MAGNIFICATION, 1000X
