INTERAGENCY REPORT NASA-119

GENERATION OF HOUSING QUALITY DATA FROM  
MULTIBAND AERIAL PHOTOGRAPHS\*

Barry S. Wellar\*\*

May 1968

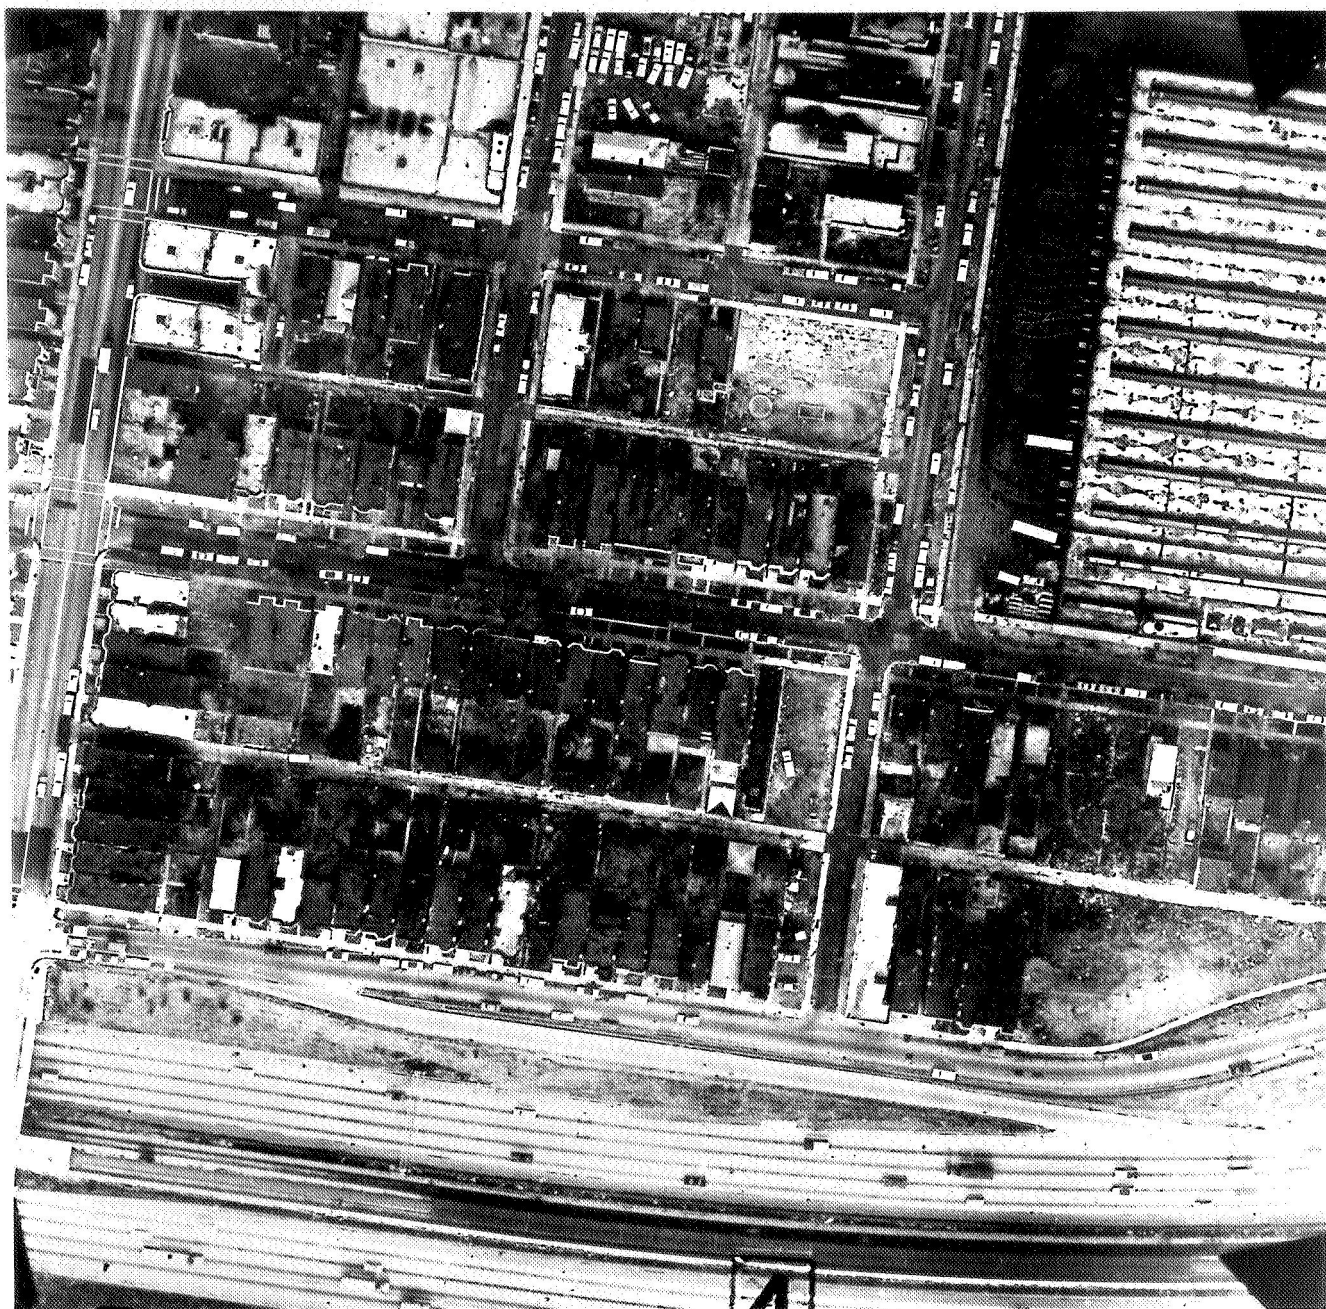
Figure 2. Multiband Imagery: Negative 735, .55-.60 microns  
W. Congress Parkway, Chicago, November 1965

Thoroughfares.--Litter is noticeable on the parkway (strip between sidewalk and street) near the vacant lots and in front of houses on the east-west running street, and also on the parkway which parallels the bus depot. One parkway and several streets are void of trees. One alley exhibits large cracks in the road-surfacing material.

heavily. Even houses with garages in the rear have cars parked in front, suggesting multiple-dwelling units, or overflow from business or some other employment agency (e.g., street near bus depot).

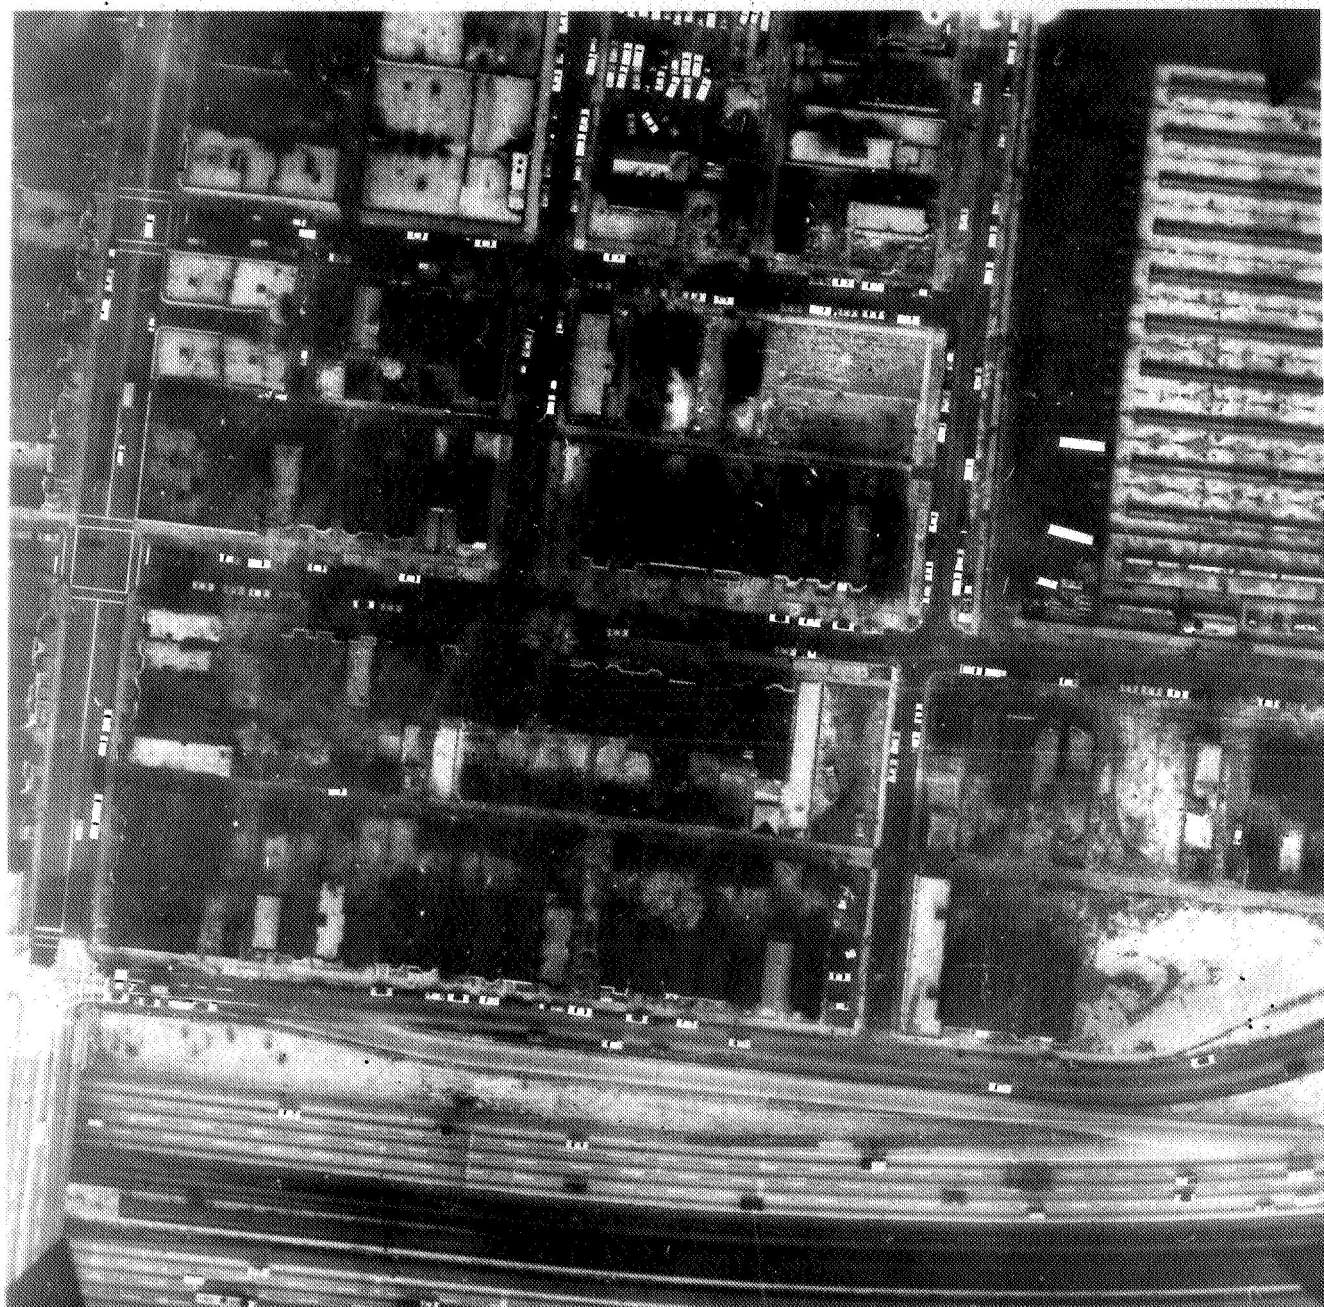
Negative 735--Frames 7, 8, 9--  
W. Congress Parkway, Chicago  
(See Figure 3)

The infrared prints reveal that many of the yards have patches of bare earth, as does much of the parkway. These prints aid in identification of objects (cars, paths, etc.) but the poor quality of the prints precludes intensive study of the prints for quality of housing evaluation.

Figure 3. Multiband Imagery: Negative 735, .70-.81 microns  
W. Congress Parkway, Chicago, November 1965

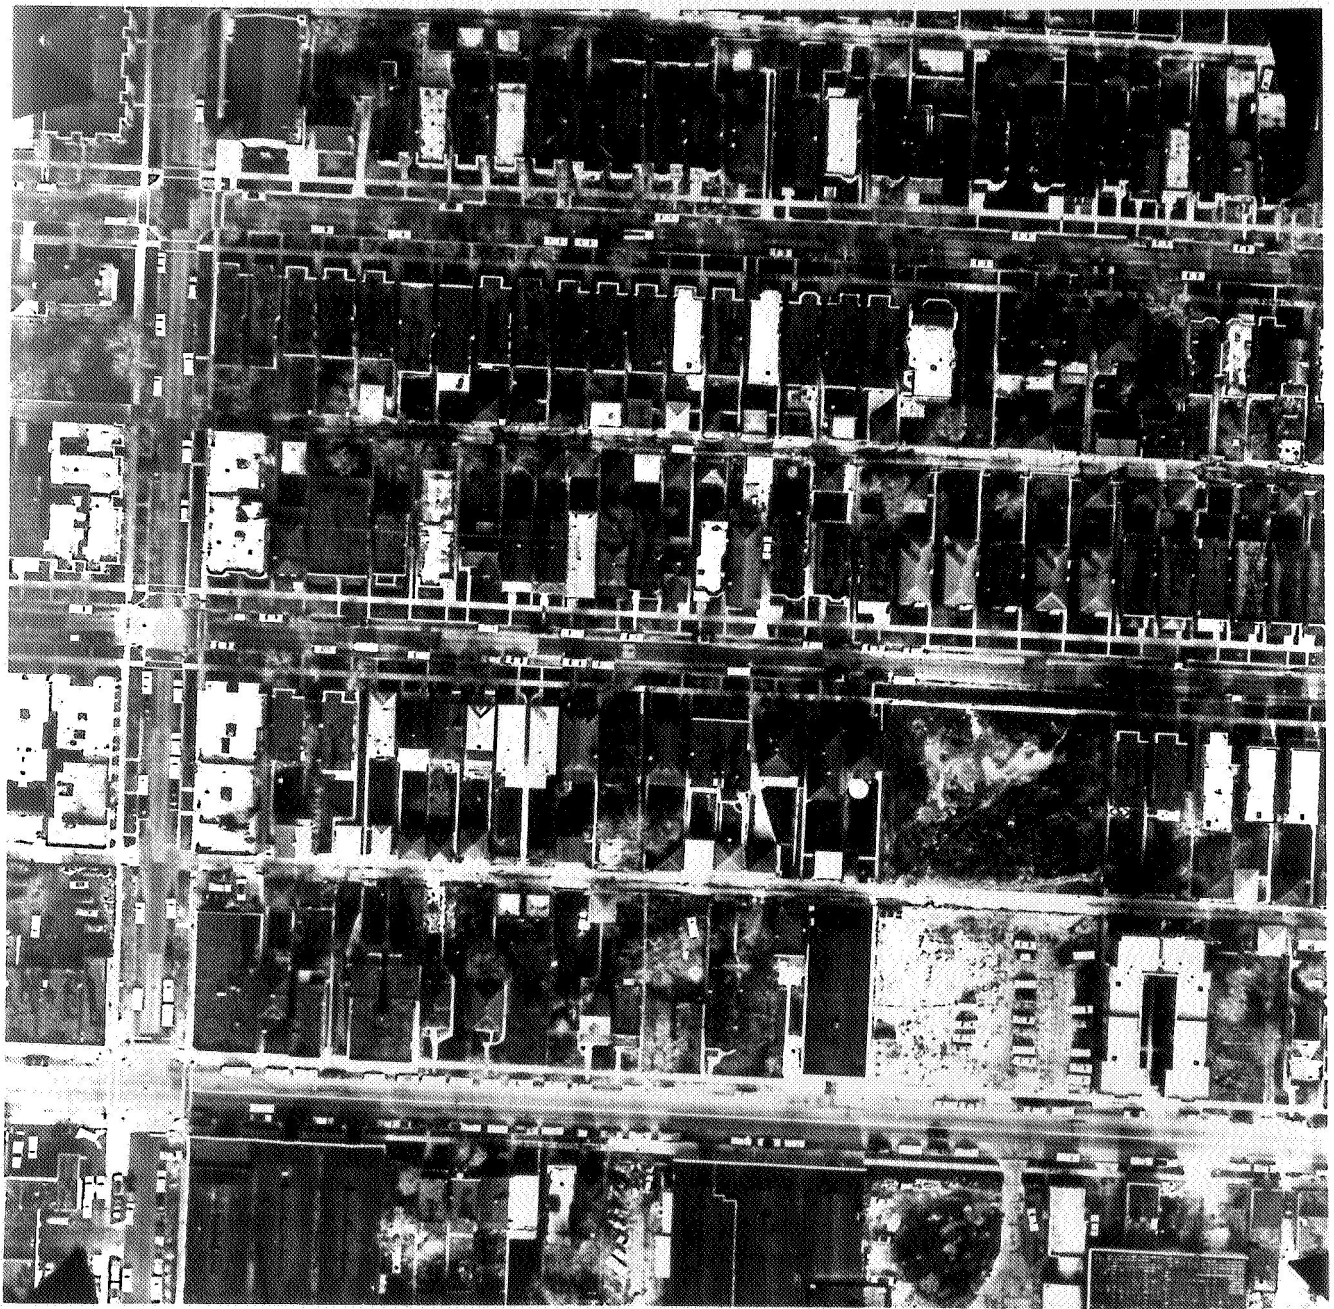
Figure 6. Multiband Imagery: Negative 752, .55-.60 microns  
Jackson Boulevard, Chicago, November 1965

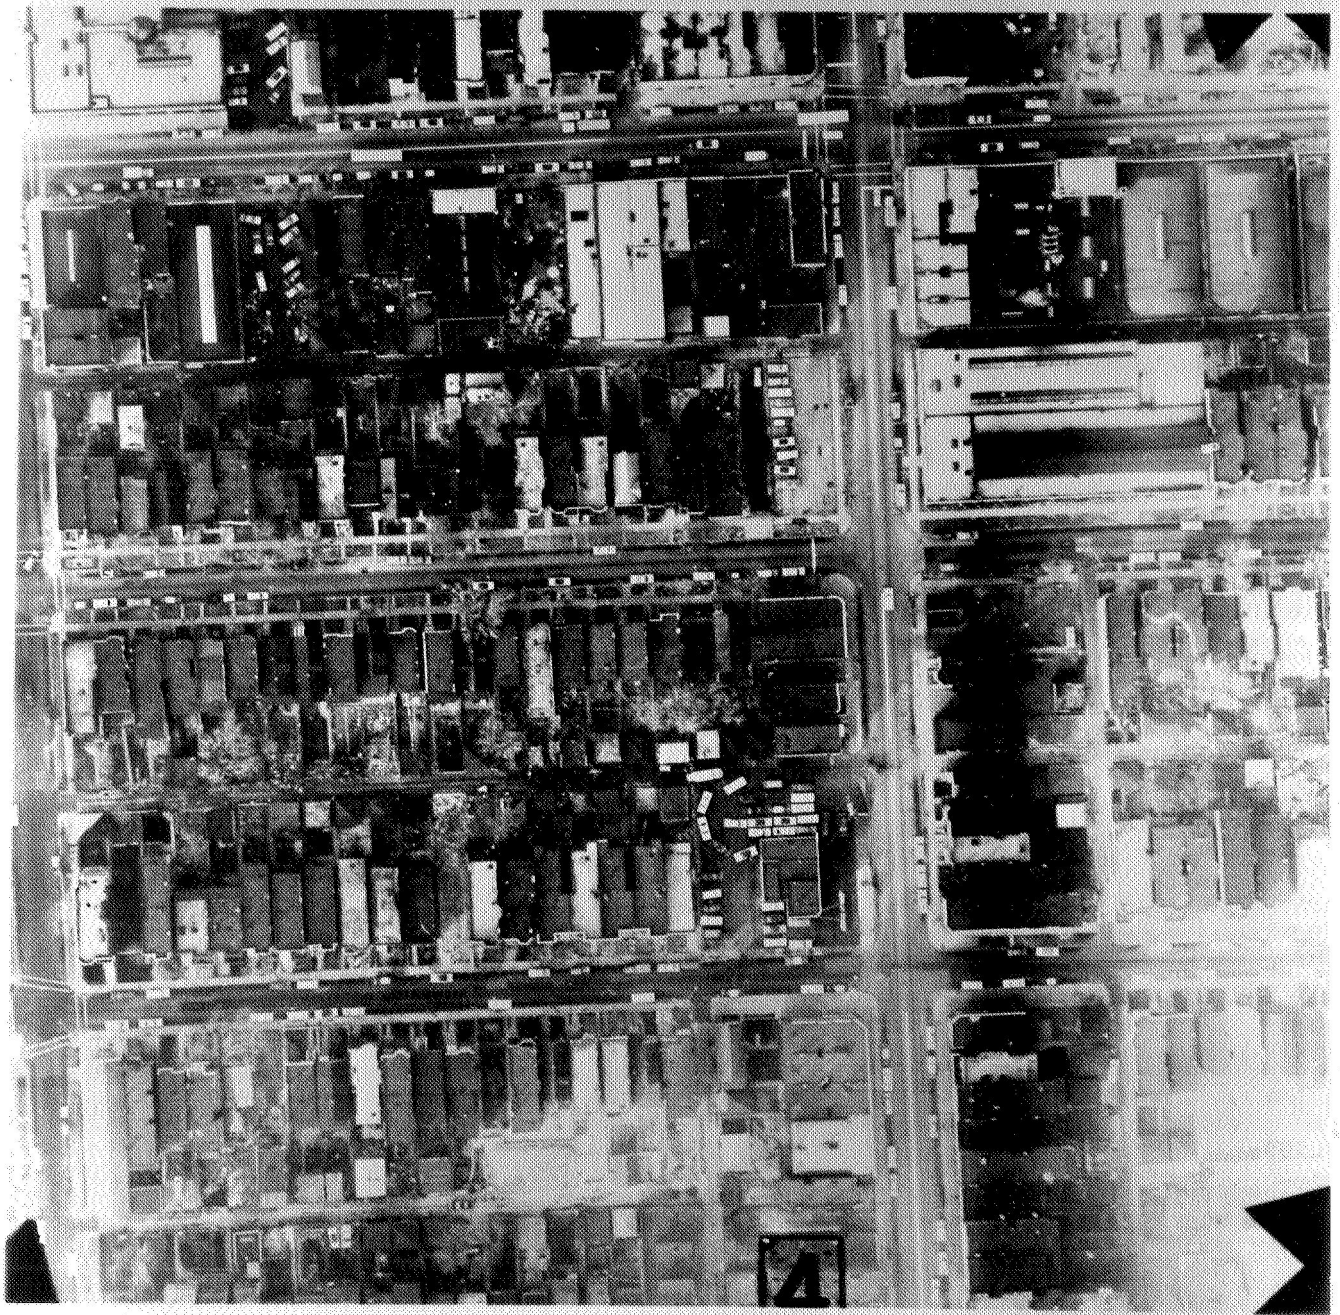
Figure 10. Multiband Imagery: Negative 208, .55-.60 microns  
Lexington Street W., Chicago, June 1966

Prints of negative 208 contain the following:

- 13 single-dwelling structures.
- 101 multiple-dwelling unit structures
  - 8 apartment buildings (more than 6 households)
- 22 commercial-residential structures
  - 2 institutional buildings
  - 1 service station and lot

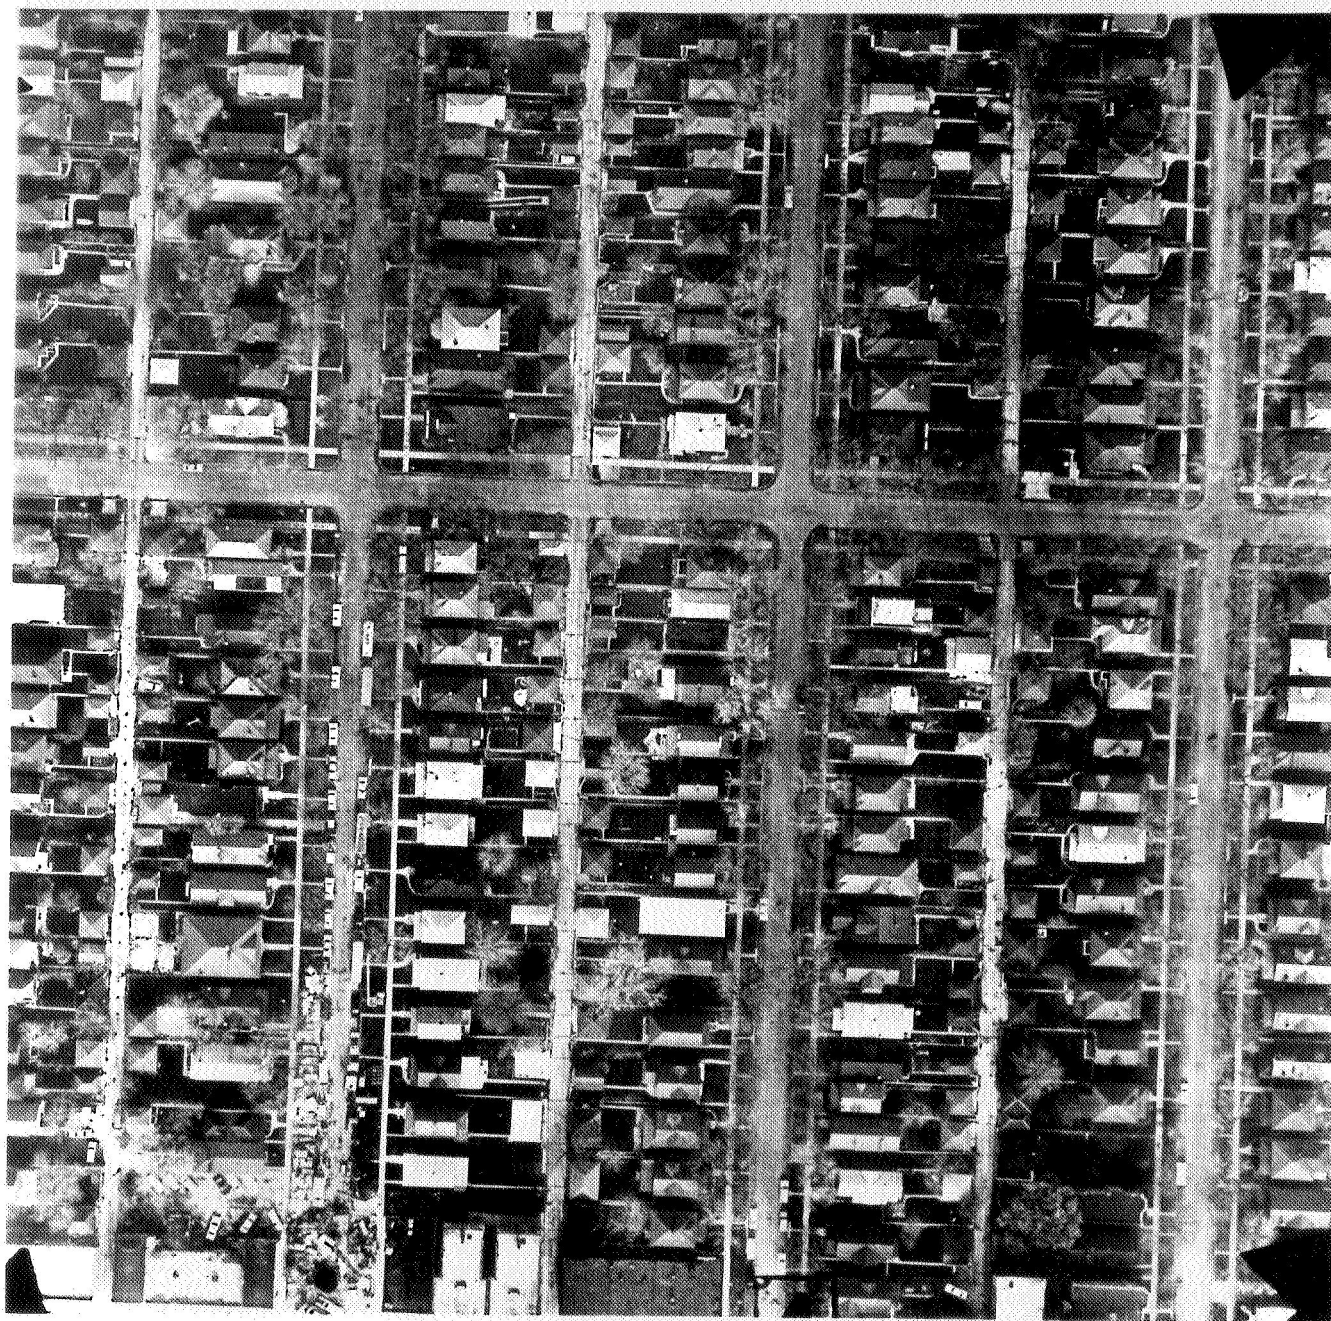
Figure 12. Multiband Imagery: Negative 758, .55-.60 microns  
Van Buren Ave., Oak Park, Ill., November 1965

Building frontages.--Frontages vary almost from house to house. On the average, houses are set back from the sidewalk between 12 and 15 feet, but the range is 6 and about 80 feet.

Non-structure-supporting land.--There are two lots which are vacant. Both are grass-covered, and both are litter-free. The single, paved parking lot is in the rear of a business establishment and could support about 18 automobiles.

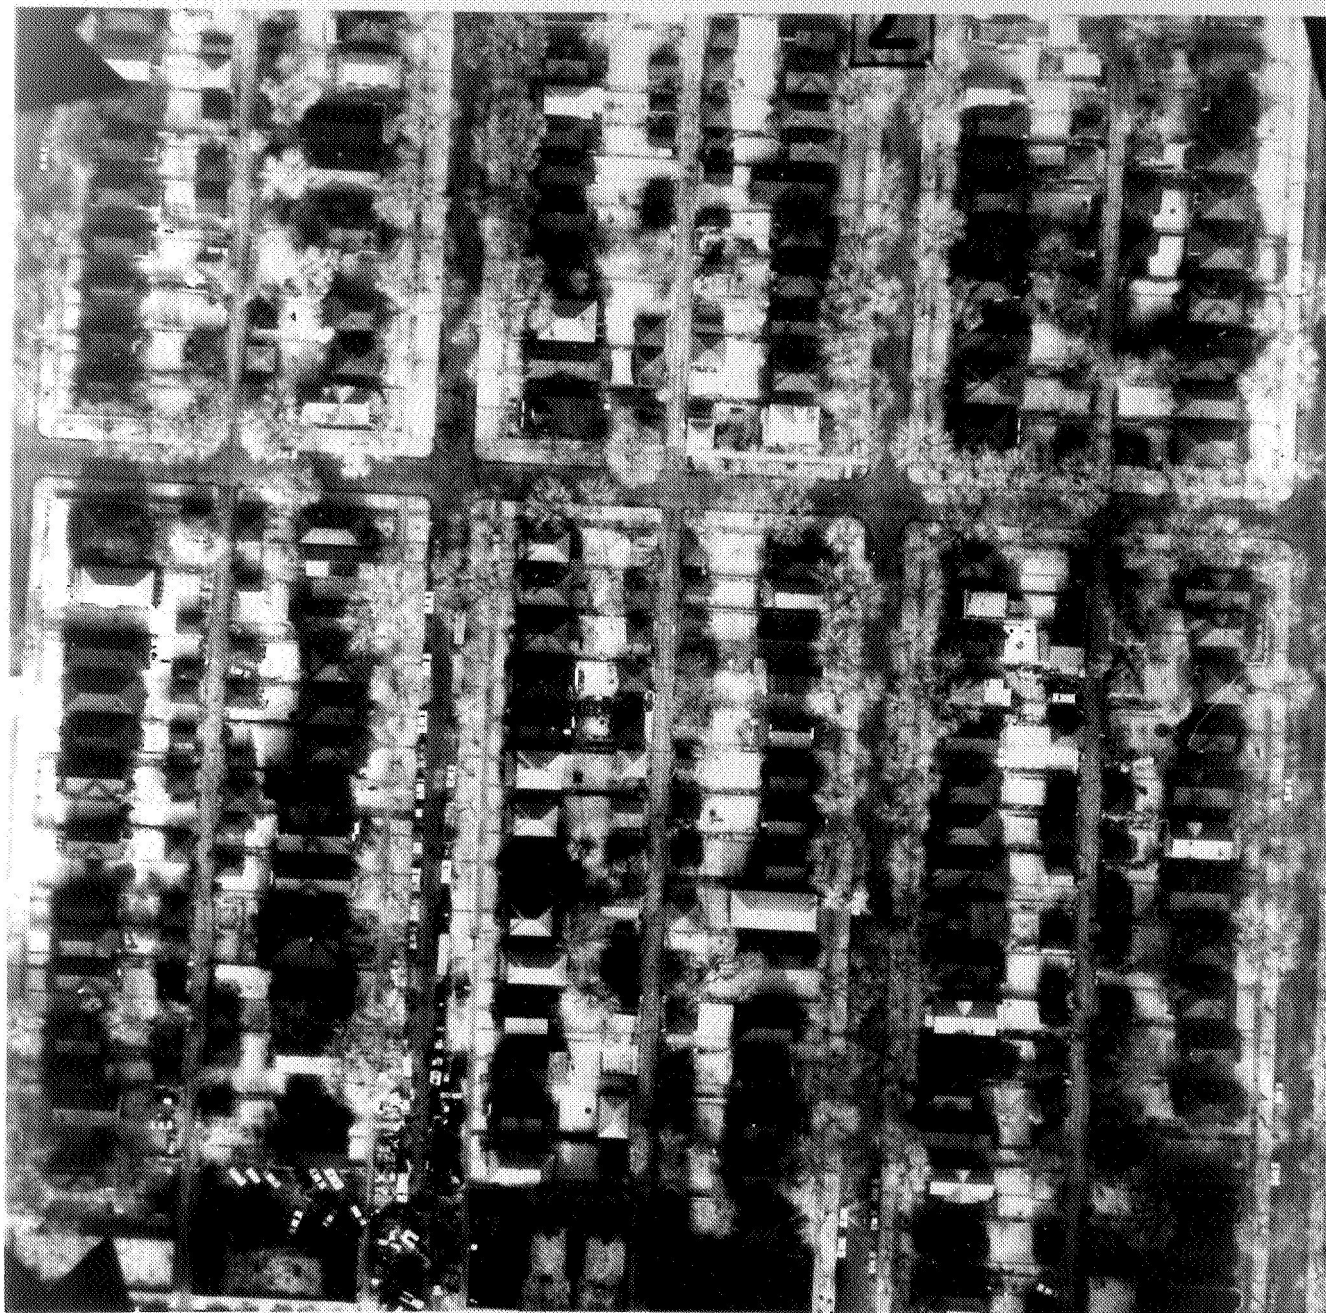
Negative 758--Frames 7, 8, 9--  
Van Buren Ave., Oak Park, Ill.  
(See Figure 13)

The infrared imagery makes obvious the care which has been exercised by

Figure 13. Multiband Imagery: Negative 758, .70-.81 microns  
Van Buren Ave., Oak Park, Ill., November 1965

property owners to produce or preserve shrubbery and grass-covered plots and parkways. There is not one yard or section of parkway which is shown as bare earth by the IR imagery. The large number of trees is also apparent.

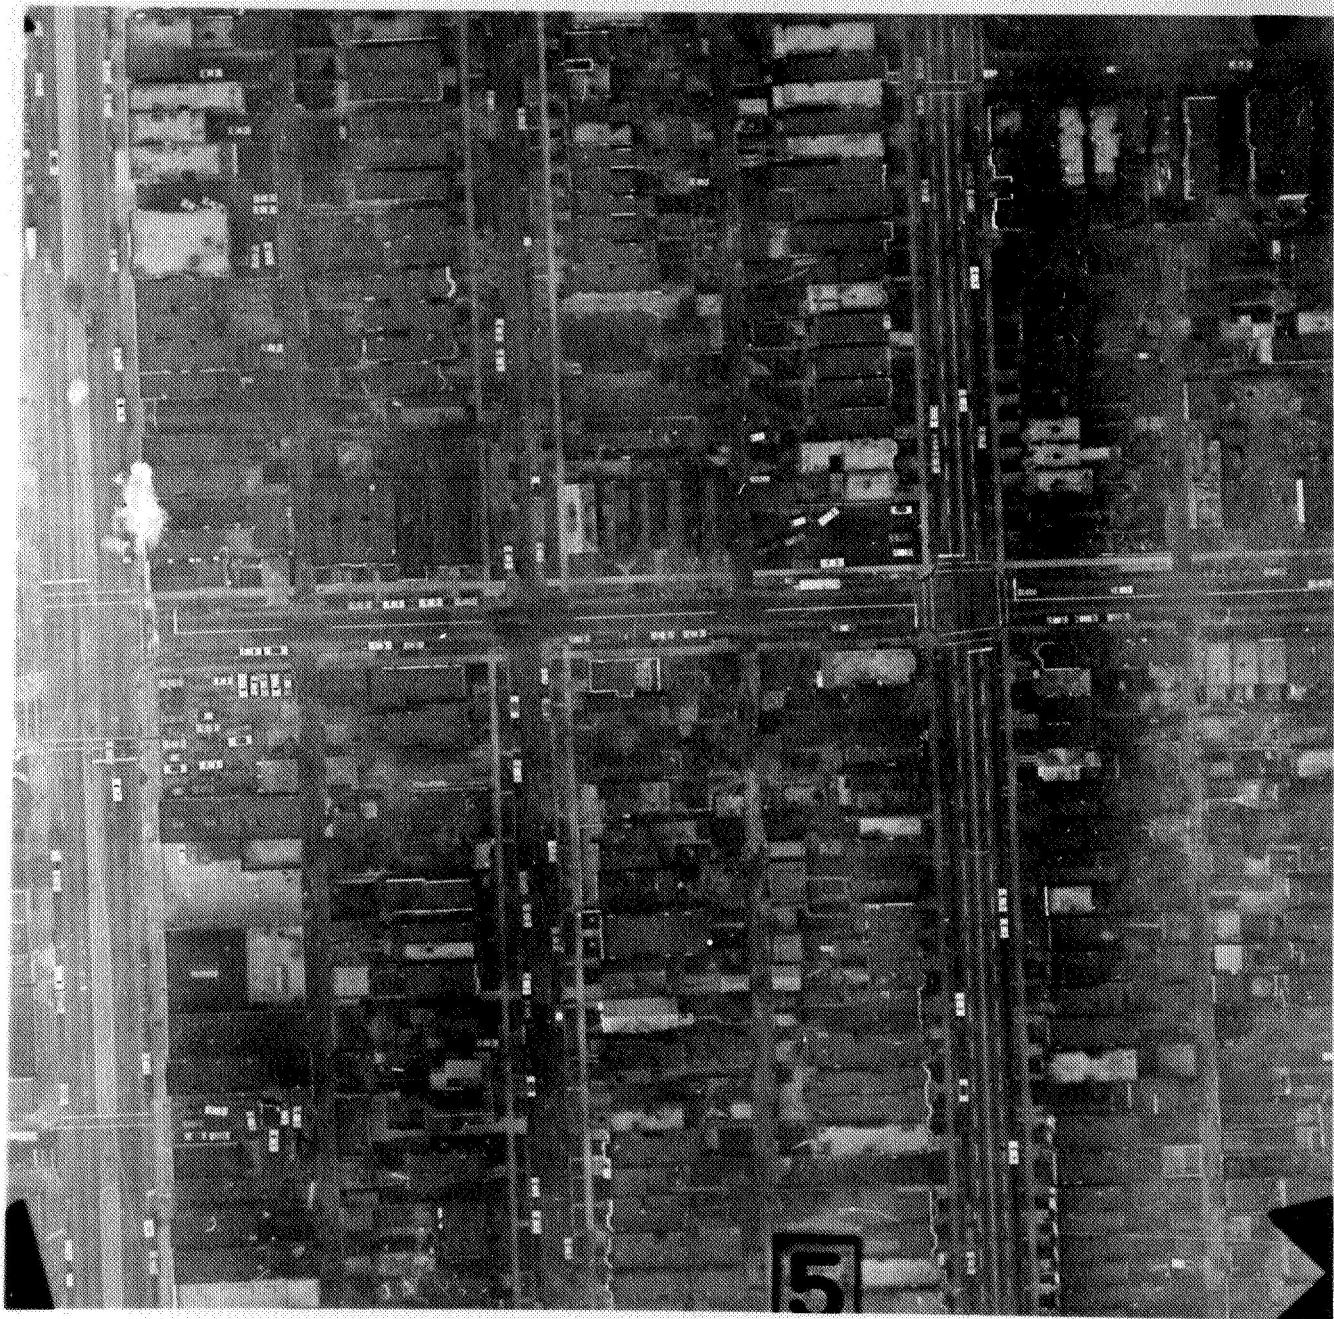
Negative 203--Frames 1, 2, 3, 4, 5, 6, 7, 8, 9--  
Polk Street W., Chicago  
(See Figure 14 and Figure 15)

The area imaged in prints of negative 203 is contiguous to the area imaged in prints of negative 202. The two areas are almost identical in terms of classifications such as land use intermingling, lot crowding, building frontages, etc. The summary statement is the same, i.e., housing and surroundings are very similar.

Figure 14. Multiband Imagery: Negative 203, .55-.60 microns  
Polk Street W., Chicago, June 1966

Figure 15. Multiband Imagery: Negative 203, .70-.81 microns  
Polk Street W., Chicago, June 1966

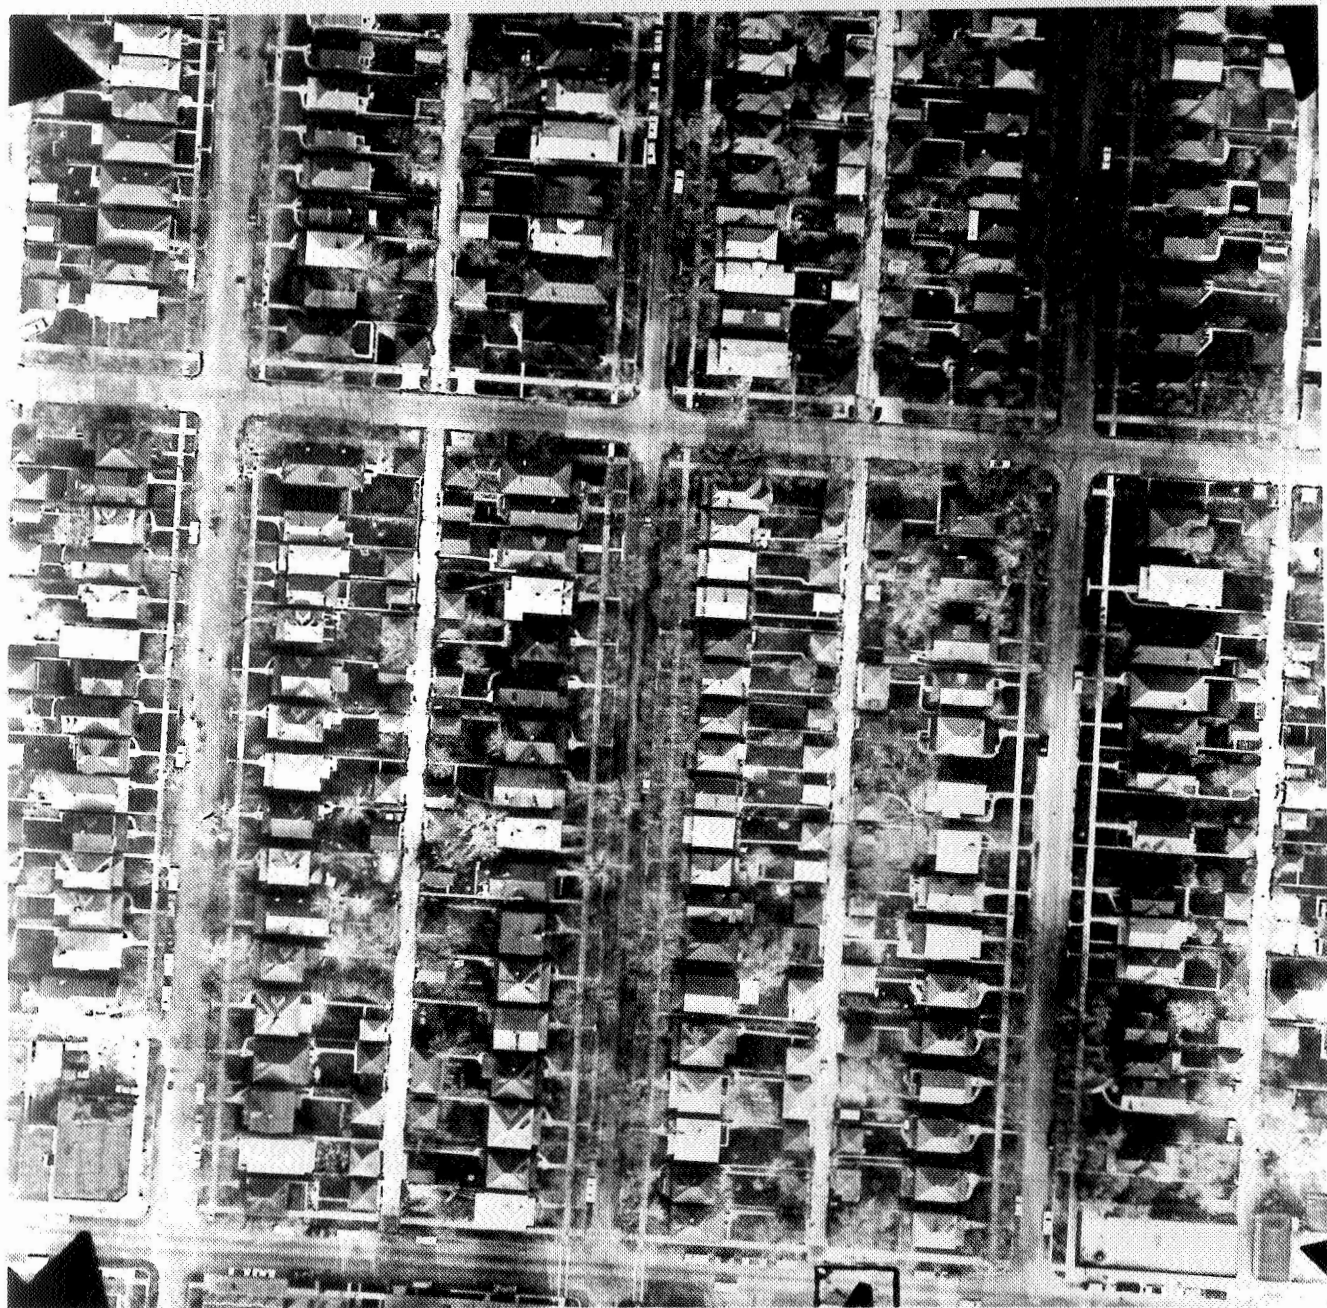
Figure 18. Multiband Imagery: Negative 759, 550-600 microns  
Van Buren St., Oak Park, Ill., November 1965

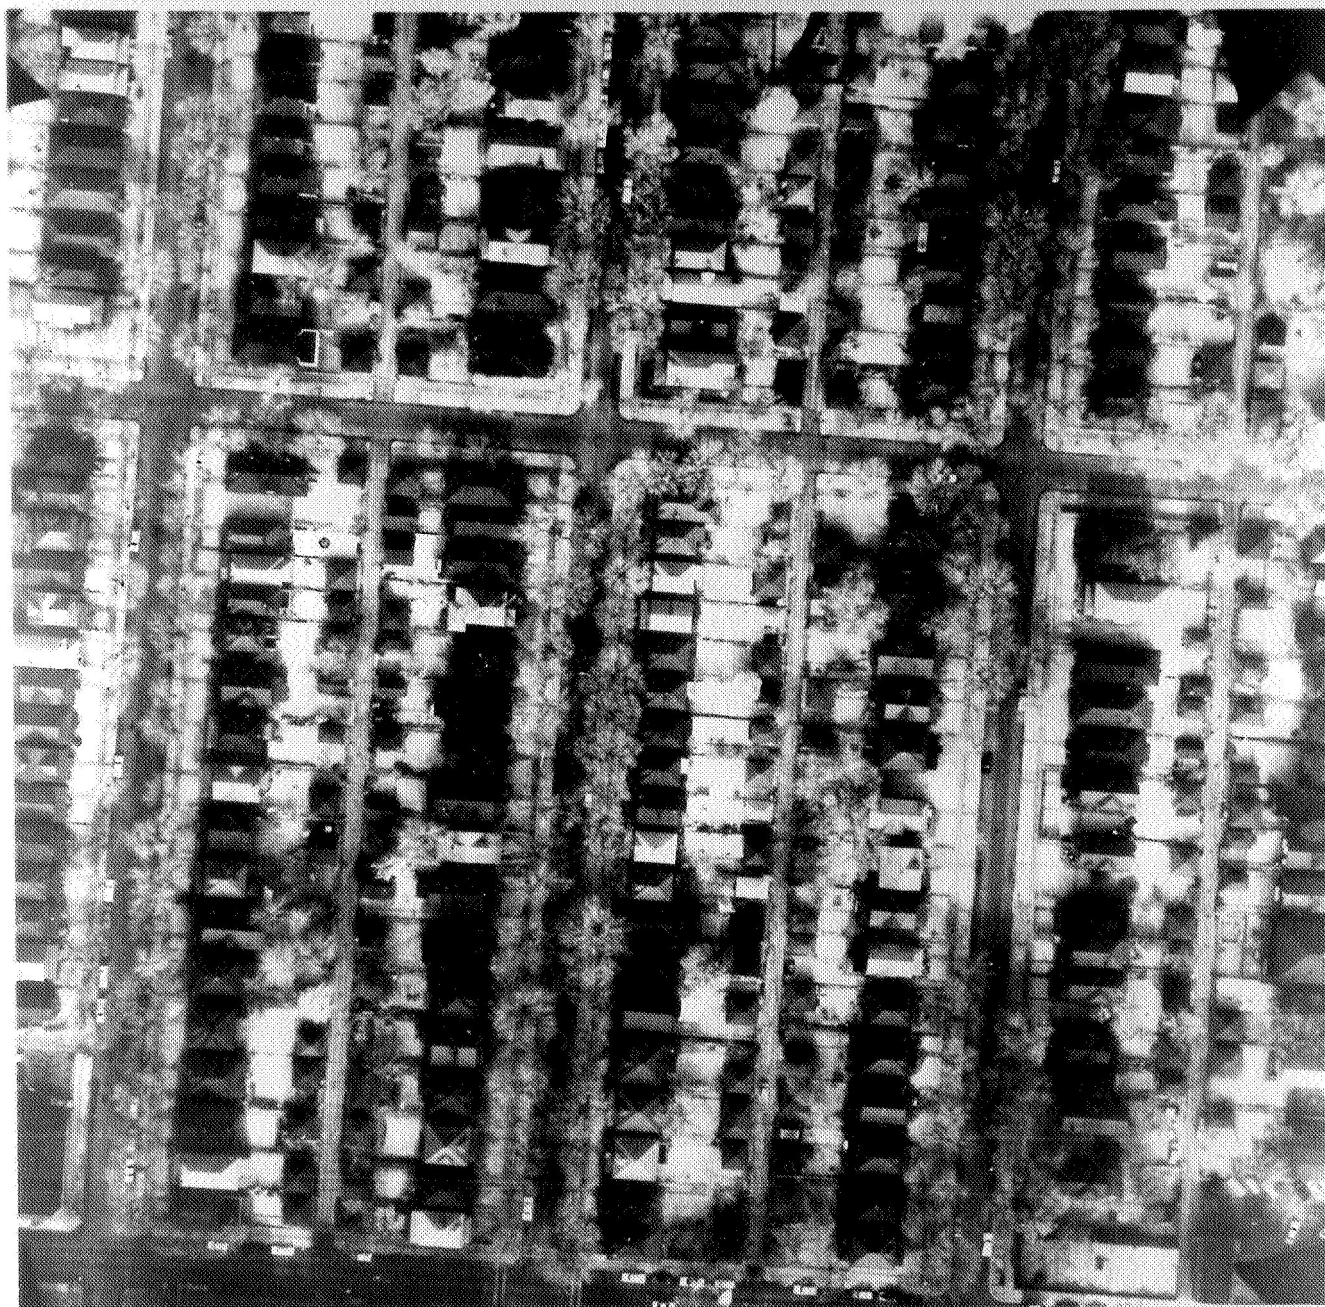
Figure 19. Multiband Imagery: Negative 759, .700-.810 microns  
Van Buren St., Oak Park, Ill., November 1965
