LUNAR ORBITER IV

Extended-Mission Spacecraft Operations and Subsystem Performance

Prepared by
THE BOEING COMPANY
Seattle, Wash.
for Langley Research Center

Issued by Originator as Boeing Document D2-100754-4 (Vol. IV)

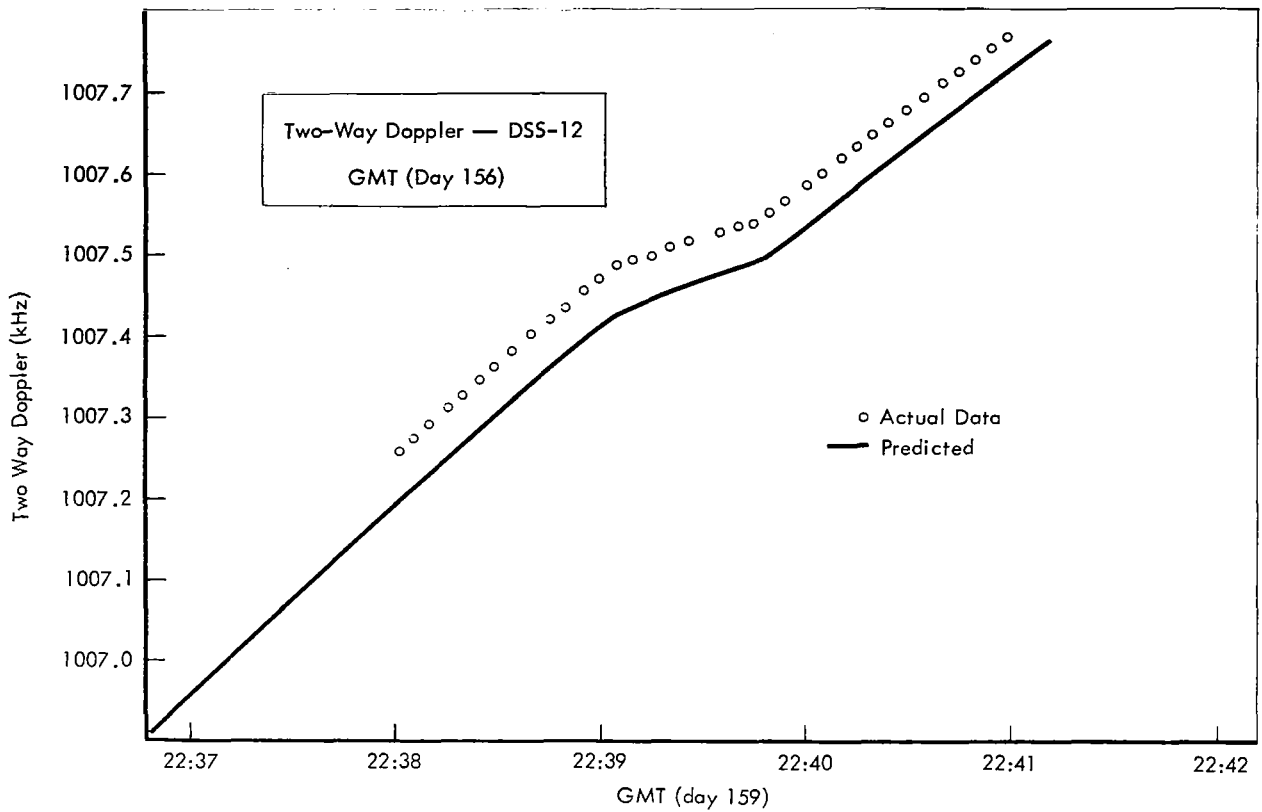
Figure 3-6: Perilune Decrease Maneuver

DSS-12 was also used to monitor Maneuver 2; the doppler plot is presented in Figure 3-6. Although predicted and actual doppler points are not coincident, the two parallel each other and indicate a successful maneuver execution. The 30-Hz bias seen before the burn was caused by epoch forwarding O.D. 6001-9 a period of 32 hours. However, only a 24-Hz bias was present after the burn. An early (approximately 1 second) engine cutoff is indicated.

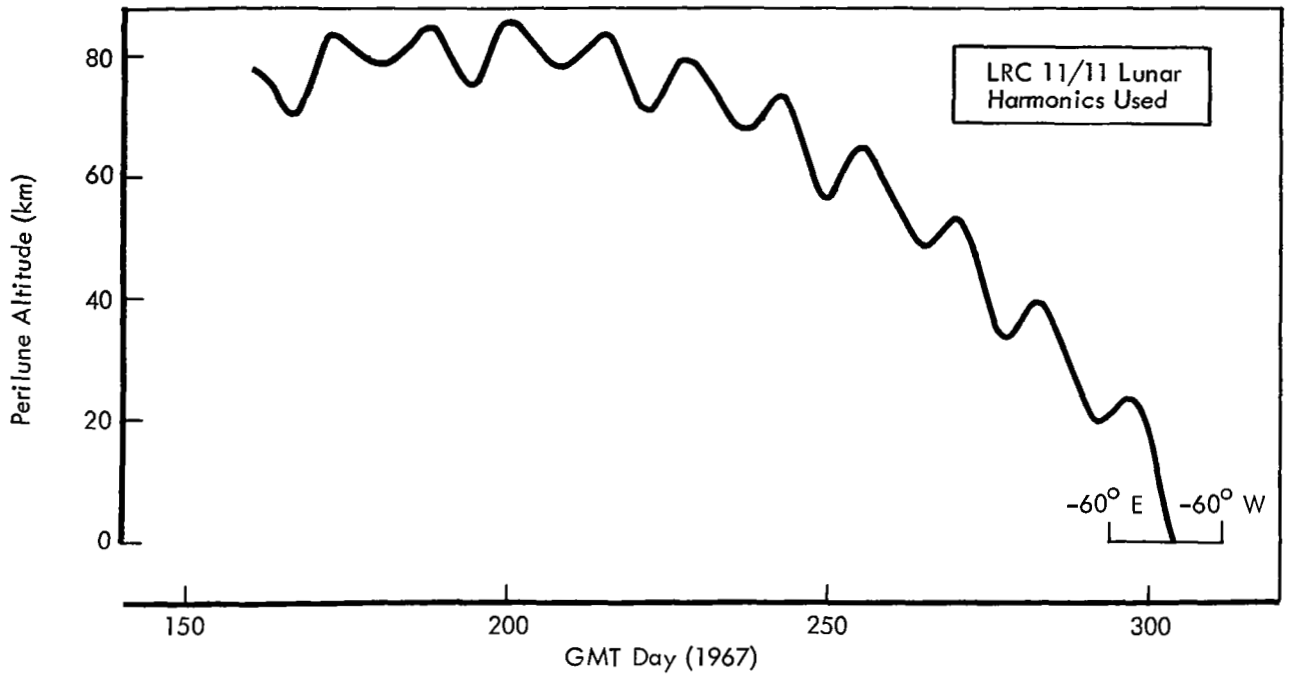
Figure 3-7: Predicted Perilune Altitude Following Perilune Decrease Maneuver

To assess the success of the transfers, perilune altitude variations (based on the LRC 11/11 lunar gravitational model) were calculated (see Figure 3-7). The plot indicates an impact on the nearside of the Moon on October 30, 1967. Furthermore, Figure 3-8 shows the expected miss distance of Site IIP-2 on July 9, 1967. Finally, the available ΔV on board the spacecraft is 20 meters/second, sufficient to cause an impact into this area if desired.

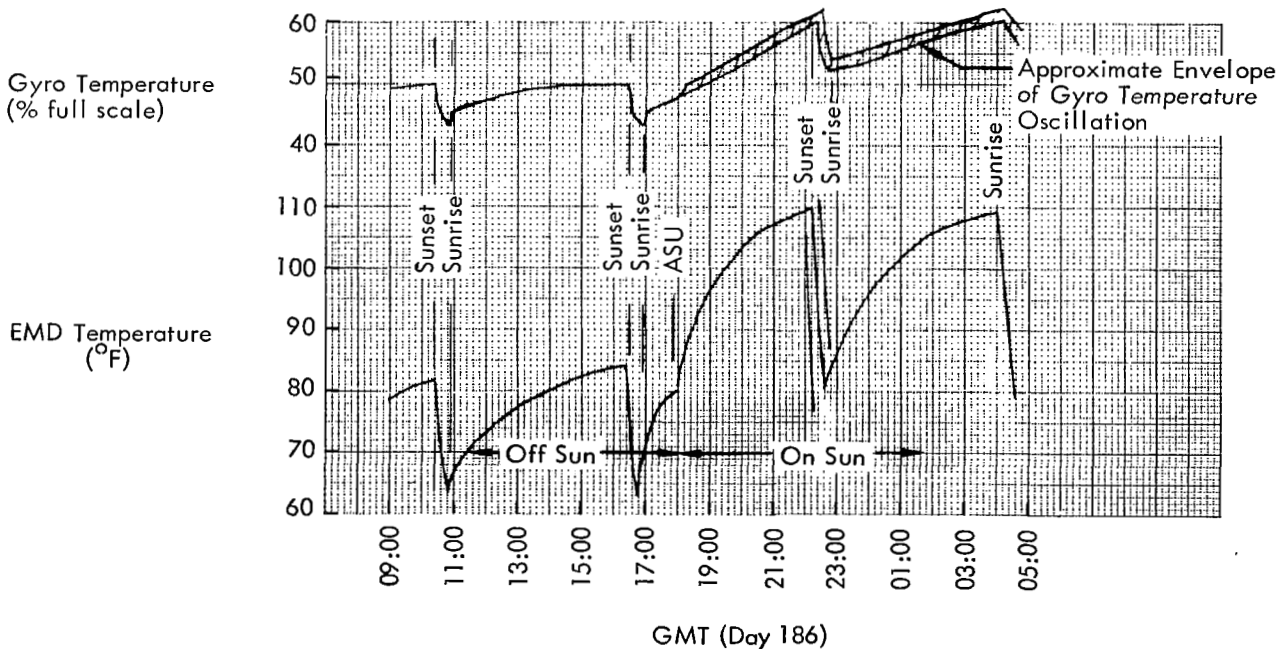
Figure 5-4: IRU and EMD Temperature vs Time

Figure 5-4 shows there is a wide temperature variation as the EMD oscillates into and out of sunlight. Despite these large variations, the gyro temperatures are controlled within a rela-

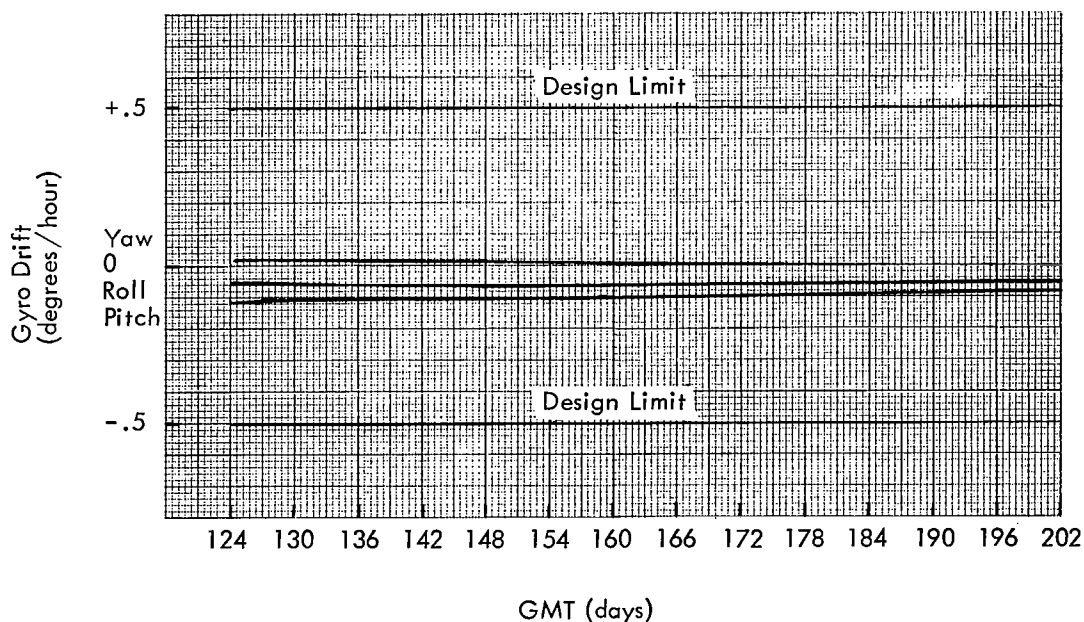
Figure 5-5: IRU Drift

Drift rates while pitched off the Sun in wide deadband appeared to be significantly different from narrow deadband rates; this is explained by the larger gyro error encountered in wide deadband operation due to being farther away from gyro null. Table 5-4 summarizes the measured narrow deadband drift rates and the estimated wide deadband drift rates during off-Sun operation.

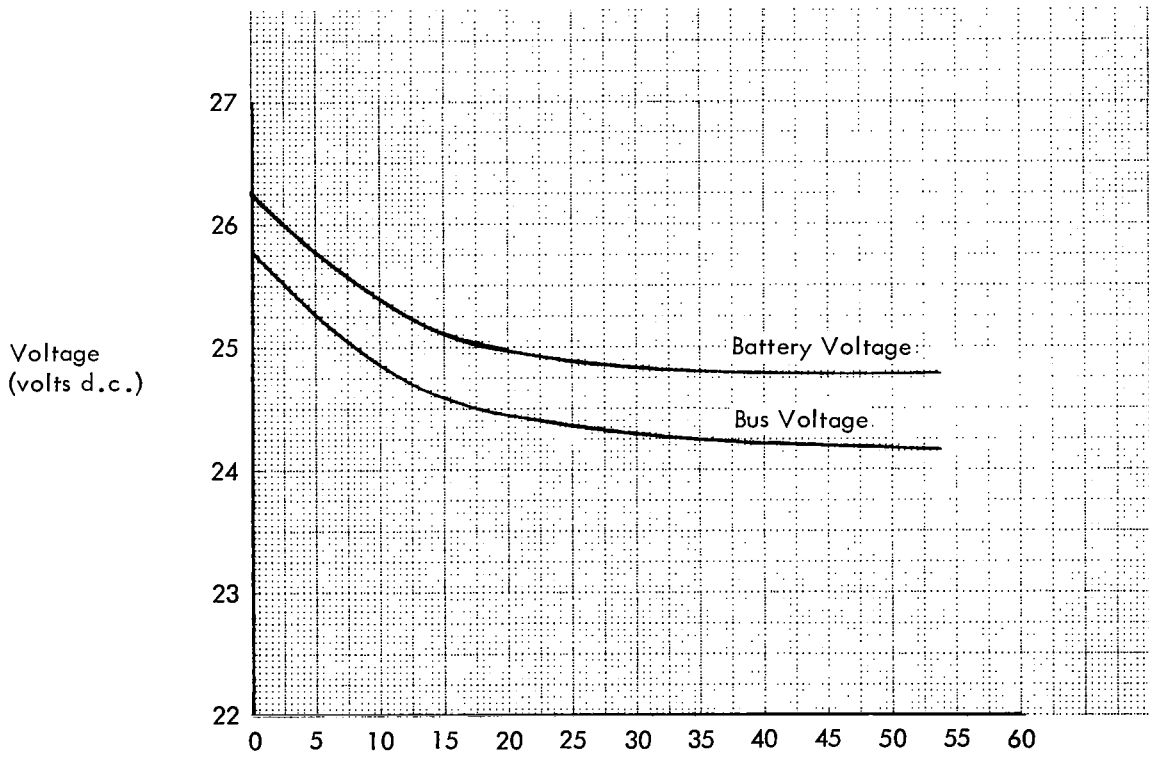
Figure 5-18: Battery Discharge Characteristic

Figure 5-18 reflects the battery discharge characteristics during a programmed exercise on Day 155 to discharge the battery following a long-term constant-charge condition during the primary mission. This discharge was normal. Later, on Day 192, the battery was discharged again (Figure 5-19) during a scheduled spacecraft maneuver. Again the discharge was normal. The lower end of discharge voltage on Day 192 is a direct result of the rate of discharge and is a

Battery Temperature:
 At Start of Discharge = 111.5°F
 End of Discharge = 95.5°F
 Energy Removed ≈ 3.33 Ampere-Hours

Time (minutes)
 Starts at GMT: 155:13:13:59.9

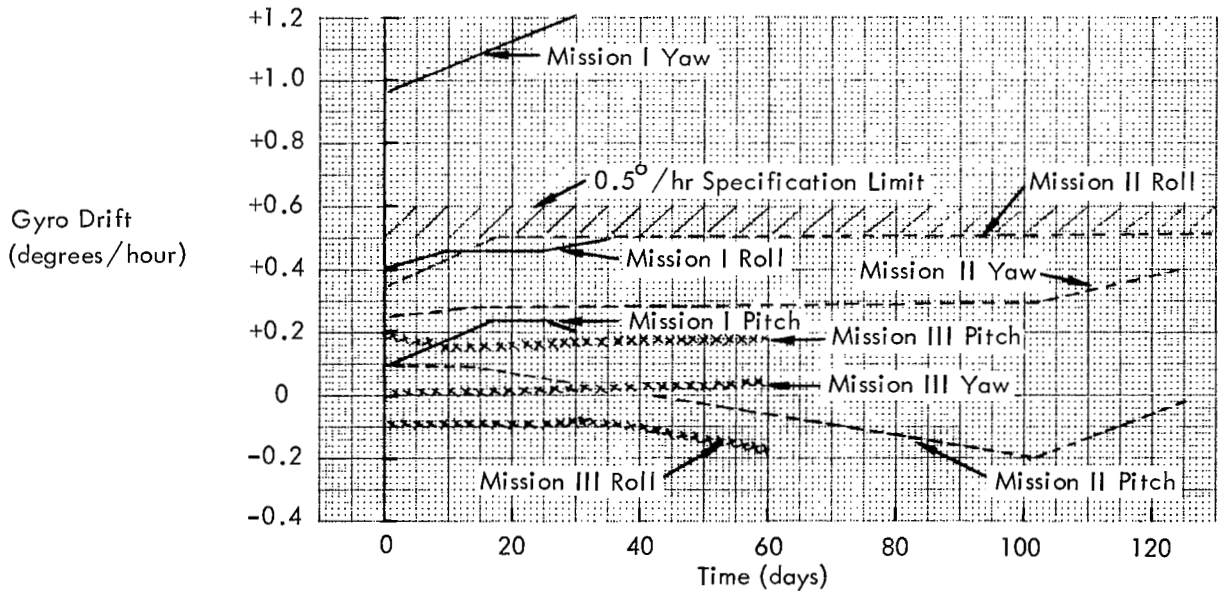
Figure 5-41: Gyro Drift Comparison

Figure 5-41 shows the average drift for gyros during all missions up to IV. Note that only one gyro shows an out-of-specification condition
