14
Paper presented at the ASTM
Symposium on Applications
Related Phenomena in Titanium
Alloys, held in Los Angeles,
California, on April 18-19, 1967;
to be published in an ASTM Special
Technical Publication.

THE INITIATION OF HOT-SALT STRESS CORROSION
CRACKING OF TITANIUM ALLOYS

By S. P. Rideout, Savannah River Laboratory,
E. I. du Pont de Nemours and Co., Aiken, S.C.

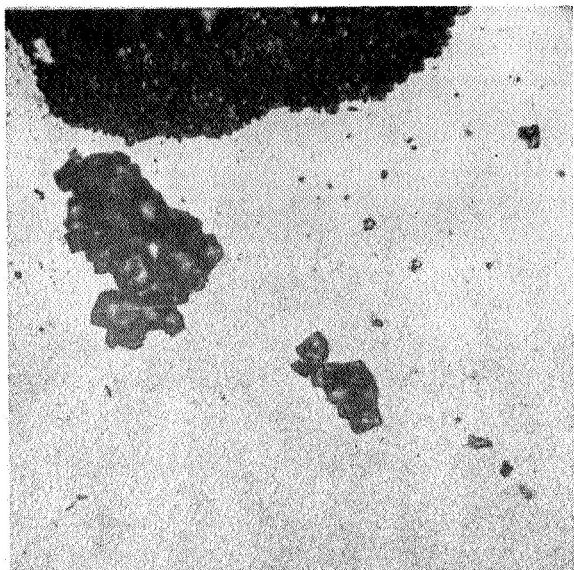
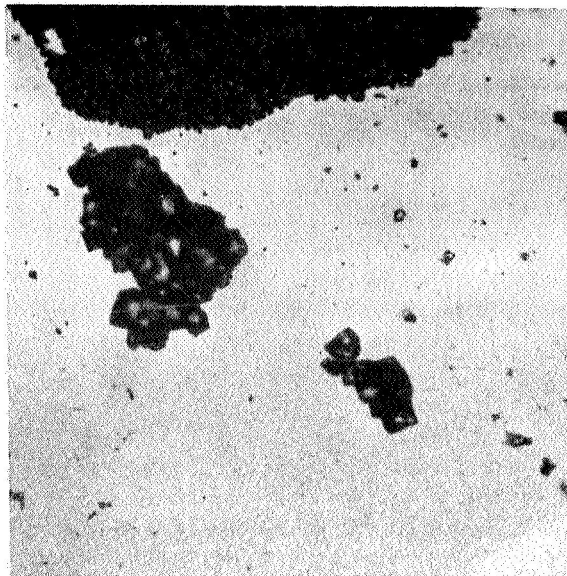
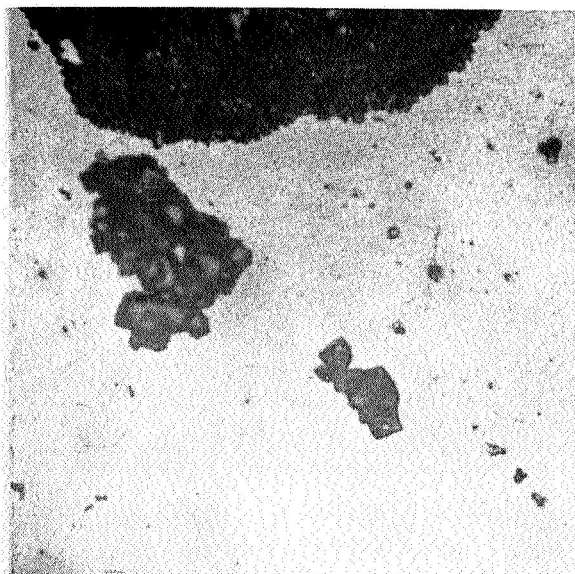
Figure 1. Hot-Stage Microscopy of NaCl Cracking of Ti-8Al-1Mo-1V at 650°F

a. Salt deposit at room temperature (320X)

b. Same as (a) after reaching 650°F (320X)

c. Same as (b) after 80 mm (320X)

d. Same as (c) enlarged to 800X

Initially, the corrosion stains appeared as microscopic speckles that developed on the metal around the salt crystals. The number of speckles increased with time, Figure 1a,b,c, and gradually formed a fairly continuous stain around the salt. However, the stains did not appear to form by surface diffusion of reaction products spreading out from salt-metal contact areas, and the initiation of cracking occurred before the stain became continuous, Figure 1d.

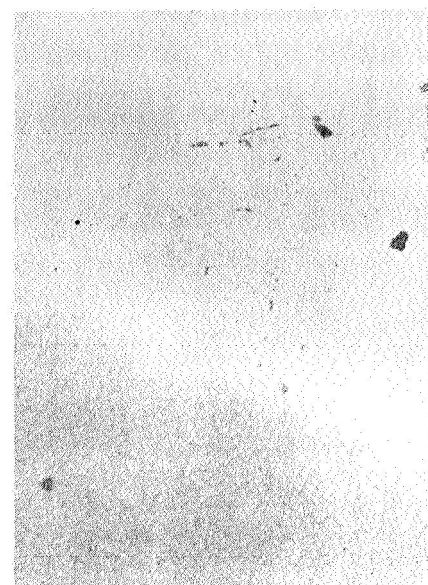
Figure 3. Hot-Stage Microscopy of Ti-8Al-1Mo-1V Exposed to
Pre-dried NaCl at 650°F (300X)

a. Room temperature

b. Same as (a) after
90 minutes at 650°F

c. Same as (b) after
cooling to room
temperature and
removal of salt
crystal

The speckled corrosion stain has not been identified, but it has been shown to be a very thin, non-adherent flaky substance which tends to spall off as the specimens cool to room temperature and which is completely removed by a water rinse. It was concluded that the speckled stain is produced by reactions with constituents (probably chloride ions and moisture) adsorbed on the specimen surface. In order to prove that the speckles were not produced by reactions with constituents in the air, specimens

that had not been wetted with salt water were heated with and without predried salt crystals on their surfaces. No corrosion stains were produced in either case, which indicated that adsorbed constituents caused the stains, and also demonstrated that moisture is a vital ingredient in the hot-salt corrosion process, Figure 3. Previous work⁽⁵⁾ with radiotracer H^3 (tritium) in the solutions from which salt was deposited on specimens showed that hydrogen is absorbed in salt-corroded areas. The combined results of the radiotracer studies and hot-stage microscopic observations support the hypothesis that absorption of corrosion-produced hydrogen promotes crack initiation.

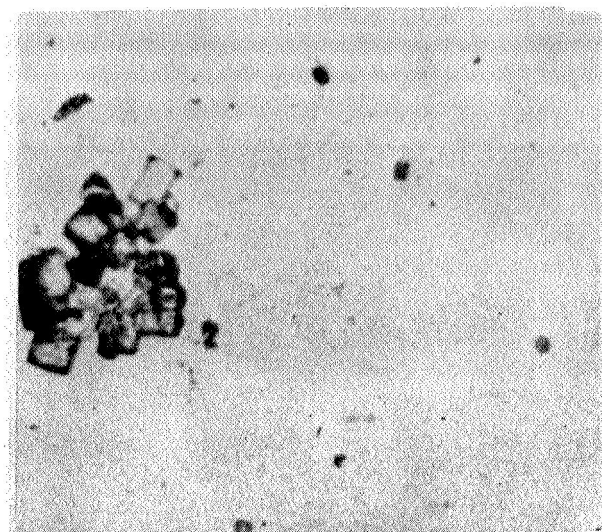
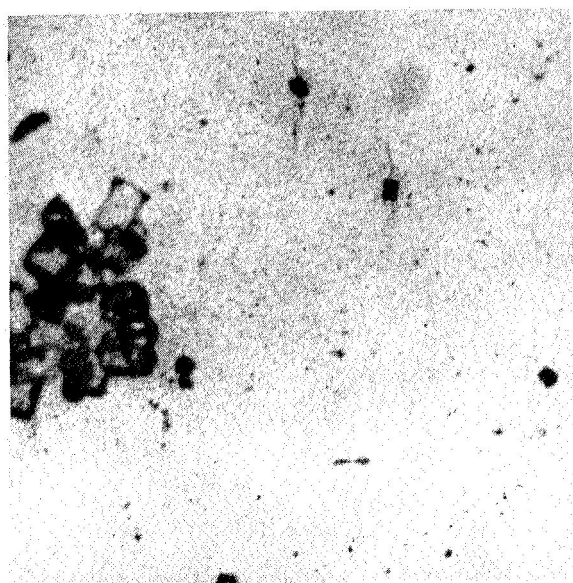
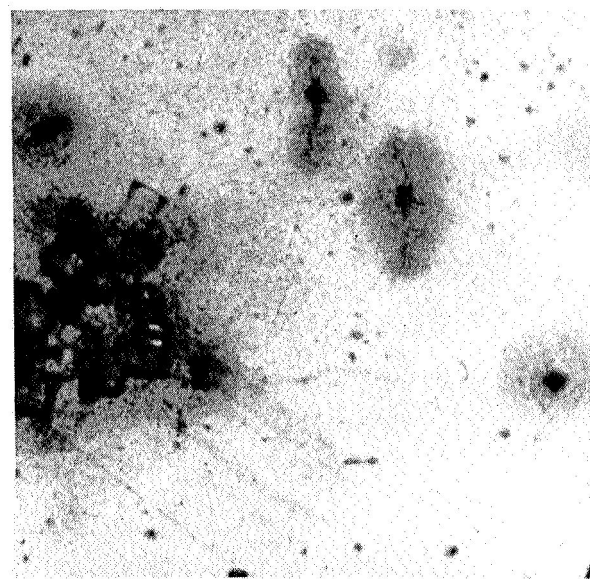
Figure 5. Hot-Stage Microscopy of NaCl Cracking of Ti-8Al-1Mo-1V at 800°F (650X)

a. Salt deposit at room temperature

b. Same as (a) after 14.5 minutes at temperature

c. Same as (a) after 15 minutes

d. Same as (a) after 17 minutes

The inflection in the incubation time-temperature curve between 700° and 750°F suggests the possible formation of either a liquid or gaseous phase(s) during hot-salt corrosion. Hot-stage microscopy at temperatures above 750°F showed corrosion stains developing very rapidly over the specimen surface for a short distance around salt crystals, but no liquid was actually observed. The stains darkened very rapidly and appeared as a solid corrosion product. It has not been established that the mechanism of cracking requires a liquid phase, or that the mechanism changes at higher temperature. There was no evidence of a liquid phase at temperatures below 700°F, and at temperatures above 750°F crack initiation was detected before the corrosion stains were fully developed. An example of this is illustrated in Figure 5, which shows several frames of a movie taken at one frame per second during heating of a specimen to

800°F. Cracks were faintly visible after 14-1/2 minutes (Fig. 5b) and became clearly visible after 15 minutes (Figure 5c). Dark stains then developed around the cracks after 17 minutes (Figure 5d). The inflection in the incubation time-temperature curve may be due to melting at the salt-metal interface on a scale that cannot be resolved by hot-stage microscopy. Further work is needed to clarify this point.

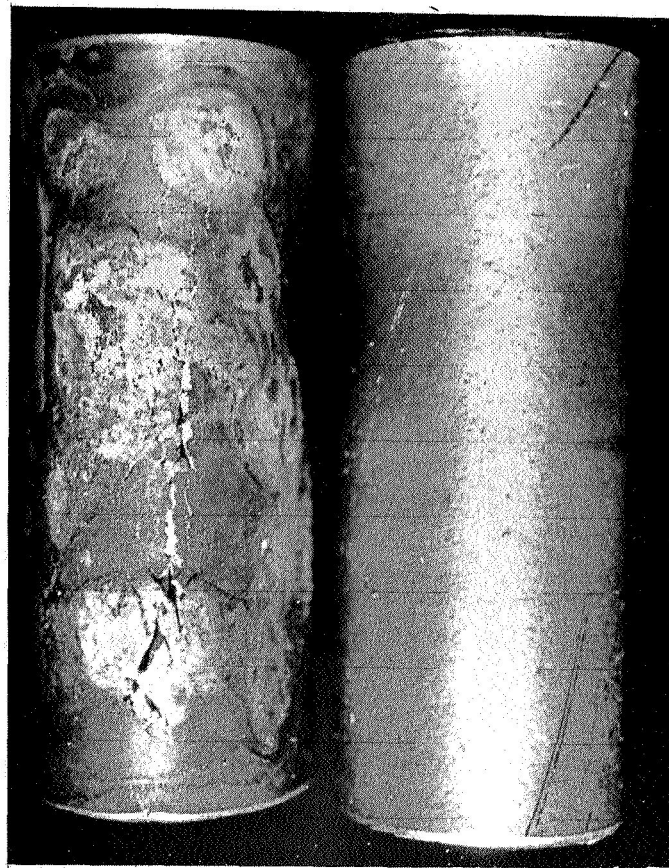
Salt Exposed

Unexposed

FIGURE 7. Corrosion-Embrittlement of
Ti-8Mn Alloy (5X)

Cracks were not visible after exposure of stressed specimen with SnCl_2 deposit at 650°F for 91 hours. Cracks were produced by bending the specimen at room temperature after the salt was washed off.

The time to initiate cracking by NaCl at 650°F in four aluminum-bearing alloys increased with decreasing aluminum content, as shown in Figure 6. Ti-8Al-1Mo-1V was the most susceptible and cracked in 1-1/4 to 1-1/2 hours, whereas Ti-4Al-3Mo-1V cracked after 28 hours. Specimens of Ti-8Mn were not cracked after 48 hours exposure. Stressed specimens of Ti-8Mn were also exposed at 650°F with SnCl_2 deposits, previously shown to be much more aggressive than NaCl . Although no cracks were visible after 91 hours, specimens cracked during bending at room temperature after the salt was washed off, showing that corrosion embrittlement had occurred, Figure 7.
