3 THE ROLE OF MOISTURE AND HYDROGEN IN  
HOT-SALT CRACKING OF TITANIUM ALLOYS

S. P. Rideout, R. S. Ondrejcin,  
M. R. Louthan, Jr., and D. E. Rawl  
Savannah River Laboratory  
E. I. du Pont de Nemours and Company  
Aiken, South Carolina, 29801

A.E.C.  
R-124

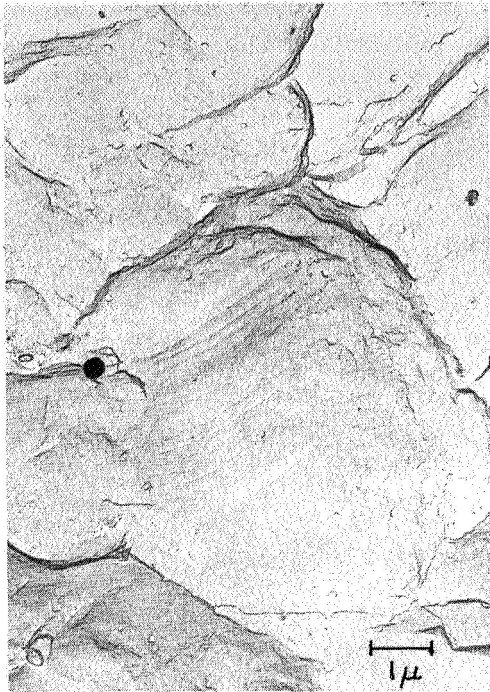
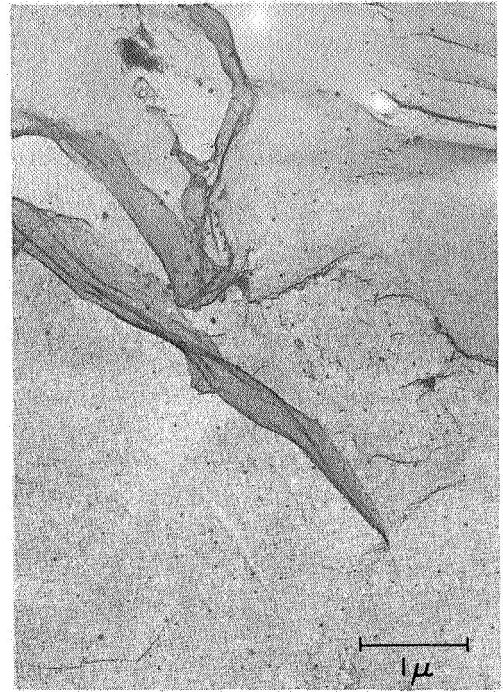
**NaCl - 650°F**

**Anhydrous HCl - 650°F**

**FIG. 9 FRACTOGRAPHS SHOWING EVIDENCE OF DISLOCATION MOVEMENT  
ACCOMPANYING FRACTURE DURING HOT-SALT CRACKING**

- C. Rough grain surfaces with areas of more or less regular ripples, steps or folds (see arrows). These regions probably result from serpentine glide, glide plane decohesion and stretching, and are interpreted as evidence of dislocation movement during the formation of the fracture surfaces. Figure 9 shows such regions in more detail.
- D. Pitting, probably resulting from corrosion after cracking was also observed in some samples (compare Figures 8a, b, and c with d and e). Severely pitted regions are shown in Figure 10 to emphasize the extent to which corrosion can occur.

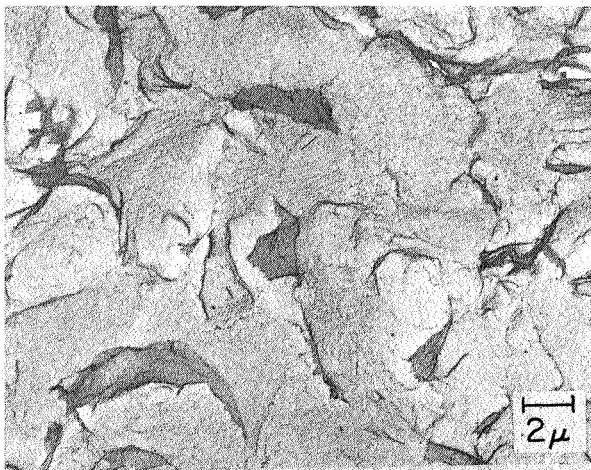
Anhydrous HCl at 650°F

SnCl<sub>2</sub> at 650°F

FIG. 10 FRACTOGRAPHS SHOWING EVIDENCE OF CORROSION OF FRACTURE FACES
