**METALLURGICAL ASPECTS OF RELIABILITY
FOR SMALL NITRIDED PARTS**

**Alfred J. Babecki
Materials R&D Branch
Systems Division**

**Goddard Space Flight Center
Greenbelt, Maryland**

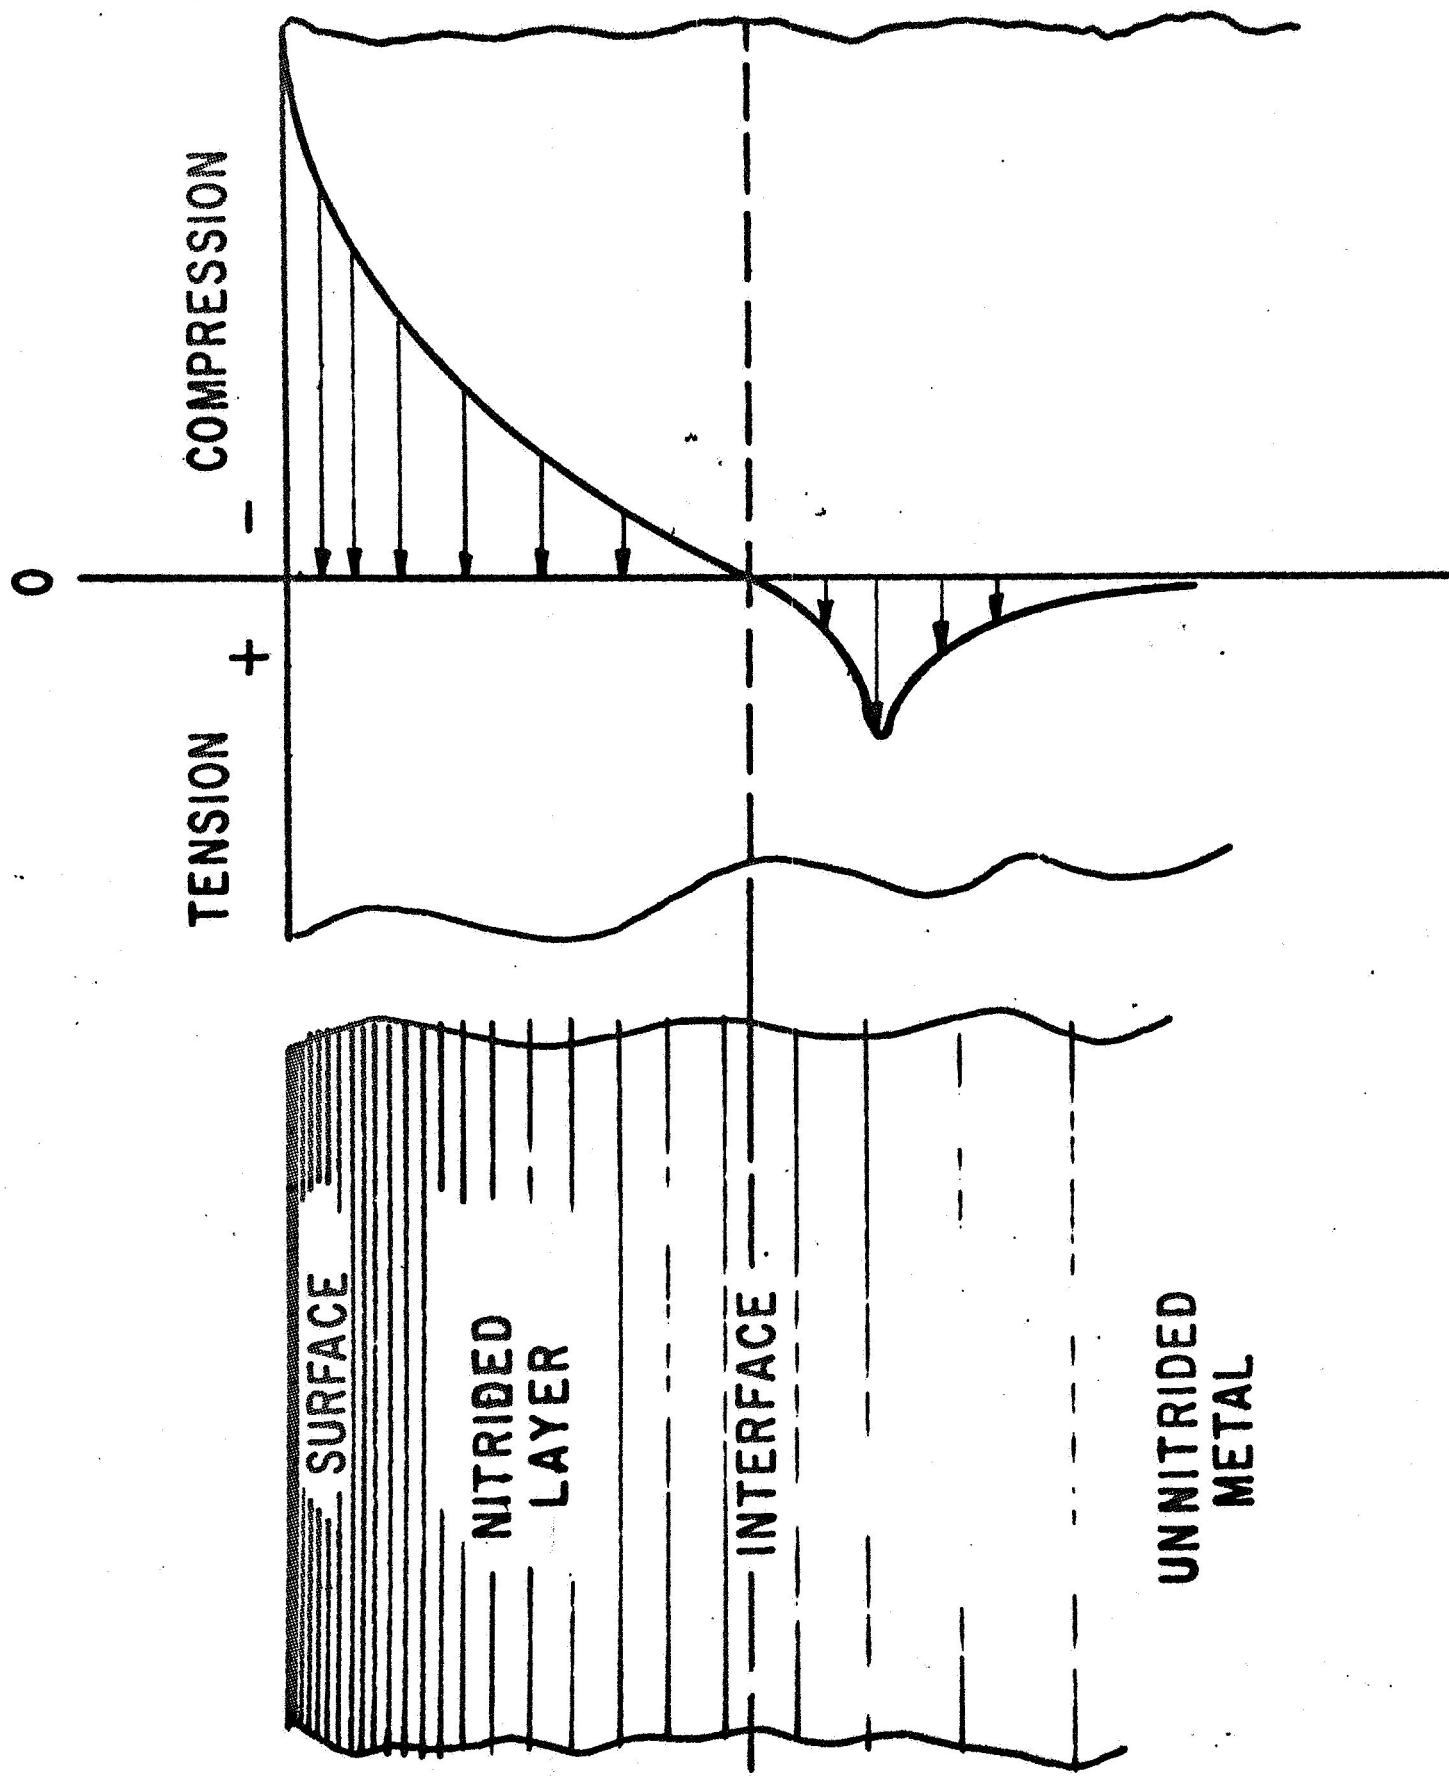
BENEFICIAL EFFECTS OF NITRIDING - The expansion of the nitrided layer on a steel part is resisted by the unnitrided metal beneath the surface. Accordingly, the stress pattern on such a processed part varies from a maximum compression on the external surface, through zero at the interface between the nitrided and unnitrided metal, to a maximum tension immediately beyond this interface, to a reduced tensile value within the core of the material, as shown in Figure 1.

Fig. 1 - Schematic of stress distribution in a nitrided surface.

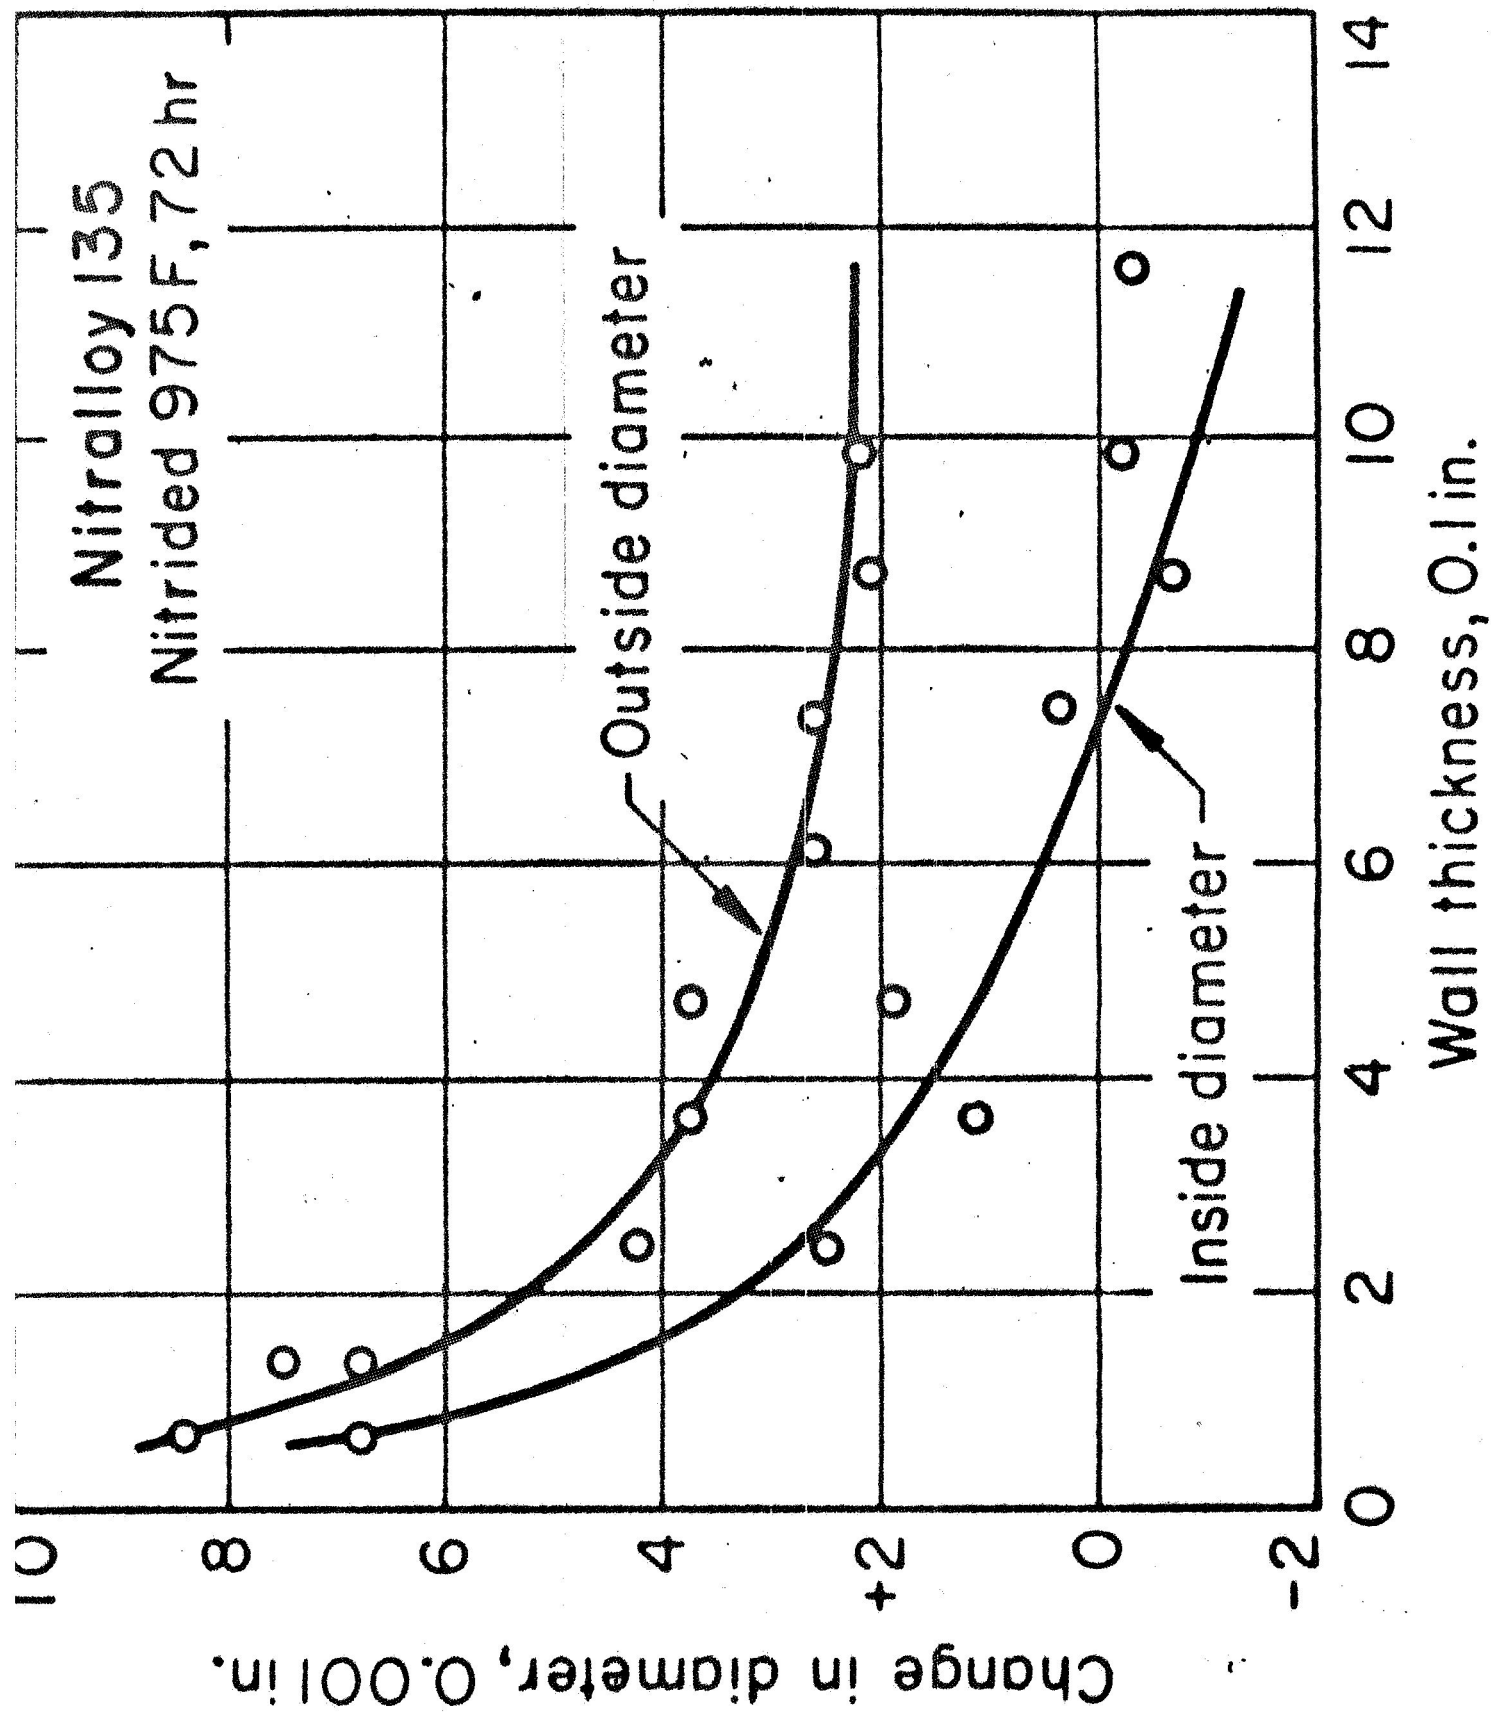
Figure 2 illustrates the growth that occurs in a nitriding alloy hollow cylinder as a function of wall thickness. In another case, the bore diameter of a 12-in.-dia. spur gear decreased by 0.001 in. while the OD increased by 0.004 in.

Fig. 2 - Growth in 2-3/4 in.-dia. hollow cylinders as a function of wall thickness.

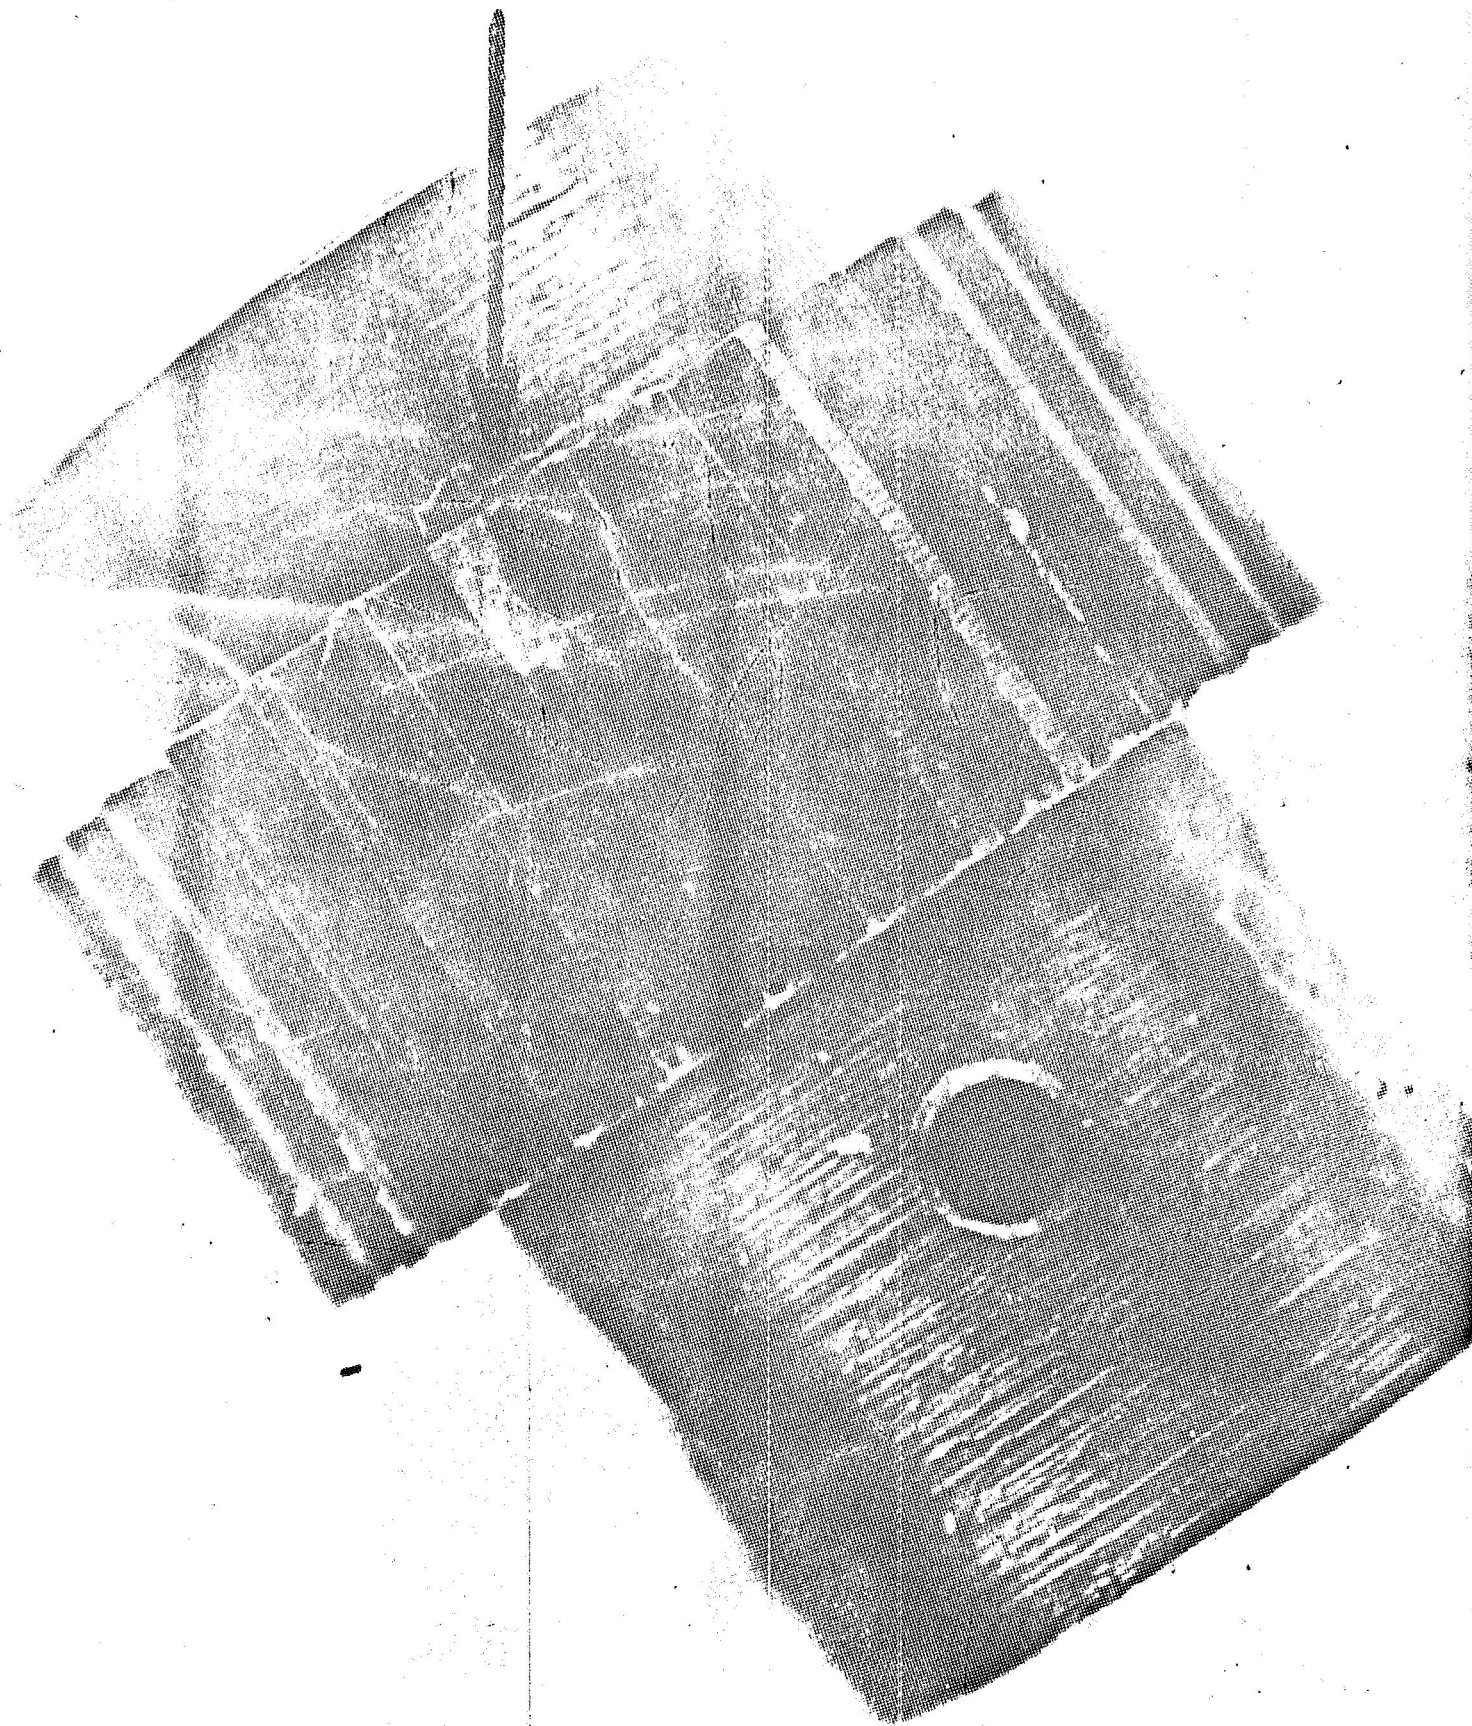
Figure 3 pictures one of the pinion gears exhibiting a broken tooth. The small size of the gear should be evident from the photo, but the size of the gear teeth is even more surprising when stated as measuring 0.025" in height and 0.017" in width at the pitch circle. The drawing for this gear called for a nitrided case depth of 3-6 mils, but failed to specify the criterion for defining the case depth. Technically, the depth of the case is regarded as the depth to which some change in composition or properties has been effected by the surface hardening process.

Fig. 3 - Output pinion gear of scanner drive with broken tooth (arrow).

Two alternative recommendations were made. These included the use of a thinner nitrided case of lower hardness formed only over the tooth wear surfaces, or a change to a through-hardening tough steel heat treated to R_C50-55 and glass-bead peened.

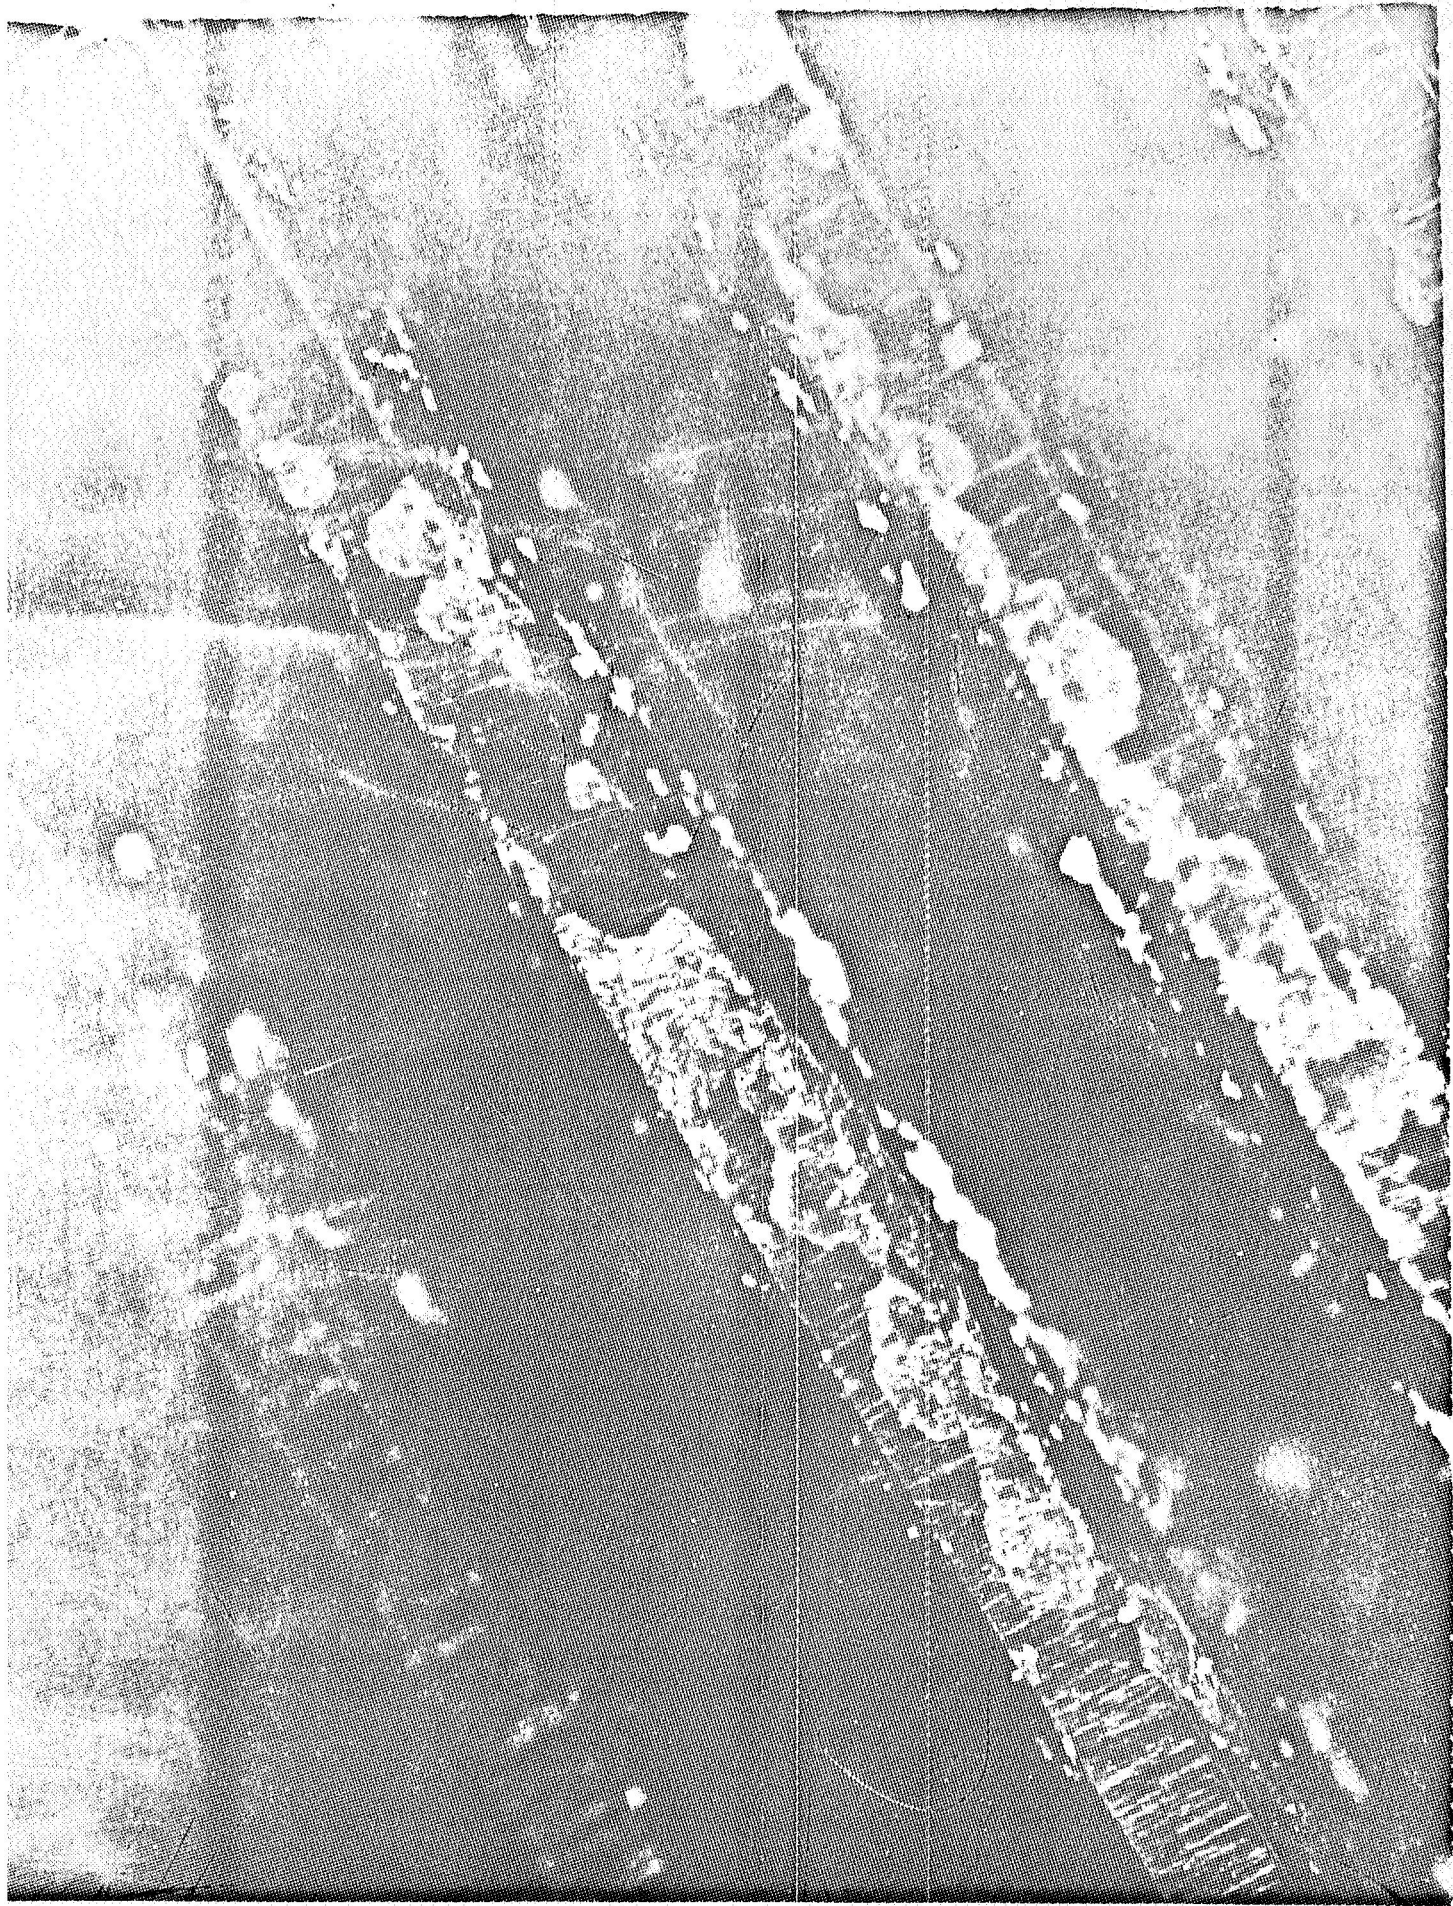
In addition to the broken tooth, the gear exhibited much chipping of the nitrided layer, Figure 4. Fractographic analysis of the fracture surfaces of the broken tooth indicated that it was not a fatigue failure, but a sudden cleavage failure, such as might happen under impact loading.

Fig. 4 - Magnified view of chipped nitride layer on teeth of scanner drive gear.

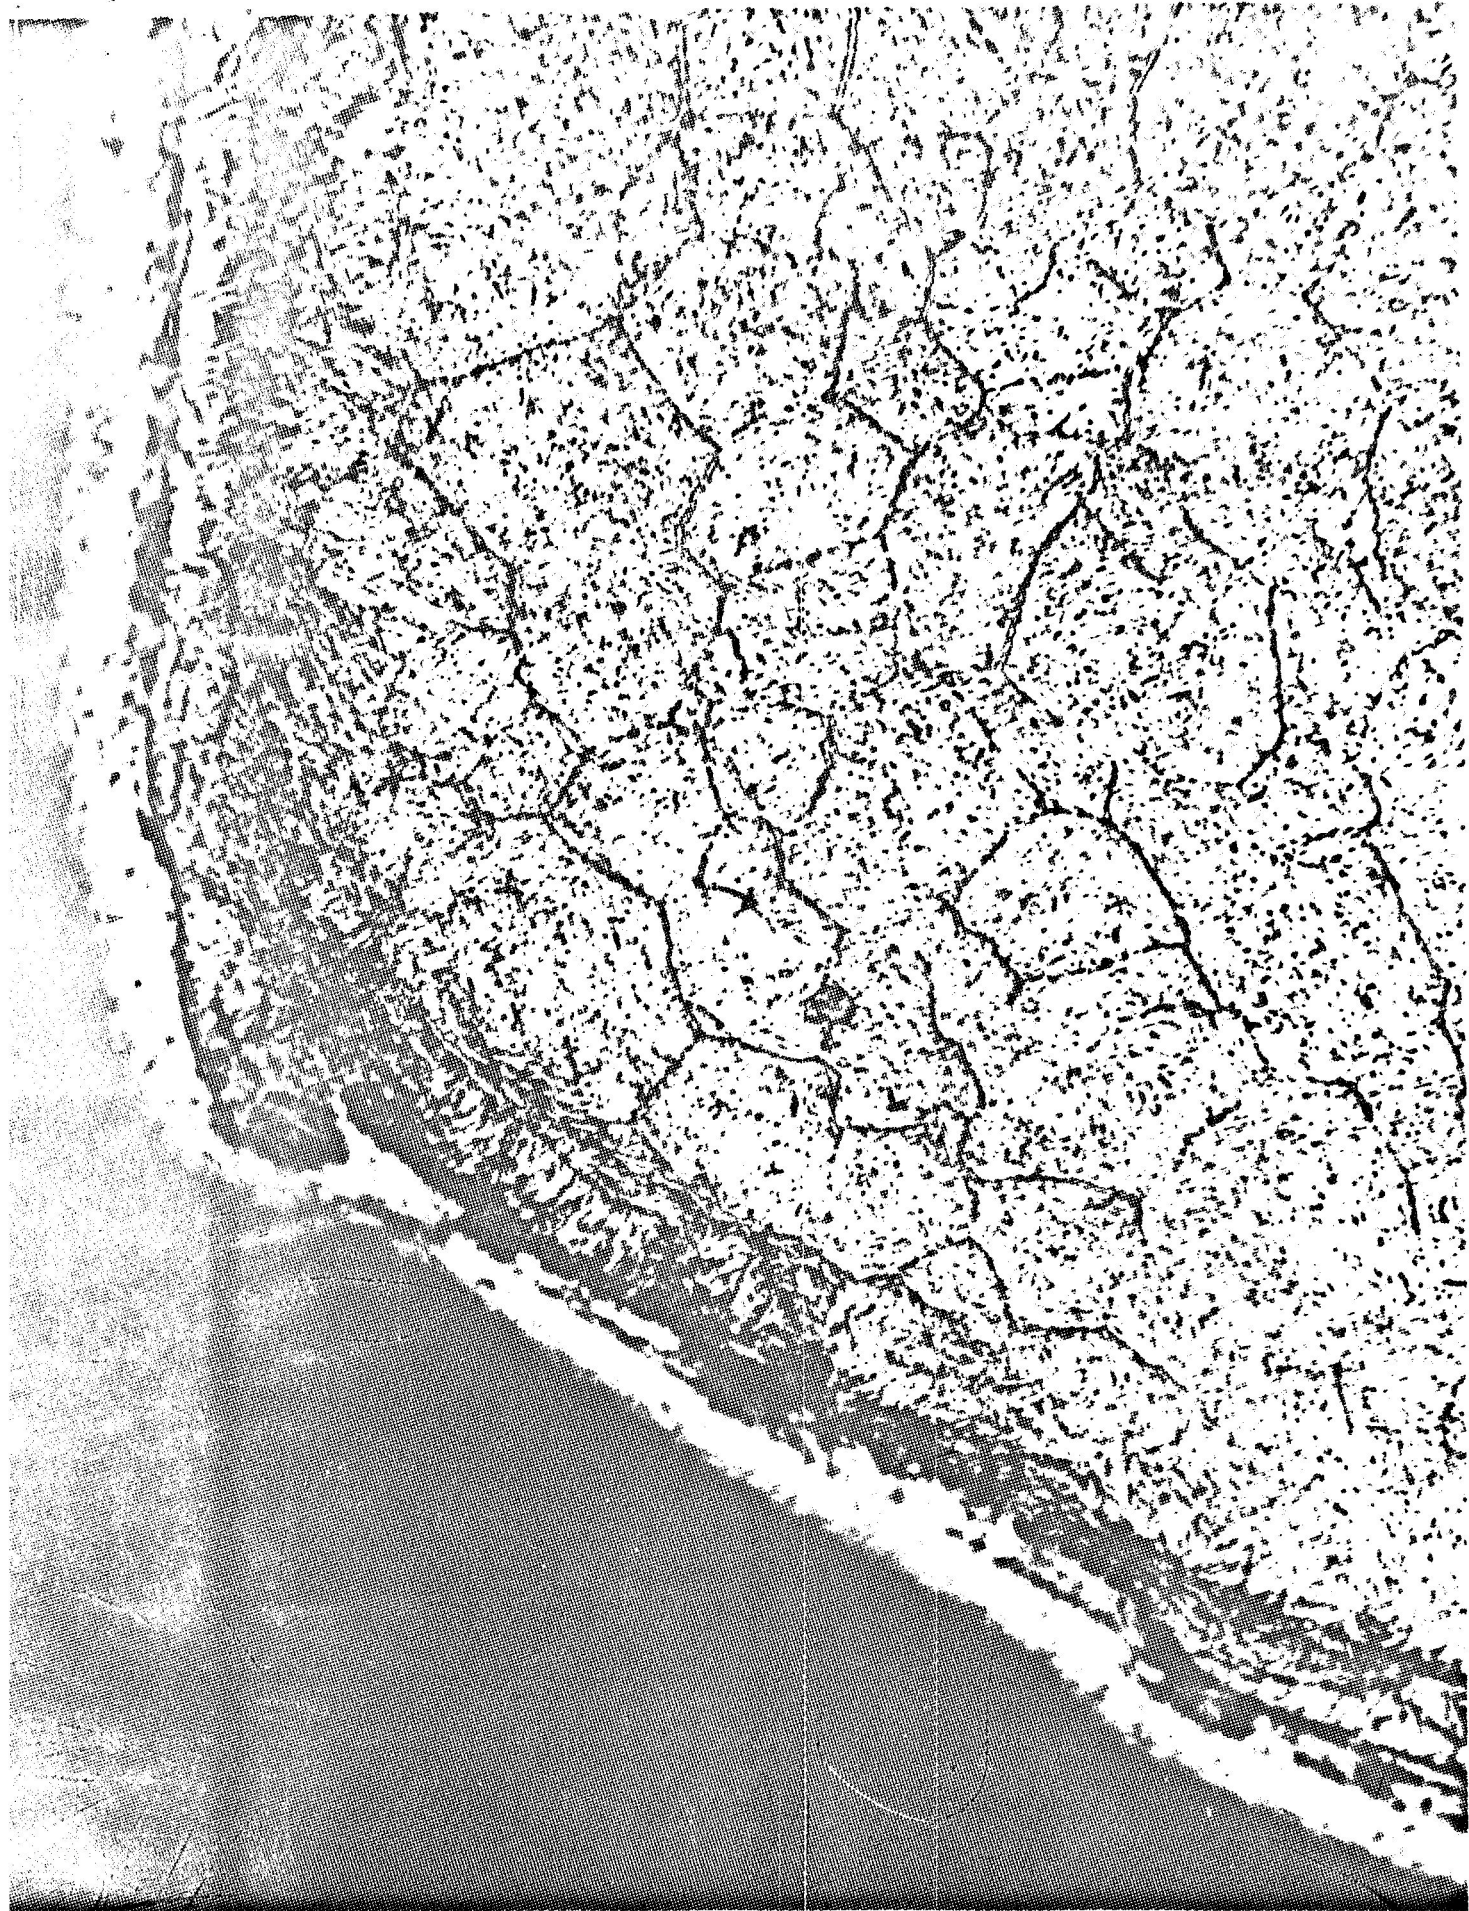
The gear was sectioned to provide both longitudinal and transverse specimens for metallographic examination. Figure 5 presents the transverse cross section of a tooth showing the chipping of the case outer layers at the external edge of the tooth apex face.

Microhardness measurements disclosed that the chipping layer represented hardness in excess of R_C70 and that this hardness persisted to a depth of 2.5 mils. The total case depth, measured to a hardness of R_C50 and representing brittle material, was 7 mils from the tooth apex face. Measured to the point of unaffected base material, the case depth was 15 mils.

In other words, the outer third of each tooth was in a highly-stressed extremely-brittle and vulnerable condition. In fact, metallographic examination of the broken tooth indicated that the break had occurred through the R_C50 hardness zone. In this case, therefore, the case-to-core ratio was excessive, and the surface hardness and internal stress also was excessive in that they both promoted cracking and chipping of this outermost layer.

Fig. 5 - Cross section of scanner drive gear etched to reveal chipped brittle nitride layer. White outer layer is nickel plating to preserve edge during polishing. Nital-picral etch.

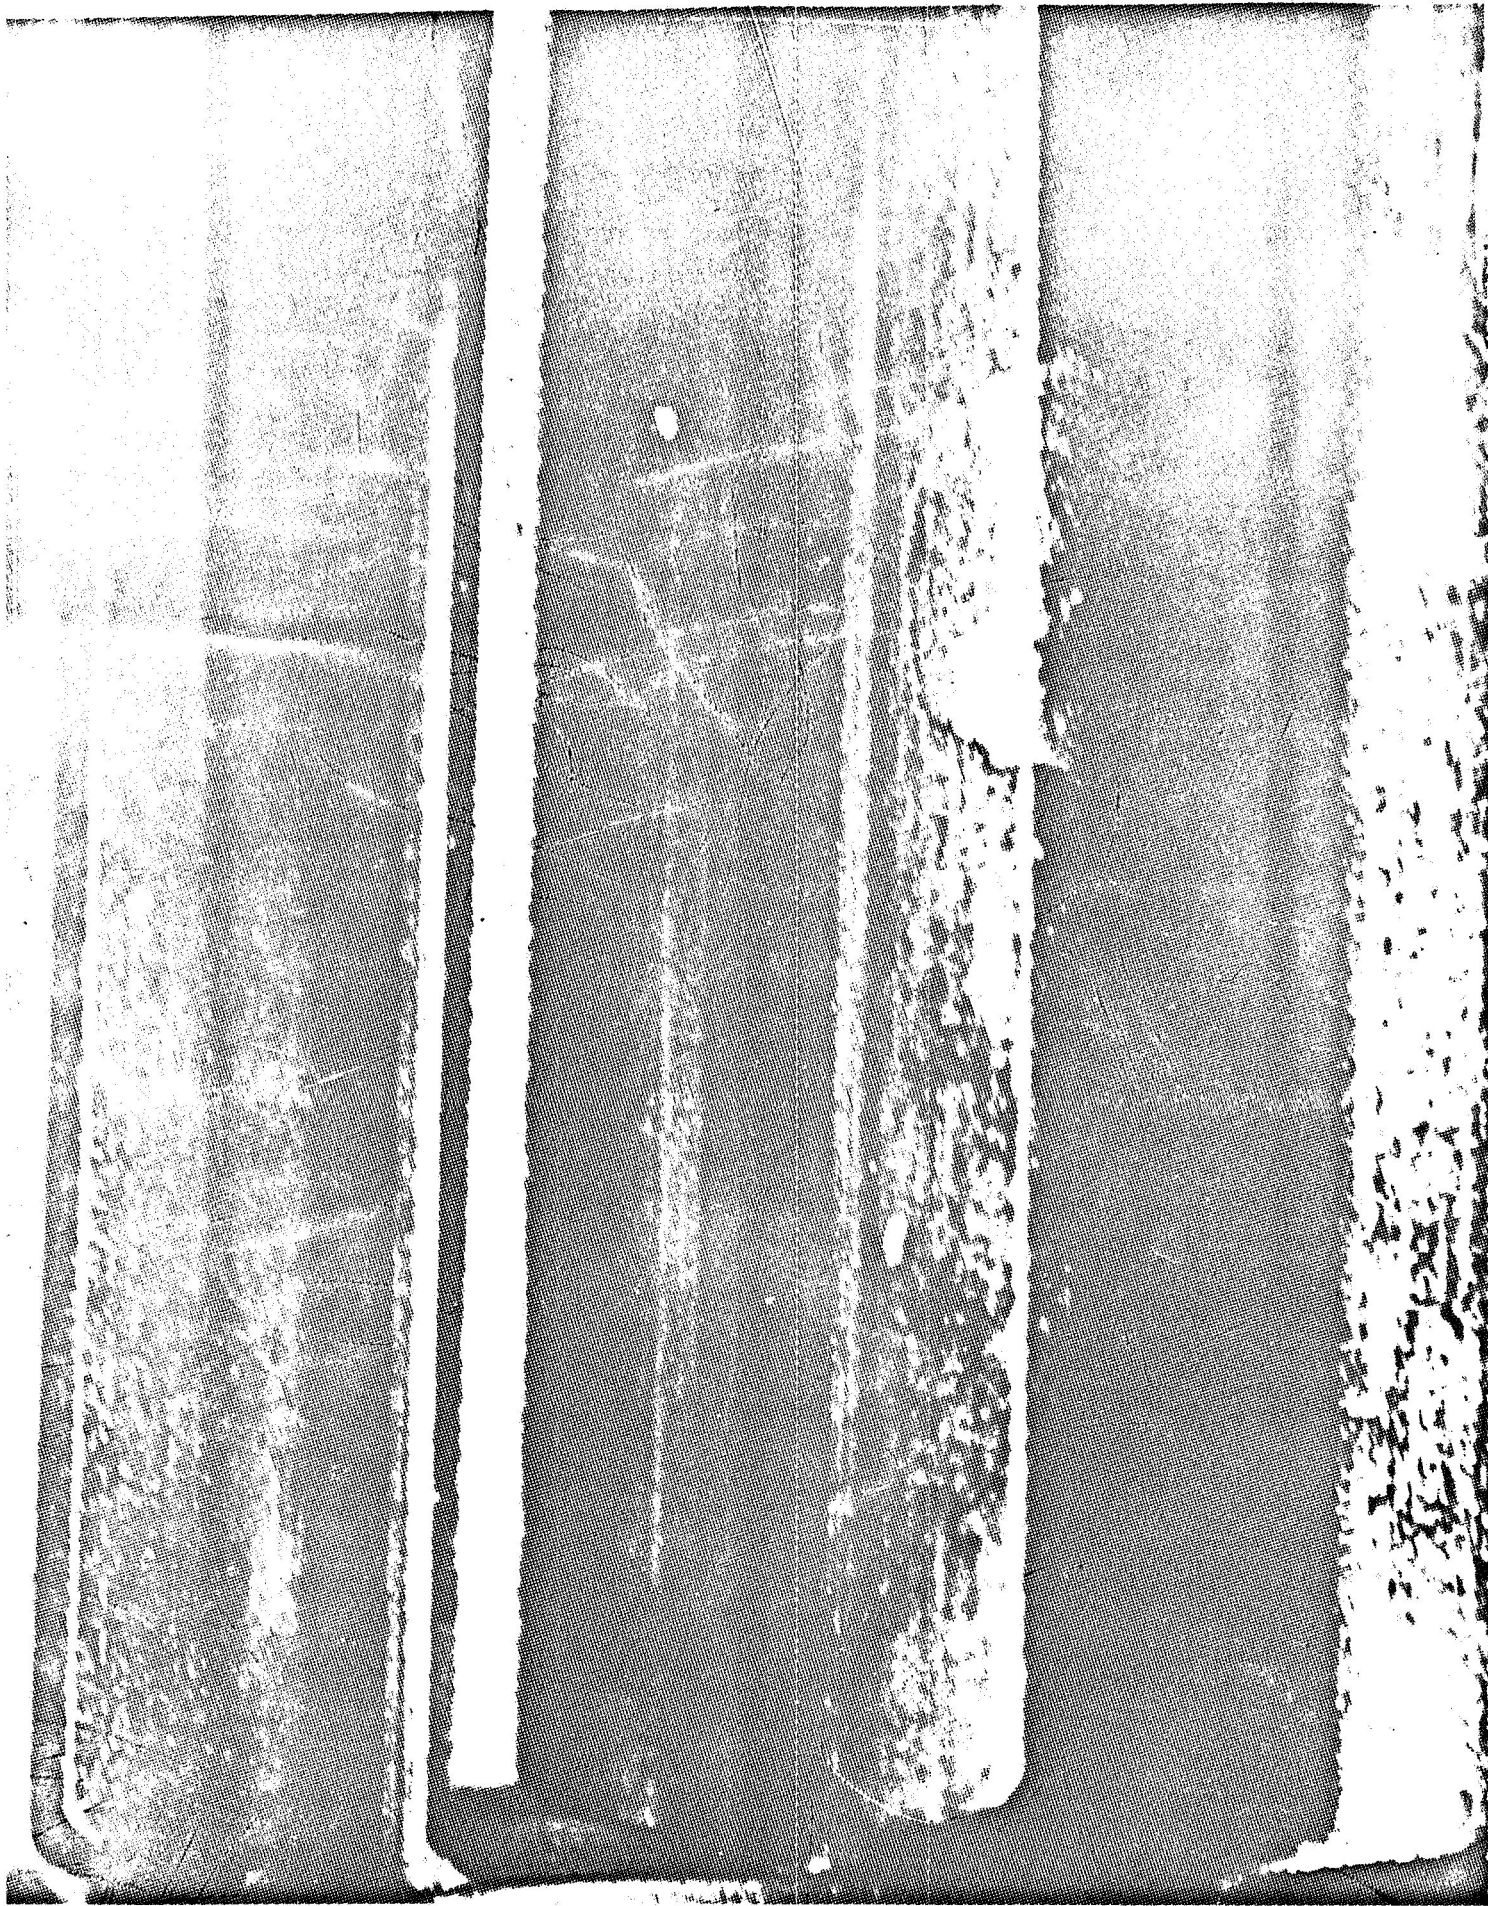
Figure 7 pictures a pinion gear showing a typical condition which existed on practically all of the gears in the train. Large areas of flaking of the nitrided case had occurred both in and out of the wear track. In fact, some flaking had also developed on the gear shafts.

Fig. 7 - Spalling of nitrided case on pinion gear of solar array drive.

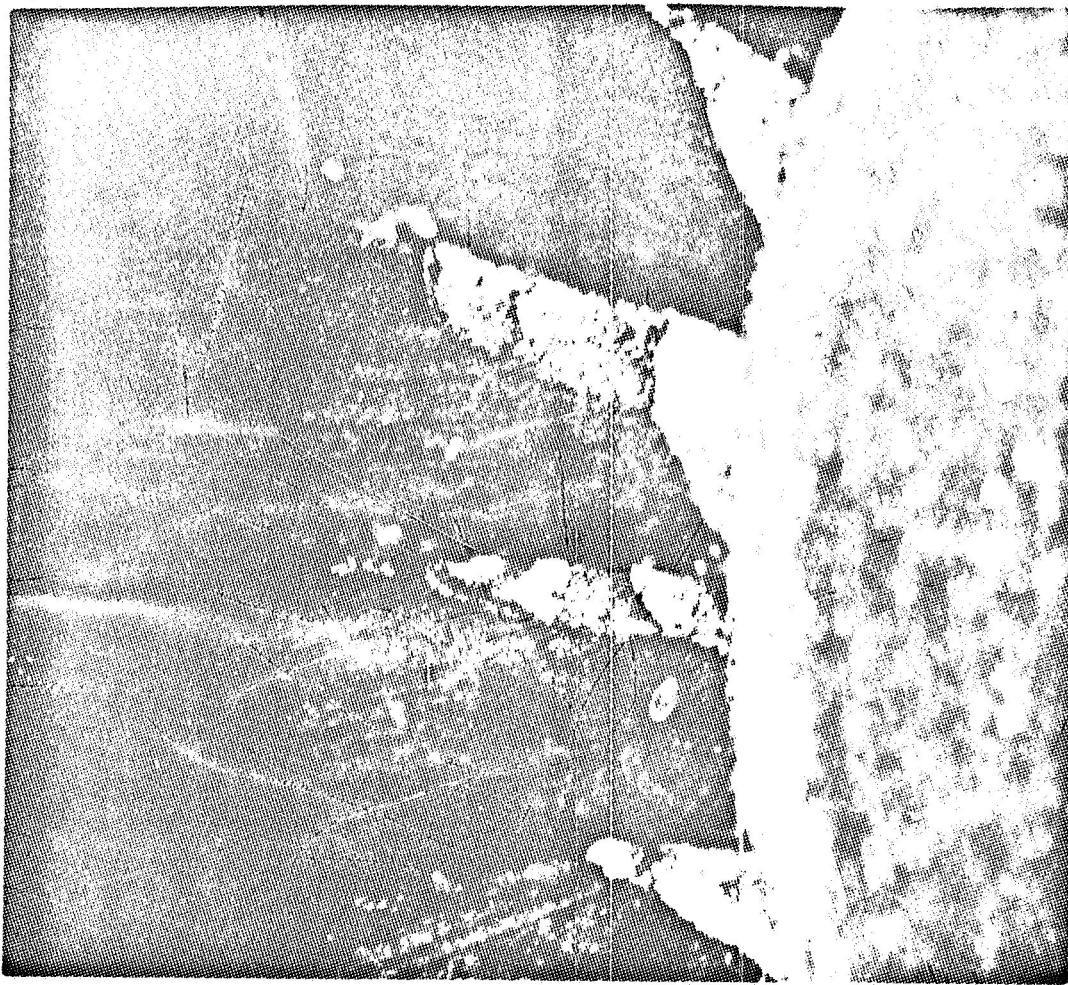
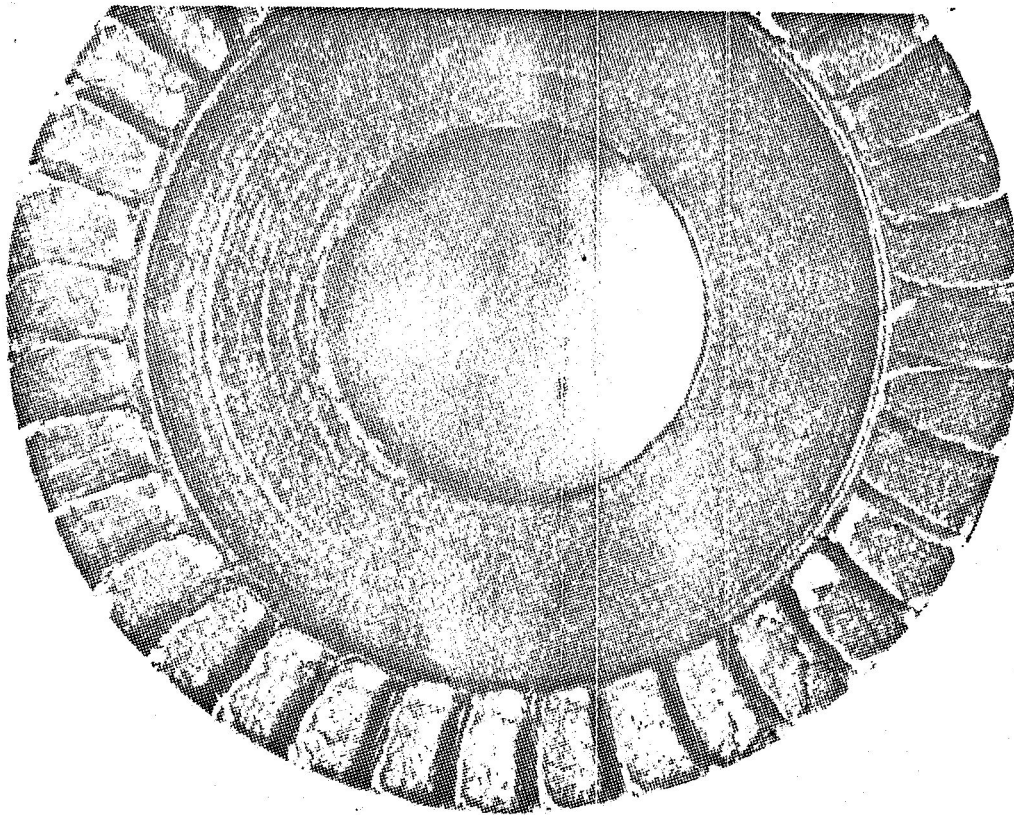
A failed motor was disassembled, and the two ratchet wheels were found to have extensive tooth damage. Figure 10 pictures a straight-on view of the ratchet wheel and a close-up view of some of the damaged teeth. With the diameter of the wheel being only about $1/4$ ", one can imagine the small size of the teeth. As a matter of fact, the teeth were set at a 45° angle and had a slant height of only 12 mils.

With the aid of a microscope, it was learned that slight pressure on the unbroken portions of the teeth with a sharp instrument caused tooth fragmentation, indicating the fragility of their condition. The appearance of the broken surfaces definitely was of a brittle nature.

Fig. 10 - Ratchet wheel from spectrometer grading drive in full view (left) and in close-up (right). Fragmented teeth are evident.

It was recommended that surface hardening techniques not be used on such small components because of the difficulty in maintaining the required control of the process and in performing adequate inspection. As a substitute for the nitrified Nitralloy, a through-hardening but tough steel was recommended, heat treated to a hardness of 50-55 R_C to match the hardness of the pawls.

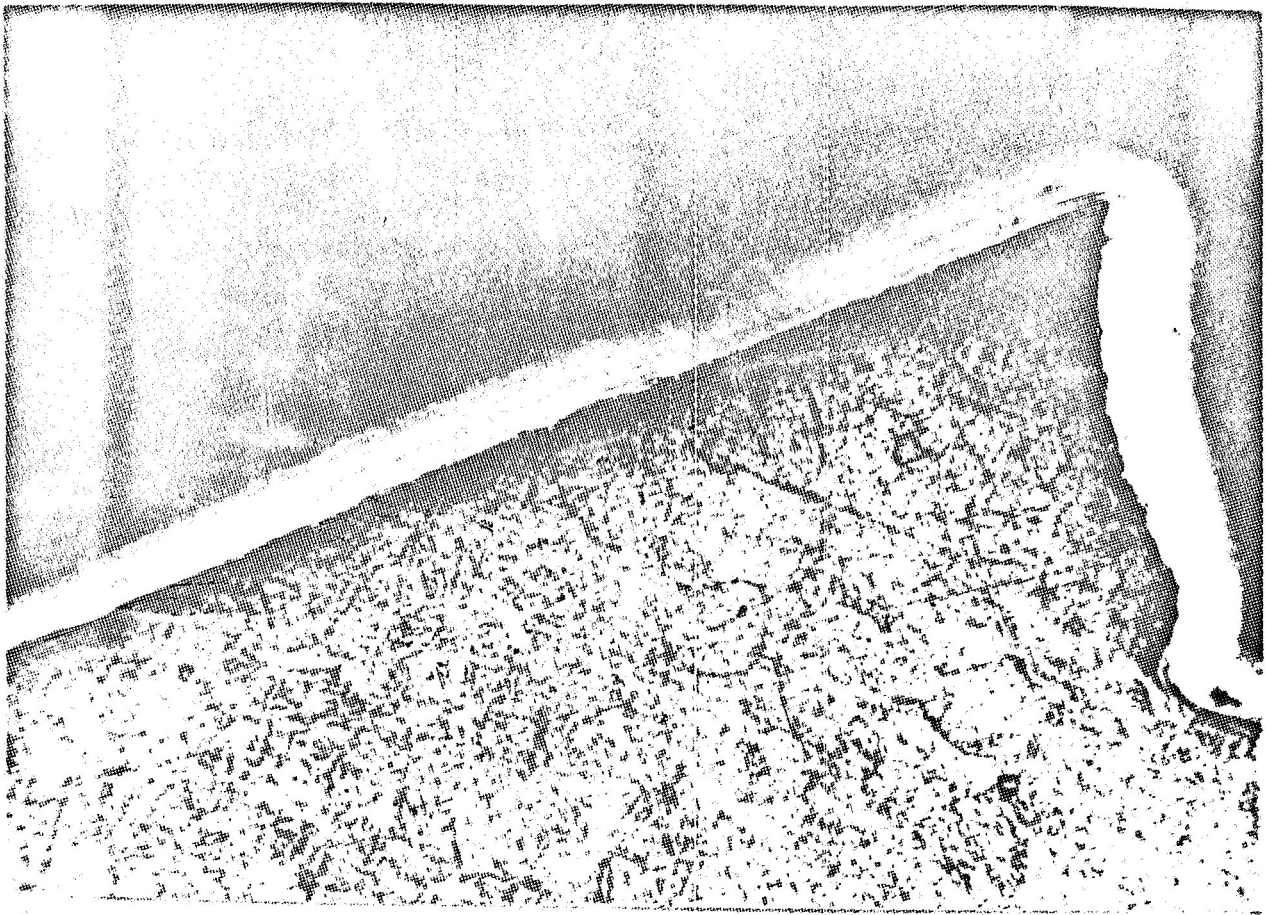
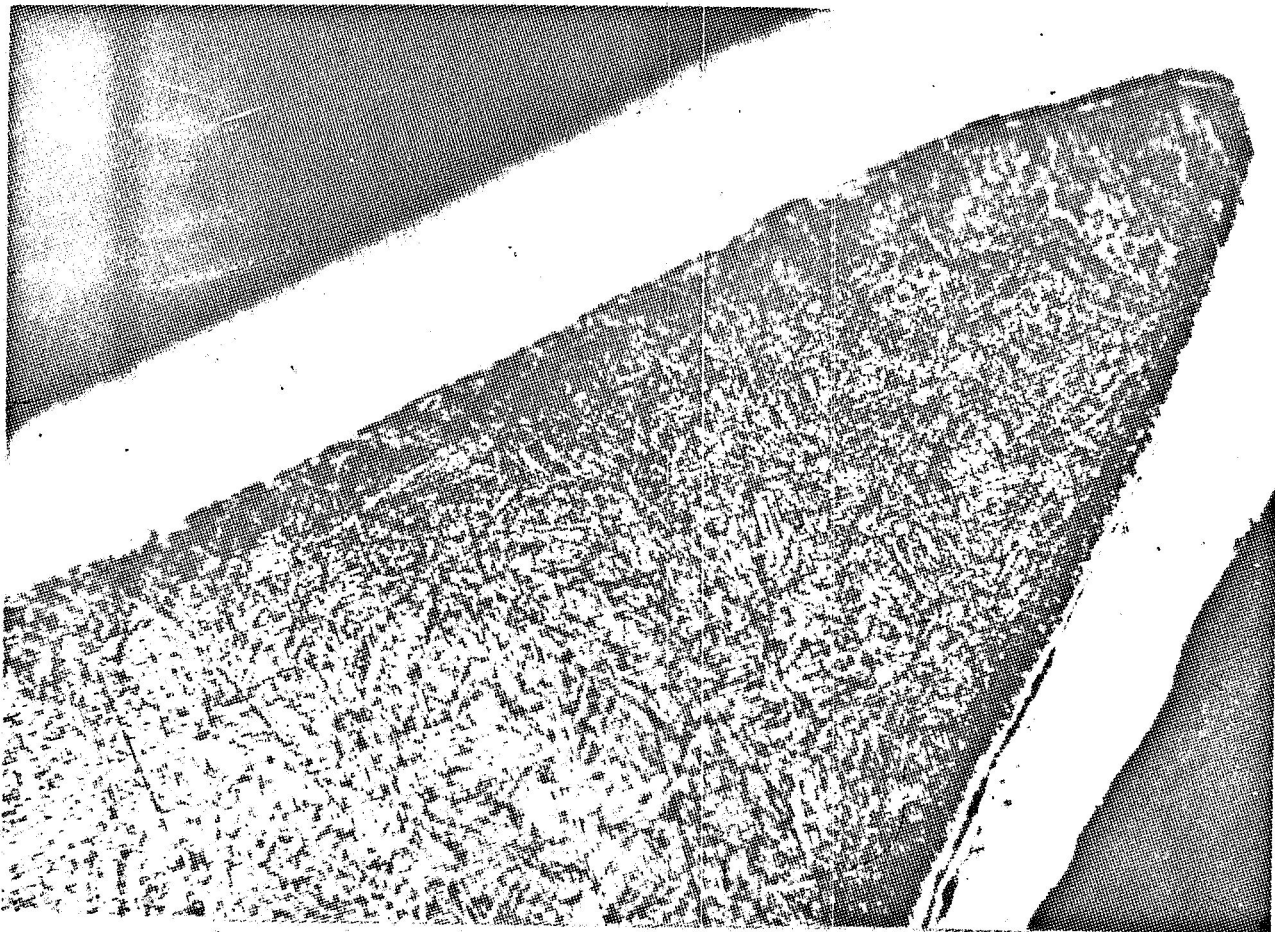
Two ratchet wheels were examined metallographically, and both gave similar results. Figure 11 shows broken and non-broken teeth in cross section and in the chemically-etched condition. The dark-etched region indicates the area of maximum nitrided hardness,

and it is seen to occupy most of the tooth depth. Microhardness measurements revealed that the typical tooth had a hardness of 65 R_C or more to a depth of 7 mils, representing more than half the height of the entire tooth. Actually, the entire tooth had been hardened by the nitriding process, as evidenced by a hardness of R_C50 at the maximum depth of the tooth, whereas the core hardness of the wheel was R_C30 .

The examination disclosed that almost the entire cross section of the ratchet teeth was embrittled by the nitriding, instead of having received only a hard surface layer. Concomitantly, the high internal compressive stresses that accompanied the nitriding tended to pop off the teeth because of the acute external angle they present. Therefore, the additional stresses imposed by subsequent service, or handling, precipitated the failures.

Fig. 11 - Cross sections of broken (left) and non-broken (right) ratchet teeth at two magnifications. Heavy white layer is nickel plating to preserve edge during polishing. Nital etch.
