DEVELOPMENT OF AN ACCELERATED
STRESS-CORROSION TEST FOR
FERROUS AND NICKEL ALLOYS

NOR 68-58

FINAL SUMMARY REPORT
Covering the Period March 1966 to March 1968

Northrop Corporation, Norair Division
3901 West Broadway,
Hawthorne, California 90250
Research and Technology Section
A. H. Freedman (Author)

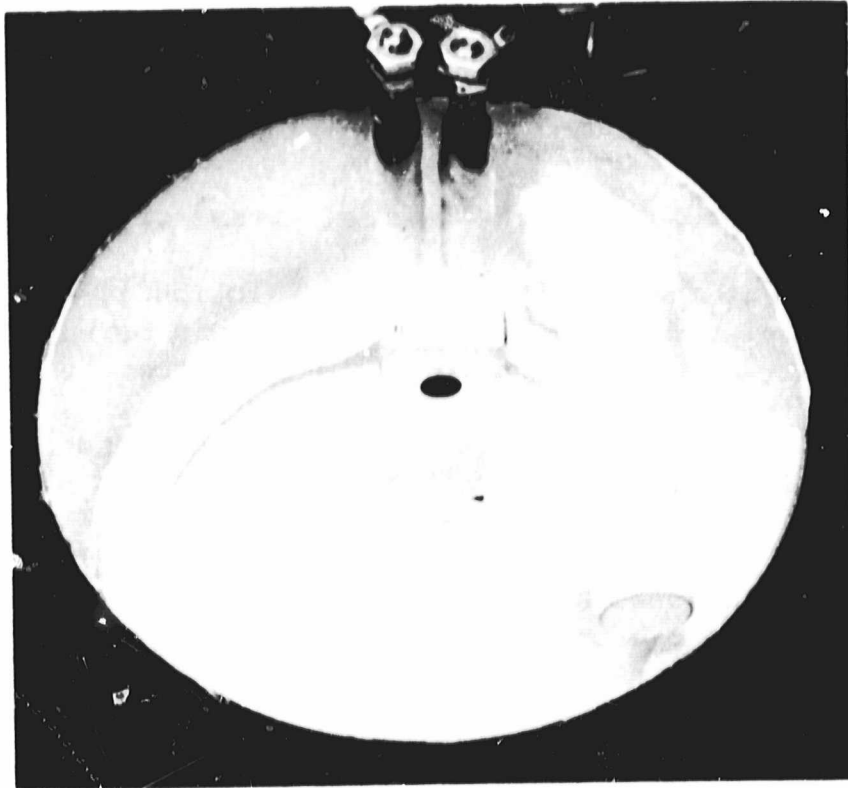
FIGURE 4 CONTAINER ASSEMBLY FOR ACCELERATED STRESS-CORROSION TESTS

A typical specimen-and-corrodent-container assembly for aqueous, accelerated, stress-corrosion tests is shown in Figure 4. The stainless steel container was coated with General Electric RTV-11 silicone rubber cured with Thermolite 12 (dibutyl tin dilaurate) during a cure cycle of two hours at 350F. The coating was applied to prevent galvanic attack as well as stray solution potentials between container and specimen. Some of these containers were equipped with annular immersion heaters and temperature control thermostats, which were also coated.

The bottom of each container was slotted so that the specimen could be extended through the slot for attachment to the loading clevice. Corrodent leakage around the slot was prevented by potting. The potting procedure used during the first year of effort³ was modified to eliminate bond-line degradation and leakage after approximately 400 hours of test time on specimens of 4340, H-11, and 18Ni Maraging steel. The modified potting technique outlined below worked effectively for all program materials.

Each container was covered with a stainless steel lid, which was sometimes taped to the container. The lid minimized water evaporation and also the splashing of the corrodent when a specimen fractured. Figure 5 shows a typical container assembly positioned in the same type of test fixture as that used for seacoast tests. The triangular stainless steel plate pinned to the clevice supported the container assembly and minimized stresses on the potting compound.

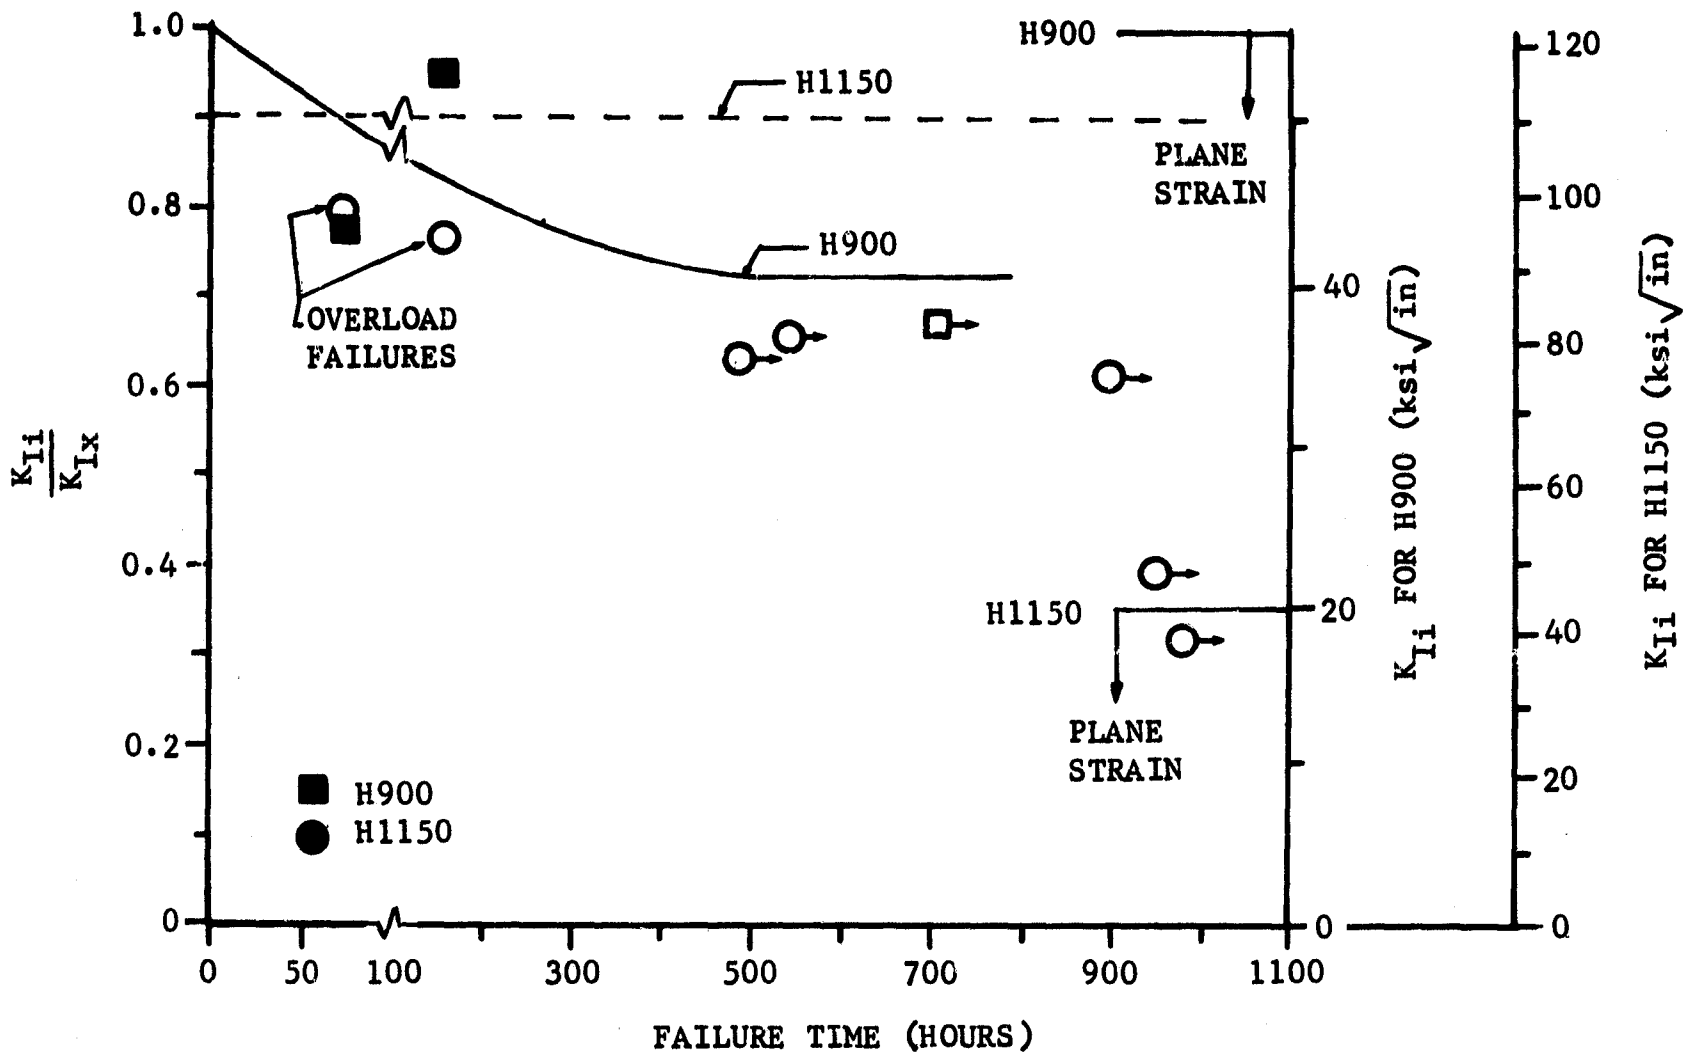
FIGURE 15 STRESS-CORROSION BEHAVIOR OF 17-4 - ACCELERATED TEST

NOTE: OPEN POINT INDICATES NO STRESS
CORROSION AND ARROW INDICATES NO FAILURE

The stress-corrosion behavior of 17-4 stainless steel is shown in Figure 15. The curve for 17-4 H1150 material was based primarily upon specimens loaded to stress-intensity ratios of approximately 0.76 and 0.8. Although these specimens failed during test, fractographic analysis showed overload failures with no evidence of stress corrosion. The threshold level for this H1150 material was far above the allowable stress intensity for plane strain.

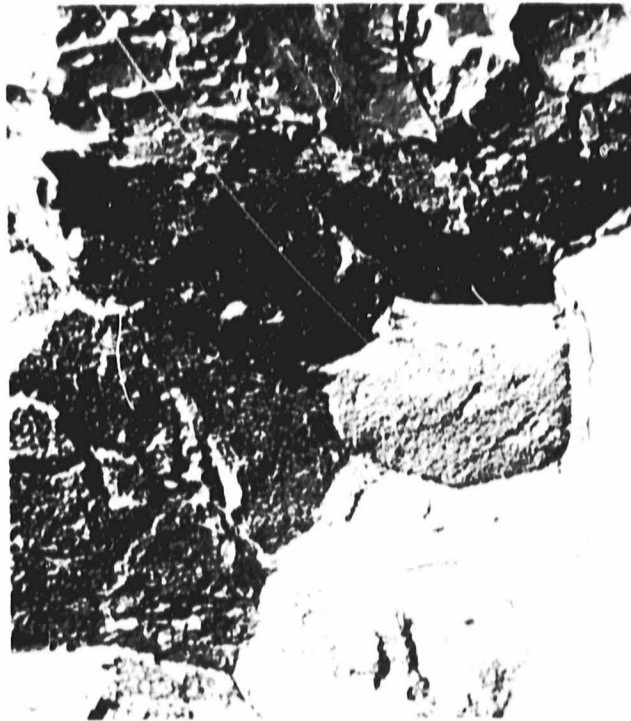
FIGURE 21 ELECTRON FRACTOGRAPHS OF STRESS-CORROSION FRACTURES OF AIR-MELTED H-11 (1000F TEMPER)

SPECIMEN A38 SEACOAST TEST

$$K_{Ii} = 26.7 \text{ ksi} \sqrt{\text{in}}$$

SPECIMEN A40 ACCELERATED TEST

$$K_{Ii} = 29.2 \text{ ksi} \sqrt{\text{in}}$$

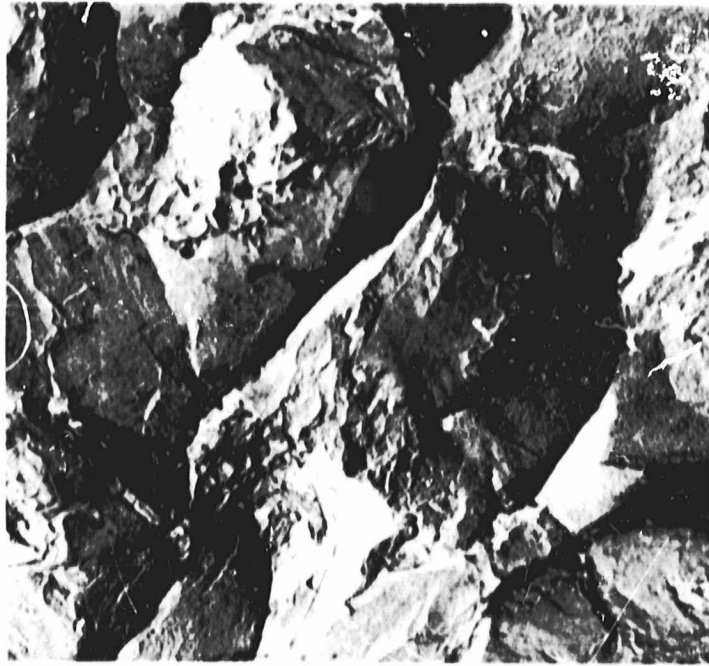
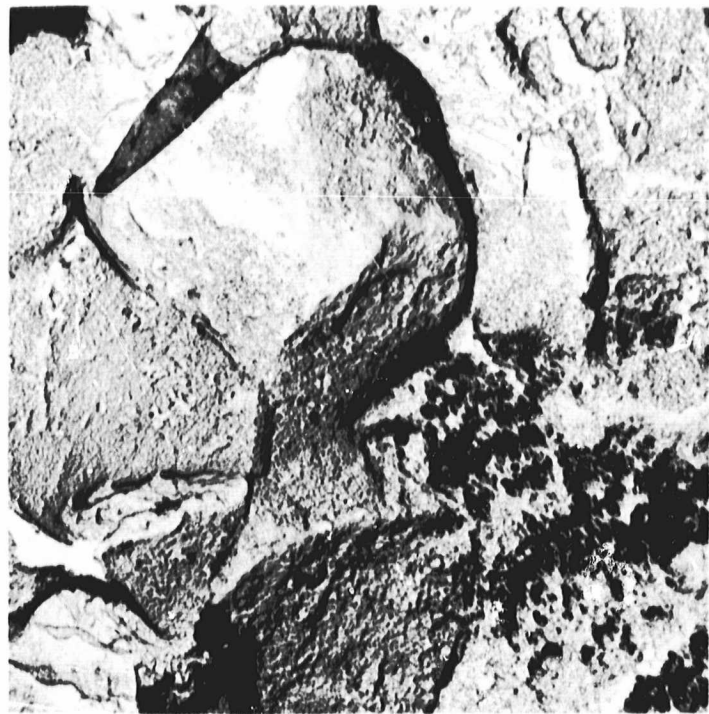
FIGURE 22 ELECTRON FRACTOGRAPHS OF STRESS-CORROSION FRACTURES OF 4340 (475F TEMPER)

SPECIMEN C9 SEACOAST TEST

$$K_{Ii} = 43.2 \text{ ksi} \sqrt{\text{in}}$$

SPECIMEN C13 ACCELERATED TEST

$$K_{Ii} = 35.9 \text{ ksi} \sqrt{\text{in}}$$

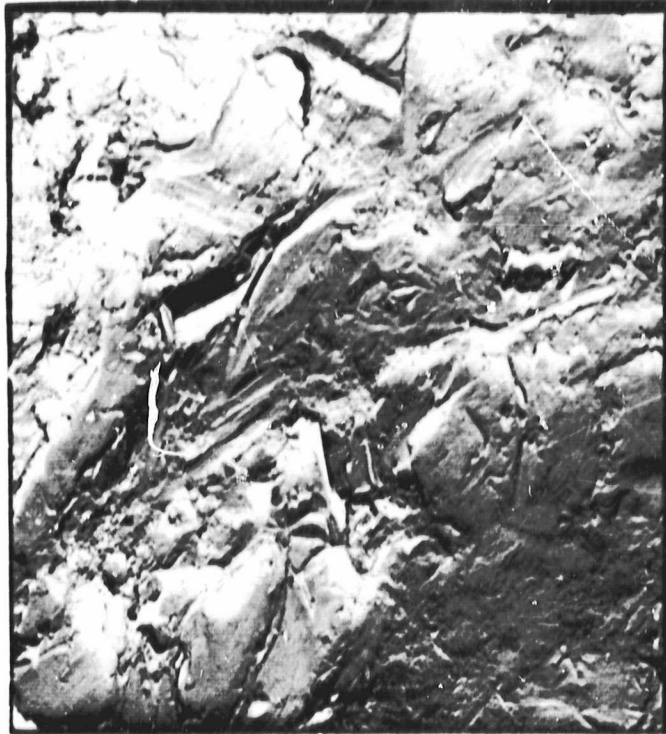
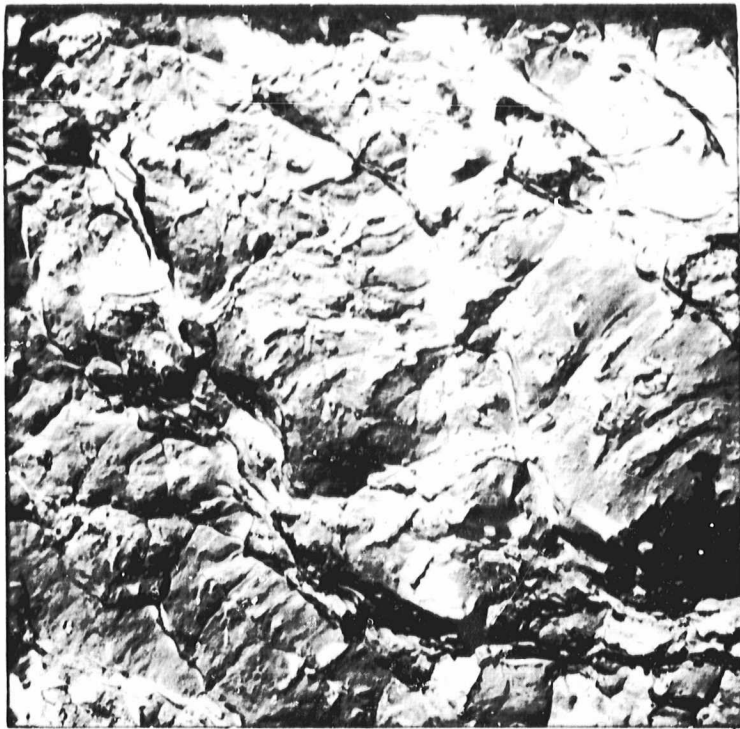
FIGURE 23 ELECTRON FRACTOGRAPHS OF STRESS-CORROSION FRACTURES OF 18Ni-250 (900F) MARAGING STEEL

SPECIMEN B5 SEACOAST TEST

$$K_{Ii} = 93.8 \text{ ksi} \sqrt{\text{in}}$$

SPECIMEN B14 ACCELERATED TEST

$$K_{Ii} = 82.5 \text{ ksi} \sqrt{\text{in}}$$

Electron fractographs of 18Ni Maraging steel are shown in Figure 23. The seacoast specimen had a semi-featureless topology which was intergranular in nature. The smooth grain-like facets and grain boundaries were not as well defined as in classical examples whereas the stress-corrosion zone of the accelerated test specimen revealed a well defined, intergranular mode of propagation. Grain boundaries were very evident, and a small amount of corrosion product was visible as particles on the grain faces.

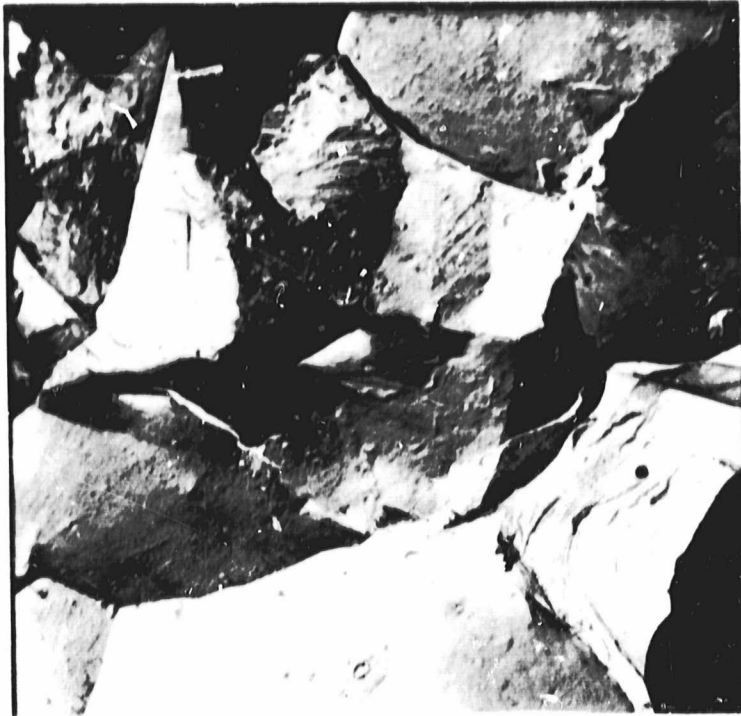
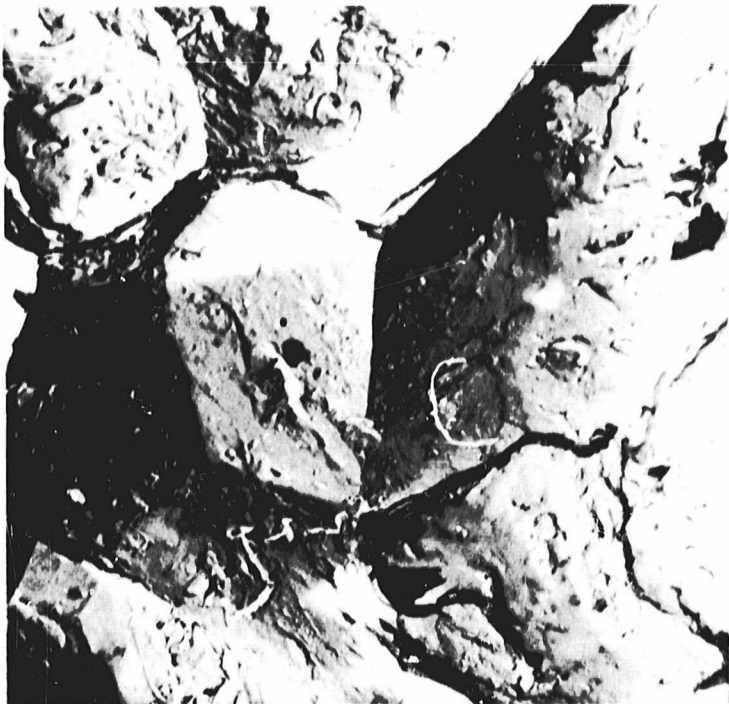
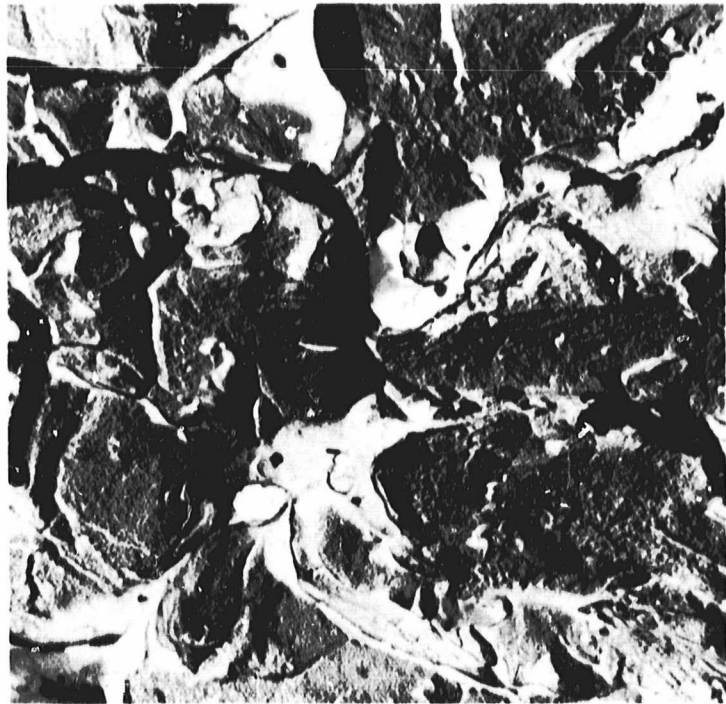
SPECIMEN E5 SEACOAST TEST

$$K_{Ii} = 76.0 \text{ ksi} \sqrt{\text{in}}$$

INTERGRANULAR FRACTURE REGION

TRANSGRANULAR CLEAVAGE REGION

Figure 24 shows fractographs of 410 tempered at 650F and tested at stress intensities well above both threshold values and allowable plane-strain loading conditions. Seacoast specimens revealed only intergranular stress-corrosion fracture, as evidenced by the sharp pyramidal facets. Very slight corrosion of the fracture facets was noticed. Analysis of the accelerated-test specimen revealed a mixed-mode fracture. Both intergranular and transgranular cleavage fracture were found. The relative proportion of intergranular-to-cleavage mode was approximated at 4:1. Hydrogen embrittlement generally produces a quasi-cleavage fracture mode in 410 tempered at 650F-700F;¹⁸ the presence of cleavage in the accelerated-test specimen suggested that hydrogen embrittlement may have contributed to failure.

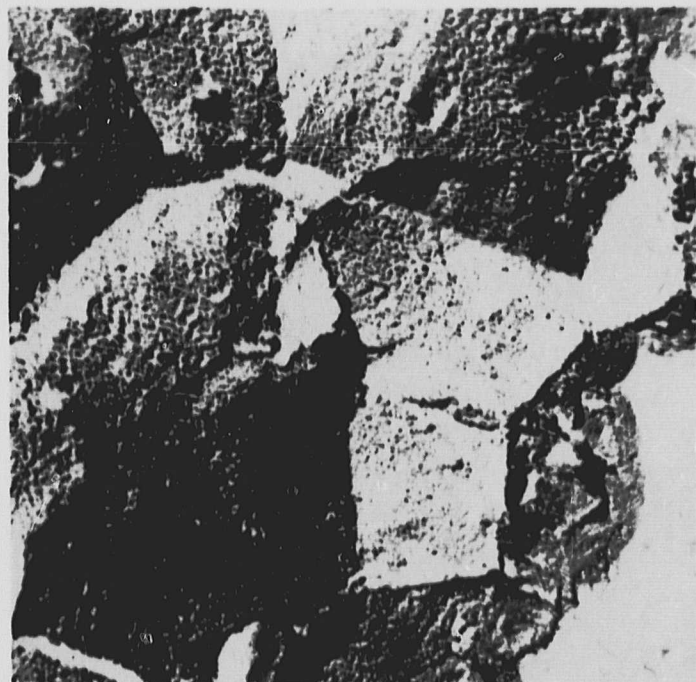
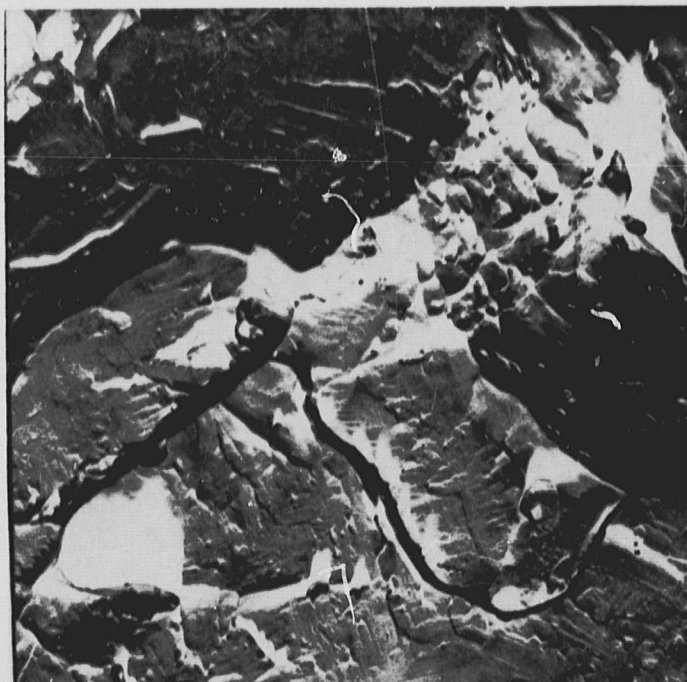
FIGURE 26 ELECTRON FRACTOGRAPHS OF STRESS-CORROSION FRACTURES OF 17-4 (H900)

INTERGRANULAR FRACTURE REGION

TRANSGRANULAR FRACTURE REGION

SPECIMEN F7 SEACOAST TEST

$$K_{Ii} = 44.1 \text{ ksi} \sqrt{\text{in}}$$

$$K_{Ii} = 43.0 \text{ ksi} \sqrt{\text{in}}$$

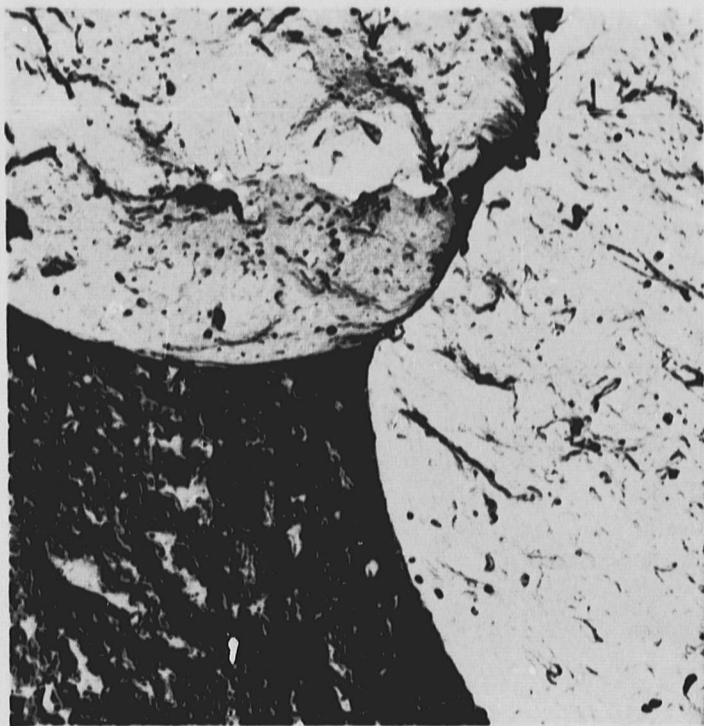
SPECIMEN G4 SEACOAST TEST
 $K_{I1} = 28.7 \text{ ksi} \sqrt{\text{in}}$

INTERGRANULAR FRACTURE REGION

QUASI-CLEAVAGE TRANSGRANULAR REGION

Figure 27 shows typical electron fractographs taken from the stress-corrosion propagation zone of AM355 heat treated to the SCT850 condition. Fracture was found to be intergranular in both the seacoast-and accelerated-test specimens. This was evidenced by the smooth grain facets observed in both fractographs. The accelerated-test specimen G27 did, however, show isolated areas of quasi-cleavage type transgranular fracture. Specimens G5, loaded to a K_{Ii} of $35.4 \text{ ksi}\sqrt{\text{in.}}$ in the seacoast environment, and G28, loaded to a K_{Ii} of $34.7 \text{ ksi}\sqrt{\text{in.}}$ in the accelerated test, also were examined fractographically. At this higher stress intensity, the seacoast specimen still exhibited an intergranular fracture mode. The fracture mode of the accelerated-test specimen changed from essentially intergranular fracture to approximately 80-percent transgranular quasi-cleavage and 20-percent intergranular fracture. However, the results on specimens of Figure 27 were considered to be more significant because K_{Ii} values were closer to the K_{ISCC} value.

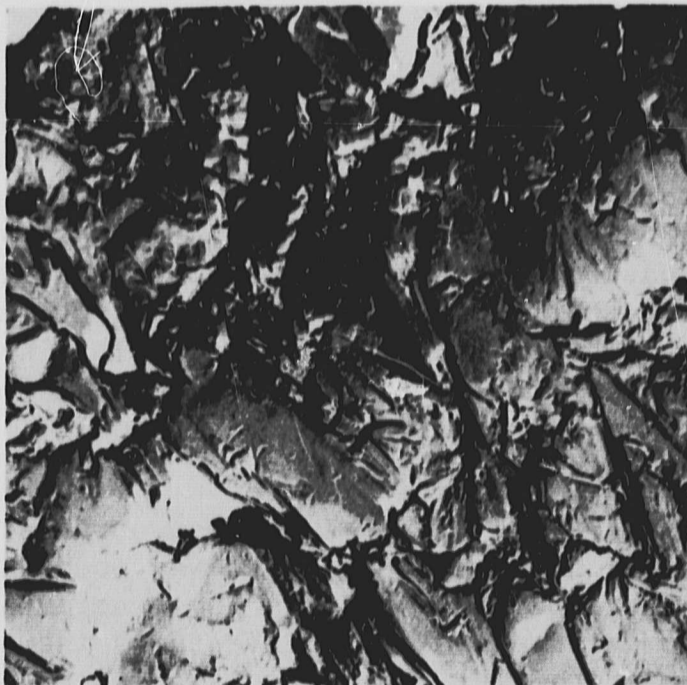
FIGURE 28 ELECTRON FRACTOGRAPHS OF STRESS-CORROSION FRACTURES IN 18Ni-250 (900F) FUSION ZONES

SPECIMEN 2WB7 SEACOAST TEST

$$K_I = 59.8 \text{ ksi} \sqrt{\text{in}}$$

SPECIMEN 2WB10 ACCELERATED TEST

In summary, some of the fractographic comparisons showed anomalies between seacoast-and accelerated-test specimens. However, none of these anomalies were observed in the stress-corrosion regions of specimens tested near threshold stress intensities. Therefore, fractography showed no definite differences in stress-corrosion failure mode for seacoast and accelerated tests. On the other hand, fractography did not prove that failure mechanisms were identical in both types of tests.
