ENGINEERING DEPARTMENT TECHNICAL REPORT

TR-RE-CCSD-FO-1136-3

SATURN IB PROGRAM

MANUAL GLOBE VALVE, 3/4-INCH, 6000 PSIG

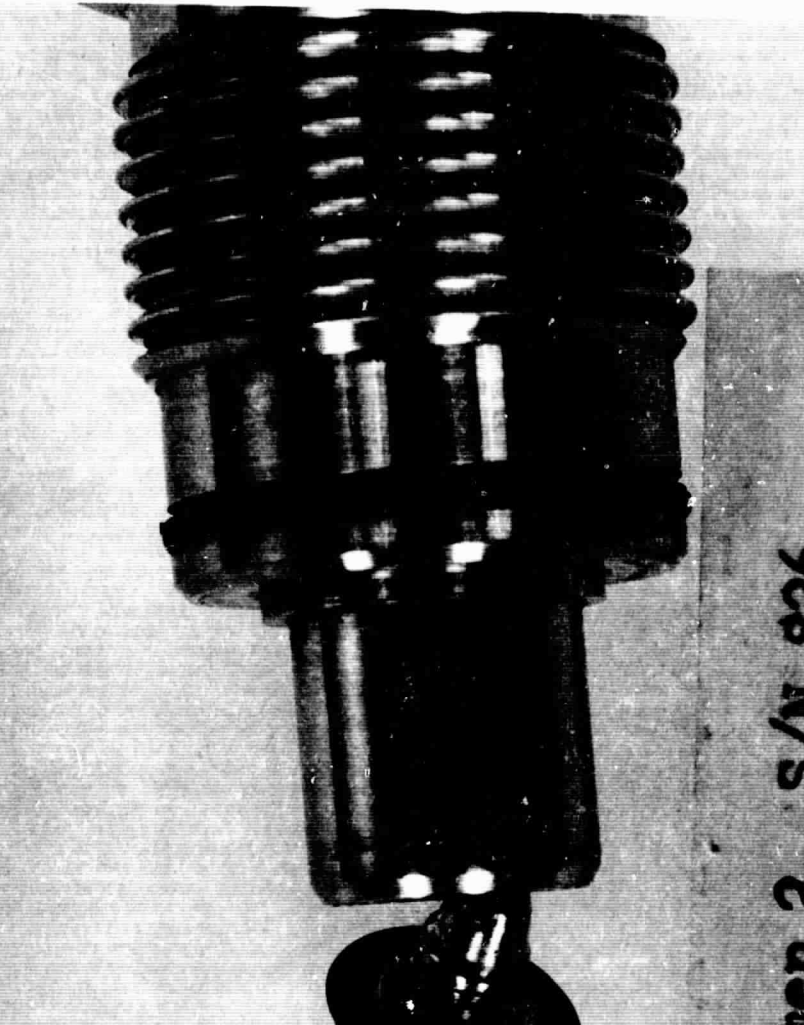
Figure 9-4. Specimen 2 - Sheared Plug After 987 Cycles

stalled and the specimen performed satisfactory until stem thread galling occurred during cycle 345. The threads were cleaned and testing resumed. The plug end of the stem sheared loose during cycle 987 and testing was discontinued on this specimen.

- 9.3.1 Specimen 2 successfully performed 50 complete cycles; however, during cycle 51 the valve would not seat. Inspection revealed scratches around the stem base and around the inner base of the seat retainer. The original type seat retainer, which allows greater stem clearance, was installed and testing was continued. During cycle 345 the stem began binding. Inspection disclosed that the male and female threads had galled. CCSD-FO requested that the stem be cleaned, the threads re-lubricated and testing continued. The specimen completed 987 cycles then failed to seat. Inspection revealed that the threads had sheared off the plug end of the stem. Apparently the plug unscrewed and the force from the stem torque contributed to the shearing. Testing of specimen 2 was permanently discontinued.

FO-1136 Specimen 2, S/N 826
Sheared Plug after 987 cycles

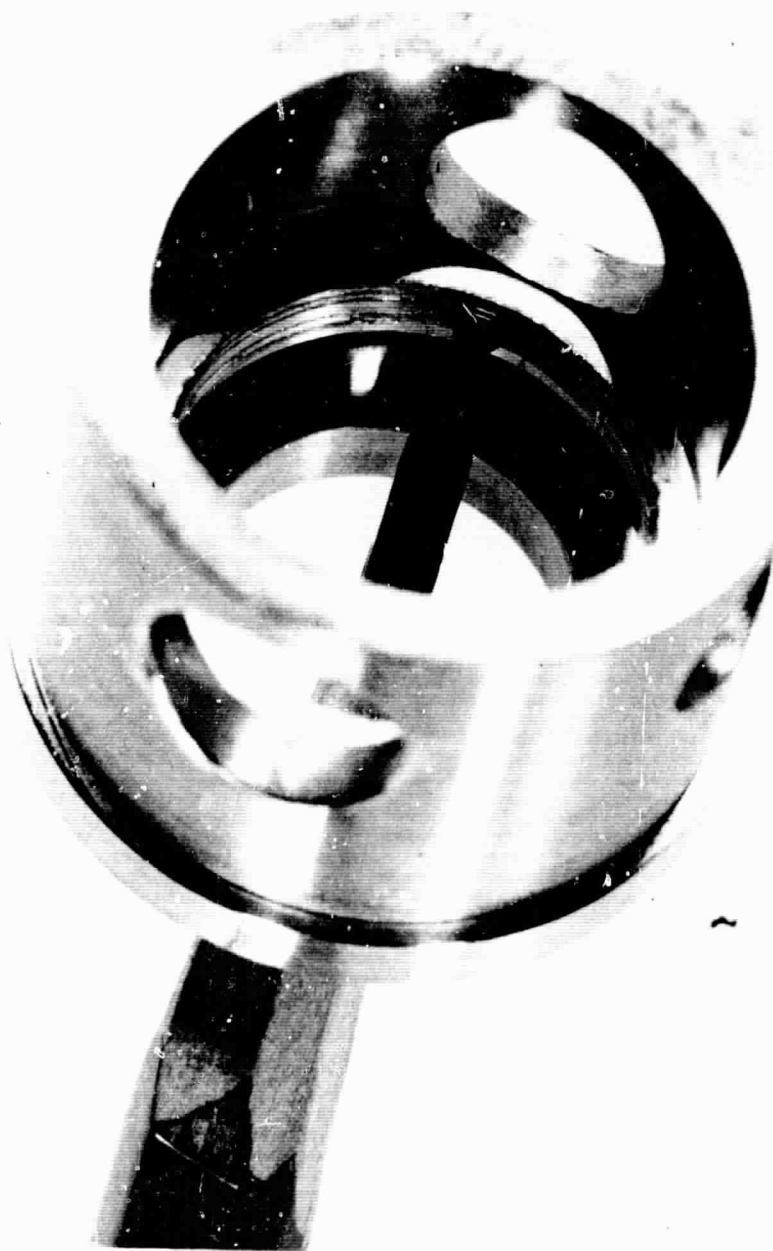
Figure 9-5. Specimens 2 and 3 - Typical Seat Retainer Damage

9.3.2 During cycle 42, specimen 3 failed to seat. Inspection revealed scratches around the stem base and around the inner base of the seat retainer, similar to that of specimen 2. An original type seat retainer was installed and testing was continued. During cycle 424 the stem threads began binding. The threads were damaged similar to those of specimen 2. At the request of CCSD-FO testing was permanently discontinued.

9.4.2 Figure 9-5 shows typical seat retainer damage to the specimens 2 and 3 during cycle 51 and 42, respectively.
