# STUDY OF CRACK INITIATION PHENOMENA ASSOCIATED WITH STRESS CORROSION OF ALUMINUM ALLOYS

SECOND ANNUAL REPORT

ALUMINUM COMPANY OF AMERICA  
Alcoa Research Laboratories  
Physical Metallurgy Division  
New Kensington, Pennsylvania

Second Annual Report  
(June 6, 1967 to June 6, 1968)

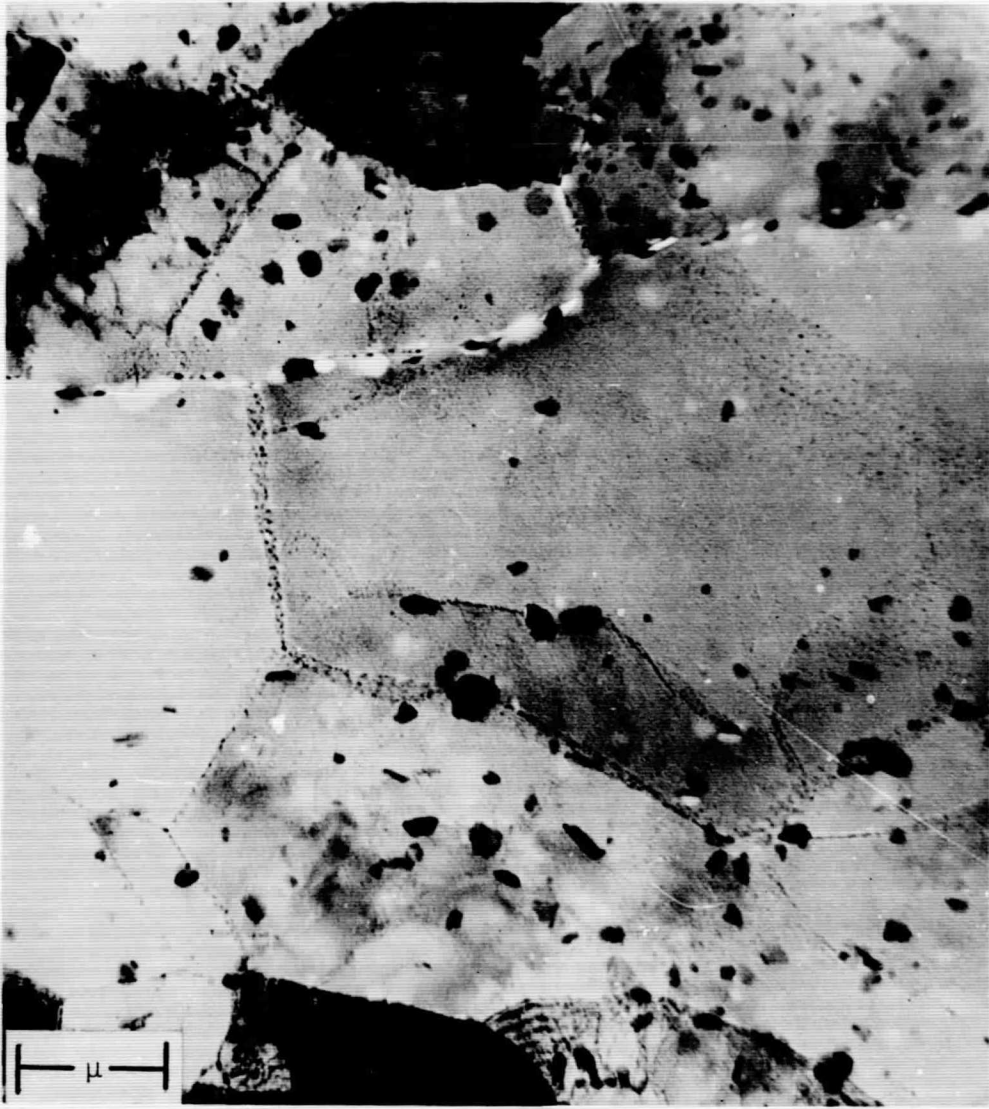
Figure 9

Electron transmission microstructure of 7039-T6 plate showing polygonized structure, dispersoid distribution and occasional dislocations.

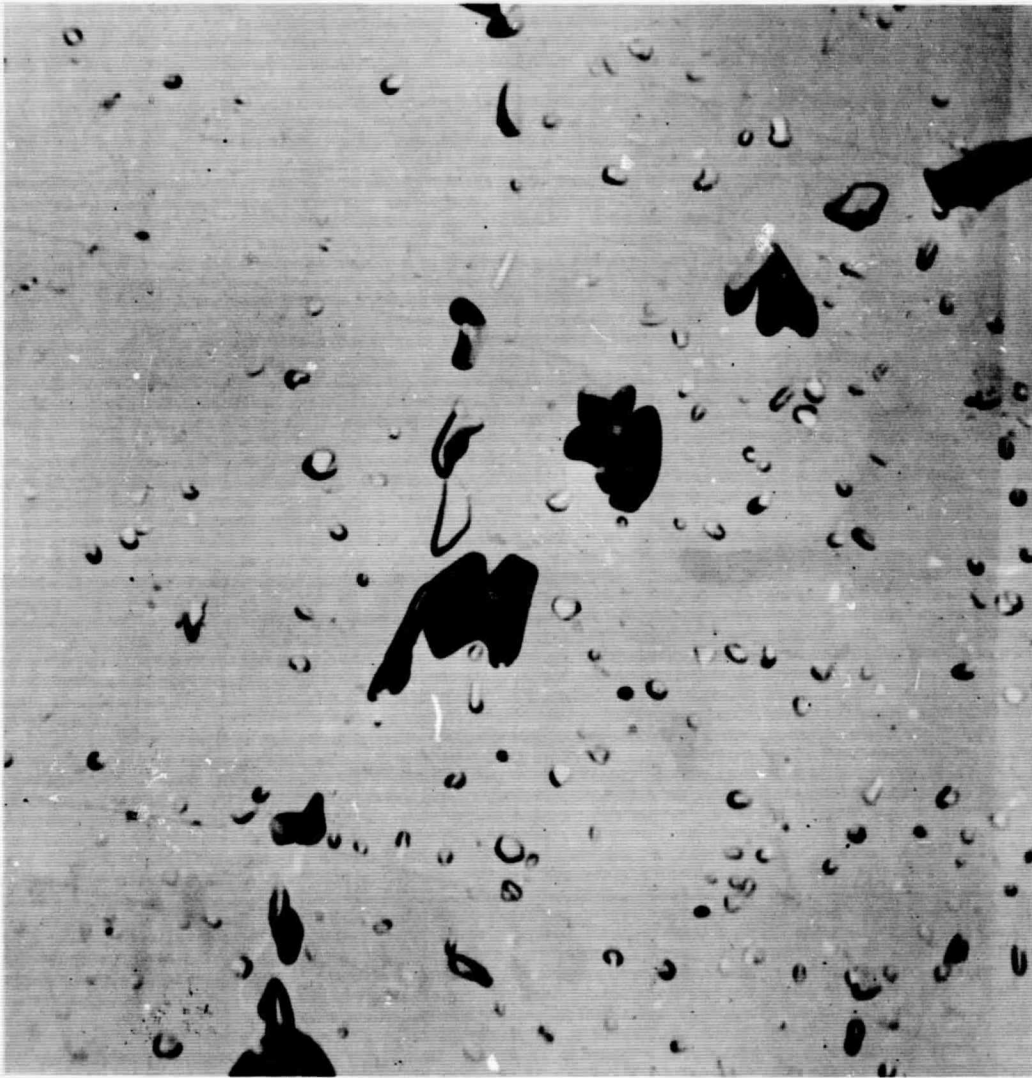
Figure 24

Cracks initiating at low angle to stress in 7075-T6 stressed longitudinally to 75% YS.

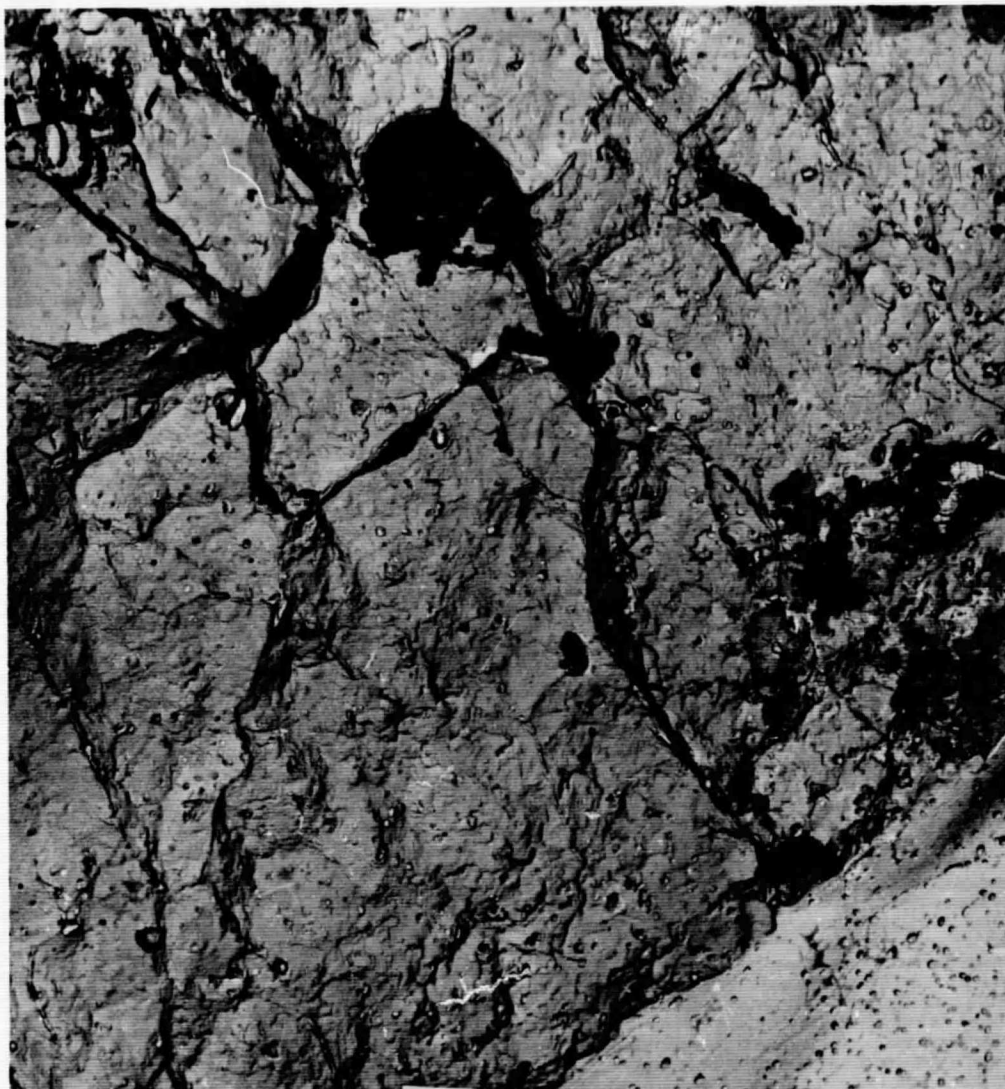
Figure 35

Stress corrosion fracture in 7075-T6 stressed to 75% YS. Stress corrosion proceeded from specimen surface seen at lower right, along polygon boundaries. At the top, a small polygon is almost completely surrounded by stress corrosion cracks. Some corrosion product is seen near the surface at right.

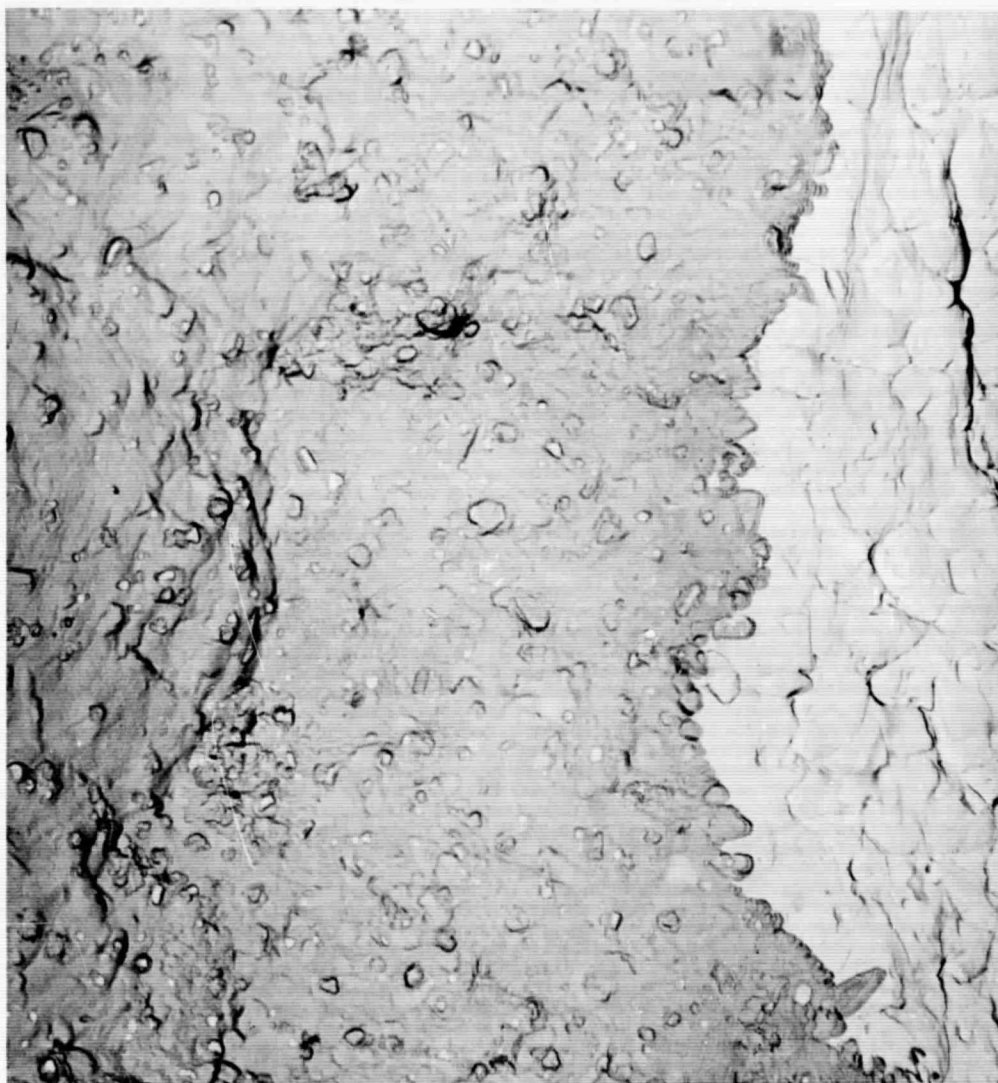
Figure 37

Transition from stress corrosion fracture (left) to tensile fracture showing that tip of stress corrosion crack is irregular. 7075-T6 stressed to 75% YS short transversely.

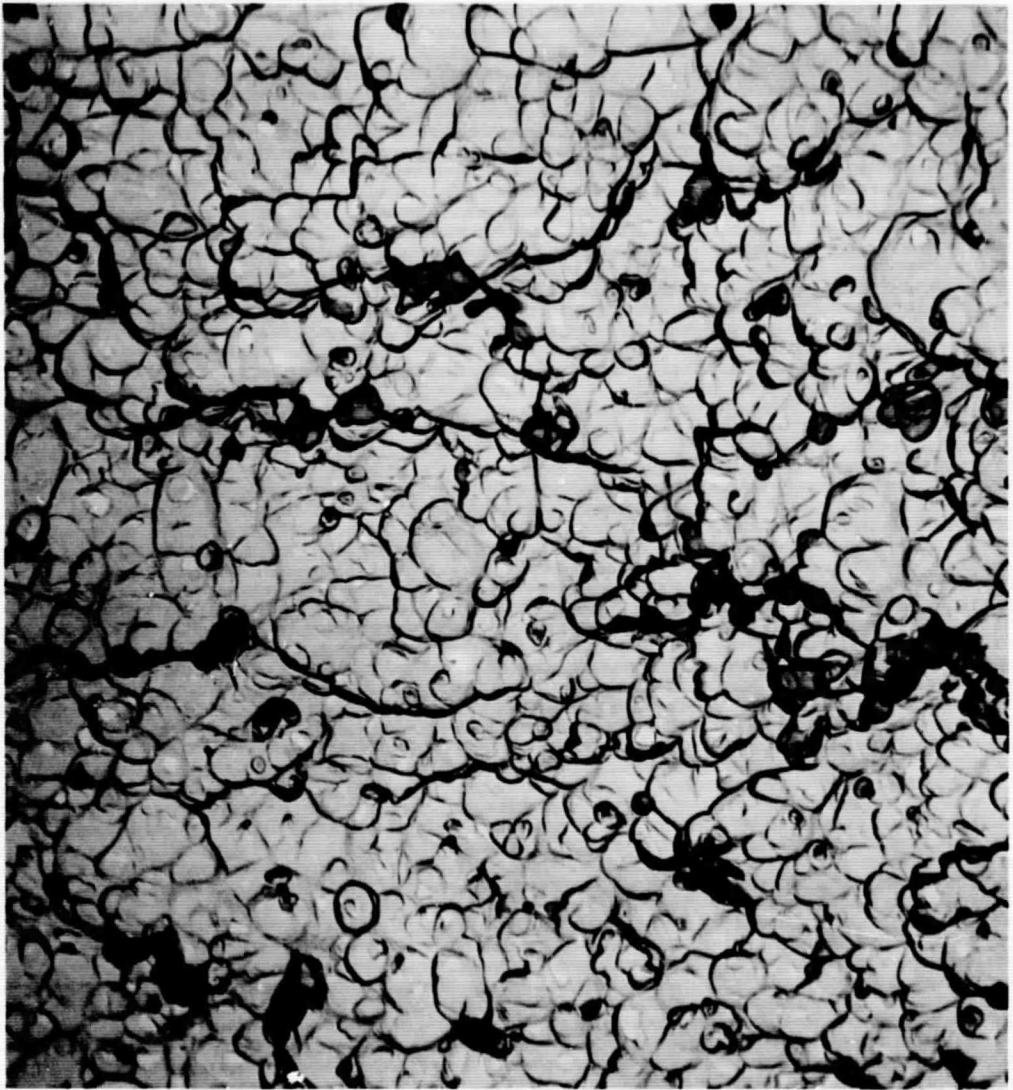
Figure 38

Typical tensile fracture in 7075-T6  
showing small particles associated with dimples.

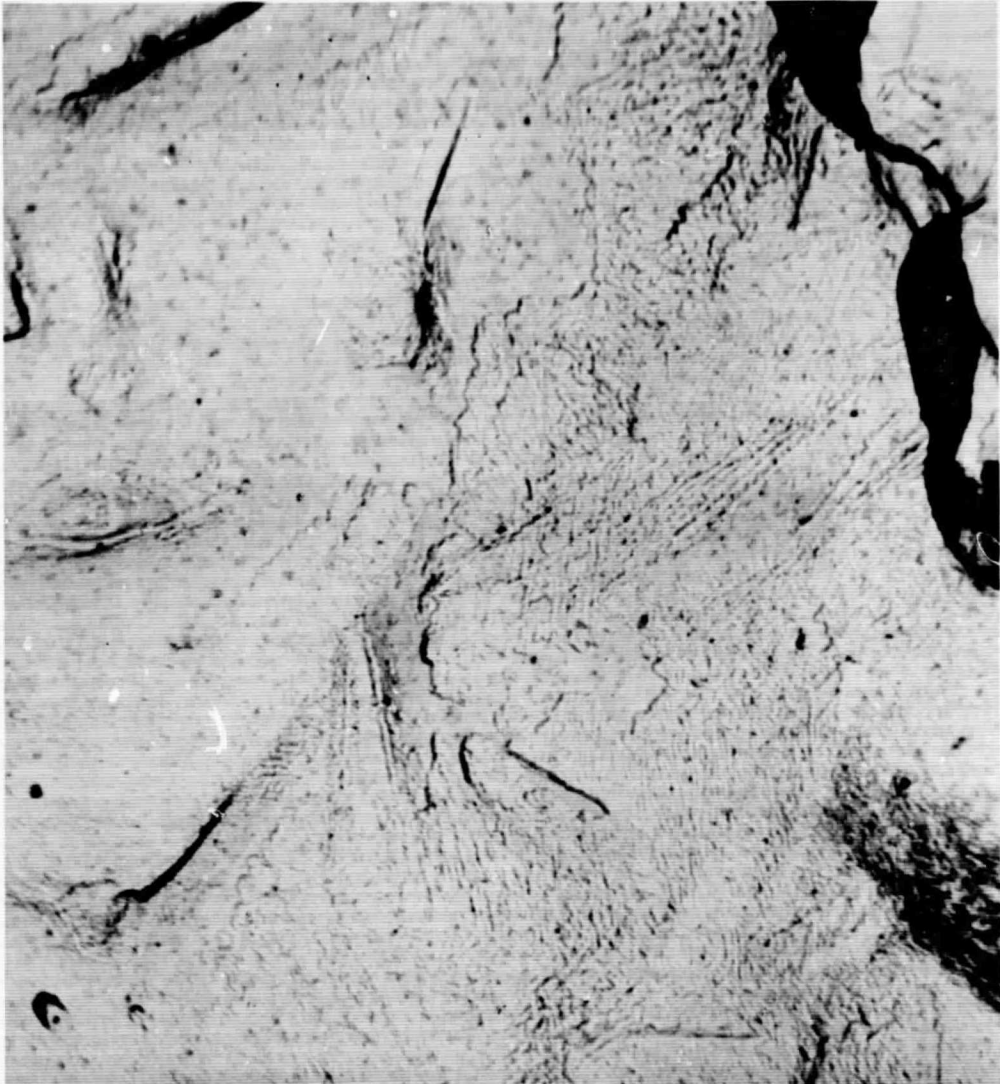
Figure 39

Parallel markings on stress corrosion fracture which might be indicative of plastic deformation. 2219-T37 with S.T. stress of 75% YS.

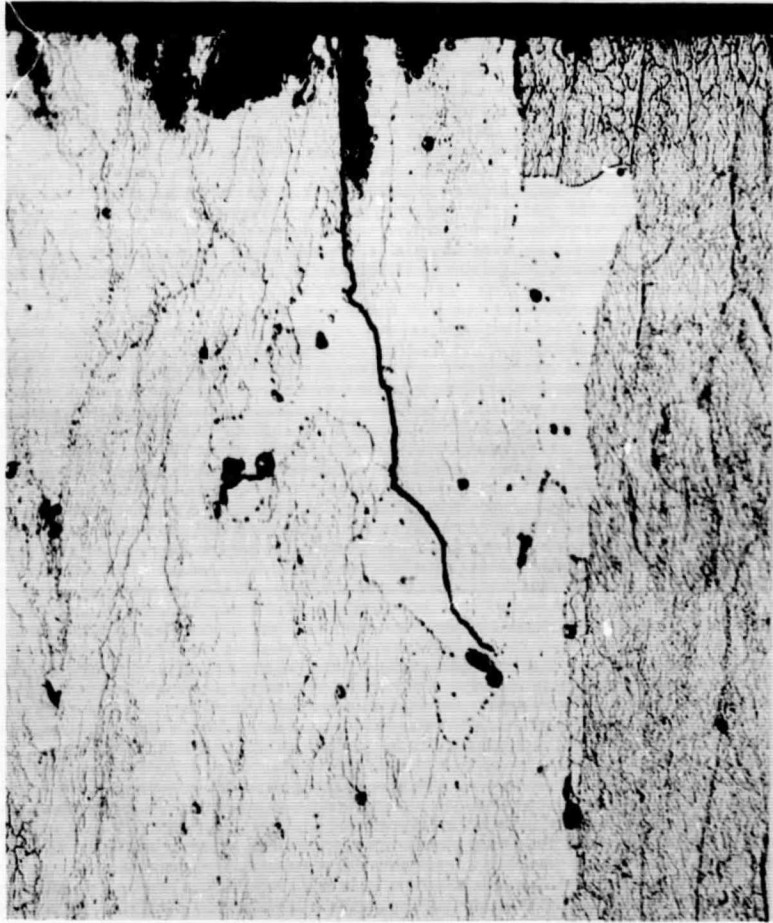
Figure 52

Cross section of crack seen in Fig. 51 (X500)

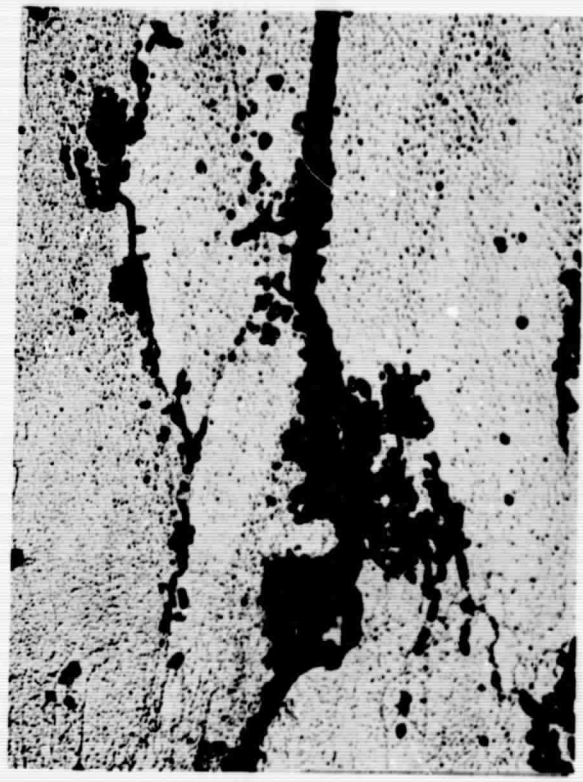
Figure 65

Crack initiation in 7079-T6 plate stressed short transversely to 90% YS and exposed to pH1 NaCl- $AlCl_3$  solution (X500).

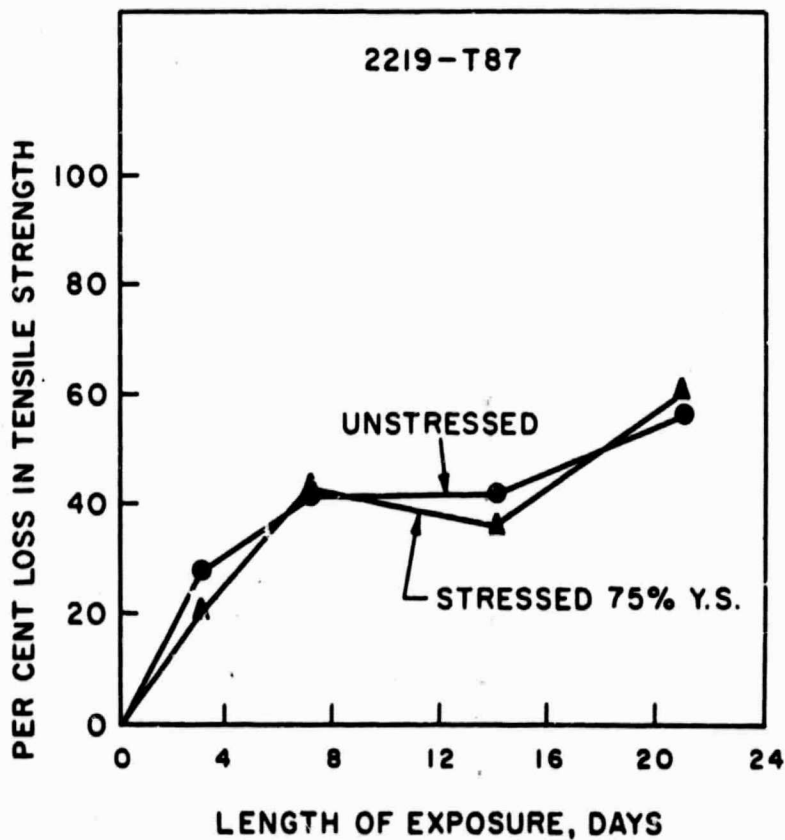
**FIGURE 76**

**EFFECT OF STRESS ON CORROSION RATE OF 2219 ALLOY IN ACIDIFIED NaCl (pH2)**

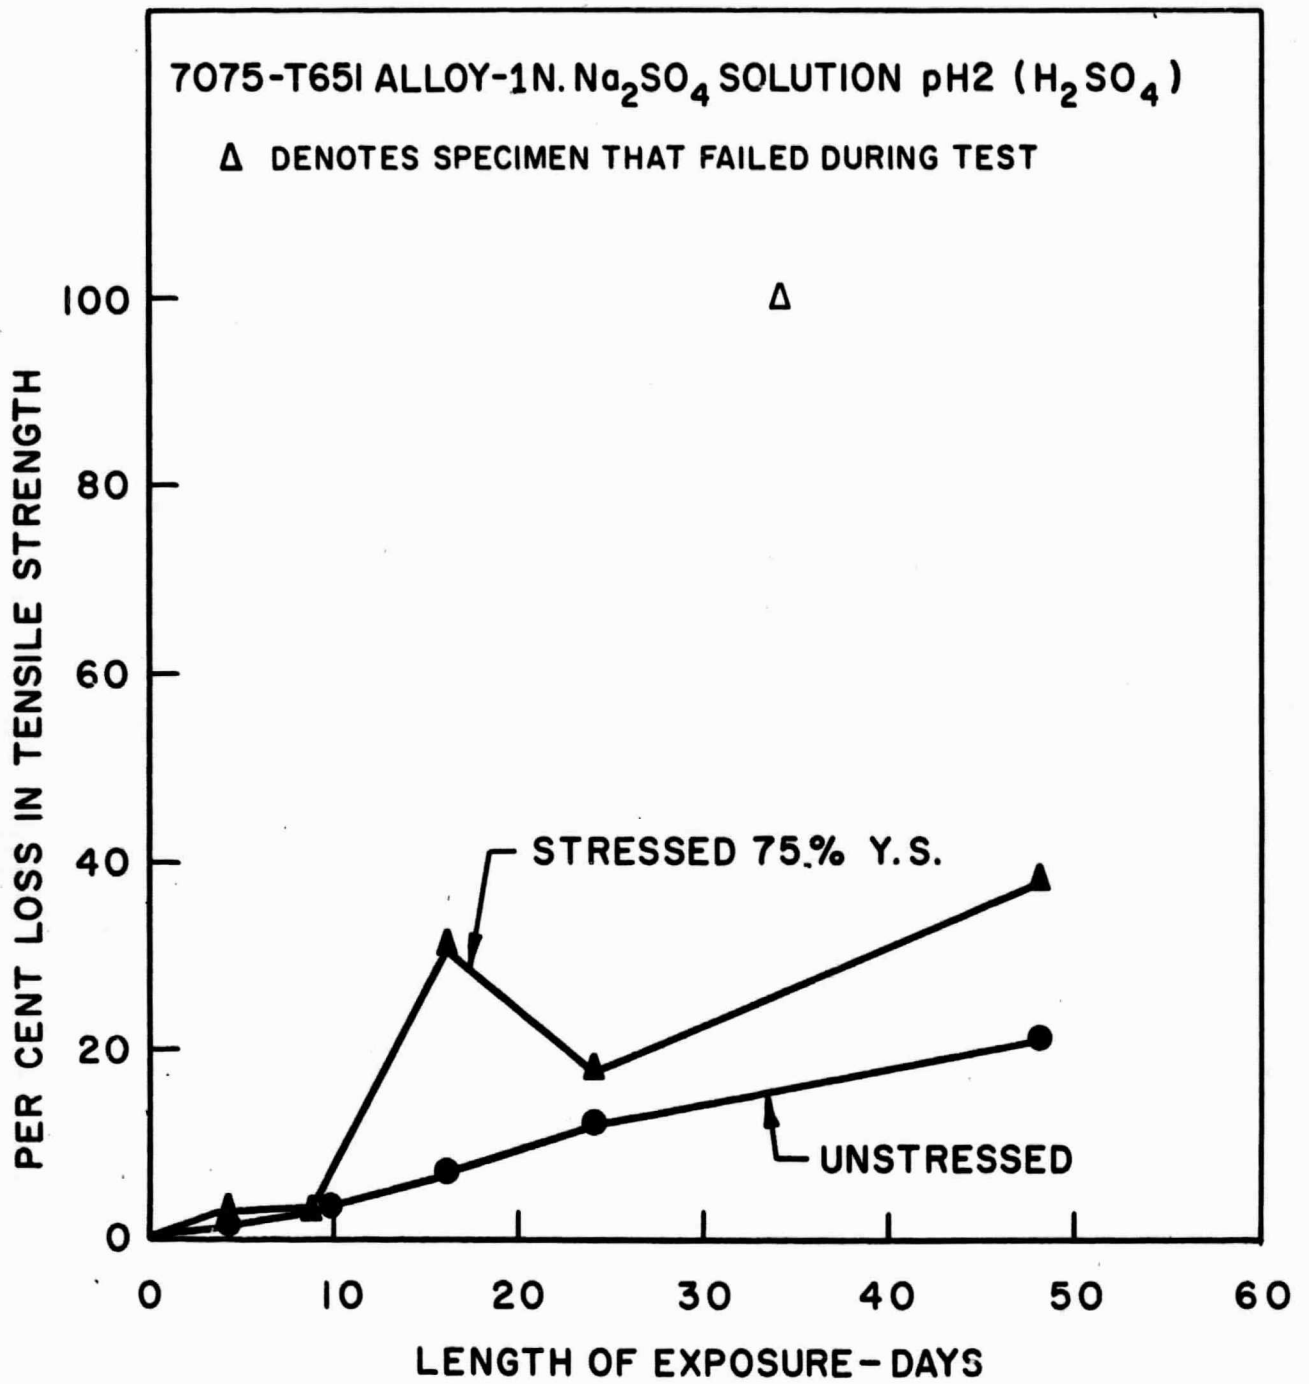
FIGURE 79

EFFECT OF STRESS ON CORROSION RATE
