PHASE I  
FINAL REPORT

ESTABLISHMENT OF QUALITY AND  
RELIABILITY STANDARDS AND DEVELOPMENT  
OF SCREENING TECHNIQUES FOR  
MOS MICROELECTRONIC DEVICES

CONTRACT NO. NAS 8-20707

GENERAL INSTRUMENT CORPORATION  
MICROELECTRONICS DIVISION  
600 WEST JOHN STREET  
HICKSVILLE, NEW YORK 11802

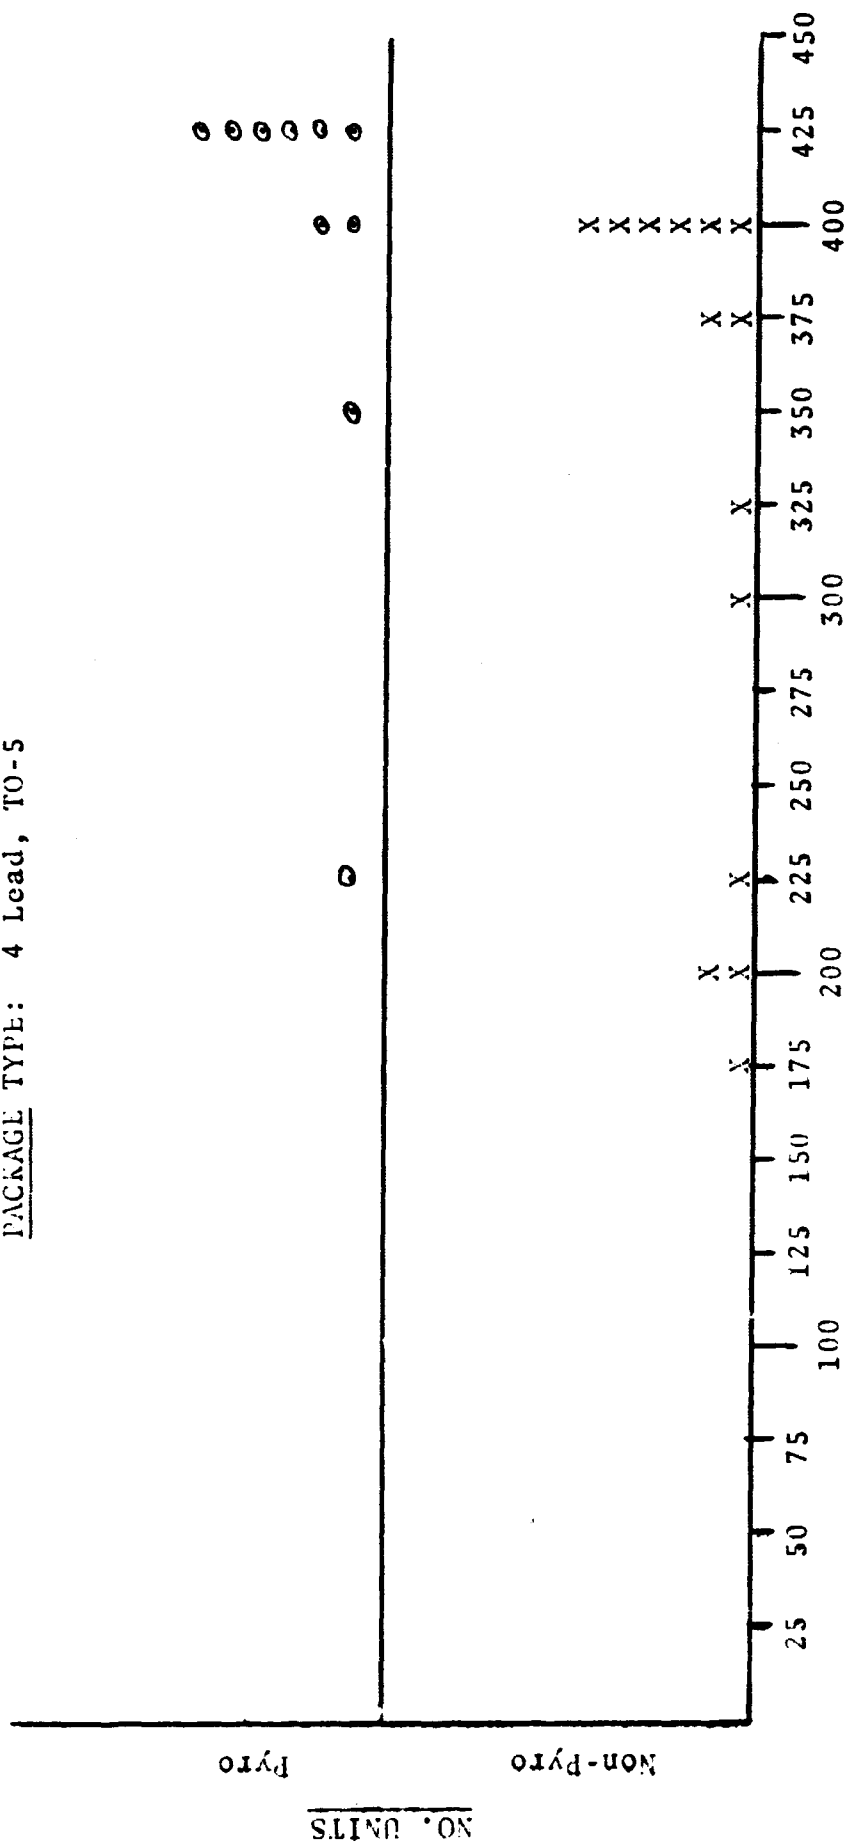
TABLE III

TEMPERATURE STORAGE STLP STRESS

EVALUATION NO. 1086

DEVICE FAILURES AT INDICATED TEMPERATURES

DEVICE TYPE: MEM 511

PACKAGE TYPE: 4 Lead, TO-5

TEMPERATURE (°C)

KEY: X Non-pyro Units  
O Pyro Units

Table II and III contain a summary of the results of the Temperature Storage Step Stress. The Raw Data is contained in Appendix I. The unglassed devices experienced their first failure at the 170°C step and all of the unglassed devices have completed a 1000 hour storage life test at 160°C. The first failure on the glassed devices occurred at 230°C and all of the glassed devices have completed a 1000 hour storage life test at 220°C. In order that this data will be more comparable with other testing performed in-house the storage life testing is being extended to 2000 hours at which time a full report of this phase will be made.

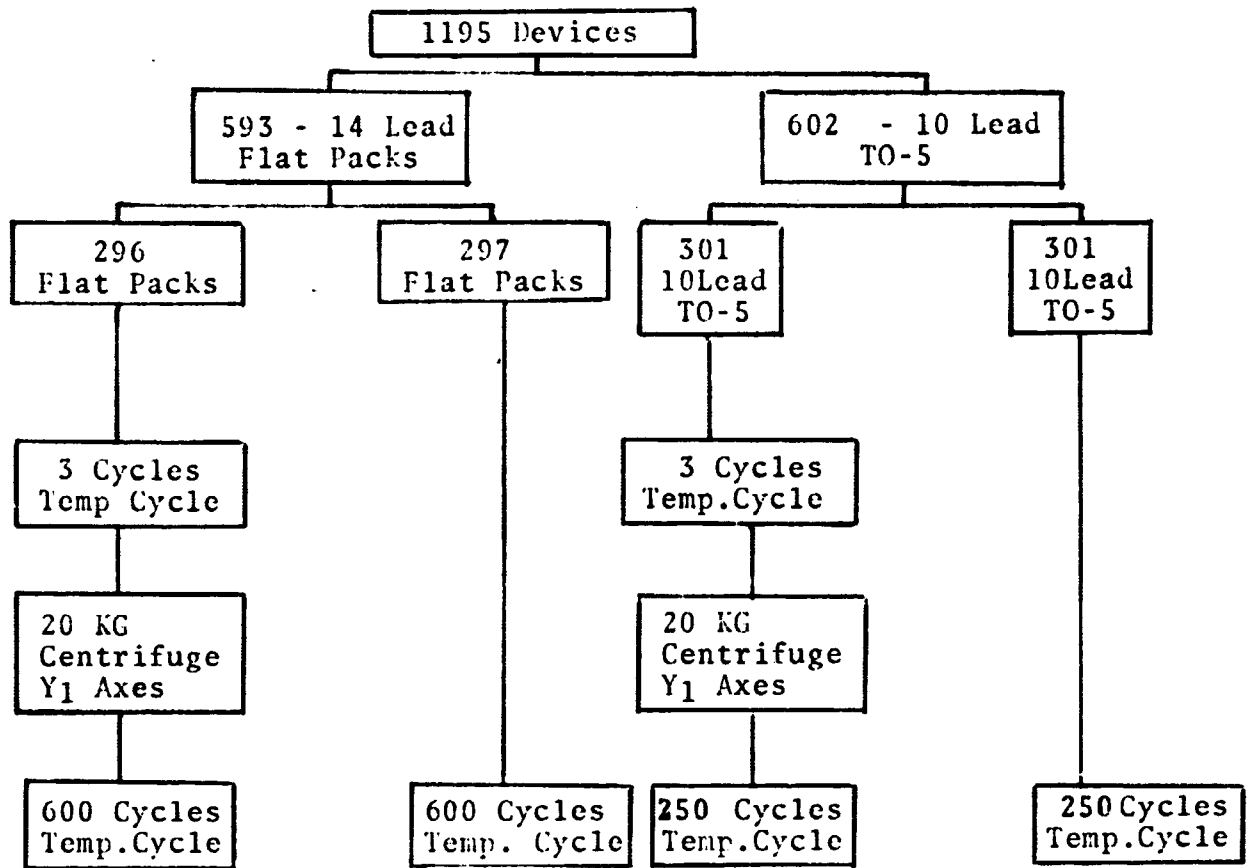
FIGURE I

TEMPERATURE CYCLE PROGRAM OUTLINE

This program was conducted on two types of packages 1) 14 lead flat pack with 14 internal ball bond connections and 2) 10 lead TO-5 packages with 9 internal ball bonds. The test outline is contained in Figure I.

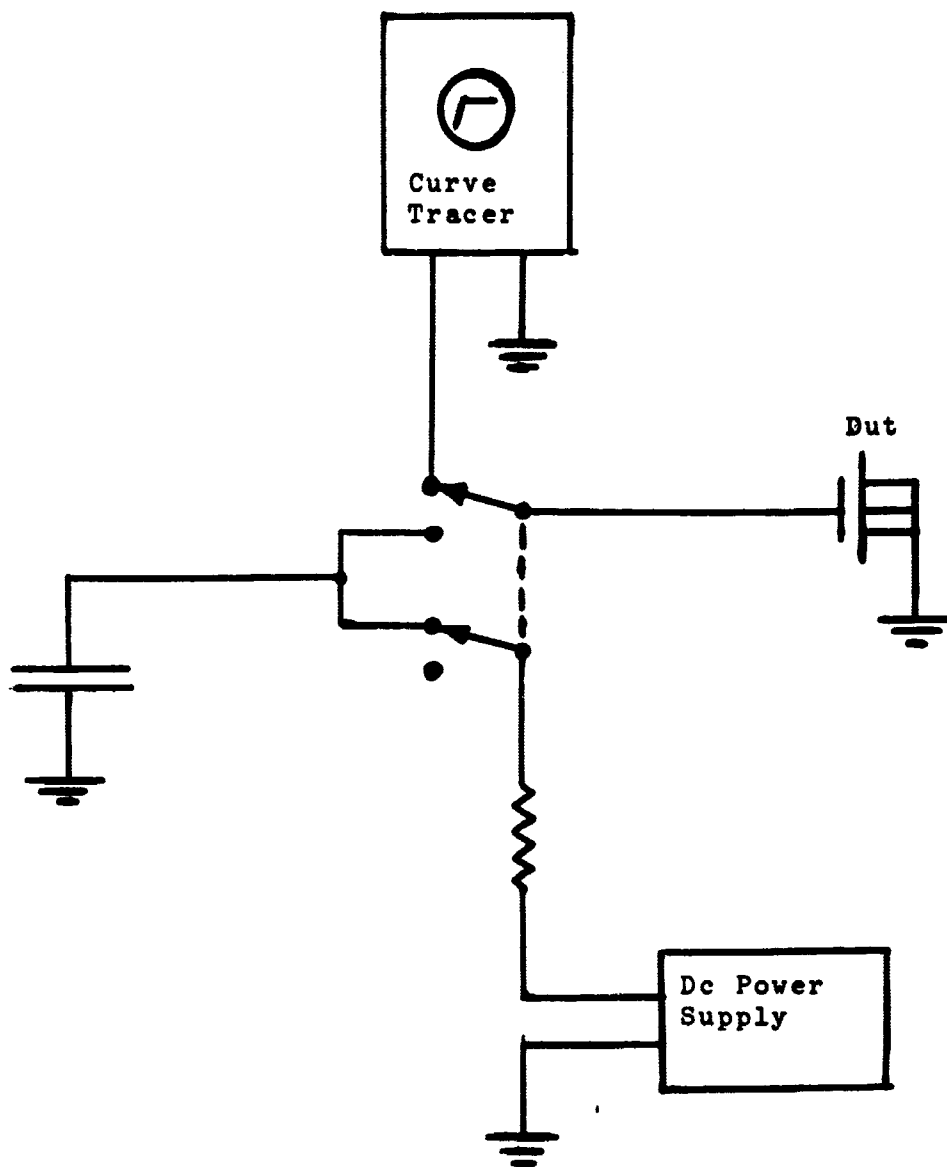
FIGURE NO. 2

STATIC VOLTAGE TEST SET

The purpose of this study was to investigate the feasibility of screening out those units which are particularly susceptible to damage by static voltage. This was accomplished by the charging and subsequent discharge of a small (10ps) capacitor into the device terminals.

The information listed below shows the results recorded from our evaluations. A block diagram of the test circuit used is shown in Figure I.
