**NASA CONTRACTOR
REPORT**

NASA CR 1244

HYDROGEN-OXYGEN ELECTROLYTIC REGENERATIVE FUEL CELLS

Prepared by
ELECTRO-OPTICAL SYSTEMS, INC.
Pasadena, Calif.
for Lewis Research Center

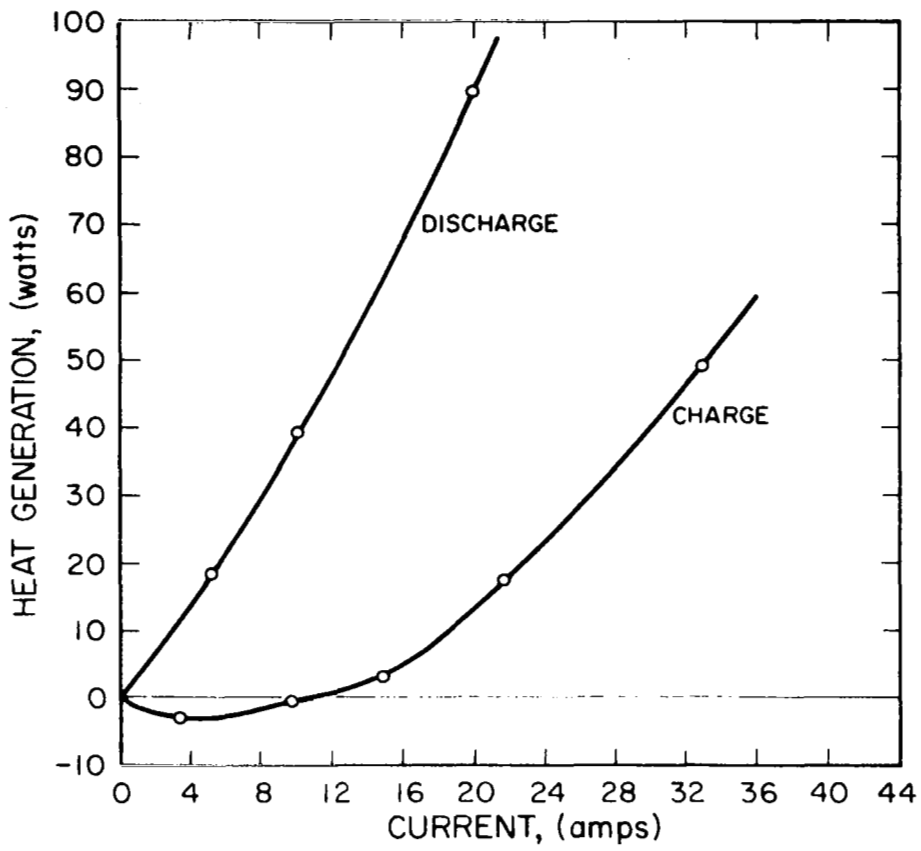
Figure 5. Heat Generation in Six Cell Prototype

The rate of heat generation in the six-cell assembly has been calculated for other current loads, and the results are given in Fig. 5. Inspection of this figure indicates that the heat generation during discharge is always positive and varies in a near linear manner with current. For charge, however, it is noted that the heat generation is slightly negative at low currents and becomes positive at higher currents. At low charge currents, then it may be said that the assembly will absorb heat from the surroundings.

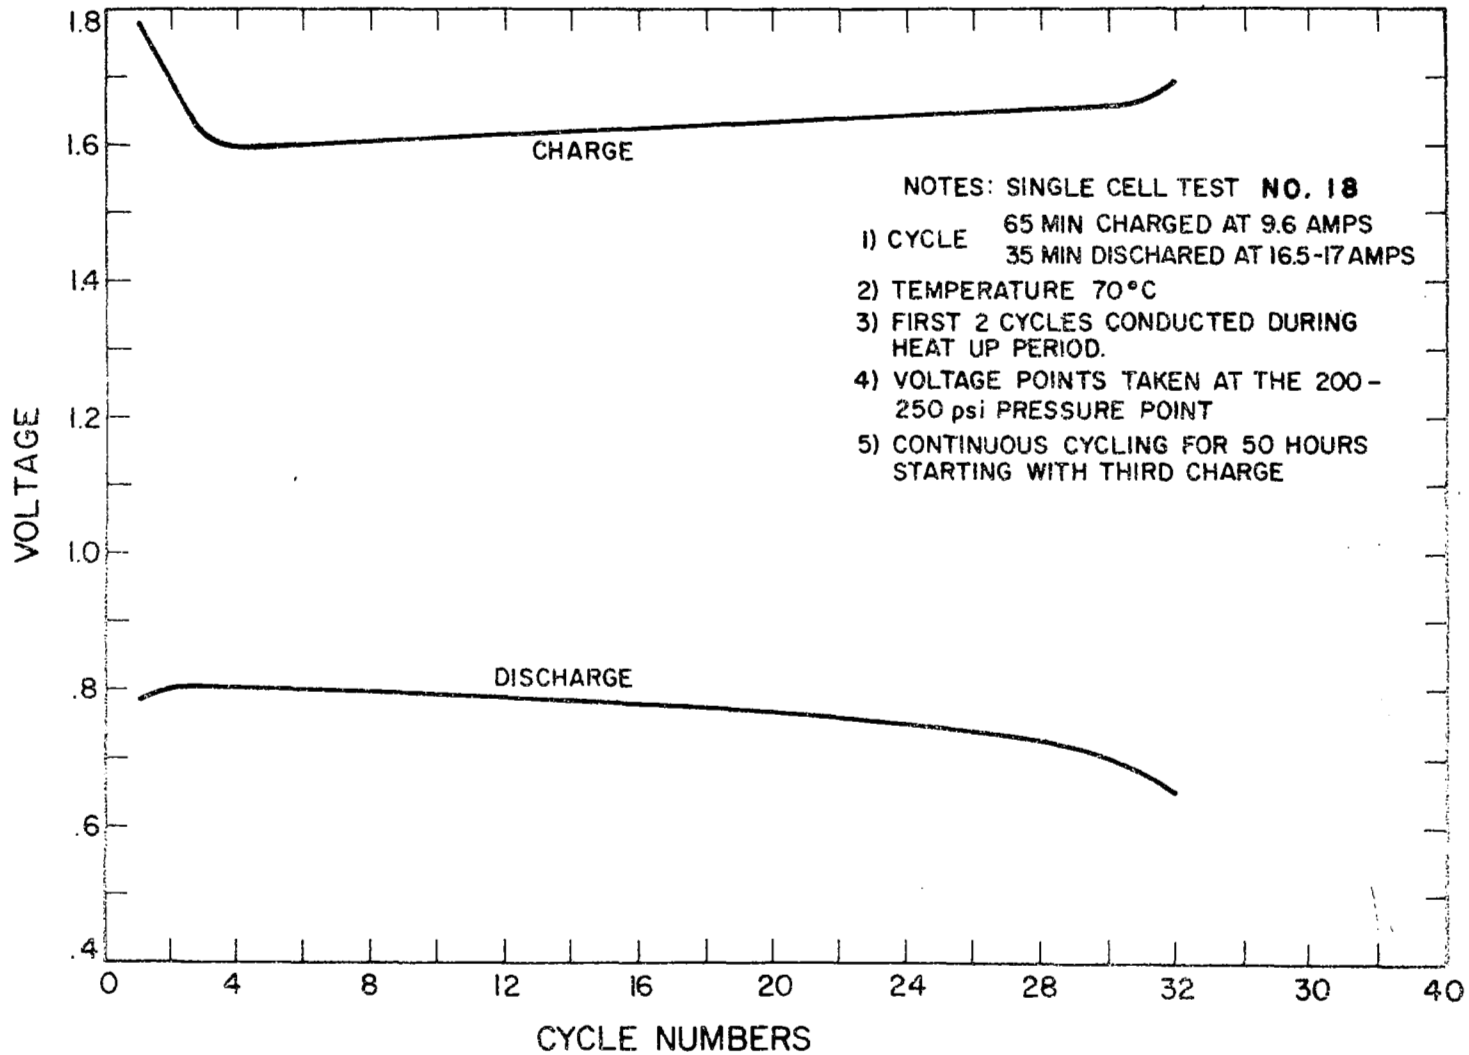
Figure 12. Effect of Cycling on Cell Voltage, Cell 18

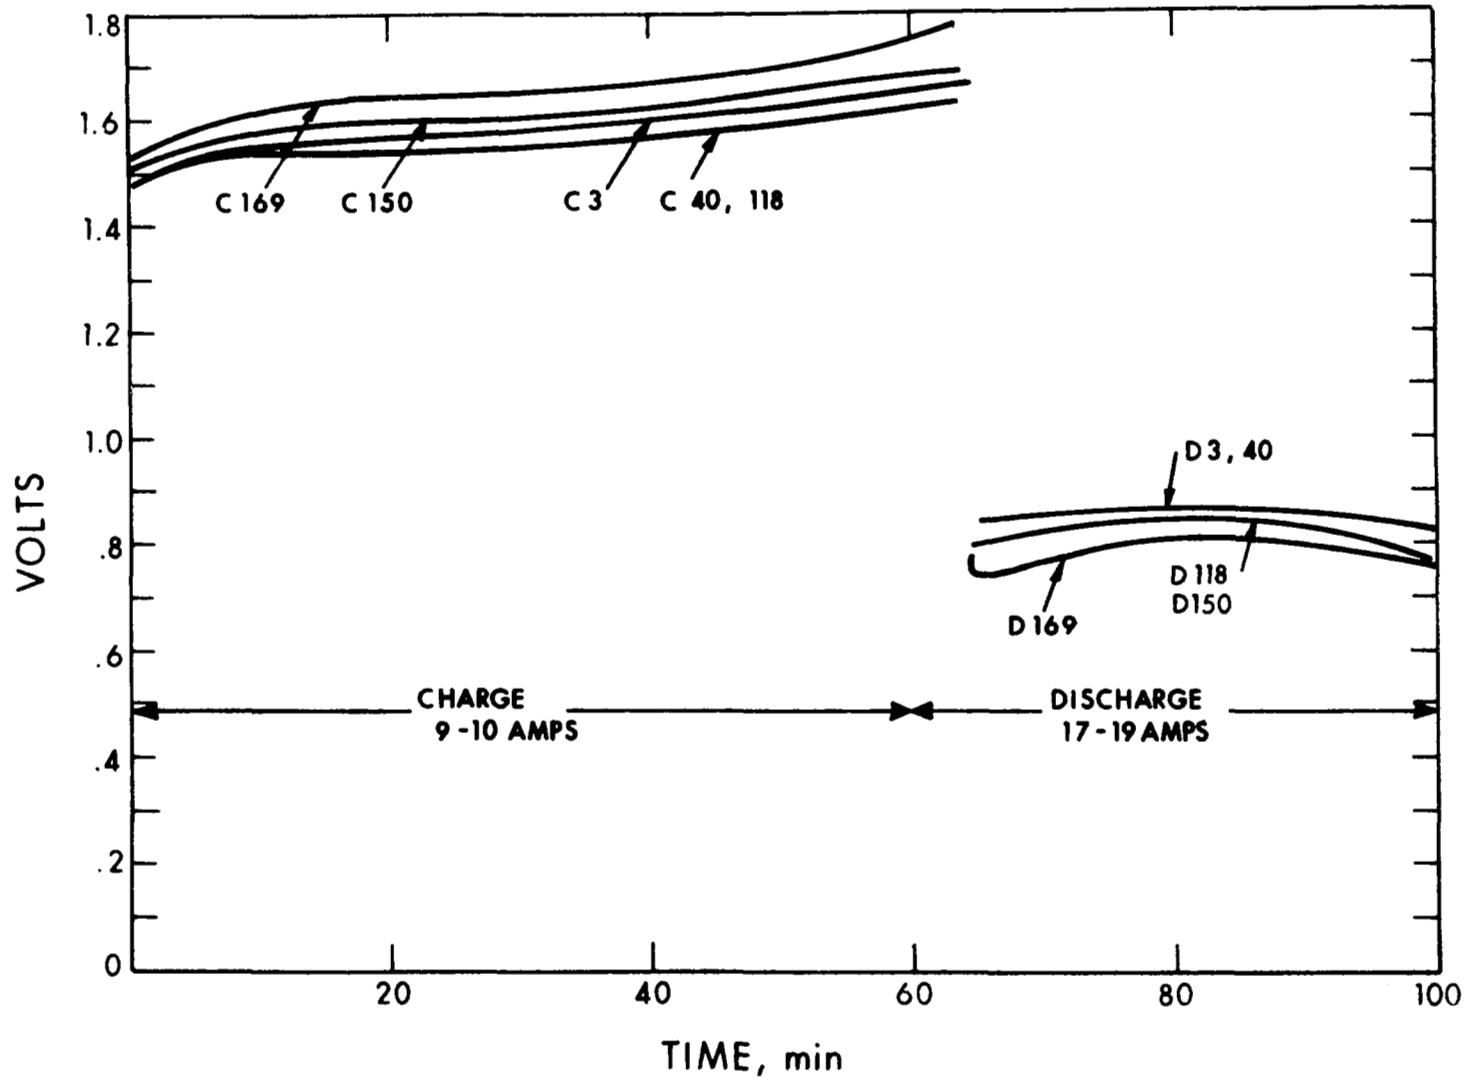
Figure 21. Cycling Performance of Cell No. 103

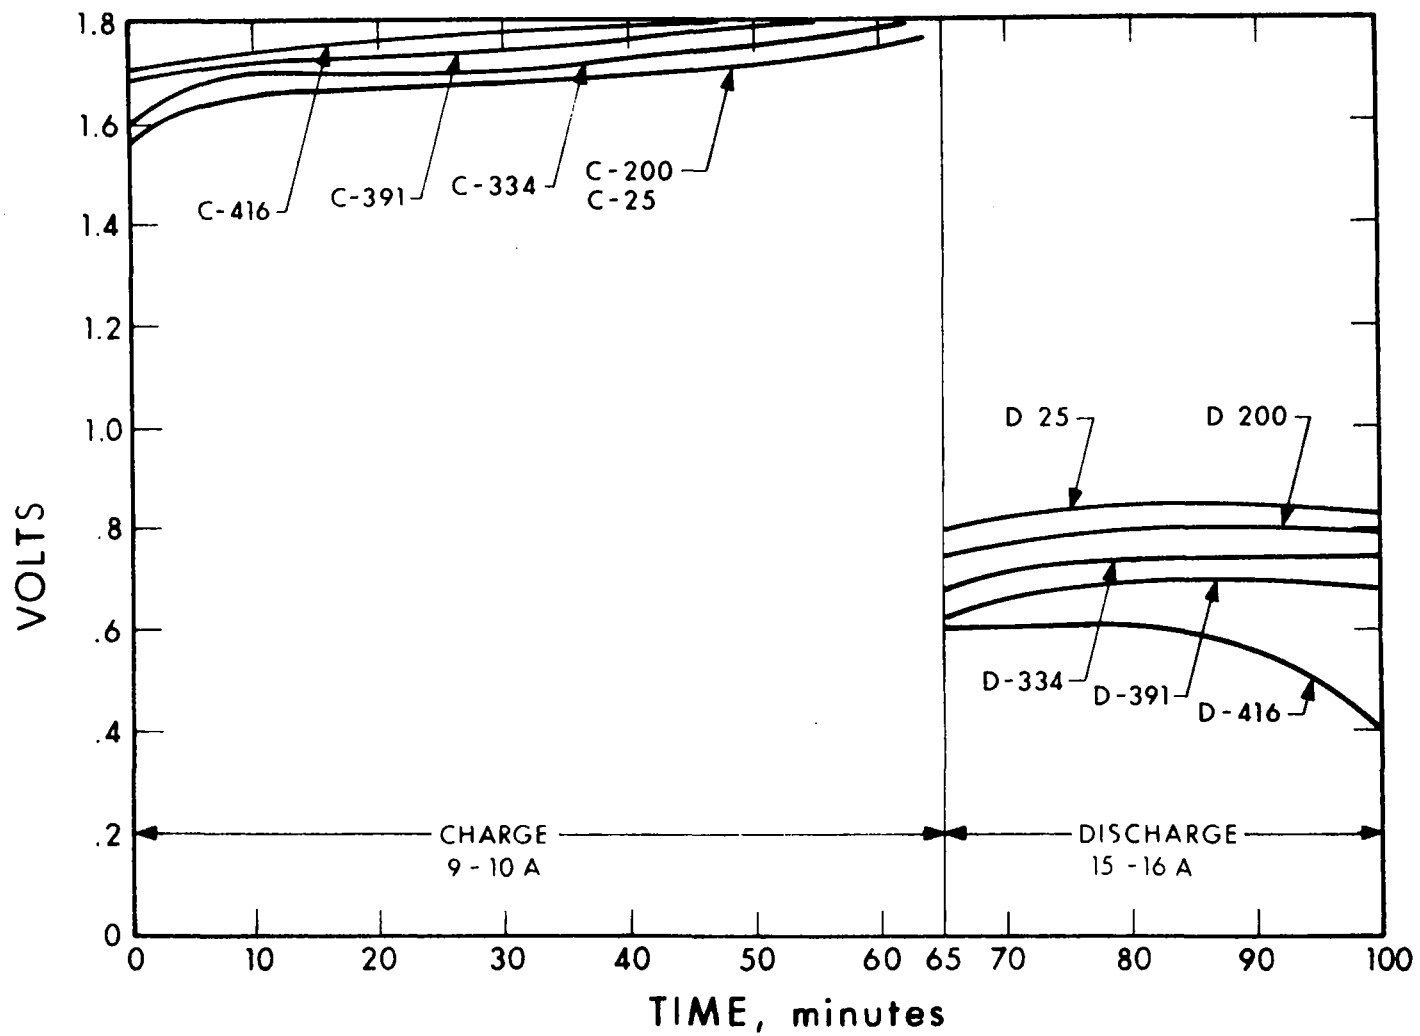
Figure 28. Cycling Performance of Cell 212

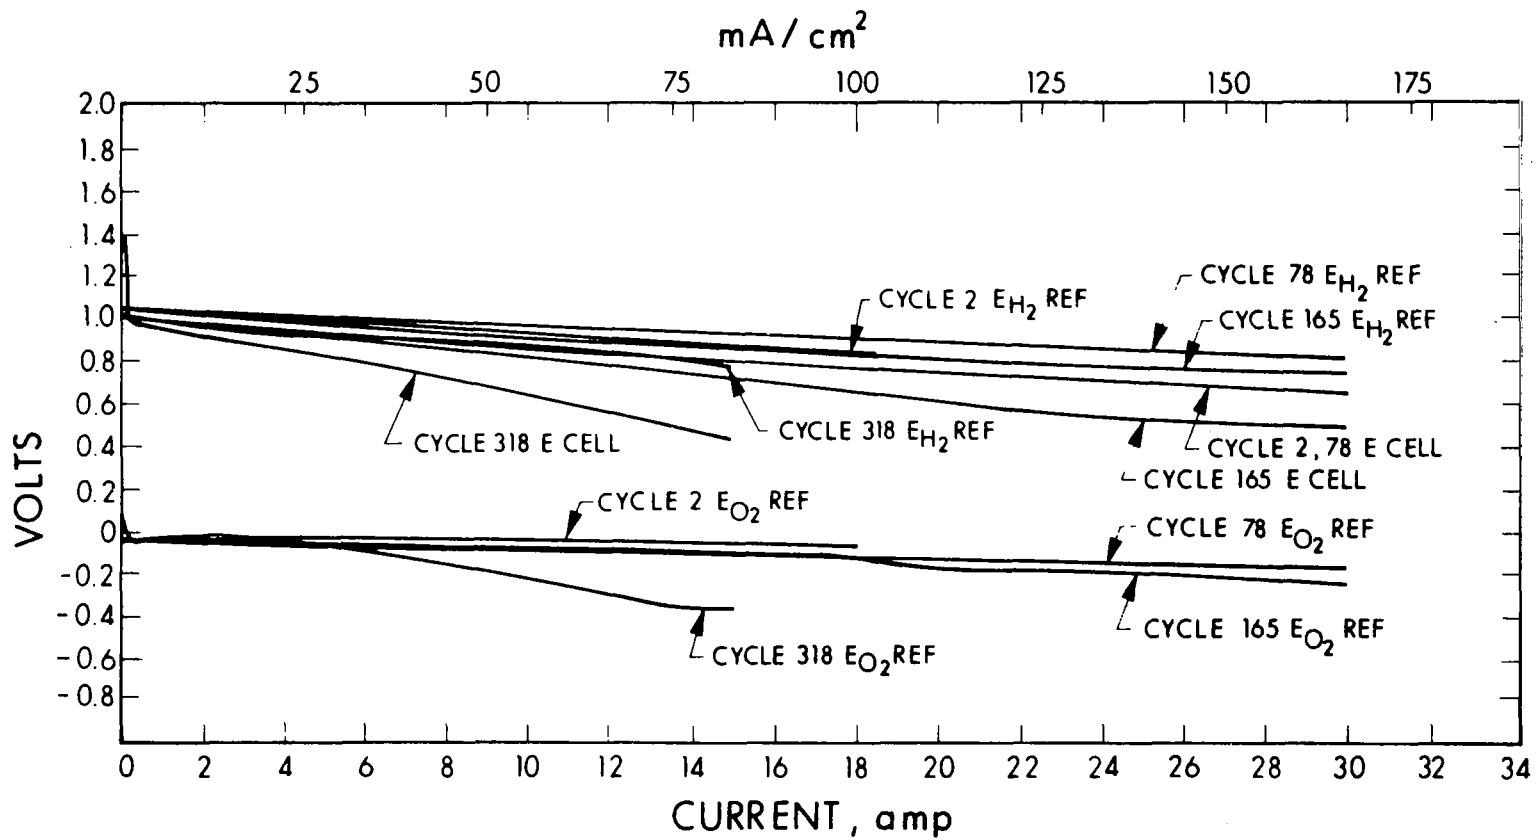
Figure 34. Cell 250, Discharge Polarization at 80°C

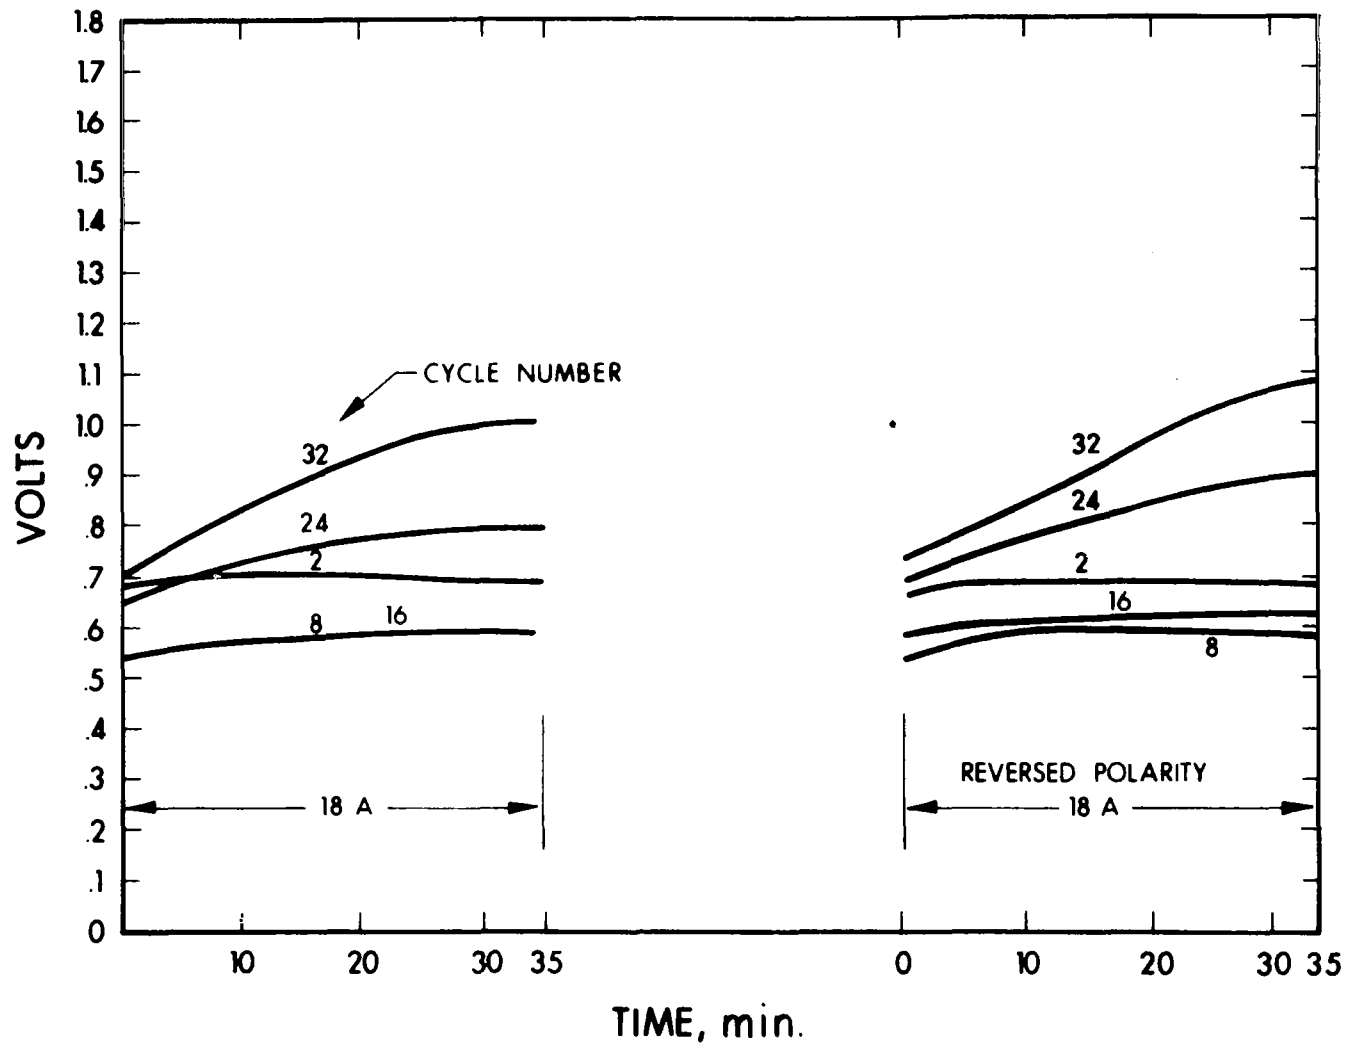
Figure 41. Cycling O_2 Concentration Cell 163

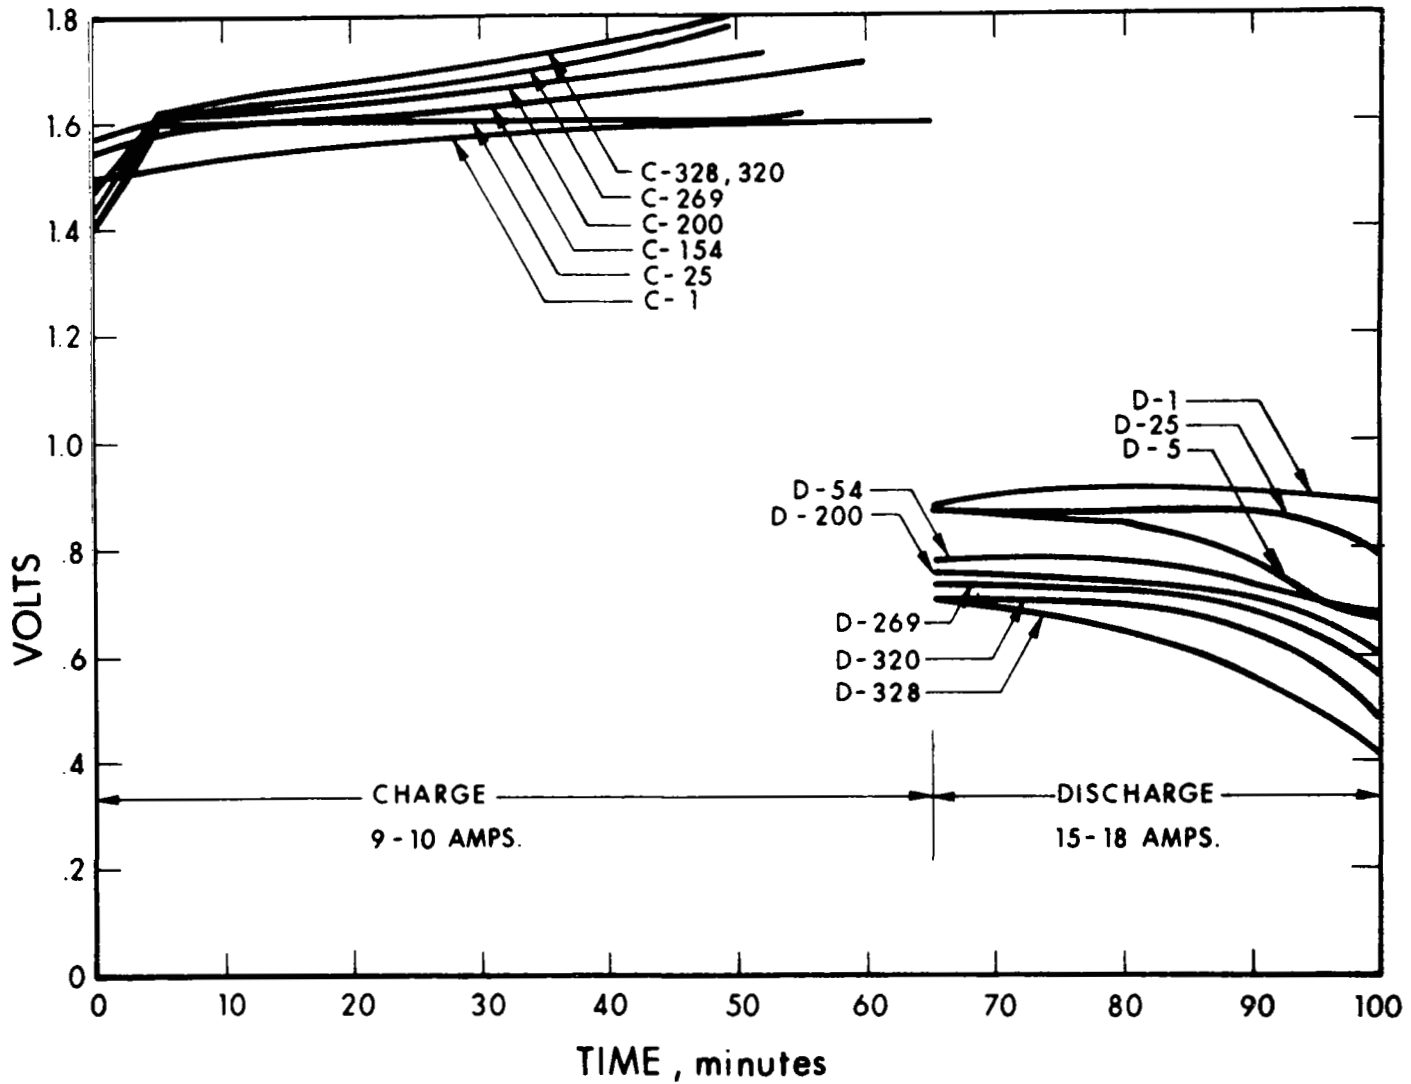
Figure 54. Cycling Performance of Cell 192

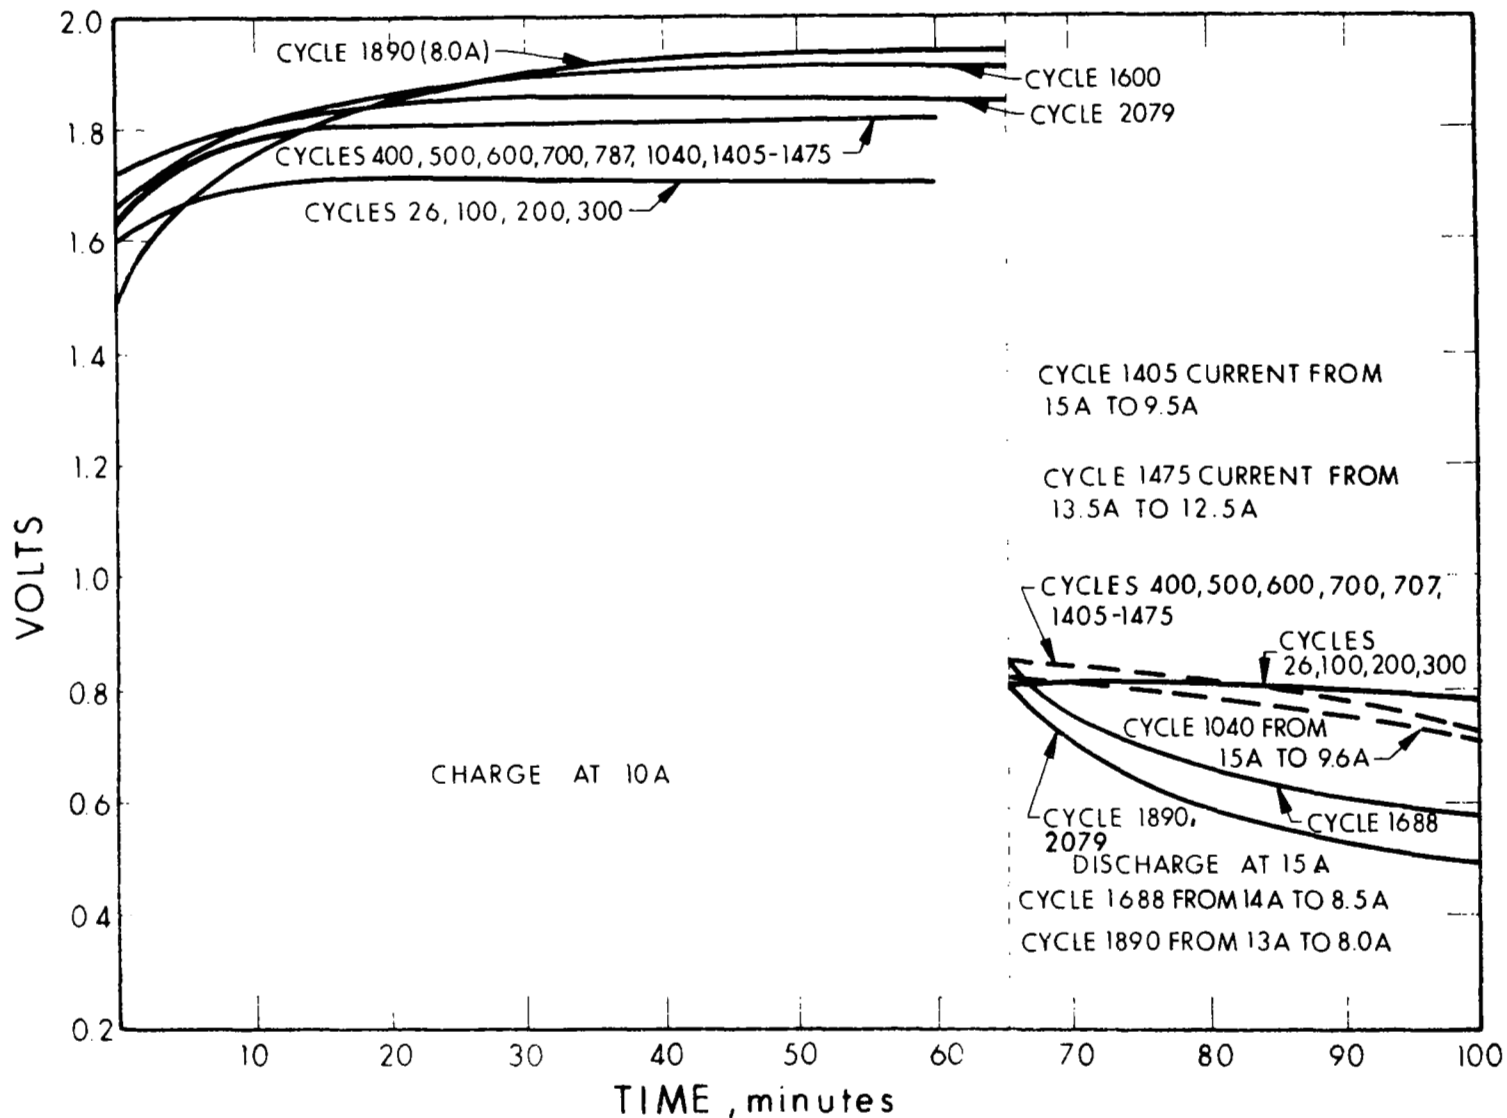
Figure 67. Cycling Performance of Cell 239

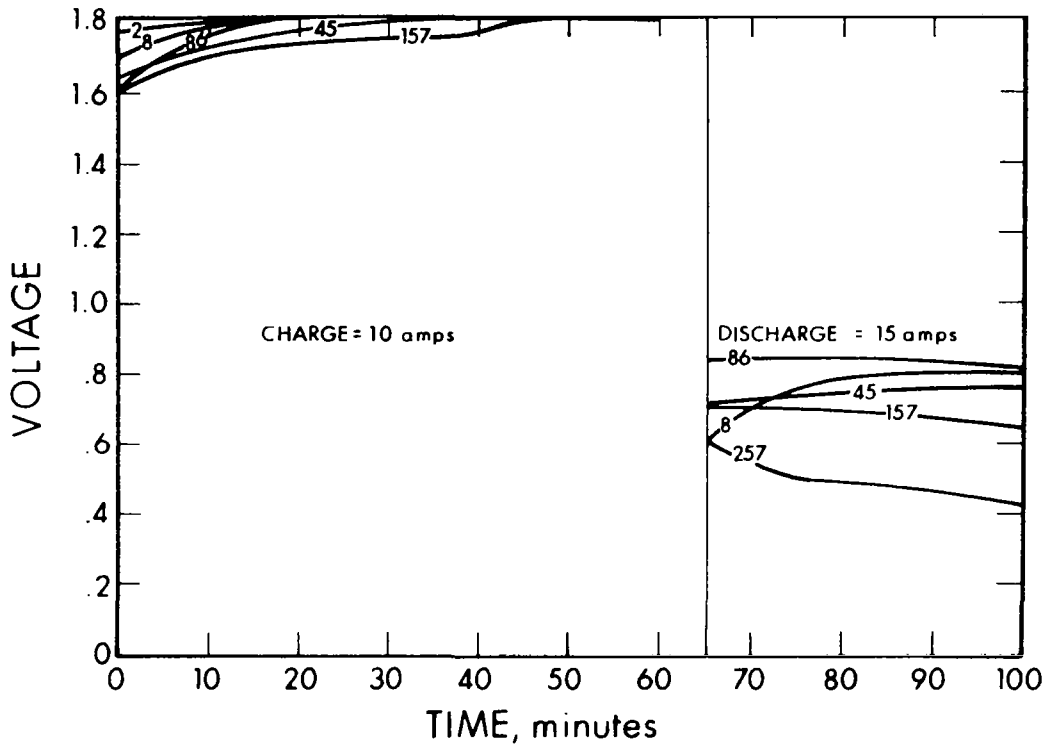
Figure 68. Cycling Performance of Cell 246

Cell 246 was a duplication of cell 239 above. The cell ran well for 151 cycles and then the performance degraded. Testing was concluded

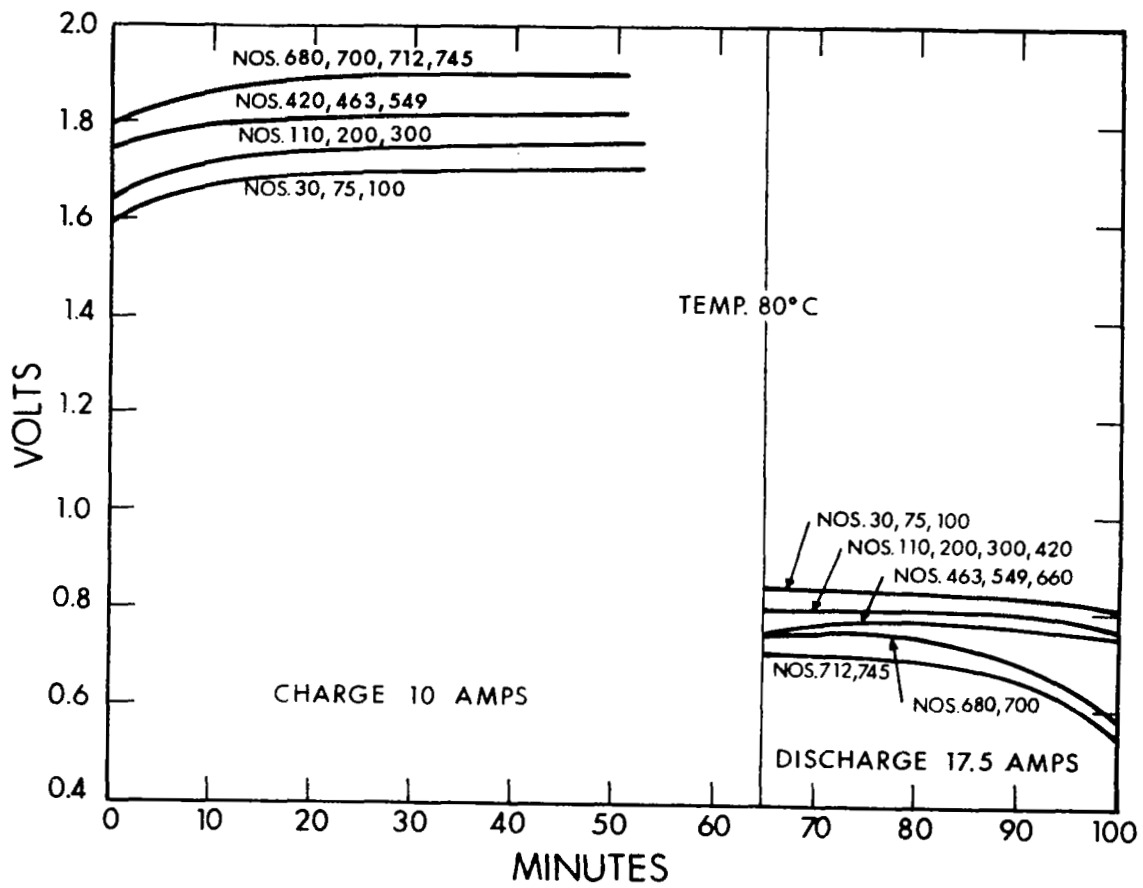
Figure 75. Cycling Performance of Cell 266

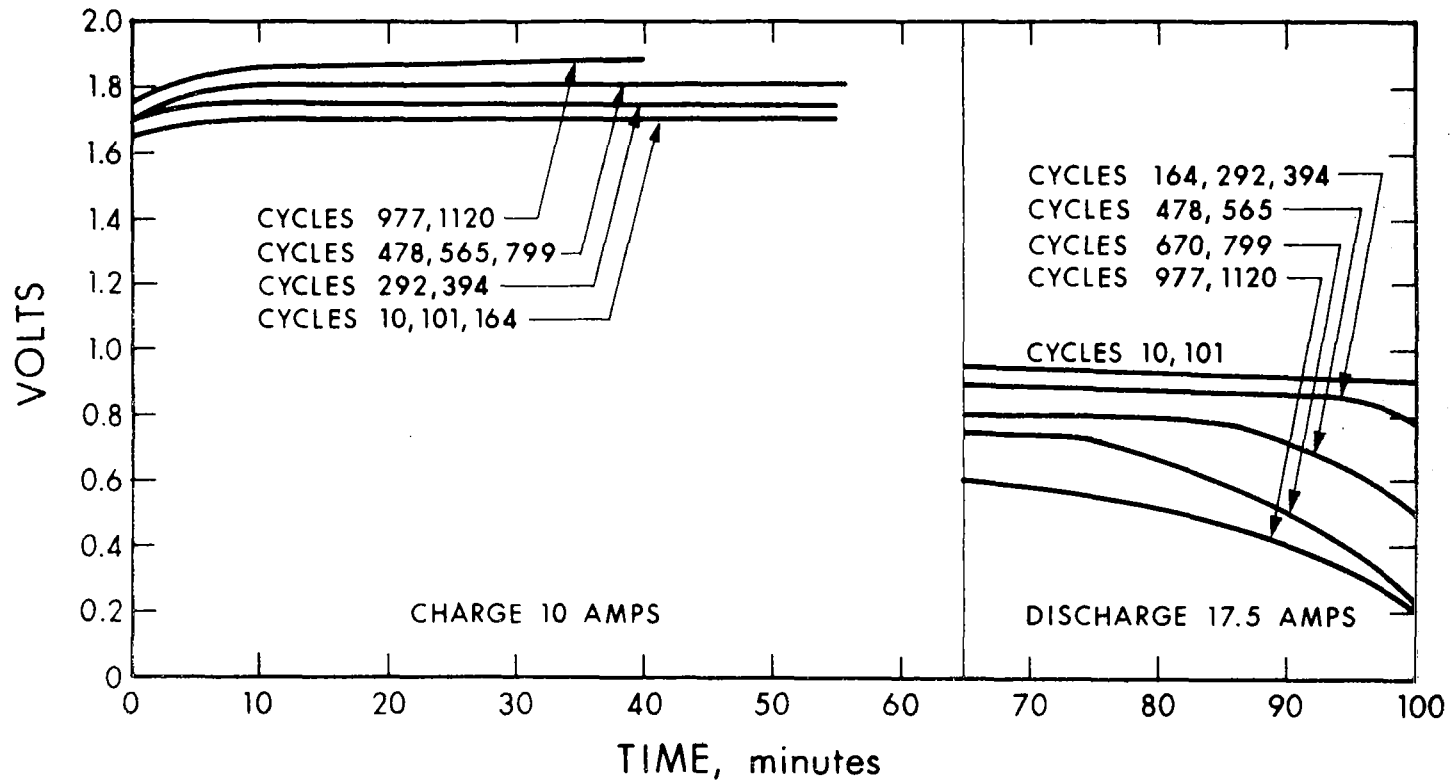
Figure 78. Cycling Performance of Cell 274

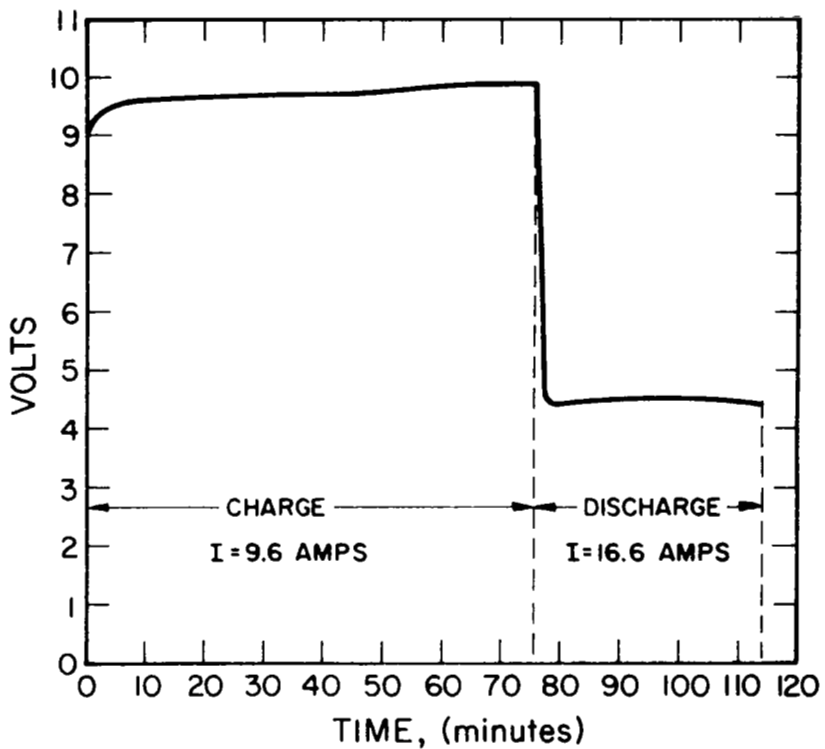
T= 51° TO 57°C
P= 75 PSIG AT START OF CHARGE
320 PSIG AT END OF CHARGE
ELECTRODE AREA = 28.3 IN.²
NO. CELLS = 6

Figure 89. Electrical Performance in Run No. 7

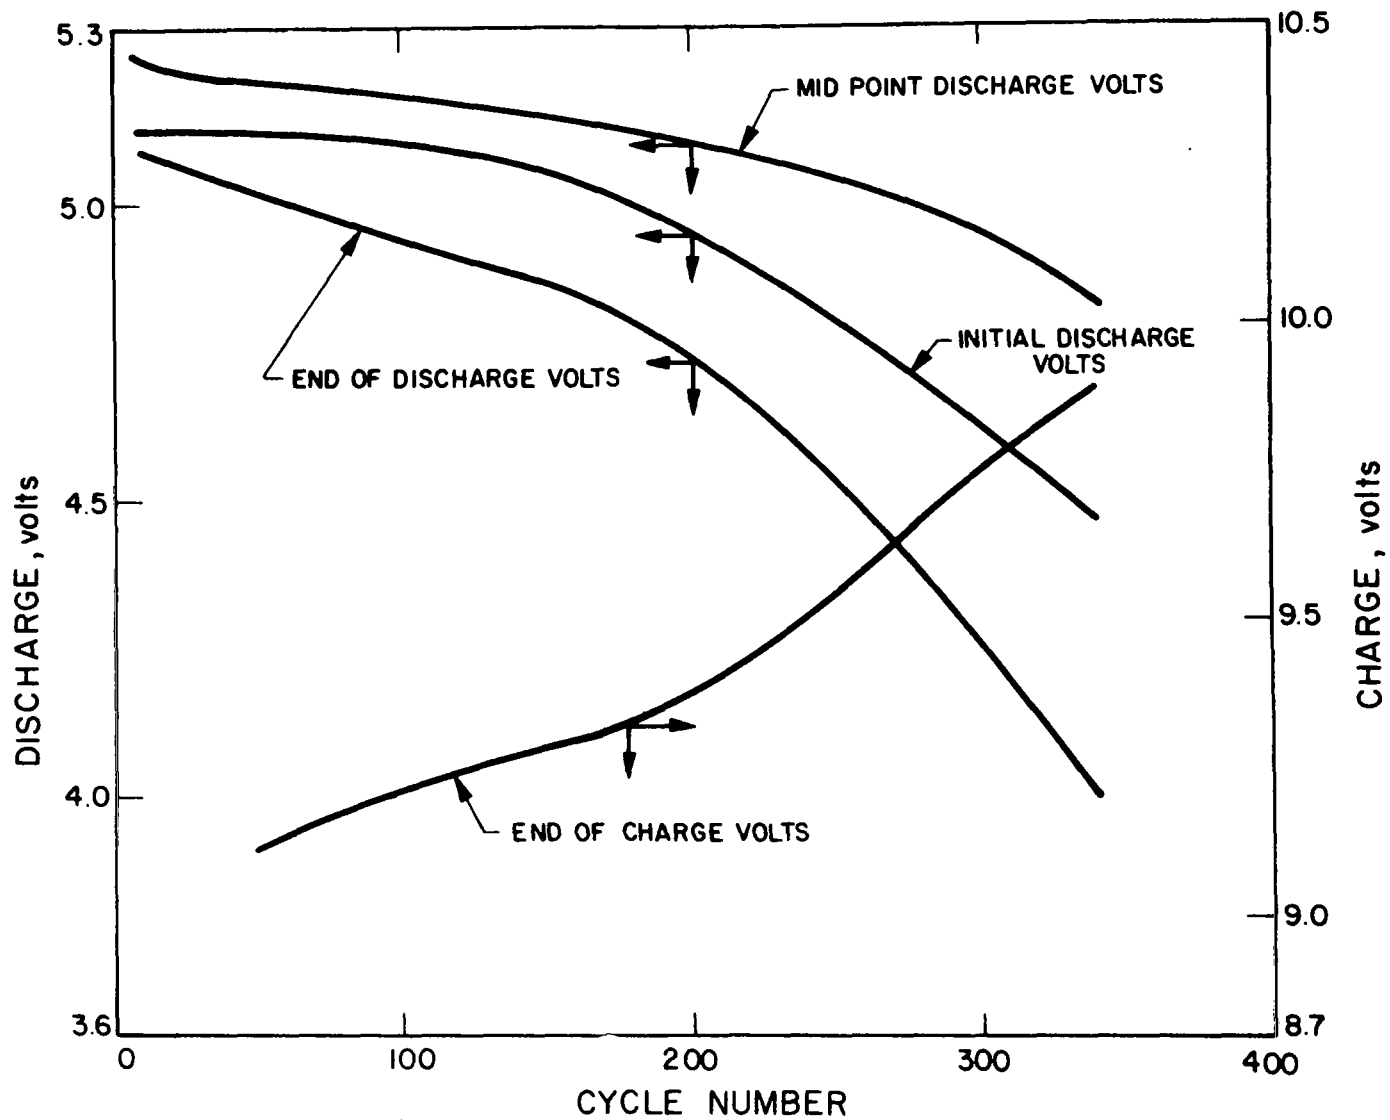
Figure 105. Effect of Fuel Cell Voltage as a Function of Cycling (S/N 107)

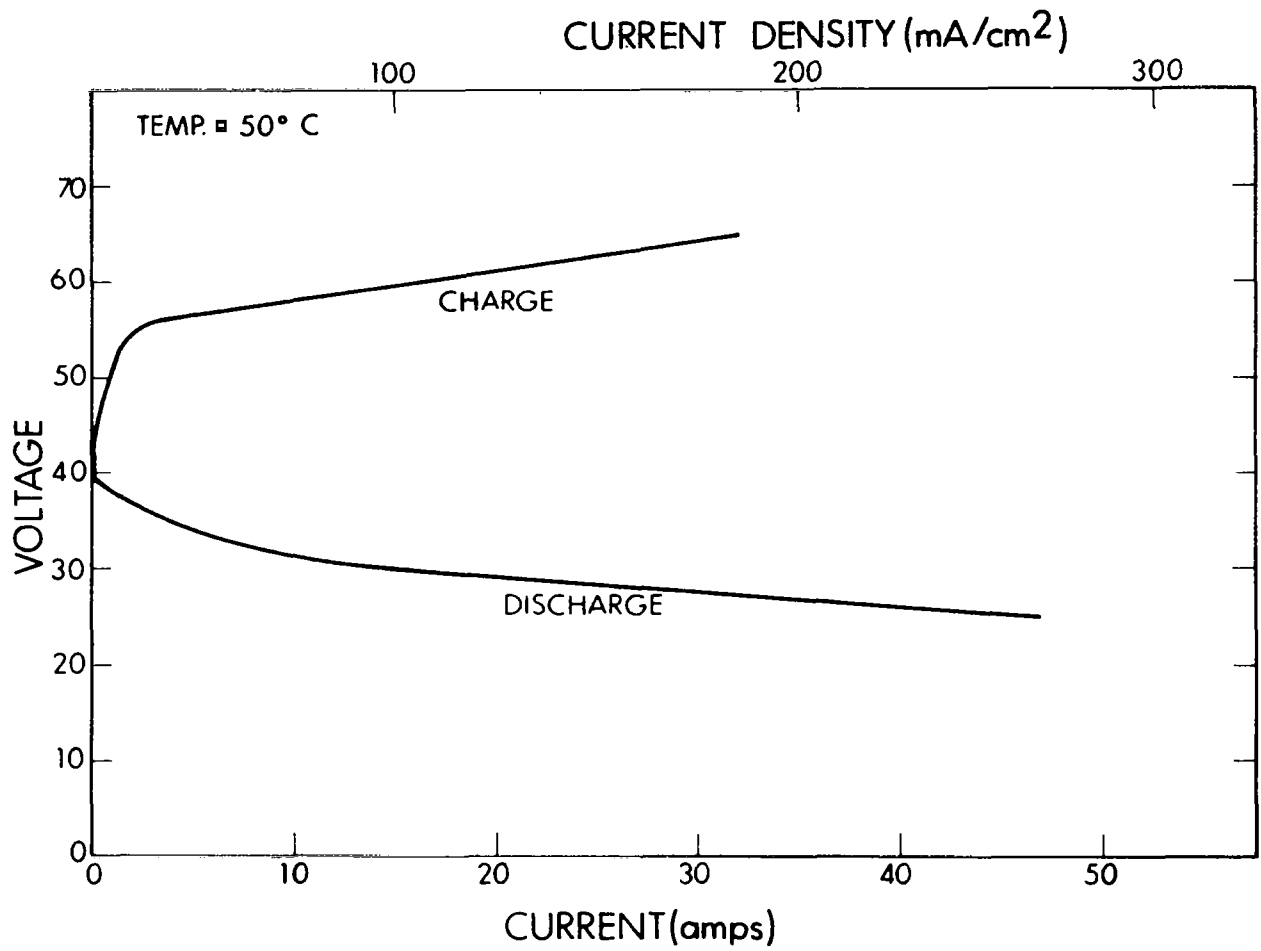
Figure 122. Polarization Curve of 500-Watt Regenerative Cell S/N 1006
