PROPERTIES OF
HIGH EMITTANCE MATERIALS

by R. E. Cleary, R. Emanuelson, W. Luoma, and C. Ammann

UNITED AIRCRAFT CORPORATION

NATIONAL AERONAUTICS AND SPACE ADMINISTRATION • WASHINGTON, D. C. • FEBRUARY 1969

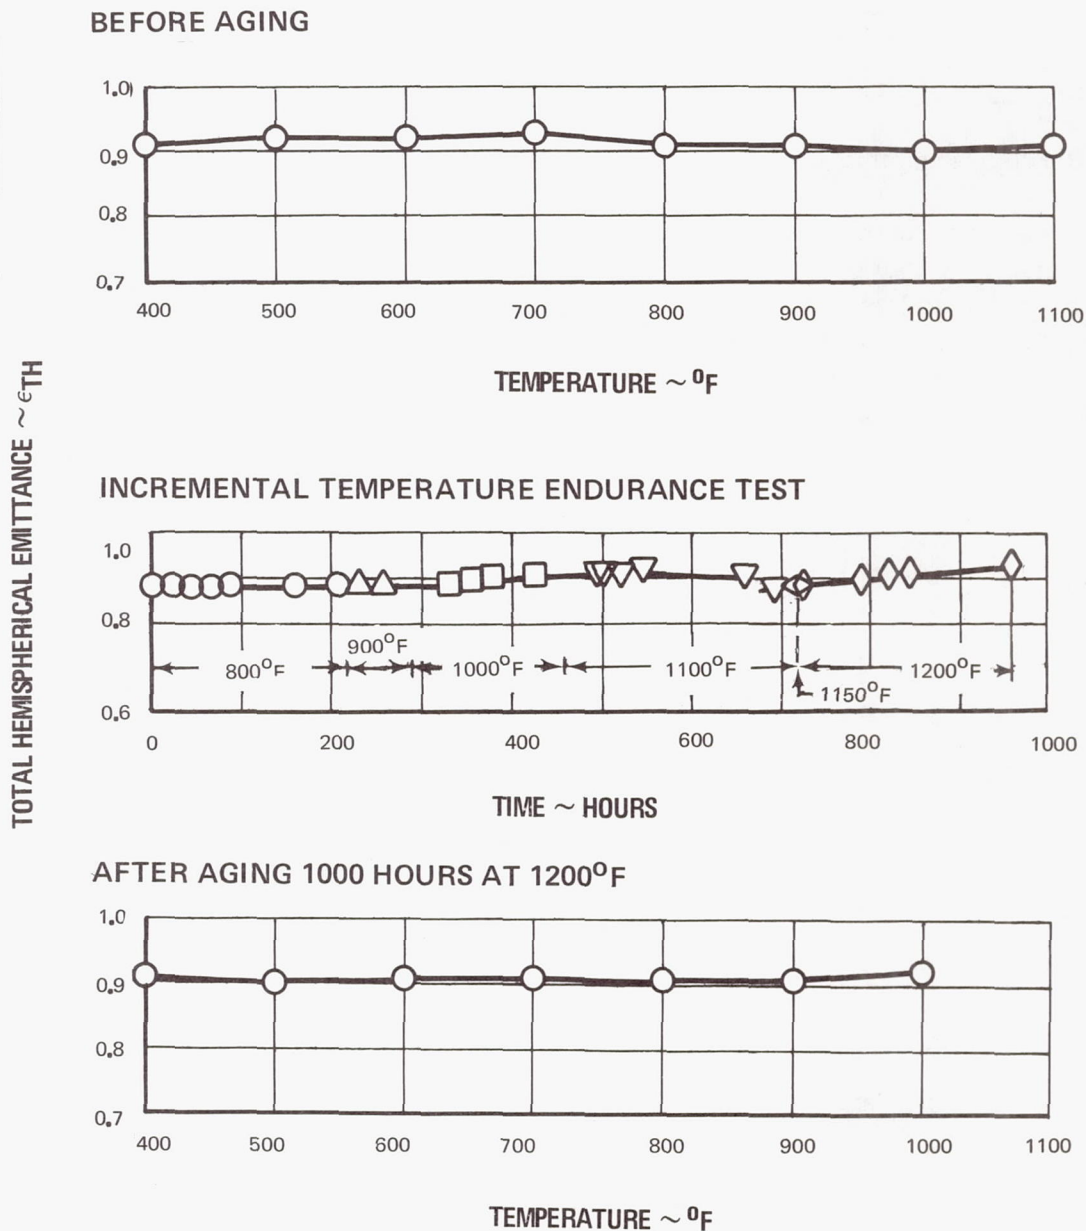
The emittance of iron-titanate-coated beryllium was measured through steady-state testing and through thermal-decay testing. The emittance values obtained are shown in Figure 10.

Figure 10 Total Hemispherical Emittance Measurement Results for Iron-Titanate-Coated Beryllium

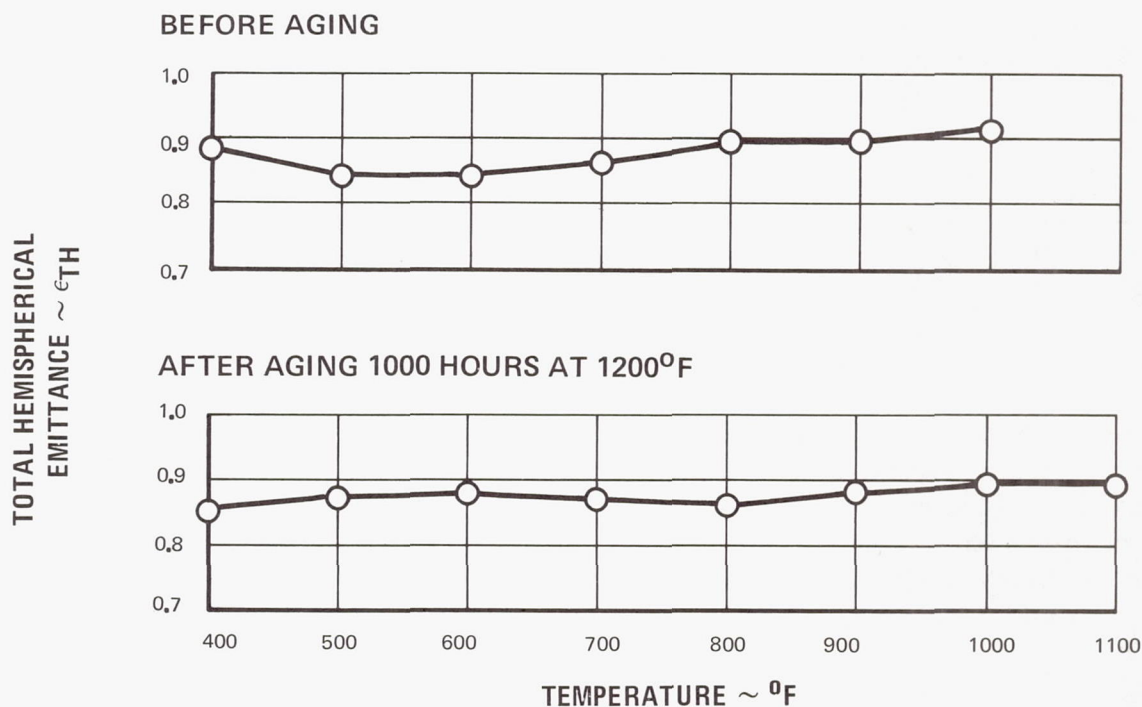
Total hemispherical emittance measurements were made on zirconium-titanate-coated beryllium specimens by the thermal decay method. Both unaged specimens and specimens which had been aged at 1200°F for 1000 hours were tested. The emittance values obtained were similar for both specimens, varying from 0.84 to 0.91 over the temperature range of 400°F to 900°F. These values are shown in Figure 13.

Figure 13 Total Hemispherical Emittance Measurement Results for Zirconium-Titanate-Coated Beryllium Plates

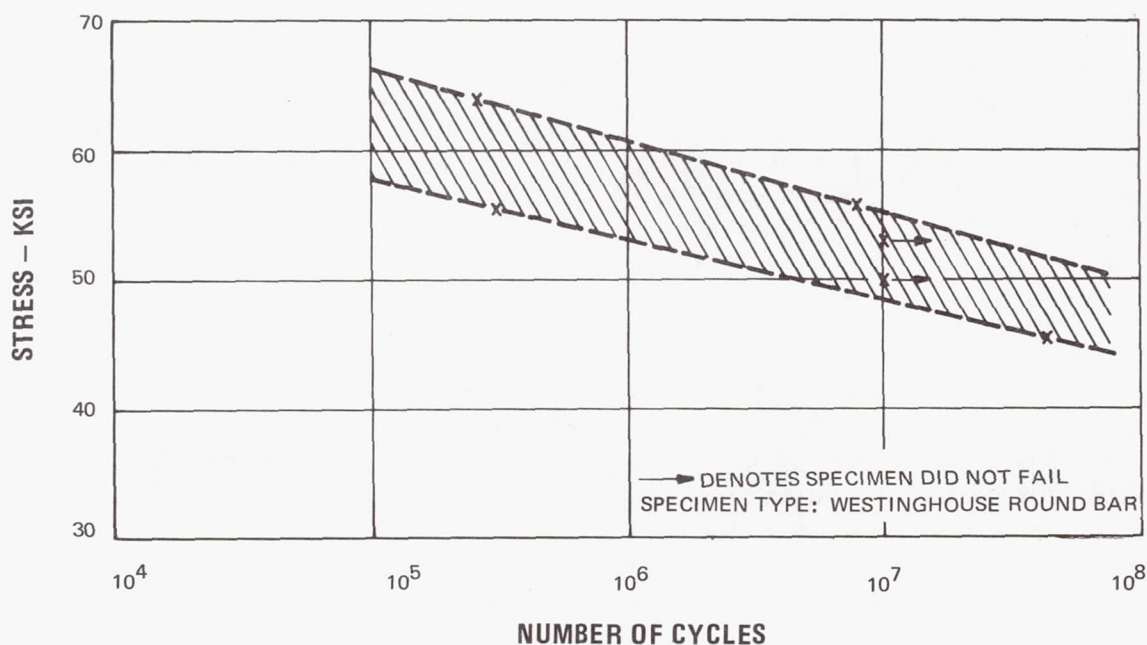
Fatigue tests were conducted on coated and uncoated AISI-310 stainless steel and columbium-1 percent zirconium tubes. The results for the uncoated stainless steel specimens are shown in Figure 20. The run-out stress for this material appears to be about 50,000 to 55,000 psi. The results for the coated stainless steel specimens were similar, as shown in Figure 21. All of the coated specimens failed through fracture of the substrate. No failures resulted from spalling or cracking. A typical failed stainless-steel specimen is shown in Figure 22.

Figure 20 Fatigue Test Results Obtained at Room Temperature for AISI-310 Stainless Steel

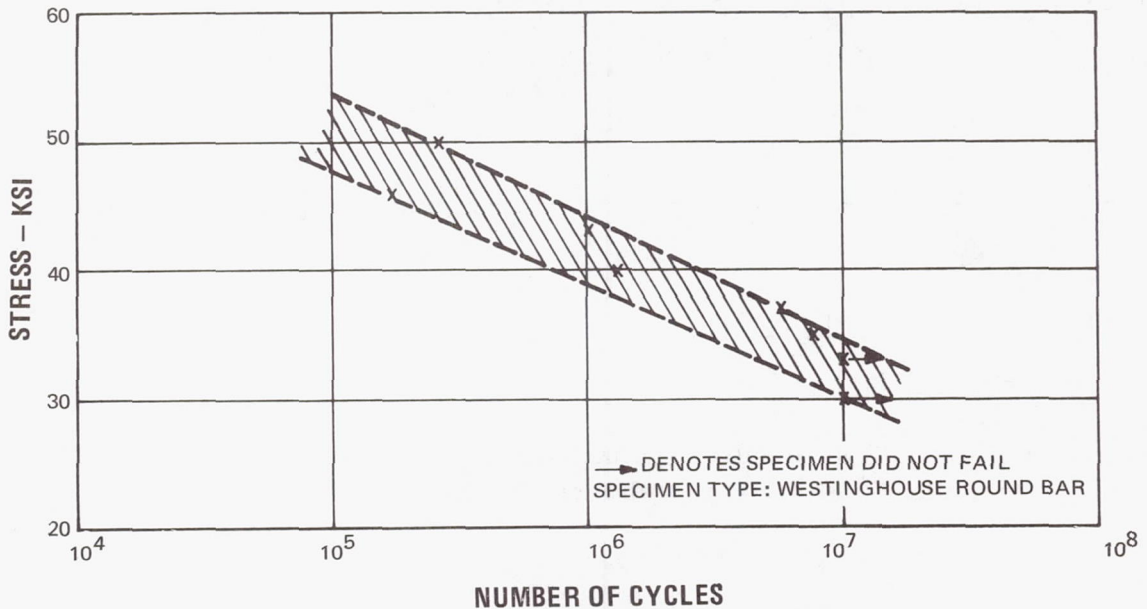
Testing of the uncoated columbium-1 percent zirconium specimens indicated that the run-out fatigue stress for this material is 30,000 to 33,000 psi (see Figure 23). The coated specimens were found to have a run-out fatigue stress of 35,000 psi, which is about the same as that for the uncoated specimens (see Figure 24). In all cases, failure was the result of fracture of the substrate rather than spalling or cracking of the coating. A typical failed specimen is shown in Figure 25.

Figure 23 Fatigue Test Results Obtained at Room Temperature for Columbium-1 Percent Zirconium

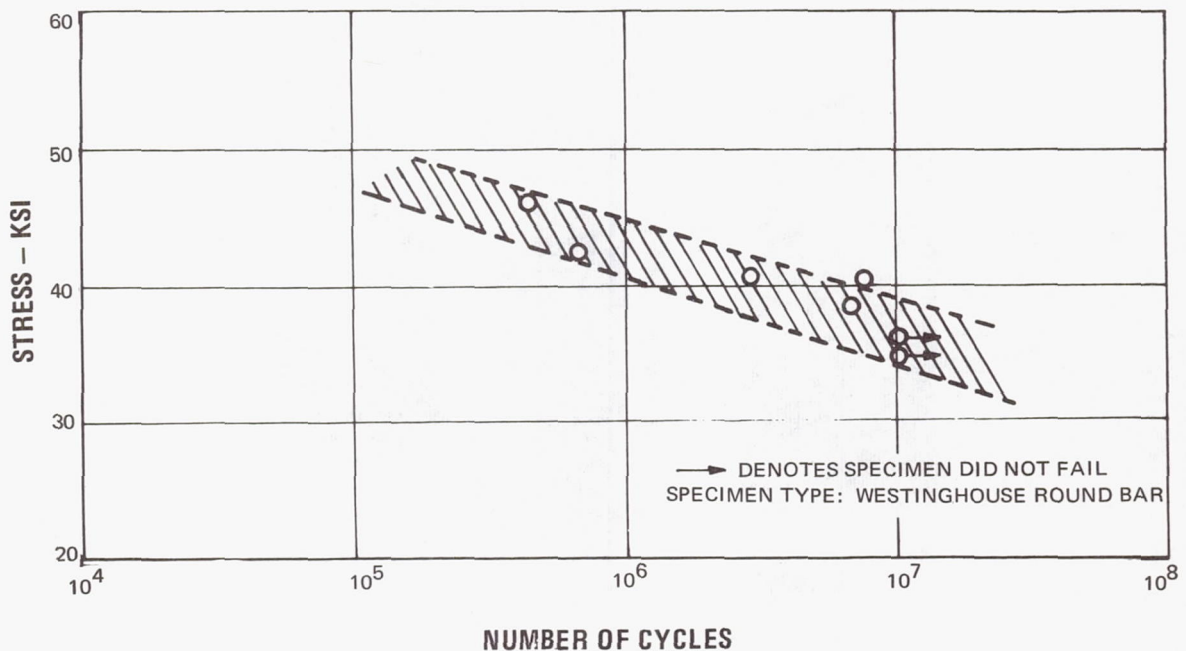
Figure 24 Fatigue Test Results Obtained at Room Temperature for Columbium-1 Percent Zirconium Coated With Iron Titanate

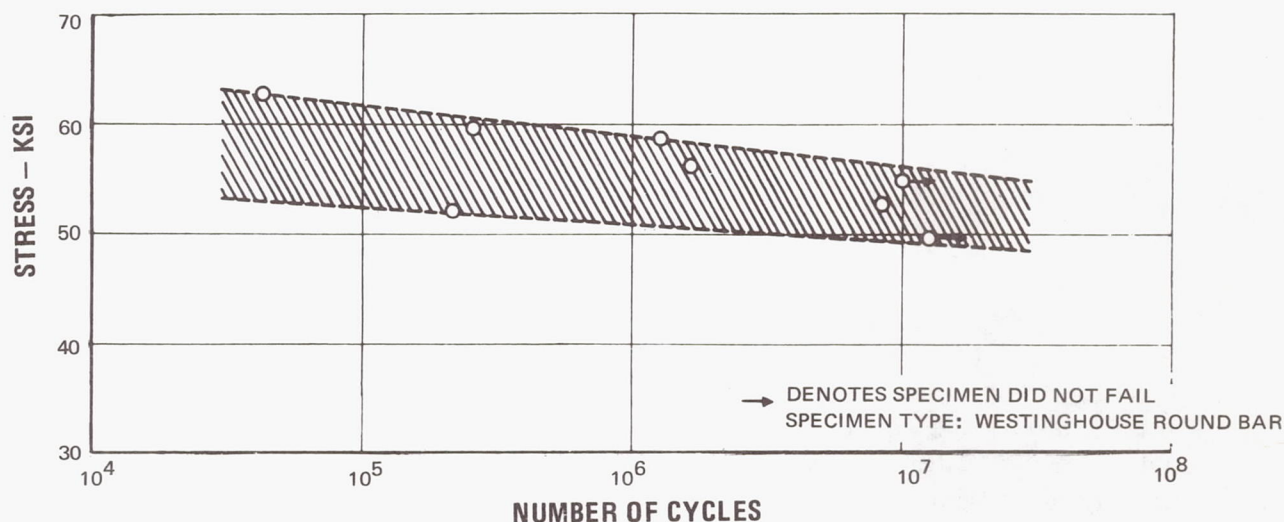
Figure 28 Fatigue Test Results Obtained at Room Temperature for AISI-310 Stainless Steel Coated With Calcium Titanate
