R-624  
FINAL REPORT  
APOLLO GAS-BEARING MATERIALS PROGRAM  
by  
Henry H. Rowe, Jr.  
October 1968

APOLLO GAS-BEARING MATERIALS PROGRAM

This report was prepared under DSR Project 55-24310, sponsored by the Manned Spacecraft Center of the National Aeronautics and Space Administration through Contract NAS 9-4576 with the Instrumentation Laboratory of Massachusetts Institute of Technology in Cambridge, Massachusetts.

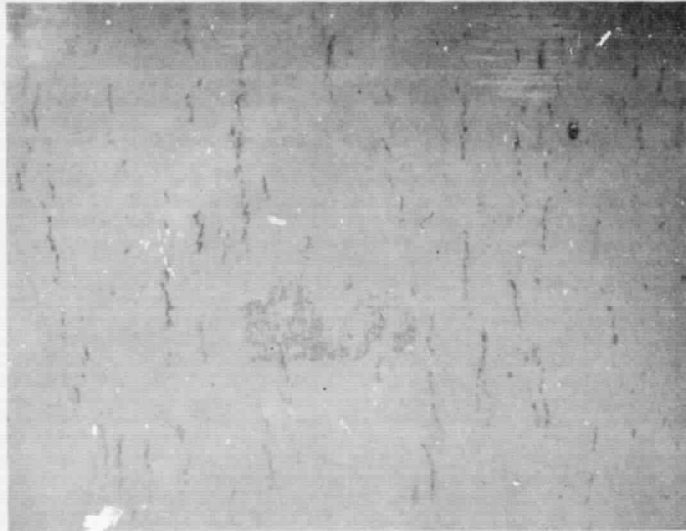
Fig. 2a Photomicrograph (100 X) and Talysurf surface finish trace on AVCO hot pressed alumina test journal.

Surface-finish measurements and photomicrographs of the finish-lapped AVCO hot-pressed alumina test sleeve and the vapor-coated AVCO test sleeve are shown in Fig. 2a and 2b. Figure 2c shows a typical lapped gas-bearing surface of the cold-pressed and sintered alumina material. From these figures it can be seen that the surface finishes attainable with the hot-pressed alumina, both with and without a vapor-deposited coating, are far superior to those obtained using the materials presently specified for gas bearings.

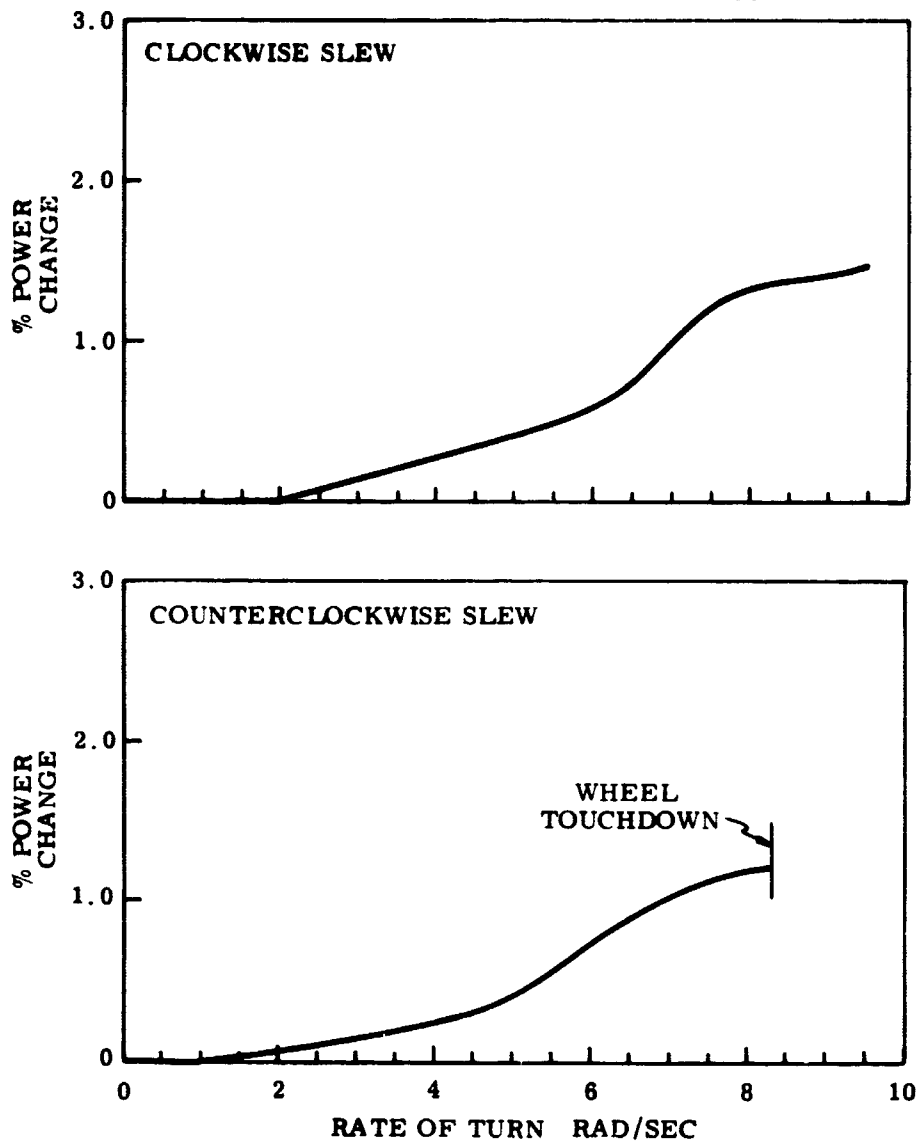
Fig. 8 Change in wheel power as a function of rate input for wheel 18BM-3.

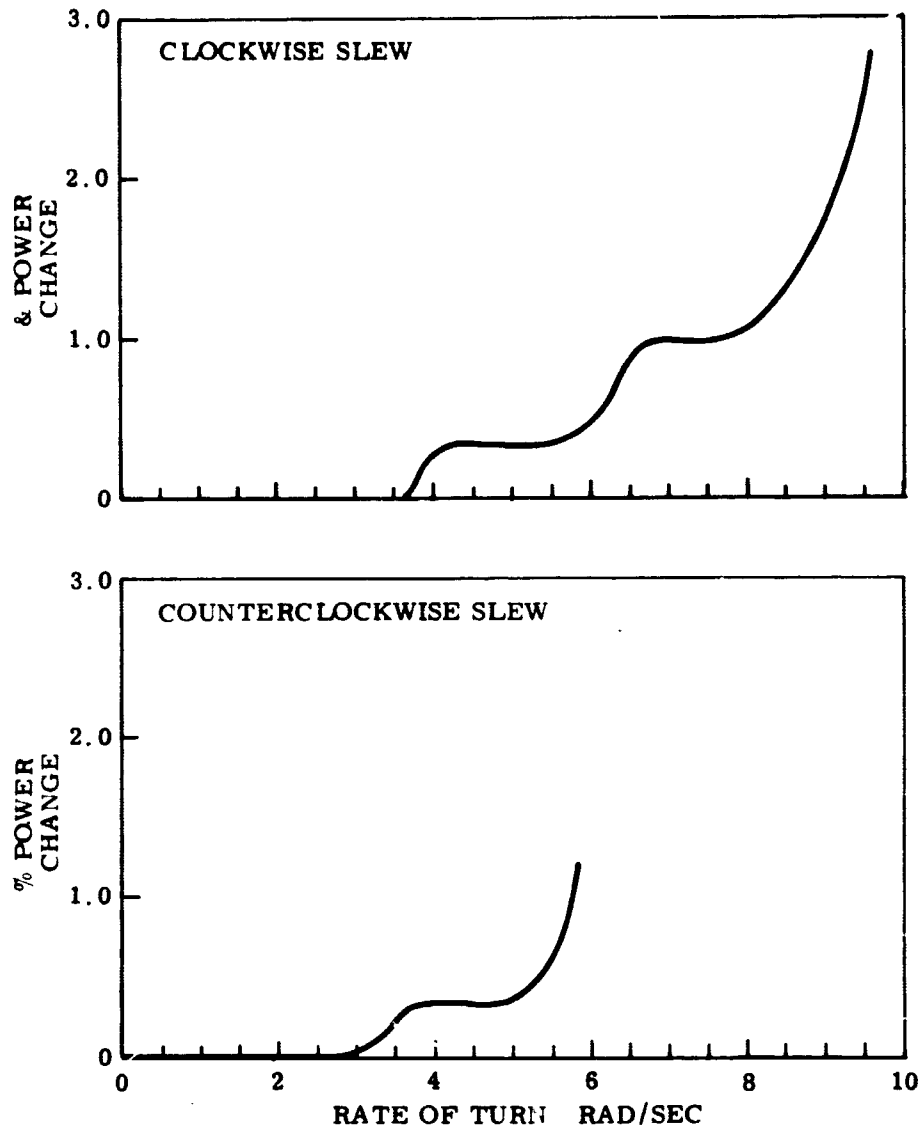
Fig. 10 Change in wheel power as a function of rate input for wheel 18BM-1. Clockwise and counterclockwise slew, initial position.

position of 75° rotation about the SRA from the initial position) when it was accidentally bottomed out at a slew rate of 12.6 rad/sec clockwise. Prior to touchdown, the wheel had exhibited a maximum slew-rate capability of 10.8 rad/sec. Although the wheel continued to run following this accidental touchdown, the slew capability of the assembly was reduced to about 1 rad/sec.

Teardown of the wheel revealed that the touchdown had occurred on the journal. However, the mode of failure for this assembly differed from that observed with the AX-1 or Lucalox ceramics previously used. That is, there were no signs of grain-boundary etching in the wear scar as observed with AX-1 or Lucalox. (See Fig. 12.) Rather, the AVCO hot-pressed material exhibited a wear scar resembling a peeling of a layer of material from the surface with no gross subsurface damage apparent.

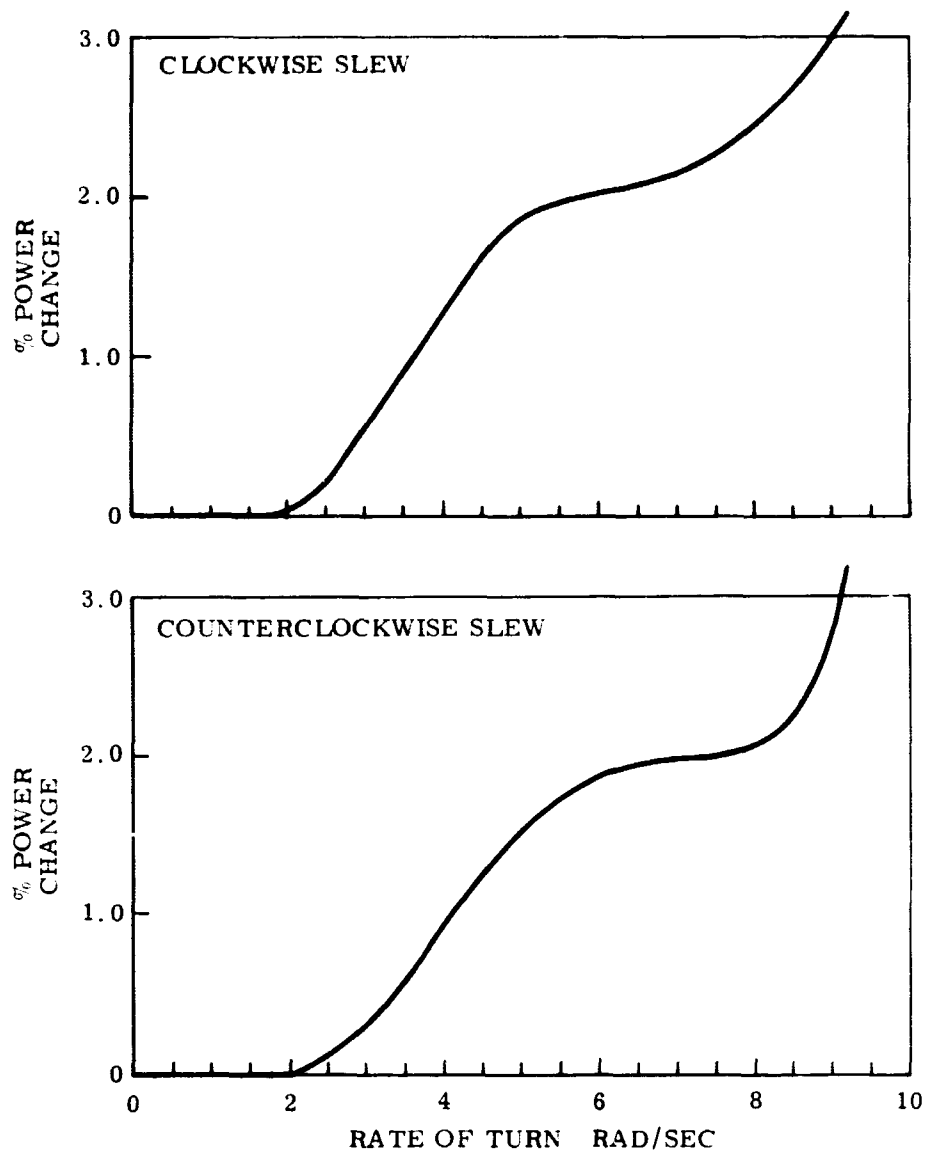
Fig. 11 Change in wheel power as a function of rate input for wheel 13BM-1. Repeat of slew test  $90^{\circ}$  from initial position, clockwise and counterclockwise slew.

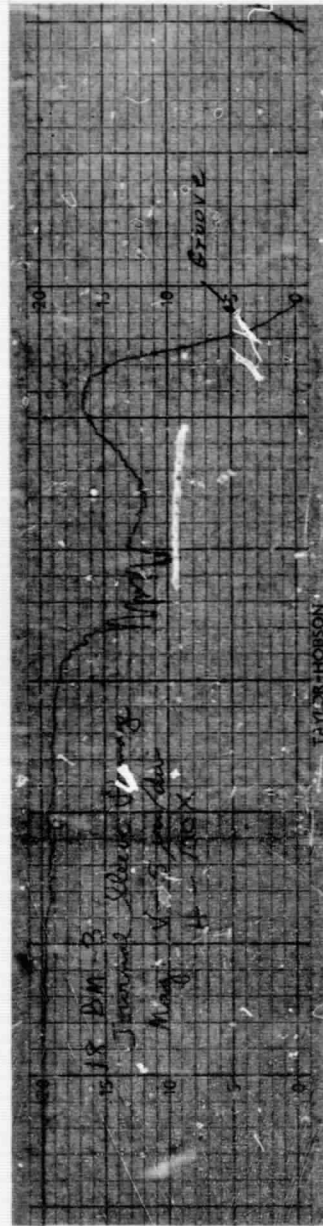
Fig. 14 Talysurf traces taken across failure scar on journal of wheel 18 BM-3 following slewing to touchdown.

Figures 13a and 13b show sections of the failure scar from the journal sleeve of wheel 18 BM-3. Figure 14 shows talysurf traces taken across the damaged area at three positions around the sleeve circumference for the wheel. From these figures it may seem that some grain boundary etching did occur in the damaged region and, though the scar did not extend across the journal grooves, at some points it did reach depths equivalent to the journal groove depths (i. e., 100 microinches).

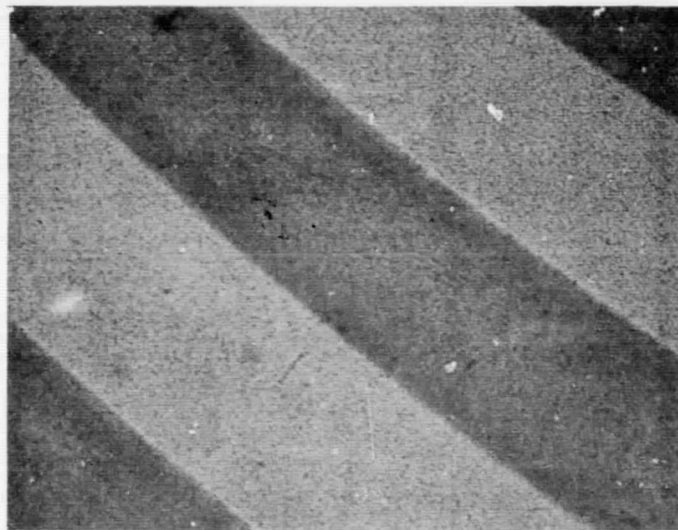
Fig. 17b Whipple grooves machined in vapor plated alumina by ultrasonic machine technique (100 X).

The fine grain-size material also results in improved machinability of thrust pads as seen in Fig. 17a, b, and c. Figure 17a represents Whipple grooves ultrasonically machined in a medium grain-size cold pressed and sintered alumina, such as AX-1 or LUCALOX; Fig. 17b and 17c show the results of the same machining process used to generate Whipple grooves in vapor plated alumina and the AVCO hot-pressed alumina (without plating), respectively. Here it is evident that the fine grain-size and uniformity of the material has greatly contributed to a finer definition of the groove edges and to a much smoother surface at the base of the groove.

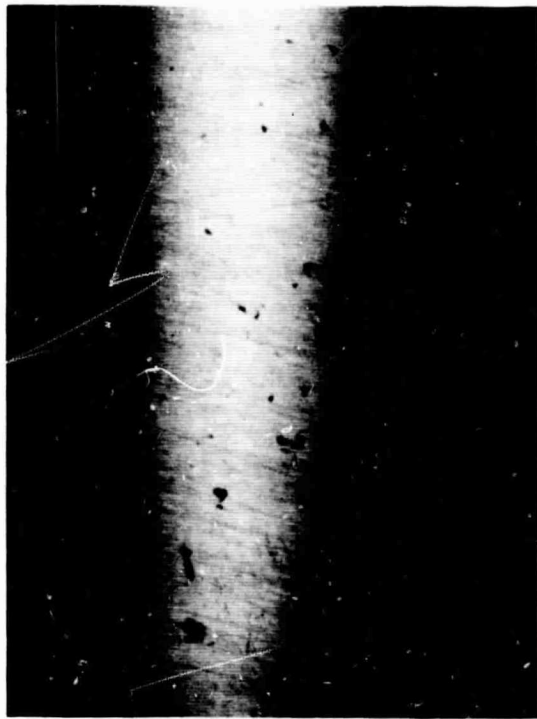
Fig. 5 Vapor Coated Hot Pressed AVCO Alumina 50X.
