NASA TN D-5076

COMPATIBILITY TESTS OF
MOLTEN URANIUM WITH TUNGSTEN AND
TUNGSTEN- 1.5 PERCENT HAFNIUM

by Philip D. Takkunen

Lewis Research Center

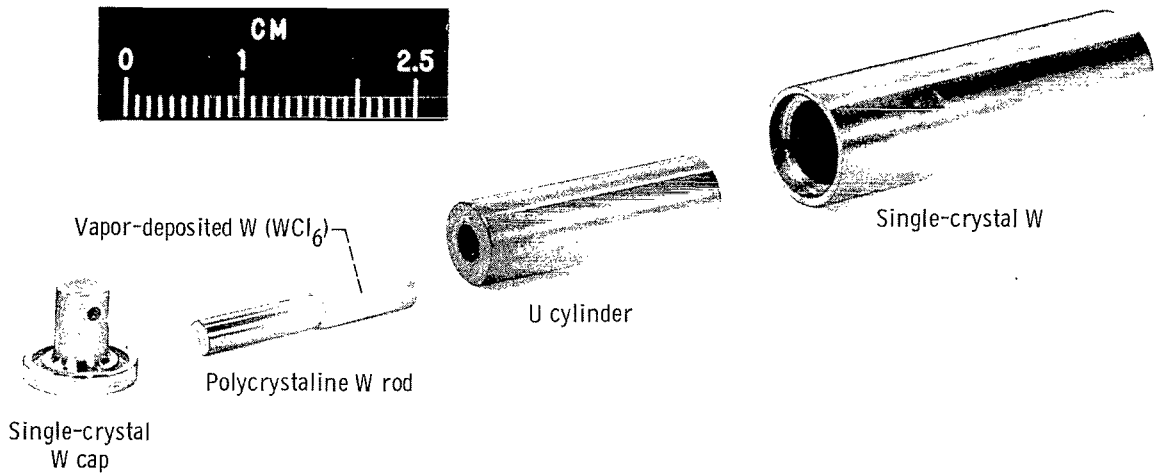
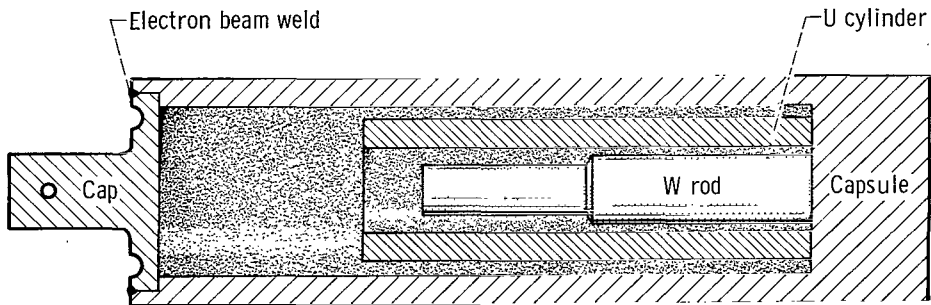
Figure 1. - Tungsten-uranium (W-U) capsule components.

Both W and W-1.5Hf capsules were fabricated for compatibility tests with U. The W capsules were fabricated from 0.50-inch- (1.3-cm-) diameter single-crystal rods. And a 0.125-inch- (0.32-cm-) diameter polycrystalline W rod (partially clad with vapor-deposited W) was inserted into most of the W capsules along with a U cylinder (fig. 1). This configuration permitted comparison of U attack on two types of polycrystalline W as well as on single-crystal W. The W-1.5Hf capsules were similar to the W capsule shown in figure 1 except that they were fabricated from wrought polycrystalline material because single crystals of this alloy were not available. Thus it was unnecessary to insert polycrystalline rods into the W-1.5Hf capsules.

(a) Exploded view.

(b) Cross section of assembled view (not to scale).

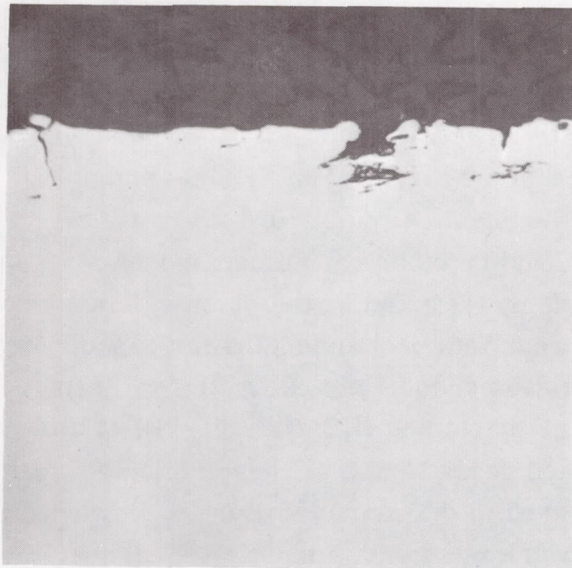
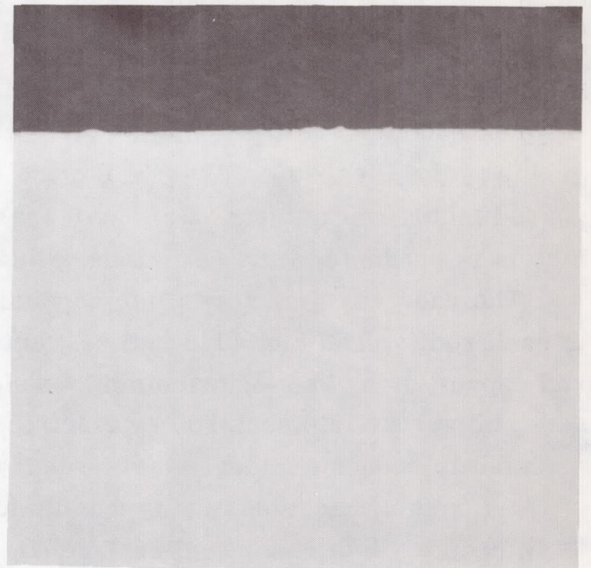
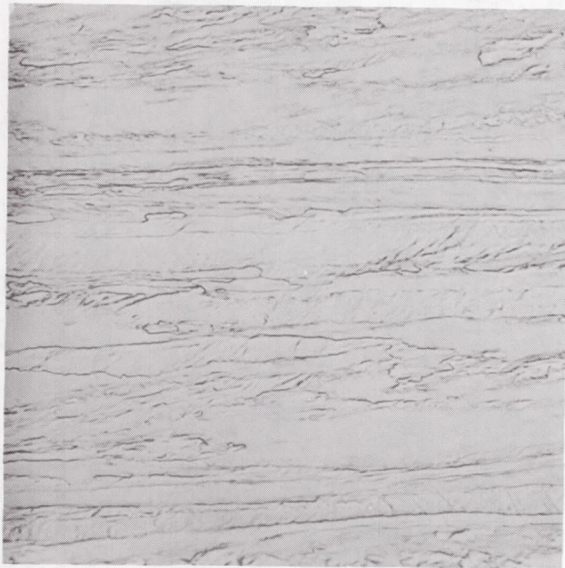
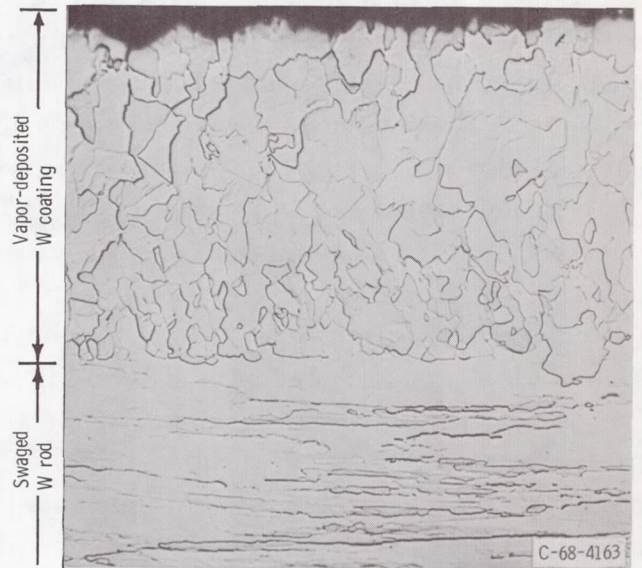
Figure 2. - Photomicrographs of tungsten (W) and tungsten - 1.5-percent-hafnium (W-1.5Hf) capsules and inserts showing the interior capsule surfaces and the microstructures in the "as-fabricated" condition. 250X.

(a) Interior capsule surface after electric discharge machining.

(b) Interior capsule surface after electropolishing.

(c) Swaged W-1.5Hf capsule. Murakami's etchant.

(d) Tungsten rod insert. Murakami's etchant.

The polycrystalline W rods (which were inserted into the single-crystal capsules) were obtained from commercially available swaged rod. One-half of each polycrystalline rod was coated with a 0.005-inch- (0.13-mm-) thick layer of vapor-deposited W (produced by hydrogen reduction of tungsten-hexachloride gas). A typical microstructure of the W rod and coating is shown in figure 2(d).

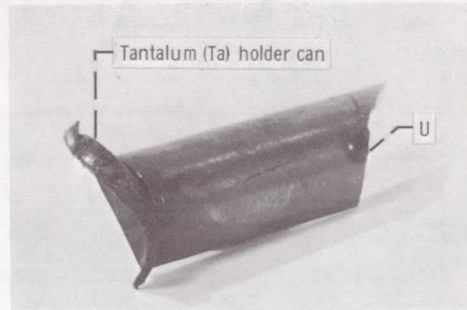
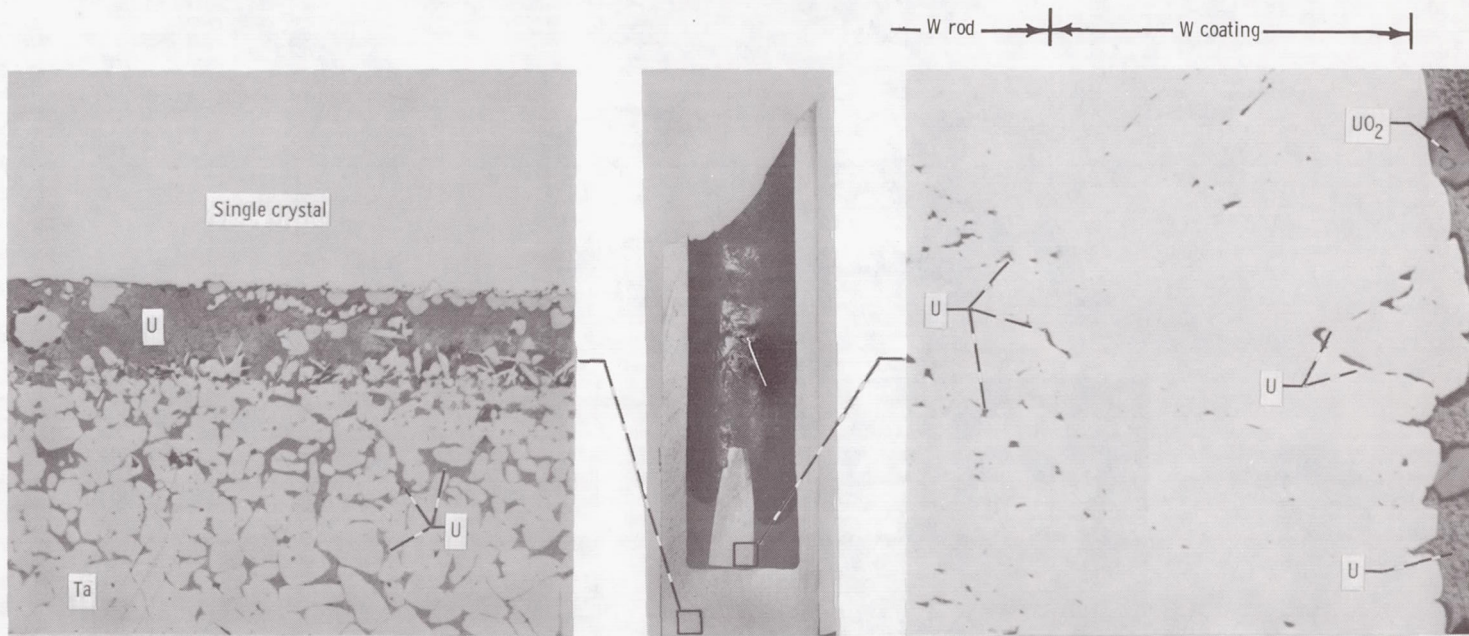
Figure 3. - Tungsten (W) capsule tested for 10 hours at 1200° C.

1200^o C for 10 hours. - The capsule tested at 1200^o C for 10 hours (capsule 1 in table II) is shown in figure 3. The top of the capsule was broken (fig. 3(a)) after the test during attempts to separate the capsule from the tantalum (Ta) can used to hold the capsule in the furnace. The adhesion between the capsule and the Ta resulted from U leakage. About 80 percent of the U had leaked out of this capsule through fabrication-induced cracks; these cracks and the resultant U leaks were observed visually (fig. 3(a)).

Although most of the U leaked out of this capsule, enough was left to ensure that part of the W capsule and the rod insert were exposed to U for the total test time. After 10 hours, attack was not observed on the single-crystal capsule; that is, the wall edges appeared similar to the "as-fabricated" walls (fig. 2(b)). A small amount of intergranular penetration of U into the polycrystalline W rod insert (the shape of the insert resulted from the angle of sectioning) was observed (fig. 3(b-2)), but this penetration did not extend across the entire rod. As may be seen, the polycrystalline rod exhibited more U penetration than did the vapor-deposited coating.

(a) Capsule.

(b-1) 250X.

(b-2) 500X.

(b) Photomicrographs of sectioned capsule.

In contrast to the polycrystalline W rod tested for 10 hours (fig. 3(b-2)), U was not observed to have penetrated into the worked grain structure of this capsule. However, U did penetrate into grain boundaries in the recrystallized weld zone. As may be observed in figure 8(b-1), U penetrated through grain boundaries in the weld zone to the external surface.

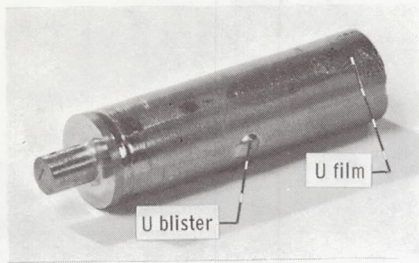
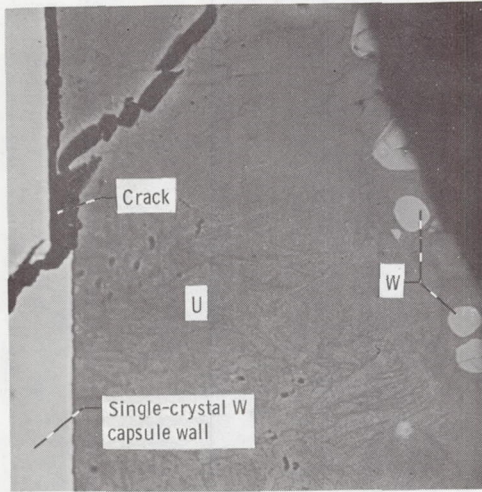
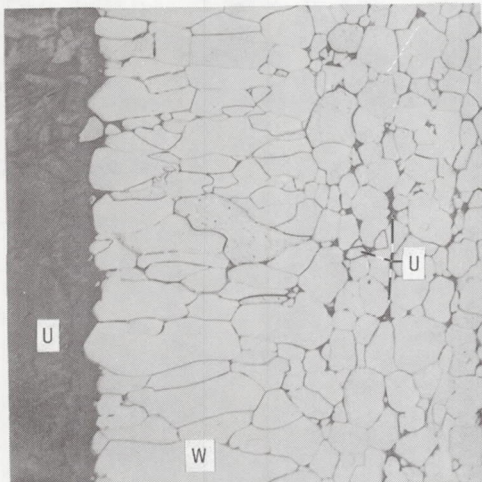
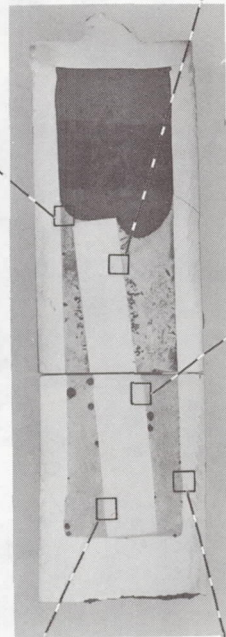
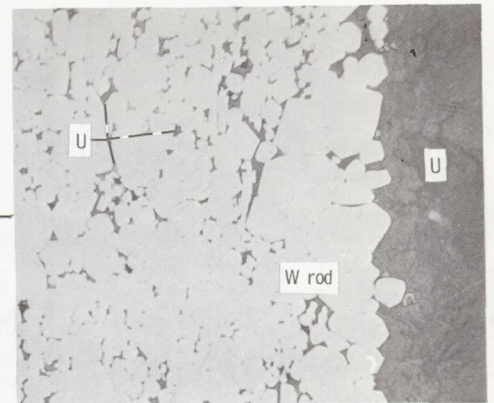
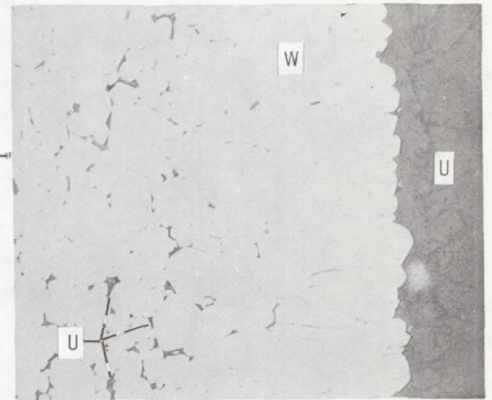
1200^o C for 100 hours. - A small amount of U leaked out of the capsule tested for 100 hours at 1200^o C (capsule 2 in table II). The leakage from the capsule appeared to come from cracks which developed just below the U meniscus (i. e., gas-liquid interface). The U which had leaked out was observed on the external capsule surface in the form of either a thin film or as a blister (fig. 4(a)). Some of the cracks observed contained no U (fig. 4(b-1)), which indicated that they formed after the U solidified-that is, during cooling or metallographic preparation.

The polycrystalline W rod insert was recrystallized during the test (fig. 4(b-2)), and U was observed to have penetrated throughout the rod and its coating. The rod appeared to be attacked to a greater extent than the coating (compare figs. 4(b-3) and (b-4)). As may be seen in these figures, some W grains separated from the rod but not from the coating. Other than some surface dissolution (roughening of the surface), no corrosive attack by U on the single-crystal capsule was observed (fig. 4(b-5)).

An interesting phenomenon was observed at the U meniscus (fig. 4(b-1)). A relatively large number of small metallic-appearing crystals were found along the meniscus compared to the rest of the uranium melt. These crystals were identified as W by electron microprobe analysis.

(a) Capsule.

(b-1).

(b-2) Murakami's etchant.

(b-3).

(b-4).

(b-5).

The extremely good wettability between U and W is perhaps best illustrated on the external surfaces of capsules from which U escaped (fig. 4(a)). In general, the U spread out over the surface, indicating a zero degree contact wetting angle. The few U "blisters" observed on the external surfaces contained some UO₂ and probably resulted from oxidation of U by oxygen impurities originally on the capsule surface or from oxygen in the furnace vacuum.

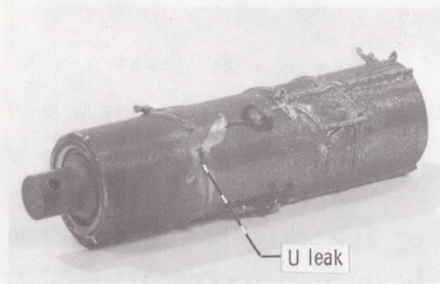
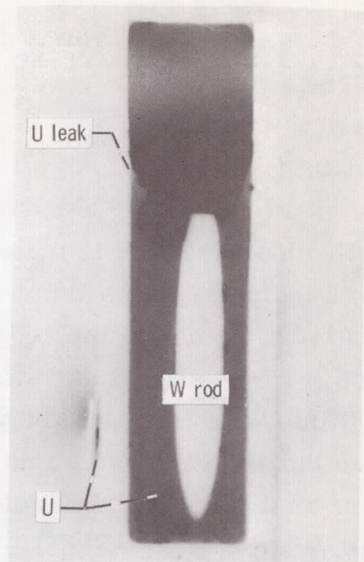
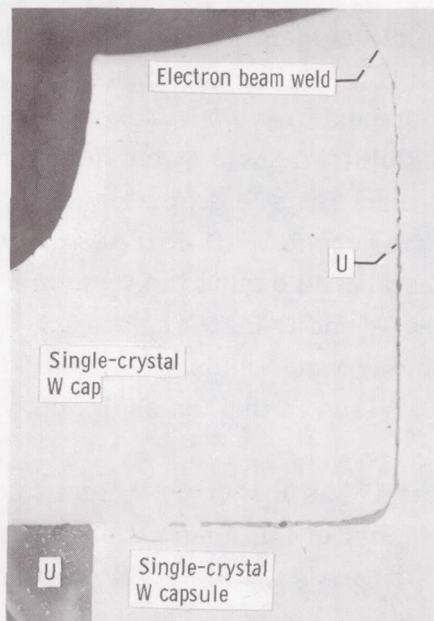
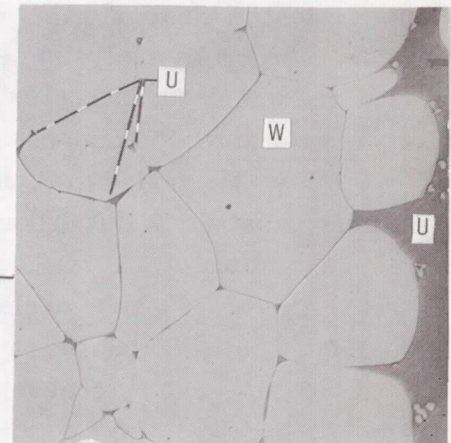
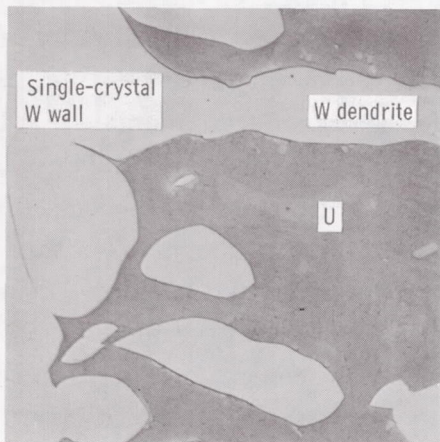
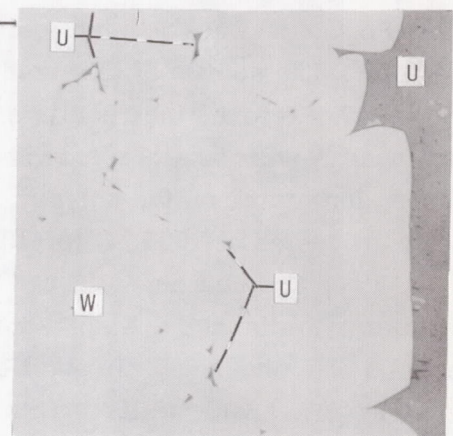
Figure 5. - Tungsten (W) capsule tested for 100 hours at 1500° C.

amount of its U through cracks near the U meniscus (fig. 5). The dull appearance of this capsule (fig. 5(a)) resulted from a reaction between U and the Ta wire used to support the capsule in the furnace.

The autoradiograph shown in figure 5(b) (typical of those taken on other capsules) illustrates two points. First, the thin film of U (resulting from leaks) on most of the external capsule surface is indicative of the good wetting between U and W. And second, the figure indicates that a thin film of U is present on the internal capsule walls above the melt level. Some of the U depicted by the autoradiograph was also metallographically observed (fig. 5(c-1)). In addition, the latter figure illustrates intergranular penetration of U into, and through, the weld.

Both the single-crystal and polycrystalline W exhibited evidence of U attack. The single-crystal wall exhibited some dissolution below the U meniscus and appeared similar to figure 4(b-2). However, the single crystal was more extensively attacked near the meniscus. As shown in figure 5(c-2), the crystal wall exhibited considerable dissolution: this was greatest in regions near the meniscus. In addition, large W dendrites (identified by electron microprobe analysis) were observed along the capsule wall near the meniscus.

(a) Capsule.

(b) Autoradiograph of sectioned capsule.

(c-1) 50X.

(c-3) 250X.

(c-2) 250X.

(c-4) 250X.

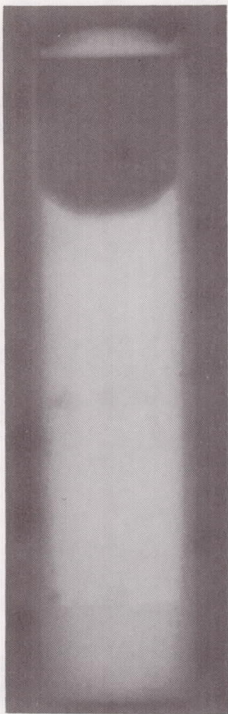
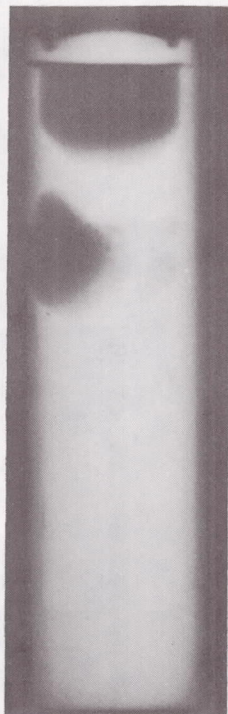
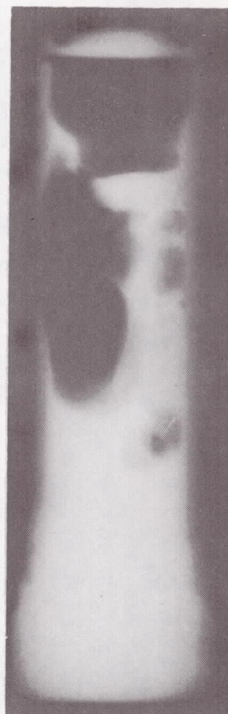
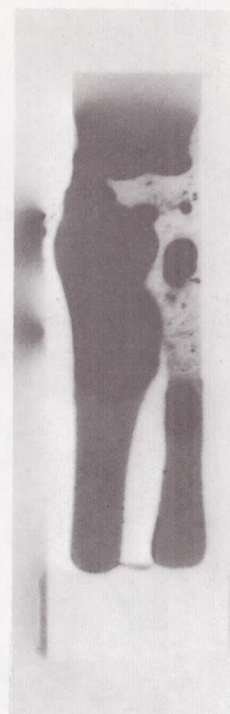
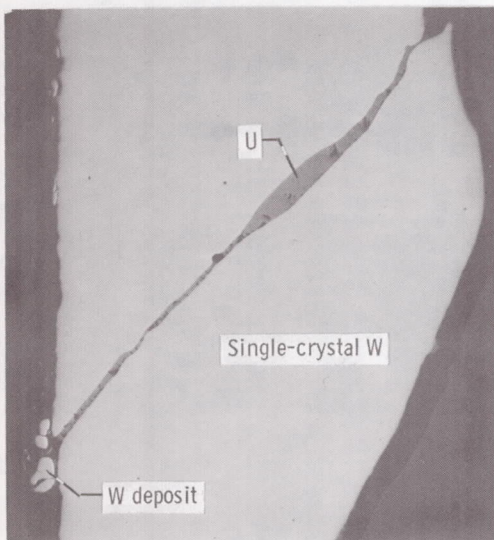
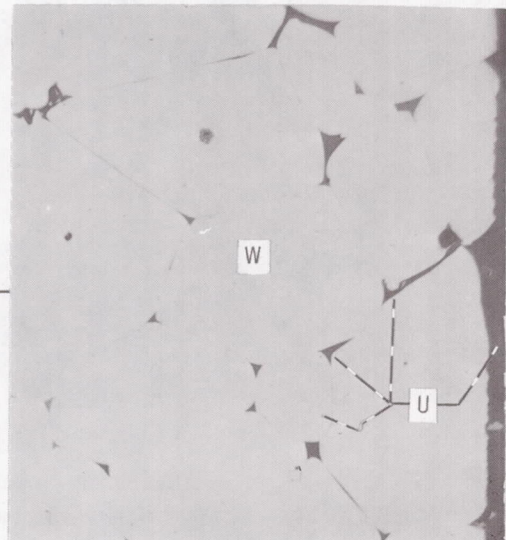
1500⁰ C for two 100-hour cycles. - About half of the U was lost from the capsule tested at 1500⁰ C for 200 hours (capsule 4 in table II). Most of this loss occurred during the second 100-hour cycle according to the radiographs (figs. 6(a) to (c)). However, formation of a large void (or gas bubble) and mass transfer from one side of the capsule wall began during the first 100-hour cycle. As can be seen in figures 6(d) and (e-1), the U leaked out of a crack located just below the original meniscus and in the vicinity of the large void. The source of this void, which was not observed in any other capsule, is unknown. Therefore, the results on this capsule should be considered anomalous. However, these results are presented herein because they may indicate a potential problem.

Uranium attack on the polycrystalline W is illustrated in figure 6(e-2). Similar to the capsule tested at 1500⁰ C for 100 hours, U penetrated into grain boundaries throughout the W rod and coating. Part of the uncoated rod was disintegrated because grains separated from the rod. Also, some surface dissolution from both the rod and the capsule walls was observed. In addition, a layer of grains was formed along parts of the single-crystal capsule walls. This recrystallized layer is presumably due to insufficient removal of the EDM-damaged surface in localized areas. According to reference 6, EDM can convert a single-crystal surface into a cold-worked polycrystalline state.

(a) Radiograph, as-fabricated condition.

(b) Radiograph, after 100 hours.

(c) Radiograph, after 200 hours.

(d) Autoradiograph, sectioned capsule after 200 hours.

(e-1) 50X.

(e-2) 250X.

The reasons for the anomalous localized mass transfer from the wall of the capsule tested for 200 hours at 1500^o C (fig. 6) are not completely understood. The radiographs in this figure indicate that localized mass transfer was present after 100 hours of testing. In contrast, no such localized attack occurred in other capsules tested for 100 to 200 hours at 1500^o C (figs. 5, 7, and 9). Perhaps the localized attack resulted from a flaw (defect) in the single-crystal capsule wall. If this flaw resulted in disturbed (e. g., worked) metal at a high energy level relative to the rest of the capsule, preferential dissolution of metal from this area might result. Although no flaws were observed in this capsule before testing, an internal flaw could have been present (e. g., an EDM-damaged surface, an internal crack, or a low angle (<2^o) grain boundary).

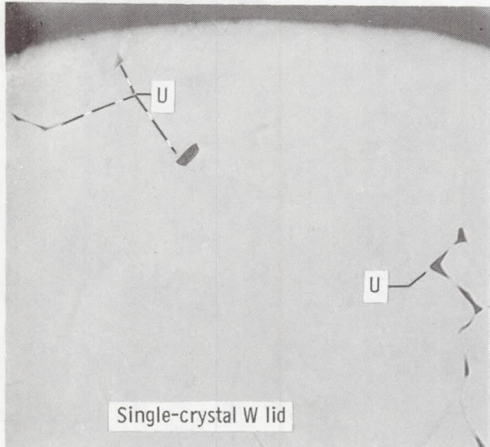
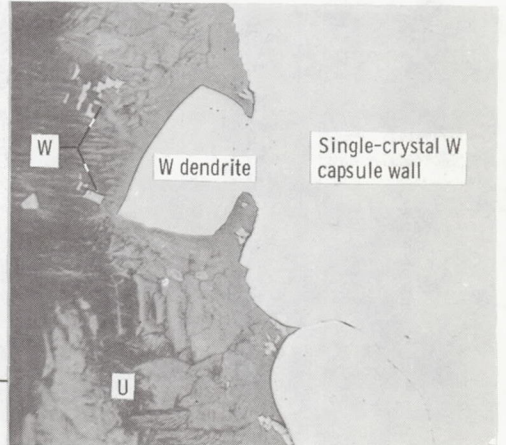
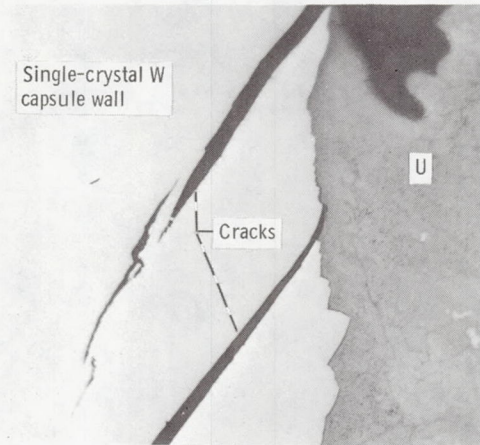
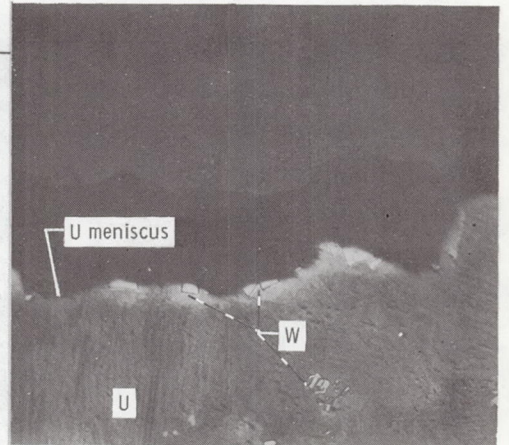
(a) Capsule.

(b-1).

(b-3).

(b-2).

(b-4).

After 200 hours at 1500° C, no U loss from this capsule was detected by either weight loss measurements or by visual examination (see fig. 7(a)) in contrast to every other capsule tested. However, metallographic examination revealed that U had almost leaked out of the capsule by penetrating along grain boundaries in the weld zone (fig. 7(b-1)). In addition, metallographic examination revealed two cracks in the capsule wall (fig. 7(b-2)) which extended across three-fourths of the wall thickness. These cracks contained no U, indicating that they were formed after the U had finally solidified. It thus appears that if a capsule is not thermally cycled, the period of effective U containment by single-crystal W depends on the rate of U intergranular attack on the weld.

The extent of U corrosive attack on the single crystal was not significantly different than for any other capsule (except for the anomalous results on the capsule shown in fig. 6). The walls of the single crystal exhibited some dissolution and, for the most part, appeared similar to figure 7(b-2) without the cracks. However, the wall near the meniscus was more heavily corroded as shown in figure 7(b-3). This figure also illustrates the relatively small dendrites beginning to grow out from the wall. And, similar to the other capsules, figure 7(b-4) indicates a higher concentration of W precipitate at the U meniscus. The amount of dendrites and other W precipitates is significantly less than the other single crystal tested at 1500° C for 100 hours less time (fig. 5). This observation indicates that most of the W transferred to the meniscus and to dendrites near the meniscus in that capsule originated from the polycrystalline W.

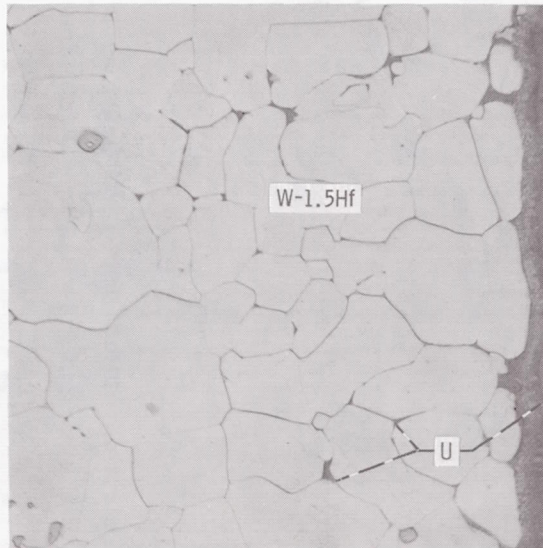
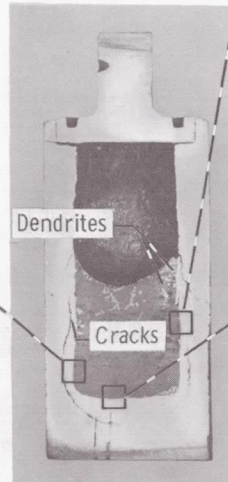
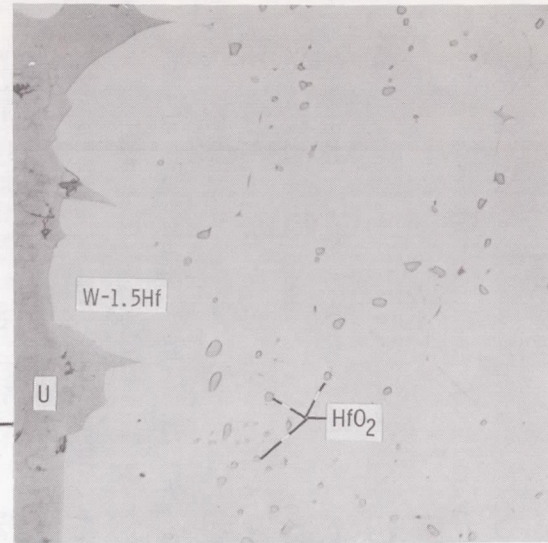
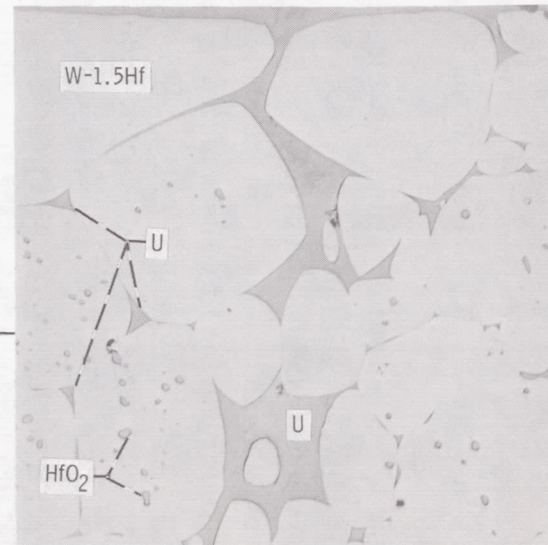
Figure 9. - Tungsten - 1.5-percent-hafnium (W-1.5Hf) capsule tested for two 100-hour cycles at 1500° C.

(a) Capsule.

(b-1) Murakami's etchant.

(b) Photomicrographs of sectioned capsule. 250X.

(b-2).

(b-3).

1500° C for two 100-hour cycles. - Less than one-fifth of the U leaked out of the W-1.5Hf capsule tested for two 100-hour cycles (capsule 7 in table II). The dull appearance of the capsule (fig. 9(a)) is due to a surface reaction with the magnesium oxide (MgO) holder can. Similar to the W-1.5Hf capsule tested for 10 hours, this capsule exhibited longitudinal cracks surrounding the U melt (fig. 9(b)). Although most of these cracks contained no U some cracks did contain U according to autoradiographs. This observation indicates that some of the cracks were formed before, and some after, the last U meltdown, that is, the second 100-hour thermal treatment.

The initial worked structure of the capsule was completely recrystallized during the test (fig. 9(b-1)). Some areas of the capsule exhibited little or no U intergranular penetration (fig. 9(b-2)) while other areas, especially in the vicinity of the weld or capsule cracks (fig. 9(b-3)), exhibited extensive intergranular attack. The small, nearly spherical phase distributed throughout the microstructure was not identified but is believed to be hafnium oxide (HfO_2). This phase was grey-colored and did not tarnish during heat tinting as U does.

Similar to the W capsules at 1500° C, fine crystals and massive dendrites (see fig. 9(b)) of W were observed in the U melt near the meniscus. And dissolution of the capsule surface by U (i. e., the roughened walls) also is evident in figure 9(b).
