26. RESULTS FROM STUDIES OF HIGHWAY GROOVING AND TEXTURING AT NASA WOLLOPS STATION

By Walter B. Horne

NASA Langley Research Center

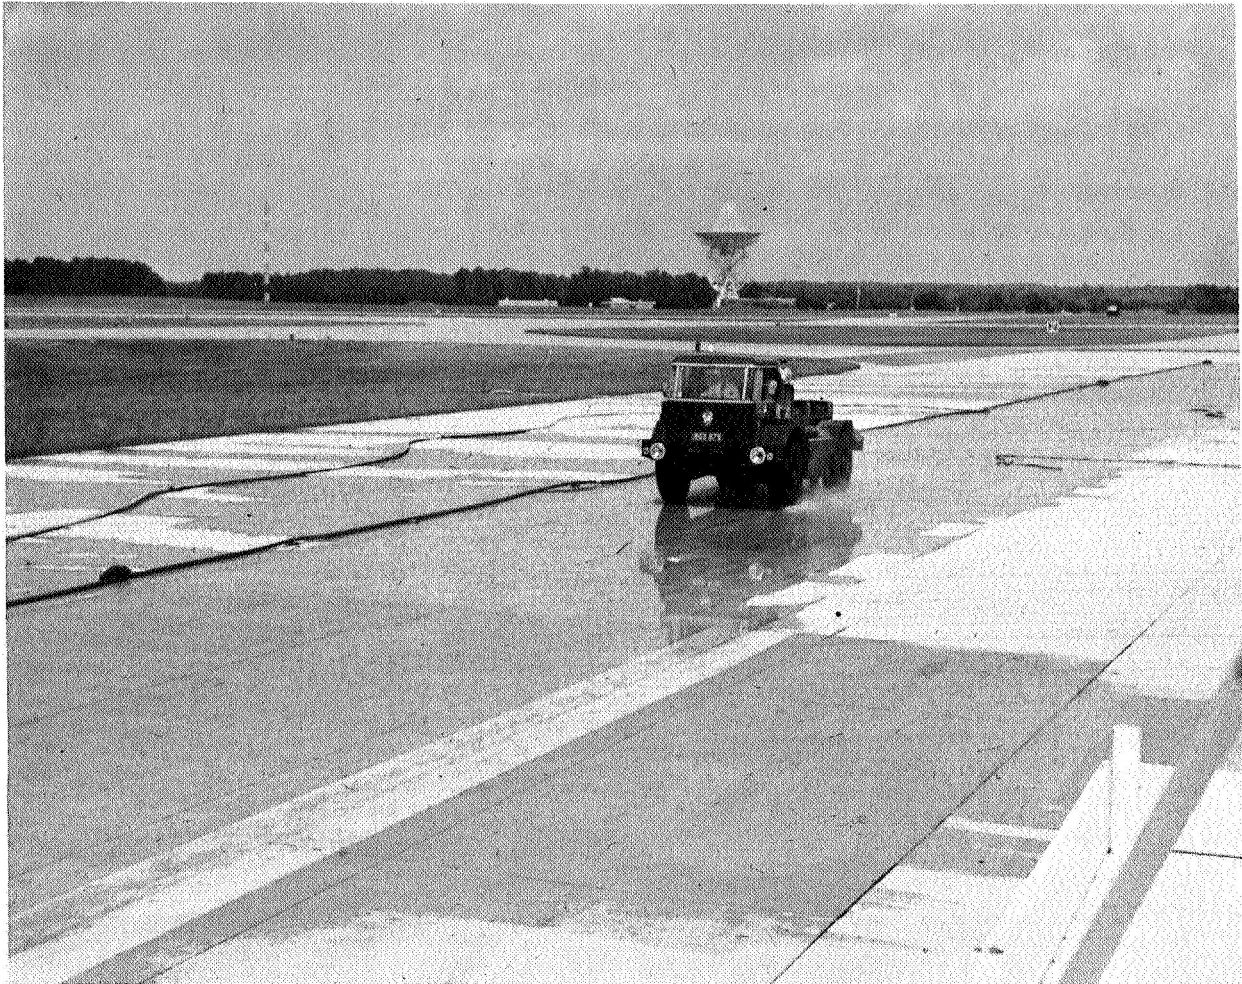
Figure 6.- The British "Juggernaut" test vehicle undergoing a braking test on surface A of site I under a wet and puddled pavement condition.

Three-thousand feet of pierced plastic pipe were placed along the edge of the runway test sections. The pipe was connected at 200-foot intervals with a water hydrant system located off the side of the runway. Through intermittent use of the sprinkler system a wet and puddled pavement condition was achieved on the desired test sections for test purposes. Continuous use of the sprinkler system produced a flooded condition on the test sections where the water depth was maintained at an average level of 0.1 inch on the pavement surfaces. Figure 6 illustrates the wet and puddled pavement condition achieved on surface A of site I during braking tests with the British "Juggernaut" test vehicle.

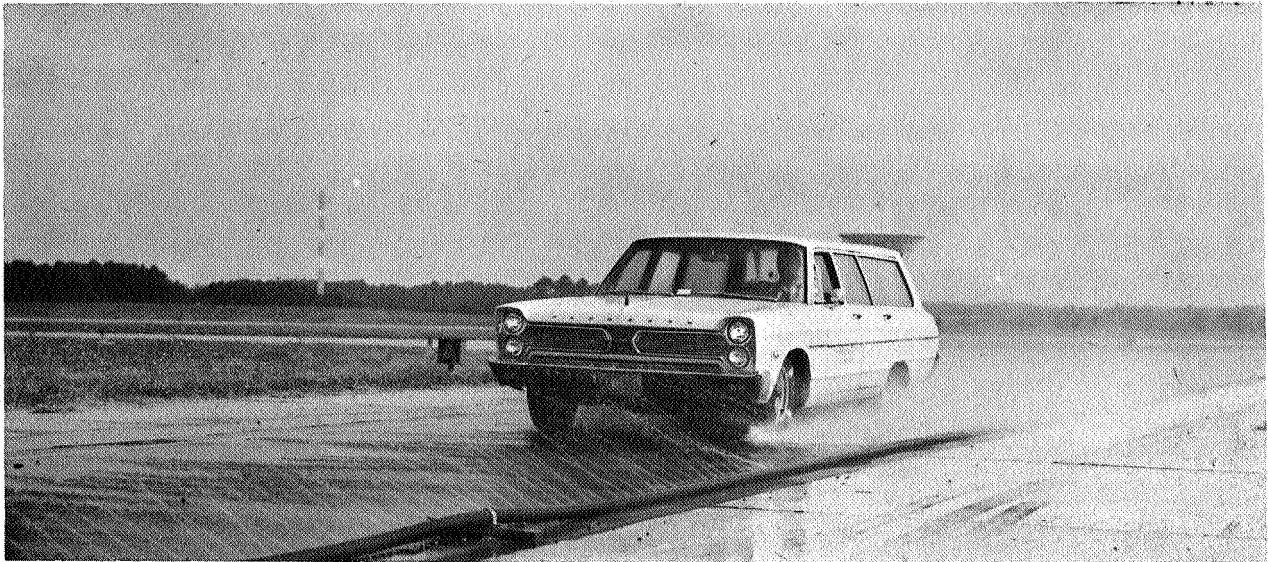
(a) NASA diagonal braking car undergoing test on surface E of site II under a flooded pavement condition provided by plastic-pipe sprinkler system.

The plastic-pipe sprinkler system used on site I was also used on site II to wet the test surfaces. The flooded pavement condition is illustrated in figure 7(a) which shows the NASA diagonal braking car making a run on surface E of site II. The wet and puddled pavement condition used on site I was not used on site II. For the wet condition on site II, the sprinkler system was turned on to wet the pavement and then turned off. A powered rotary broom was then driven over the test surfaces to remove puddled water. This technique left the surface wet for test purposes but without water puddles. When the test surfaces were seen to be drying out, this procedure was repeated to maintain uniform test conditions.

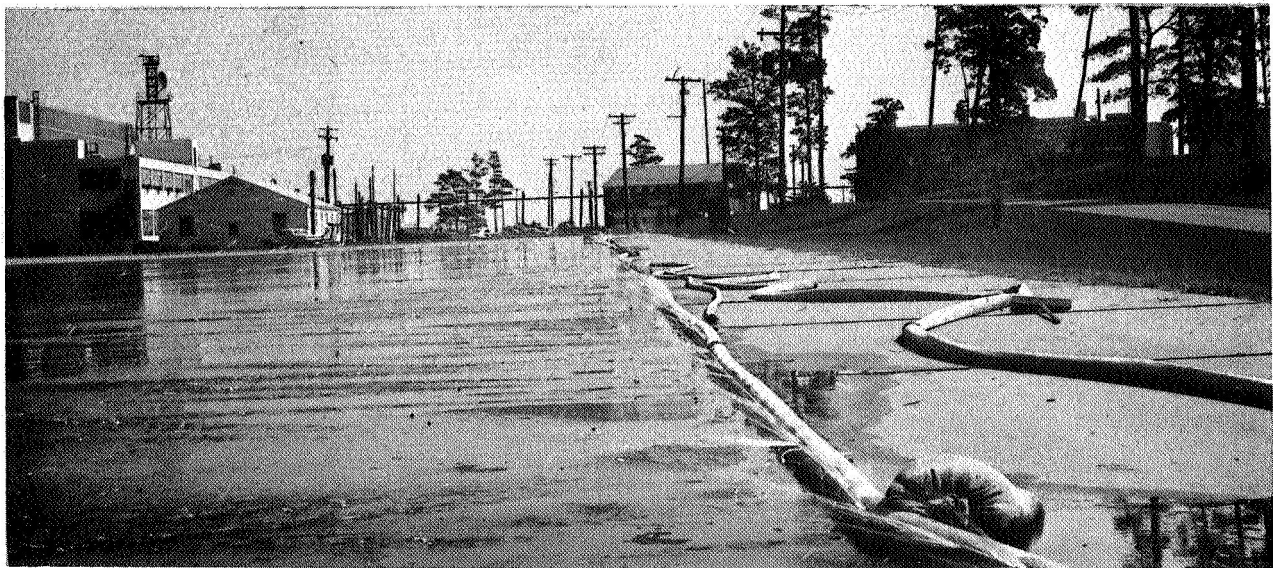
(b) Pierced-canvas-fire-hose sprinkler system used to wet or flood site III skid pad.

Figure 7.- Water sprinkler systems used to wet or flood site II and site III test surfaces.

The concrete apron forming the site III skid pad was a flat tilted slab. Pierced canvas fire hose was placed along the upper edge of the slab. When the sprinkler system was turned on, the water flowed from top to bottom which allowed a fairly uniform water film to be established over the entire skid pad surface. This sprinkler system is shown in operation to produce a flooded pavement condition in figure 7(b). The sprinkler system,

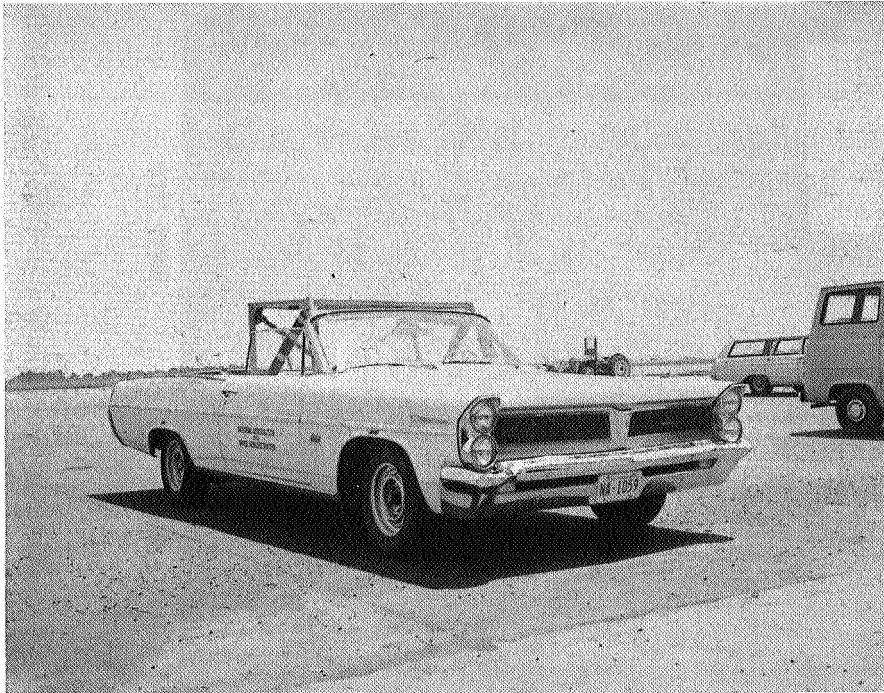
Figure 9.- Stripped convertible with protective cage used by NASA in vehicle spin-out tests on site III skid pad.

The operating characteristics of the General Motors braking trailer, FAA Swedish Skiddometer, B. F. Goodrich diagonal braking car, and the NASA diagonal braking car are described in reference 3. The NASA stripped convertible used in the vehicle spin-out tests on site III is shown in figure 9.

Wet and flooded conditions.- The NASA convertible test car shown in figure 9 was equipped with a Tapley meter mounted on the floor of the car and sideways to the direction of vehicle motion. The test car was then driven at increasing speeds around the 500-foot-radius grooved and ungrooved curves of site III until vehicle spin-out occurred. The lateral friction coefficients and spin-out speeds obtained with the test vehicle equipped with ASTM bald-tread tires, new production tires, and worn production tires (wear marker

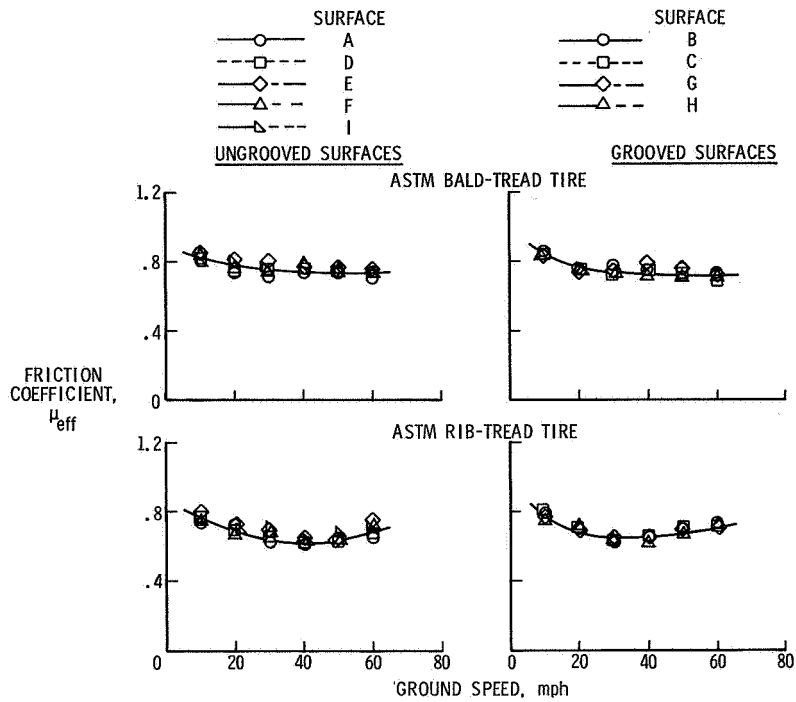
Figure 10.- Skid resistance of site I surfaces rated by NASA diagonal braking car under near transient peak braking conditions. ASTM bald- and rib-tread tires; dry pavement; Tapley meter.

Dry conditions.- The dry-surface skid resistance of site I surfaces was rated by the NASA diagonal braking car. A Tapley meter installed in this car measured an effective friction coefficient μ_{eff} which is between transient peak μ_{max} and locked-wheel μ_{skid} friction-coefficient values. These data are presented in figure 10 where effective friction coefficient μ_{eff} is plotted as a function of ground speed. It is interesting to note that no significant differences in dry-surface friction values exist between the ungrooved or grooved surfaces of site I at speeds up to 60 miles per hour. The data in figure 10 indicate that the dry-surface friction values for the ASTM rib-tread tire are somewhat lower than those for the ASTM bald-tread tire, especially at medium test speeds.

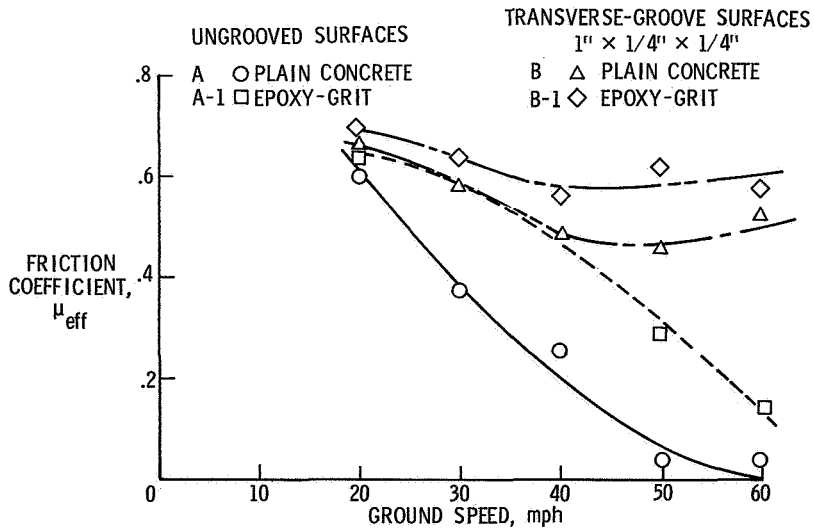
Figure 13.- Improvement in pavement skid resistance by increasing pavement average texture depth by use of epoxy-grit. NASA diagonal braking car; worn tires (wear markers showing); flooded pavement from natural rain; Tapley meter.

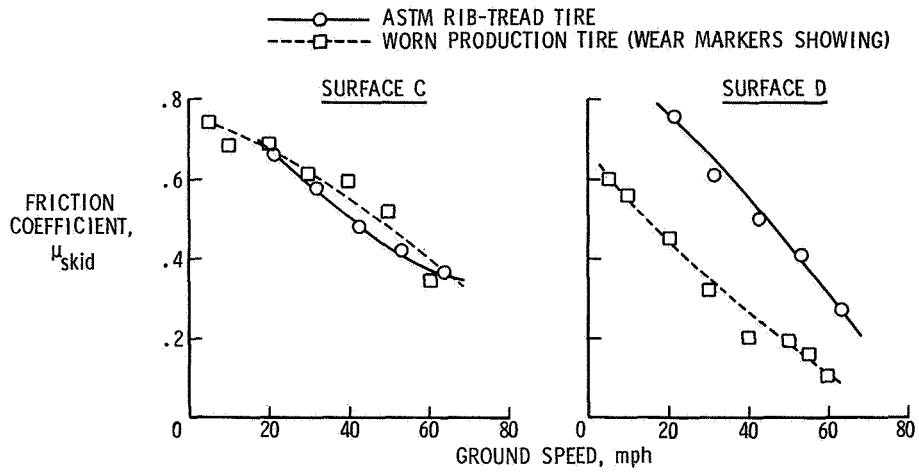
Figure 14.- Comparison of braking performance of ASTM rib-tread and worn production tires on site I surfaces. B. F. Goodrich diagonal braking car; flooded pavement conditions.

A most important feature of the pavement grooving used on site I is the restoration of the skid resistance of worn tires on wet pavements to resistance values of new tires. This feature was first noted during the aircraft tests on site I. Figure 12 illustrates this point with ASTM bald- and rib-tread tires. The B. F. Goodrich diagonal braking car also made braking tests with a worn production tire and the ASTM rib-tread tire under flooded pavement conditions on surfaces C and D of site I. These results are compared in figure 14. It can be seen that the worn tire (wear markers showing) at speeds greater than 40 miles per hour on the ungrooved concrete has less than one-half the skid resistance of the ASTM rib-tread tire, yet on the 1- × 1/4- × 1/4-inch transverse-groove pavement both tires have about equal skid resistance.

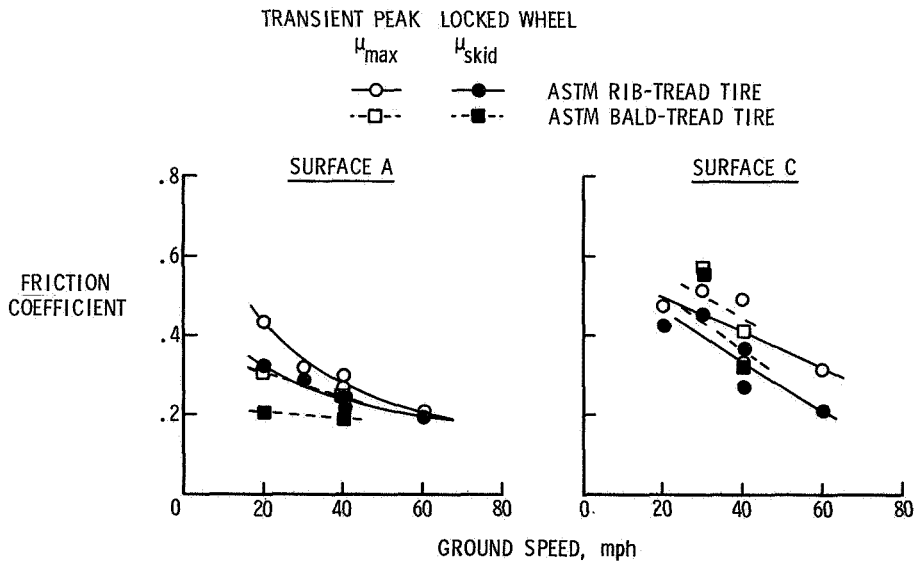
Figure 15.- Skid resistance of site I surfaces under deep slush pavement conditions (0.5 to 2.0 inches). General Motors braking trailer.

Slush conditions.- Several tests were made on surfaces A (ungrooved) and C (grooved) of site I where a slush layer ranging from 0.5 to 2 inches covered the pavement. This slush layer quickly became rutted with the passage of vehicles during tests. Figure 15 presents the skid resistance of these pavements under this slush cover in terms

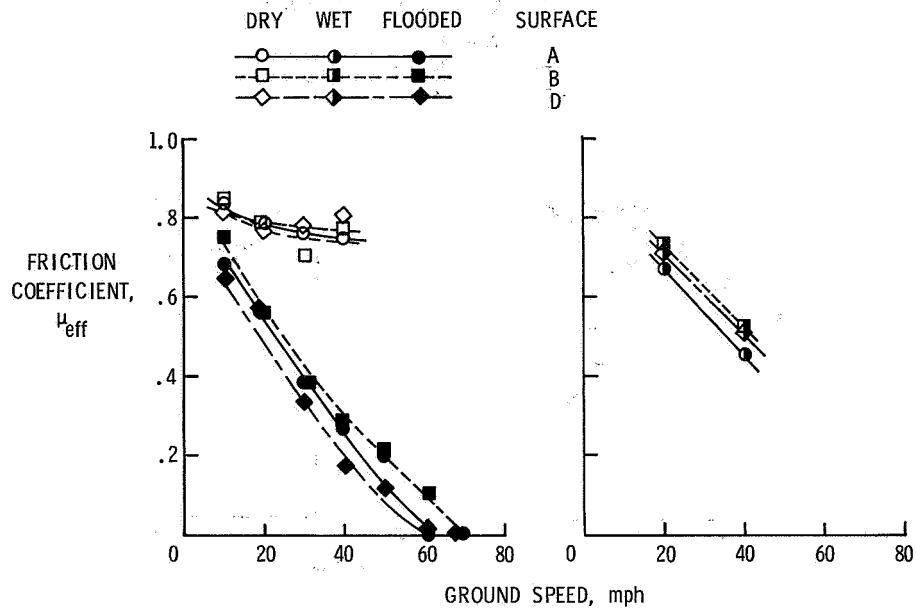
Figure 17.- Skid resistance of conventional site II surfaces. NASA diagonal braking car; Tapley meter; ASTM bald-tread tires.

Figure 17 shows the skid-resistance rating by the NASA diagonal braking car of the more conventional test surfaces of site II under the aforementioned dry, wet, and flooded conditions. It can be seen that the skid resistance for all surfaces in figure 17 decreased from dry-surface values as speed increased for this essentially damp pavement condition. Larger losses in skid resistance developed on the surfaces under flooded pavement conditions. All surfaces in figure 17 had a closed texture with a small average texture depth (fig. 3). These results are in agreement with results obtained on site I surfaces which showed the smooth closed-texture-pavement surfaces as having poor skid resistance at high speed under wet conditions.

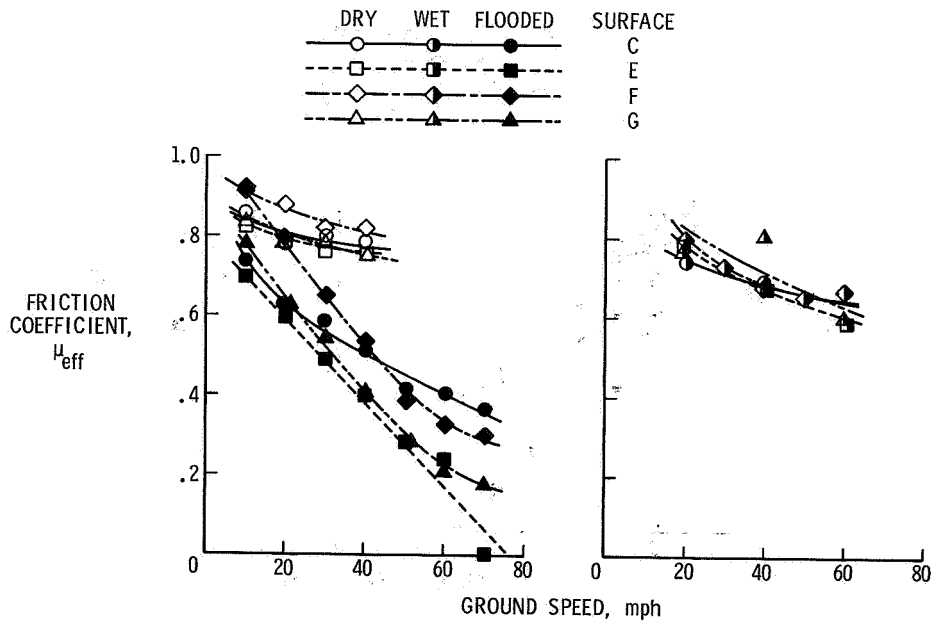
Figure 18.- Skid resistance of treated site II surfaces. NASA diagonal braking car; Tapley meter; ASTM bald-tread tires.

The improved skid resistance that more open-texture-pavement surfaces provide under wet and flooded conditions is illustrated in figure 18. This figure compares the skid resistance of surfaces C, E, F, and G which, as indicated in figure 3, had higher average texture depths than surfaces A, B, and D. The order of improvement in skid resistance for the surfaces shown in figure 18 apparently follows the degree of texturing provided in the surface.

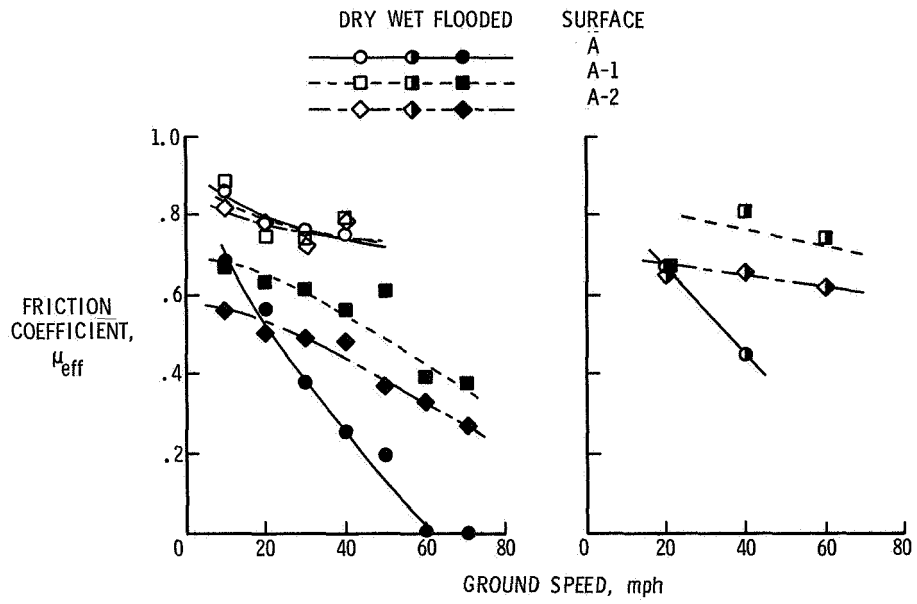
Figure 19.- Improvement in skid resistance of site II concrete pavement by using $\frac{3}{4} \times \frac{1}{8} \times \frac{1}{8}$ -inch groove patterns. NASA diagonal braking car; Tapley meter; ASTM bald-tread tires.

grooving. Both the transverse and longitudinal groove patterns used improved the pavement skid resistance under the wet and flooded test conditions as is noted by the higher and therefore safer friction values. The transverse-groove pattern also restored more of the dry-surface skid performance of the pavement than did the longitudinal-groove pattern. The improvement in skid resistance for the best groove pattern was about equal to that obtained by the asphalt dressing treatment shown in figure 18 for flooded pavement conditions. Similar results are shown in figure 20 where surface B, the 13-year-old asphalt seal coat of site II, was provided with the same $3/4$ - \times $1/8$ - \times $1/8$ -inch transverse and longitudinal grooves as the 25-year-old concrete surface A. An interesting result shown in figure 20 for the flooded pavement condition is that the longitudinal-groove pattern is as effective at 70 miles per hour as the transverse-groove pattern in raising the surface skid resistance.

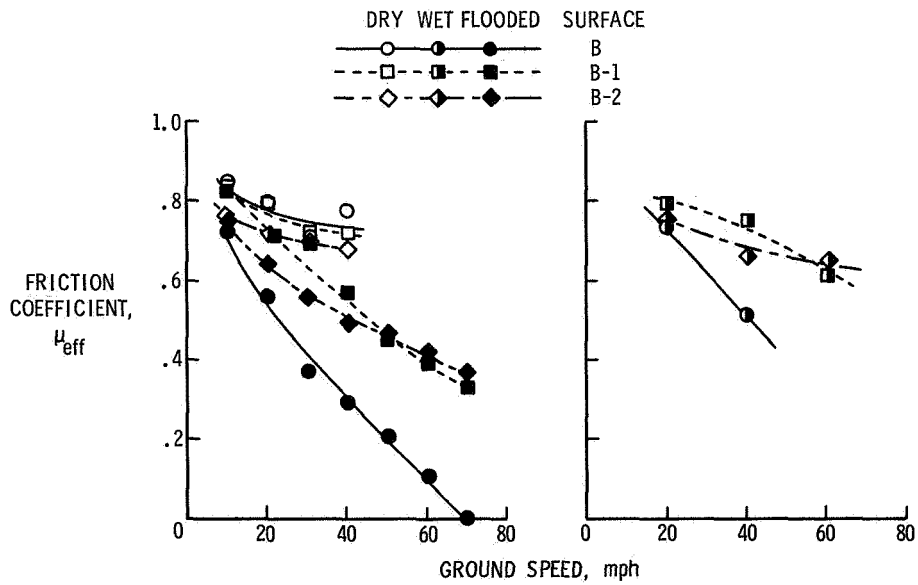
Figure 20.- Improvement in skid resistance of site II asphalt (seal coat) pavement by using $\frac{3}{4} \times \frac{1}{8} \times \frac{1}{8}$ -inch groove patterns. NASA diagonal braking car; Tapley meter; ASTM bald-tread tires.

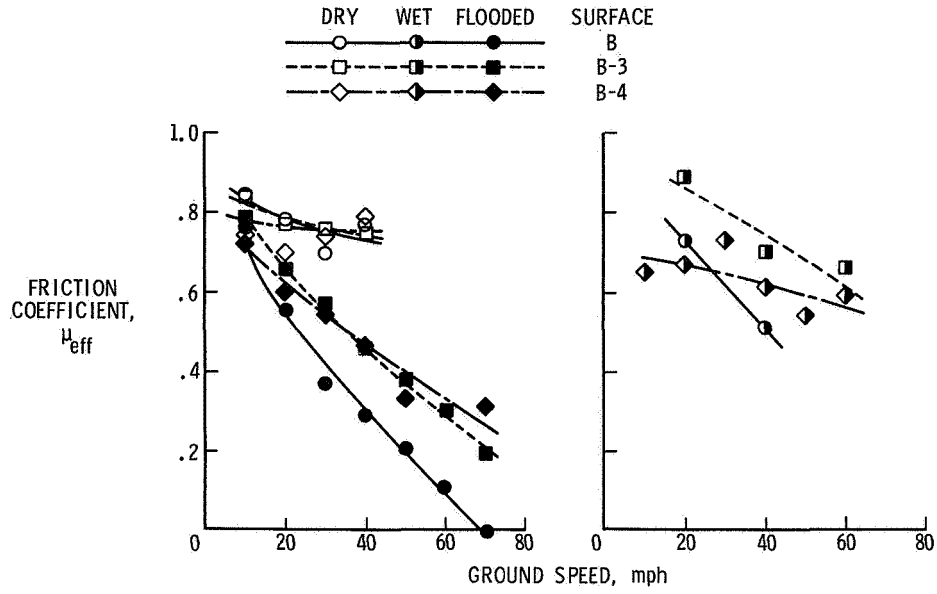
Figure 21.- Improvement in skid resistance of site II asphalt (seal coat) pavement by using $1 \times \frac{1}{8} \times \frac{1}{8}$ -inch groove patterns. NASA diagonal braking car; Tapley meter; ASTM bald-tread tires.

Figure 21 shows the improvement in skid resistance obtained on surface B, the 13-year-old asphalt seal coat, when 1 - \times $1/8$ - \times $1/8$ -inch transverse- and longitudinal-groove patterns were cut in the surface. Comparison of these data with the $3/4$ -inch-groove data presented in figure 20 reveals that the 1-inch grooves (fig. 21) are as effective as the $3/4$ -inch grooves when the surface is wet. Under flooded conditions, the $3/4$ -inch groove pattern with its higher water-drainage capacity provides the greater improvement in skid resistance to surface B.

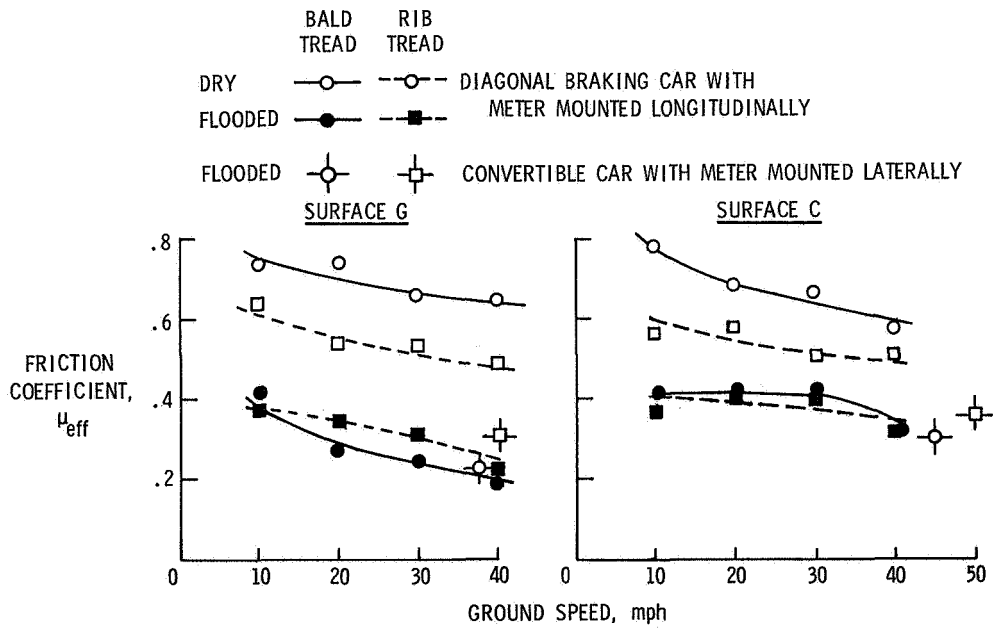
Figure 22.- Comparison of braking and lateral friction coefficients obtained on 500-foot-radius curves of site III skid pad. Jennite surface; NASA diagonal braking and convertible cars; ASTM tires.

Dry conditions.- Figure 22 presents effective dry-surface friction coefficients measured by the NASA diagonal braking car on the specially prepared skid pad of site III. The skid pad was covered with a liquid coating of Jennite, a coal-tar product, without the sand or aggregate content that is normally used when Jennite is applied to highway surfaces. (See table III.)

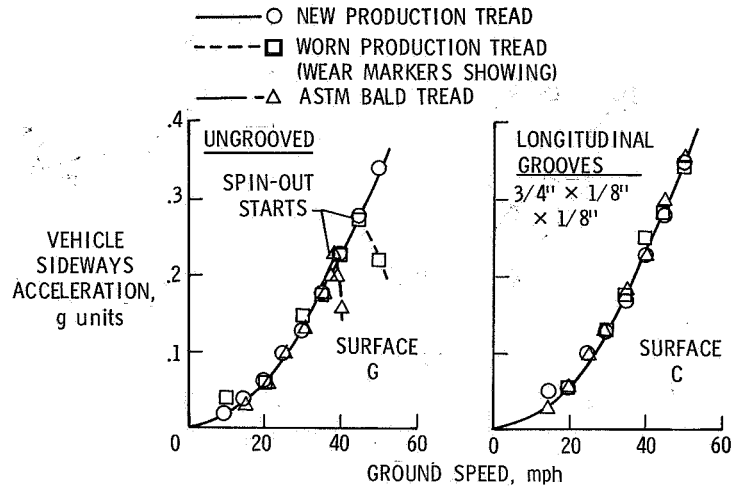
(a) Wet pavement conditions.

Figure 23.- Vehicle spin-out speeds obtained on 500-foot-radius curves of site III skid pad. NASA convertible car; Tapley meter mounted sideways.

showing) are shown in figure 23(a) for a wet pavement condition (surface wet but no puddles). Photographs of these tires are shown in figure 8. The wet pavement condition was achieved by driving a powered rotary broom over the test surface to remove surplus water from the surface after it was initially wetted by the sprinkler system installed at site III. The data shown indicate that longitudinal grooves on a highway curve can improve the skid resistance of a pavement when ASTM bald-tread and worn production tires are used on a vehicle. The maximum test speed for site III of 50 miles per hour was obtained before spin-out conditions occurred for the new production tire tested. This result shows the importance of having and maintaining an effective tread design on road vehicle tires.

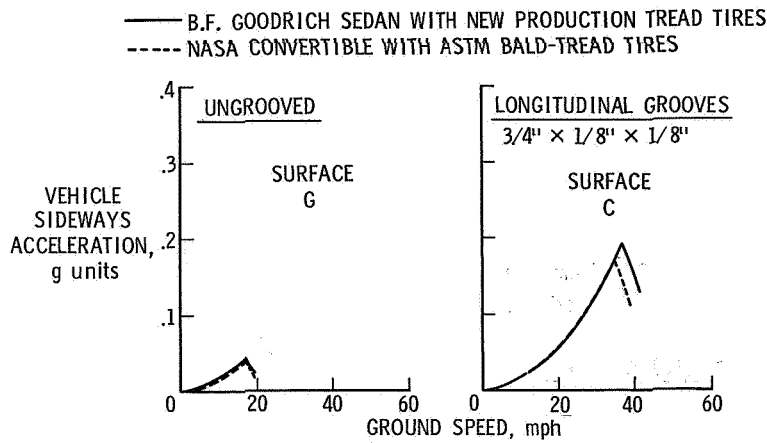
Figure 24.- Vehicle spin-out speeds obtained on 500-foot-radius curves of site III skid pad under slippery pavement conditions (mixture of water and hydrolube).

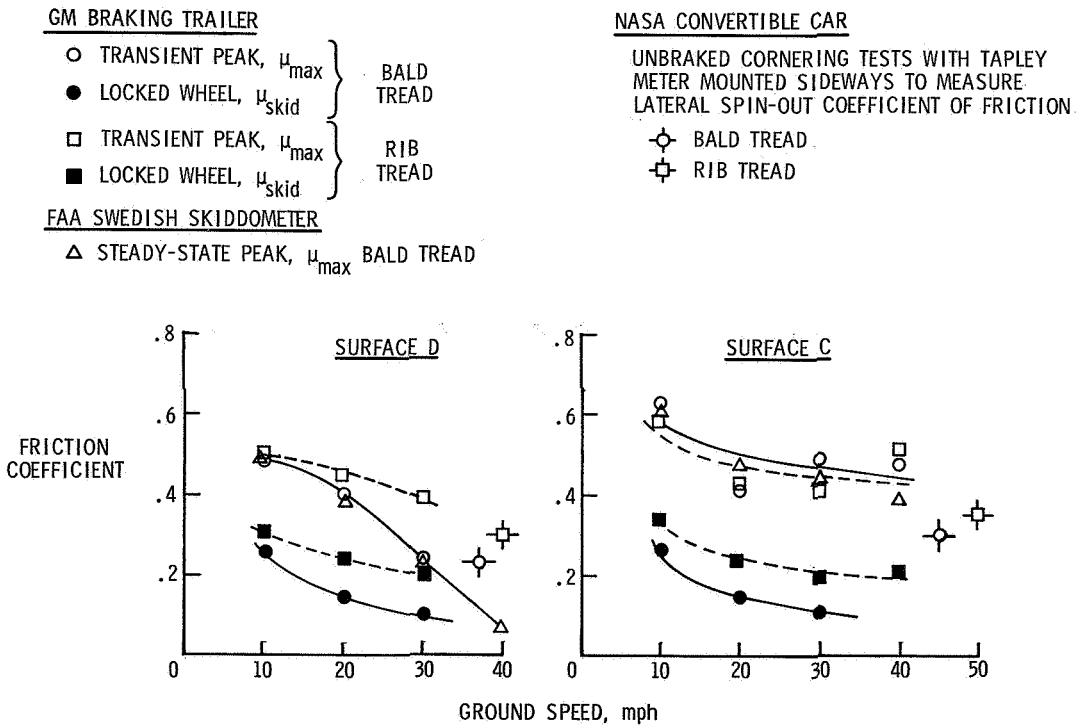
Figure 25.- Comparison of braking and lateral friction coefficients obtained on 500-foot-radius curves of site III skid pad. Flooded pavement conditions; ASTM tires.

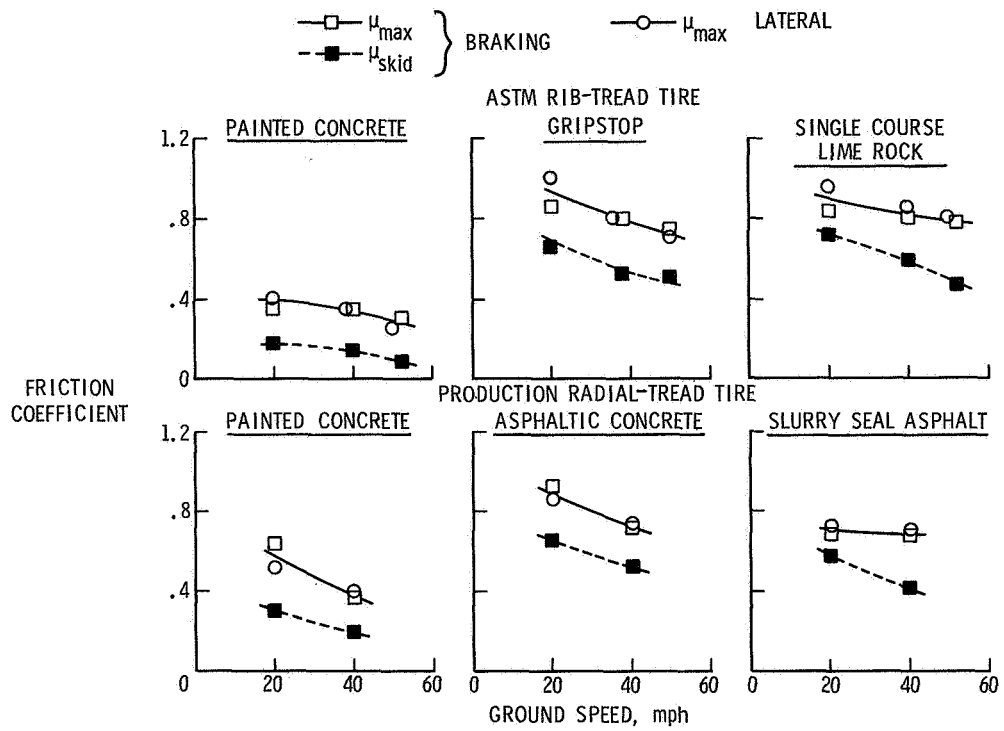
Figure 26.- Comparison of steady-state peak lateral, transient peak, and locked-wheel braking coefficients of friction. NASA research truck; surfaces wetted by sprinkler system; Florida Skid Correlation Study.

The NASA research truck, which has the capability of measuring transient peak and locked-wheel braking coefficients of friction as well as steady-state peak lateral coefficient of friction, participated in the Florida Skid Correlation Study. Figure 26 presents some of the data obtained on five of the test surfaces under a wet pavement condition with the ASTM rib-tread tire and a production radial-tread tire. It can be seen that the transient peak braking coefficient was in close agreement with the steady-state peak lateral
