NASA CR-72354
FHR 2702-4

HIGH-TEMPERATURE HYDRAULIC SYSTEM ACTUATOR SEALS FOR USE IN ADVANCED SUPERSONIC AIRCRAFT

September 15, 1967

FAIRCHILD HILLER
REPUBLIC AVIATION DIVISION
FARMINGDALE, LONG ISLAND, NEW YORK

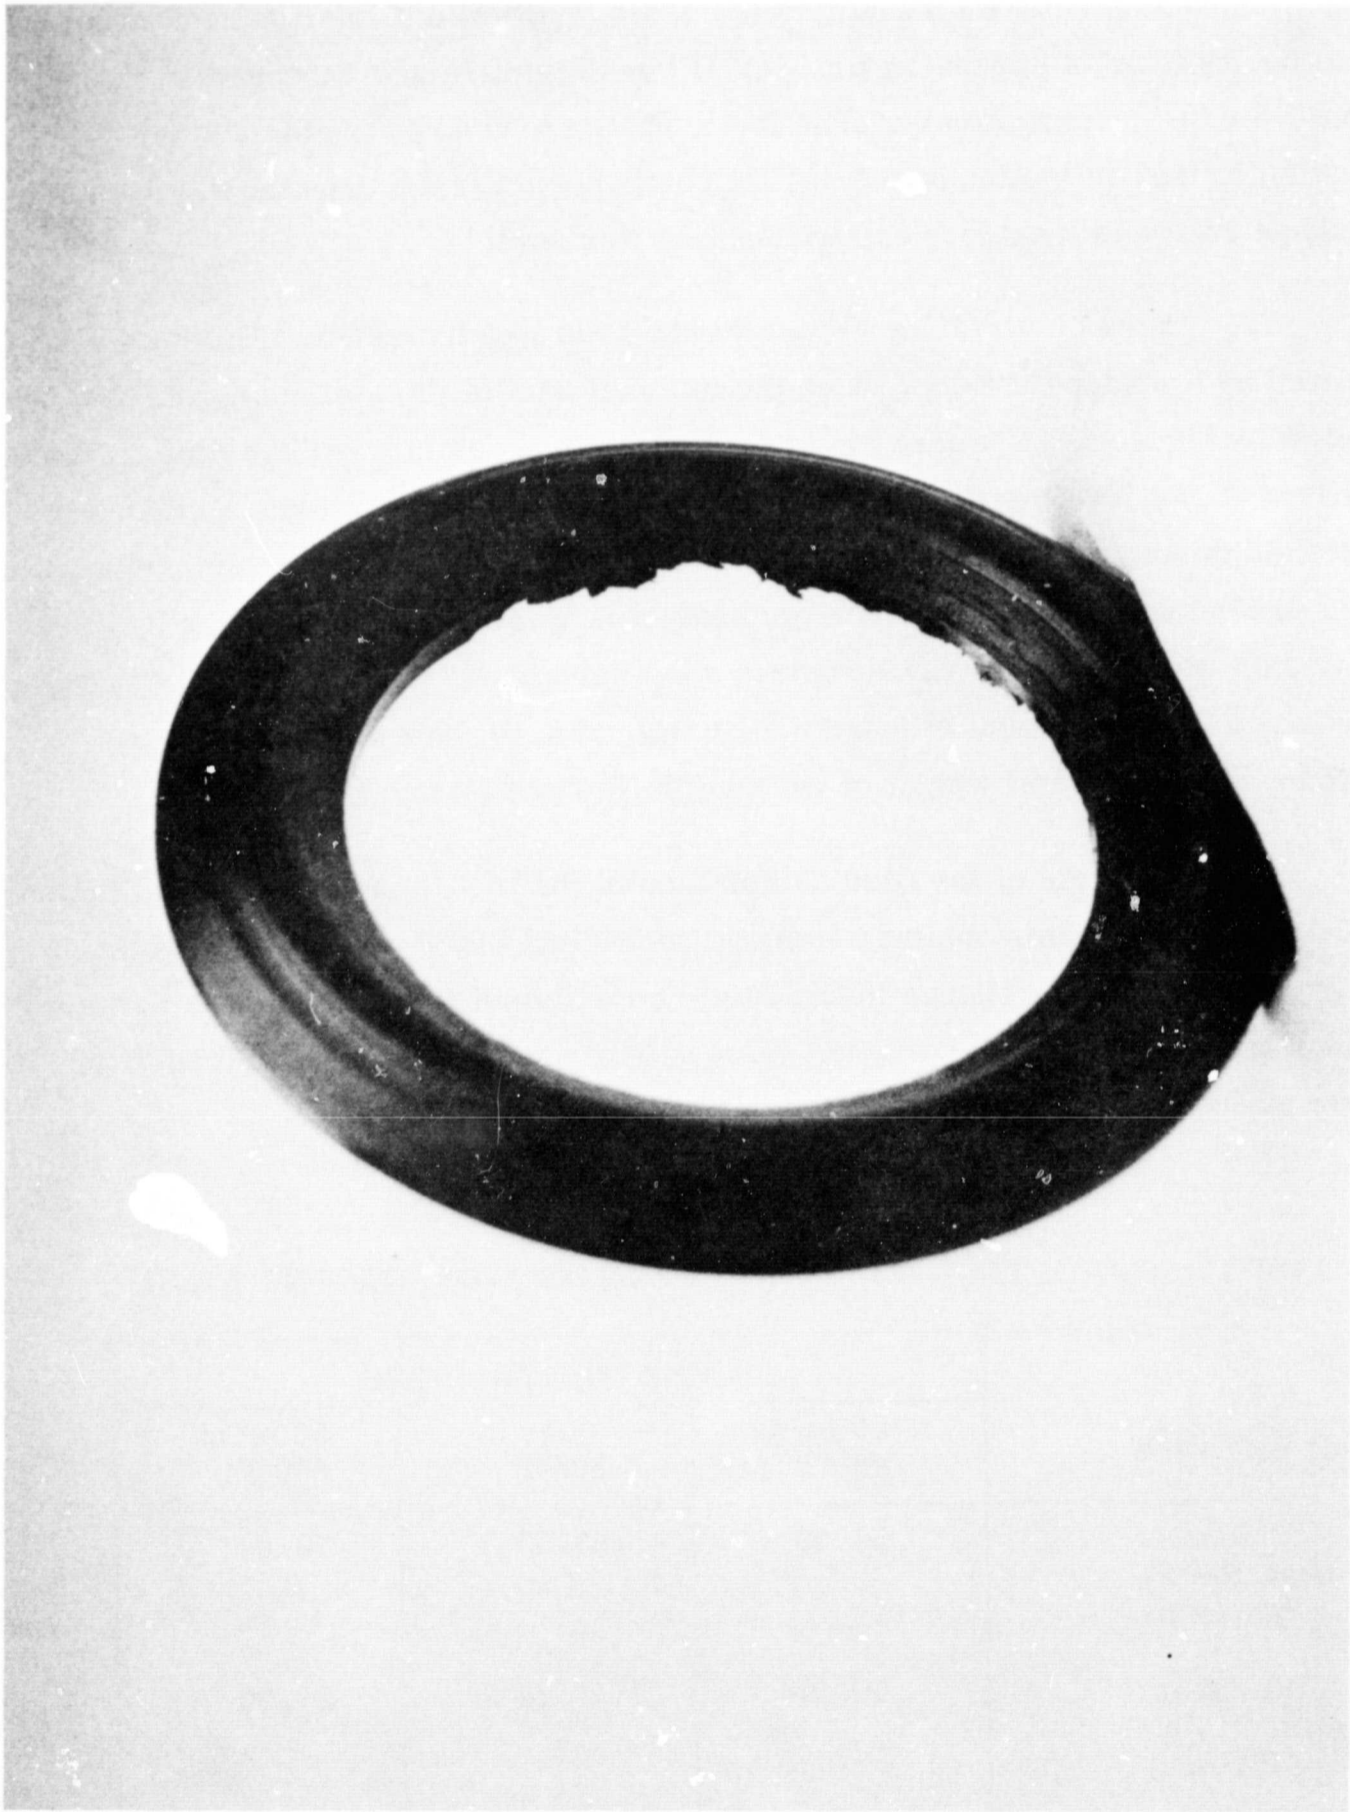
Figure 5-11. Extrusion of Polyimide V-Seal - B-End

The observations described above showed that, with the exception of extrusion on one of the three sealing elements on the B-end, all seals were in good condition. Excessive leakage at 600°F appears to be caused by differ-

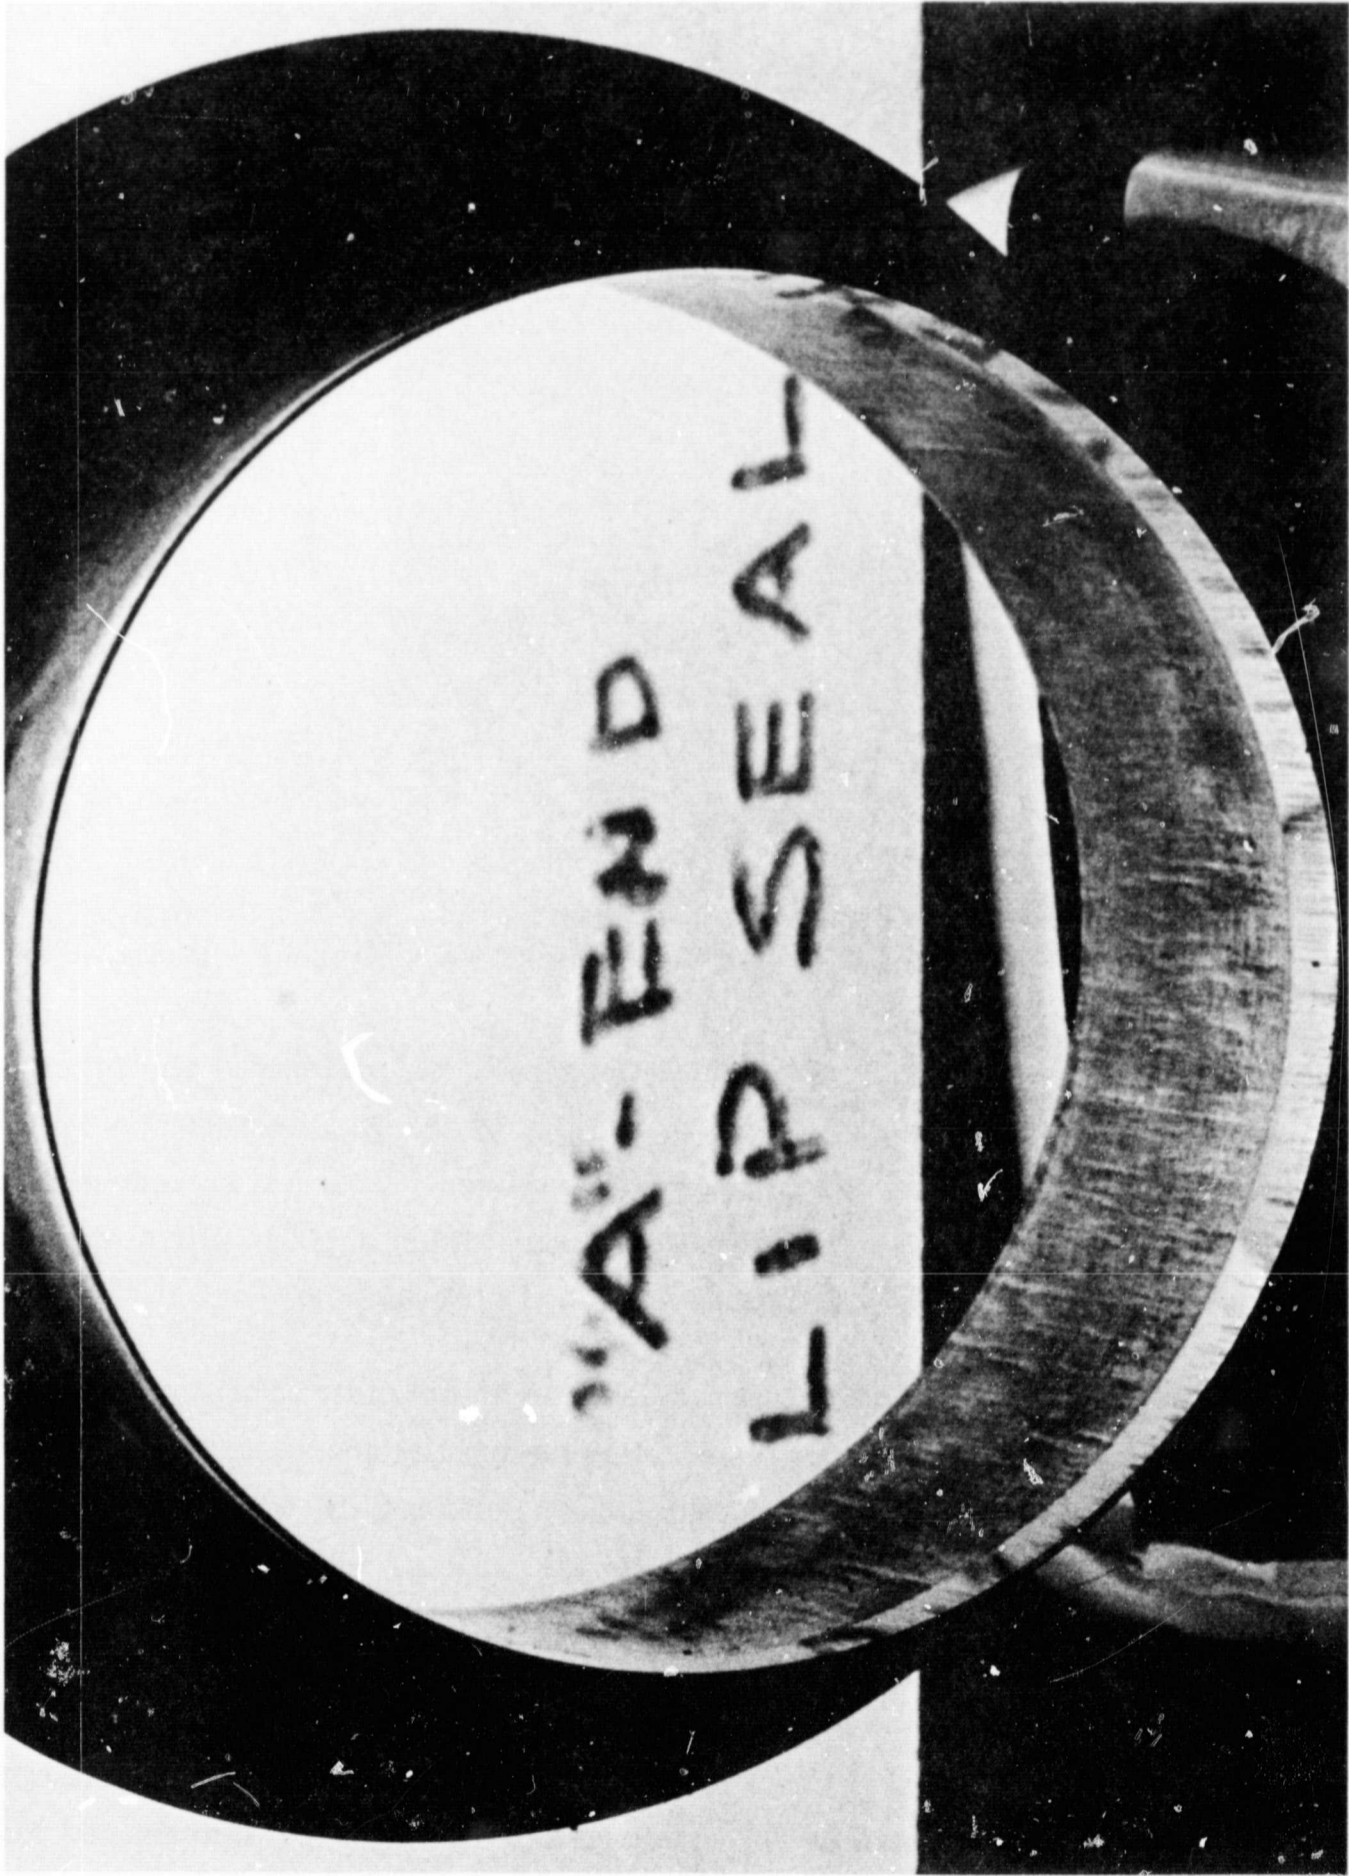
Figure 5-21. Vascojet 1000 Lip Seal - A-End

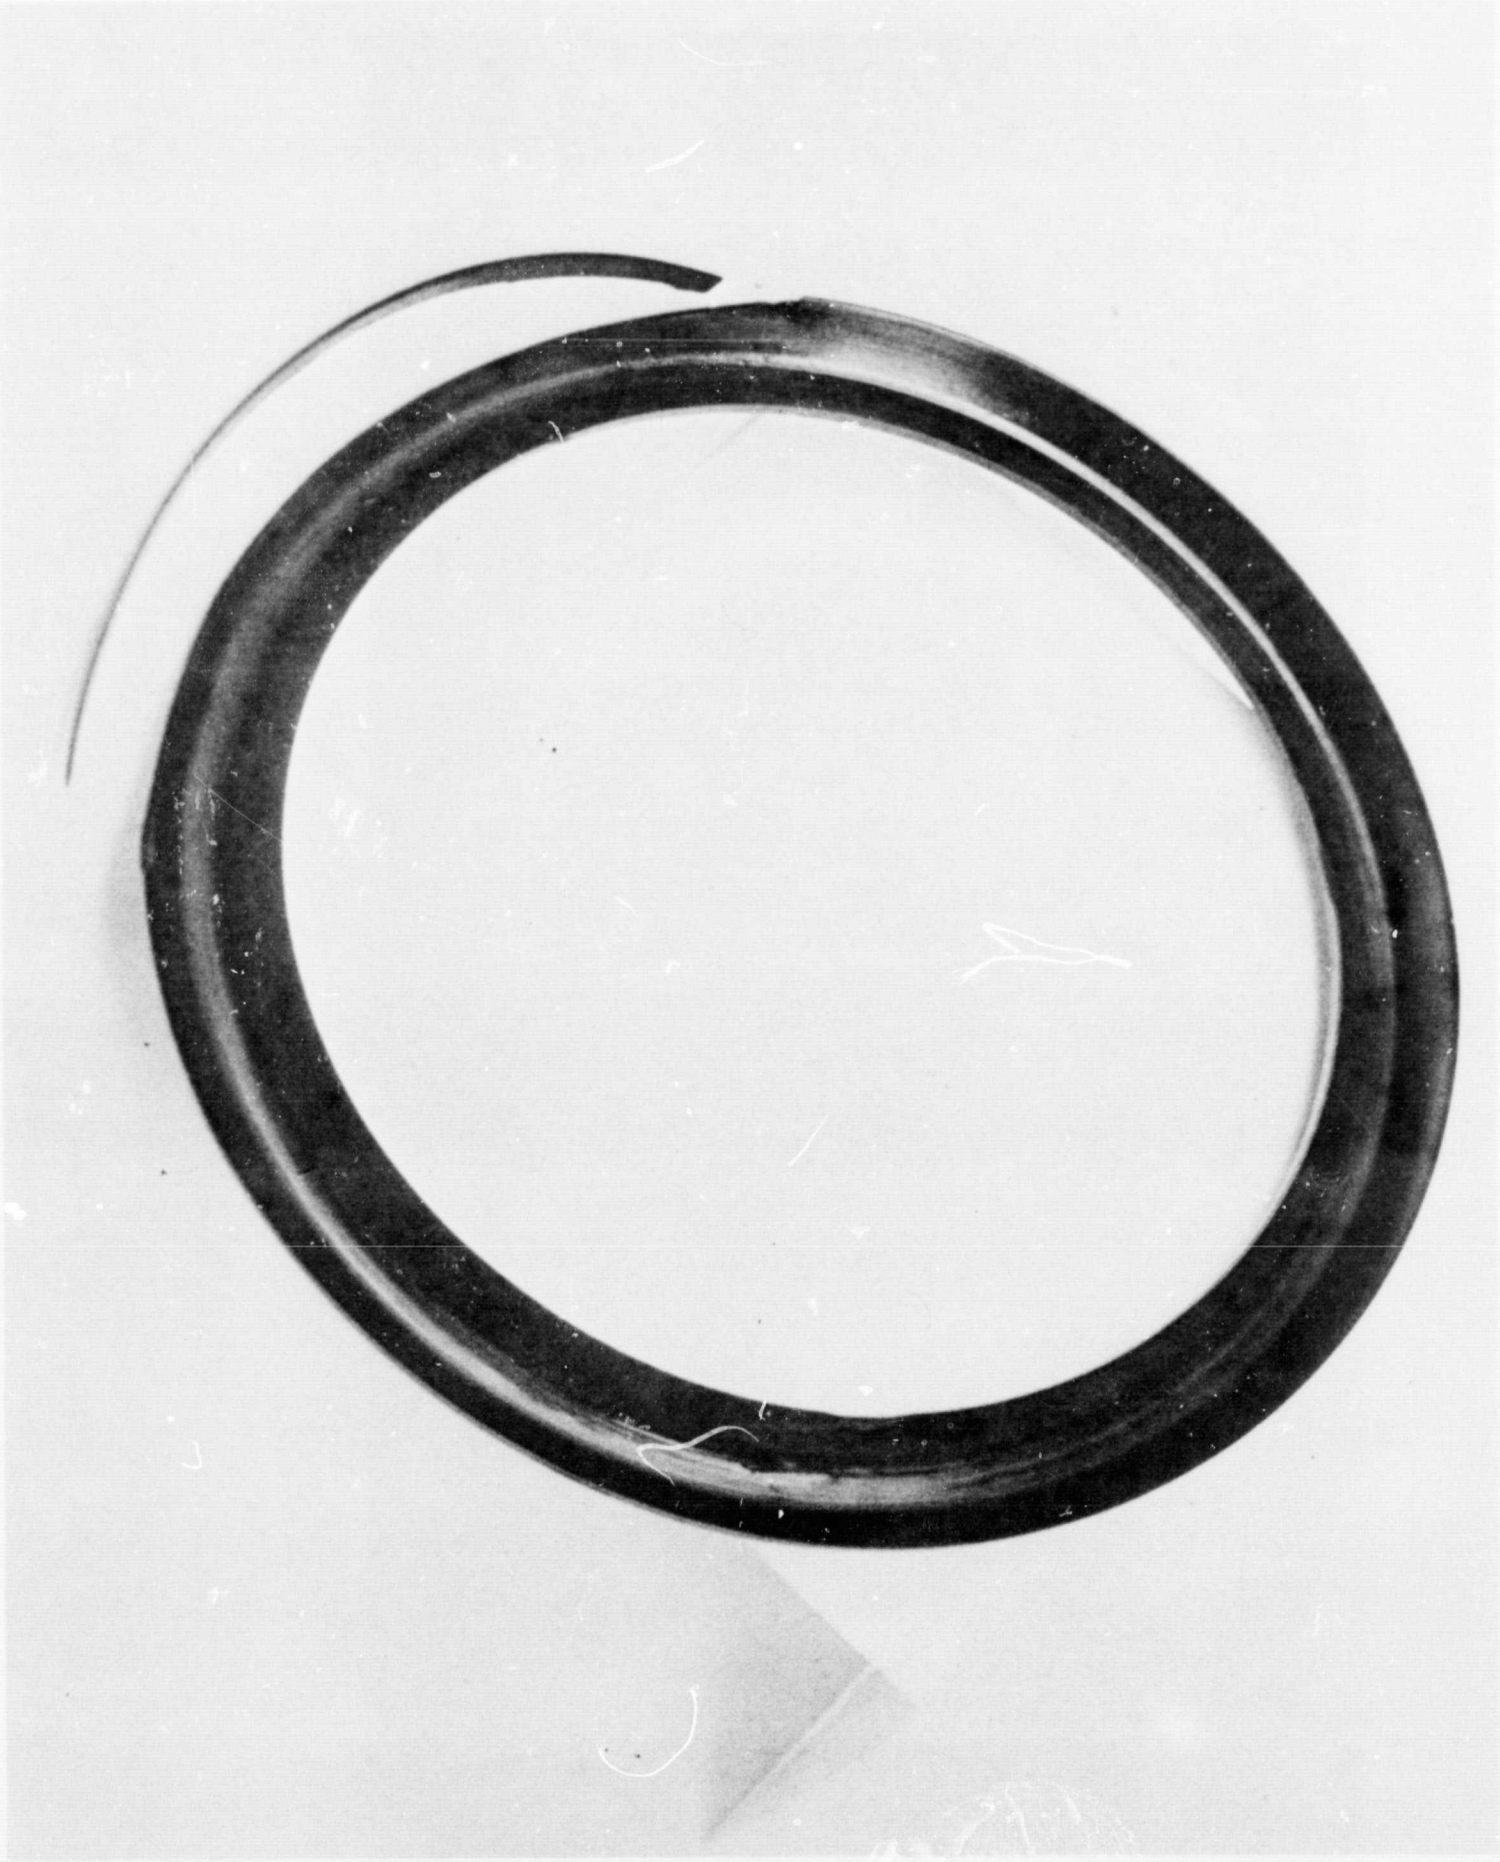
Figure 6-19. Three-Inch Polyimide V-Seal, B-End (Circumferential Cracks)
