FOURTH INTERIM PROGRESS REPORT  
ON  
THE STUDY OF INFRARED EVALUATION  
IN  
QUALIFICATION AND FAILURE ANALYSIS  
OF  
SEMICONDUCTOR DEVICES

covering the period  
28 April 1968 to 28 July 1968

Prepared for  
GEORGE C. MARSHALL SPACE FLIGHT CENTER  
HUNTSVILLE, ALABAMA

PHILCO-FORD CORPORATION  
Microelectronics Division  
Blue Bell, Pennsylvania • 19422

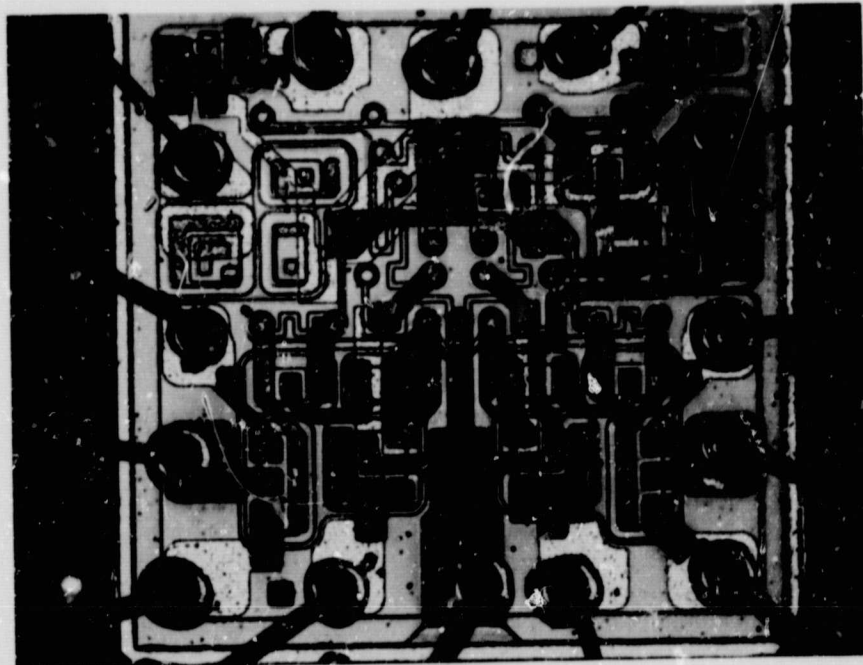
During this reporting period color modulated infrared threshold displays of the infrared characteristics of four electrically good and ten electrically defective devices were generated. The devices used in this evaluation were silicon planar epitaxial DTL triple three input gates fabricated with bilayer metalization patterns. A photomicrograph of the device is shown in figure 1.

Figure 1-Photomicrograph of Bi-layer DTL three input gate.

The initial evaluation was performed using bilayer metalized DTL devices. A photomicrograph of this vehicle is shown in Figure 1. The test circuit was arranged to cause various levels of d.c. current to flow through the via in the Vcc stripe. This particular via is 1/4 mil by 1/4 mil in cross section and approximately 12,000 Å in length. In the case of these vehicles localized heating at the via was initiated as current levels between 16 and 22 mA. At current levels of about 30 mA, considerable heating was observed at the via as indicated below:

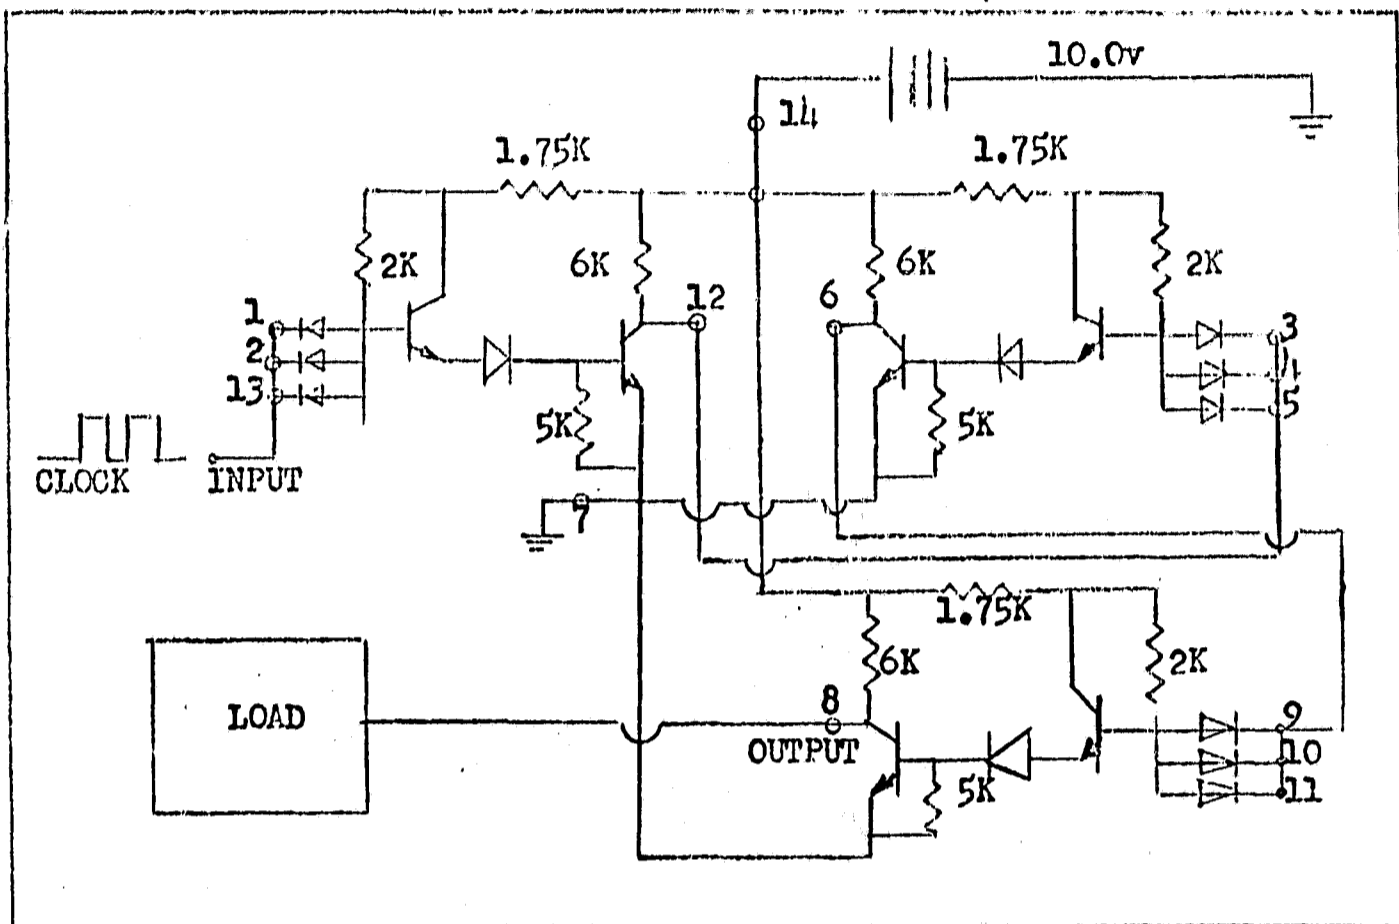
The infrared displays were obtained by scanning the devices during the time they were operating under identical voltage conditions. The electrical test circuit is shown in figure 2.

FIGURE 2. Bilayer Triple Three Input Gate Test Circuit.

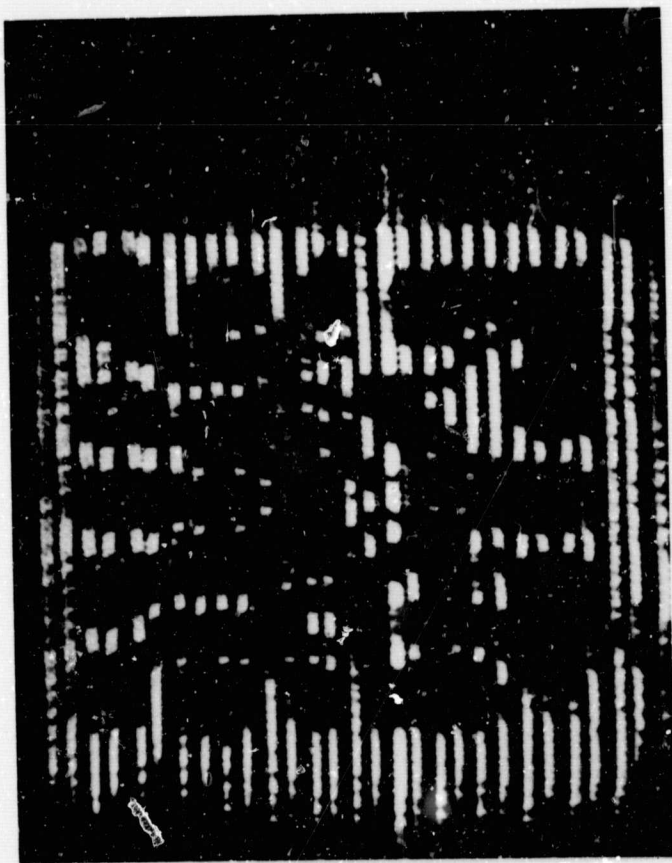
Figure 5- Color modulated infrared display of defective Bi-layer device showing significant difference from good device.

Based on the analysis given in table 1, and the color modulated infrared displays of figures 3, 4, 5 and 6, to the extent that a given device process is uniform, it is possible to determine some device operational condition that will permit definite infrared differentiations of some electrically defective devices from good electrical devices. In this evaluation devices 12, 14, 15, 18, and 20 exhibited infrared characteristics sufficiently different from the electrically good devices to immediately characterize them as defective. Devices 11, 13, 16, 17 and 19 were also electrically defective, but the infrared characteristics of these devices appear to show only subtle differences from the good devices. These subtle differences however may be related to the failure mode. Further evaluation of this data is necessary to substantiate whether these differences are significant.

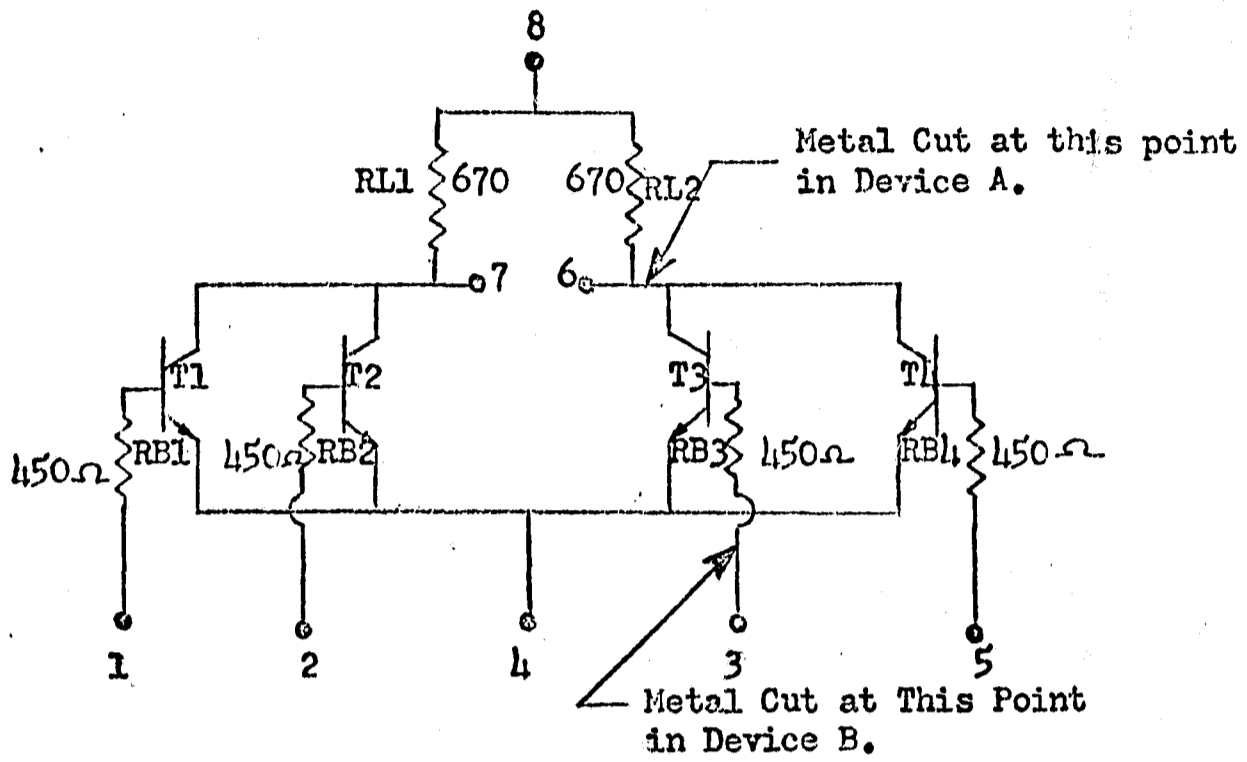
A total of six silicon epitaxial planar dual two input gate devices were subjected to infrared analysis. Four of these devices were electrically good and two were made defective by opening metalization patterns as indicated in figure 7.

FIGURE 7. Location of induced defects in dual two input gate devices.

In this circuit the average dissipations in the individual components of a normal device and of the device with open collector metalization (point A of figure 7) would be:

COMPONENT	NORMAL DEVICE	DEVICE WITH DEFECT AT POINT "A"
$R_{L1}$	96 MW	96 MW
$R_{L2}$	96 MW	67 MW
$R_{B1}, R_{B2}, R_{B3}, R_{B4}$	2.2 MW	2.2 MW
$T_1$ and $T_2$	3.4 MW	3.4 MW
$T_3$ and $T_4$	3.4 MW	1.5 MW

In the case of the device with the open base metalization, the dissipation levels are essentially the same as the normal devices. If the infrared characteristics of the defective device (defect at point A) are to show some differences from the normal devices, it could be expected that  $R_{L2}$  would operate at a slightly lower temperature than  $R_{L1}$  because this resistor dissipates an average of 30 MW less than  $R_{L1}$ ; and that the defective device chip would operate at a slightly lower temperature than a normal device because the average calculated input current into the defective device at 9.5 volts is 2.15 mA, as opposed to the average current into a normal device is 23 mA at the same voltage. Inspection of the color modulated infrared display shows that chip does operate at a lower temperature, but the display does not resolve a temperature difference between  $R_{L1}$  and  $R_{L2}$ .

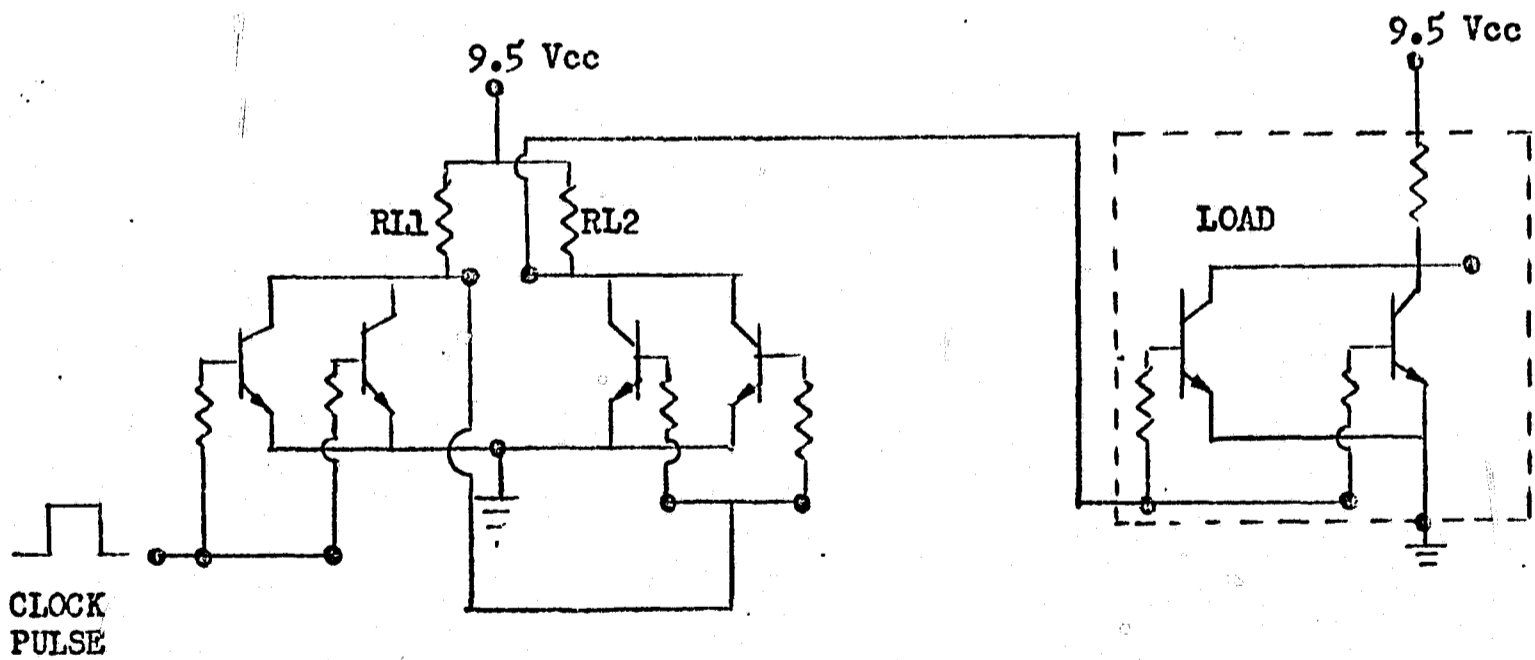
The infrared analysis was performed by generating color modulated displays of the infrared characteristics of each device during the time it was operating in the test circuit of figure 8.

FIGURE 8. Electrical Test circuit for dual two input gate devices.

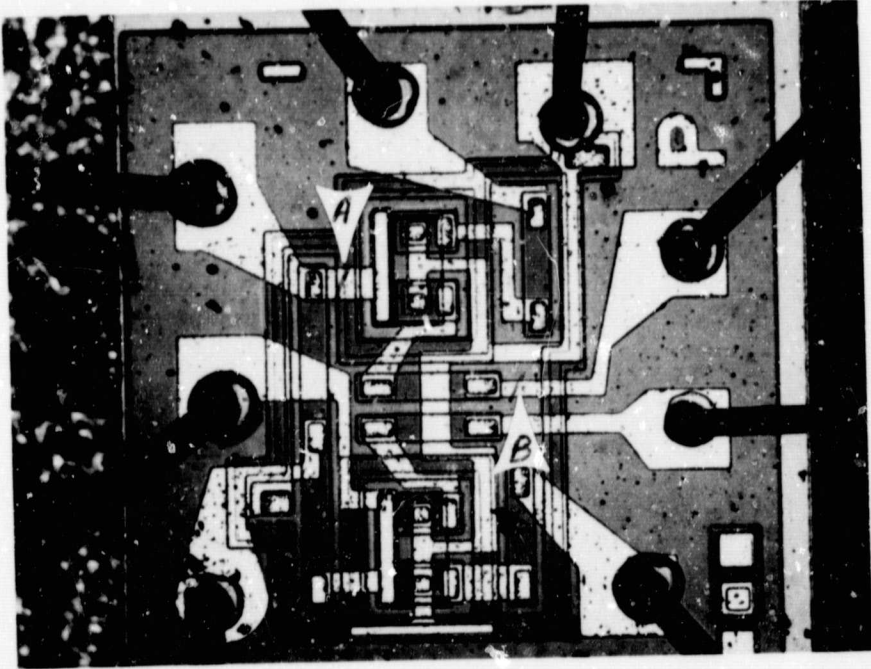
Figure 9- A photomicrograph of a dual two input gate

In the case of the device with the open base resistor metalization, one would not expect the infrared display to vary significantly from the normal devices, and no appreciable difference is seen. Figure 9 is a photomicrograph of the test vehicle and figures 10, 11 and 12 are photographs of the infrared displays of the device with the

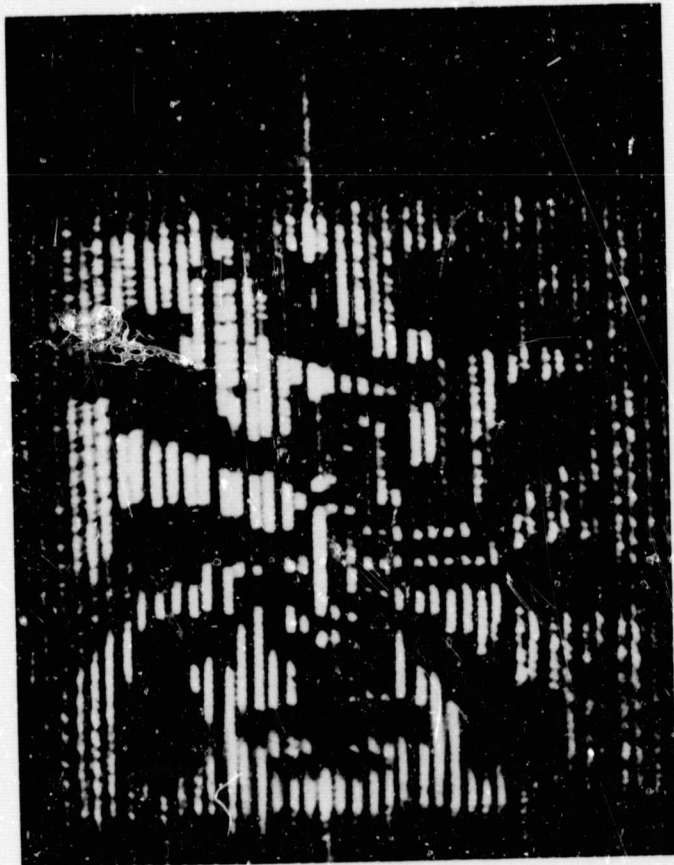
Figure 11- A color modulated infrared display showing a defect in point B.

defect at point A, the device with the defect at point B, and a normal device respectively.

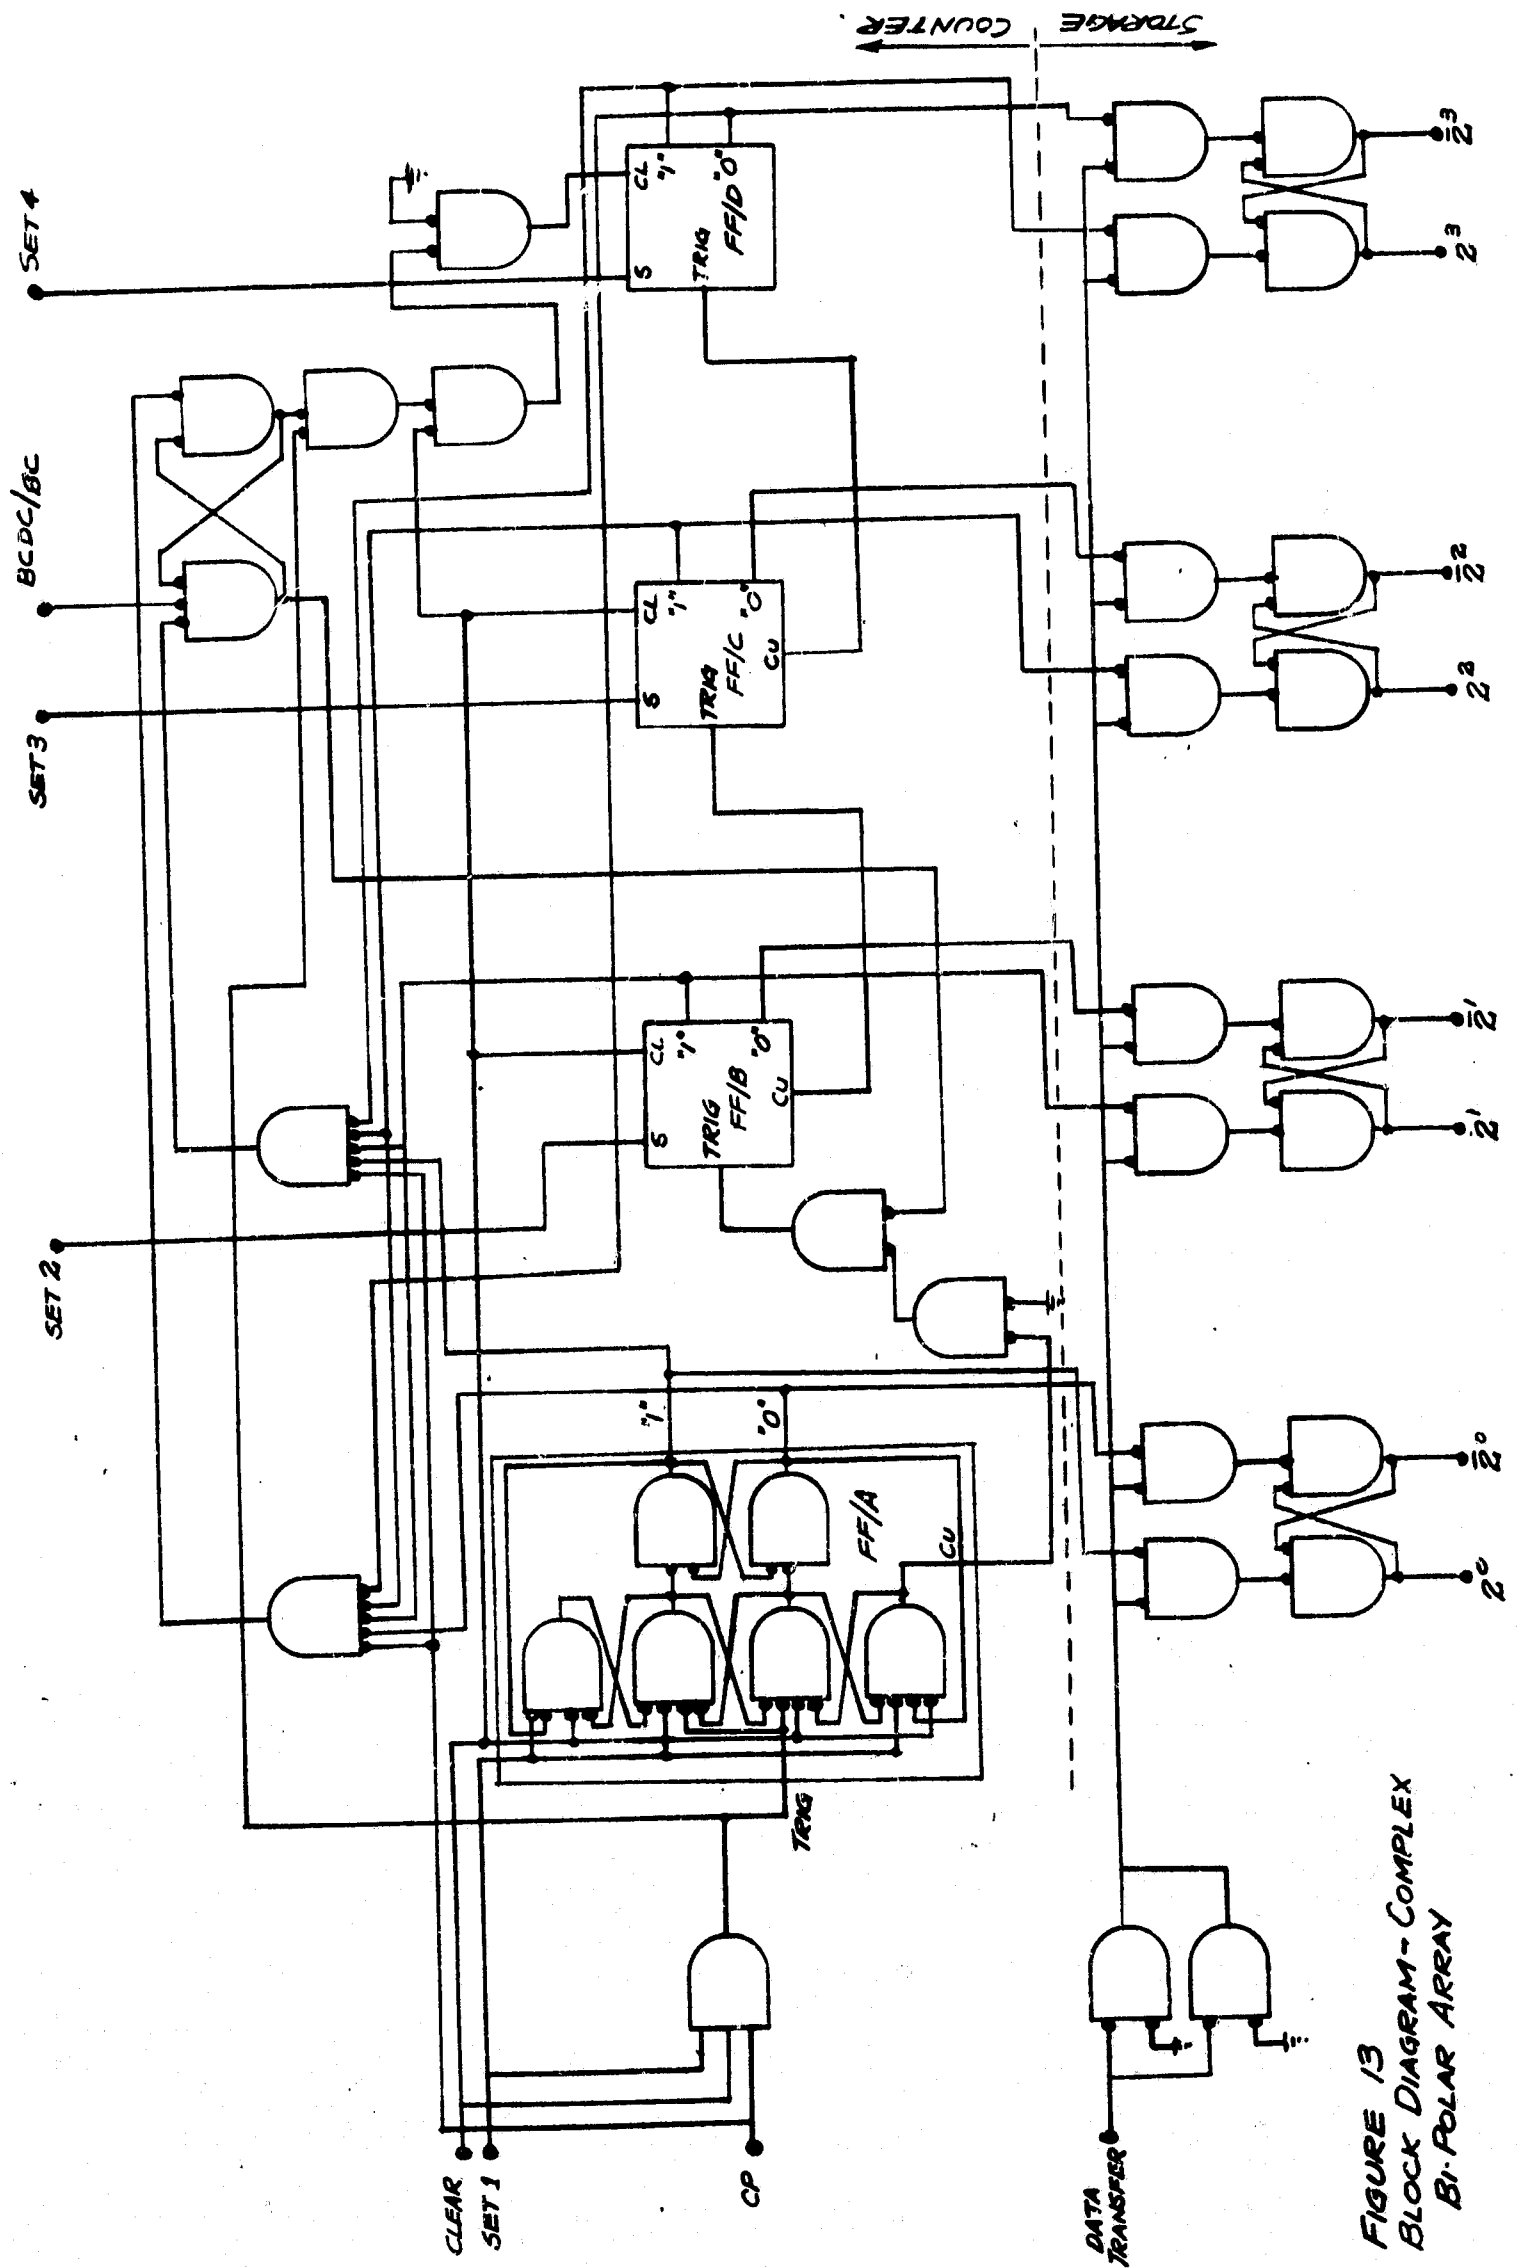
Color modulated infrared displays of one electrically good, and three electrically defective complex bipolar array devices were generated. Each device contains 415 components interconnected with the use of bilayer metalization techniques in an RTL configuration. A block diagram of the device is shown in figure 13. The infrared displays were made during the time the devices were operating under a supply voltage of 3V and 2V, 10KHz clock. The circuit is shown in figure 14. The color displays of two of the defective devices were significantly different from the electrically good device. The color display of the third defective device was similar to the good device, but did show some slight differences in thermal characteristics. The initial evaluation of the electrical cause for failure of device #54 indicated difficulty in the  $2^1$  output flip flop and electrical evaluation of device #108 indicated difficulty in the  $2^0$  and  $2^1$  output flip flops. These were the two devices which showed significant differences in the infrared characteristics when compared to the electrically good device. The initial evaluation of the characteristics of device #49 was inclusive as far as the location of the defective area. Further evaluation will be made, but the differences in the thermal characteristics do not seem to be related to the electrical difficulties associated with the device.

FIGURE 13  
BLOCK DIAGRAM - COMPLEX  
BI-POLAR ARRAY

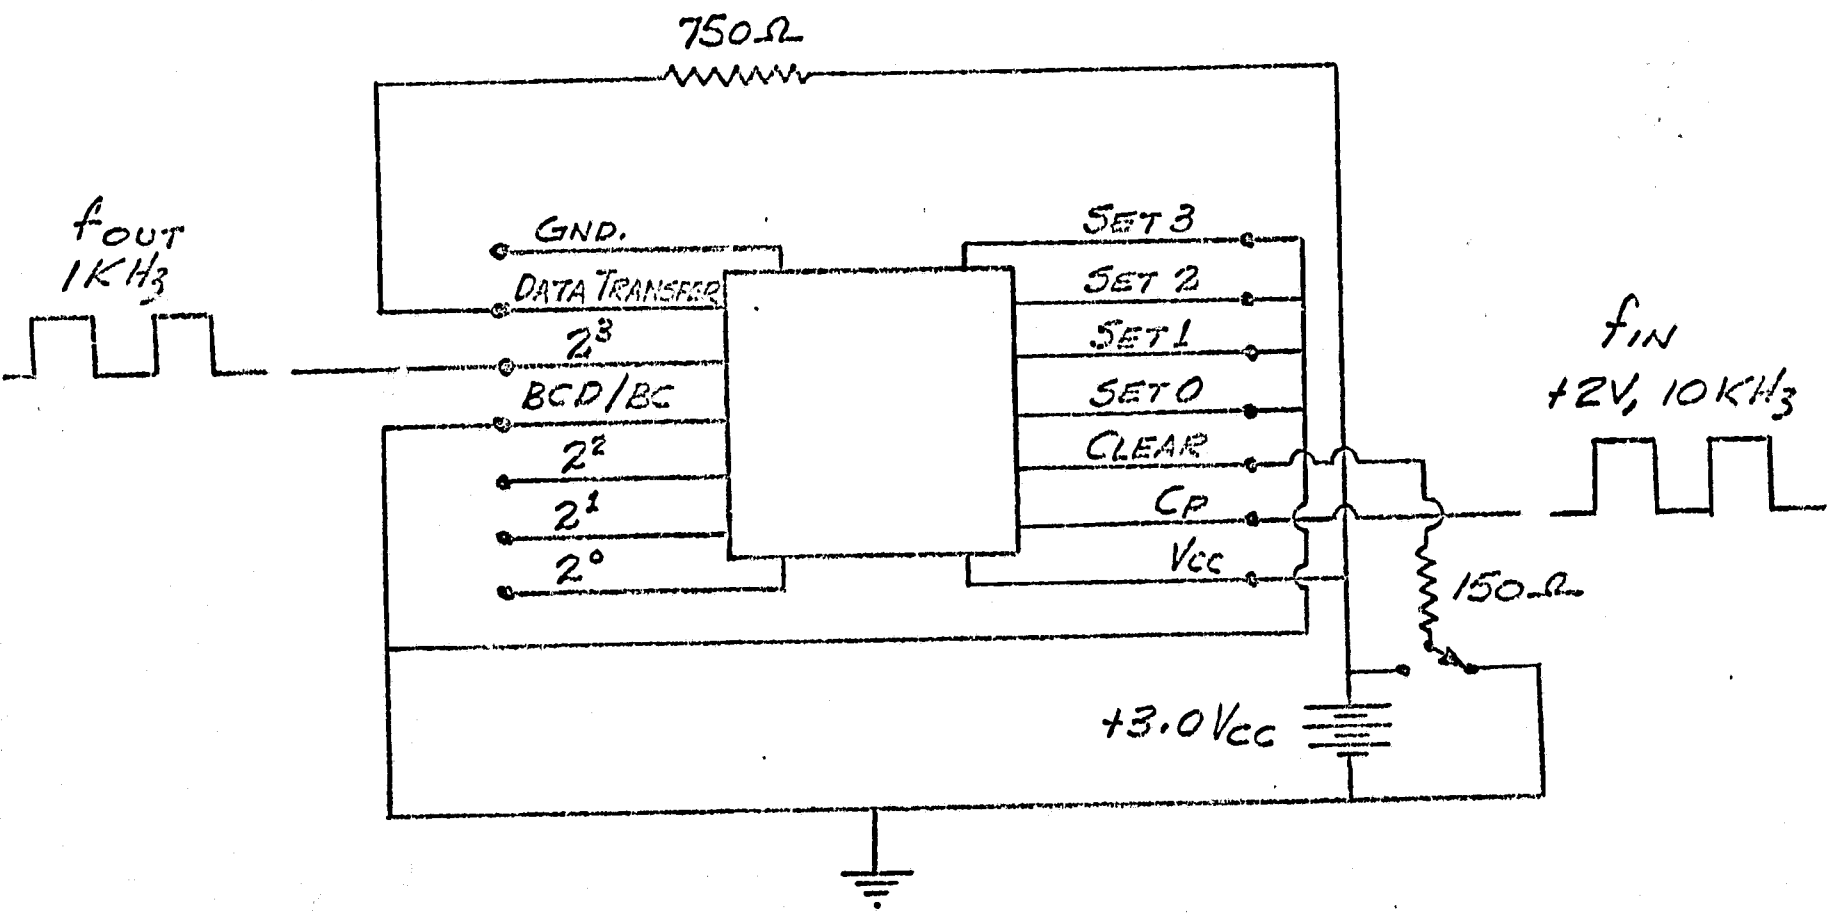
NOTE: A POSITIVE PULSE MUST BE APPLIED TO CLEAR LINE TO INITIATE THE OPERATION OF THE DEVICE IN THE BCDC MODE.

FIGURE 14. TEST CIRCUIT FOR COMPLEX BI-POLAR ARRAY

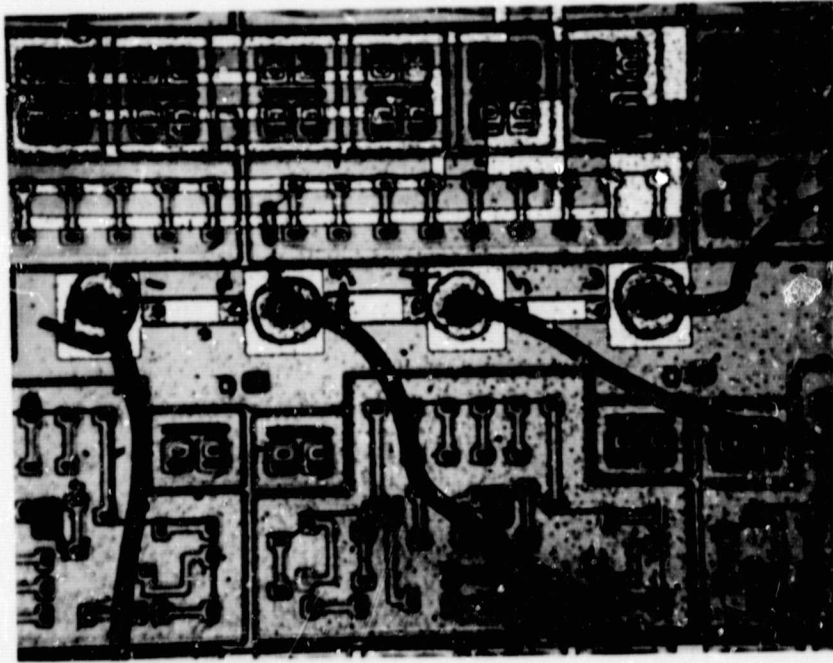
FIGURE 15. Test Vehicle for Evaluation of Localized Heating at Vias.

The vehicle consists of a series of upper and lower metalization stripes connected by vias approximately  $1/4$  mil by  $1/4$  mil in cross section and  $12,000 \text{ \AA}$  in length. Line scans made along the center line of these metalization stripes on 8 different devices at current levels as high as 50 mA, did not indicate any appreciable heating at any via. Unfortunately, not all of the data obtained was usable because the location of the nail head bond obscured the infrared radiation from some of the vias.

The second evaluation was performed using the test vehicle shown in figure 15.

From the data obtained during these evaluations, it appears that in the case of the bilayer metalized DTL devices, electrical resistance occurred in the vias and caused localized heating because of ohmic heating. The test vehicles used in the second part of the evaluation however, did not indicate any appreciable heating. This demonstrates that if bilayer metalization processing is properly defined and accomplished, no heating will occur in the vias, and the use of bilayer metalization techniques should not have any adverse effect on reliability.

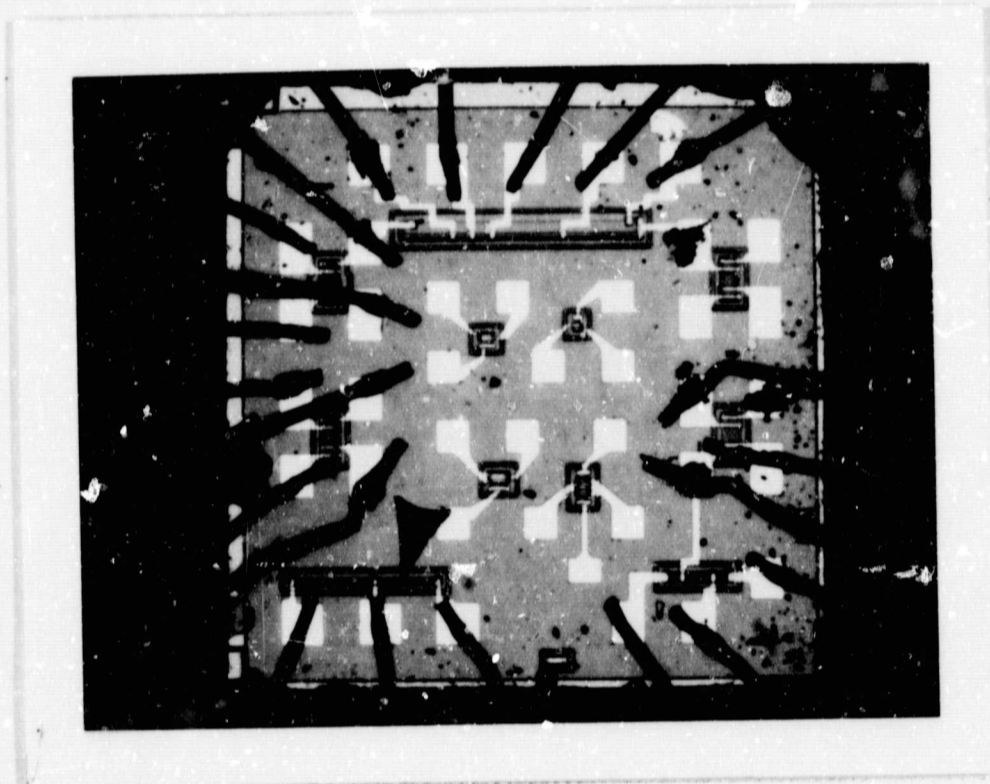
Figure 16 is a photograph of the test vehicle selected for this evaluation. It is a 35 X 35 mil chip containing several discrete elements and is mounted in a metal bottom flat package.

FIGURE 16. Photomicrograph of 35 X 35 Mil Chip  
Utilized for heating and cooling rate evaluation.  
Resistor R-8 is indicated by the arrow.

The initial evaluation consisted of pulsing D.C. power into a discrete diffused resistor (R-8 indicated by the arrow on figure 16) and measuring the rate of temperature increase and the rate of temperature decrease immediately over the resistor, 10 mils from the resistor, and 20 mils from the resistor. In this evaluation the component was supported only by its external leads and the heating and cooling rates determined are referenced to free air. The data obtained from this evaluation is shown in Figures 17, 18, and 19.

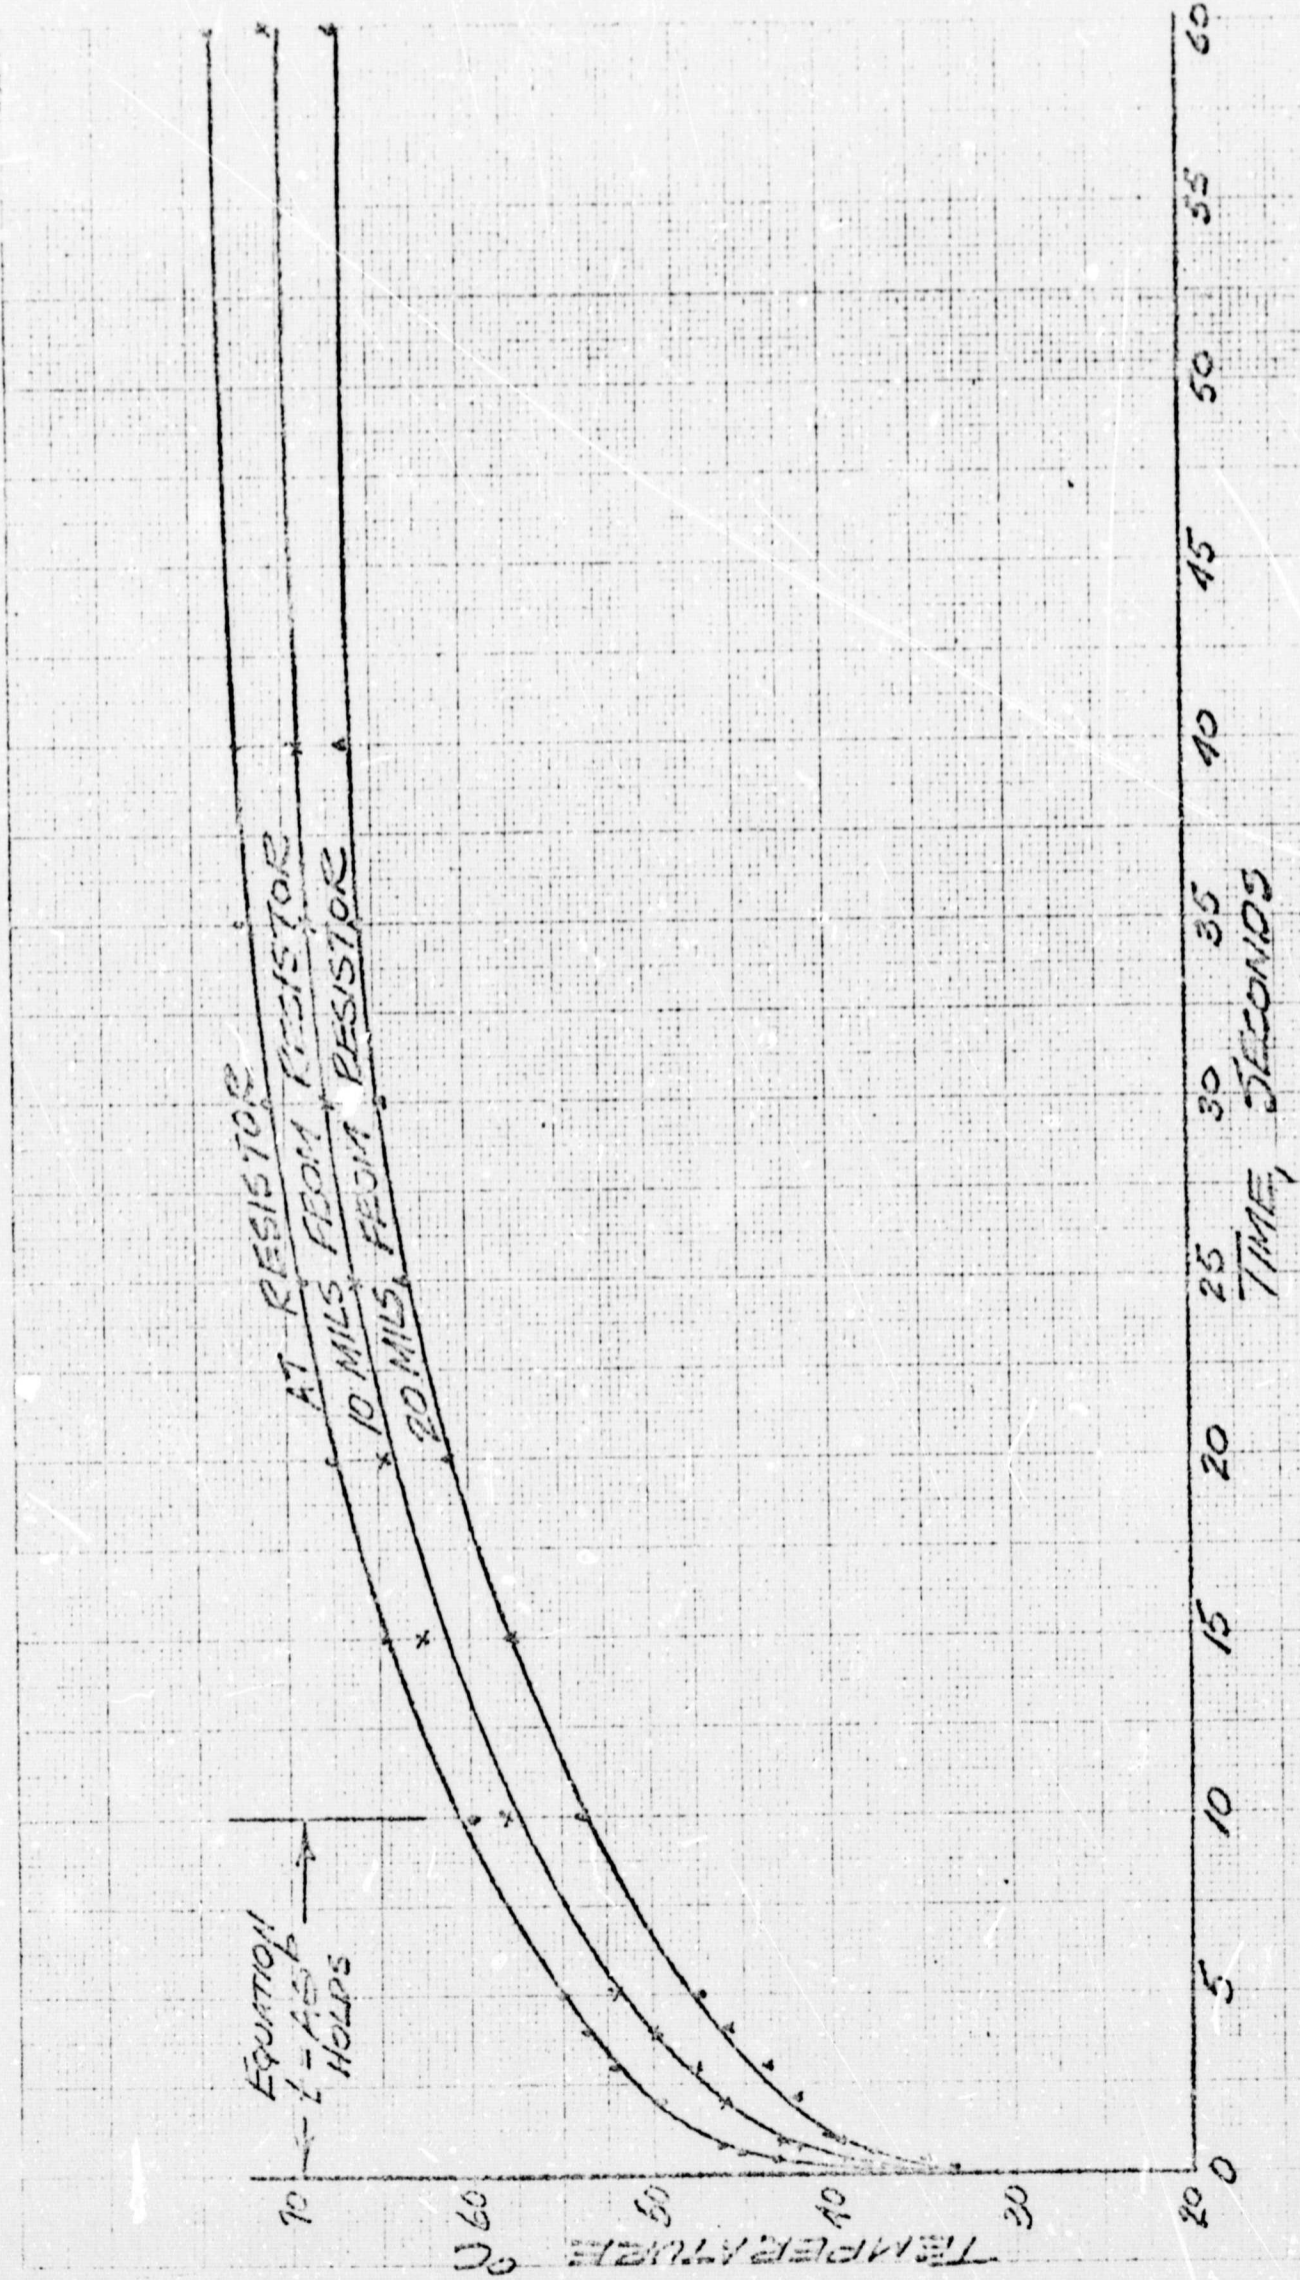
FIGURE 17

HEATING RATE FOR TEST VEHICLE  
WHEN  
MOUNTED IN FREE AIR  
DISSIPATION = 500 mW

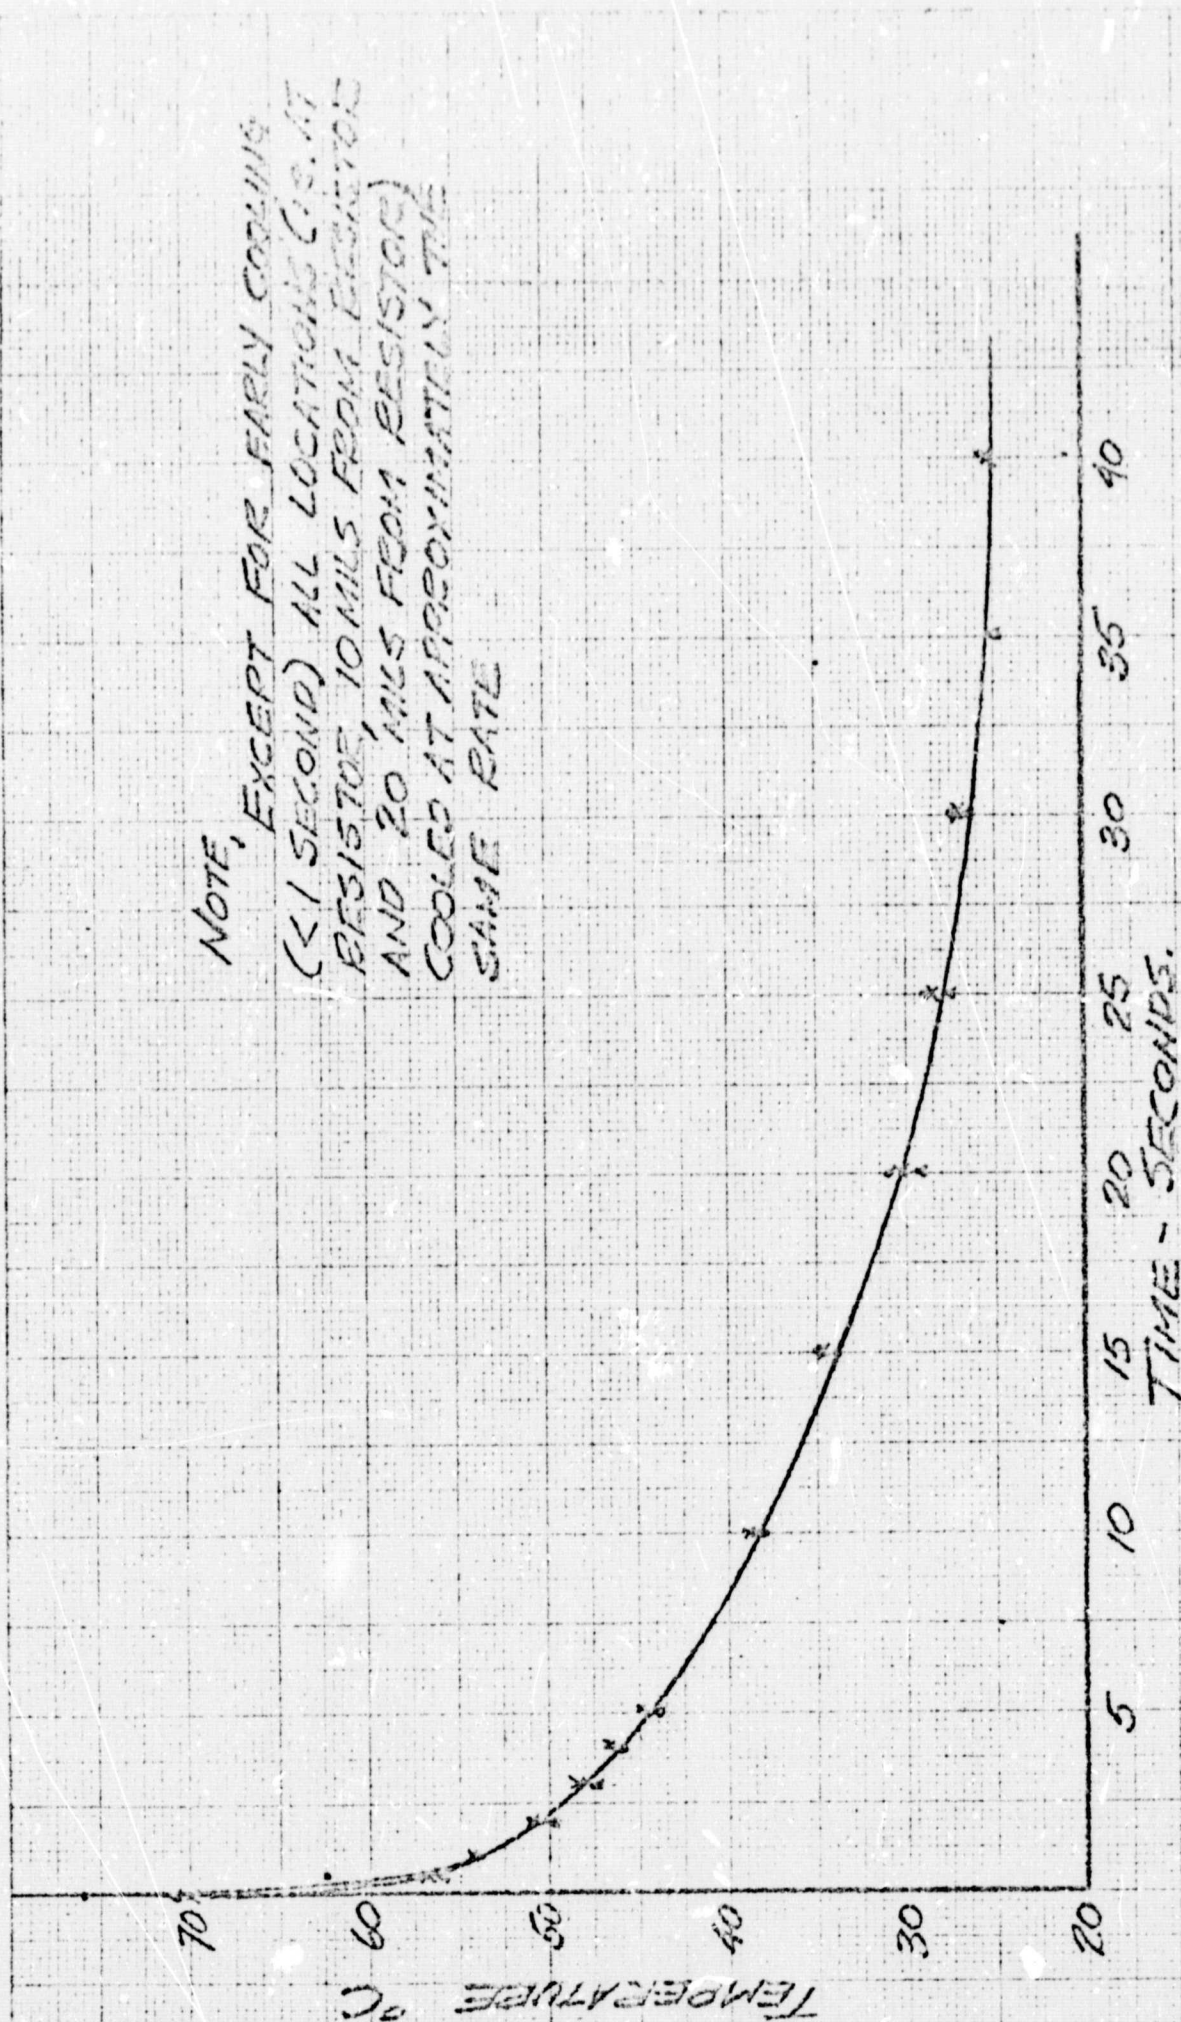
FIGURE 18

NOTE, EXCEPT FOR EARLY COOLING  
(< 1 SECOND) ALL LOCATIONS (I.E. AT  
RESISTOR, 10 MILS FROM RESISTOR  
AND 20 MILS FROM RESISTOR)  
COOLED AT APPROXIMATELY THE  
SAME RATE

COOLING RATE FOR TEST VEHICLE  
MOUNTED IN FREE AIR.  
DISSIPATION = 350 MW
