FOURTH INTERIM PROGRESS REPORT  
ON  
THE STUDY OF INFRARED EVALUATION  
IN  
QUALIFICATION AND FAILURE ANALYSIS  
OF  
SEMICONDUCTOR DEVICES

covering the period  
28 April 1968 to 28 July 1968

Prepared for  
GEORGE C. MARSHALL SPACE FLIGHT CENTER  
HUNTSVILLE, ALABAMA

PHILCO-FORD CORPORATION  
Microelectronics Division  
Blue Bell, Pennsylvania • 19422

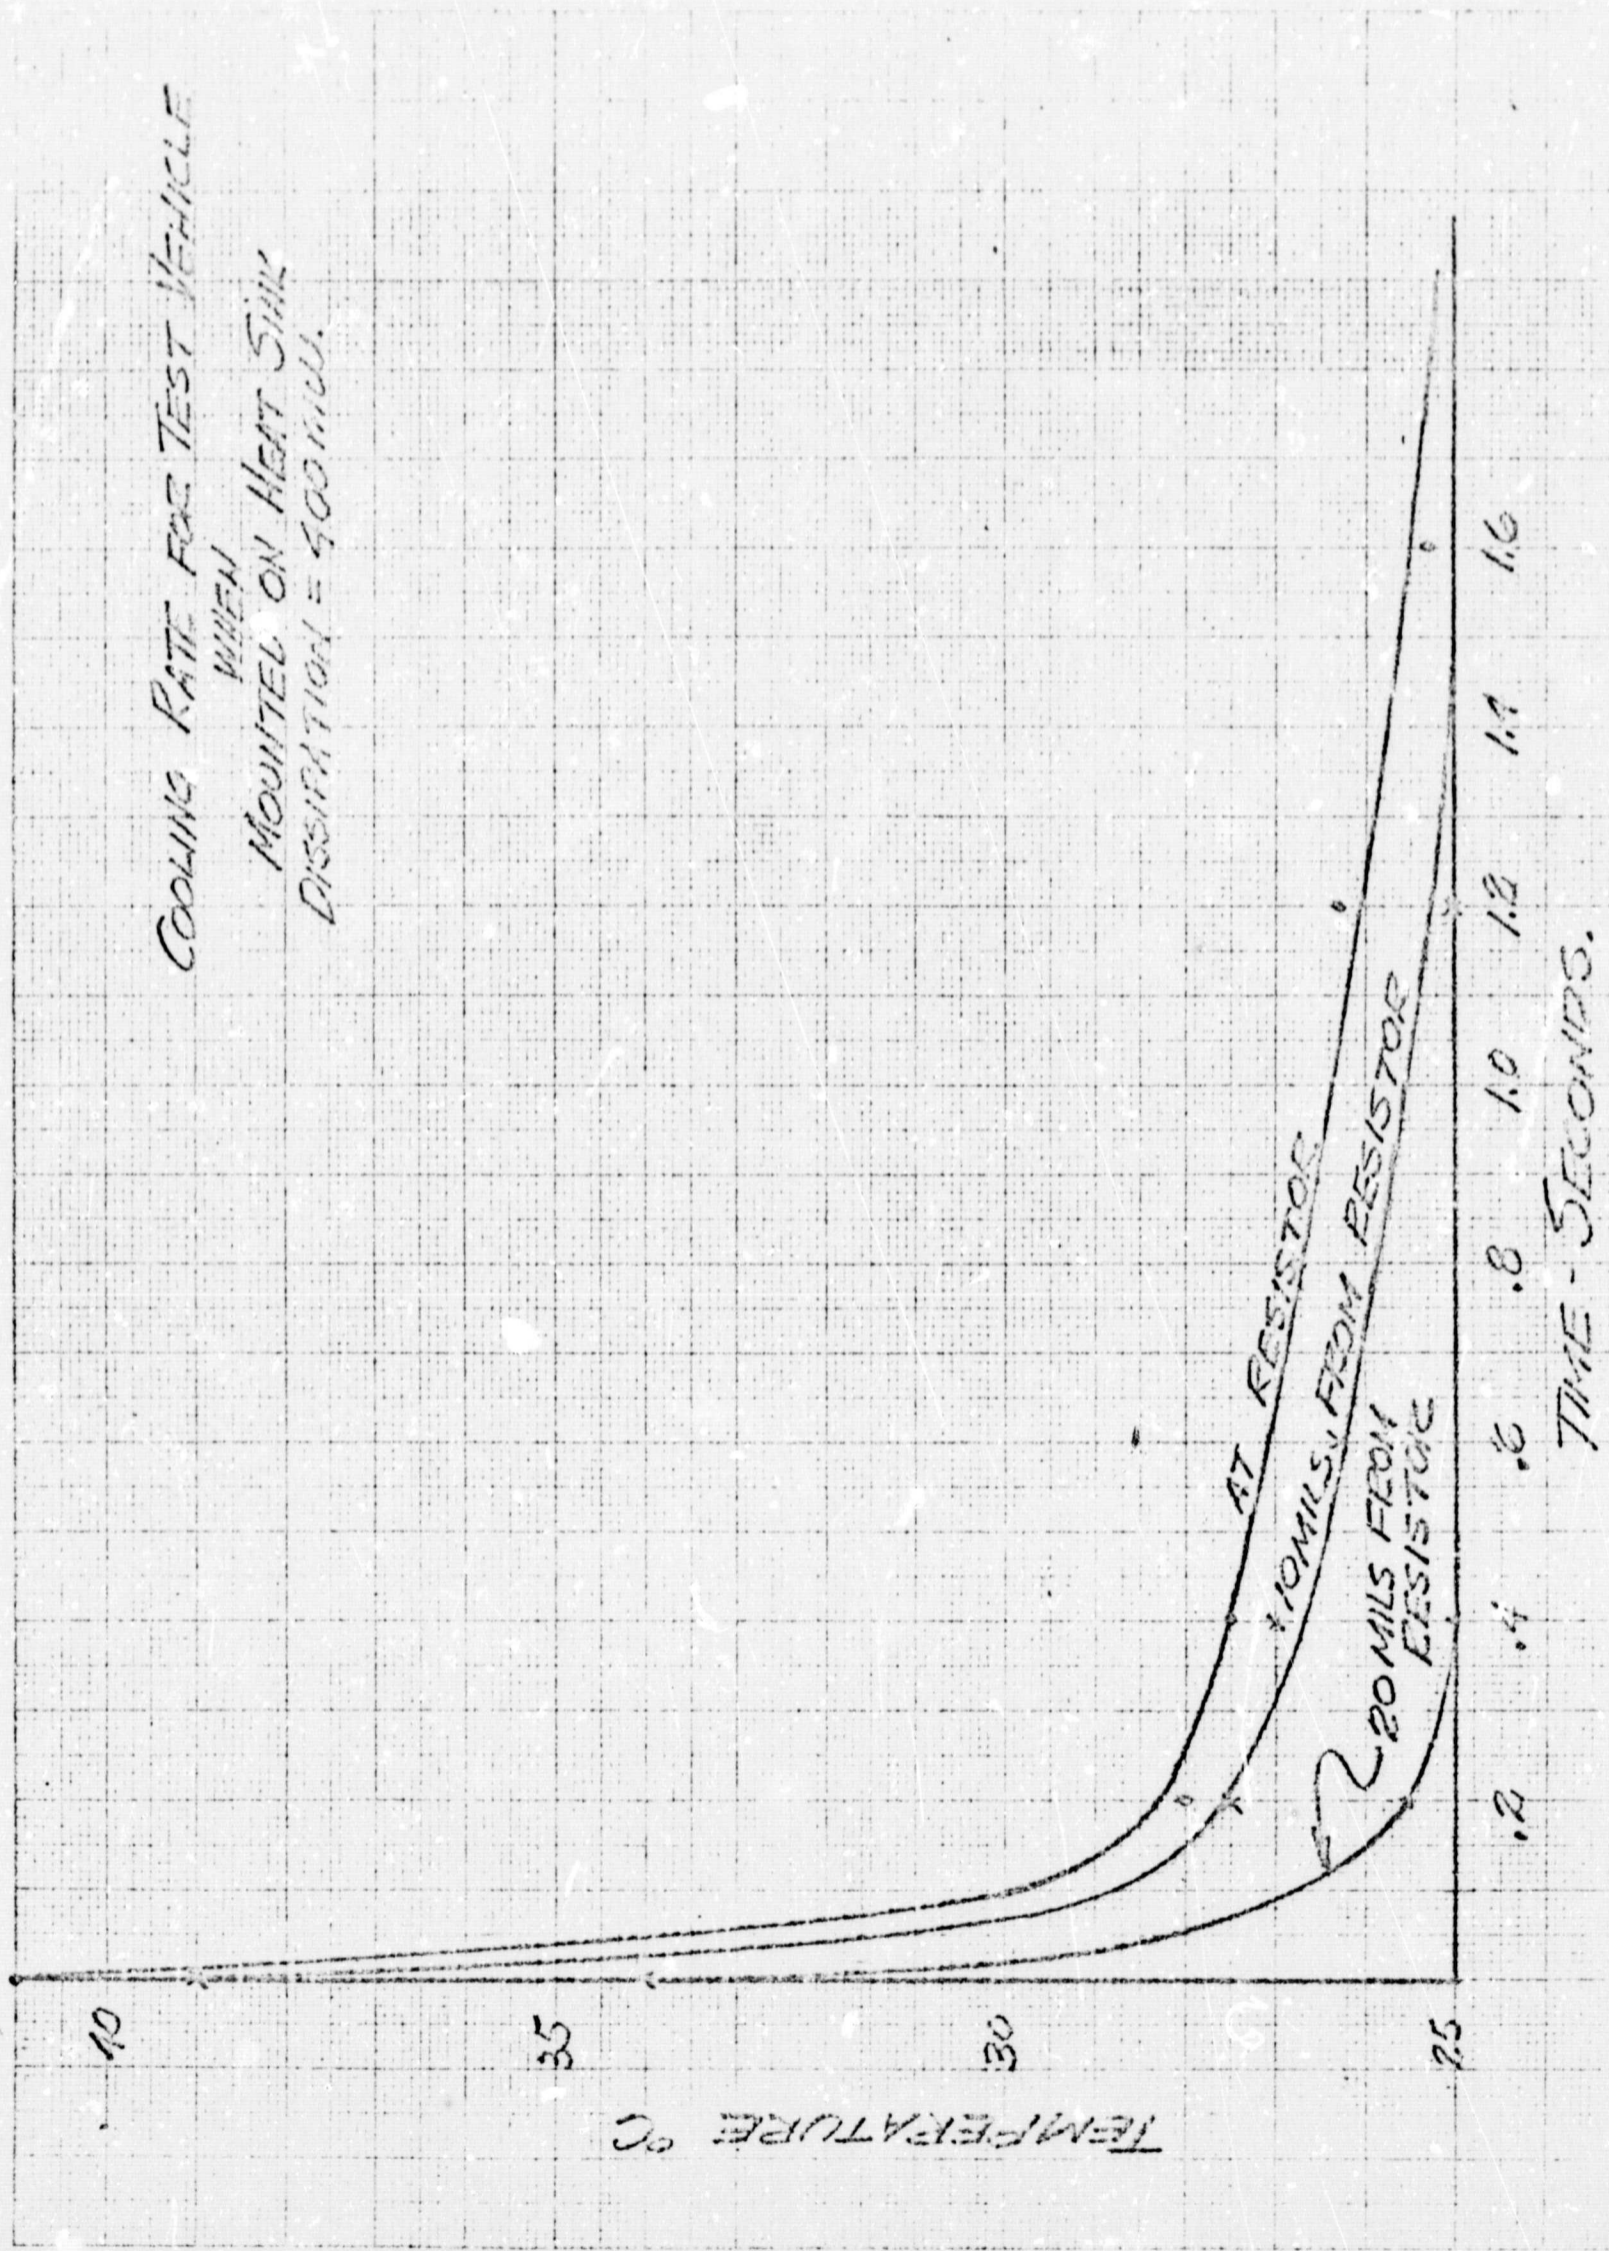
FIGURE 2.1

COOLING RATE FOR TEST VEHICLE  
WHEN  
MOUNTED ON HEAT SINK  
DISSIPATION = 400 MW.

A second evaluation was performed with the same vehicle mounted on a heat sink and the data derived from this portion of the evaluation is shown in Figures 20, 21, and 22. In both of the above cases the initial heating and cooling fits an equation of the form:

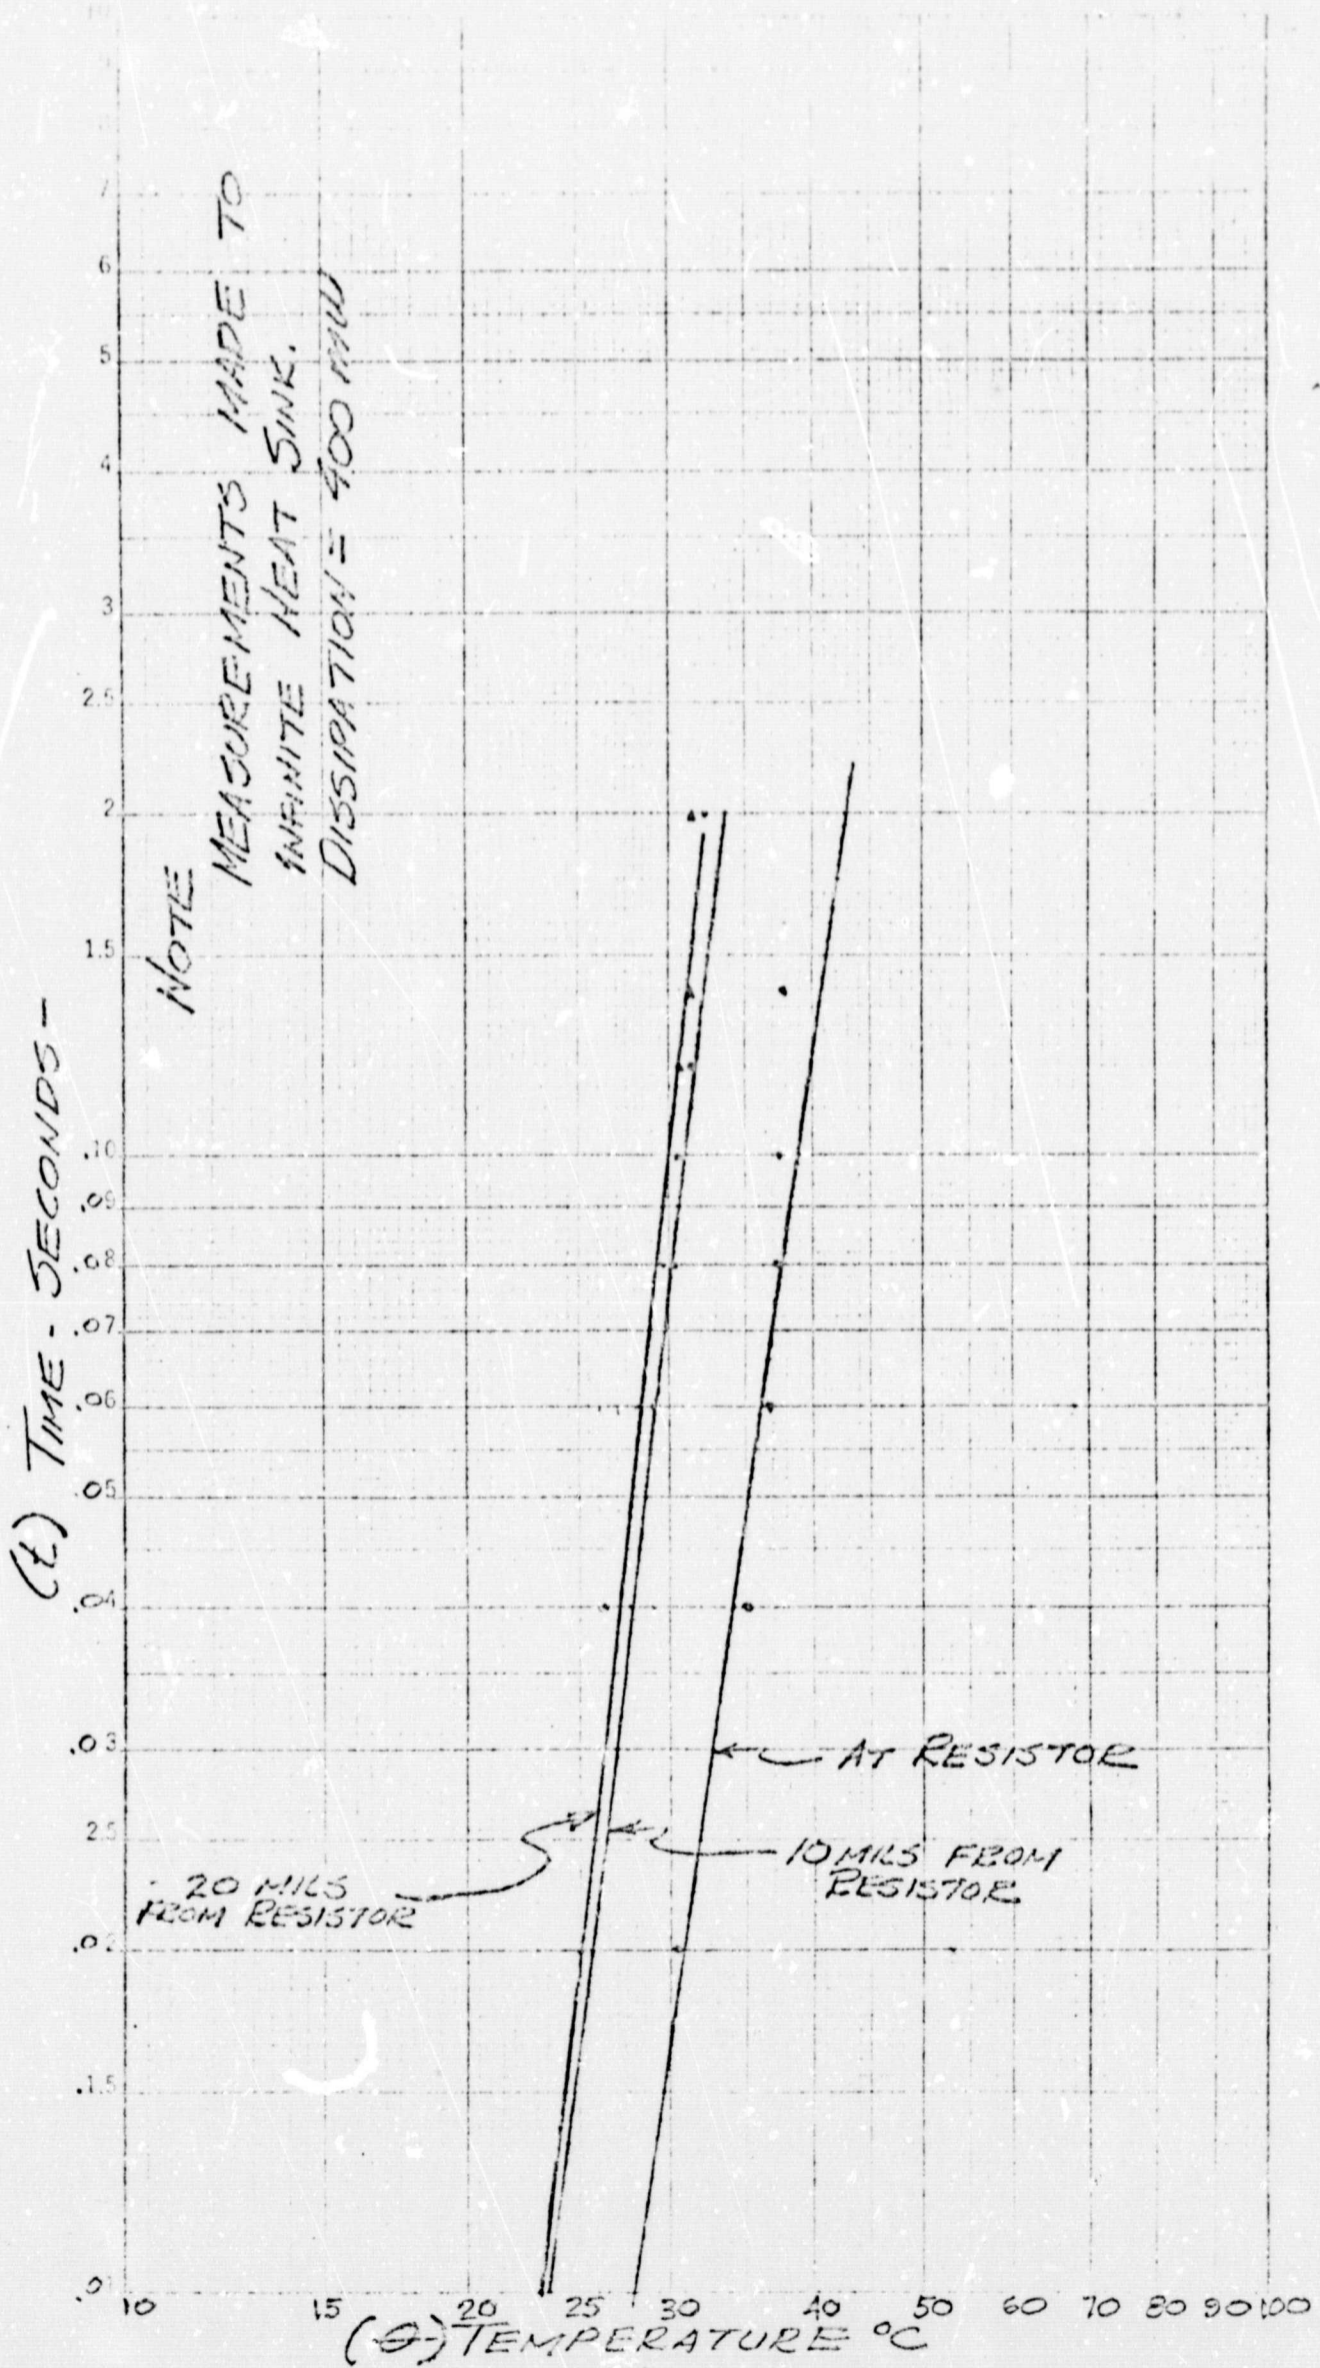
FIGURE 2.7

HEATING RATE IN THE RANGE  
WHERE  
THE EQUATION  
 $t = A\theta^b$   
HOLDS

$$t = A\Theta^b$$

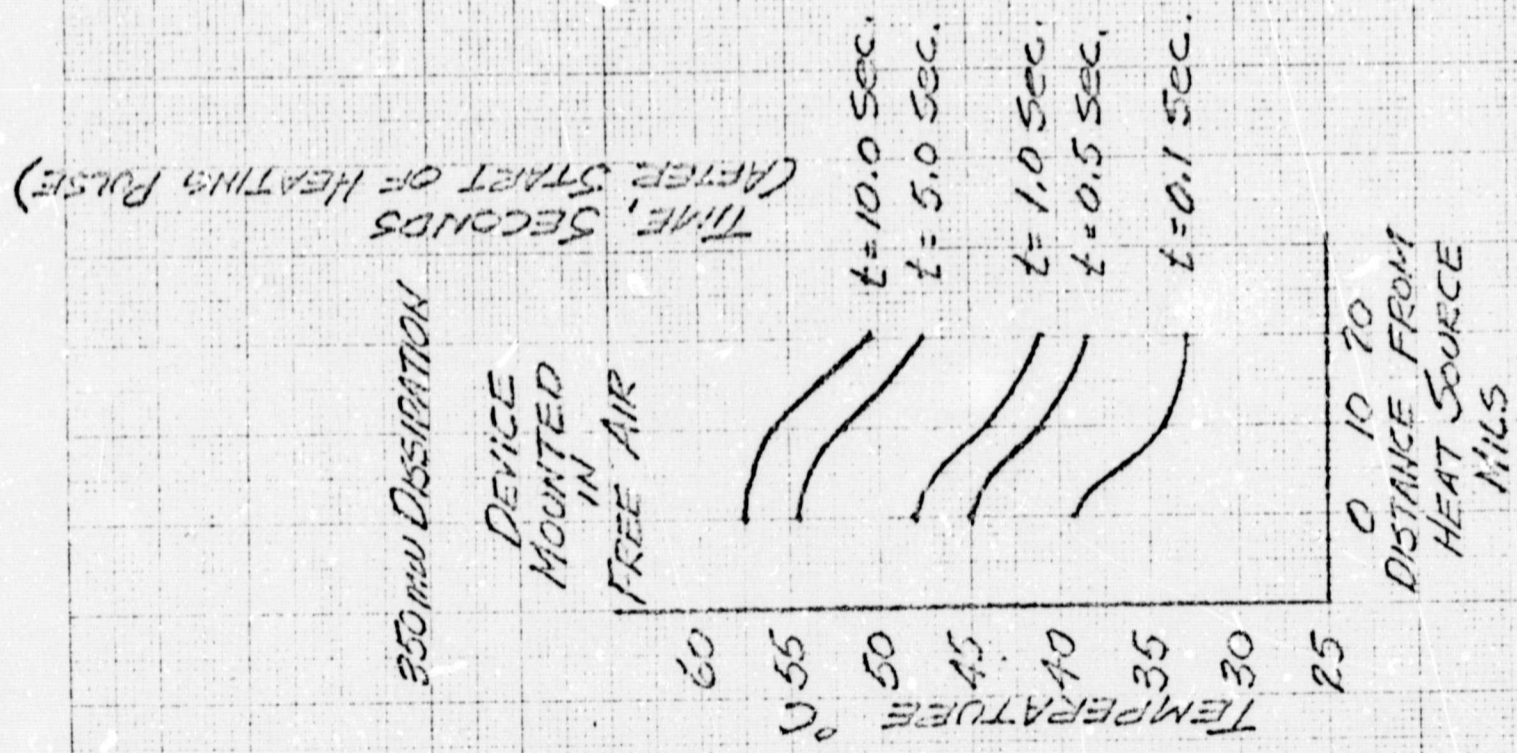
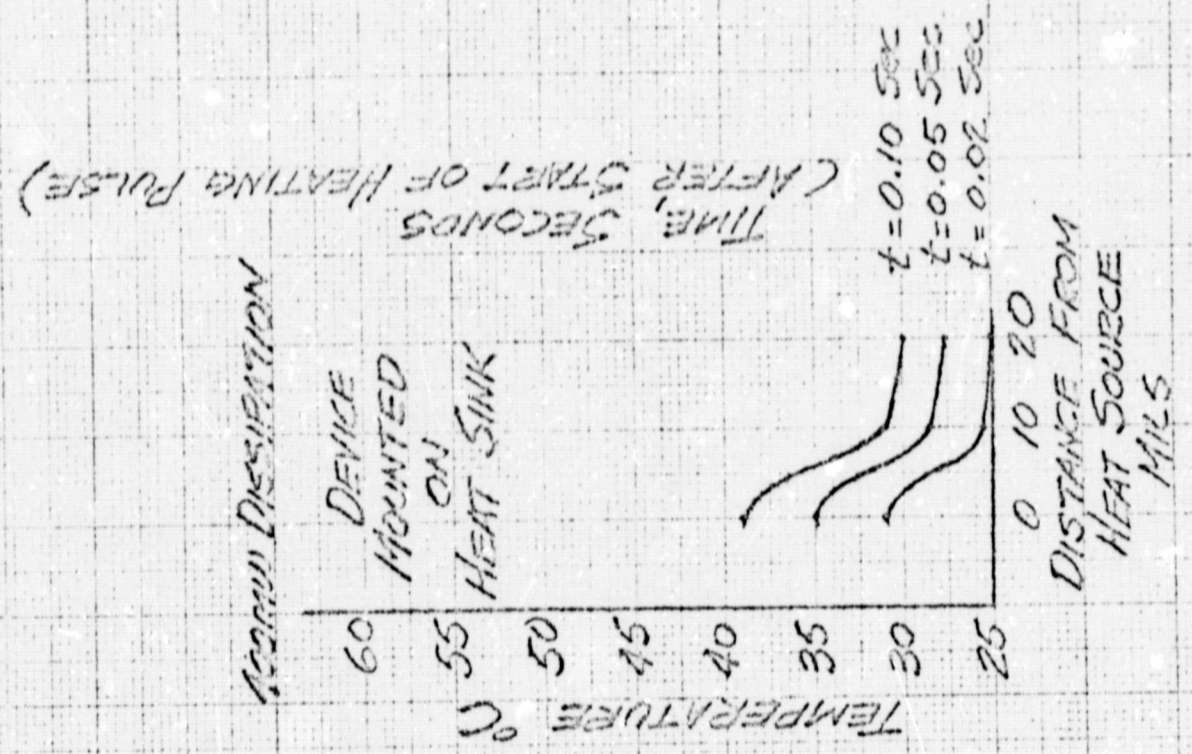
FIGURE 23

After the fast initial rise or fall of temperature, the rate of change becomes very gradual and the equation fails. Figure 23 indicates the operating temperature at the three locations at various times after the turn on of the power pulse. It is observed from these curves that when the device is dissipating to free air, increased time results in "blurring" of localized hot spots, but when the device is mounted on a heat sink, increased time results in enhancement of the localized hot spot, and the time required for the device to reach its maximum temperature is much shorter than with the device dissipating to free air.

TEMPERATURE GRADIENT  
 VS  
 TIME

The data thus far obtained indicates that localized hot spots can be enhanced by operating the device on a heat sink. It also indicates that when the device is heat sinked the maximum operating temperature is achieved about 0.10 seconds after the application of the power pulse. The difficulty with operating the device on heat sink is that at the normal dissipation levels of most integrated circuits the operating temperature of the device is close to room temperature, the lower limit of the temperature detection capability of existing infrared equipment. However, if small localized
