A-1080

FINAL REPORT

APOLLO SM-LM RCS ENGINE DEVELOPMENT
PROGRAM SUMMARY REPORT

Contract NAS 9-7281

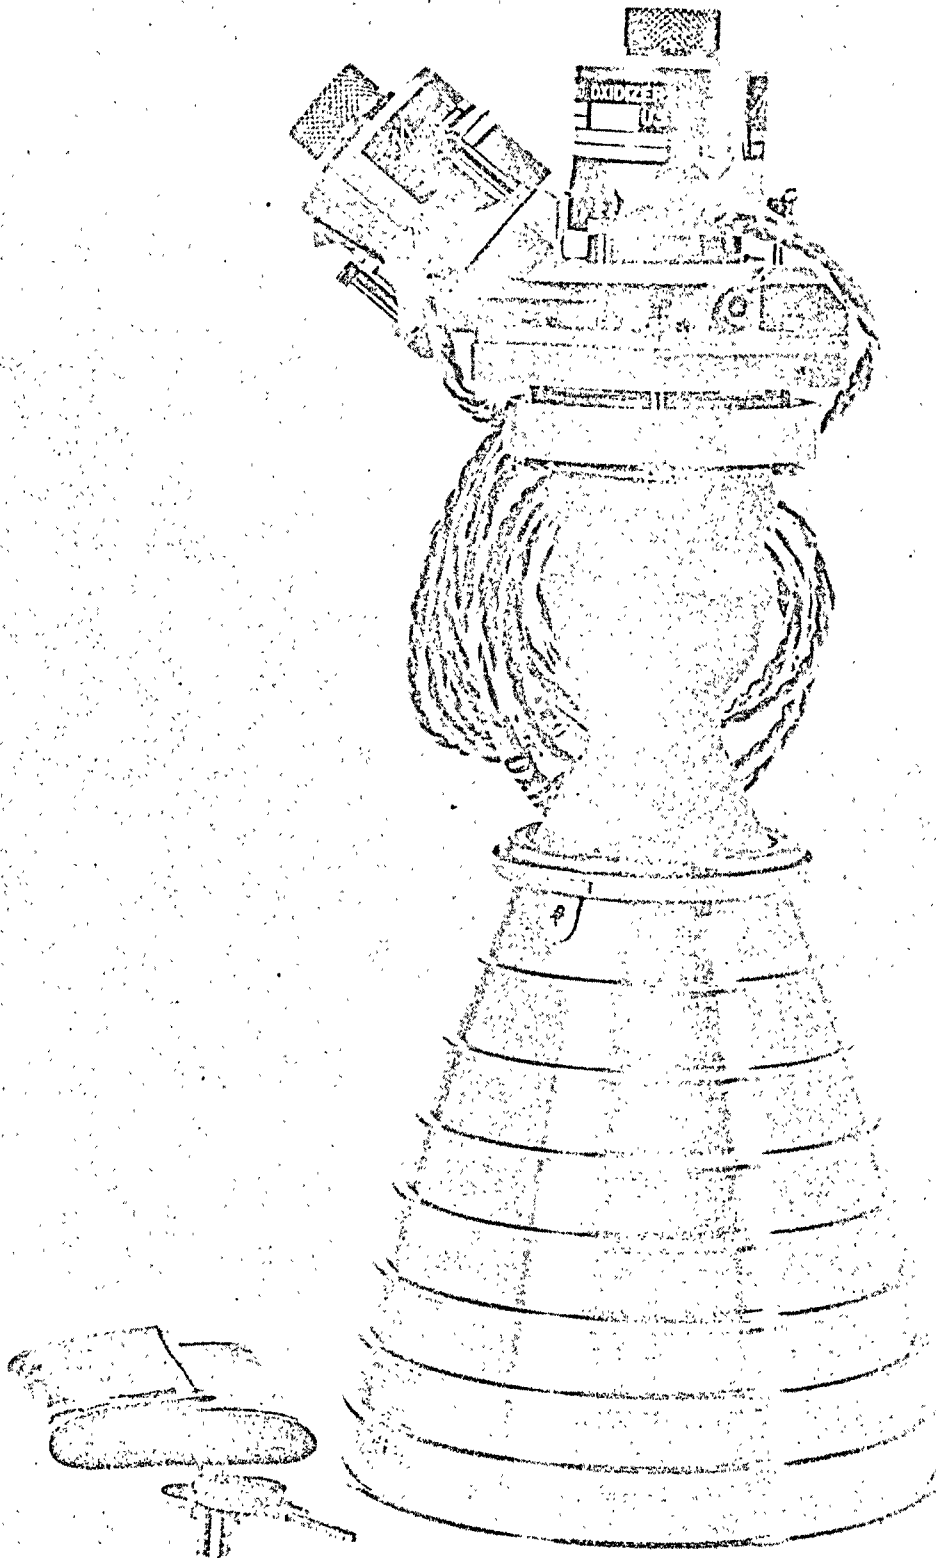
NEG. 6839-3

Marquardt's R-4D rocket engine has been used on the Apollo Service Module and Lunar Module for attitude control and ΔV maneuvers. The engine was used as the ΔV engine on the Lunar Orbiter and it is presently being qualified for use on other programs. The nominal thrust of the engine is 100-pounds and the propellants are nitrogen tetroxide and monomethylhydrazine or Aerozine-50. The engine is fuel film-radiation cooled and has an extremely long life - projected to be in excess of 100 hours of burn time. Figure 1 is a picture of the engine.

R-4D engine
