MCR-68-119

STERILIZABLE LIQUID PROPULSION SYSTEM  
FINAL REPORT  
PART I

JPL Contract 951709

MARTIN MARIETTA CORPORATION  
P. O. Box 179  
Denver, Colorado

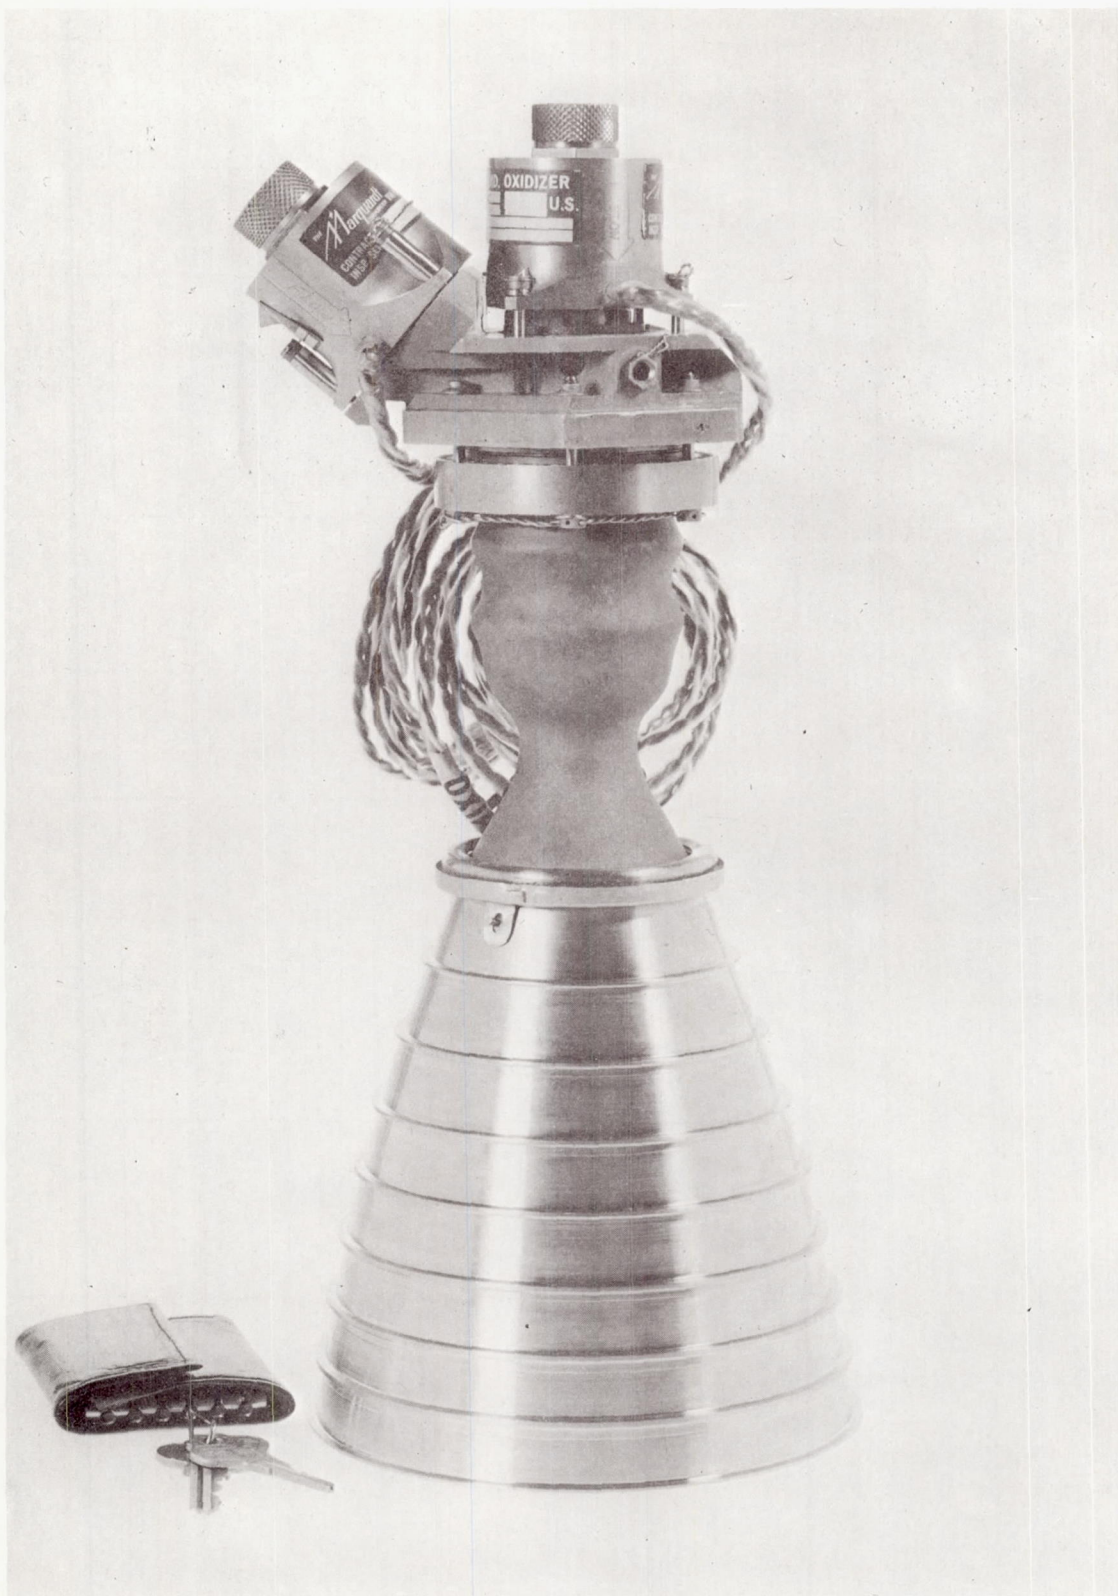
Fig. III-1 Marquardt R-4D Rocket Engine

Data were also provided on the injector head and valve assemblies. Flow pressure drop and response under water flow calibration were measured to provide a baseline for component degradation during sterilization.

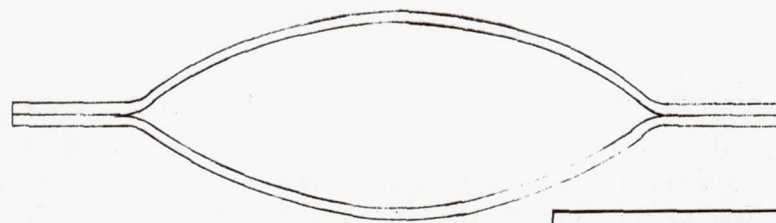
Note: Surface finish to be between 16 and 32 RMS.

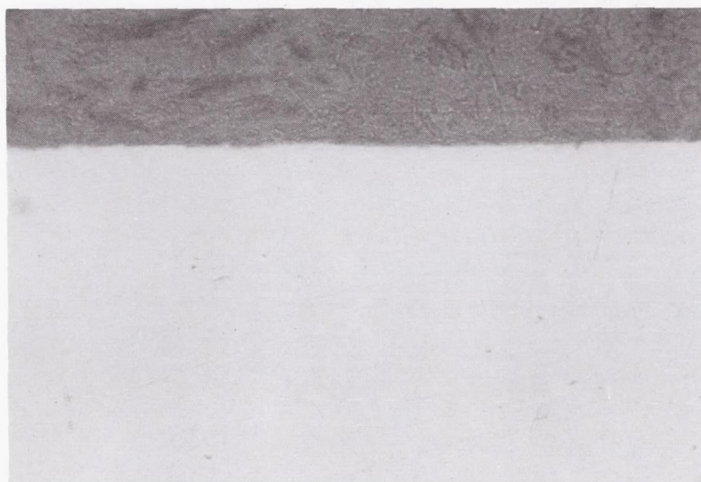
The photomicrographs of the specimens shown in Fig. IV-26 show no detrimental effects resulting from the tests.

(a) Unnotched Specimen, Titanium  
6Al-4V (200X)

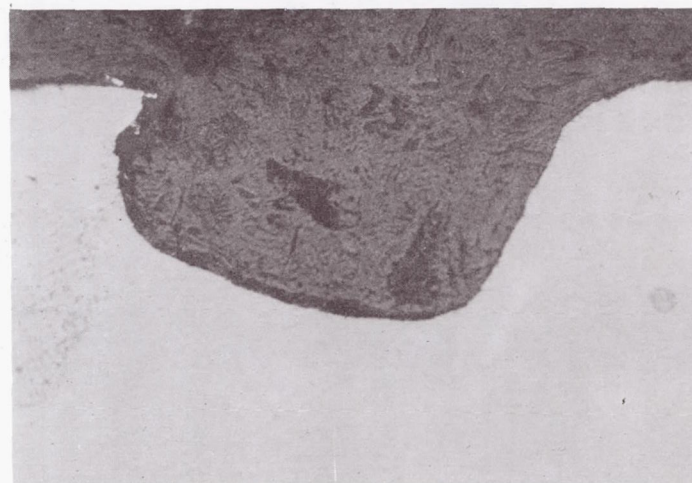
(b) Notched Specimen, Titanium  
6Al-4V (200X)

Fig. IV-26 Titanium 6Al-4V Alloy Exposed to ET0/Freon 12

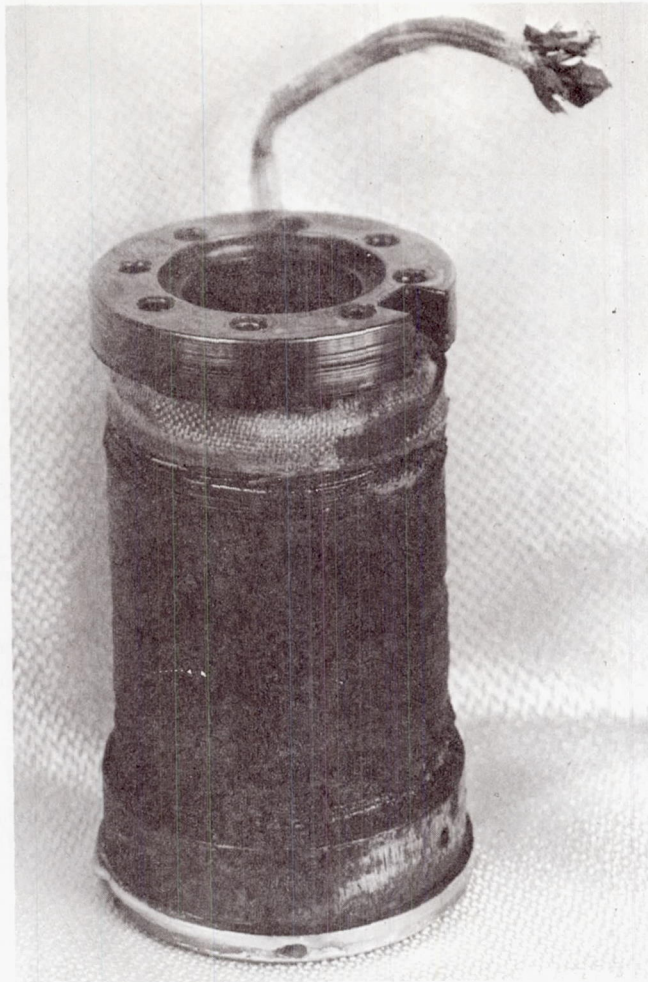
Fig. V-23 Solenoid Valve Coil

The insulation on the outside of the coil winding was charred black (Fig. V-23). The magnet wire used for the coil was No. 27 single Formvar. According to the Bridgeport Insulated Wire Company's catalog, the rated temperature limit for Formvar insulation is 221°F. The varnish used in wet winding the coil, Tri Var No. 116, is also rated at 221°F.

Any future design should be specific in calling out a Teflon-coated wire insulation or some other high temperature-type insulation that is definitely suitable for extended exposure to sterilization temperatures. Coil impregnation, coil wrappings, and potting compounds must also be included in this high temperature category.

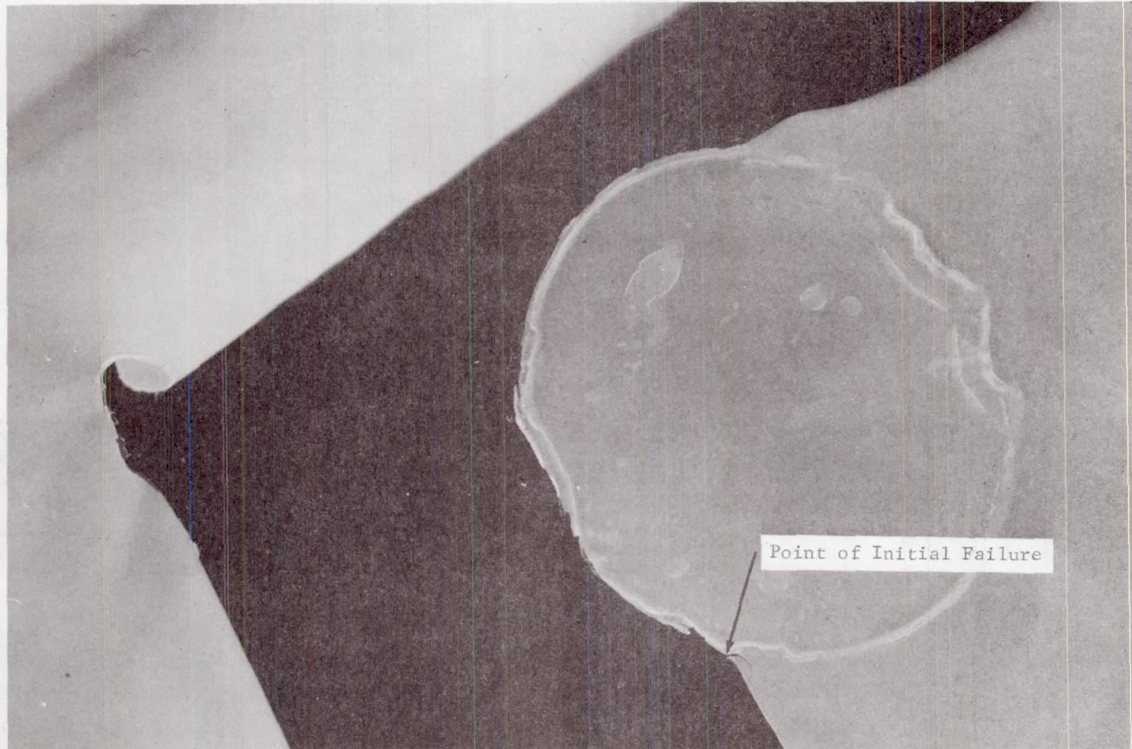
Fig. VI-17 Diaphragm Apex Doubler

It was concluded the diaphragm ruptured because of propellant depletion. Performance calculations indicated the diaphragm would have been required to stretch 0.022 in. This represents a surface stretch of only 0.3%. Biaxial loading of a Teflon membrane should result in stretch of up to at least 2%. Therefore, the evidence seems to point to the initial failure at the stress riser at the apex doubler, as shown in Fig. VI-17.
