Chemistry Support Services

Report No. 951581-9

## PRELIMINARY EVALUATION OF A THIN ORGANIC FILM COATING

*By:* N. H. G. DANIELS and M. C. GARRISON

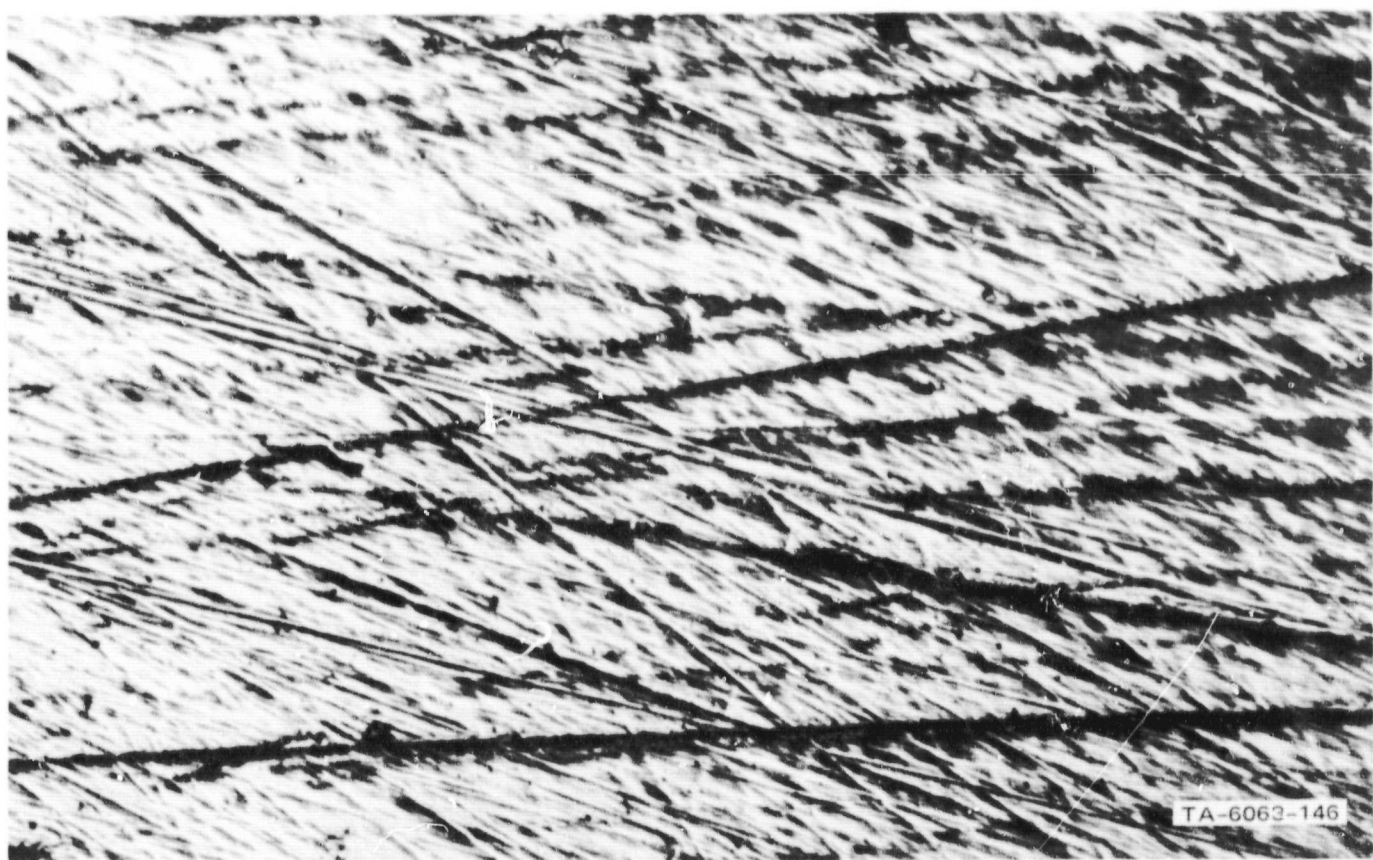
FIGURE 2 TYPICAL SURFACES OF GROUP I SPECIMENS X200

A photograph of the group I specimens is shown in Fig. 1, and typical surface areas for each of the four specimens at X200 magnification are shown in Fig. 2. Corresponding series of photographs for group II (Figs. 3 and 4), group III (Figs. 5 and 6), and group IV (Figs. 7 and 8) follow.

It will be seen that the substrates have a variety of surface finishes and textures. Considerable differences exist both within and between groups. Group I generally shows polishing scratches of somewhat random direction with deep, generally longitudinal furrows; specimen 15 of this group has areas of pitting (Fig. 2). In this group of specimens, the coating was applied in two sections, and there is a gap of uncoated, or very thinly coated, substrate between the two sections. Group II (Fig. 4) specimens showed the most uniform finish, characterized by rather deep, randomly oriented polishing scratches. Group III (Fig. 6) shows a wide variation from the pitted surface of specimens 21 and 23 to the highly directional, transverse ground finish of specimen 22, which also showed some deep voids. The coatings of the group IV (Fig. 8) specimens appeared less uniform than those of the other groups, particularly at the ends of the coated area, and showed a range of interference colors. This group also shows wide variations of substrate surface texture.

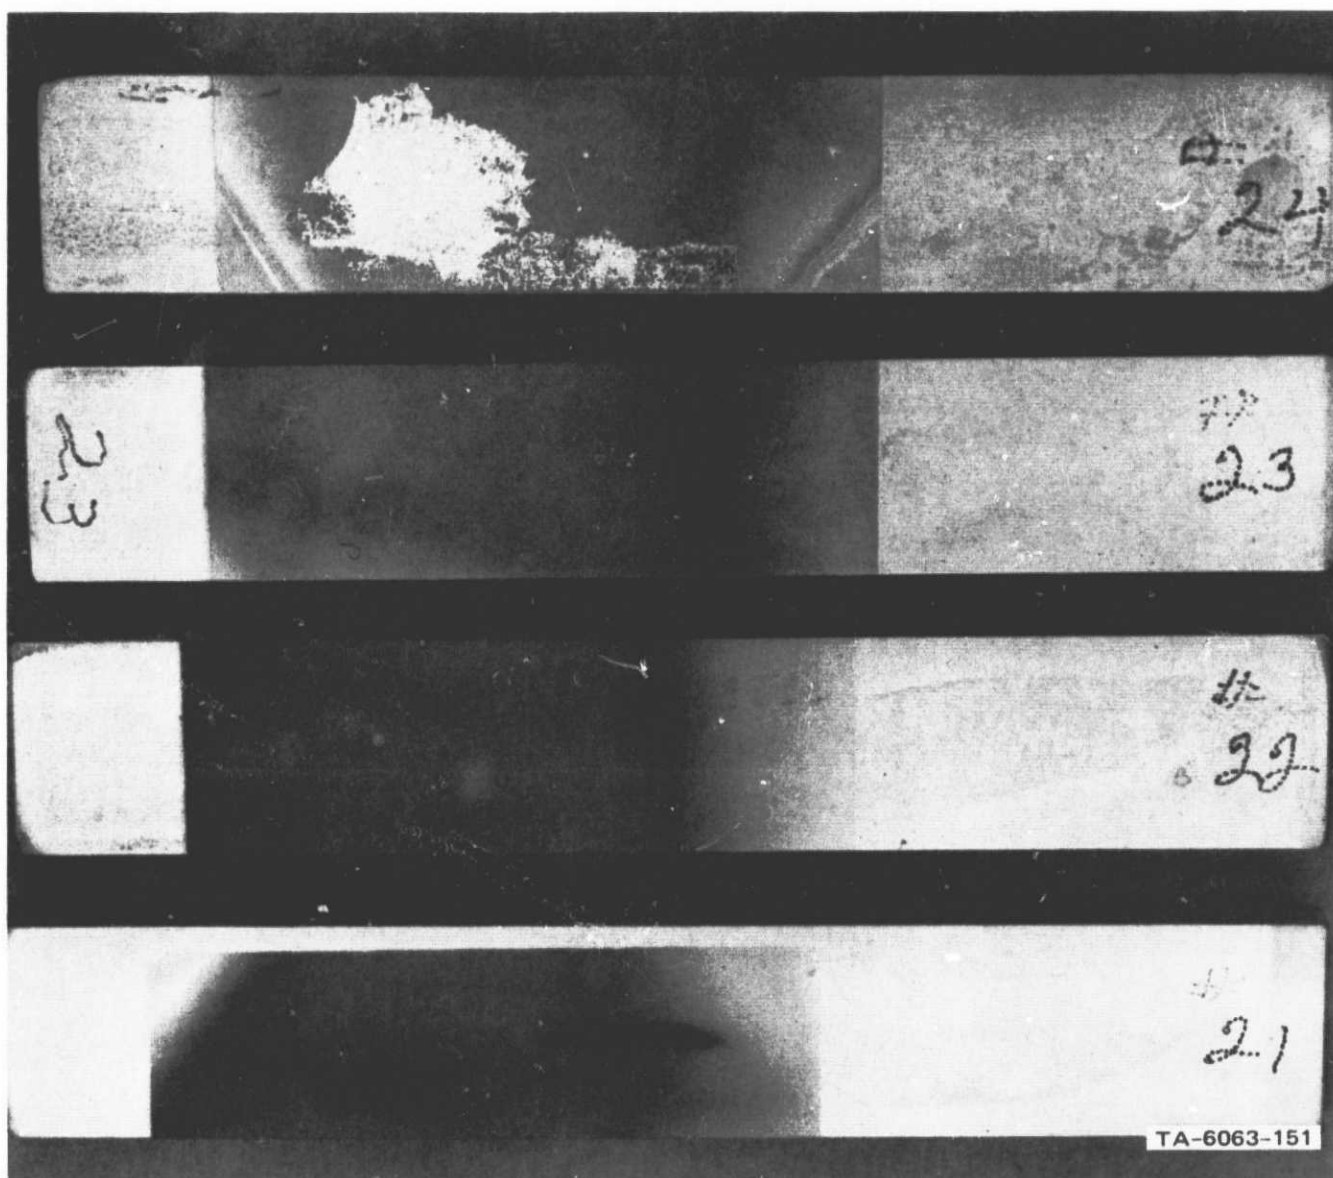
FIGURE 5 GROUP III SPECIMENS, AS RECEIVED

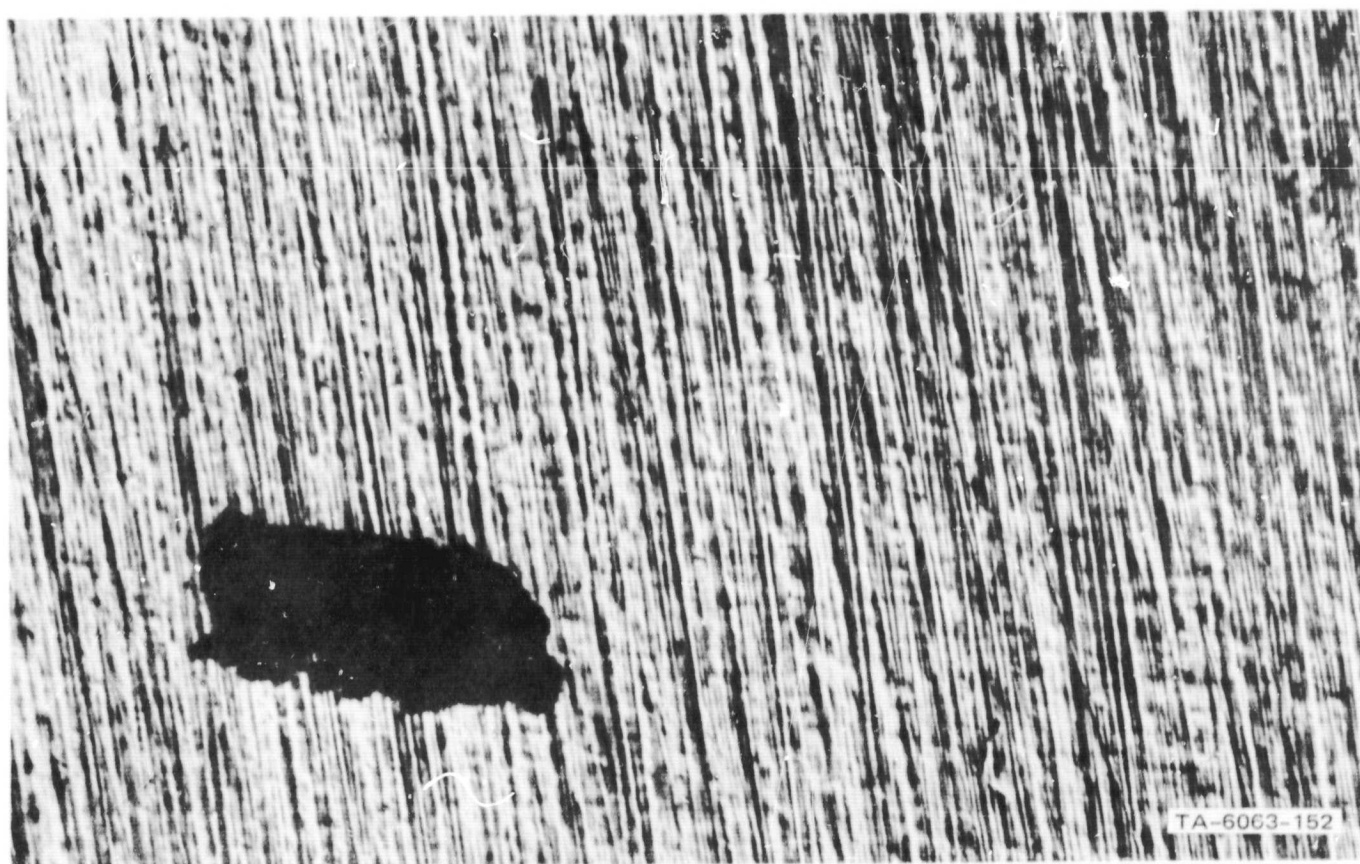
FIGURE 6 TYPICAL SURFACES OF GROUP III SPECIMENS X200

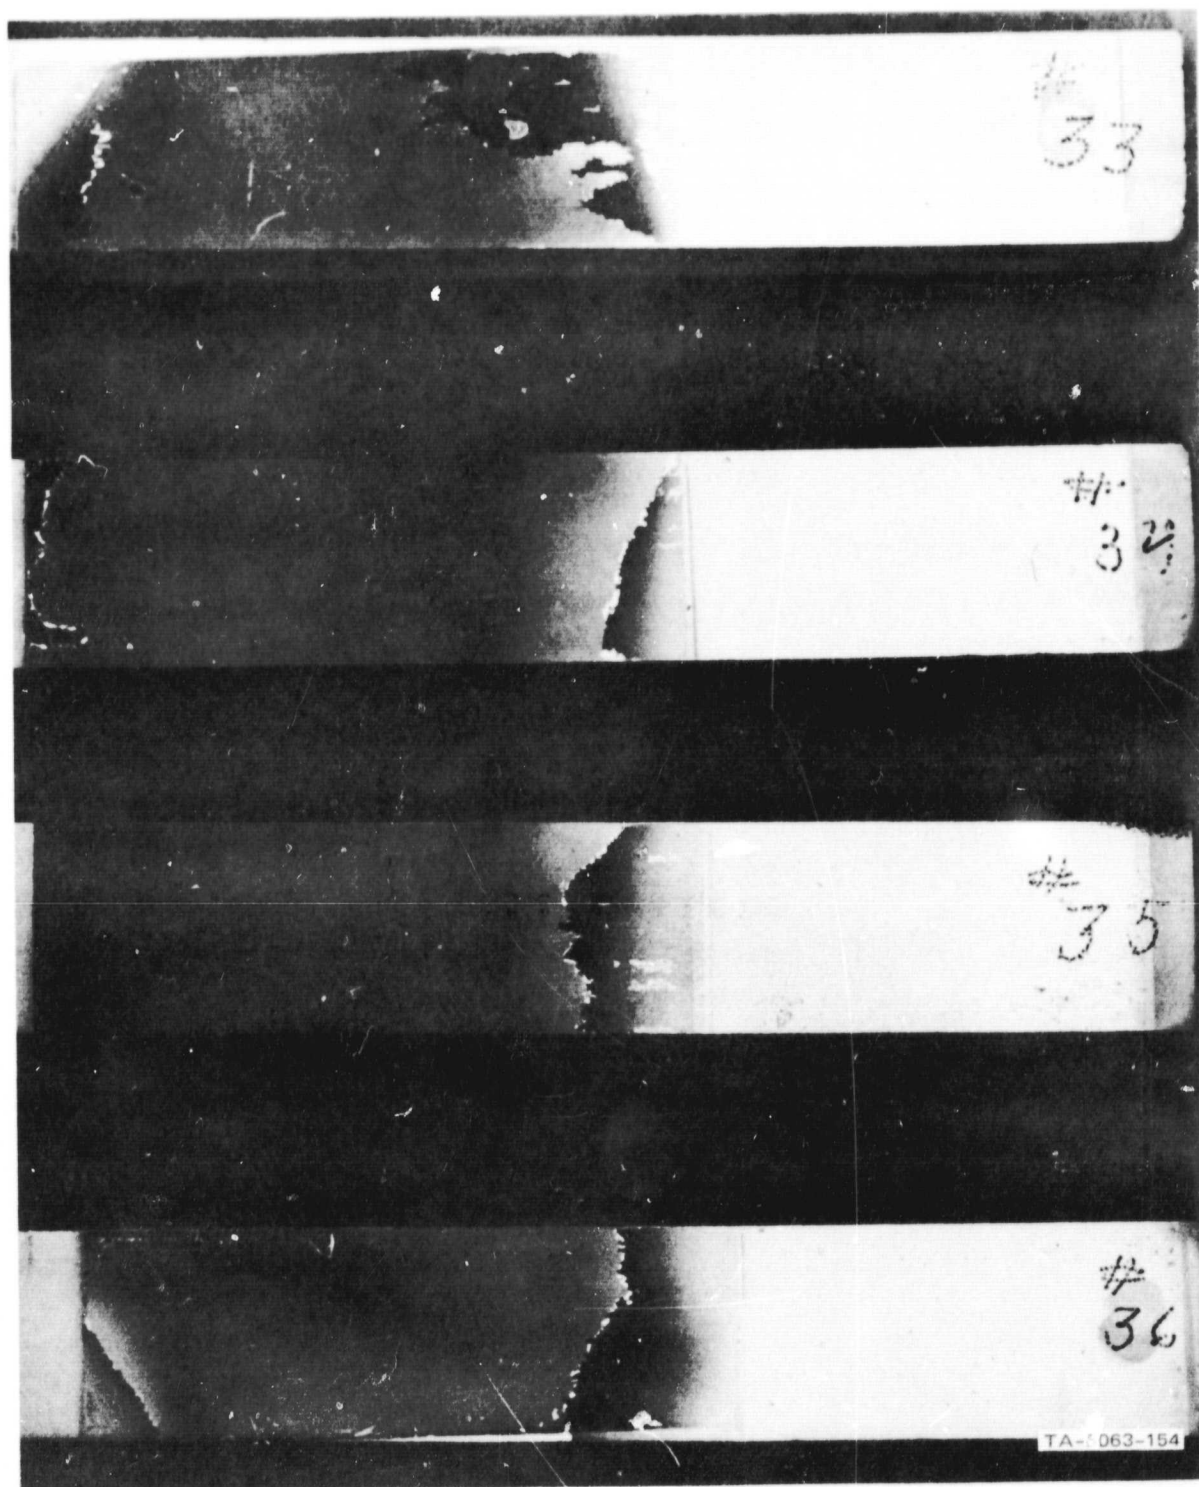
FIGURE 7 GROUP IV SPECIMENS, AS RECEIVED

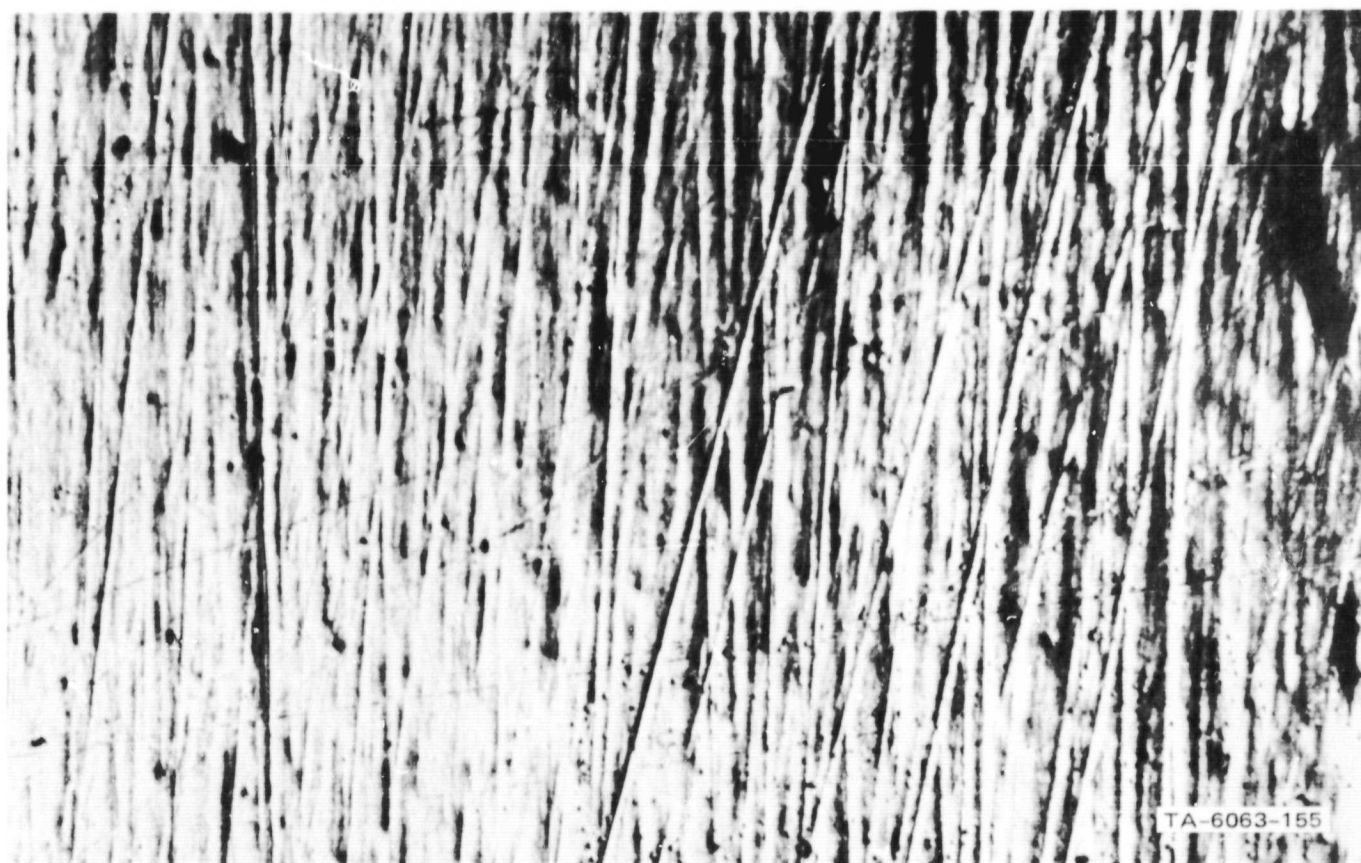
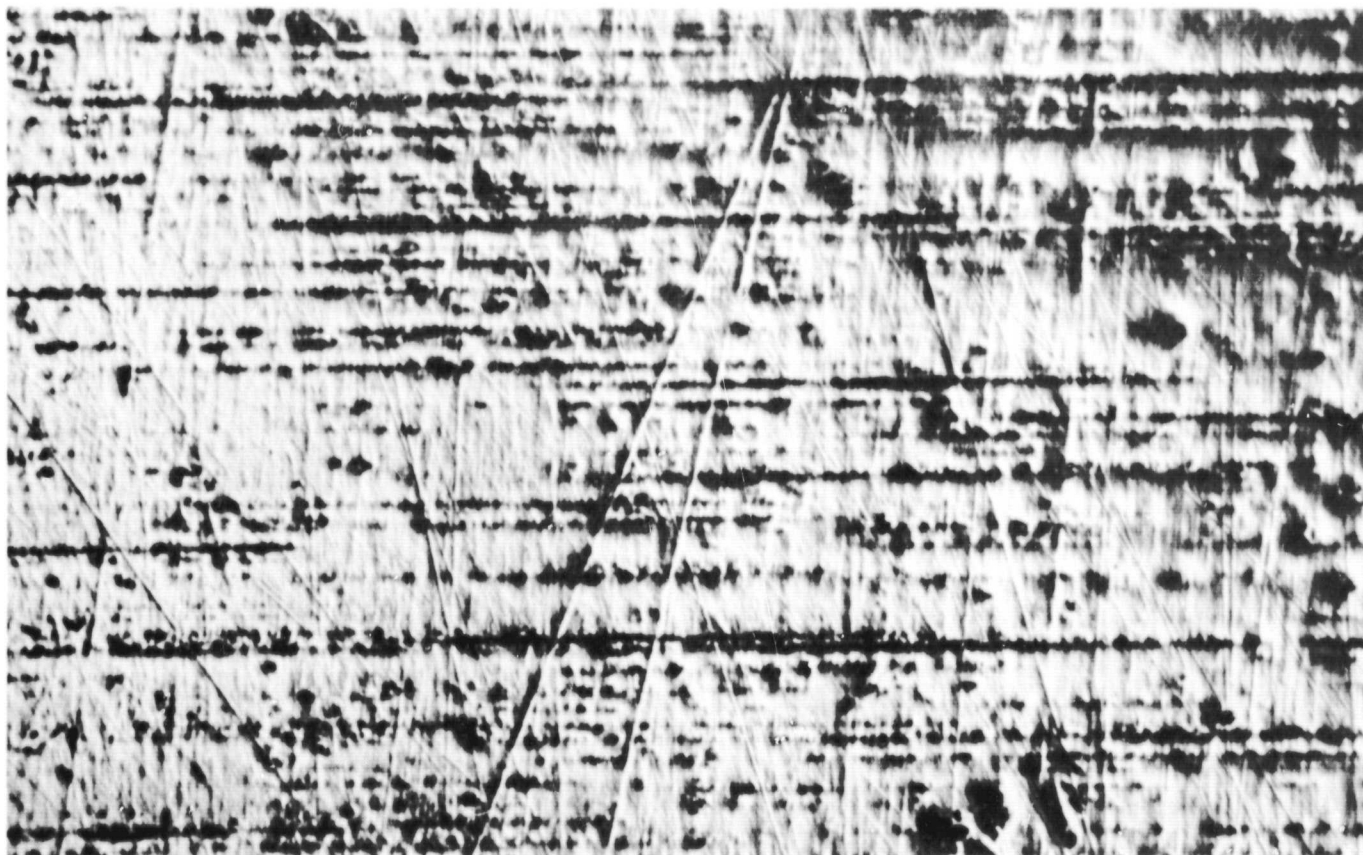
FIGURE 8 TYPICAL SURFACES OF GROUP IV SPECIMENS X200

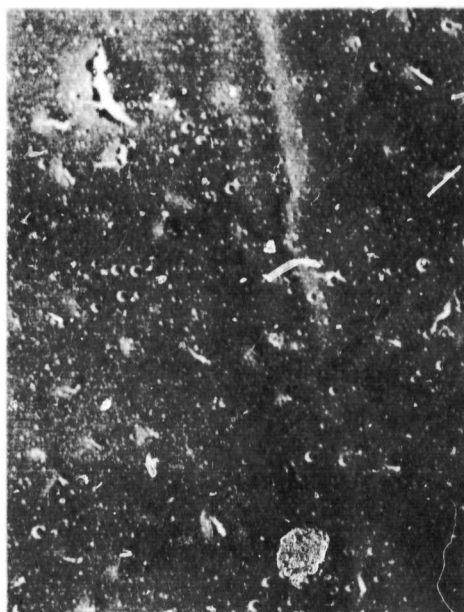
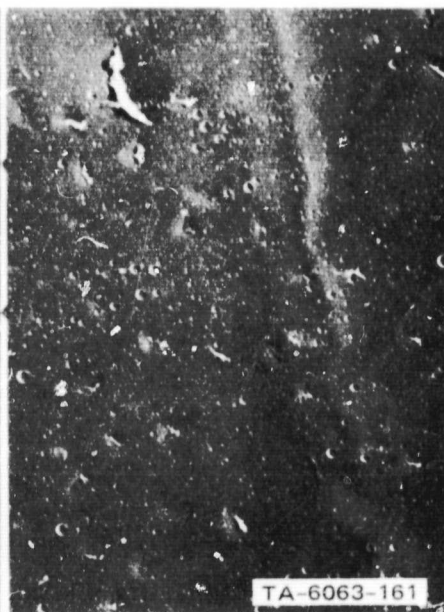
FIGURE 18 STEREO ELECTRON MICROGRAPH OF SPECIMEN 34 (Group IV) AFTER THERMAL CYCLING

Electron microscope replicas showed that a variety of changes in the films had occurred as a result of exposure to the temperature cycling test. Specimen 15 (Fig. 16) showed a wrinkled surface from which discrete areas appeared to have defoliated, exposing a lower layer of coating; it does not appear that the coating has separated from the substrate. This specimen also showed small white particles generally of circular or annular form. The distribution and size of these particles is reminiscent of the pits or bubble-like features of specimen 36 (group IV) in the as-received condition (Fig. 13). Specimen 20 (group II, Fig. 17) showed surface features suggestive of thermal etching. Small checks or fissures were found in the surface of specimen 34, and were associated with small blisters apparently caused by gas entrapped or liberated at the film/metal interface (Fig. 18).
