*Technical Memorandum 33-427*

*Observed Vibration Environment of a Panel Van  
for Representative Urban Road Conditions*

**JET PROPULSION LABORATORY**  
**CALIFORNIA INSTITUTE OF TECHNOLOGY**  
**PASADENA, CALIFORNIA**

October 1, 1969

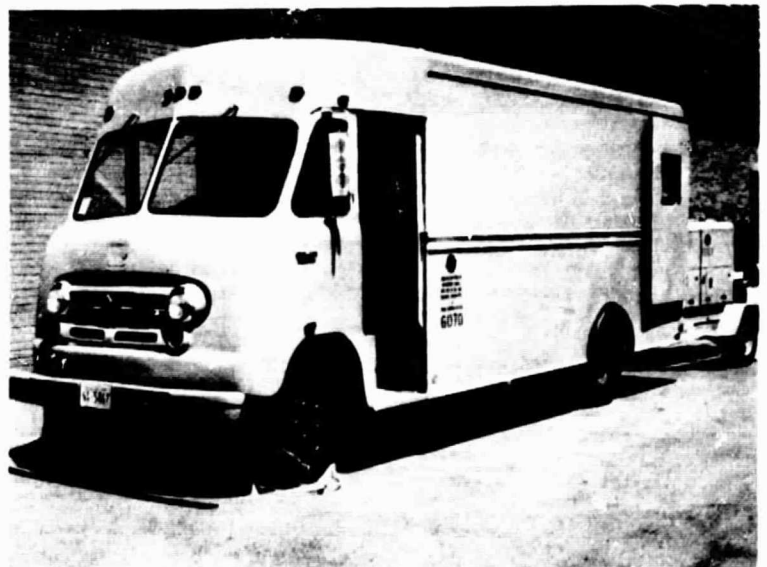
Fig. 1. SEAN System van and trailer

The van or panel truck to be instrumented was a GMC Model P4710P chassis with a fiberglass body built to JPL specifications. It was powered by a 293-in.<sup>3</sup>, 6-cylinder engine developing 170 hp, and had an unladen sprung weight of 6270 lb. The total unladen weight of the van was 8270 lb, and gross vehicle capability was 18,000 lb (See Fig. 1). During the test the van carried simulated weight load of approximately 5000 lb including the weight

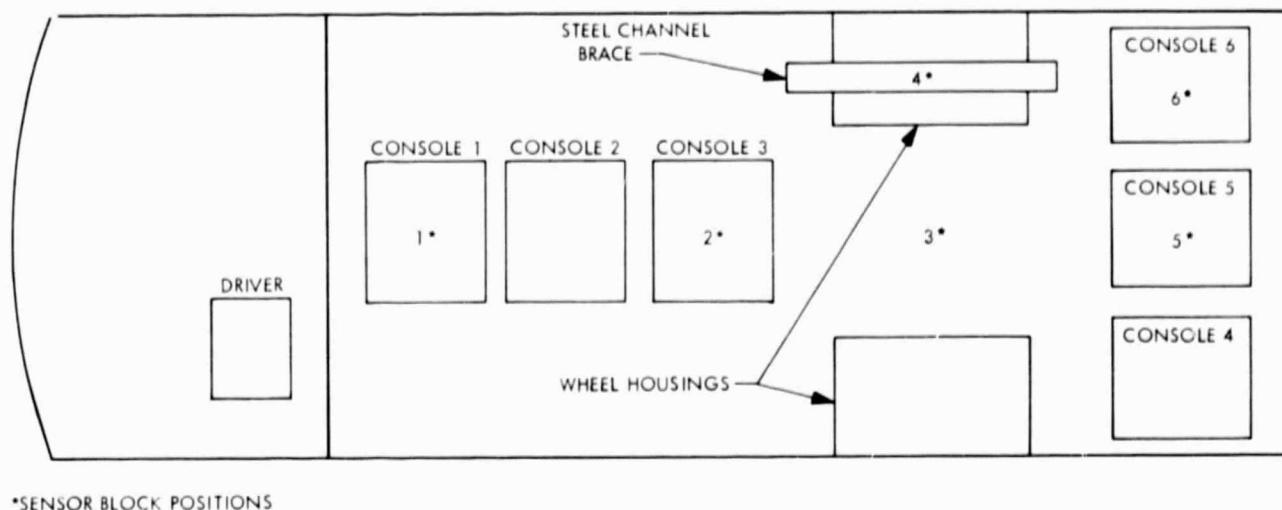
\*SENSOR BLOCK POSITIONS

**Fig. 2. Console and sensor block locations**

components. The consoles were arranged as shown in Fig. 2. One of the consoles was shock-mounted, but the top was constrained only by tying it to the next console with nylon rope. The others were bolted to the floor.

The six positions to be monitored were selected and are shown in Fig. 2. Positions 1, 2, and 5 were located on the bases of simulated consoles that were bolted to the van floor. Position 3 was located on the floor over the rear axle, and position 4 was on a steel channel brace over the wheelwell. Position 6 was on the base of the shock-mounted console. A sensor block was glued at each of these positions when it was to be monitored. In each case the longitudinal, lateral, and vertical axes of the block were oriented to the corresponding axes of the van. Because of the recorder capacity, only three positions could be monitored at one time.

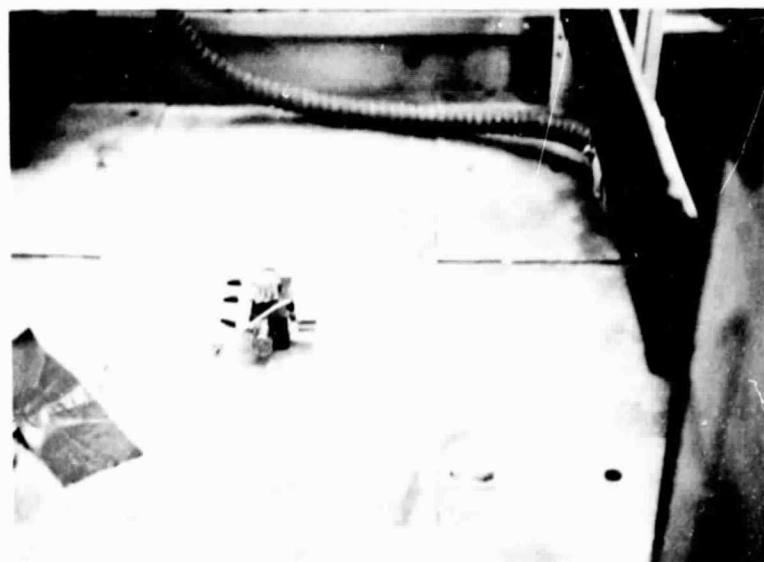
**Fig. 3. Accelerometer orientation**

Four accelerometers of the piezoelectric crystal type were glued to each of three phenolic blocks. As shown in Fig. 3, each sensor block had one accelerometer with its sensitive axis in the longitudinal direction, one with its sensitive axis in the lateral, and two with their sensitive axes in the vertical direction. Only three sensor

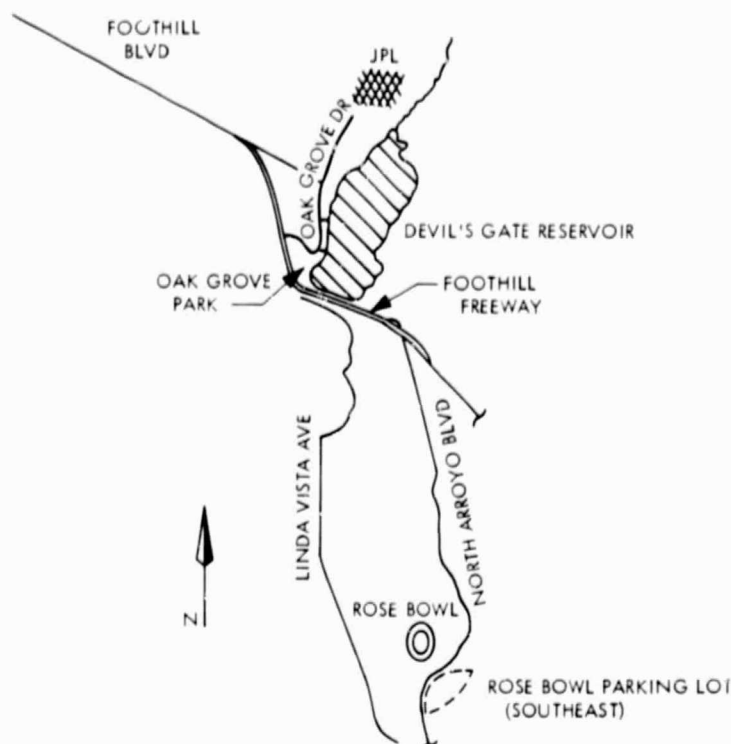
**Fig. 4. Road test locale**

These conditions were available on city streets and off-road locations near JPL. Refer to the map shown in Fig. 4. Foothill Boulevard, the Foothill Freeway, and Oak Grove Drive were selected as smooth roads; North Arroyo Street was taken to be a moderately rough road; the southeast Rose Bowl parking lot was used as a rough surface; and a chuckhole 5 in. deep located in the parking lot at Oak Grove Park was used as the abrupt dropoff. Two runs were made over a course including these locations. For the first run the sensor blocks were placed in positions 1, 2, and 3, and for the second runs they were placed in positions 4, 5, and 6. Smooth roads were traversed at speeds up to 45 mph, moderately rough roads up to 35 mph, and rough roads up to 25 mph; the 5-in. dropoff was taken at approximately 5 mph during each run. Total driving time including both runs represents about 3 h. A voice description of situations encountered was logged on channel 13 of the tape so that the data could be correlated to events at a later time.

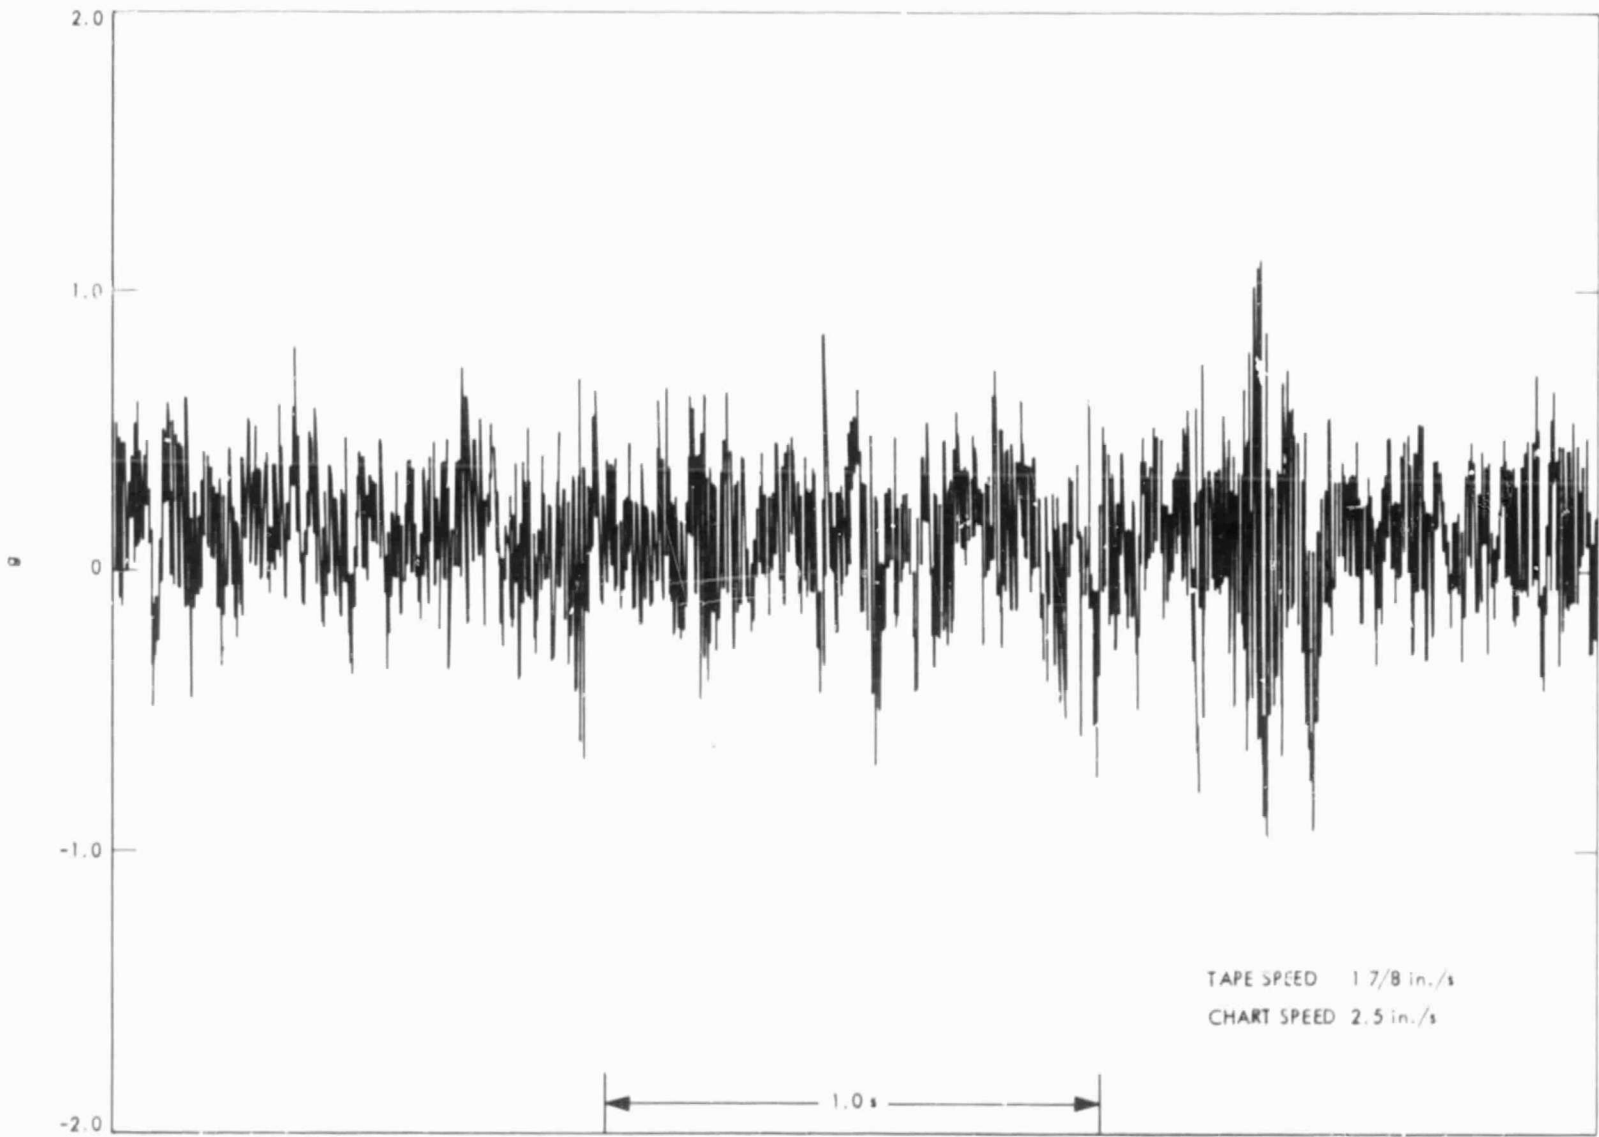
Fig. 5. Sample expanded data for position 1, moderately rough road, 30 mph

Maximum *g* levels observed at various speeds and road conditions were scaled from expanded oscillographic data samples. Examples are shown in Figs. 5 and 6. The results are shown in Table 1.

moderately rough road conditions. Samples of data expanded for time scaling that correspond to Figs. 5 and 6 are shown in Figs. 9 and 10.

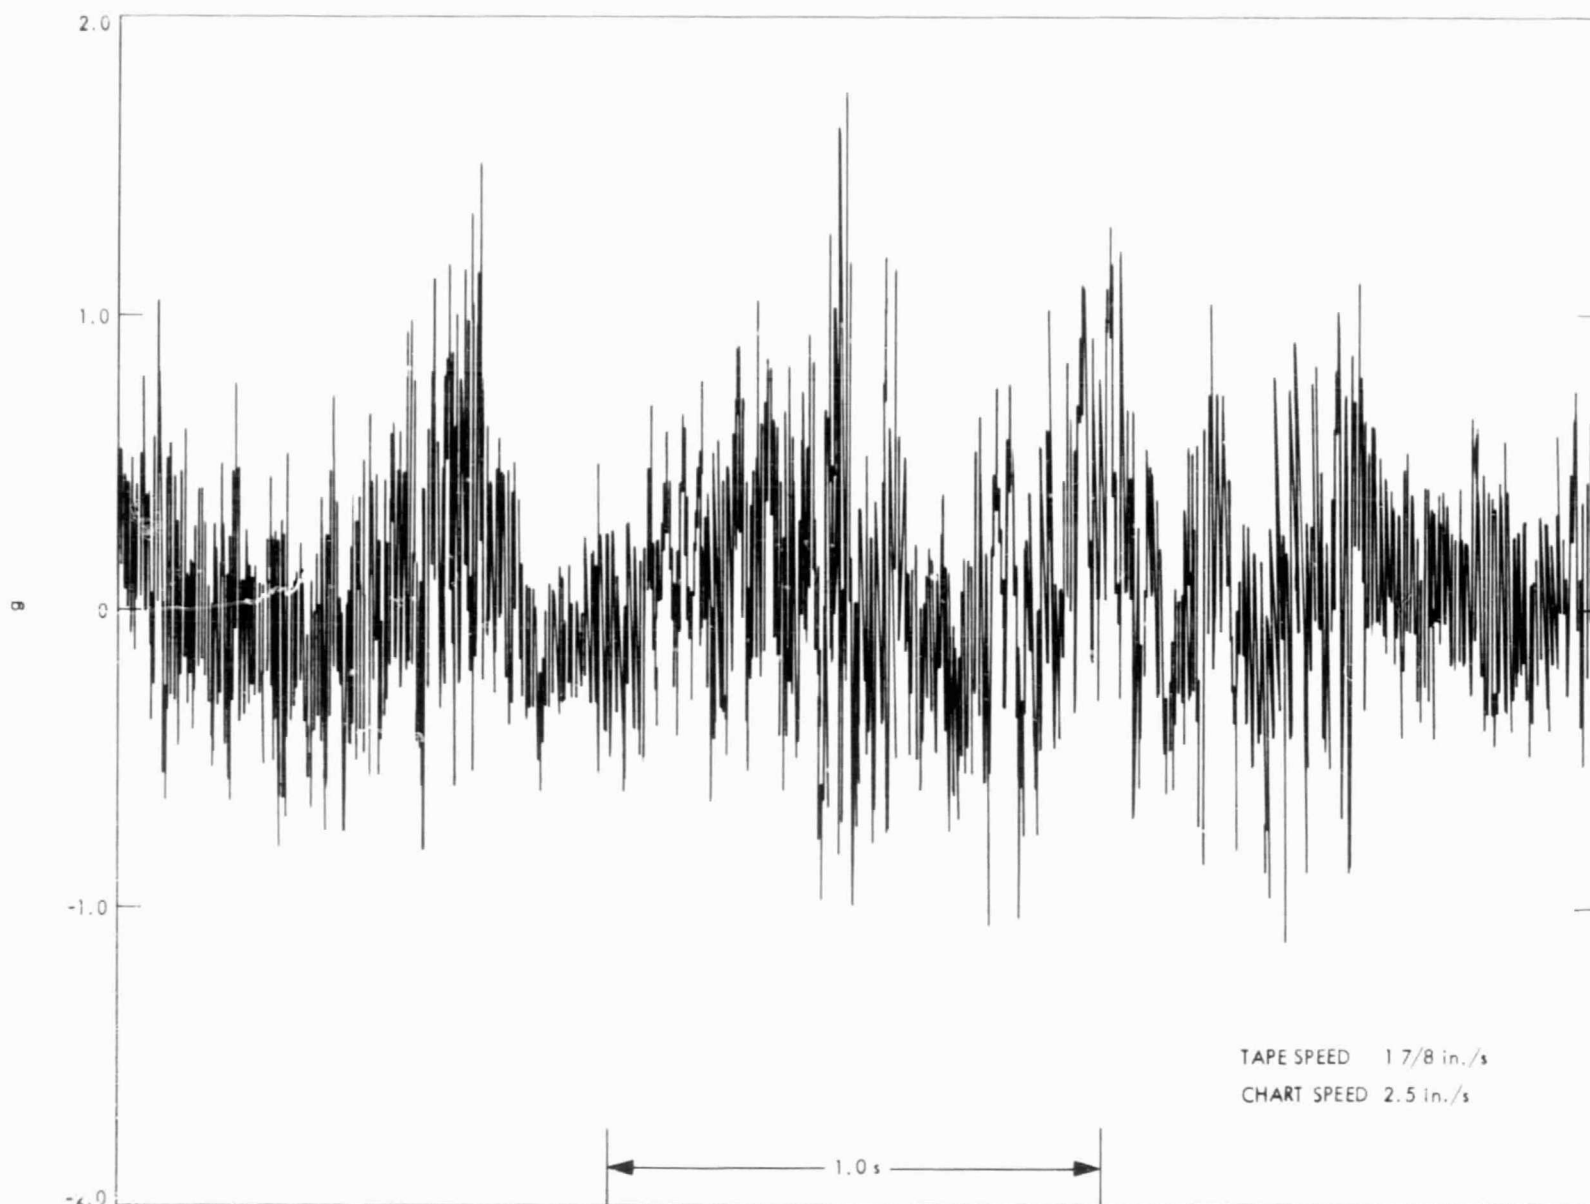
Fig. 6. Sample expanded data for position 5, moderately rough road, 30 mph

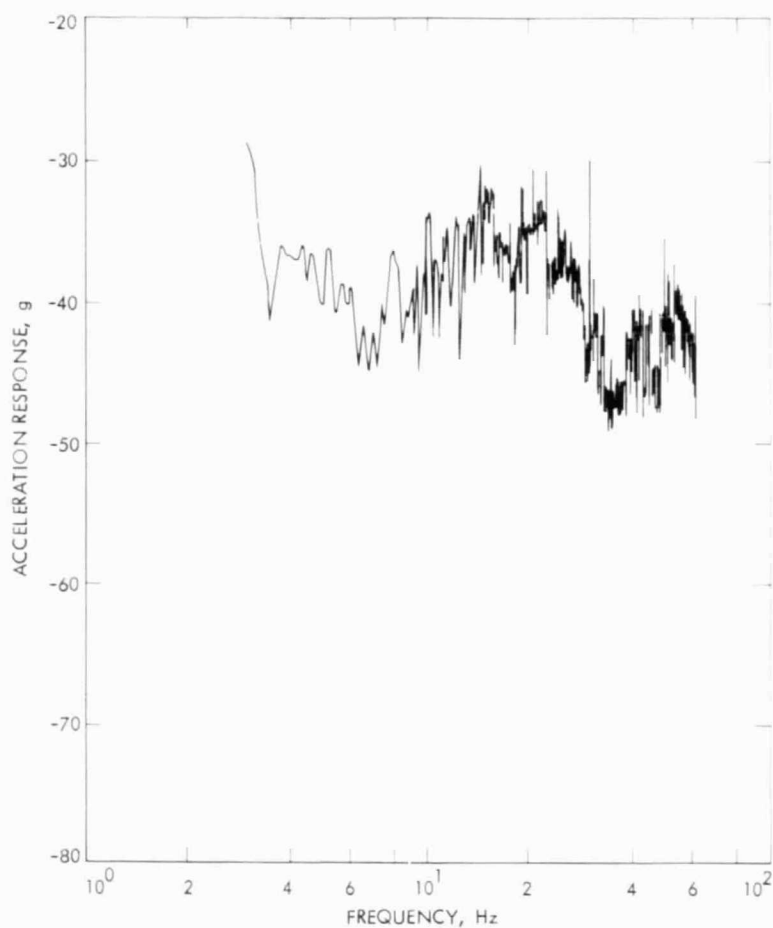
**Fig. 7. Sample PSD plot for position 1,  
moderately rough road, 30 mph**

To this point the expanded raw data samples had only been observed for peak effects without regard to frequency. The next step was to produce power spectral density plots for selected data. The portions of data reduced to PSD plots were partial segments of the expanded samples mentioned above for positions 1 and 5. Since it was felt that smooth and moderately rough road surfaces were the most representative for test purposes, PSD plots were made for these conditions only. This refinement of the data was concentrated in the low-frequency range, and a 0.244-cycle resolution was employed. The resulting plots showed the rms contributions of frequencies between 2 Hz and approximately 60 Hz. A digital computer program available at JPL was used to produce the PSD plots, and further details can be obtained from Ref. 2. The reference for the plots is 0 dB = 1g<sup>2</sup>/Hz.

The maximum observed rms *g* levels for the frequency range of 2 to 60 Hz over moderately rough roads were 0.1 *g* at position 1 and 0.2 *g* at position 5. Sample PSD plots showing these conditions are shown in Figs. 7 and 8.

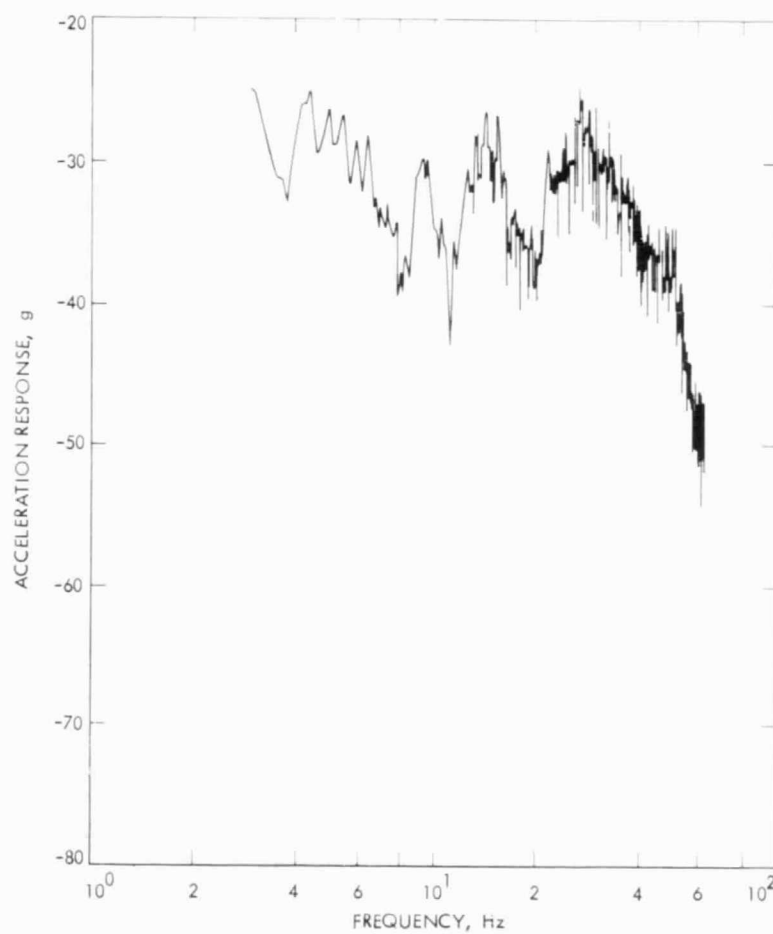
**Fig. 8. Sample PSD plot for position 5,  
moderately rough road, 30 mph**

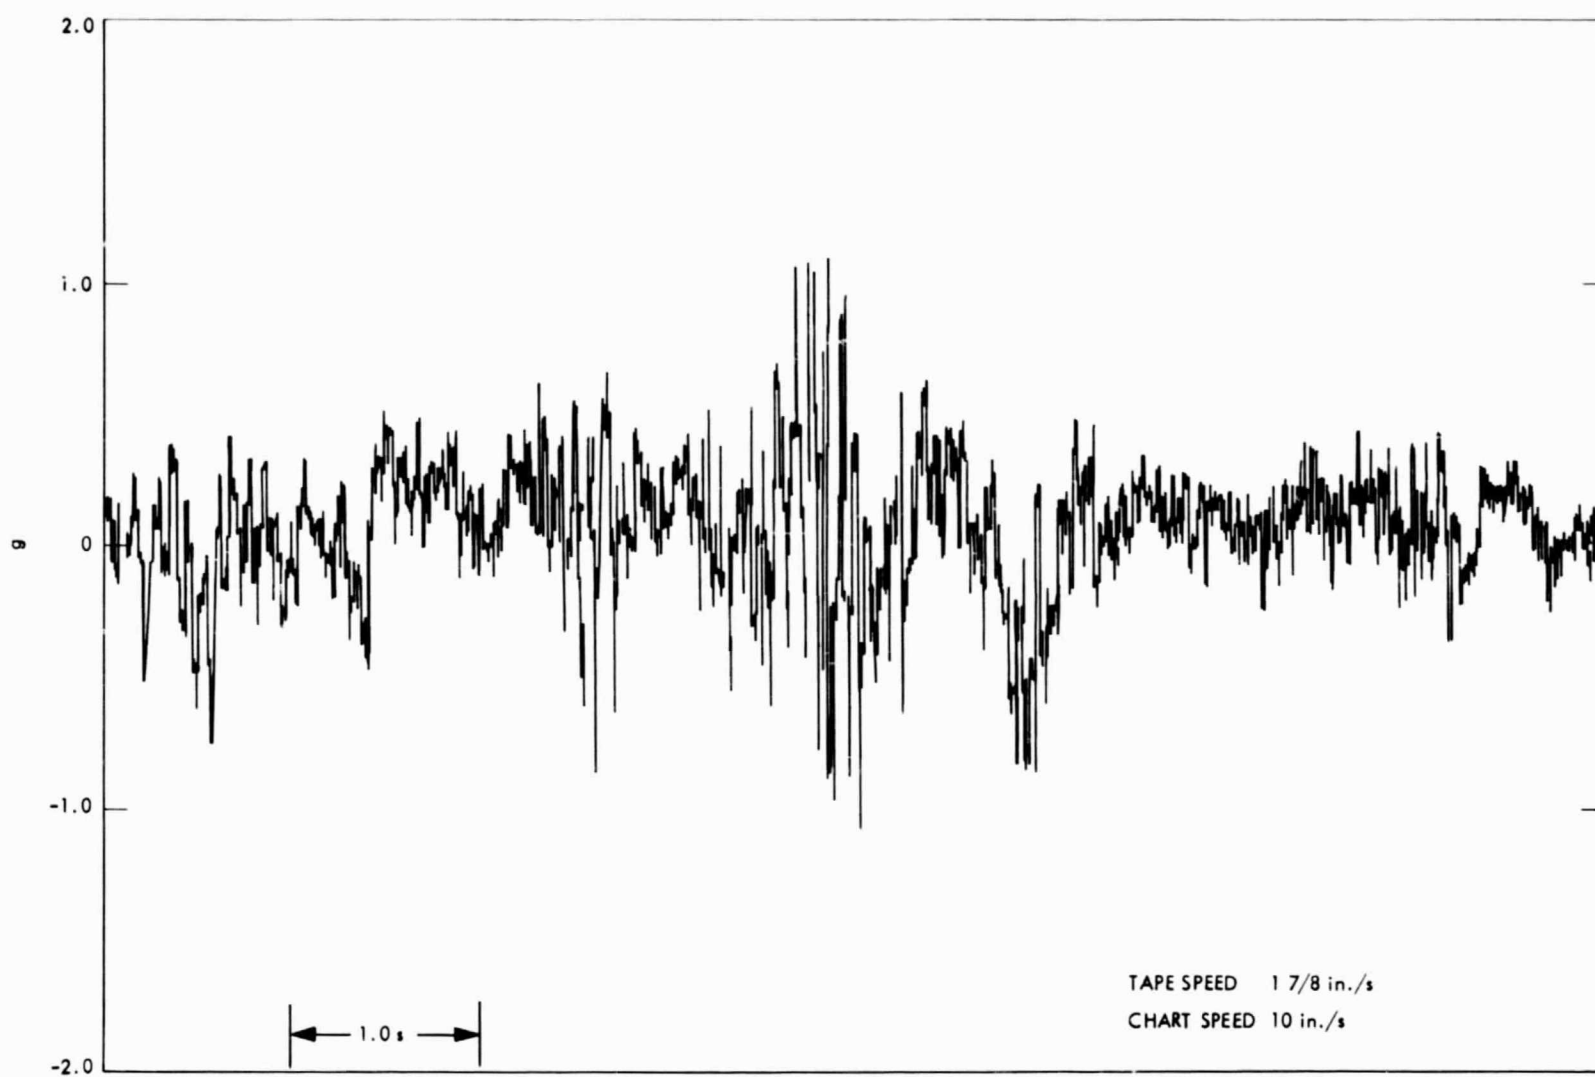
Fig. 9. Sample data for position 1 (vertical), moderately rough road, 30 mph

The minimum duration of acceleration spikes that was markedly higher than ambient vibration was scaled to be approximately 2 millisecc. The range of values for these observed times appeared to be from 2 to 10 millisecc. The above figures were observed for both smooth and

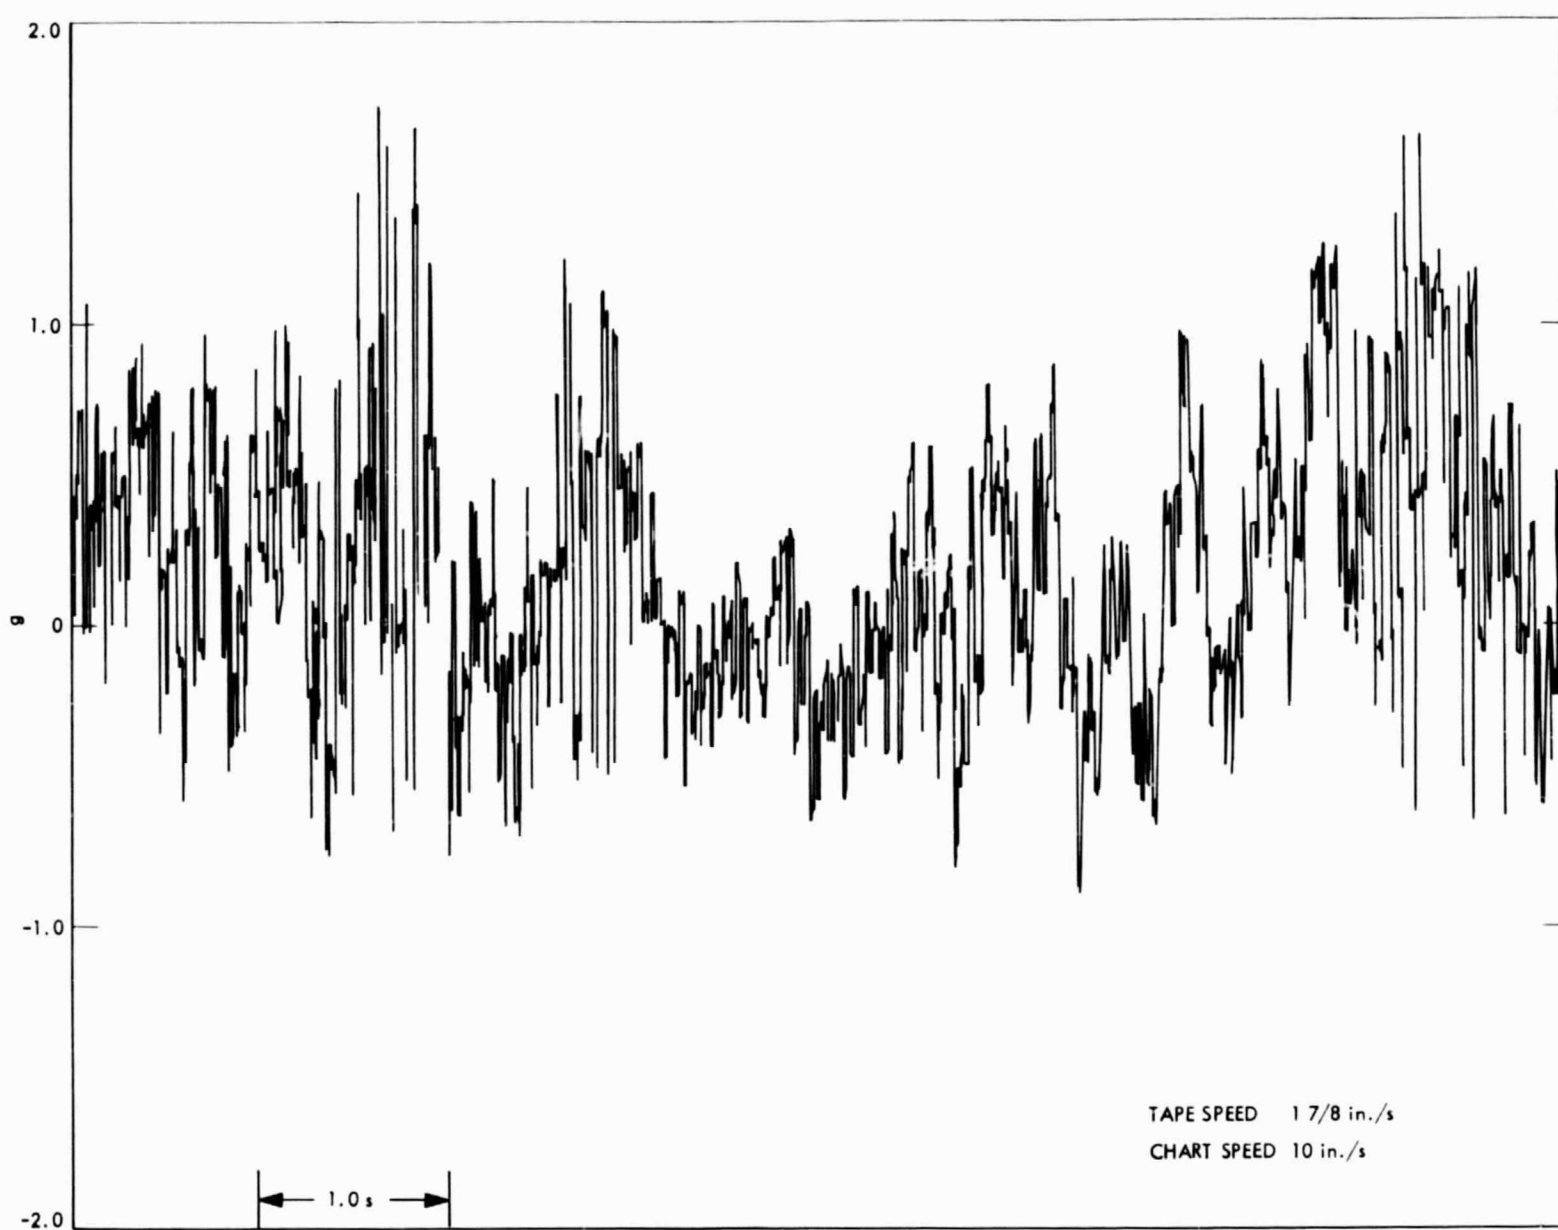
**Fig. 10. Sample data for position 5 (vertical), moderately rough road, 30 mph**
