**RESEARCH AND DEVELOPMENT  
OF HIGH TEMPERATURE GAS BEARINGS**

**II - Selection and Evaluation of Gas Bearing Materials  
in Argon at 900 F and 1400 F**

*by S. F. Murray*

*Prepared by*  
**MECHANICAL TECHNOLOGY INCORPORATED**  
Latham, N. Y.  
*for Lewis Research Center*

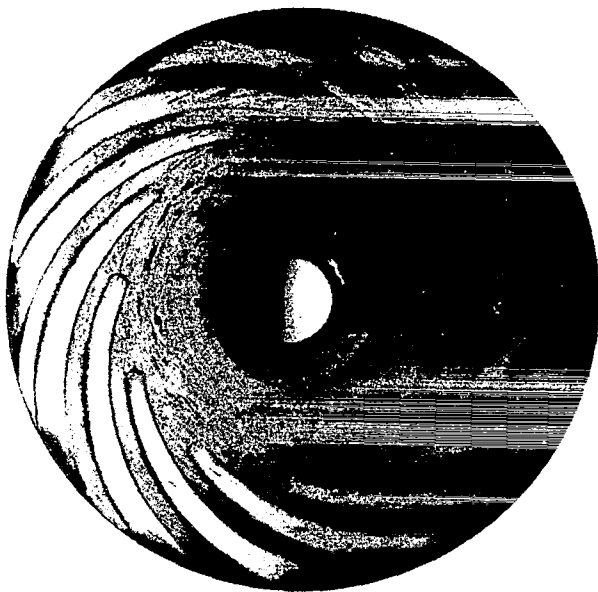
Fig. 19 Chrome Carbide Coated Grooved Thrust Bearing vs.  $\text{Al}_2\text{O}_3$  Coated Thrust Collar. Completed 1000 Starts and Stops at 2.5 psi. Stress and an Additional 270 Starts and Stops at 3.2 psi in Argon at 900 F.

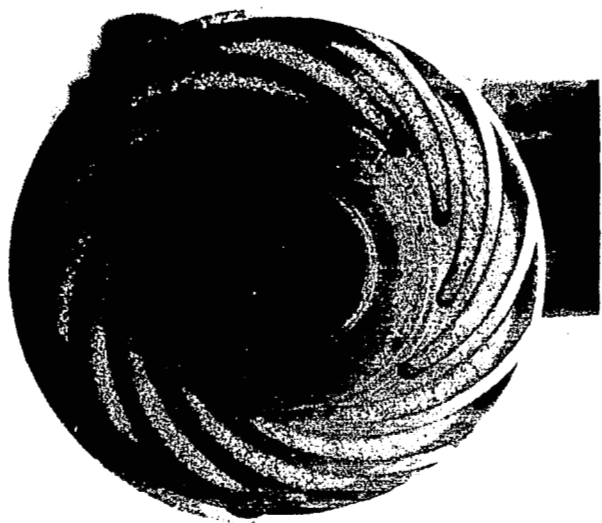
Fig. 31 Chrome Carbide Coated Grooved Thrust Bearing vs.  $Al_2O_3$  Coated Thrust Collar. After High Speed Rubs at 900 F in Argon 38,500 rpm.

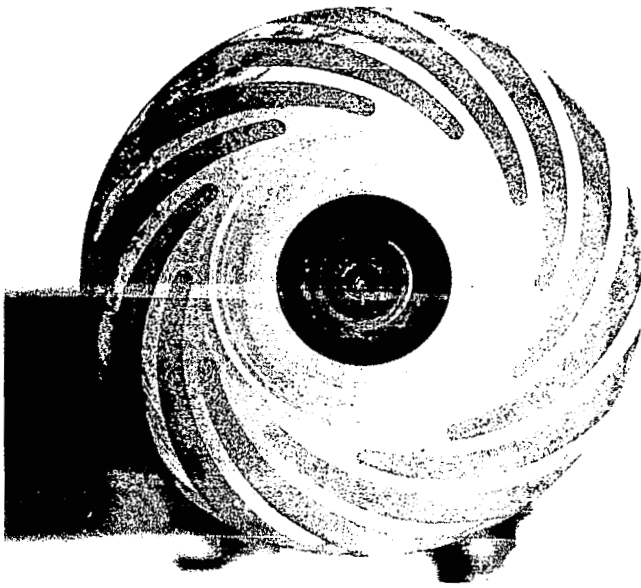
Fig. 33 Nickel-Chrome Groove Pattern on Rene 41 Thrust Bearing vs.  $\text{BaF}_2/\text{CaF}_2$  Eutectic on Rene 41 Thrust Collar. After High Speed Rubs at 1400 F in Argon at 38,500 rpm.

| Material Combination | Before Test | | Appearance | Roughness<br>$\mu$ in. | Crowning Due to<br>Wear of Grooves |
|---|---|---|---|---|---|
| BaF <sub>2</sub> /CaF <sub>2</sub> eutectic<br>film on Rene 41<br>thrust collar | Dull green<br>film | 14 | Film gone<br>off most of<br>bearing<br>except outer<br>edges. | 14<br>(peaks 40 $\mu$ in.<br>valleys 40 $\mu$ in.) | --<br>(See Fig. 33) |

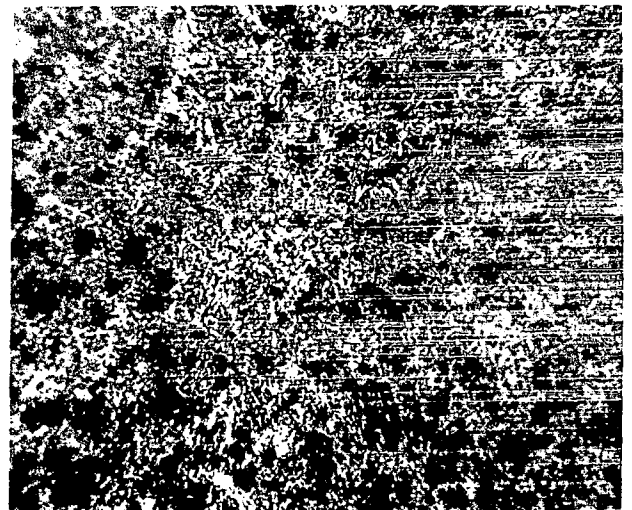
Fig. B-2 Microstructure of AISI 4340 Steel  
Before and After 100 Hours at 900 F.

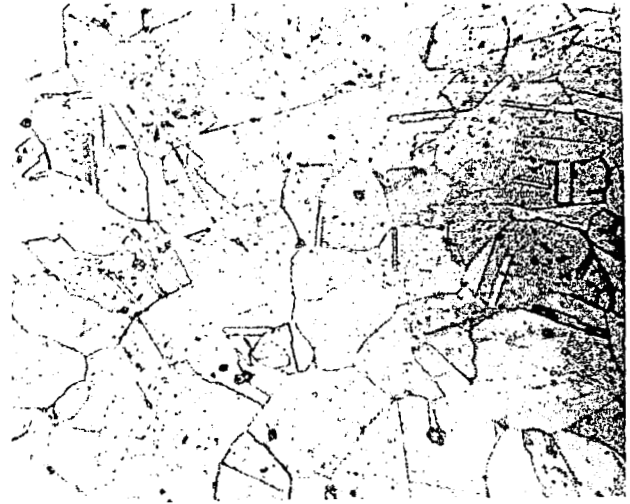
Fig. B-3 Microstructure of A-286 Stainless  
Before and After 100 Hours at 900 F.

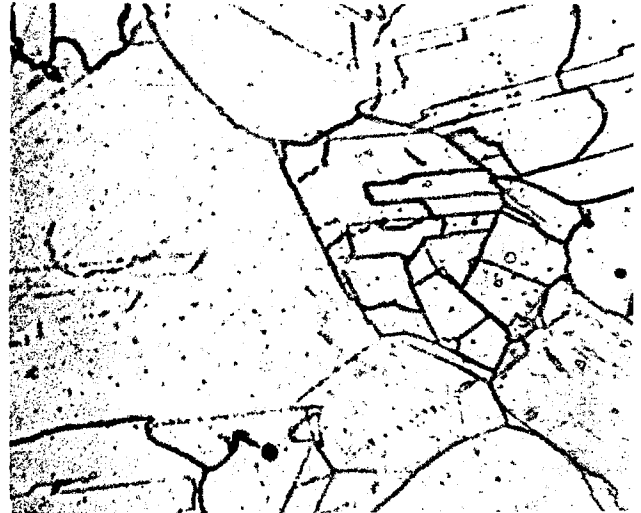
Fig. B-4 Microstructure of Cold-Worked Haynes 25  
Before and After 100 Hours at 900 F.

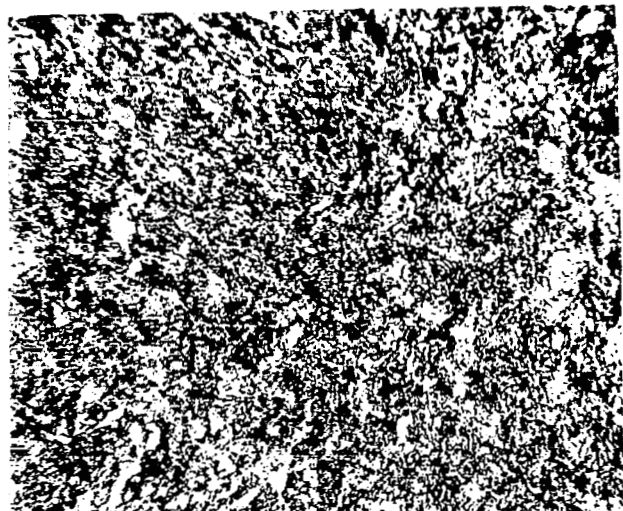
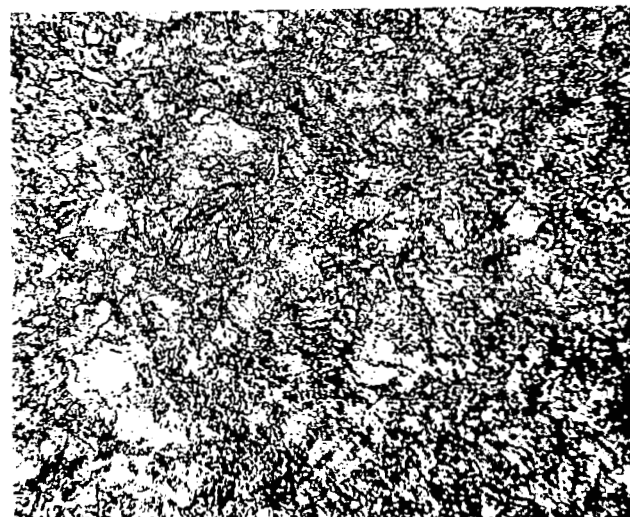
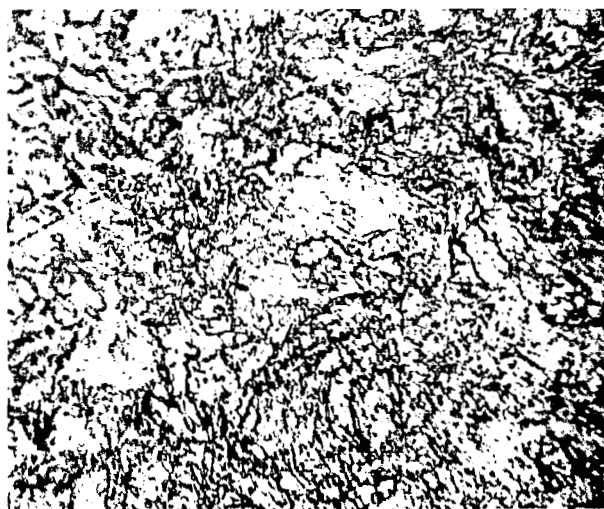
Fig. B-5 Microstructure of TzM Molybdenum  
Before and After 100 Hours at 900 F.

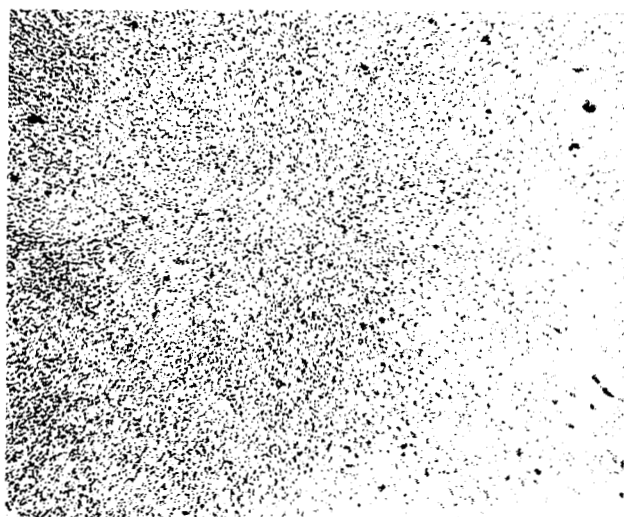
Fig. B-6 Microstructure of TD Nickel  
Before and After 100 Hours at 1400 F.

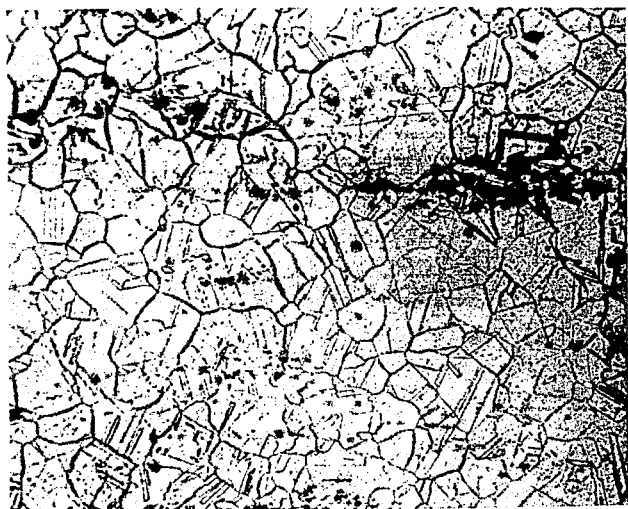
Fig. B-7 Microstructure of Rene 41  
Before and After 100 Hours at 1400 F.
