STUDY OF THE PARAMETERS AFFECTING NASA CR 86321
CONTACT PERFORMANCE OF HIGH RELIABILITY RELAYS

By Charles P. Nunn and S. Bradford McRickard

September, 1969

Prepared Under Contract No. NAS 12-634 by
DEUTSCH RELAY DIVISION
E. Northport, New York

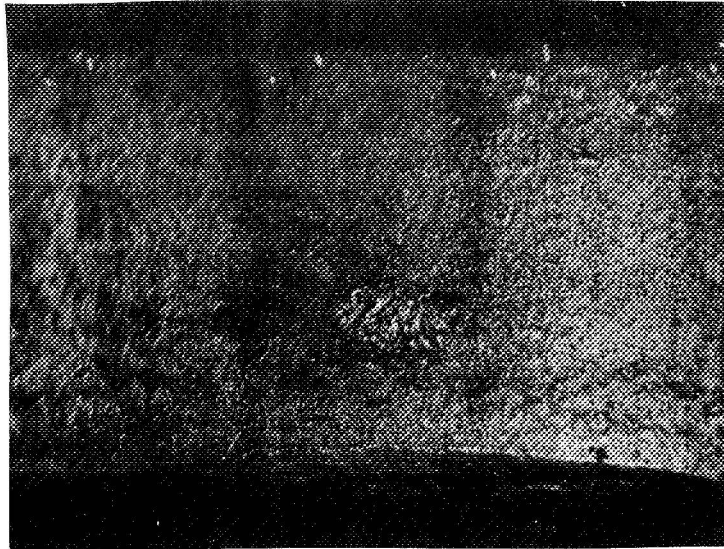
FIGURE 8 150X, Typical Contact Wear Scar On Relay Operated In High Levels Of Water Vapor (Greater Than 1,000 ppm) During Low Level Tests, 100,000 Operations.

Figure 8 is a contact surface that successfully completed the low level life without failure but indicated low temperature contact resistance failures. There is little evidence of contact wear and no exposure of the soft silver alloy substrate material.

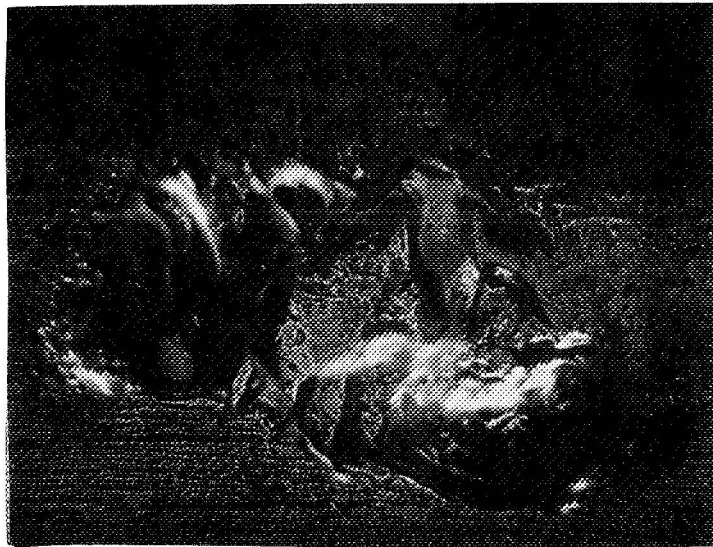
FIGURE 9 150X, Typical Wear Scar On Relay Operated In "Dry" Atmosphere (Less Than 100 ppm). Silver Substrate is Exposed. After Low Level Life Test For 100,000 Operations.

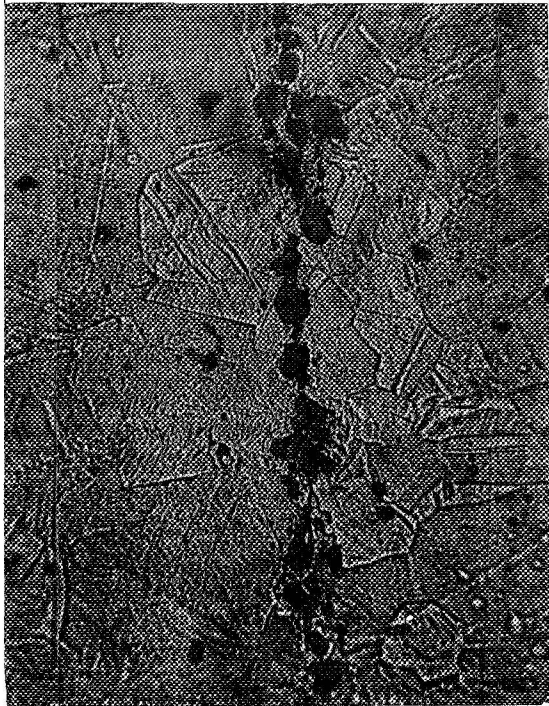
FIGURE 15
300X, Alloy 10A(Ag-Pt-Be),
Example of Impurities or
Macro-Segregation

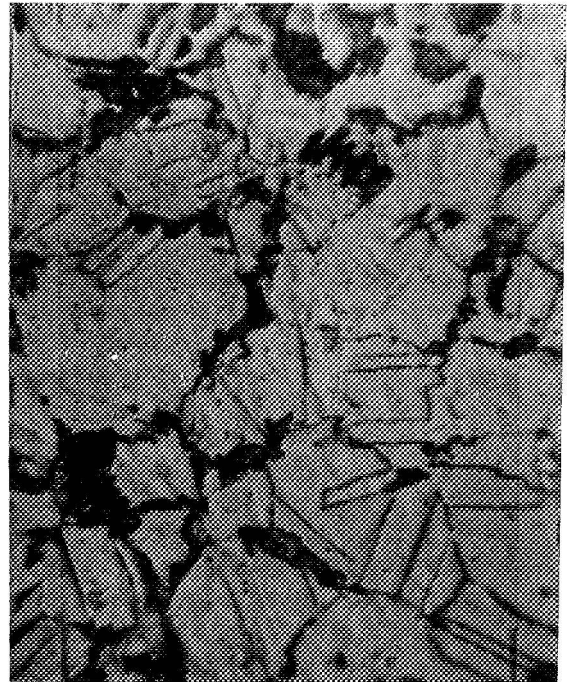
FIGURE 19 1100X
Alloy 1B (Ag-Pd-Cu), Microstructure After Optimum Heat
Treatment (800°C, 2-hours, Quenched Plus 350°C for 1-hour)

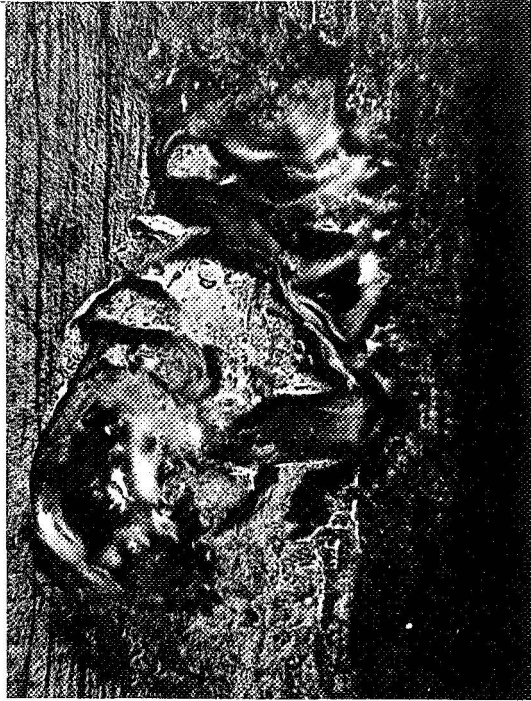
FIGURE 21
150X, Au Plated, Ag Alloy
Movable Contact, "Dry"
Atmosphere, After 10,000
Cycles Low Level Life Test
(Lot 16)

The most significant findings were found on the relays that had successfully completed the low level life test, did not show any indication of atmosphere discrepancies as evidenced by the low temperature tests, and had leak rates of less than $5(10^{-9})$ atm cc/sec before and after the life tests. The contact surfaces of these relays showed at least an order of magnitude less wear and evidence of adhesion when compared to the gold plated contacts of the standard relays. The wear characteristic was one of material smearing on the surface of the rhodium with some evidence of slight adhesion of the gold plate from the mating contact. Figures 21 and 22 are a comparison of gold plated silver alloy contacts and a typical rhodium plated contact operated under very dry conditions. This damage was strictly due to mechanical effects, since the contacts operated with a low level signal, and minimal cable discharge effects. The silver alloy is clearly exposed on the gold plated contacts which accounts for the cold welding, while the rhodium plated contact surface has not been markedly damaged. In no case was the silver alloy exposed in less than 100,000 operations.
