*Technical Report 32-1419*

*Capsule System Packaging for Mars Rough Lander*

**JET PROPULSION LABORATORY  
CALIFORNIA INSTITUTE OF TECHNOLOGY  
PASADENA, CALIFORNIA**

March 15, 1970

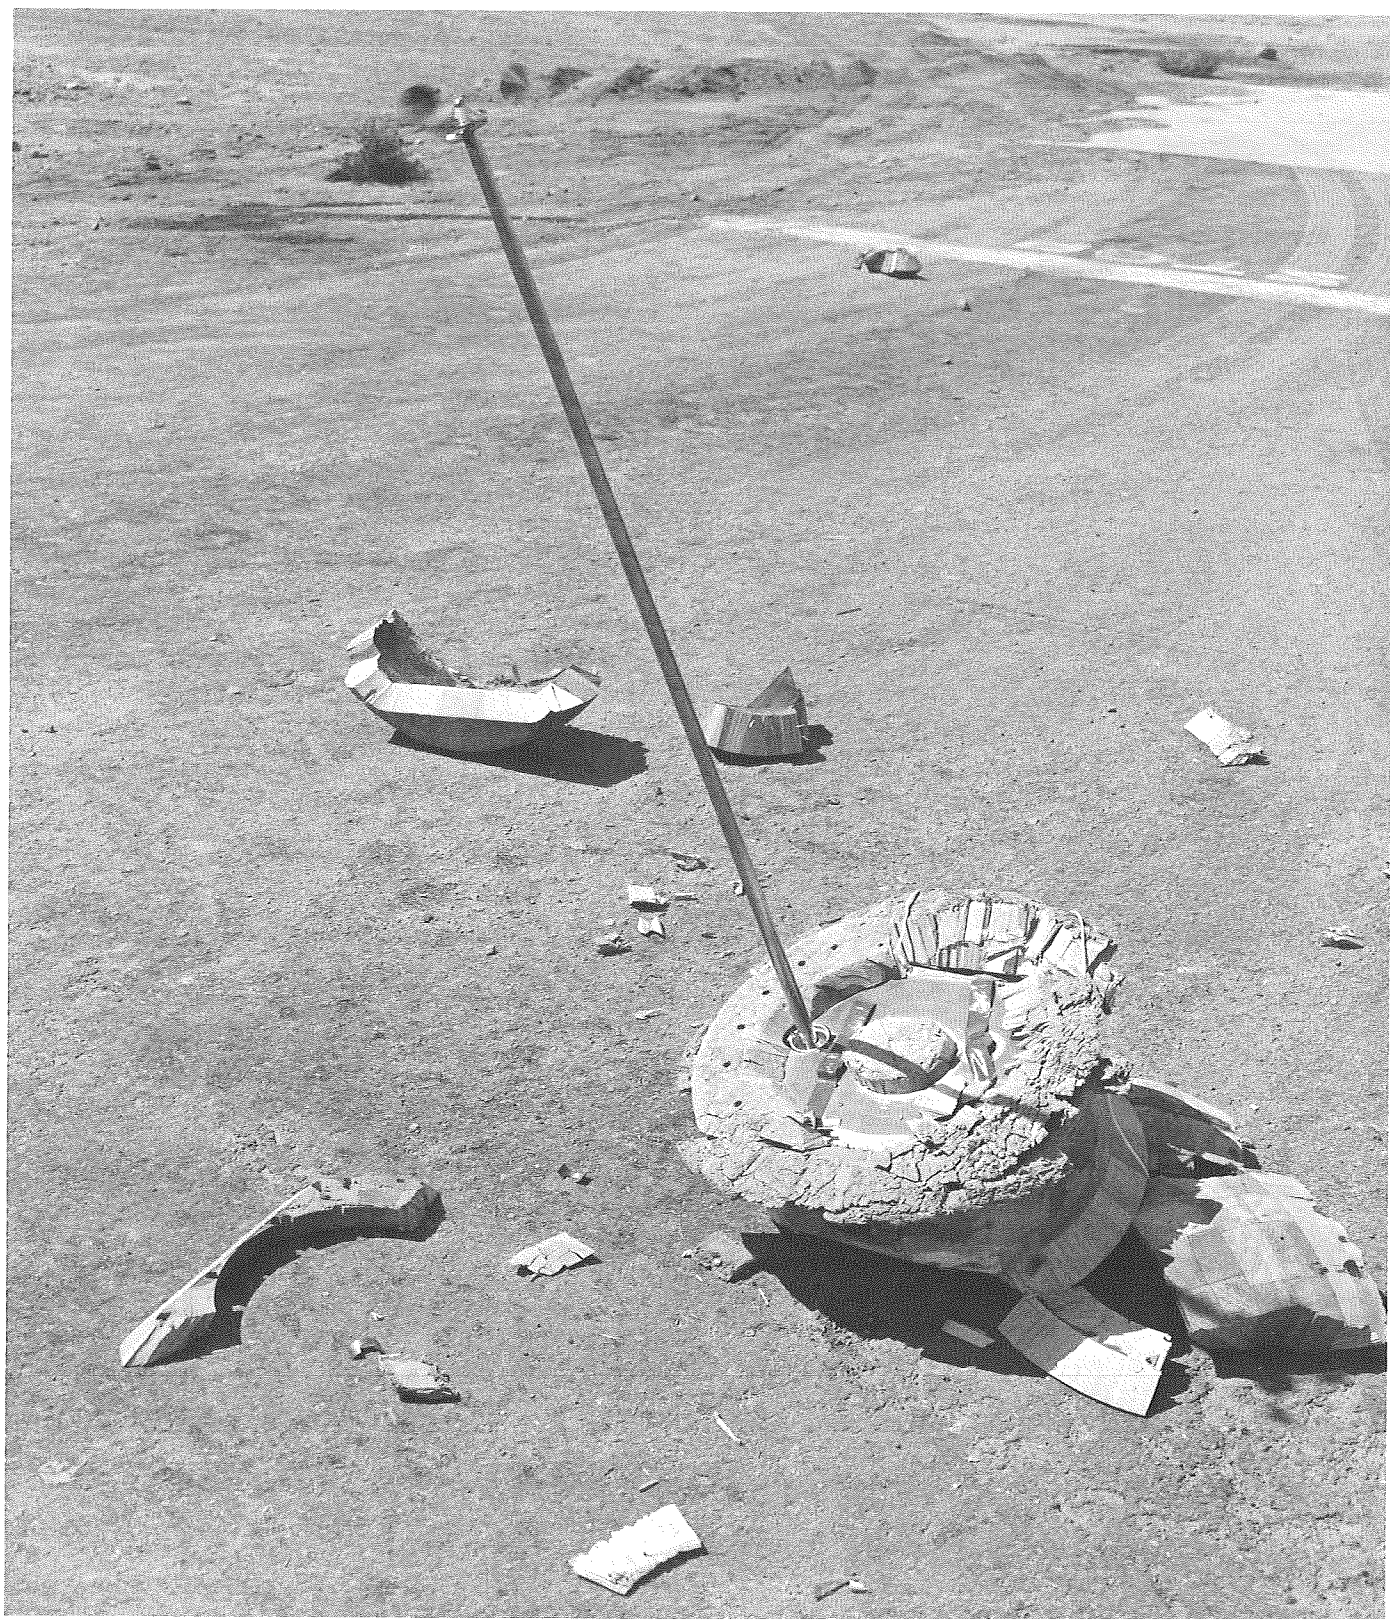
surface) at about 120 ft/s with an impact force of 1500 g. The lander (again with instrument boom extended) is shown in Fig. 5 after impacting an asphalt runway (non-yielding surface) at the same approximate speed and a 2500-g impact force. Figures 4 and 5 show the condition of the lander after drop tests 1 and 2, respectively.

**Fig. 5. Lander after drop on asphalt (nonyielding surface)**
