**LUNAR ORBITER PROGRAM  
GUIDANCE & CONTROL SYSTEM  
DESIGN SURVEY**

**9 May 1969**

**NASA/ERC DESIGN CRITERIA PROGRAM  
GUIDANCE AND CONTROL**

**AEROSPACE SYSTEMS DIVISION  
THE BOEING COMPANY  
Seattle, Washington**

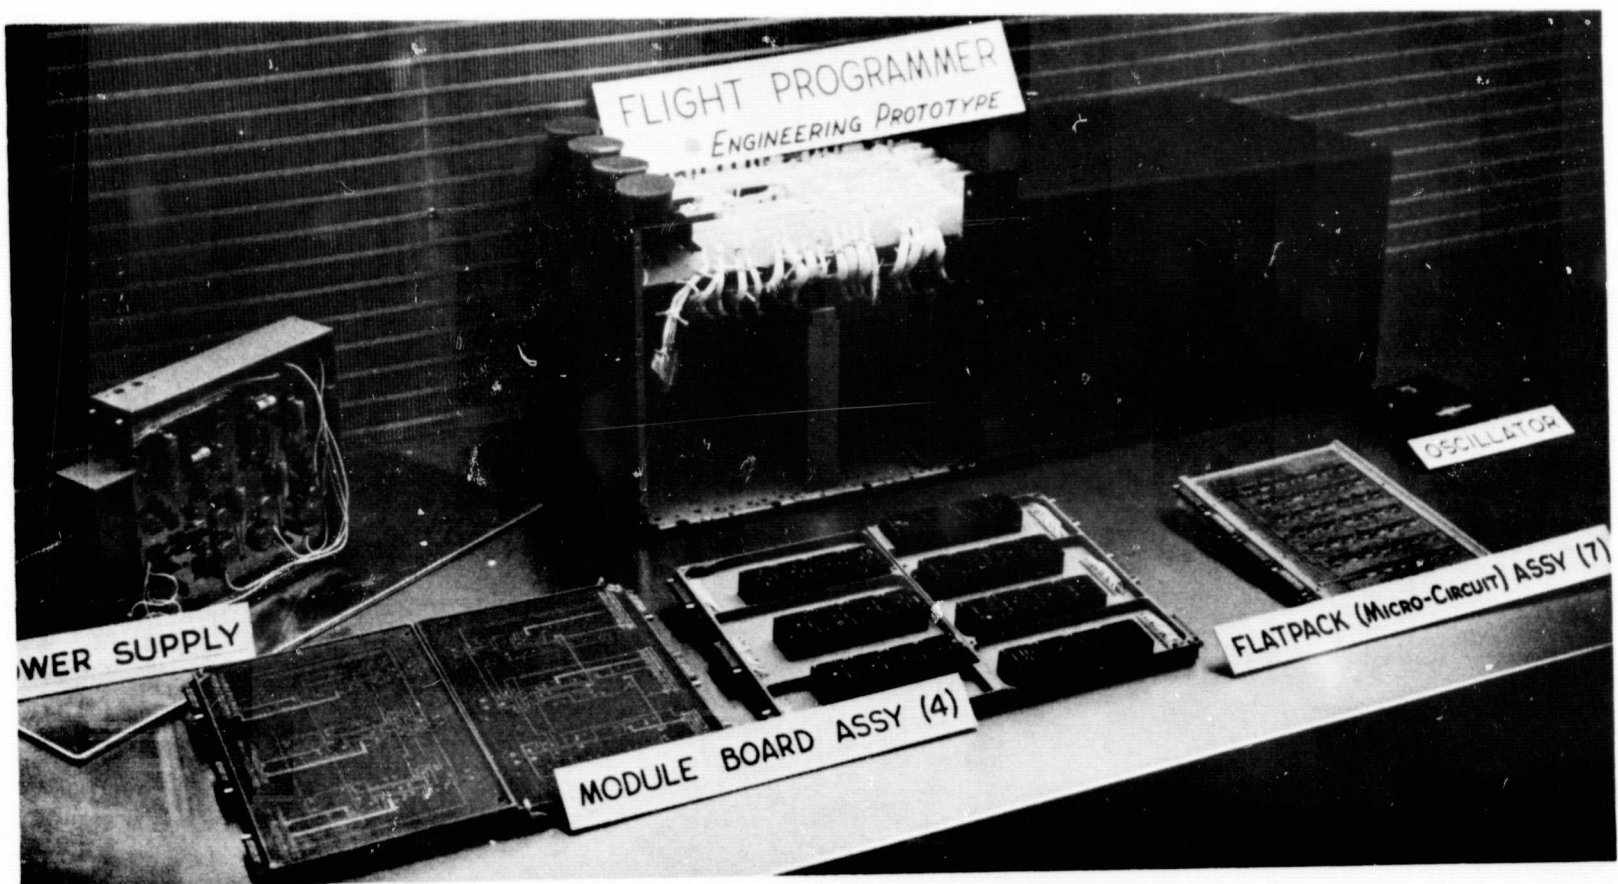
Figure 8-29: FLIGHT ELECTRONICS CONTROL ASSEMBLY
