NASA TN D-5834

FURNACE AND HIGH-VELOCITY OXIDATION OF ALUMINIDE-COATED COBALT SUPERALLOY WI-52

*by Salvatore J. Grisaffe, Daniel L. Deadmore,
and William A. Sanders*

*Lewis Research Center
Cleveland, Ohio 44135*

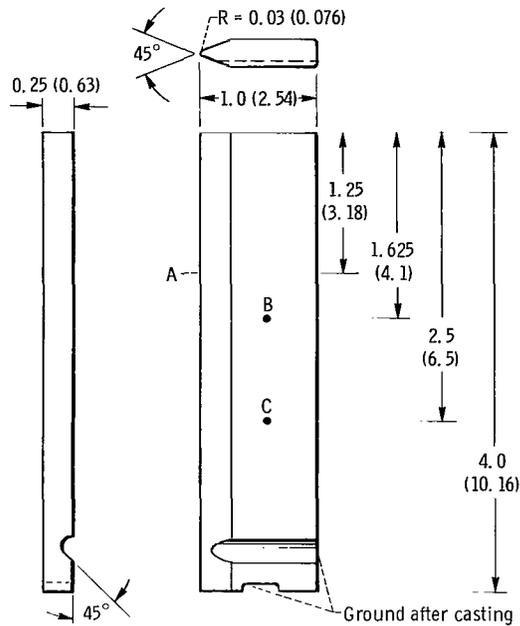
Figure 1. - High-velocity oxidation specimen. Dimensions are in inches (cm); A, B, and C are points for metallographic cross sectioning.

The nominal composition of WI-52 is 21 percent chromium (Cr), 11 percent tungsten, (W), 2 percent columbium (Cb), 2 percent iron (Fe), 0.4 percent carbon (C), 0.25 percent manganese (Mn), 0.25 percent silicon (Si), and the balance cobalt (Co). High-velocity test specimens were cast to shape and ground at the base as shown in figure 1.

After testing, the bars are cross sectioned at points A, B, and C shown in figure 1 to provide metallographic cross sections at various temperature regions.

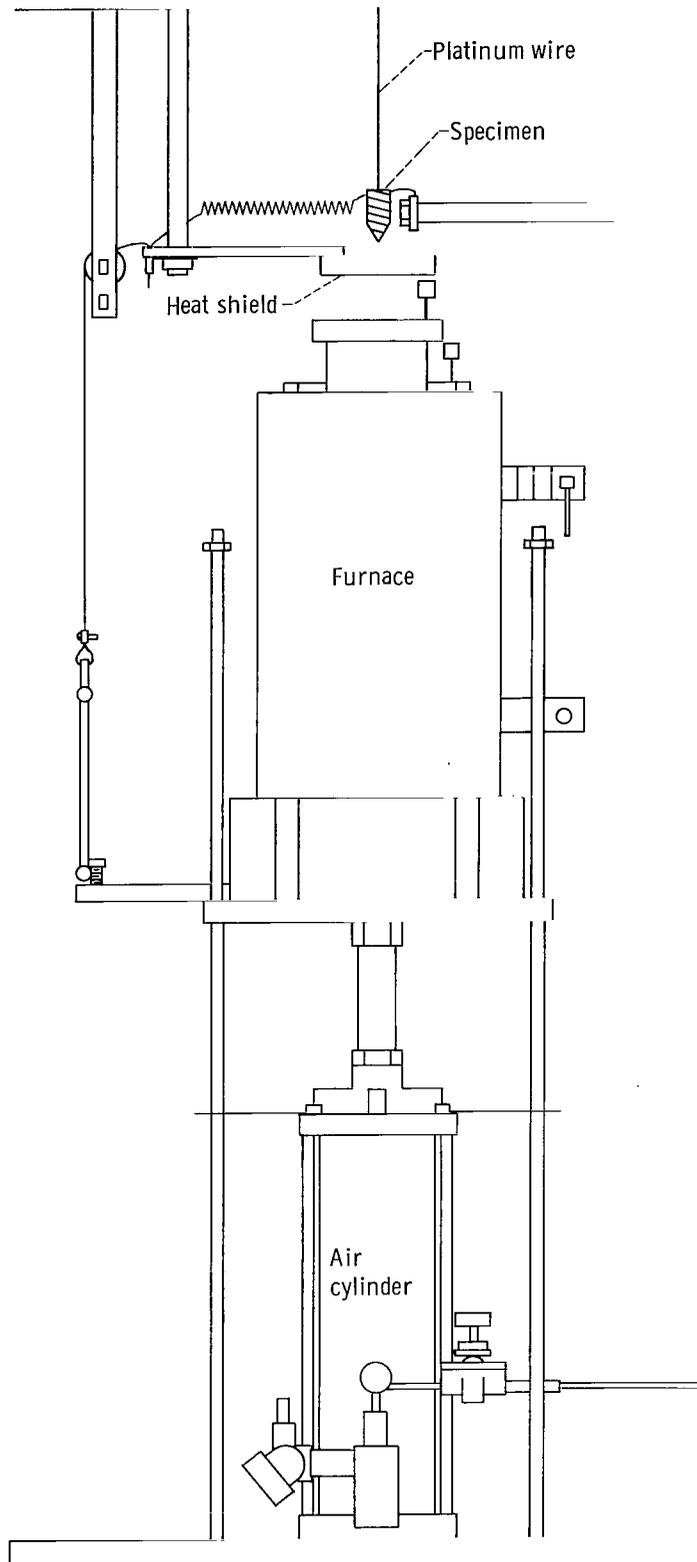
Figure 2. - Automatic cycling furnace.

multitube horizontal furnace. Here individual coupons were rested against one edge of high-purity alumina boats and the specimens were turned after each cycle. On each manual cycle, the boats were slowly inserted and later slowly removed from $1\frac{1}{2}$ -inch- (3.8-cm-) diameter high-purity alumina tubes through which air flowed at 2 standard cubic feet per hour ($\sim\frac{1}{2}$ L/min). The other type of tests was conducted in vertical tube furnaces. Here the specimens were suspended in platinum wire harnesses and the furnace slowly raised or lowered around the specimen on each cycle. Only natural convection was employed to change the air in the tubes. In some cases, such furnaces were automated so that many short time (1 to 5 hr) exposure cycles could be achieved without the necessity of constant attendance by support personnel. A schematic diagram of the automatic cycling furnaces employed is shown in figure 2. The specimen hangs from a platinum wire. A heat shield blocks direct radiation and convection currents from the furnace allowing the specimen to cool to about 200^o F after 10 minutes out of the furnace. Two timers operate the air solenoid valves which raise and lower the furnace. One controls the time in the up position - at temperature; the other the time in the down position - cooling.

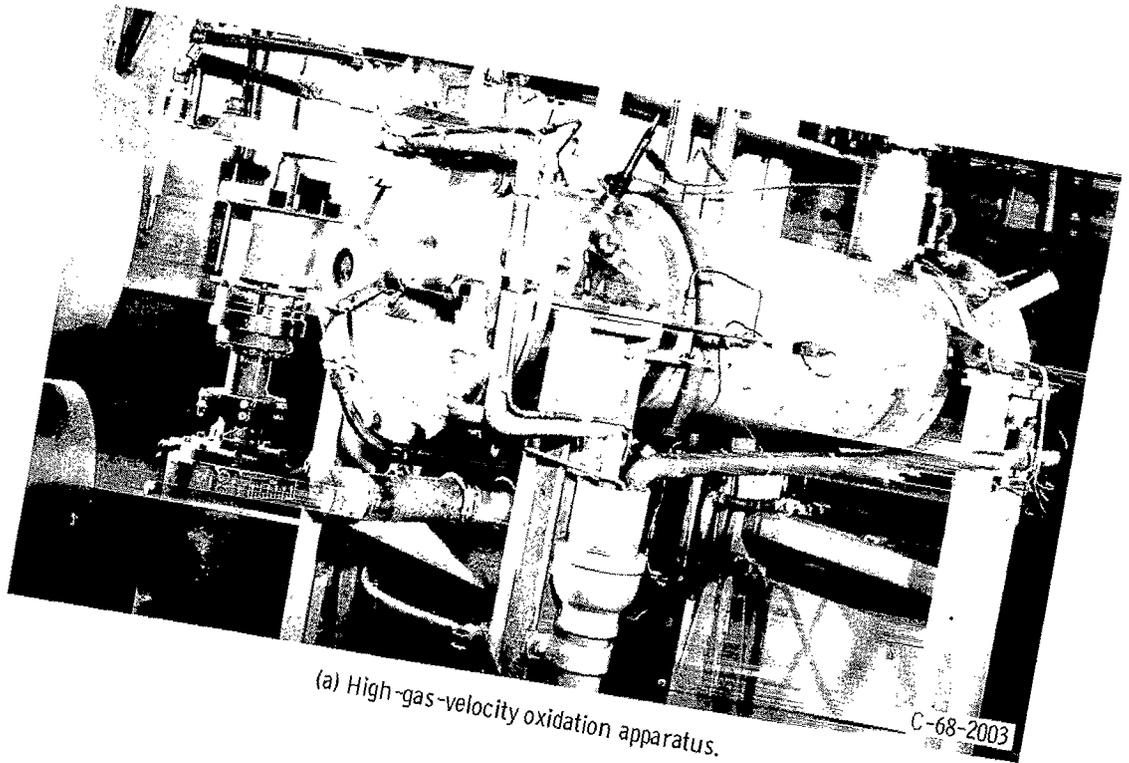
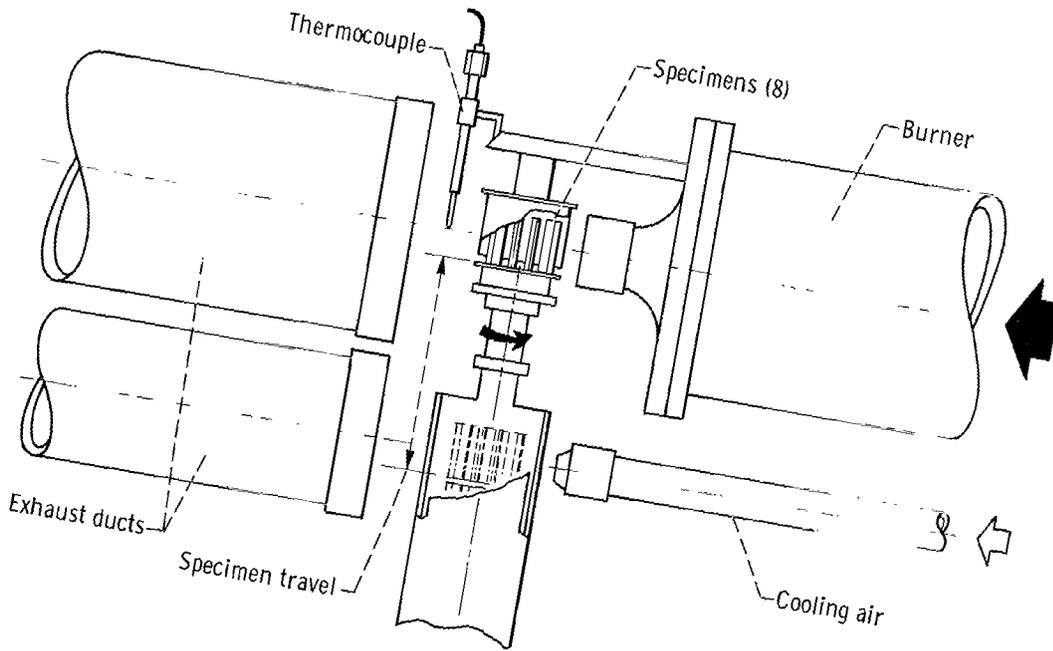
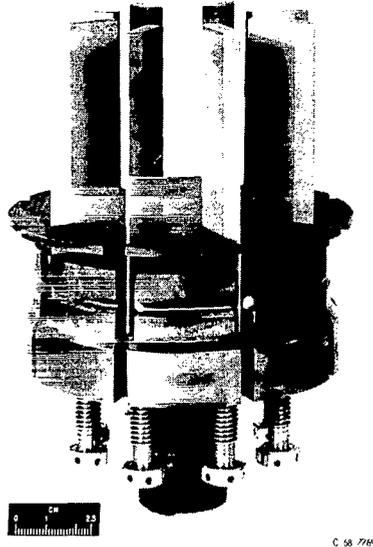
(a) High-gas-velocity oxidation apparatus.

(b) Schematic of apparatus.

Figure 3. - High-gas-velocity oxidation apparatus.

(c) Specimen holder assembly.

Figure 3 shows a picture (a), a schematic diagram (b), and a photograph of the specimen holder assembly (c) of the Mach 1, natural gas fueled test apparatus described in reference 1. The combustion gas from this apparatus is mostly air since the air to fuel ratio is approximately 30 to 1. Eight bar specimens rotate in the hot gas stream with the wedge portions closest to the nozzle. To provide rapid cooling ($\sim 100^{\circ}$ F/sec or 55° C/sec), the rotating fixture is lowered into the path of Mach 1 cooling air. Temperatures are measured using a slip ring thermocouple arrangement connected to a dummy specimen in the rotating fixture and are controlled by a stationary control thermocouple downstream of the test bars. Temperature checks are made by a calibrated optical pyrometer. Specimen temperatures are maintained within $\pm 15^{\circ}$ F (8° C) during test.

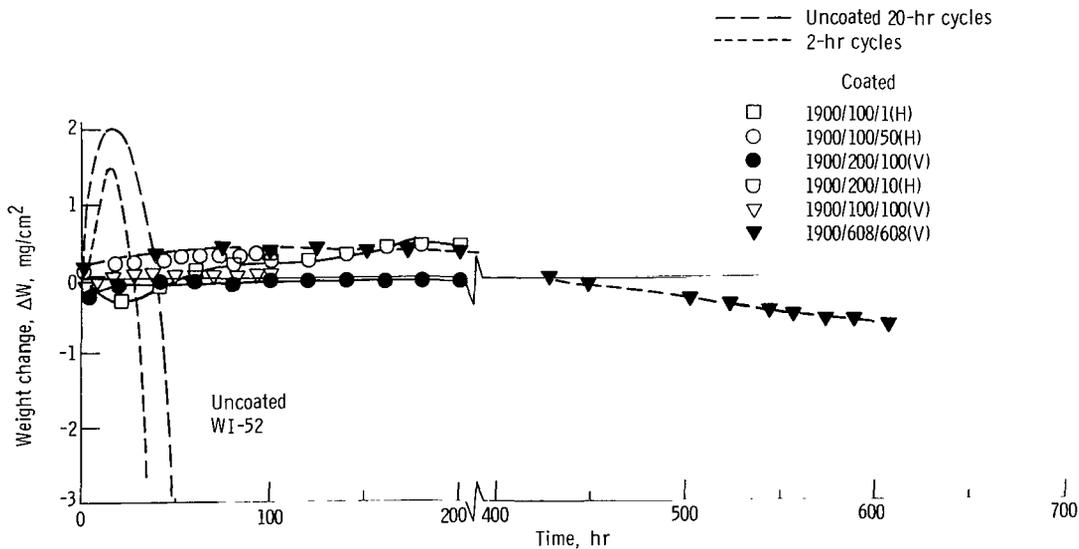
Figure 4. - Effect of cycle frequency and exposure duration on furnace oxidation resistance of aluminized WI-52 at 1900°F (1038°C).

Figure 4 represents the weight change against time data for both uncoated WI-52 (2- and 20-hr cycles) and for aluminide-coated WI-52 (1-, 2-, 20-, and 100-hr cycles). Uncoated specimens gained weight for the first few cycles and then spalled heavily. Generally, the coated specimens spalled slightly on the first cycle and experienced a weight loss. Thereafter, generally, the coated specimens gained weight. After 200 hours at 1900°F (1038°C) little difference existed in weight change (-0.05 to 0.4 mg/cm^2) regardless of how many cycles had been applied. Only after about 420 hours of testing did

the 1900/608/608(V) specimen again begin to spall to the extent that a net weight loss was observed.

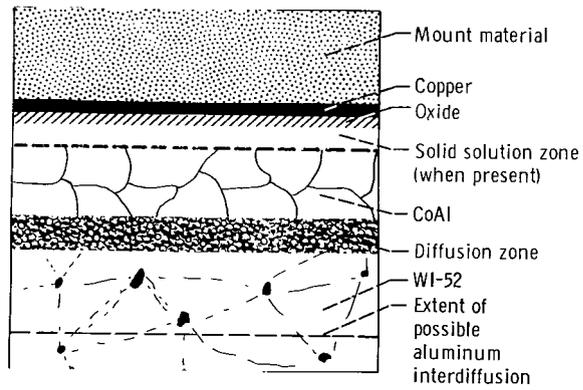
As-received

1900/100/1(H)

1900/100/50(V)

1900/200/10(H)

1900/608/608(V)

Figure 6. - Selected cross sections of aluminized WI-52 after cyclic furnace exposures at 1900 F (1038° C). X250.

Metallographic analysis was conducted on cross sections of tested specimens exposed for various times and cycles. Figure 6 presents typical photomicrographs of some of these cross sections and a schematic drawing identifying the major microstructural features observed. For all specimens furnace tested at 1900°F (1038°C), table II summarizes thickness data for the various coating layers observed - aluminum depleted solid solution zone between the oxide and CoAl, CoAl layer, diffusion layer under the CoAl, and aluminum interdiffusion zone in the substrate. These data represent average measurements made from $\times 250$ photomicrographs.

Several aspects of the metallographic data are worthy of note. Initially, the CoAl layer increases slightly in thickness. When the number of cycles and the cycle times are increased, which promotes spalling of the aluminum oxide scales, the CoAl layer appears to become thinner while the multiphase diffusion zone remains about the same. Also, while some cracks are shown in the as-deposited coating, cracks heal or appear less prone to form in the exposed specimens.

A white phase is seen randomly above the CoAl layer in the 1900/200/10(H) specimen. In the 1900/608/608(V) specimen this phase is a continuous layer ~ 0.2 mil or ~ 5 microns thick. This is believed to be the cobalt solid solution phase detected by X-ray diffraction on the latter specimen. Since none of the other specimens gave simi-

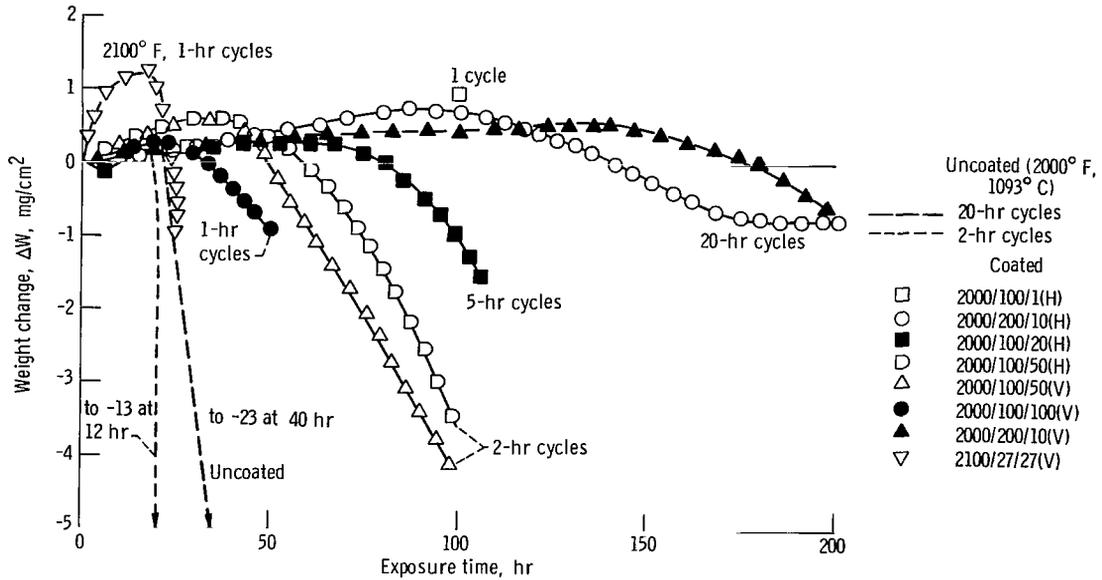
Figure 7. - Effect of cycle frequency and exposure duration on furnace oxidation resistance of aluminized WI-52 at 2000° F (1093° C) and 2100° F (1140° C).

In figure 7, the weight change against furnace exposure time plots are presented for uncoated (2- and 20-hr cycles) and aluminide coated WI-52 tested under 1-, 2-, 5-, 20-, and 100-hour cyclic conditions at 2000° F (1093° C). The uncoated WI-52 lost weight rapidly after only a modest period of weight gain. In contrast to figure 4, the cycle frequency has a definite effect on coating weight change. As the number of cycles in a given total exposure time increases, the time to experience a net weight loss decreases. Figure 7 also shows that for the same test conditions, the results for either the horizontal or vertical tube furnace tests agree satisfactorily (compare the two curves for 20-hr cycles and the two for 2-hr cycles).

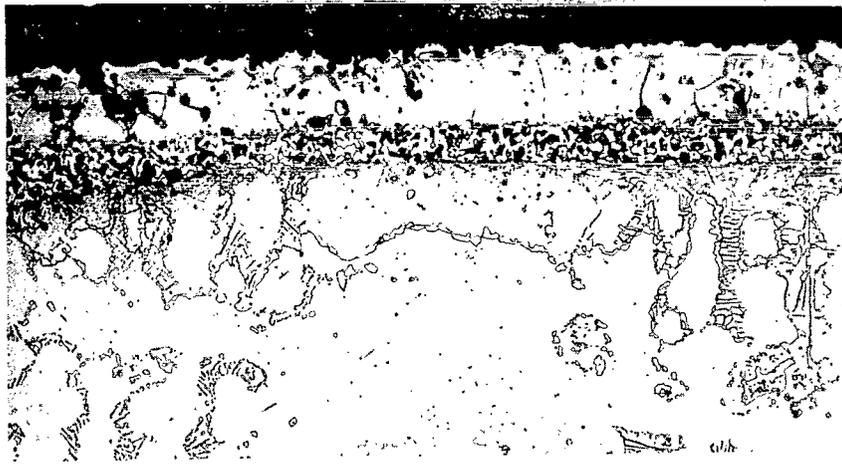
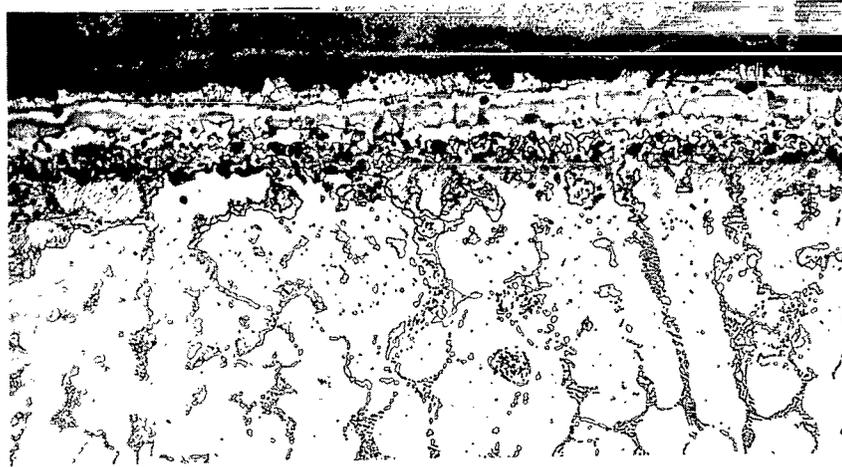
Exposure condition, 2000/100/5(H).

Exposure condition, 2000/100/50(V).

Exposure condition, 2000/200/10(H).

Figure 8. - Degradation of aluminized W1-52 at 2000° F (1093° C) with increasing cycles or exposure time. X250.

Pertinent metallographic cross sections are shown in figure 8. These cross sections illustrate further steps in the degradation of the coating. The thickness data for the various coating layers of all tested specimens are presented in table IV. As can be seen from figure 8, the degradation process is significantly accelerated by temperature

and cycling. At 2000^o F (1093^o C), the cobalt solid solution layer formed on the CoAl after only five 20-hour cycles, 2000/100/5(H), whereas at 1900^o F (1038^o C), a complete layer was observed only on the 1900/608/608(V) specimen. With further cycling the CoAl became thinner and the cobalt solid solution became more extensive above and below the CoAl - 200/100/50(V). Figure 9 presents a second micrograph of this specimen showing a single microprobe beam path as well as the resultant raw traces for Co and Al, obtained using two spectrometers simultaneously. These are uncorrected traces. They show, however, a relatively low aluminum content in the solid solution zone beneath the oxide, a higher aluminum concentration in the CoAl phase, a decrease in aluminum in the solid solution zone beneath the CoAl, and finally the gradual drop of aluminum to zero in the interdiffusion region. After 200 hours of exposure, figure 8 shows that complete coating failure is imminent (2000/200/10(H)). In areas where some CoAl still remains, no internal oxidation can be observed, and the scale was white (Al₂O₃) and blue (CoAl₂O₄). In areas where the CoAl was completely consumed, internal oxidation has taken place to a depth of 4 to 5 mils (10 to 12×10⁻³ cm) (not shown

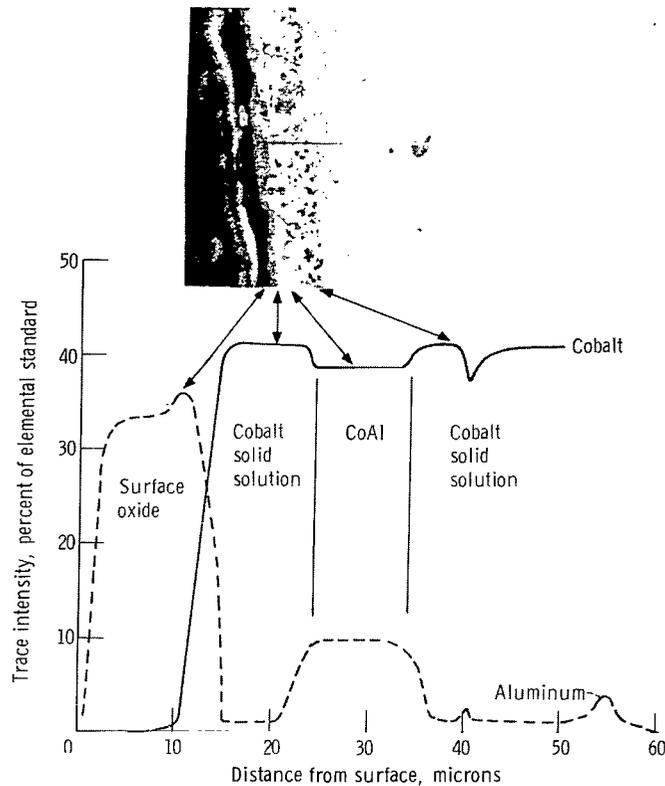
Figure 9. - Electron microprobe trace on cross section of 2000/100/50(V) exposed aluminide coated WI-52 specimen.

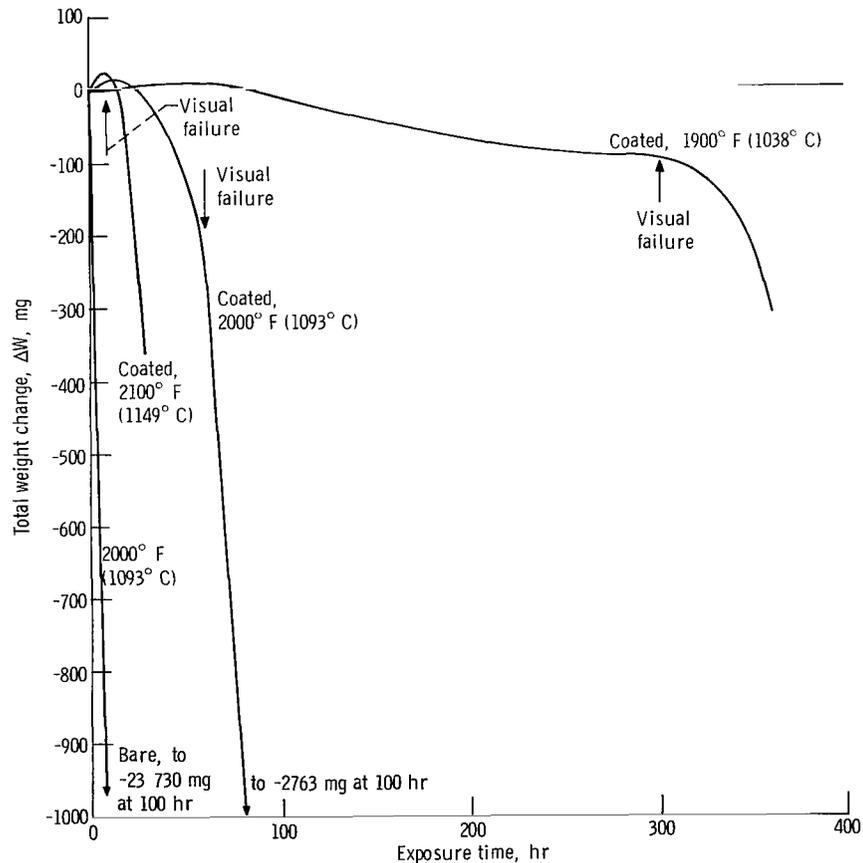
Figure 10. - Effect of temperature on oxidation weight changes of aluminized WI-52 in Mach 1 apparatus for 1-hour cycles.

The weight change data presented in figure 10 represent the total weight change for coated WI-52 tested at 1900° , 2000° , and 2100°F (1038° , 1093° , and 1149°C) using 1-hour exposures. Also plotted are data for uncoated WI-52 similarly tested at 2000°F (1093°C). The simple aluminide coating under investigation survives only 12 hours at 2100°F (1149°C) and 60 hours at 2000°F (1093°C), as shown by the arrows in figure 10 which indicate visual failure. Even at 1900°F (1038°C), the coating visually failed

within 300 hours. The visual failure criteria was the change in scale color from white or gray-blue to black, indicating the presence of cobalt oxide (CoO) which is the same major oxide that forms on the uncoated WI-52.

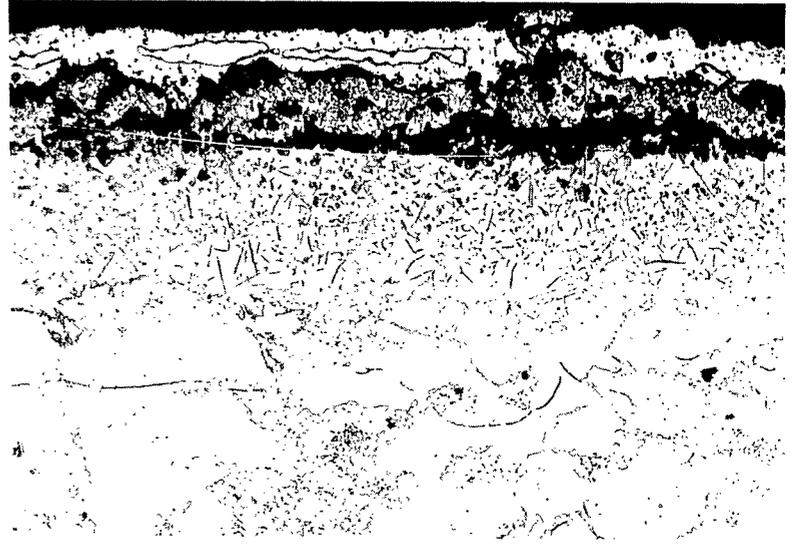
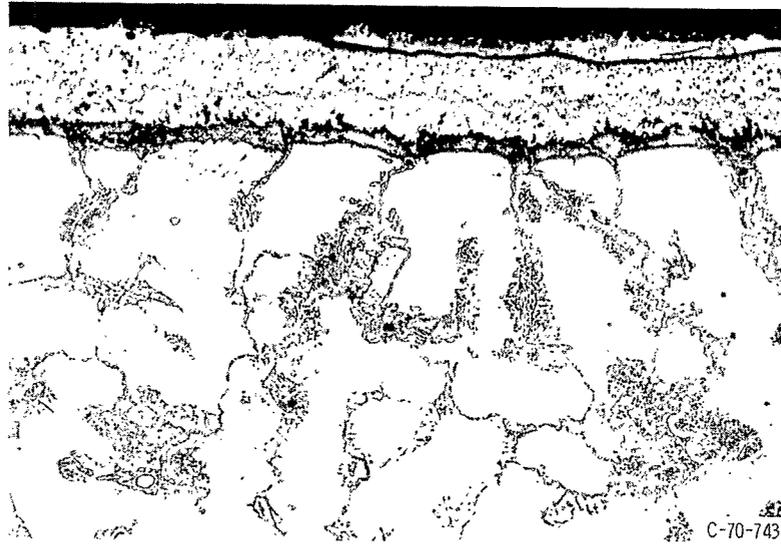
(a) Temperature, 1915° F (1046° C); position A; leading edge. X100.

(b) Temperature, 1925° F (1051° C); position B; side. X250.

(c) Temperature, 1640° F (893° C); position C; side. X250.

Figure 11. - Degradation of coating on aluminized WI-52 at three locations after mach 1 oxidation testing at ~1900° F (1038° C) for 380 hours (1-hr cycles).

Cross sections of appropriate regions (locations A, B, and C in fig. 1) were examined after test. These cross sections are illustrated in figure 11 for a bar tested at 1900° F (1038° C). This figure shows the leading edge of the hot zone (A), the side of the bar in the hot zone (B), and the side of the bar in a cooler zone near the base (C). Observed temperatures measured by an optical pyrometer are also presented. This figure shows how the coatings generally fail at the leading edge, which is the region subjected to the most rapid temperature changes. Once failed, oxidation appears to proceed down the carbide phases and significant loss of load bearing area results. At approxi-

mately the same temperature, the coating on the side of the specimen (B) shows imminent failure and considerable internal oxidation which lead to cracking during sample preparation. The cooler region (C), more representative of current commercial engine service temperatures, is still in very good condition. Thickness data for all coating layers at all three temperatures are presented in table V.

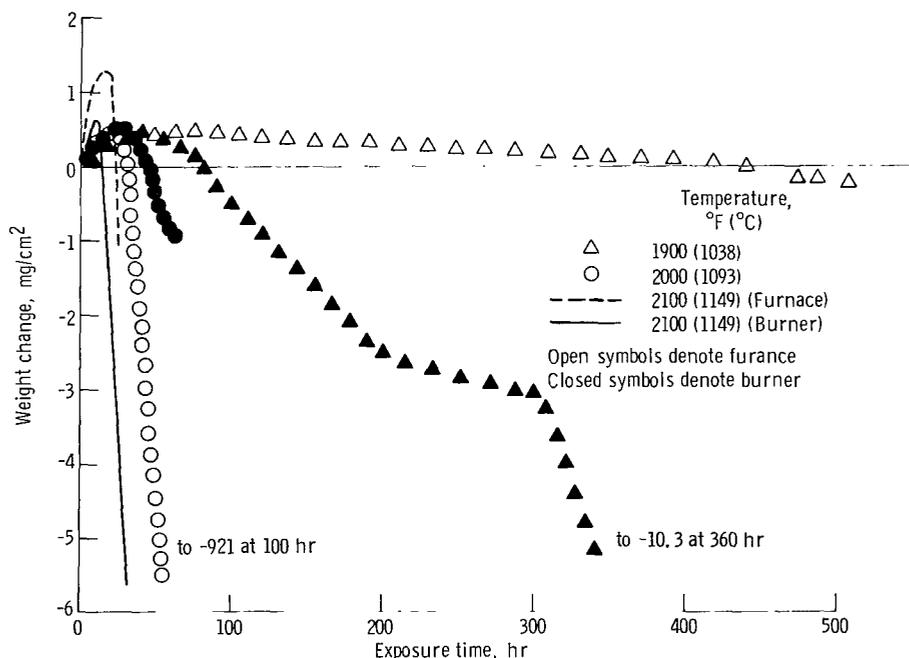
Figure 12. - Comparison of 1-hour cyclic oxidation weight change for furnace and burner rig tested aluminide coated WI-52.

Figure 12 compares the 1-hour cyclic furnace weight change data with the 1-hour cyclic data obtained in the Mach 1 test apparatus. The weight change data shown in figure 10 were converted to milligrams per square centimeter by dividing by 30 square centimeters, the approximate area of the hot zone. These data show that at both 2100° and 2000° F (1149° and 1093° C) the cyclic furnace tests are only slightly less severe than the Mach 1 tests. At 1900° F (1038° C), however, the furnace weight change behavior is significantly less severe than that in the high-velocity apparatus. These differences may well be related to the differences in alumina scale growth rate with temperature. Thick alumina scales are developed at the higher temperatures, and thick scales spall more readily than thinner scales. Thus, at the higher exposure temperatures, both the relatively slow cool down in the furnace tests and the very rapid cool down in the burner tests

may both have been sufficient to produce significant spalling. Because the 1900° F (1038° C) scales appeared much thinner, only the rapid quench in the Mach 1 cold air stream may have been enough to cause them to spall significantly.

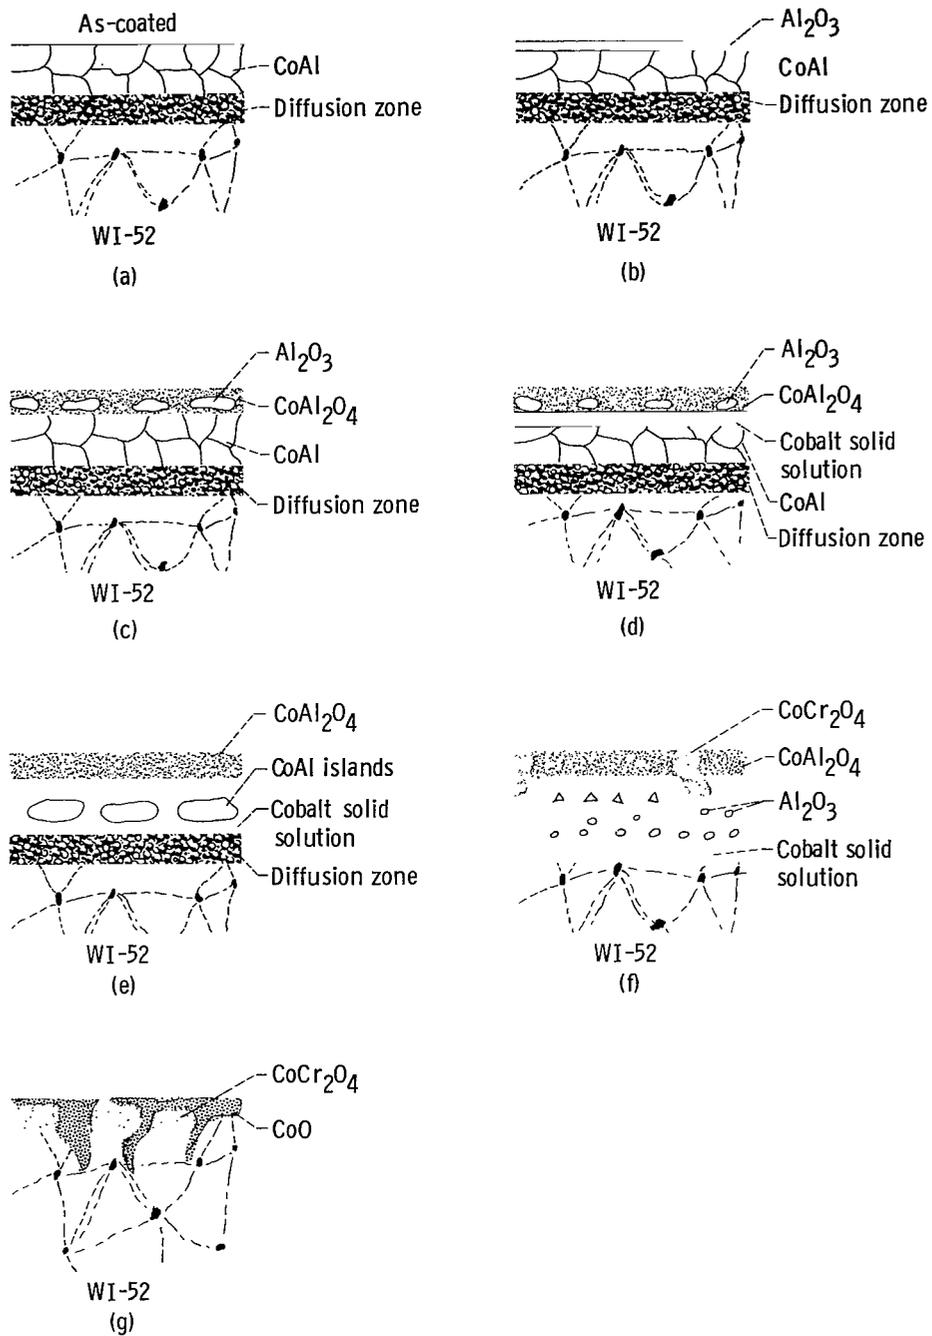
Figure 13. - Schematic degradation of an aluminide coating on WI-52.

Based on the surface and cross-sectional metallography, coupled with observed weight losses and X-ray diffraction data, the degradation of the aluminide coating is schematically summarized in figure 13. This process is continuous even though for ease of presentation it is shown as a series of steps.

First, white to gray alumina (Al_2O_3 aluminum oxide) forms on the surface of the CoAl phase during oxidation (b). Some interdiffusion and growth of the CoAl layer also occurs in the early stages of testing. With increased time and cycling, spallation of the alumina surface scale takes place, greater amounts of CoAl_2O_4 (a spinel oxide-cobalt aluminide) form, and the surfaces appear a gray-blue color (c). Further exposure produces continued spalling of Al_2O_3 and CoAl_2O_4 . The oxide scale that then grows on the surface contains more of the CoAl_2O_4 phase. The loss of aluminum in reforming the $\text{Al}_2\text{O}_3/\text{CoAl}_2\text{O}_4$ scale depletes the CoAl of enough aluminum so that a cobalt solid solution layer forms between the external scale and the remaining CoAl phase (d). Then, further spalling and oxide formation remove more aluminum from the coating and the continuous layer of CoAl begins to break into islands surrounded by the solid solution (e). During these stages some aluminum also appears to diffuse inward (as indicated by very subtle etching effects). As the islands of CoAl disappear due to the continued loss of aluminum caused by CoAl_2O_4 scale spalling, internal oxidation (to Al_2O_3) of the region enriched by inward diffusion of aluminum occurs. With the aluminum reservoir in the coating nearly depleted, CoCr_2O_4 (a spinel oxide-cobalt chromate) and perhaps Cr_2O_3 begin to form in the oxide scale (f). Beyond this stage, as observed on the high-velocity test specimens, the black CoO forms; this oxide spalls severely on thermal cycling.

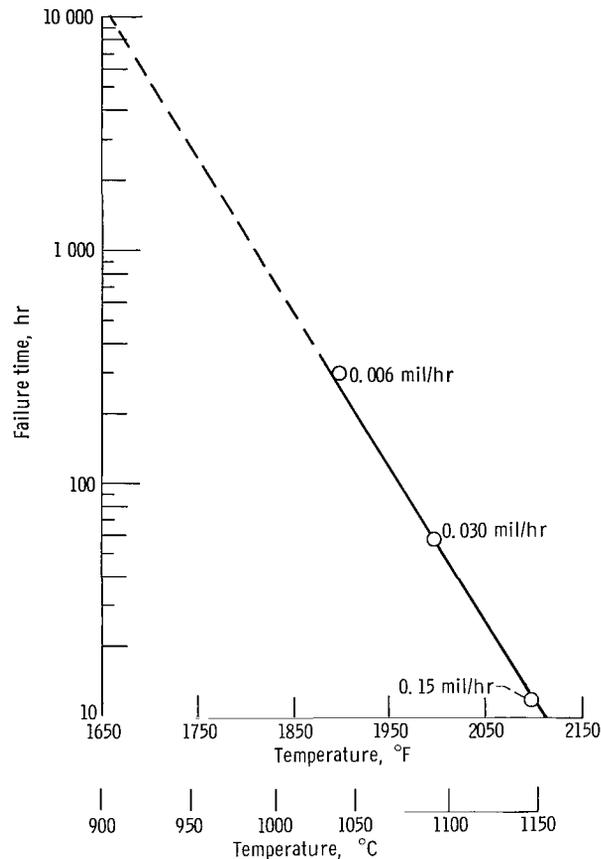
Figure 14. - Effect of temperature on life of aluminide coated WI-52 in high-velocity tests using 1-hour cycles.

If the time to visual failure in the high-velocity test specimens is plotted logararithmically against exposure time as in figure 14, the three failure points from this study fall on a straight line. Assuming that rapid interdiffusion allows the CoAl layer to reach a thickness of approximately 1.8 mils (4.5×10^{-3} cm) as shown in figure 6, the consump-

tion of CoAl can be determined for the failure time in mils per hour. These approximate values are also shown in figure 14. The times to failure decrease by an order of five for each 100° F (55° C) increase in temperature. If these relations hold true for lower temperature exposure as well, the coating tested would have a life of about 1500 hours at 1800° F (982° C) and about 7500 hours at 1700° F (927° C).
