**THIRD INTERIM TECHNICAL REPORT**  
**For The**  
**STUDY ON INTEGRATION OF SILVER-ZINC BATTERY IMPROVEMENTS**

Contract No.: NAS 5-11579

Prepared By  
HUGHES AIRCRAFT COMPANY  
AEROSPACE GROUP  
Space Systems Division  
Propulsion And Power Systems Laboratory  
El Segundo, California

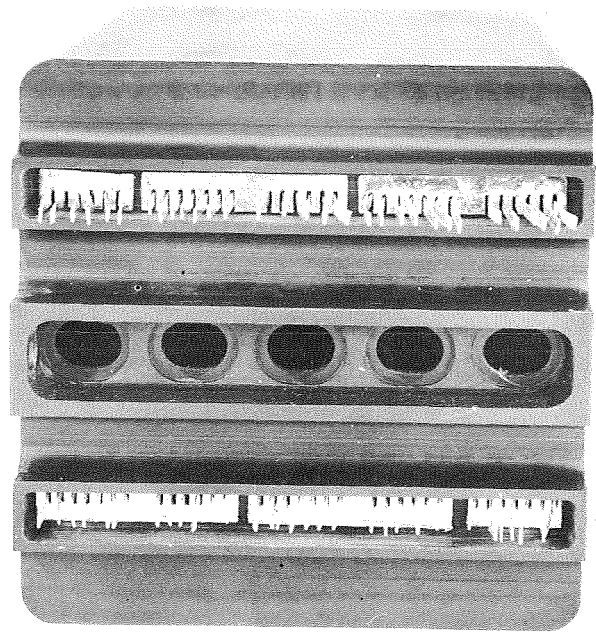
Figure 8. Battery Case Cover

a) Plate Tabs Inserted Through Cover  
(Photo A24852)

b) Copper Intercell and Intracell  
Connectors in Place  
(Photo A24855)

c) Instrumentation and Lead Wires  
Connected  
(Photo A24850)

All intracell and intercell electrical connections were accomplished by use of the machined copper parts x3182884 and x3182885. Copies of these drawings were included in the appendix of the Second Interim Report of this contract. All of the silver tabs from both the positive and negative plates of each of the five cells were fed through their respective slots in the machined Noryl thermoplastic cover. The copper connecting parts were put into place and silver soldered, effecting individual plate tab connections for each cell, the intercell connections required to form a battery, and all necessary instrumentation wiring. These copper connectors and all individual plate tabs were epoxied into the channel designed for that purpose, thereby producing the first seal at the location of the cover plate tabs.

All of the instrumentation wiring and lead wires then were positioned prior to the filling of both channels with epoxy that encapsulated these wires and provided a second seal. Figure 8 shows how these processes occurred.

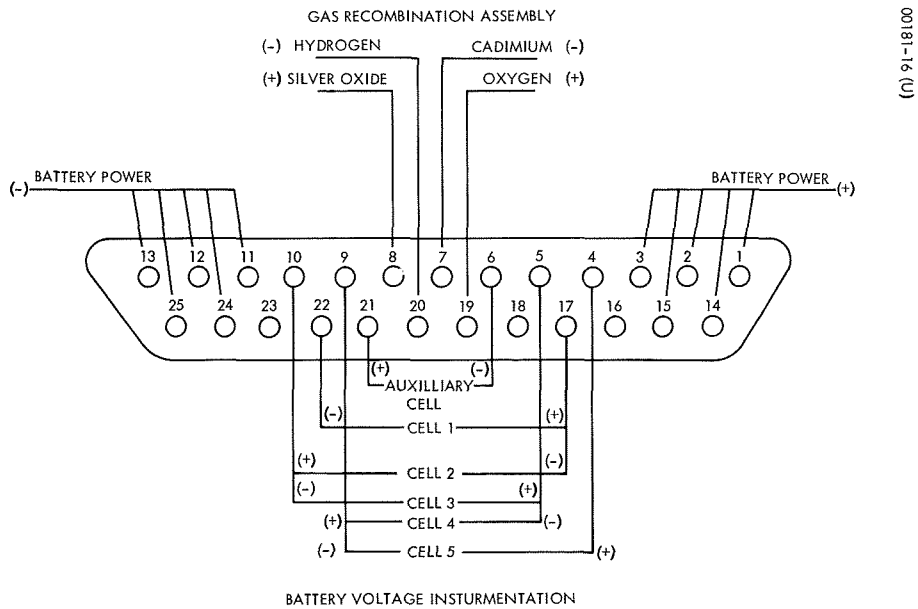
Figure 14. Connector Pin Utilization

The connector pin utilization diagram has been more specifically defined in Figure 14. The pin utilization shown in the Second Interim Technical Report still is applicable, but this is a further refinement of the previous plan.
