INVESTIGATIONS OF THE POTENTIAL PERFORMANCE CHARACTERISTICS  
OF SELECTED CONTACT LUBRICANTS FOR APPLICATIONS IN  
MINIATURE SLIP-RING CAPSULES OF THE TYPE USED IN  
ST 124 M STABILIZED INERTIAL GUIDANCE PLATFORMS

FINAL TECHNICAL REPORT

Contract Number NAS 8-21323

J. B. Baker, G. B. Gaines, and K. E. Meiners

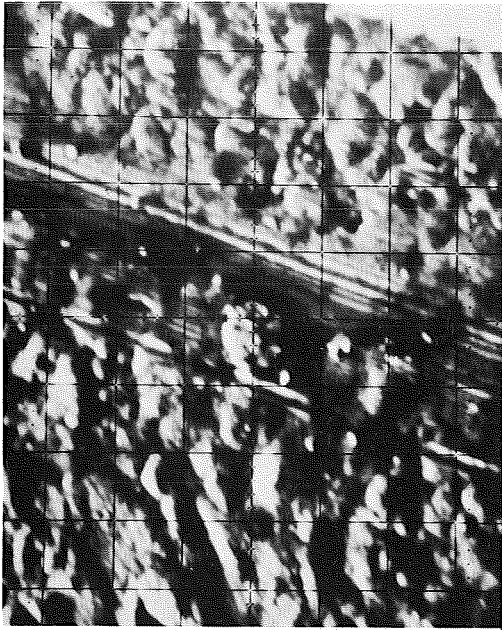
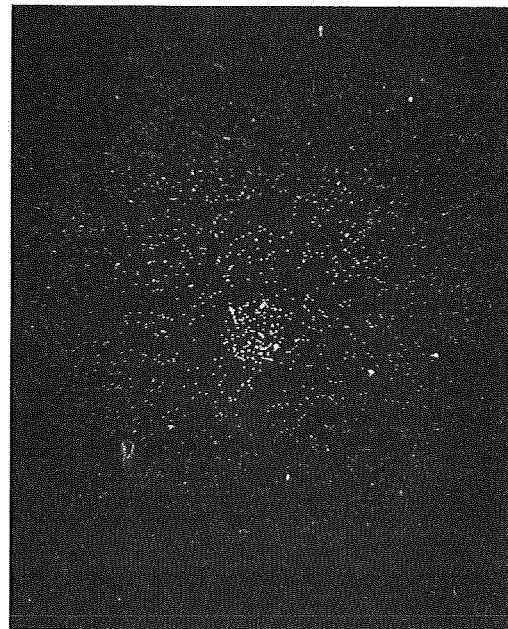
a. Topography as Shown by Back-Scattered Electrons

b. Image Produced by X-Rays From Gold

c. Image Produced by X-Rays From Nickel

d. Image Obtained With Detector Adjusted for X-Rays From Silver

FIGURE 4. ELECTRON-MICROPROBE IMAGES OBTAINED FROM AN UNCLEANNED SECTION OF A ROTOR RING REMOVED FROM SLIP RING DP 1506 SN 181
