THE
Marquardt
CORPORATION

DESIGN STUDY AND EVALUATION
OF A HYPERGOLIC ENGINE
FOR A SPACE POWER SYSTEM

Final Report for Phase II
and Phase II, Modification I
for the Period 1 July 1964 to 10 February 1966

Contract: NAS 9-857
Phase II and Phase II, Modification I

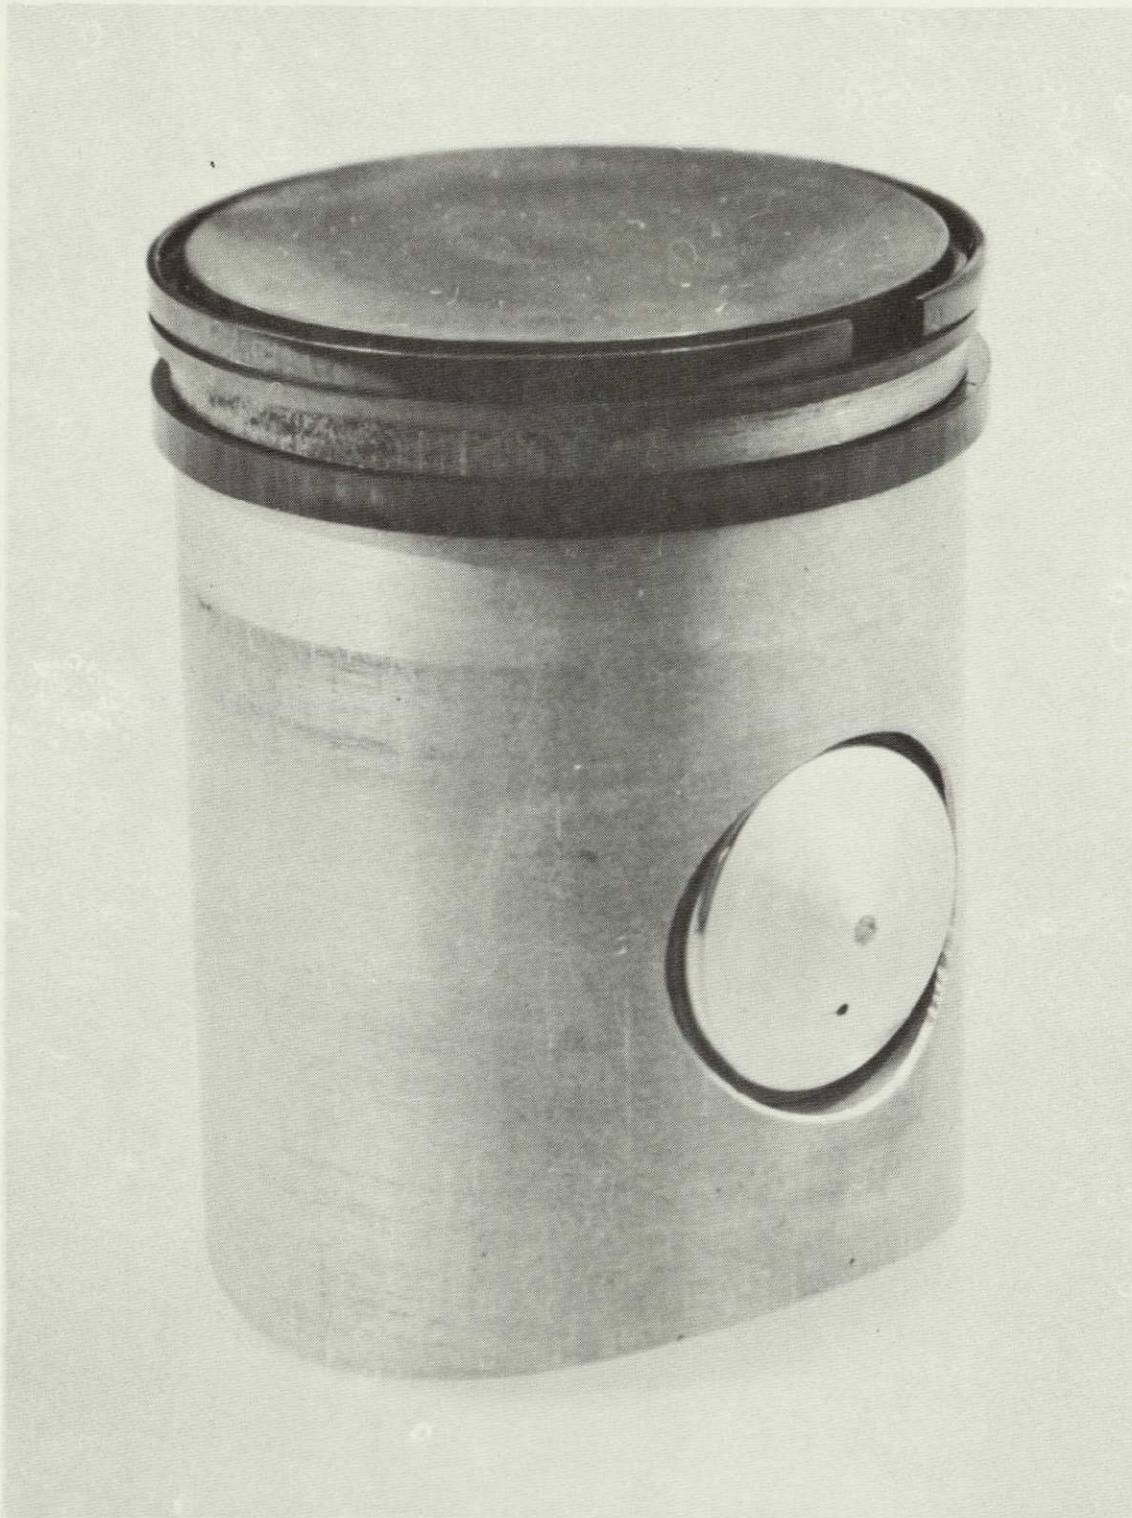
T 5151-19

FIGURE 12. Baseline Piston Assembly Used in the SPU-3 Engine,
After Test

Two successful piston and ring designs have been developed for the SPU-3 engine. Both designs feature a Rene' 41 crown, a D132 aluminum skirt, and piston rings fabricated from 440-C stainless steel. The two pistons are identified as the "Baseline" piston and the "Mod 1" piston.

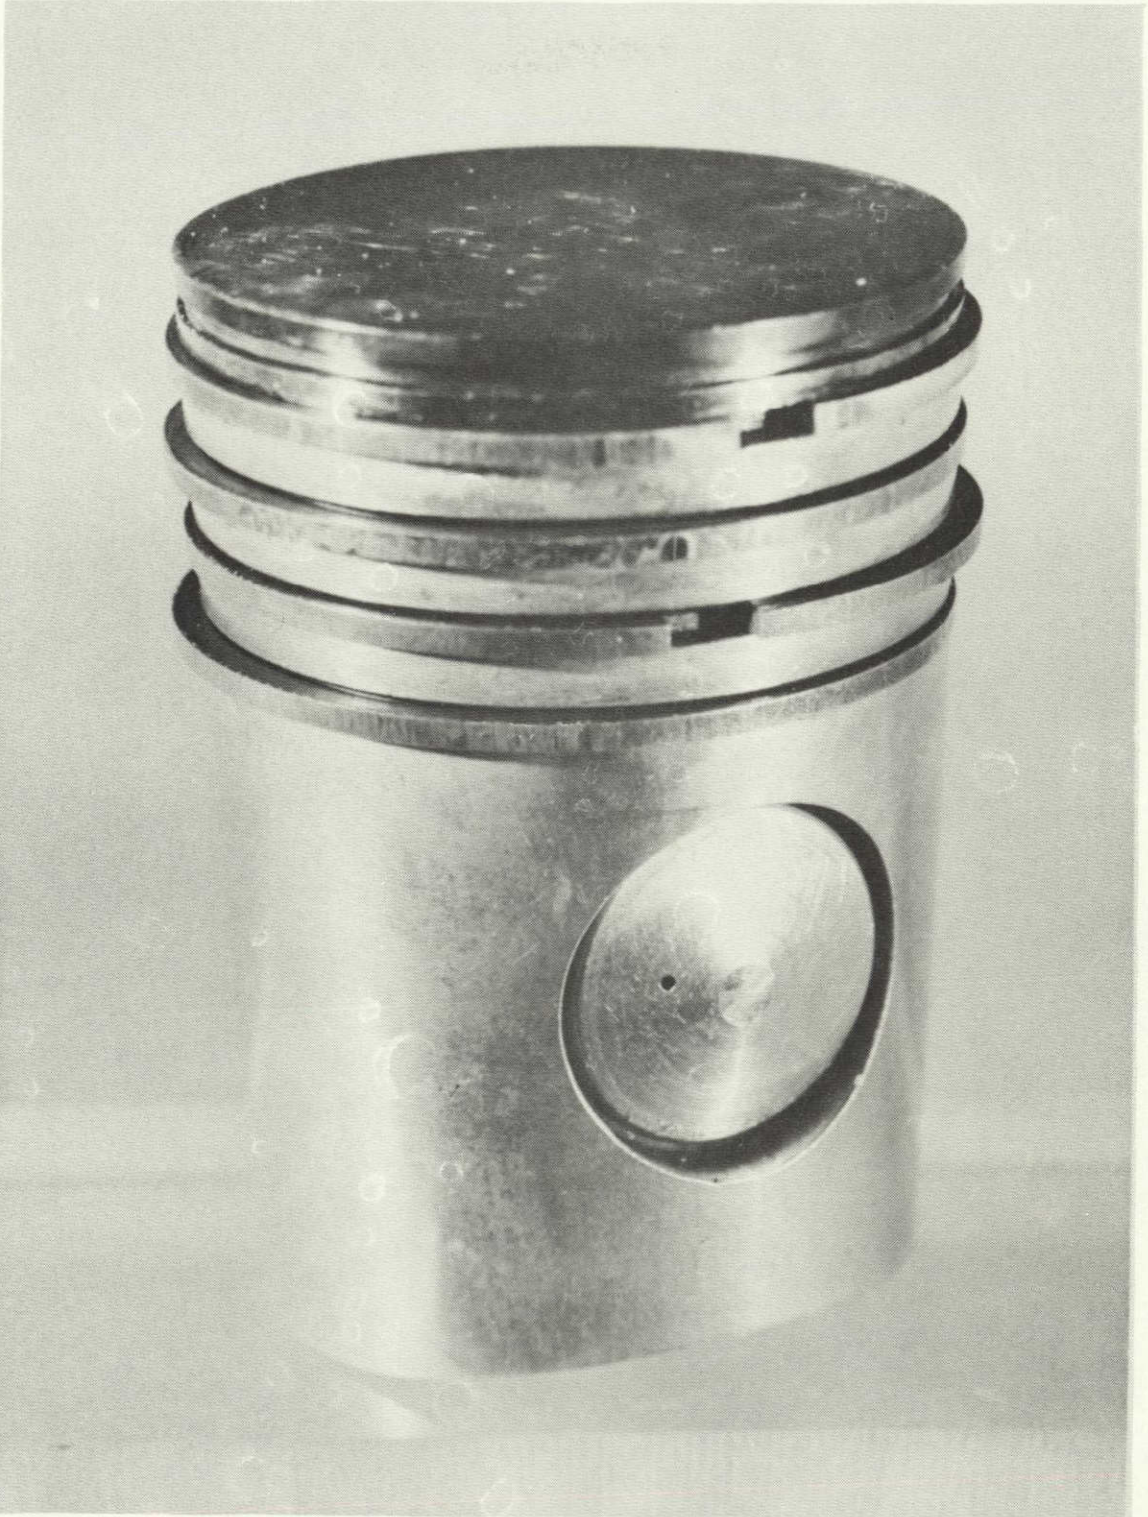
T 5151-44

FIGURE 13. Modification 1 Piston Assembly Used in the SPU-3 Engine, After Test

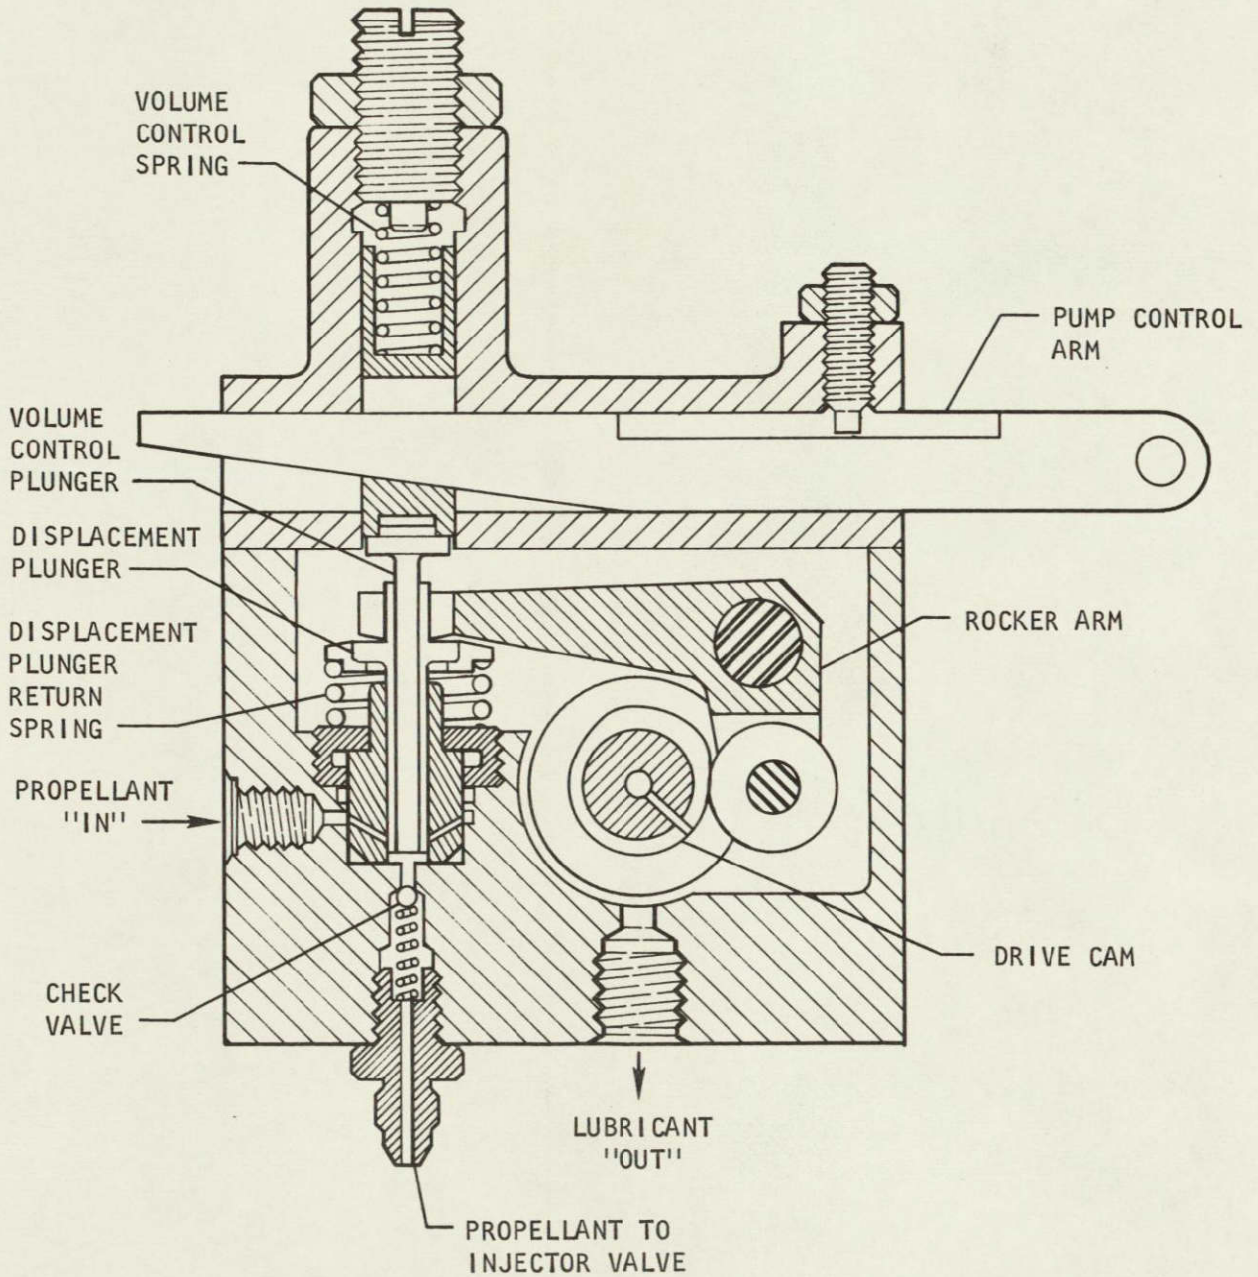
FIGURE 18

SCHEMATIC OF PROPELLANT PUMP FOR THE SPU-3 ENGINE

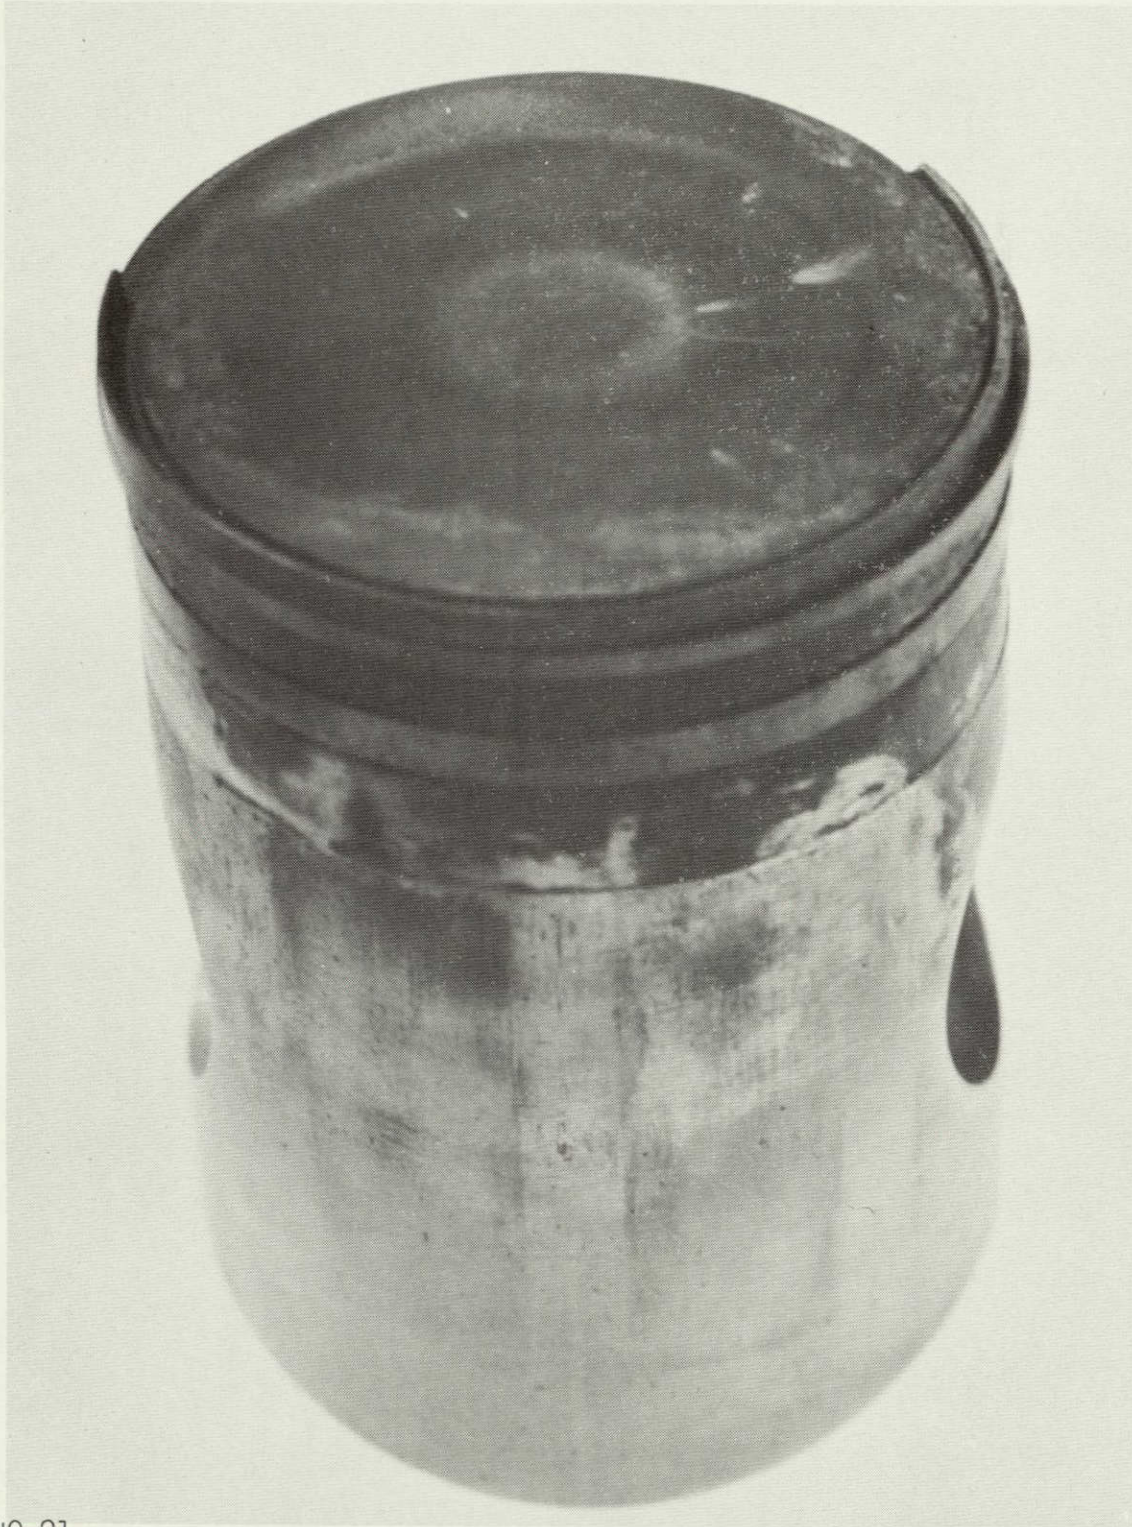
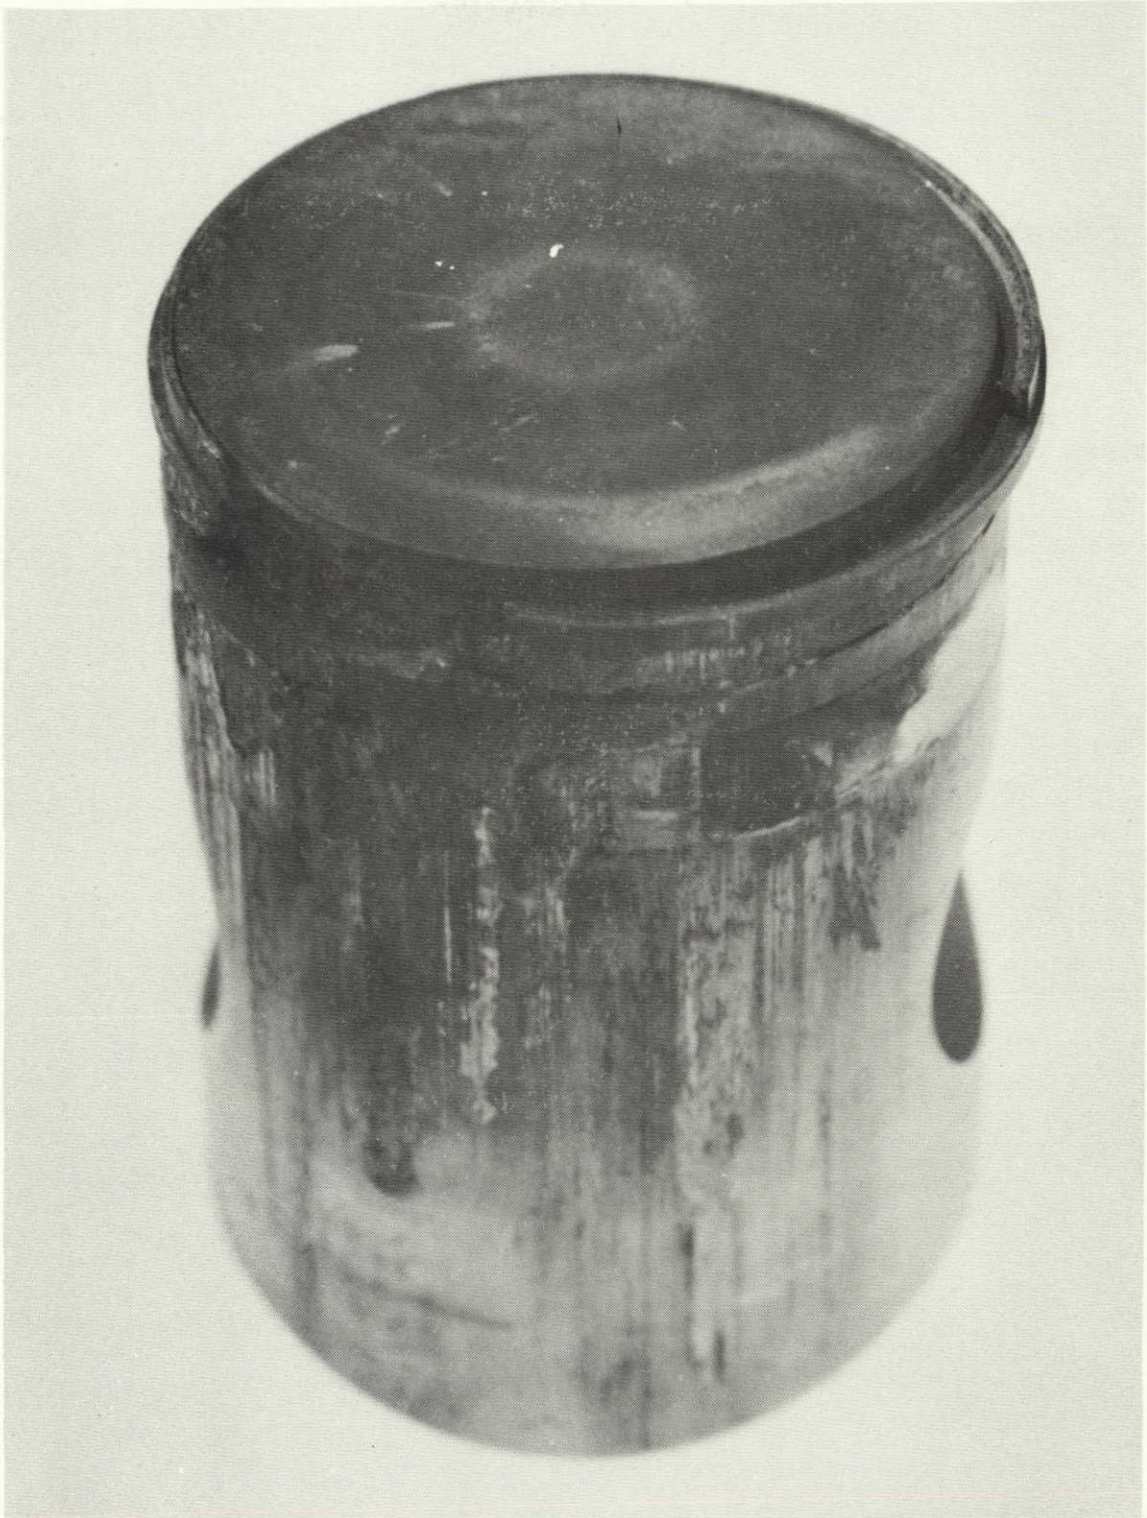
T 5140-21

FIGURE 27. Configuration C Piston after Operation for 4.76 hours in the SPJ-2A-2 Engine

FIGURE 28. Configuration C Piston after Operation for 4.76 hours
in the SPJ-2A-2 Engine

The Configuration C piston was again used in the SPU-2A-2 engine for evaluation of the ball and roller bearing crankcase assembly. The total operating time with this piston during this test was 5.66 hours, including a 4.76-hour duration run. Teardown inspection of the engine following these tests disclosed a partially failed piston assembly. The two top rings had broken and some heavy erosion of the upper section of the skirt above the third ring was found. Two views of this piston assembly are shown in Figures 27 and 28. This failure was attributed to a badly warped cylinder bore resulting from several plugged water transfer passages in the area of the piston failure. The cylinder had been fitted with three thermocouples and the wires had partially blocked two of the water passages and caused a localized hot spot on the cylinder wall.

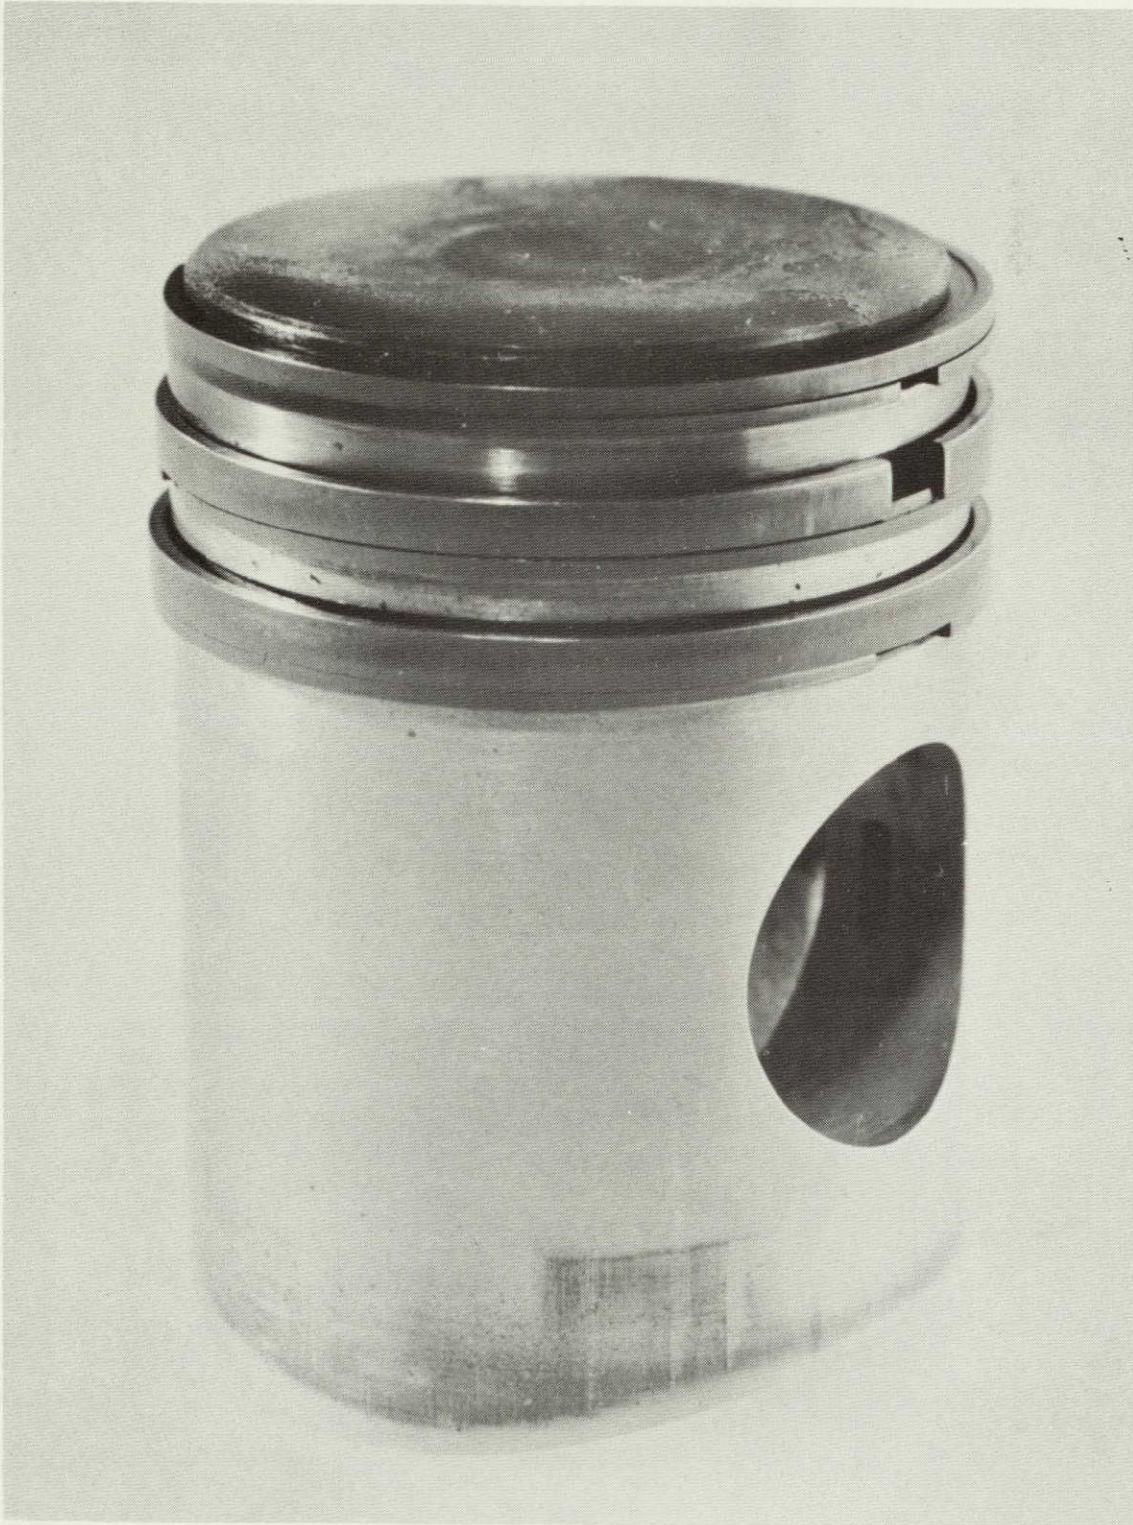
T 5149-11

FIGURE 29. Configuration D Piston after Operation for 17 minutes in the SPU-2A-3 Engine

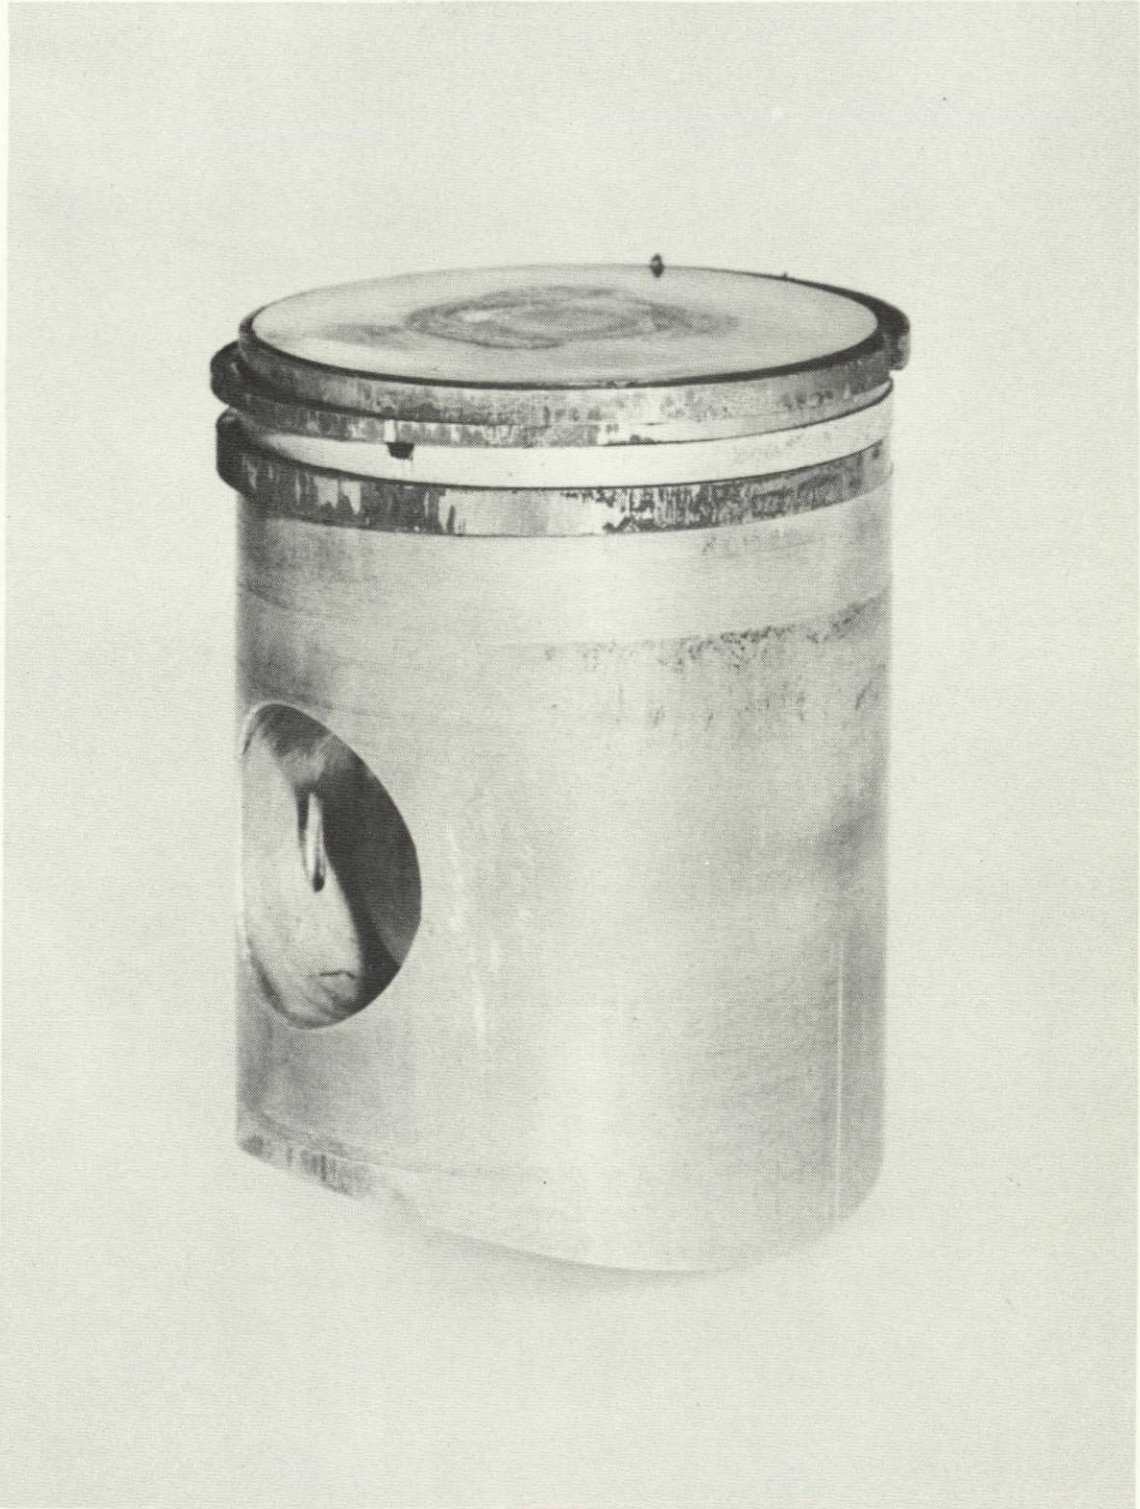
T 5151-42

FIGURE 32. Piston Assembly with 440-C CRES Rings after
46-hour Endurance Test

In order to insure that the 440-C CRES material would perform properly under more adverse conditions and in a different configuration, the Configuration G piston was fitted with 440-C rings and installed.
