**APOLLO TIE
WASHINGTON, D. C.**

DOCUMENT NO. D2-120001-2

TITLE SUMMARY OF VIBRATION AND ACOUSTIC TESTS ON
FOUR SPACECRAFT PROGRAMS

This document summarizes the vibration and acoustic test programs for four spacecraft: Mariner, Lunar Orbiter, Gemini and Surveyor. Information is presented on laboratory test programs and results, flight results, derivation of test levels, identification of test factors, and spacecraft contractor conclusions and recommendations.

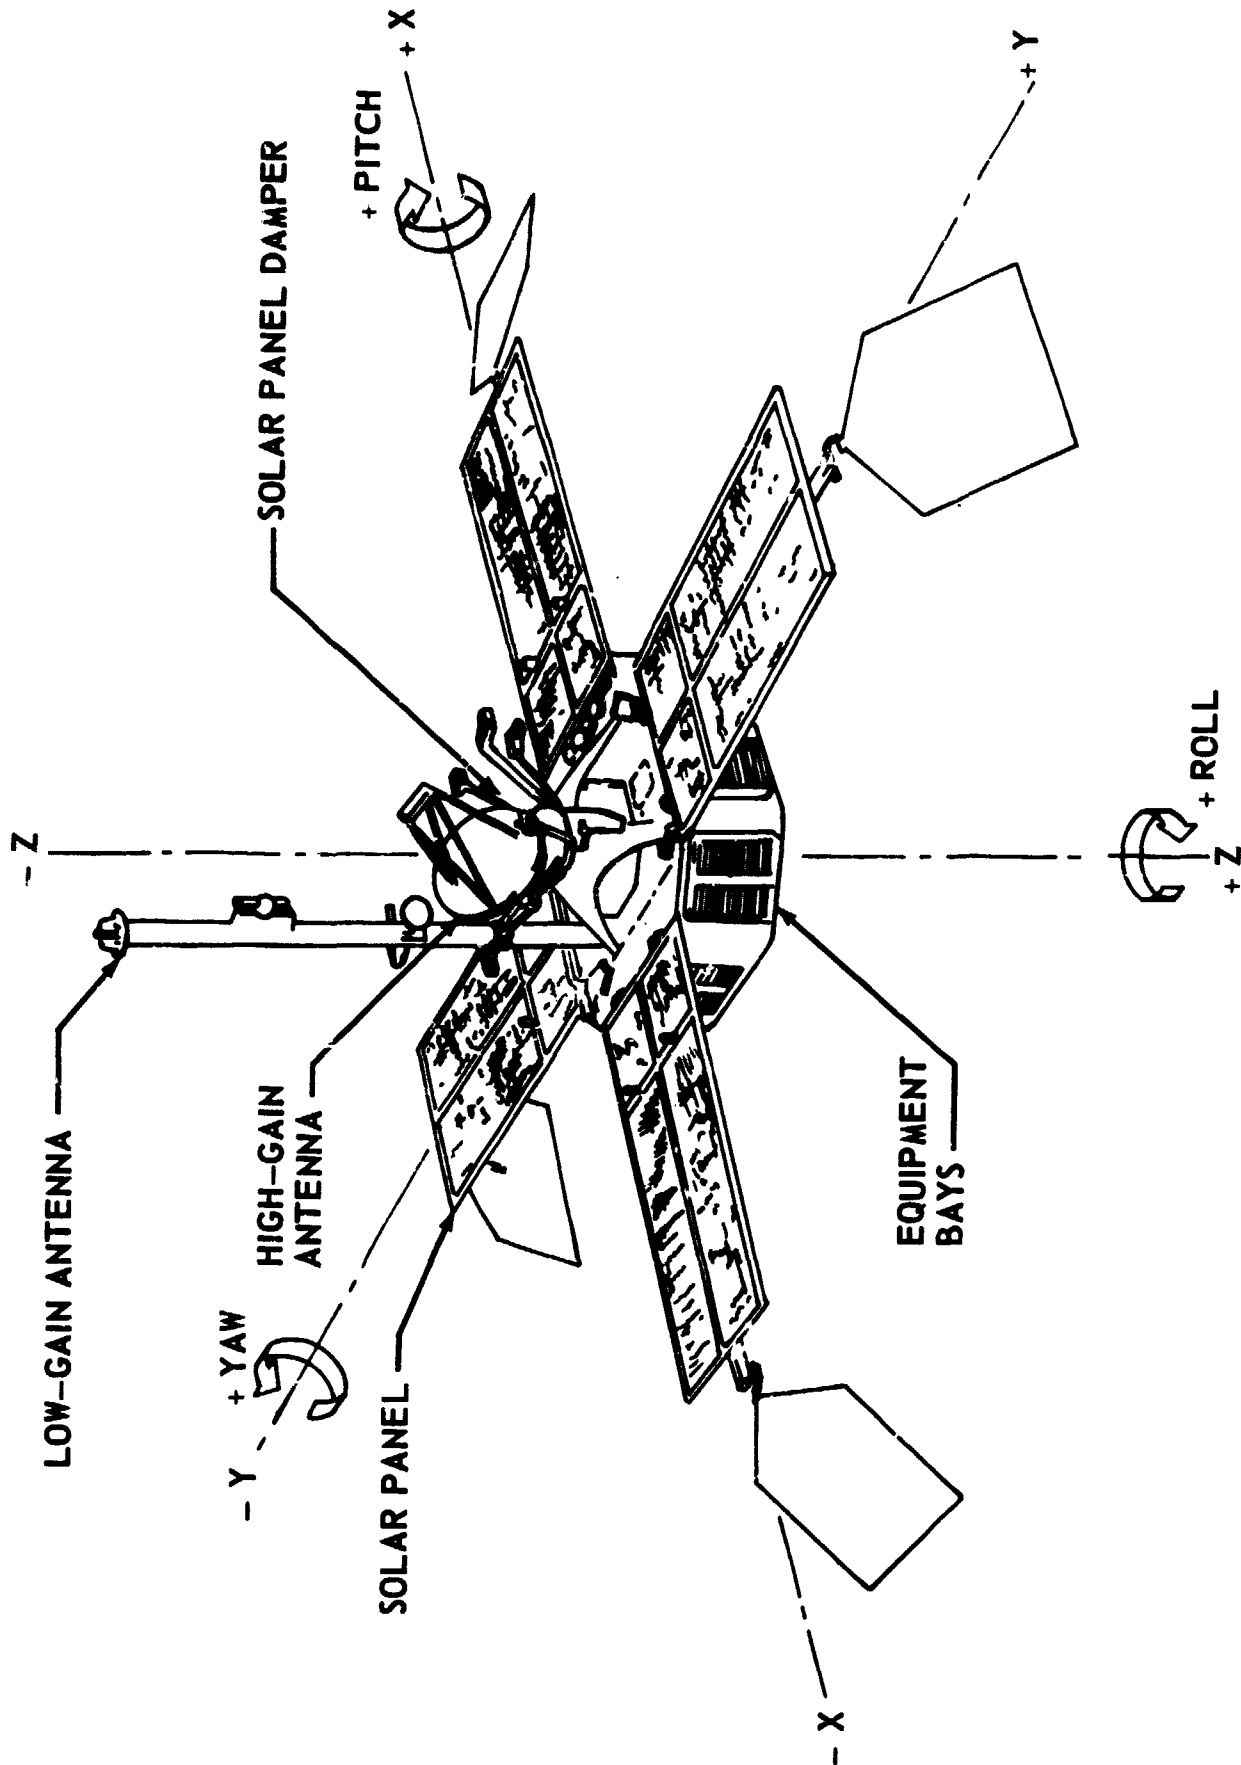
Figure 3-1: MARINER 64 CONFIGURATION

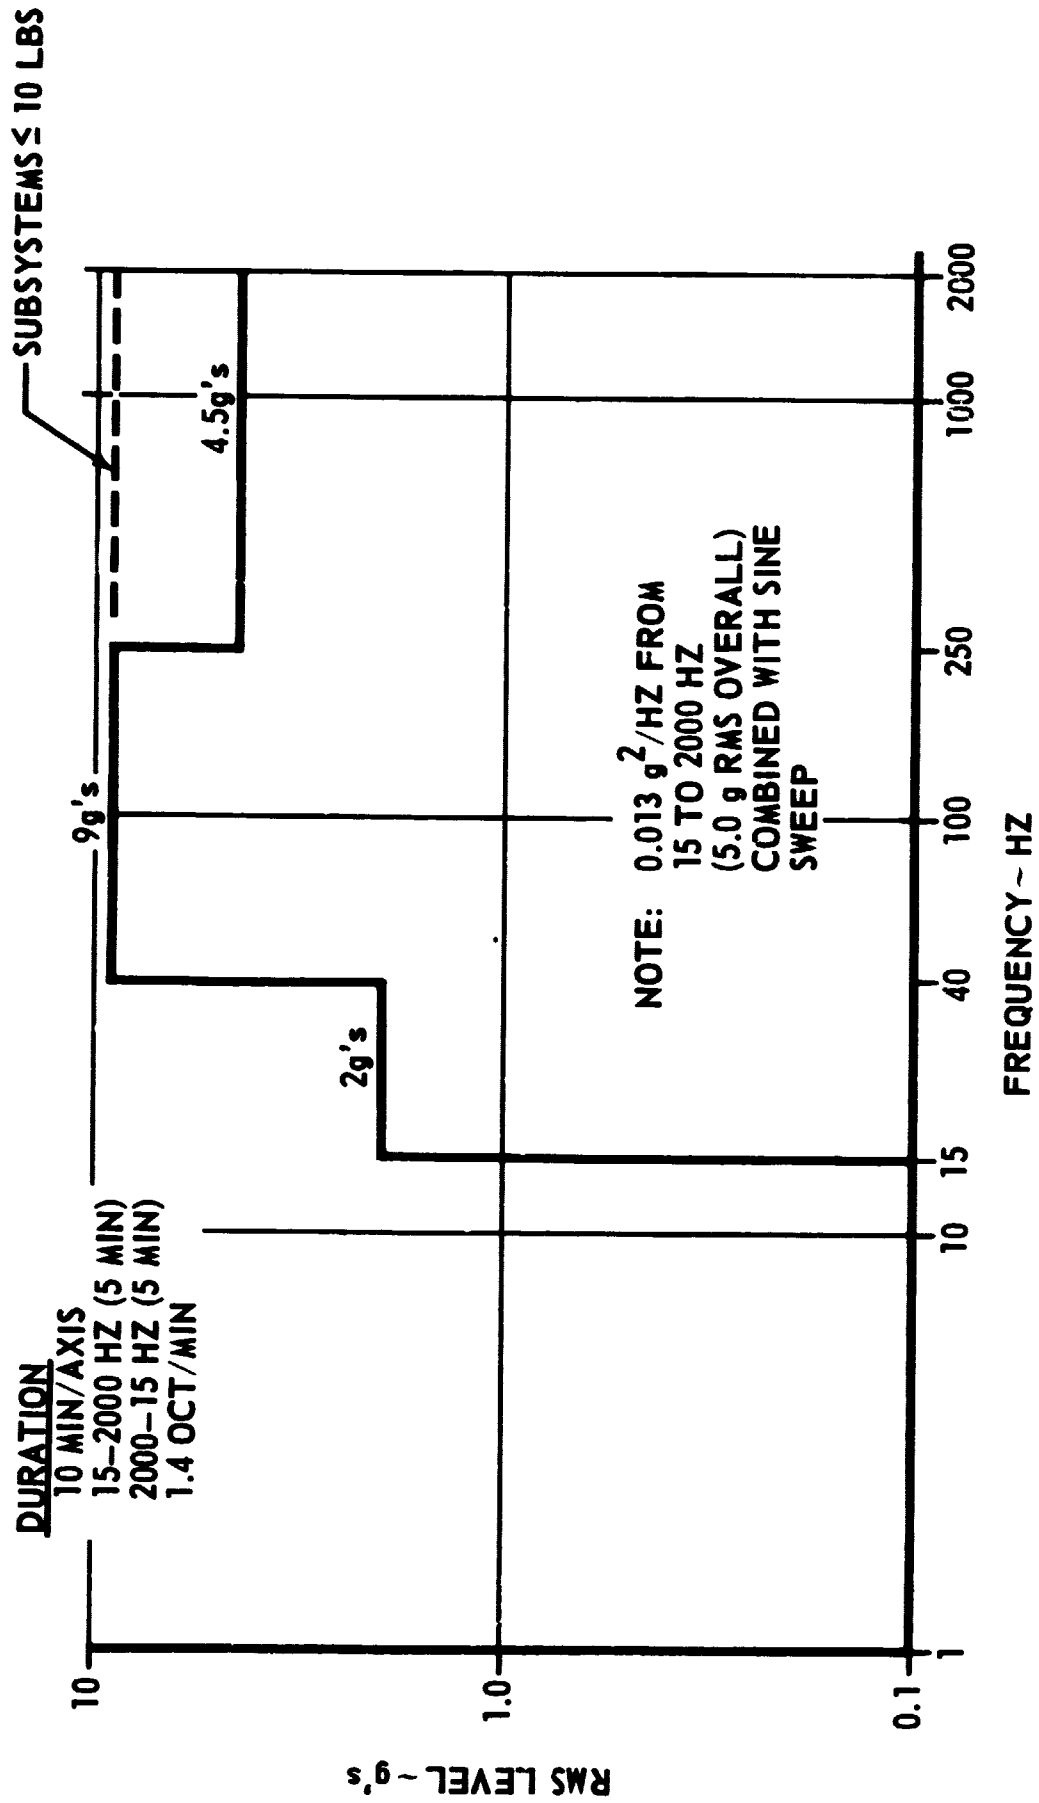
Figure 3-5: SUBSYSTEM QUALIFICATION TEST COMBINED RANDOM VIBRATION AND SINE SWEEP

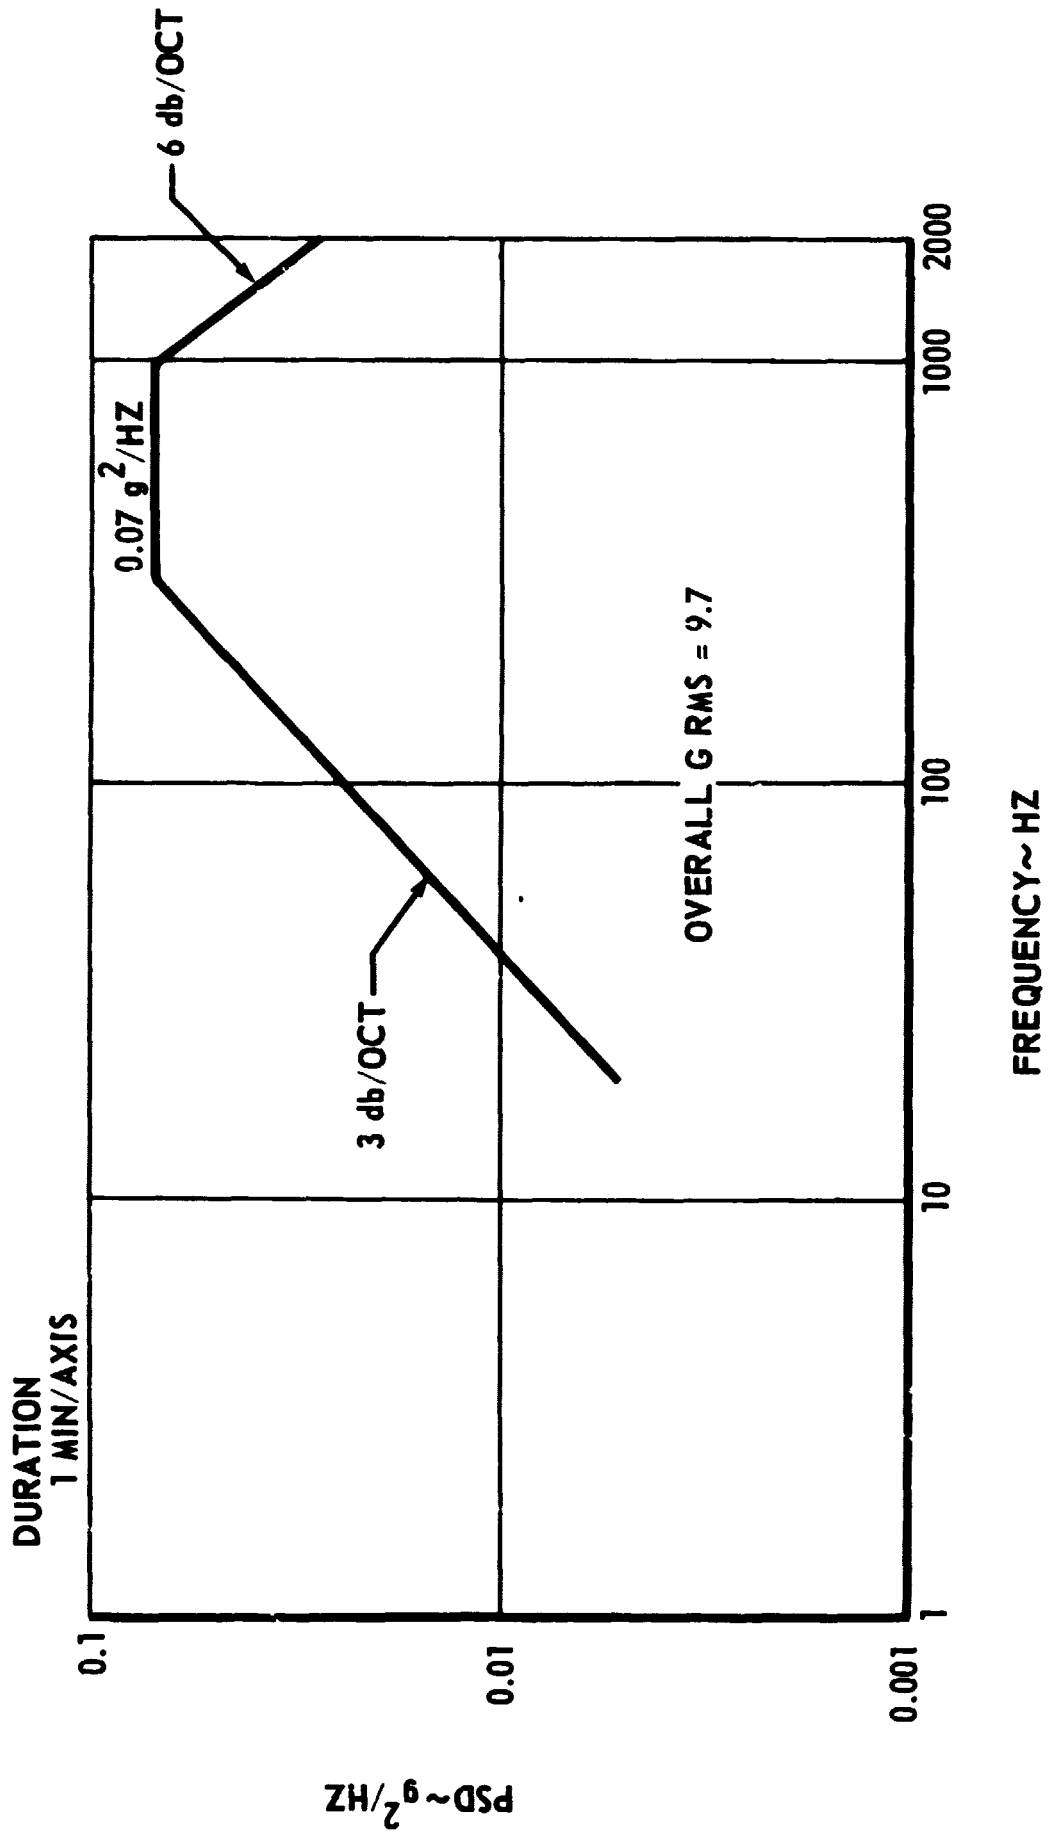
Figure 3-6: SUBSYSTEM ACCEPTANCE TEST RANDOM VIBRATION

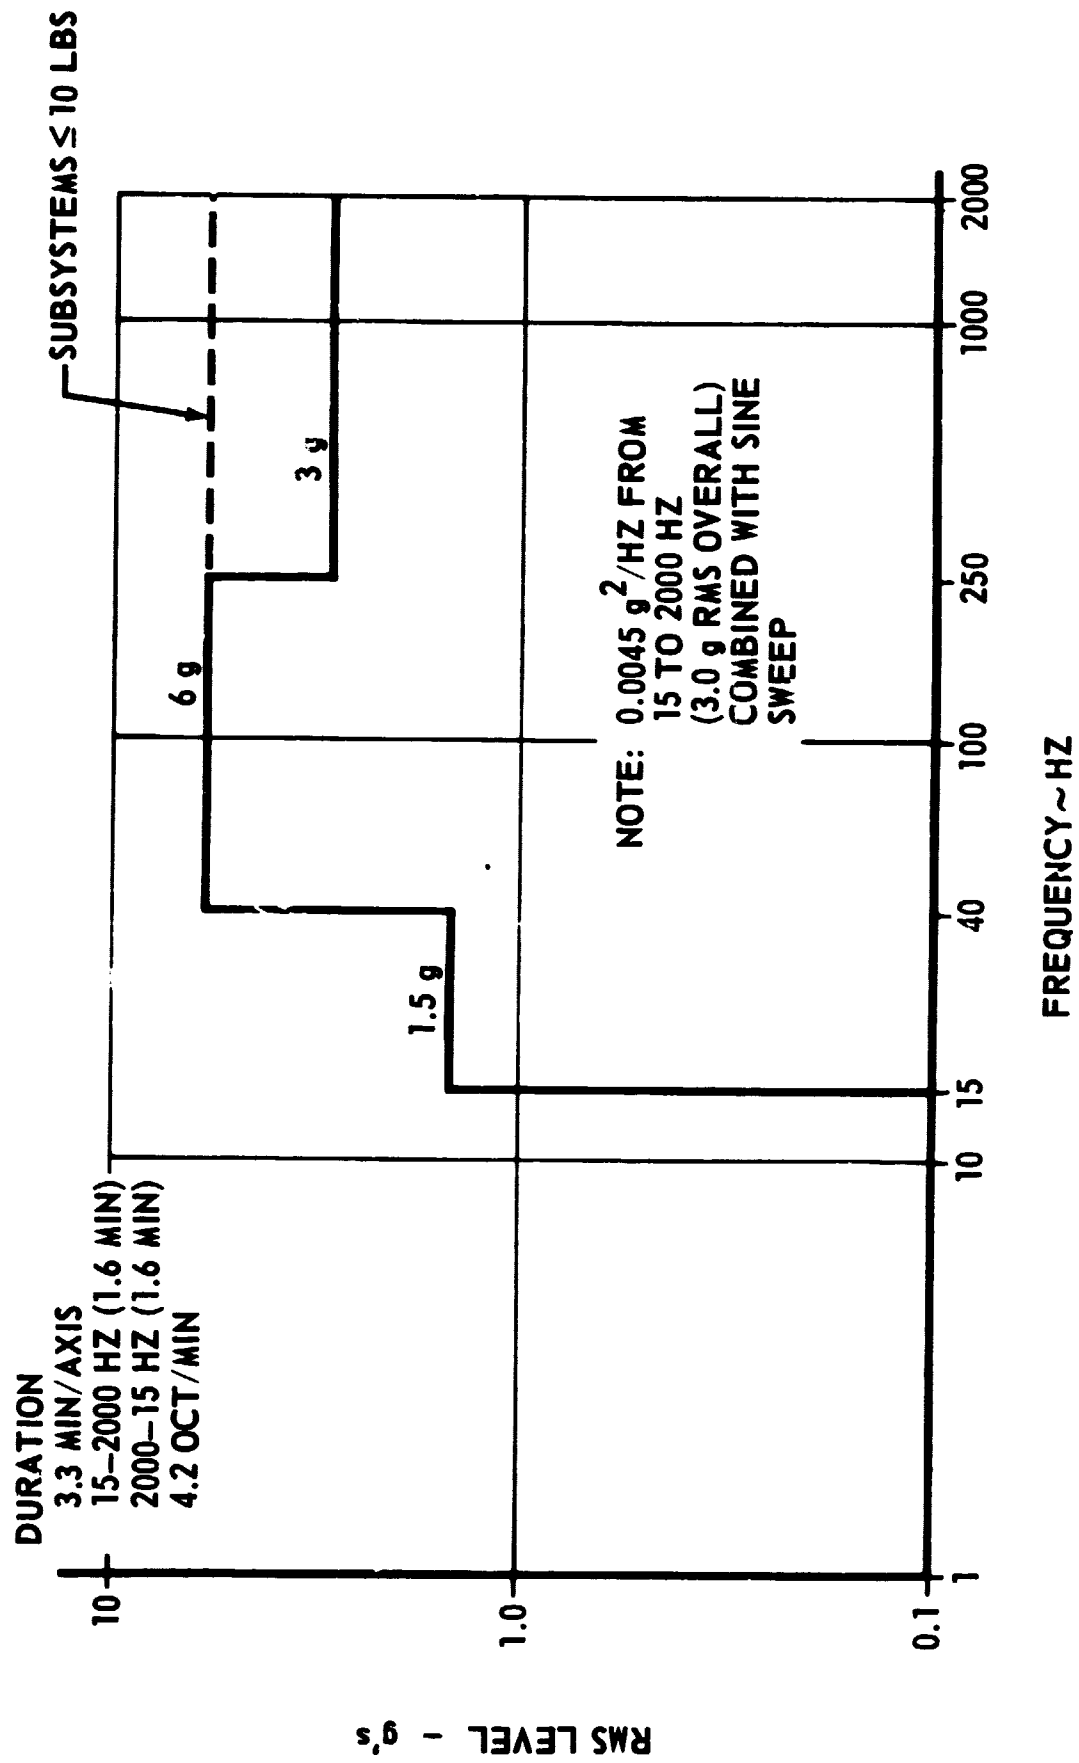
Figure 3-7: SUBSYSTEM ACCEPTANCE TEST COMBINED RANDOM VIBRATION AND SINE SWEEP

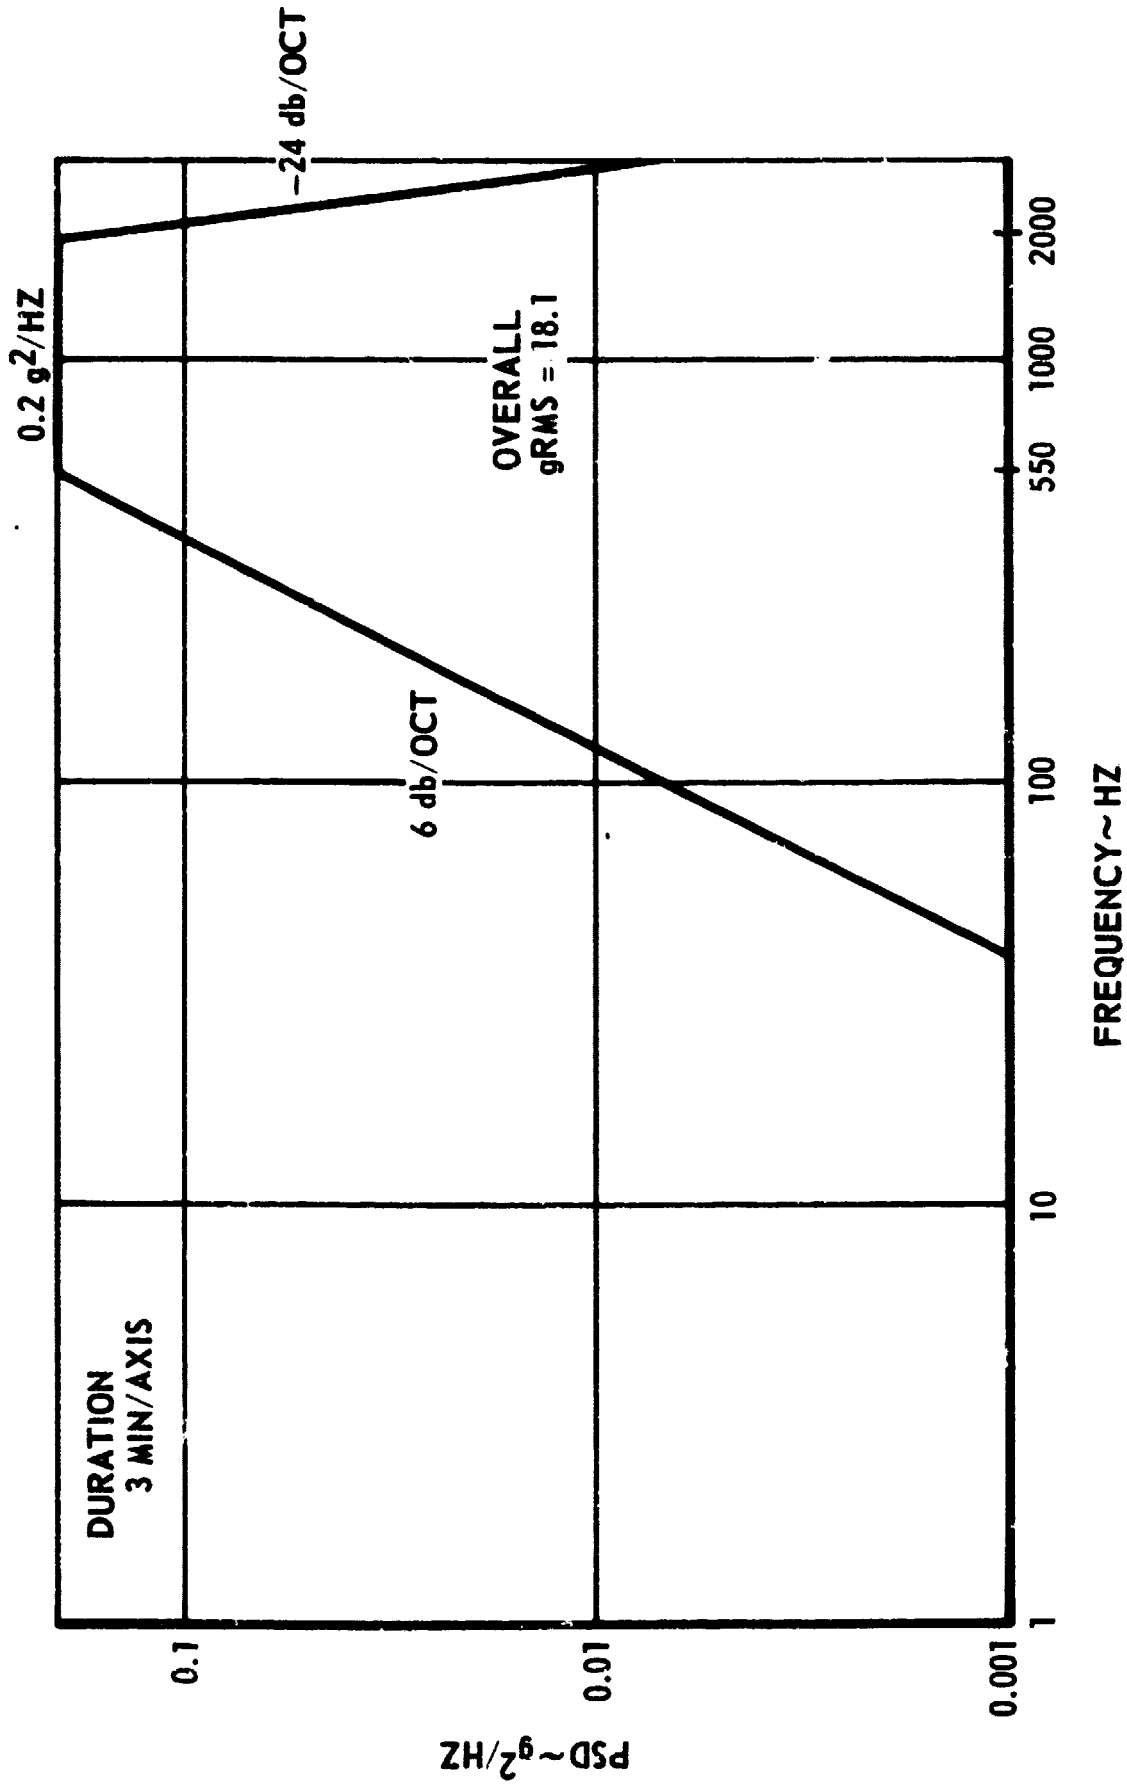
Figure 3-10: SYSTEMS QUALIFICATION TEST RANDOM VIBRATION

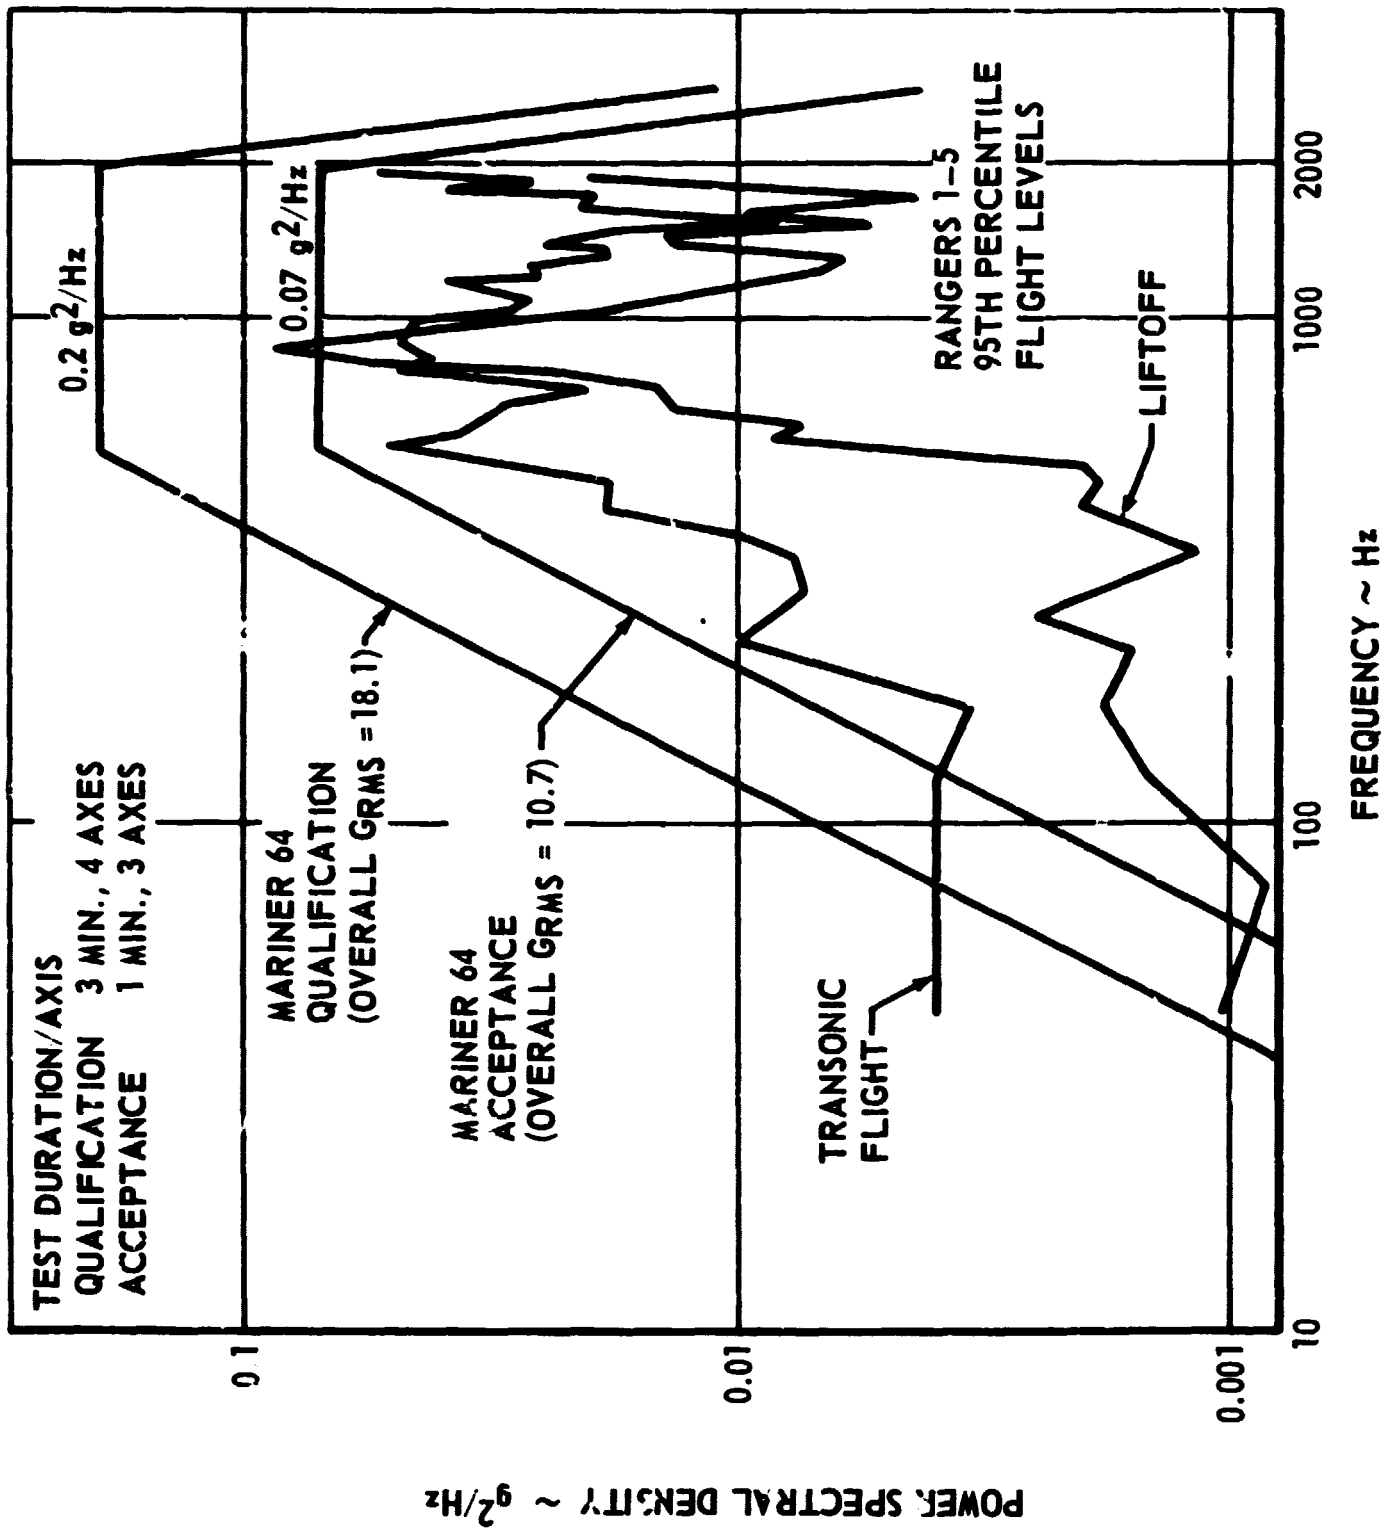
FIGURE 3-14 DERIVATION OF SYSTEM VIBRATION LEVELS

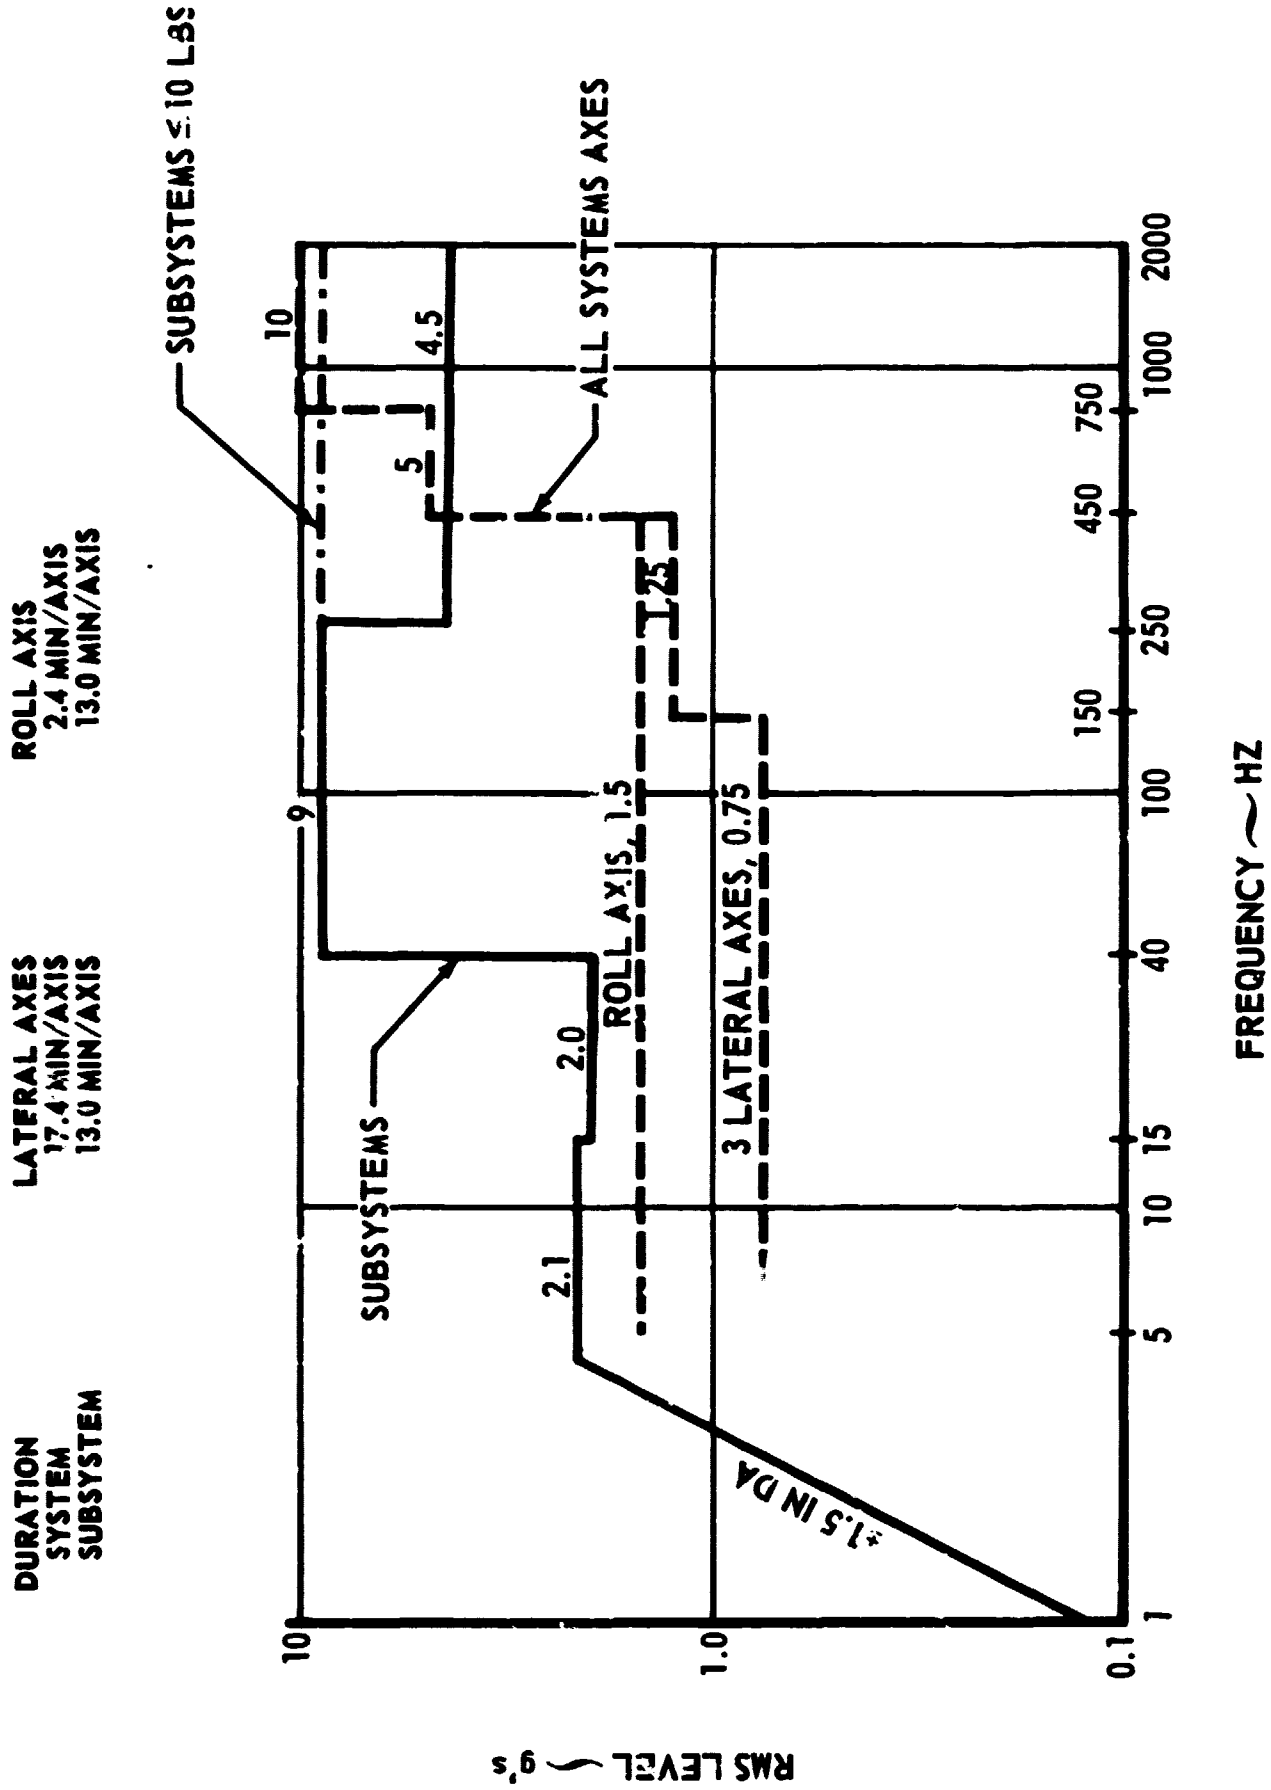
Figure 3-17: COMPARISON OF SYSTEM AND SUBSYSTEM QUALIFICATION LEVELS - SINE SWEEP VIBRATION

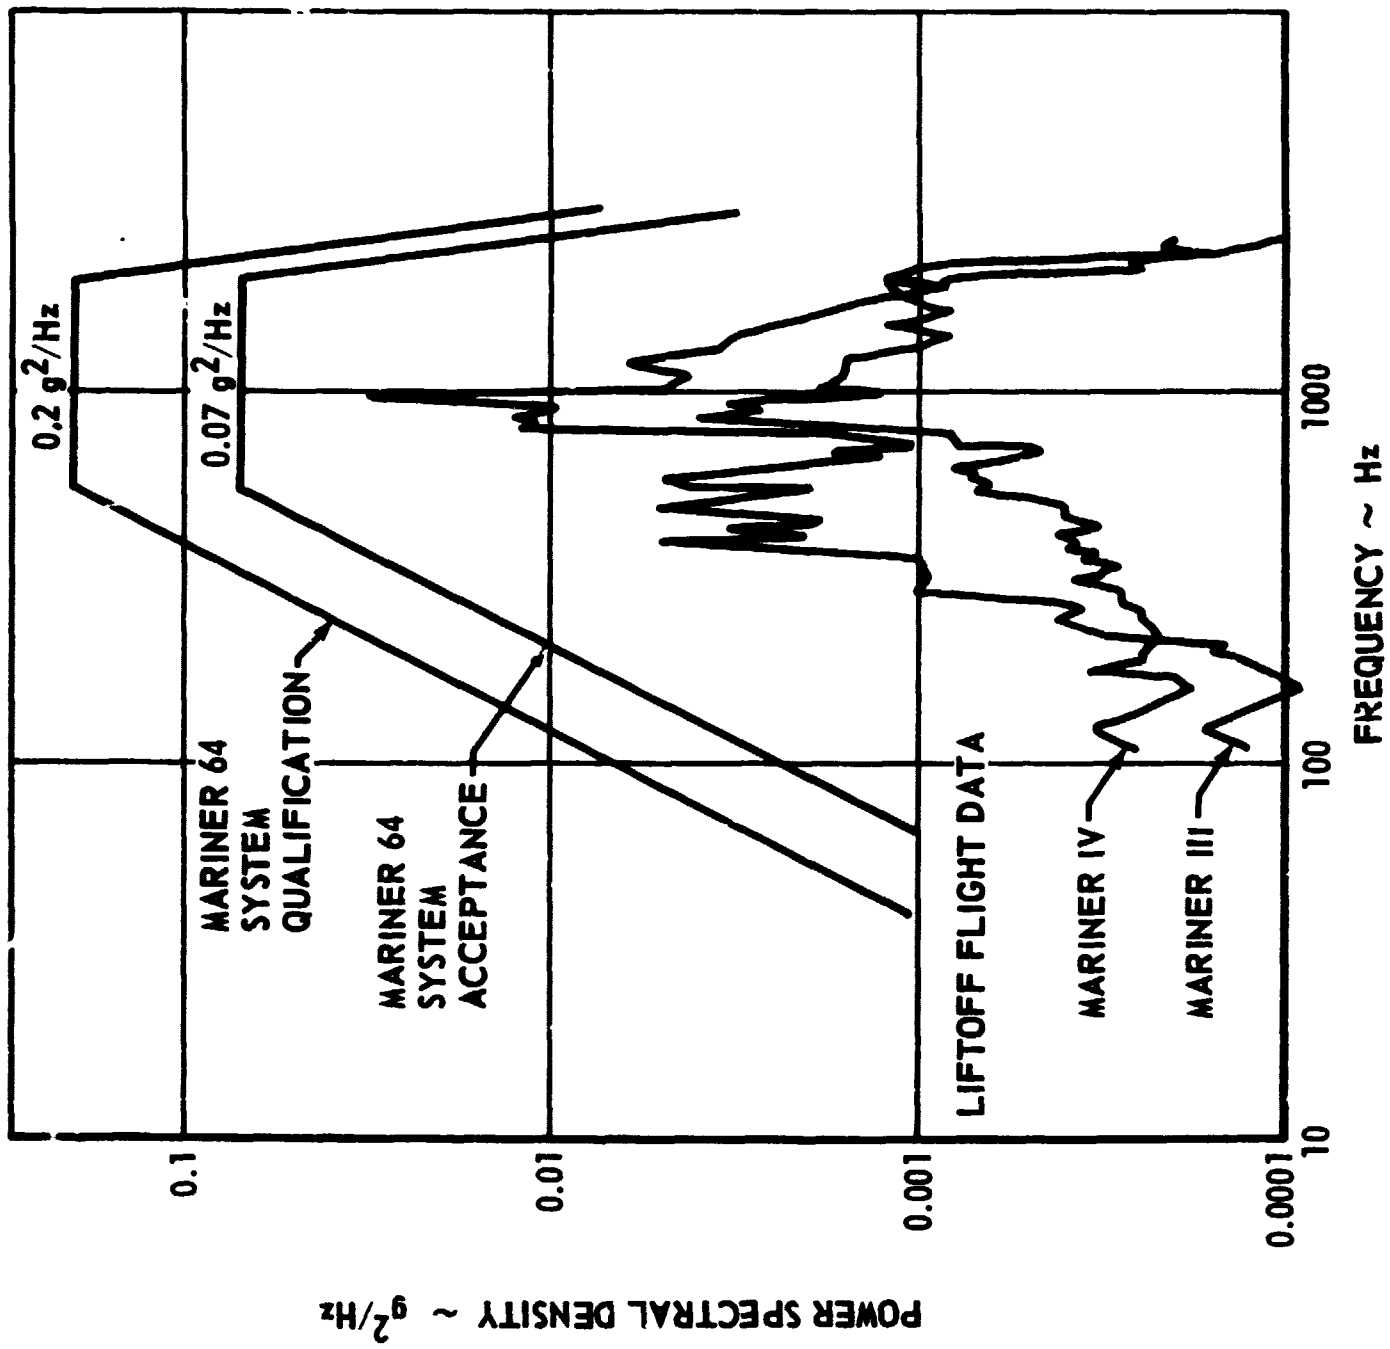
Figure 3-19: COMPARISON OF FLIGHT VIBRATION DATA AND SYSTEM TEST LEVELS - LIFTOFF

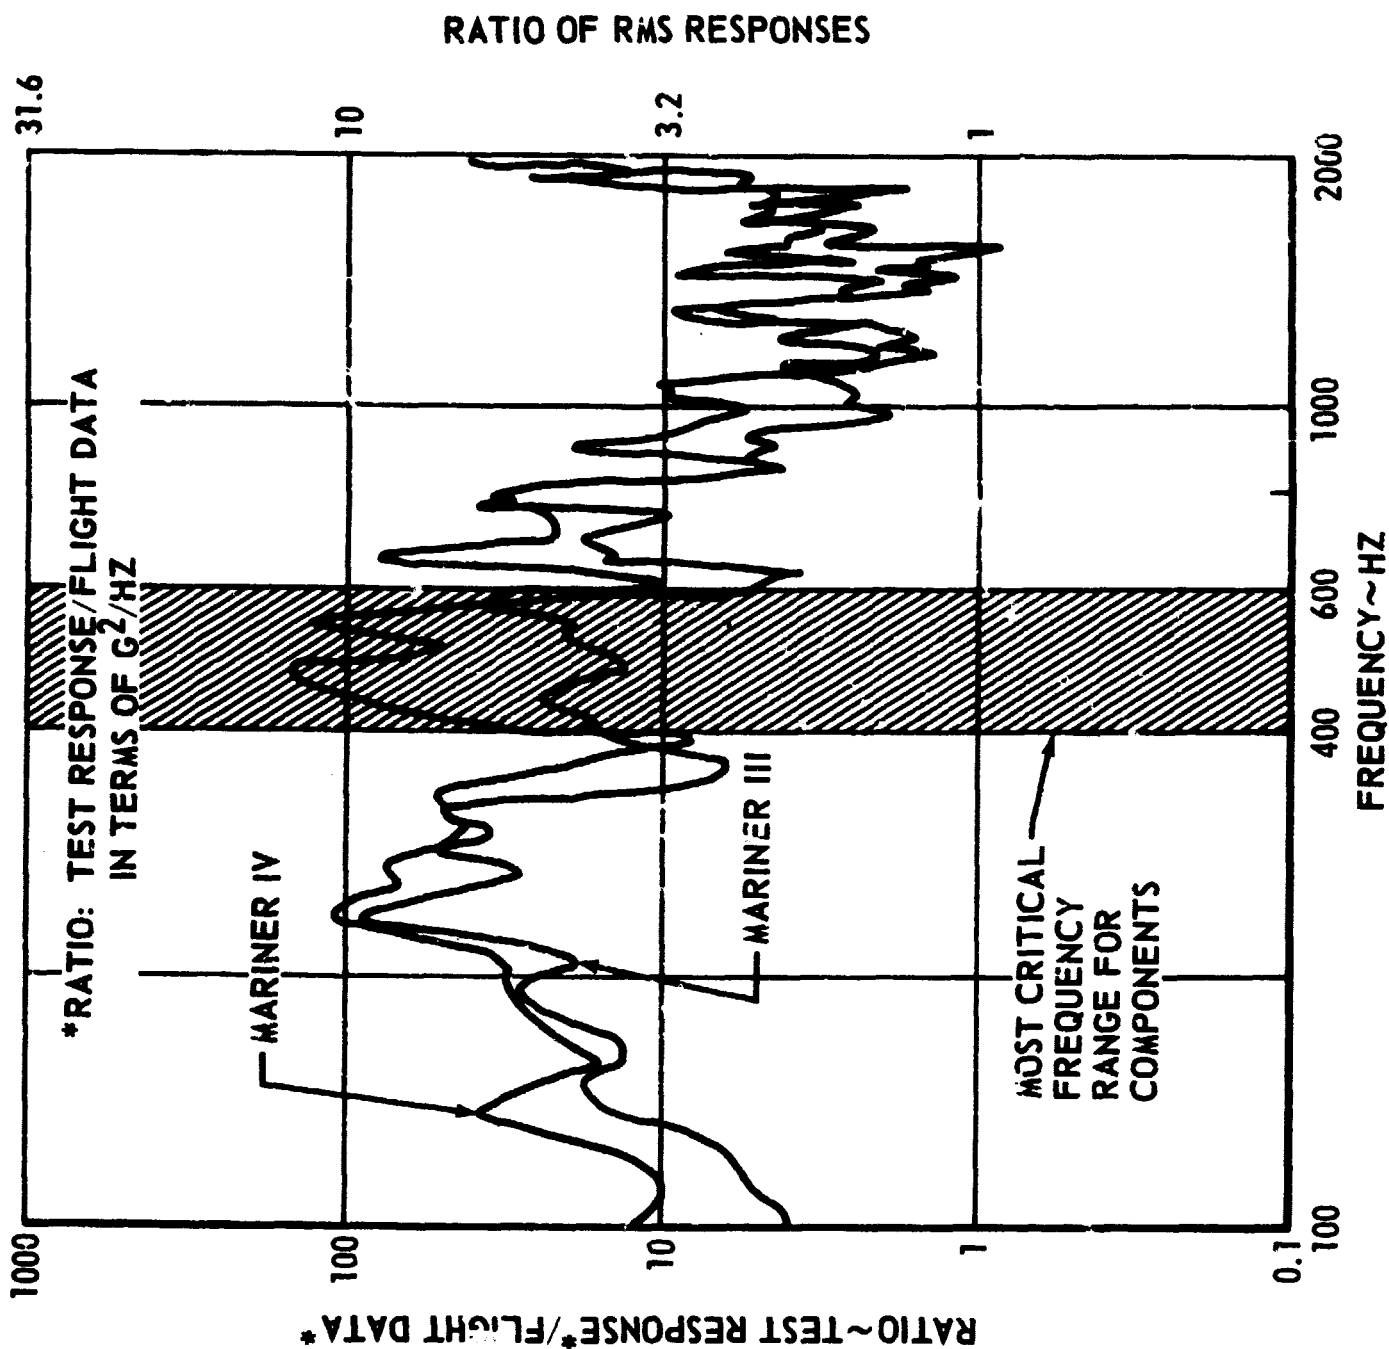
Figure 3-21: COMPARISON OF LAB TEST VIBRATION RESPONSE TO MEASURED FLIGHT RESPONSE ON SPACECRAFT ADAPTER

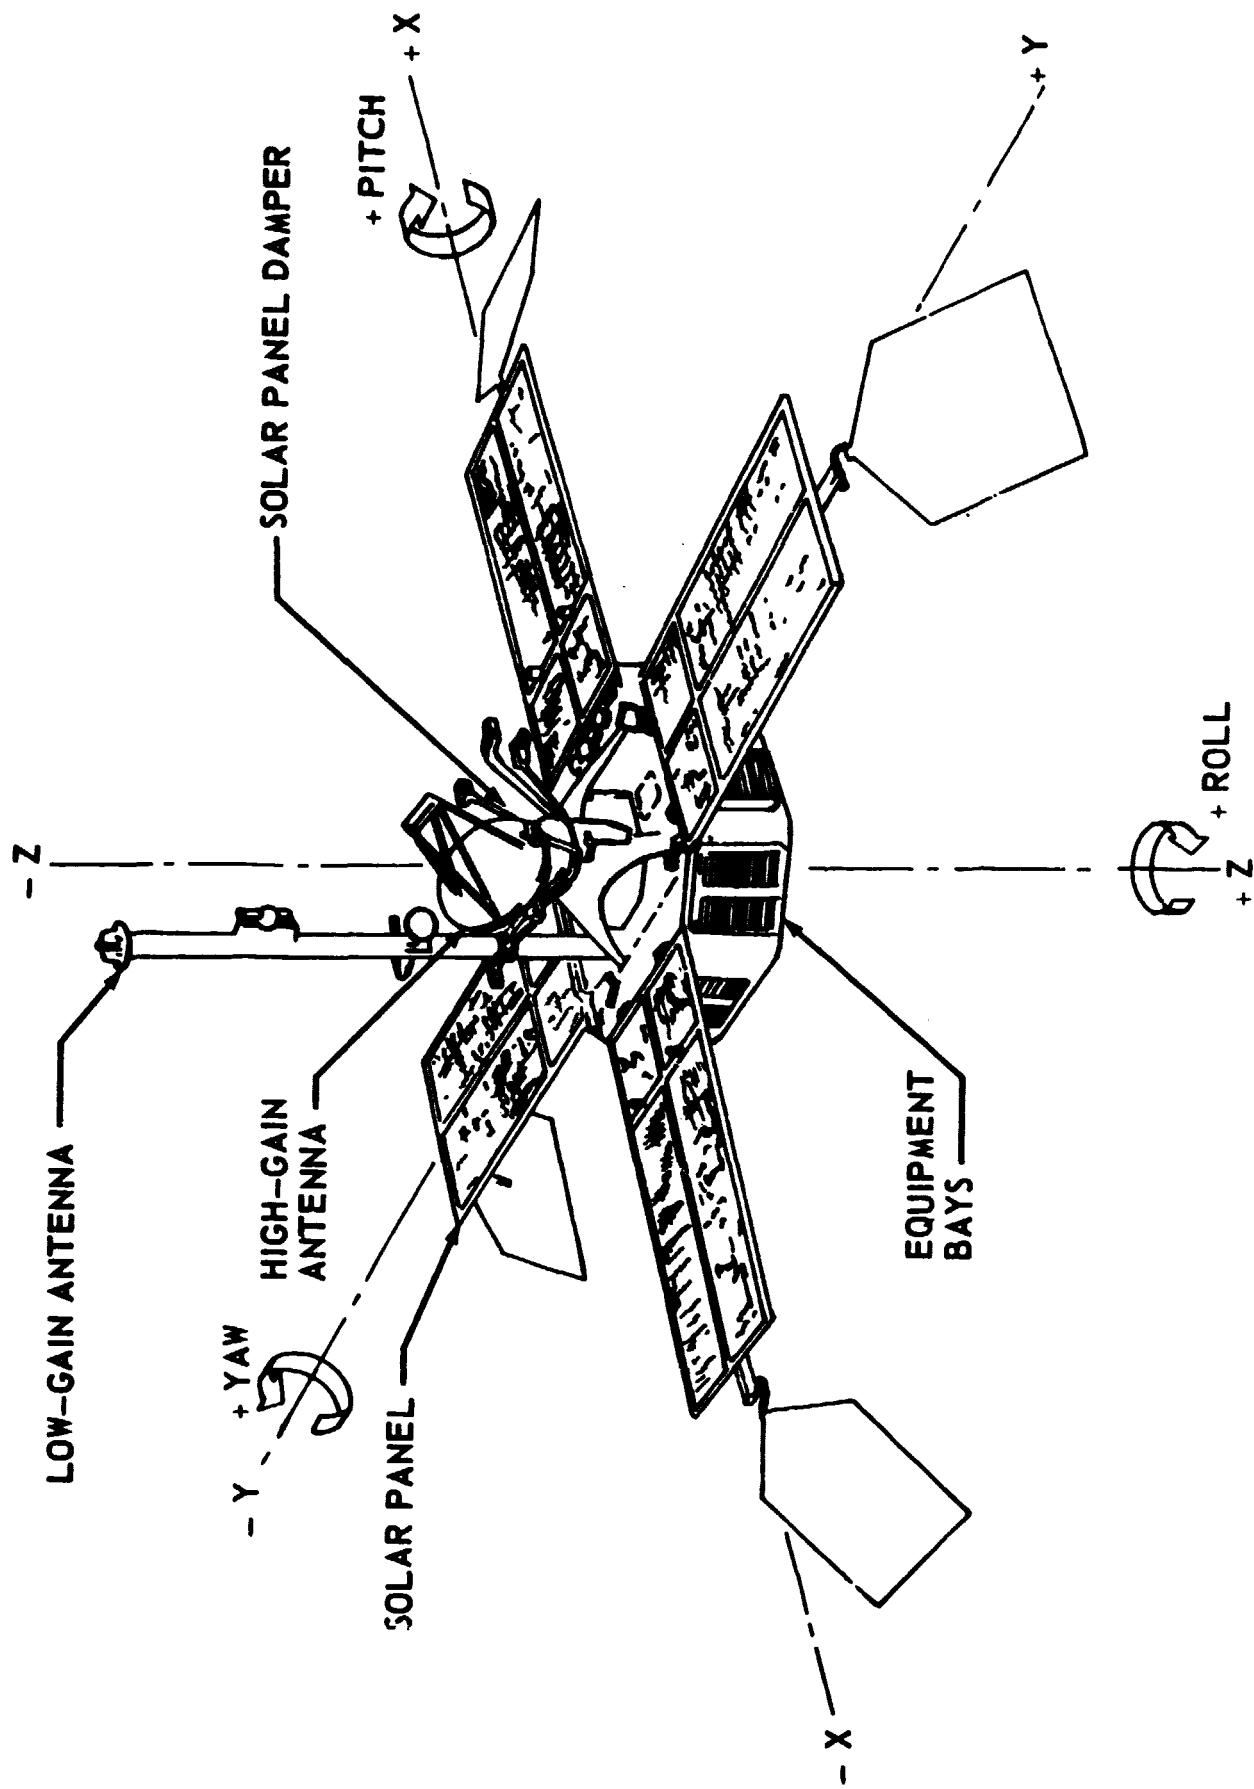
FIGURE 4-1. MARINER 67 CONFIGURATION

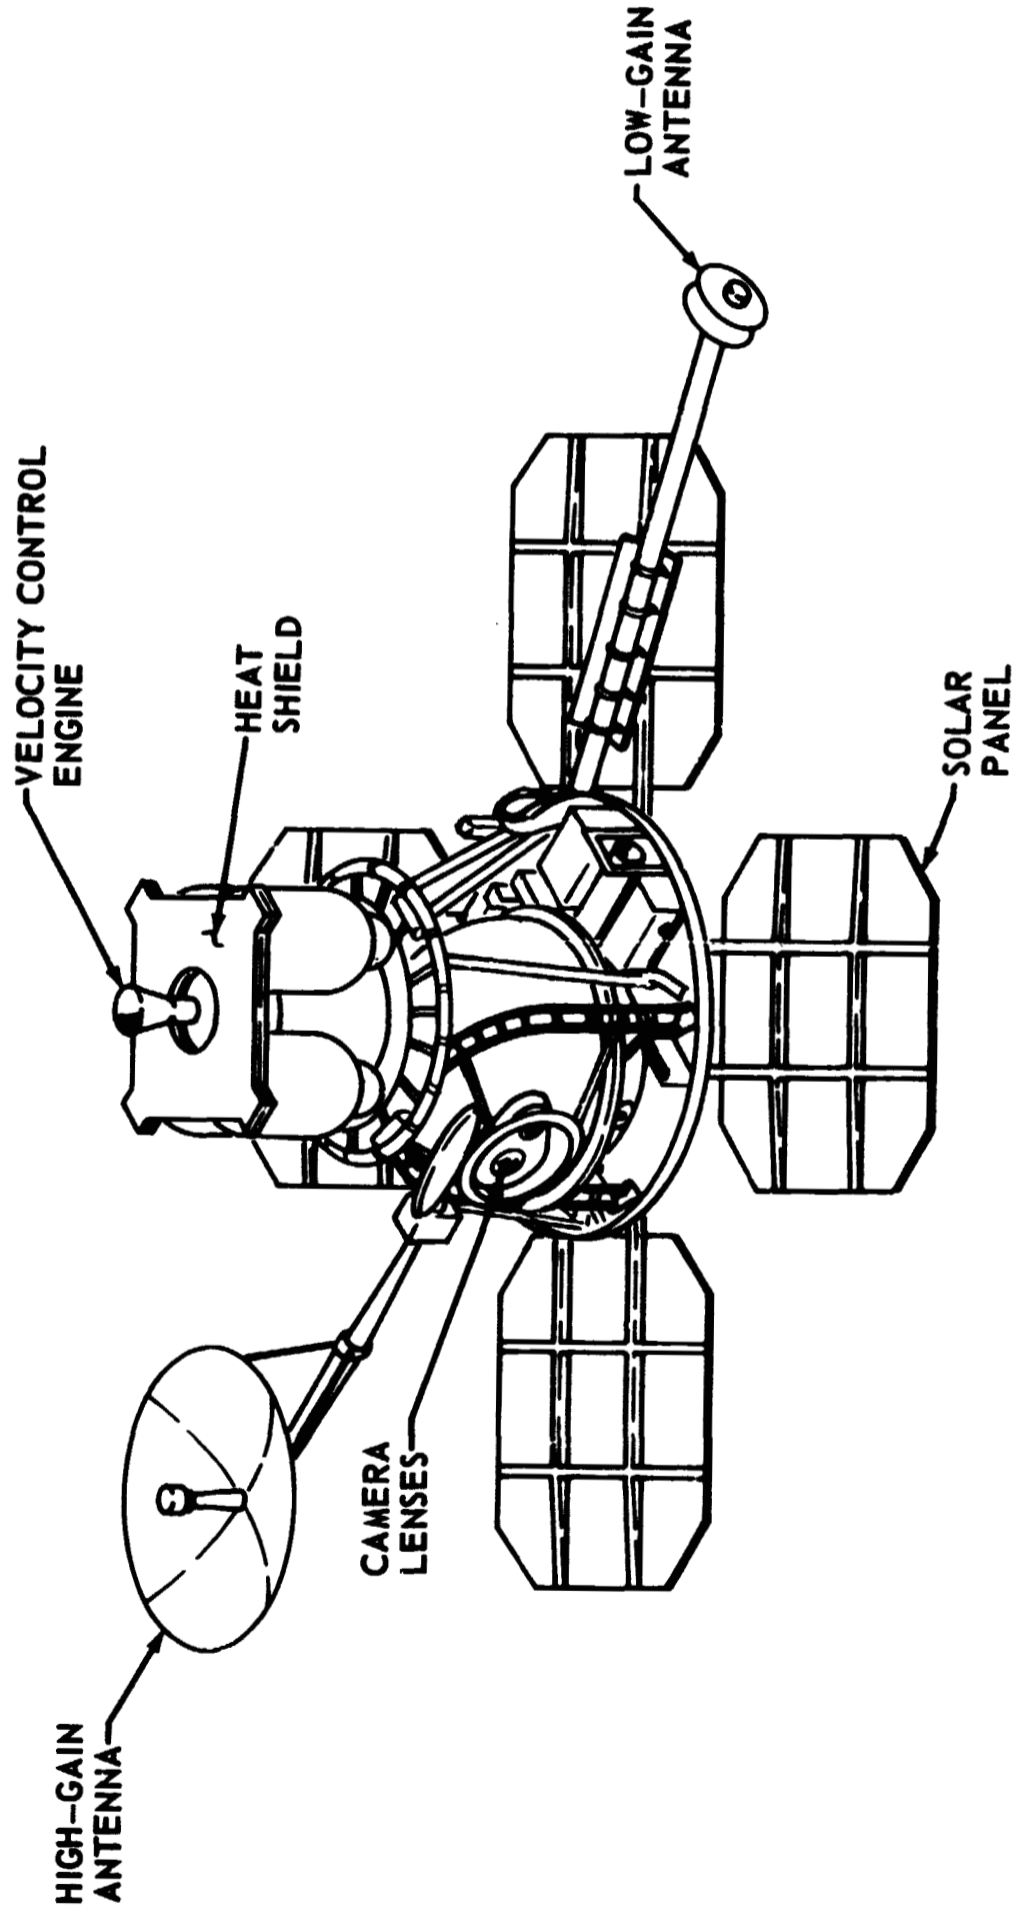
FIGURE 5-1. LUNAR ORBITER CONFIGURATION (THERMAL BARRIER REMOVED)
