**APOLLO TIE
WASHINGTON, D. C.**

DOCUMENT NO. D2-120001-2

TITLE SUMMARY OF VIBRATION AND ACOUSTIC TESTS ON
FOUR SPACECRAFT PROGRAMS

This document summarizes the vibration and acoustic test programs for four spacecraft: Mariner, Lunar Orbiter, Gemini and Surveyor. Information is presented on laboratory test programs and results, flight results, derivation of test levels, identification of test factors, and spacecraft contractor conclusions and recommendations.

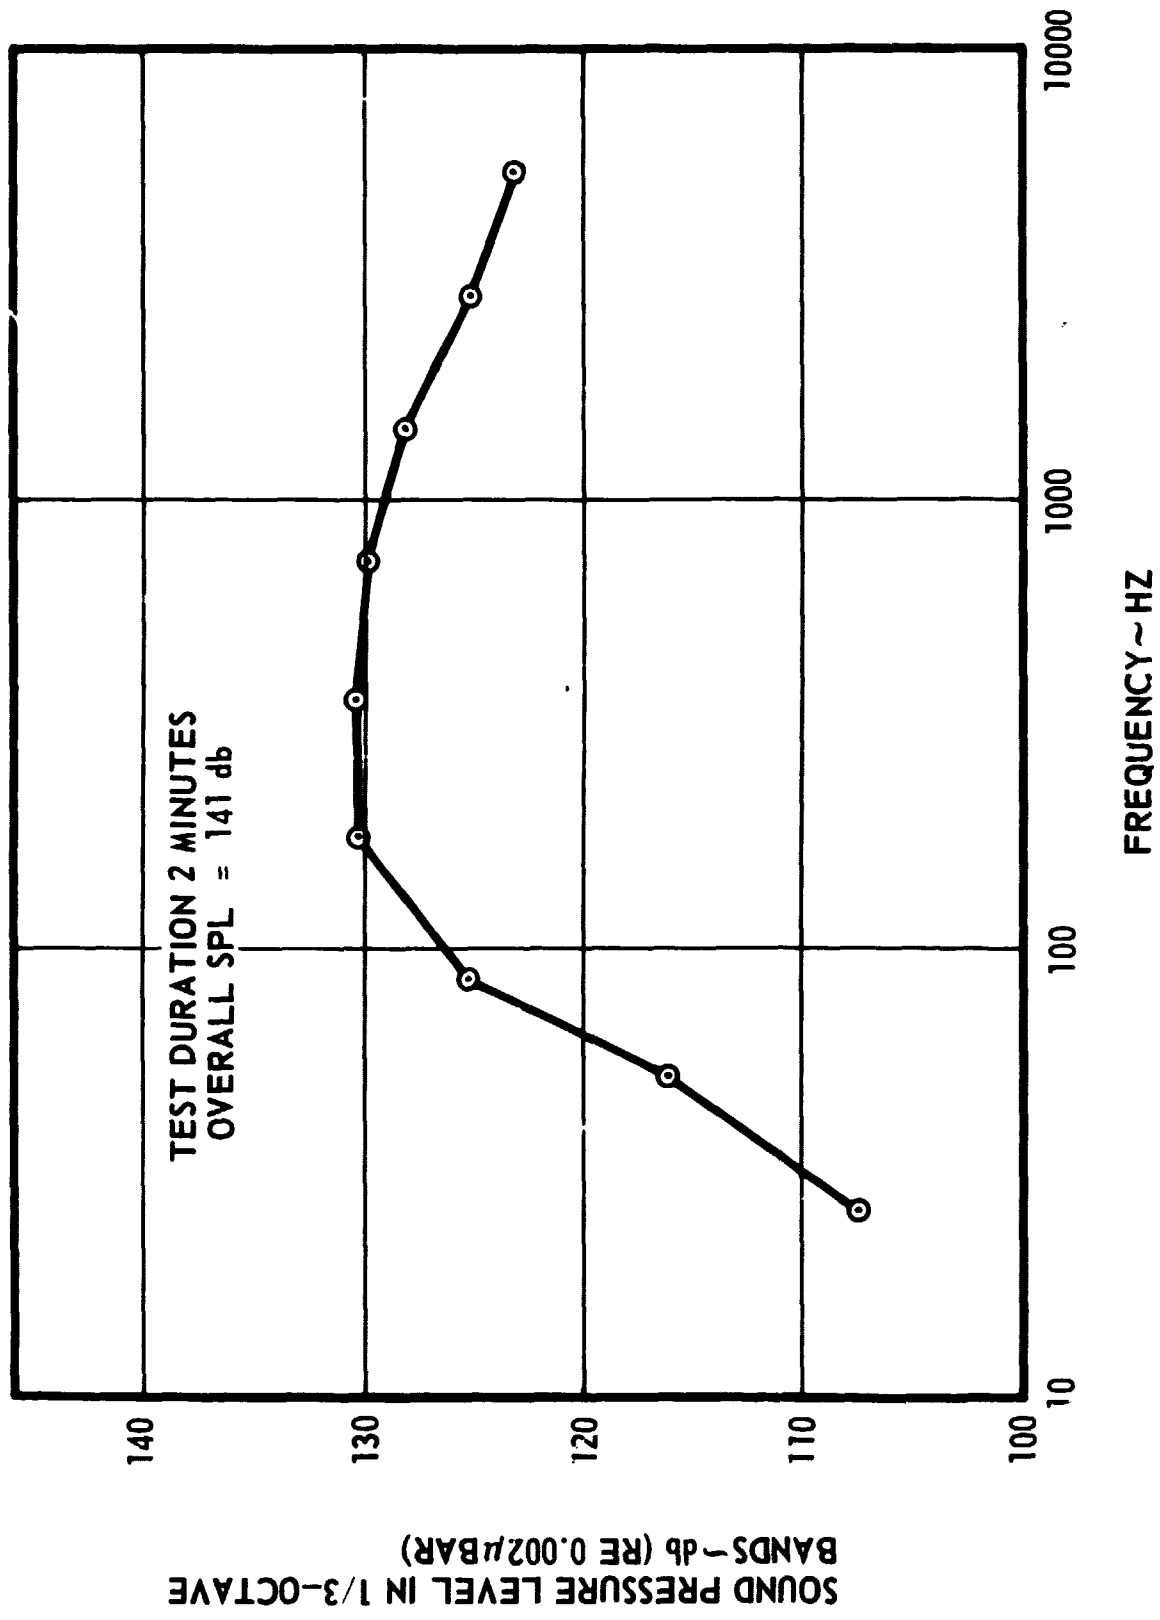
Figure 5-3. HEAT SHIELD DEVELOPMENT TEST
ACOUSTIC NOISE, 1/3 OCTAVE BAND

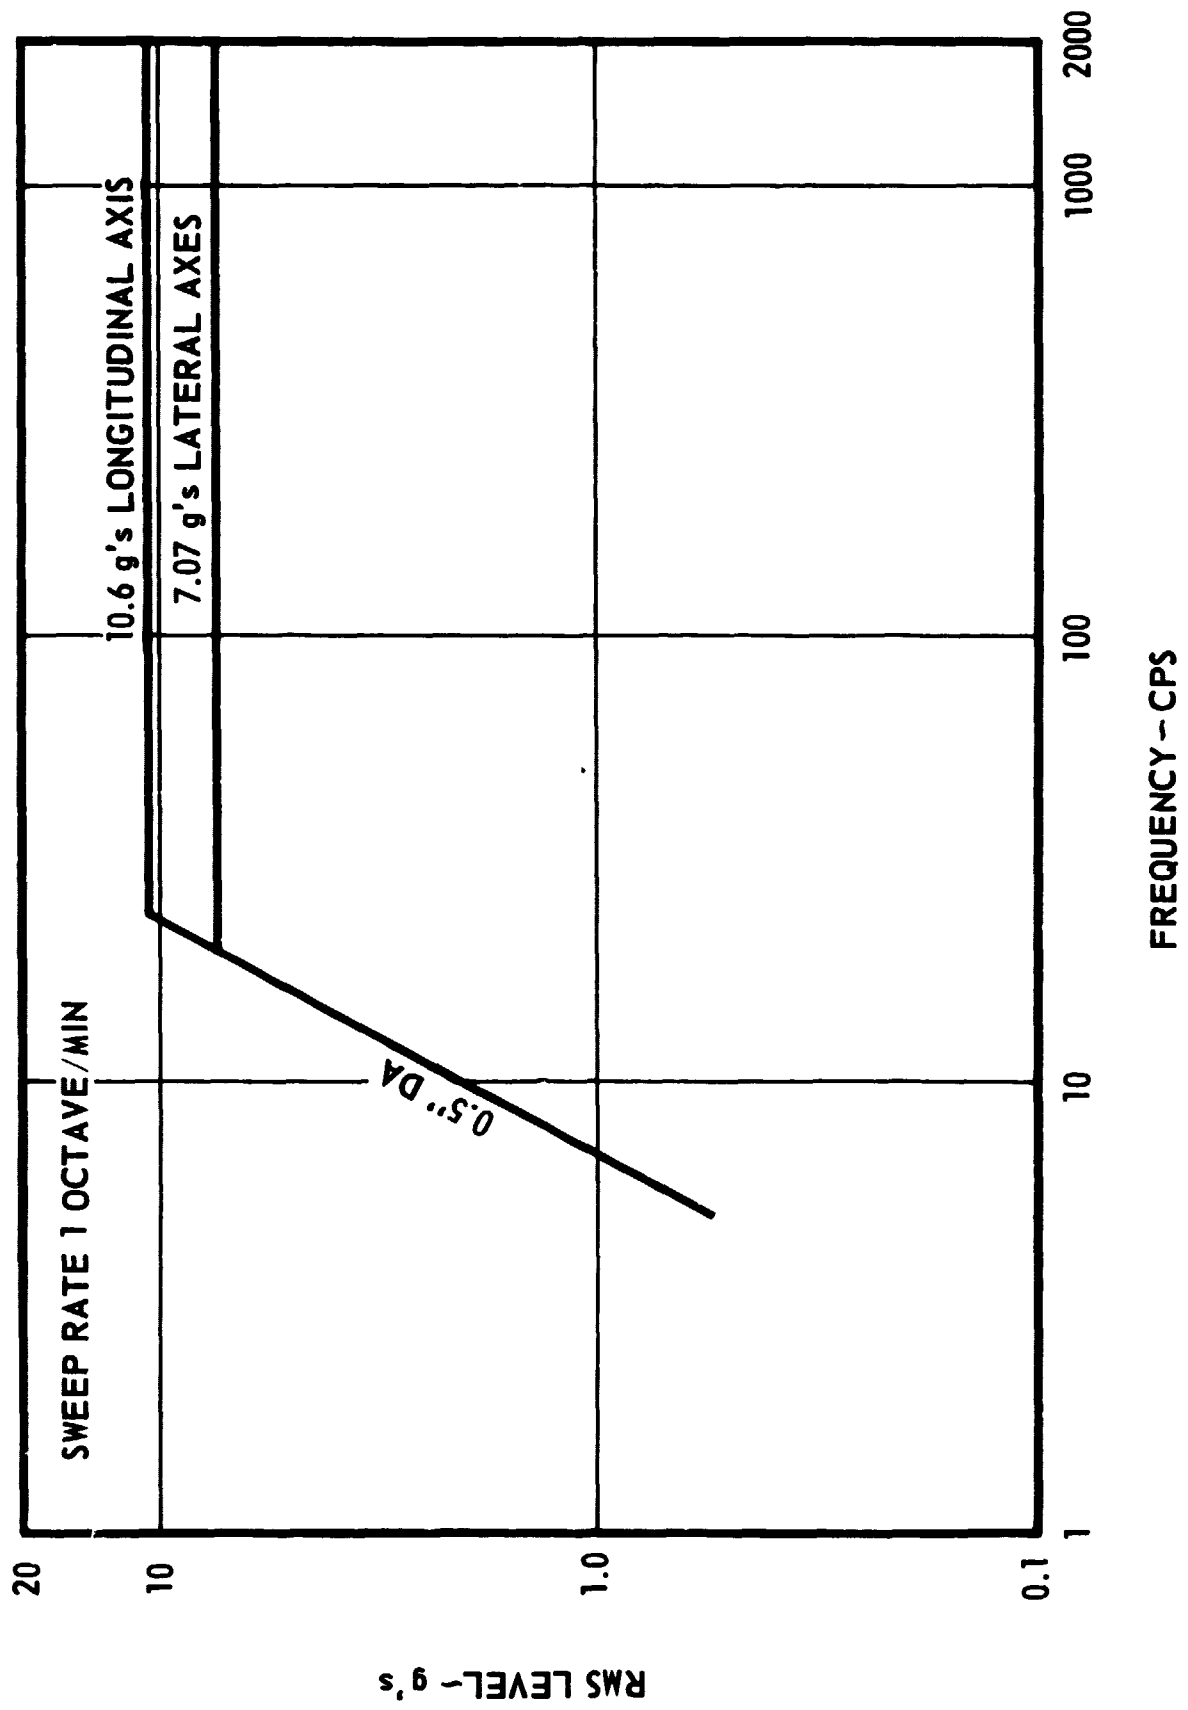
Figure 5-4. COMPONENT QUALIFICATION SINE SWEEP

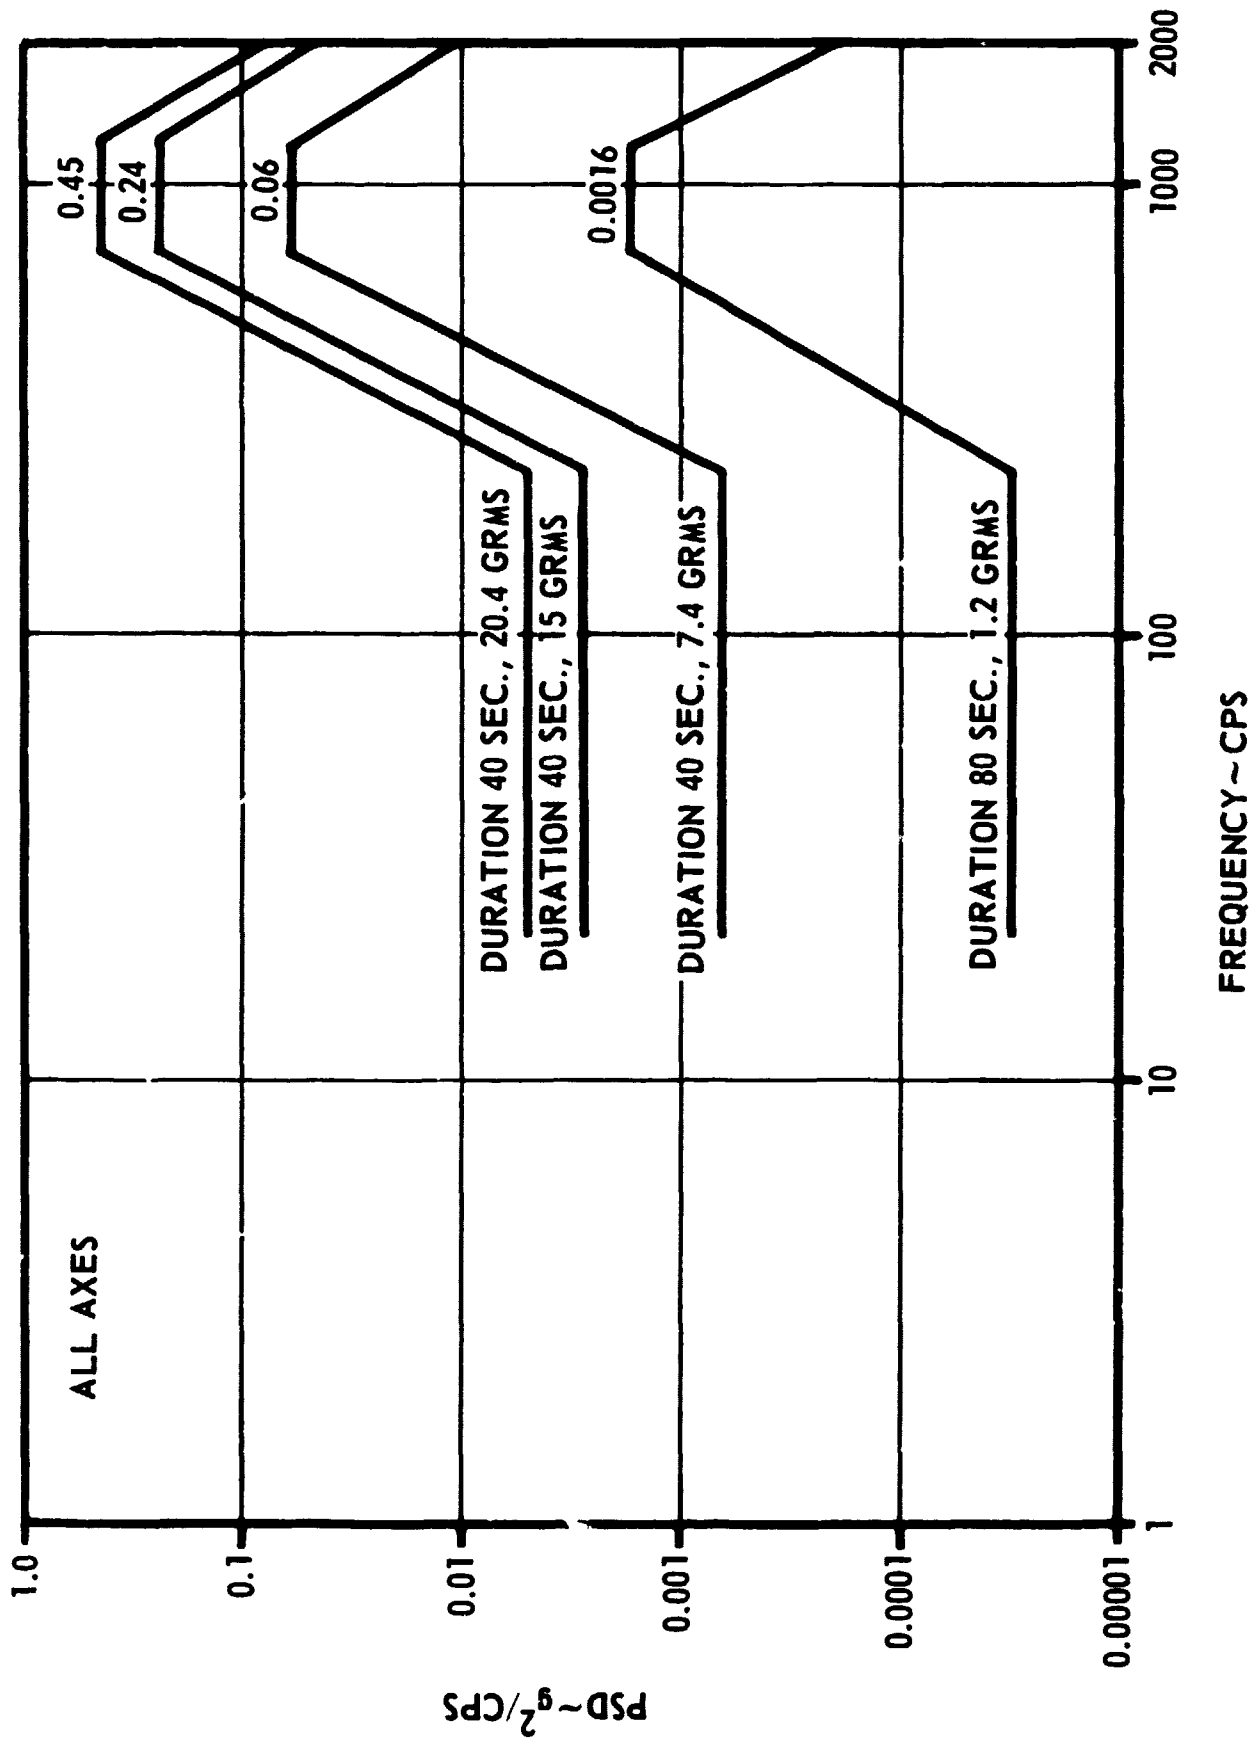
Figure 5-5. COMPONENT AND SYSTEM QUALIFICATION TEST RANDOM VIBRATION

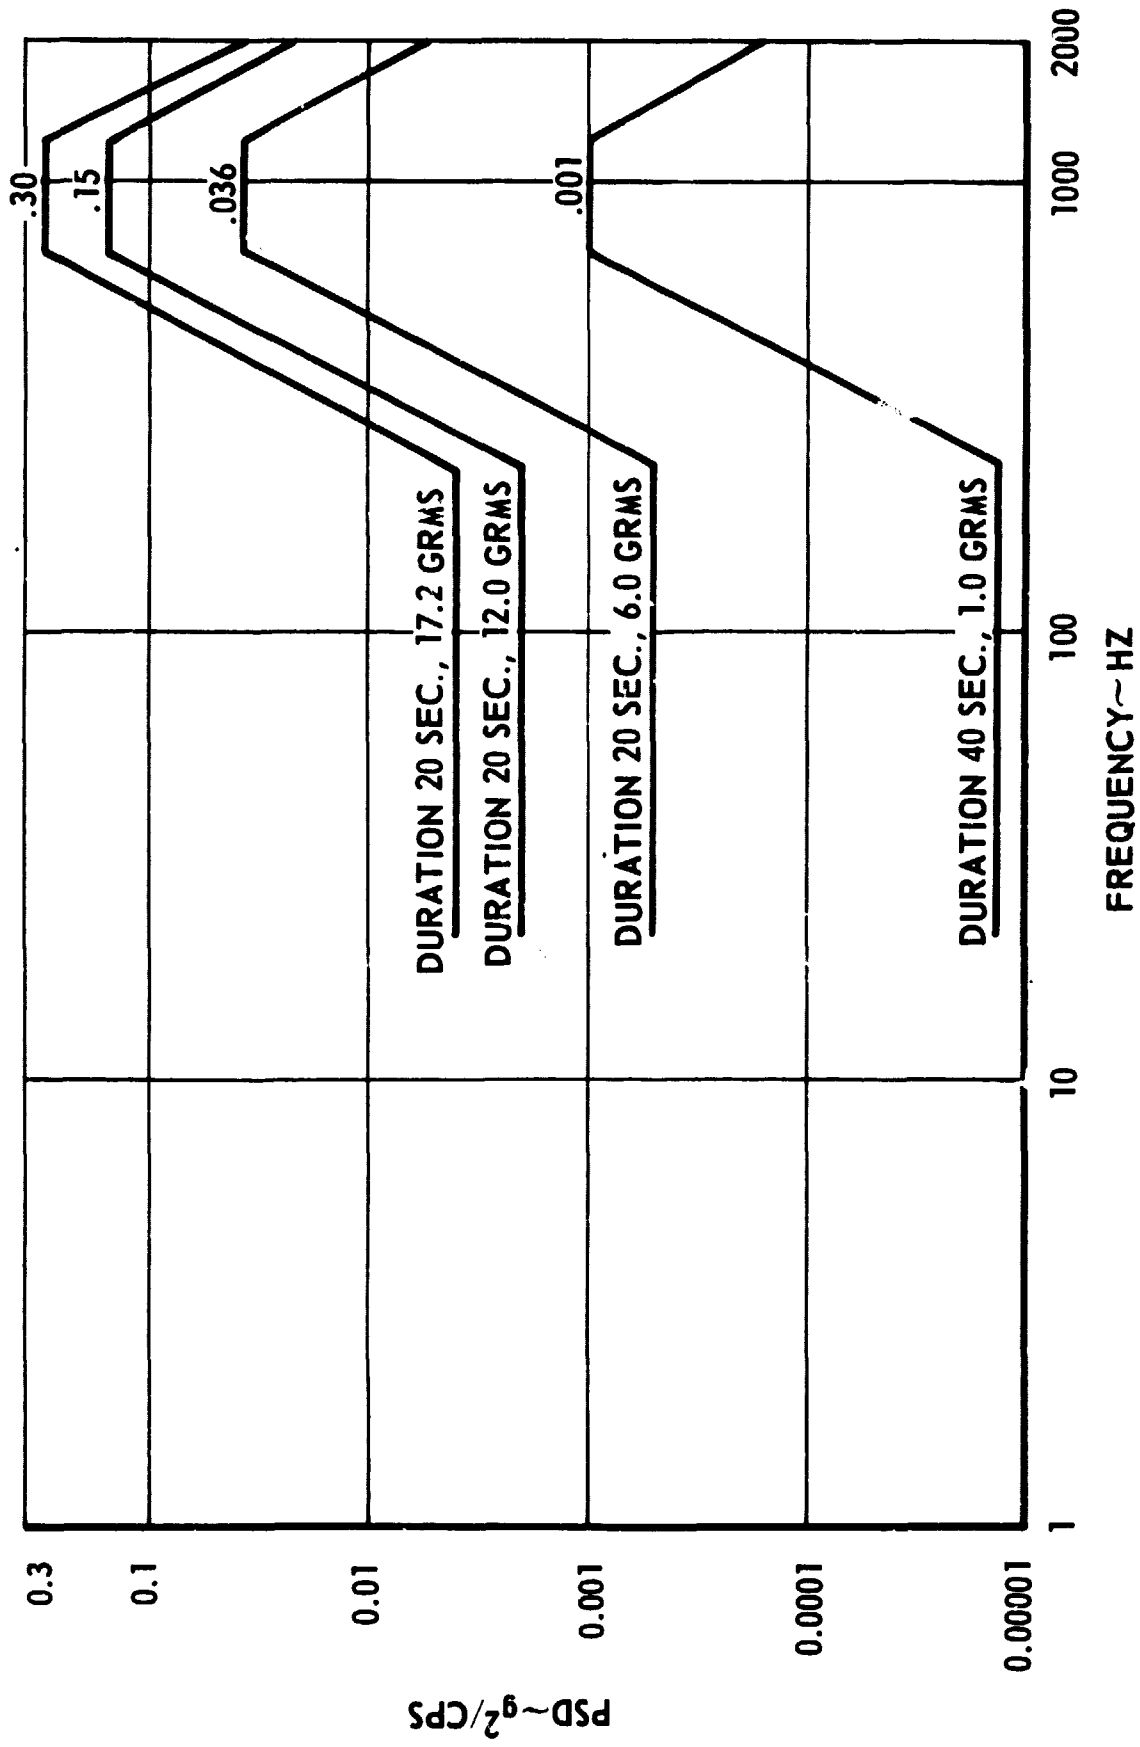
FIGURE 5-7. COMPONENT ACCEPTANCE TEST RANDOM VIBRATION

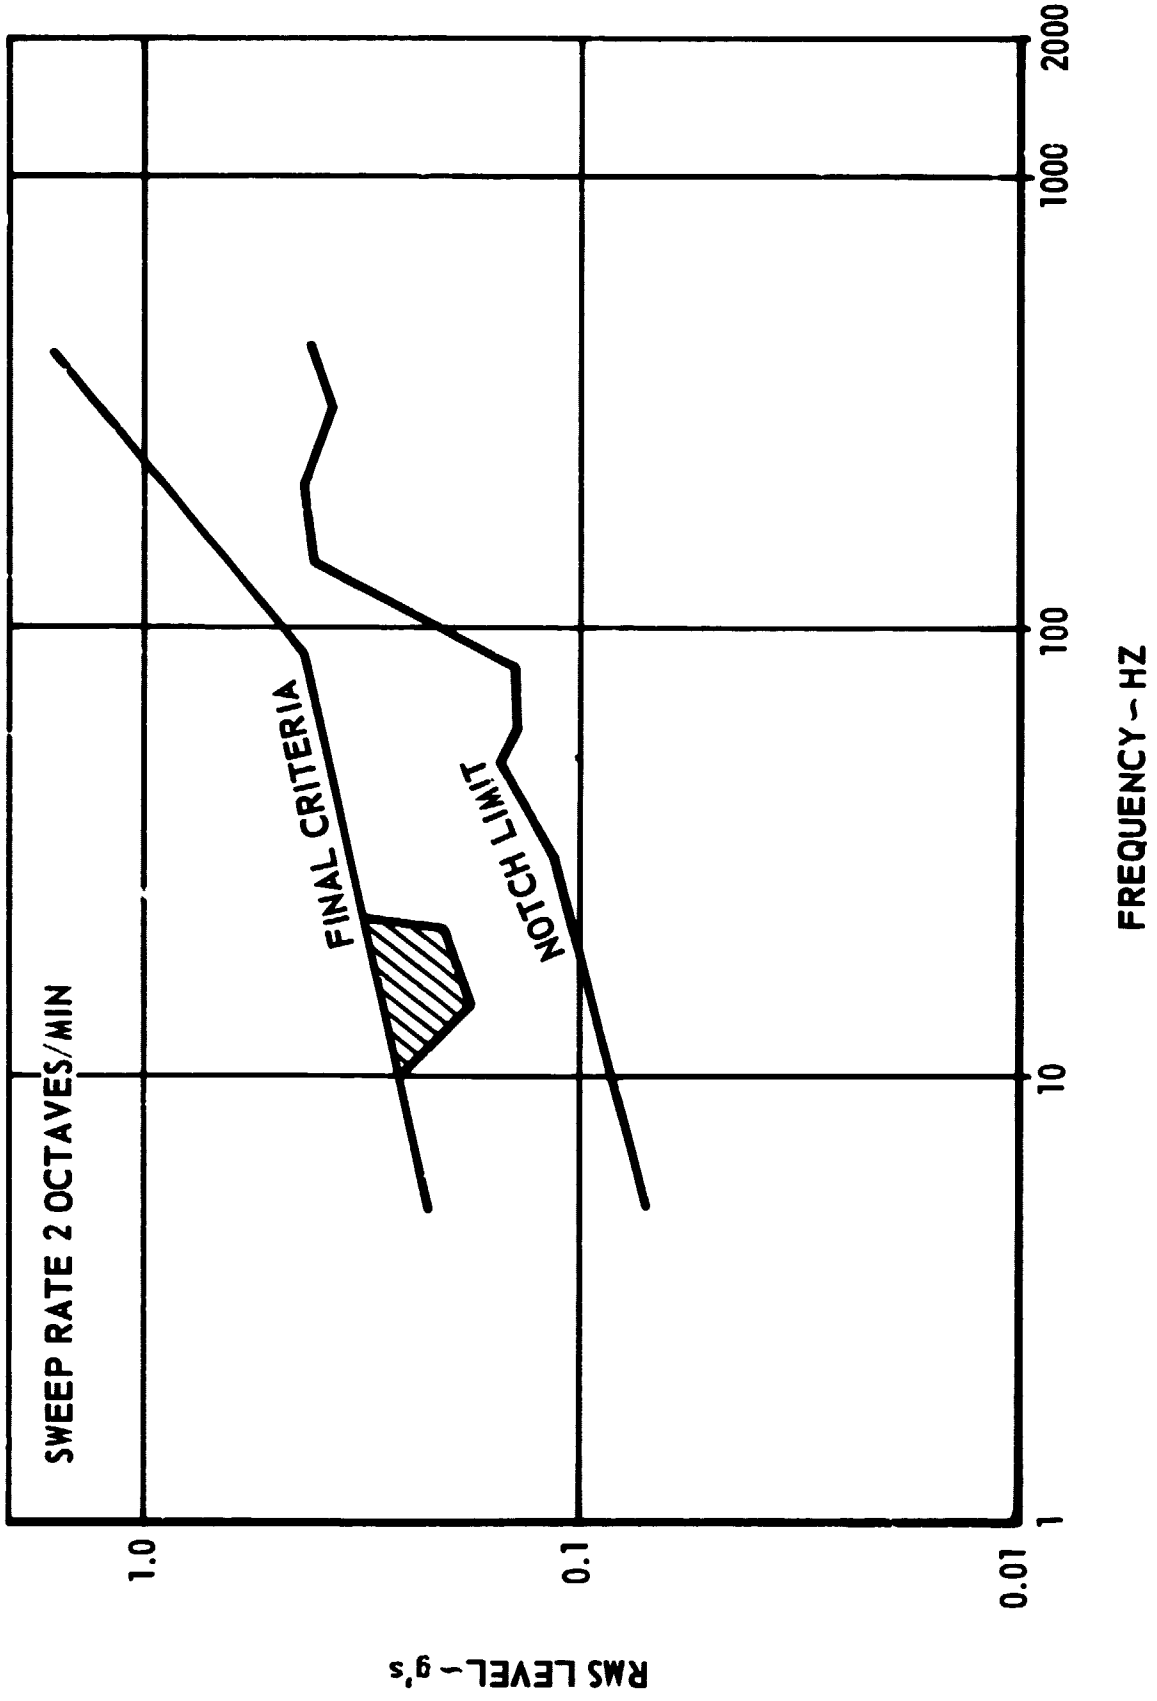
Figure 5-11. SYSTEM ACCEPTANCE TEST
SINUSOIDAL VIBRATION, LATERAL AXIS

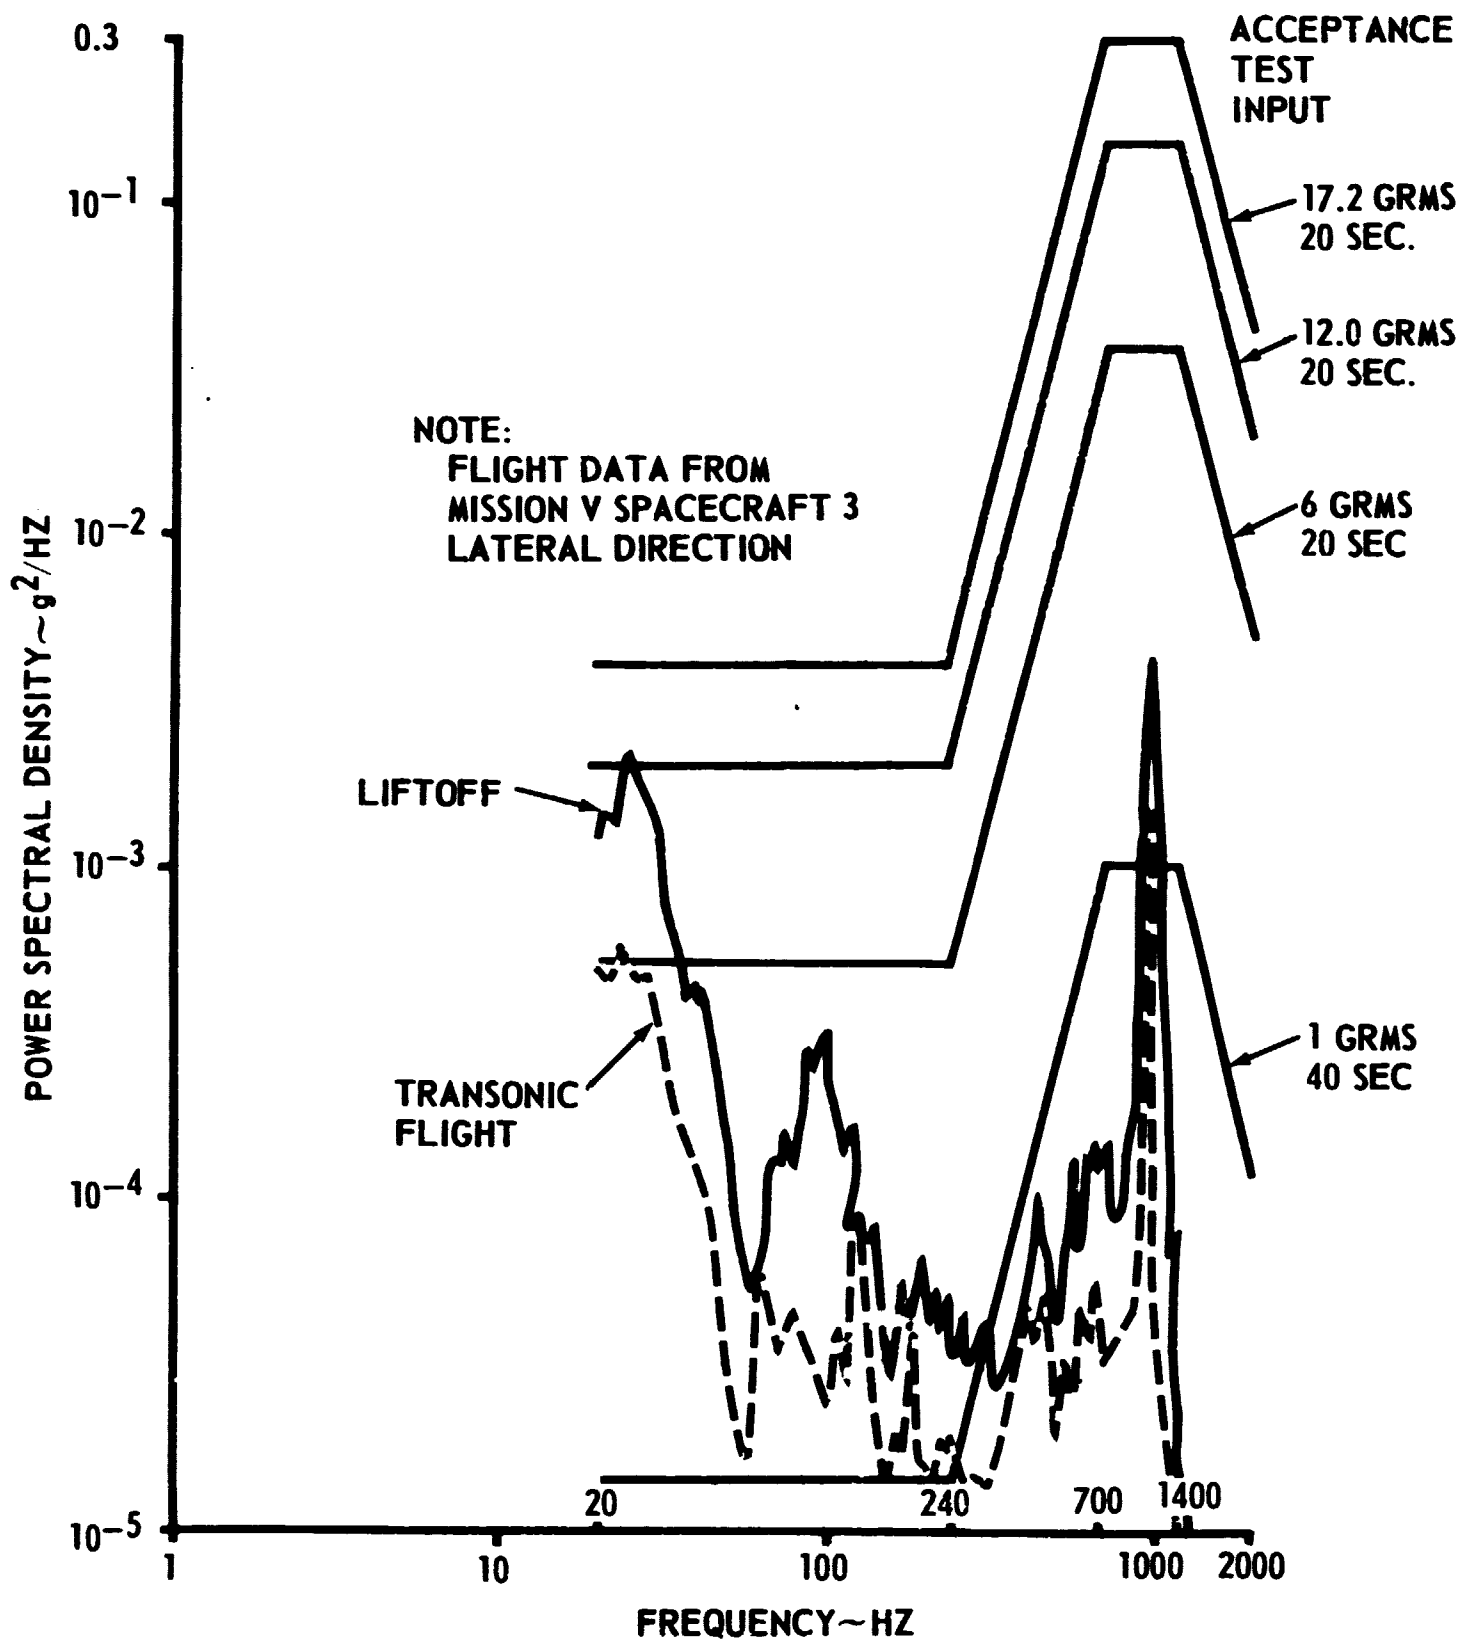
Figure 5-13. COMPARISON OF ACCEPTANCE TEST LEVELS WITH MEASURED FLIGHT RESPONSE LEVELS, RANDOM VIBRATION

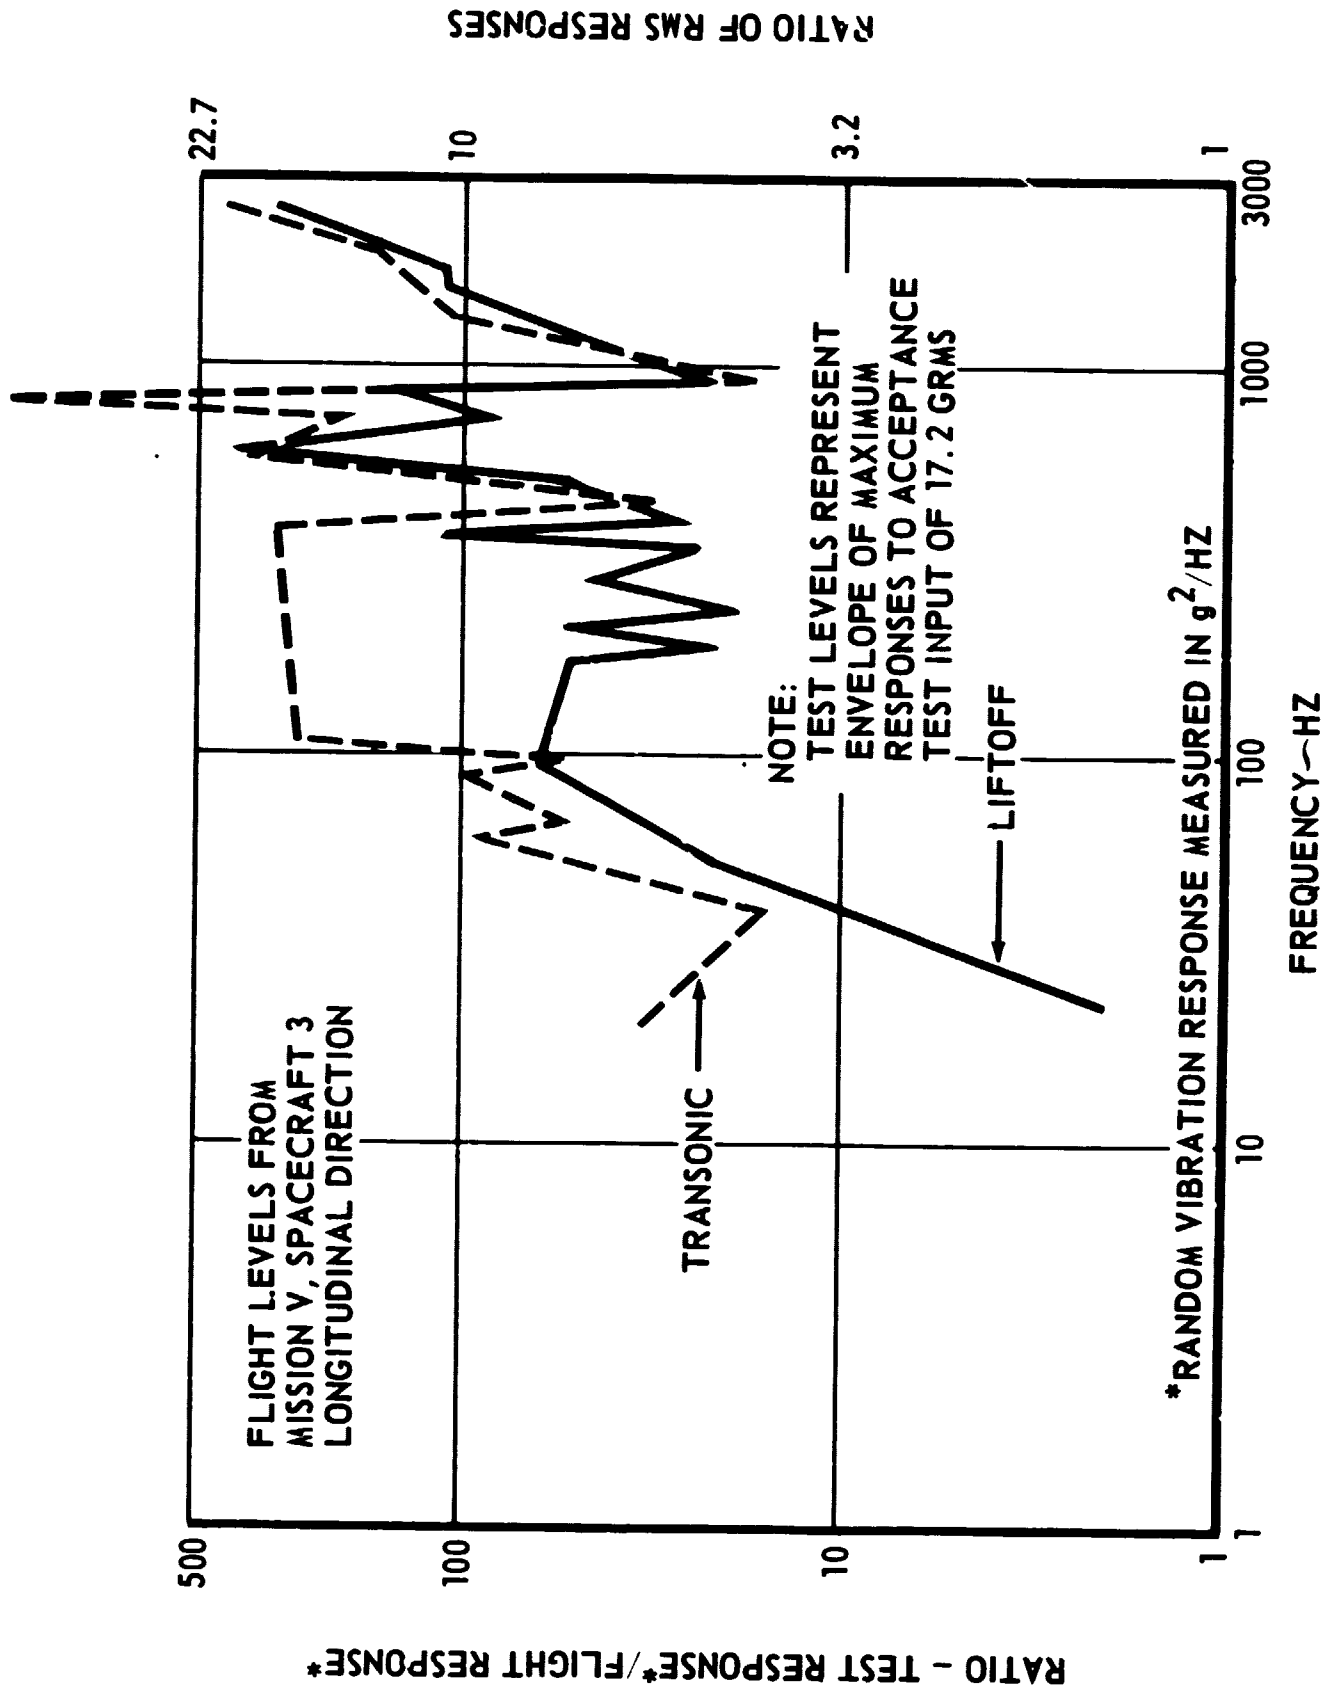
Figure 5-14. COMPARISON OF LAB TEST VIBRATION RESPONSE TO MEASURED FLIGHT RESPONSE IN LONGITUDINAL DIRECTION

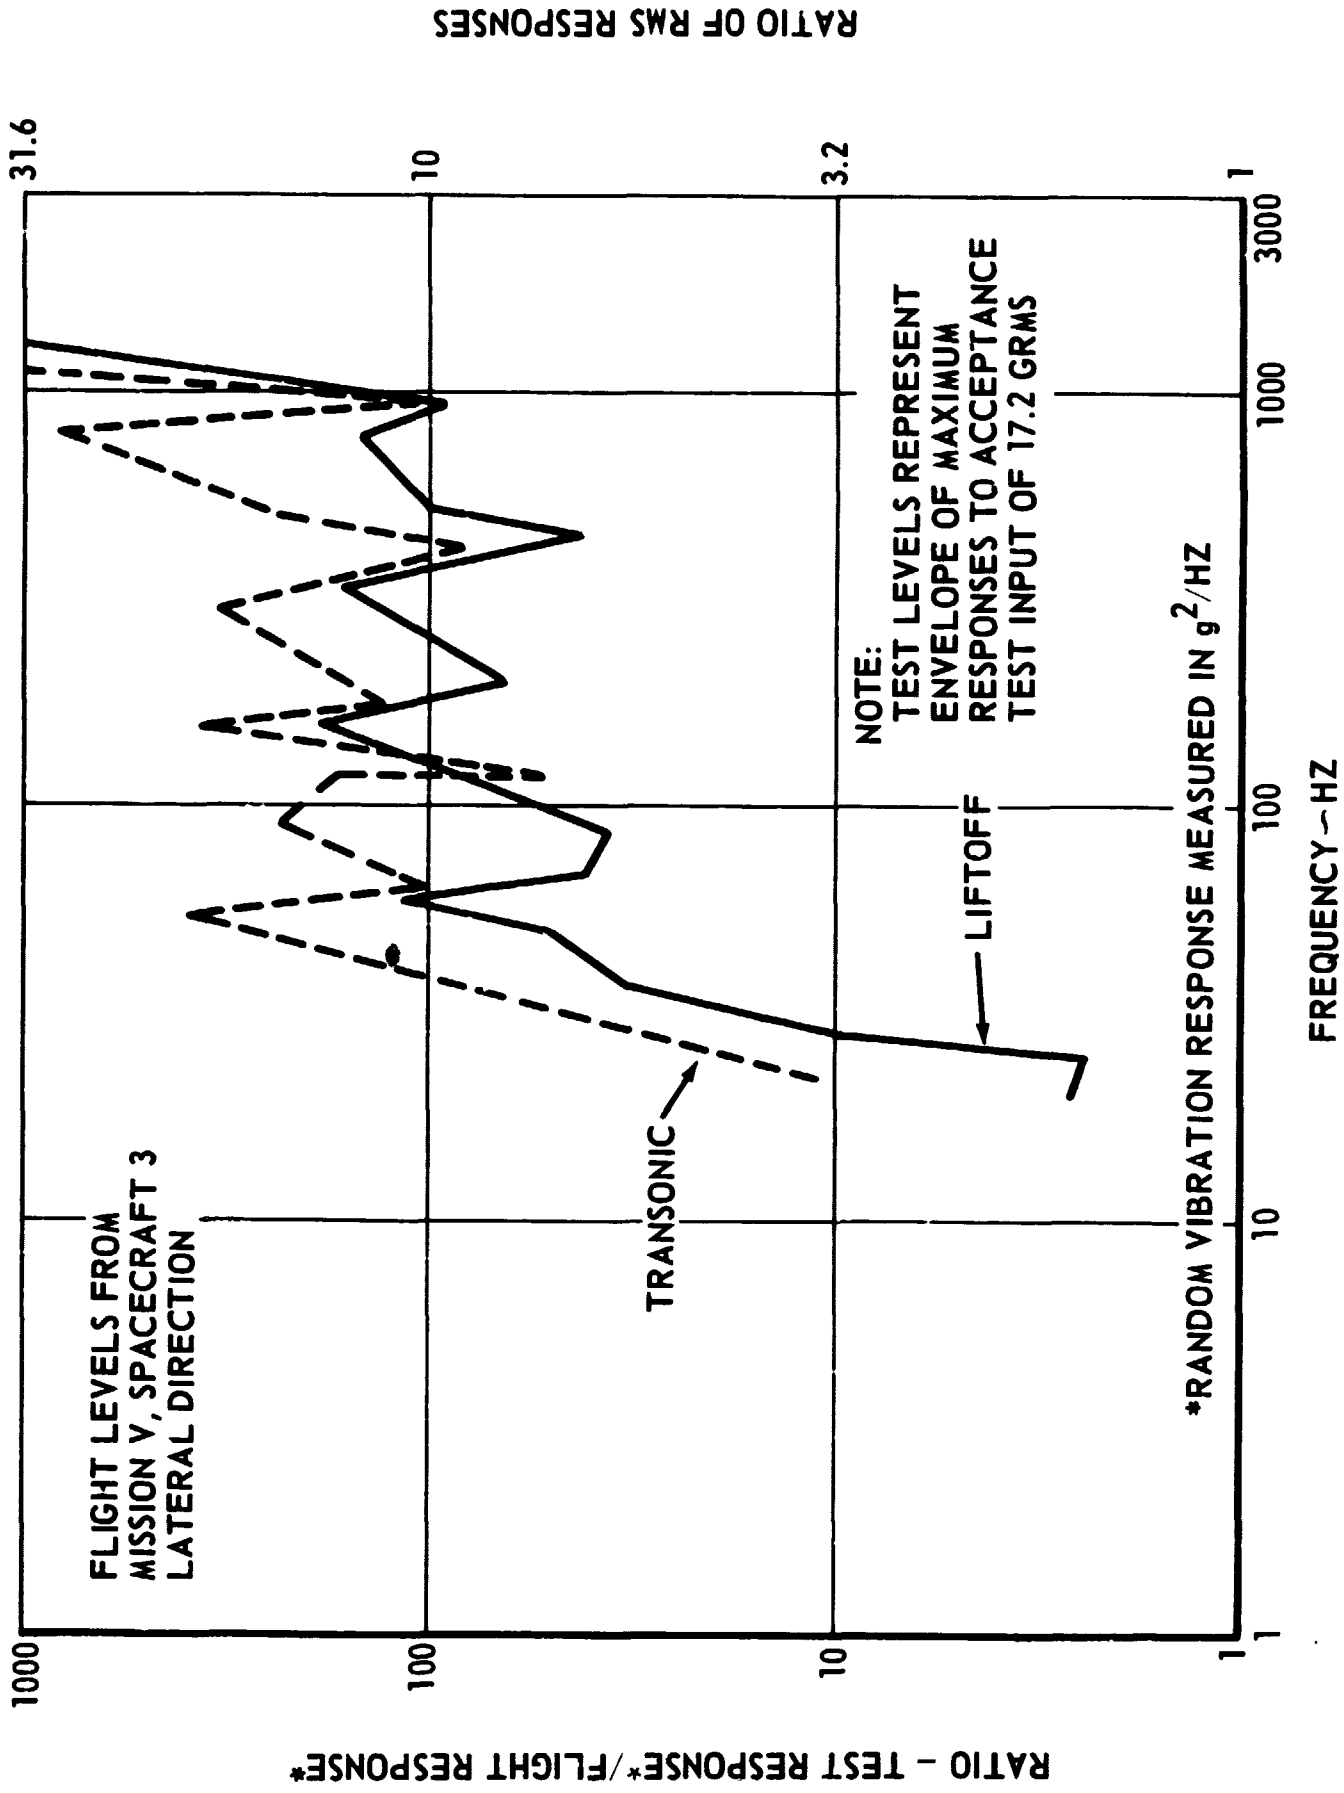
Figure 5-15. COMPARISON OF LAB TEST VIBRATION RESPONSE TO MEASURED FLIGHT RESPONSE IN LATERAL DIRECTION

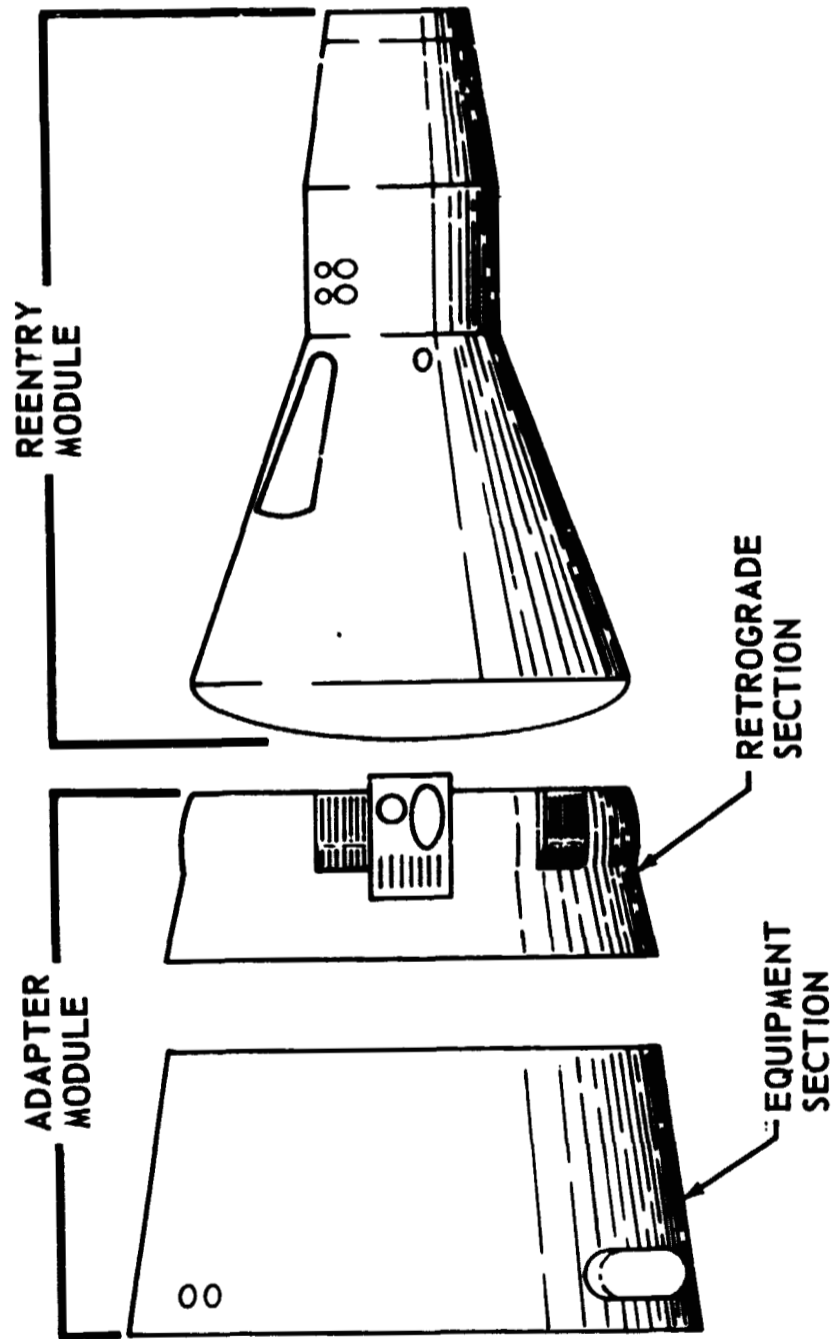
Figure 6-1: GEMINI SPACECRAFT

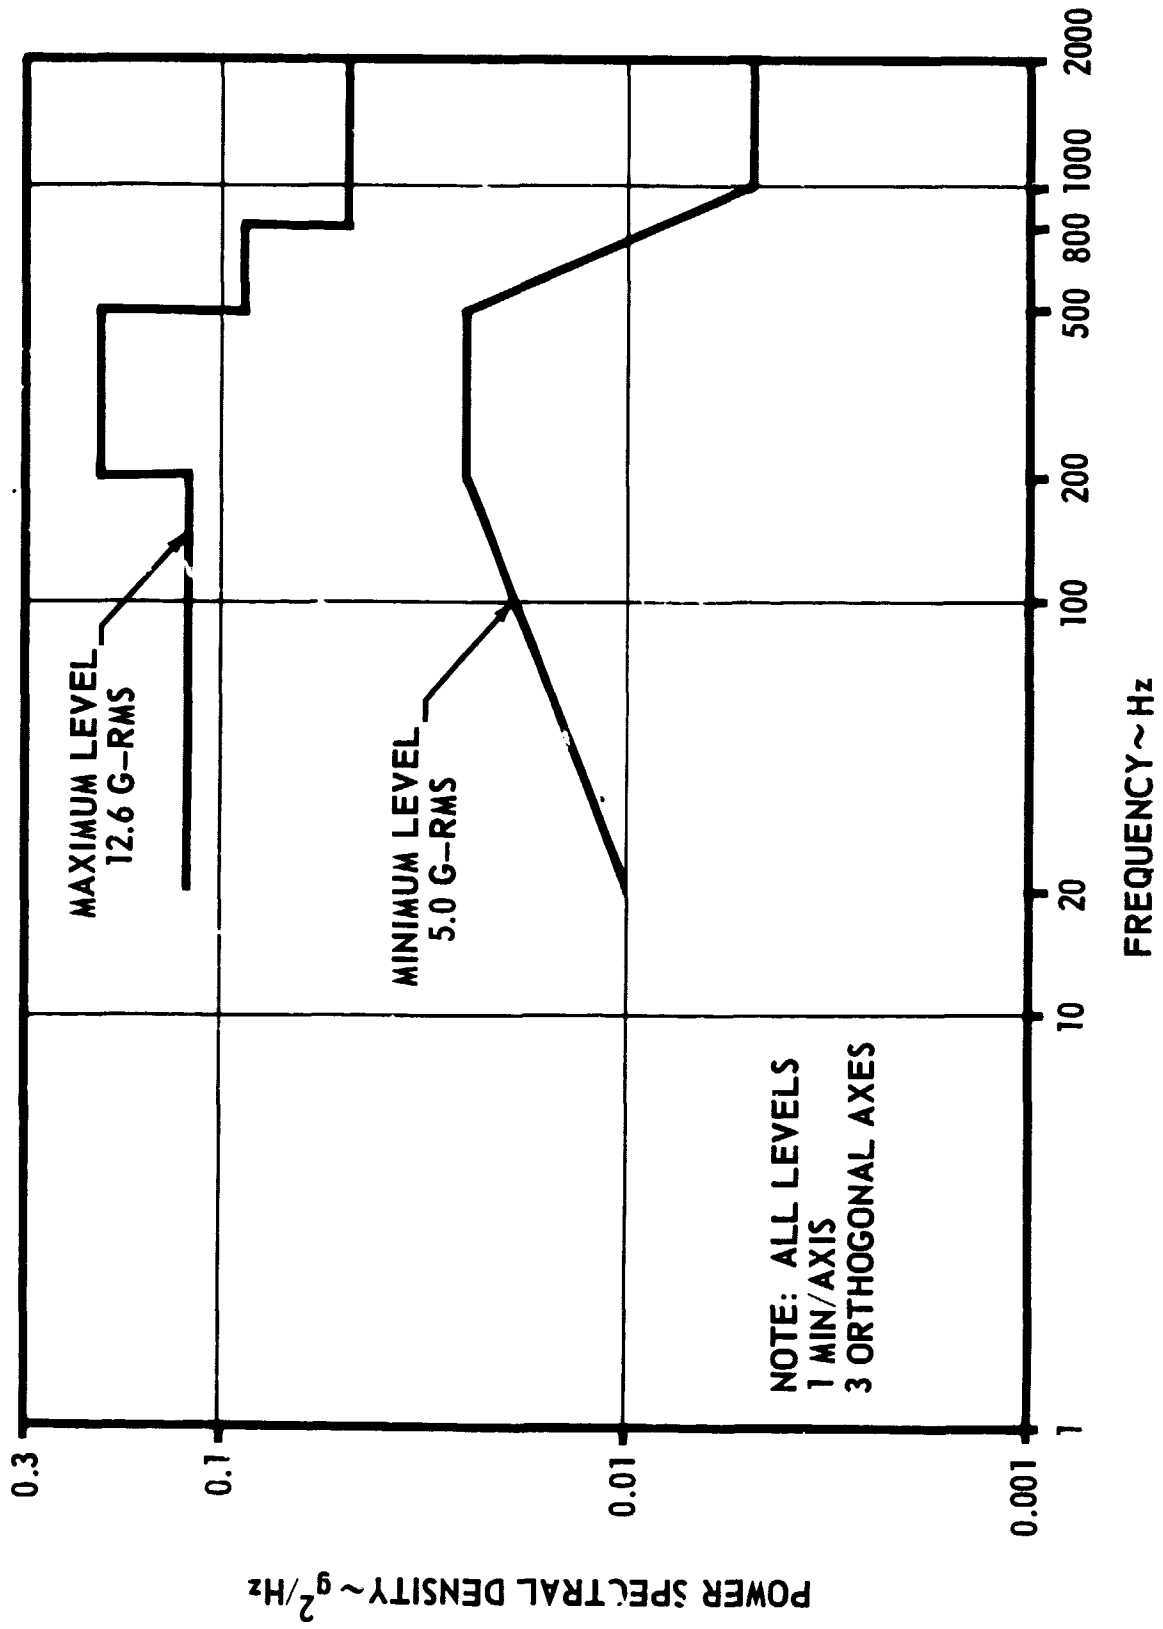
Figure 6-7: ENVELOPE OF COMPONENT ACCEPTANCE TEST LEVELS,
RANDOM VIBRATION

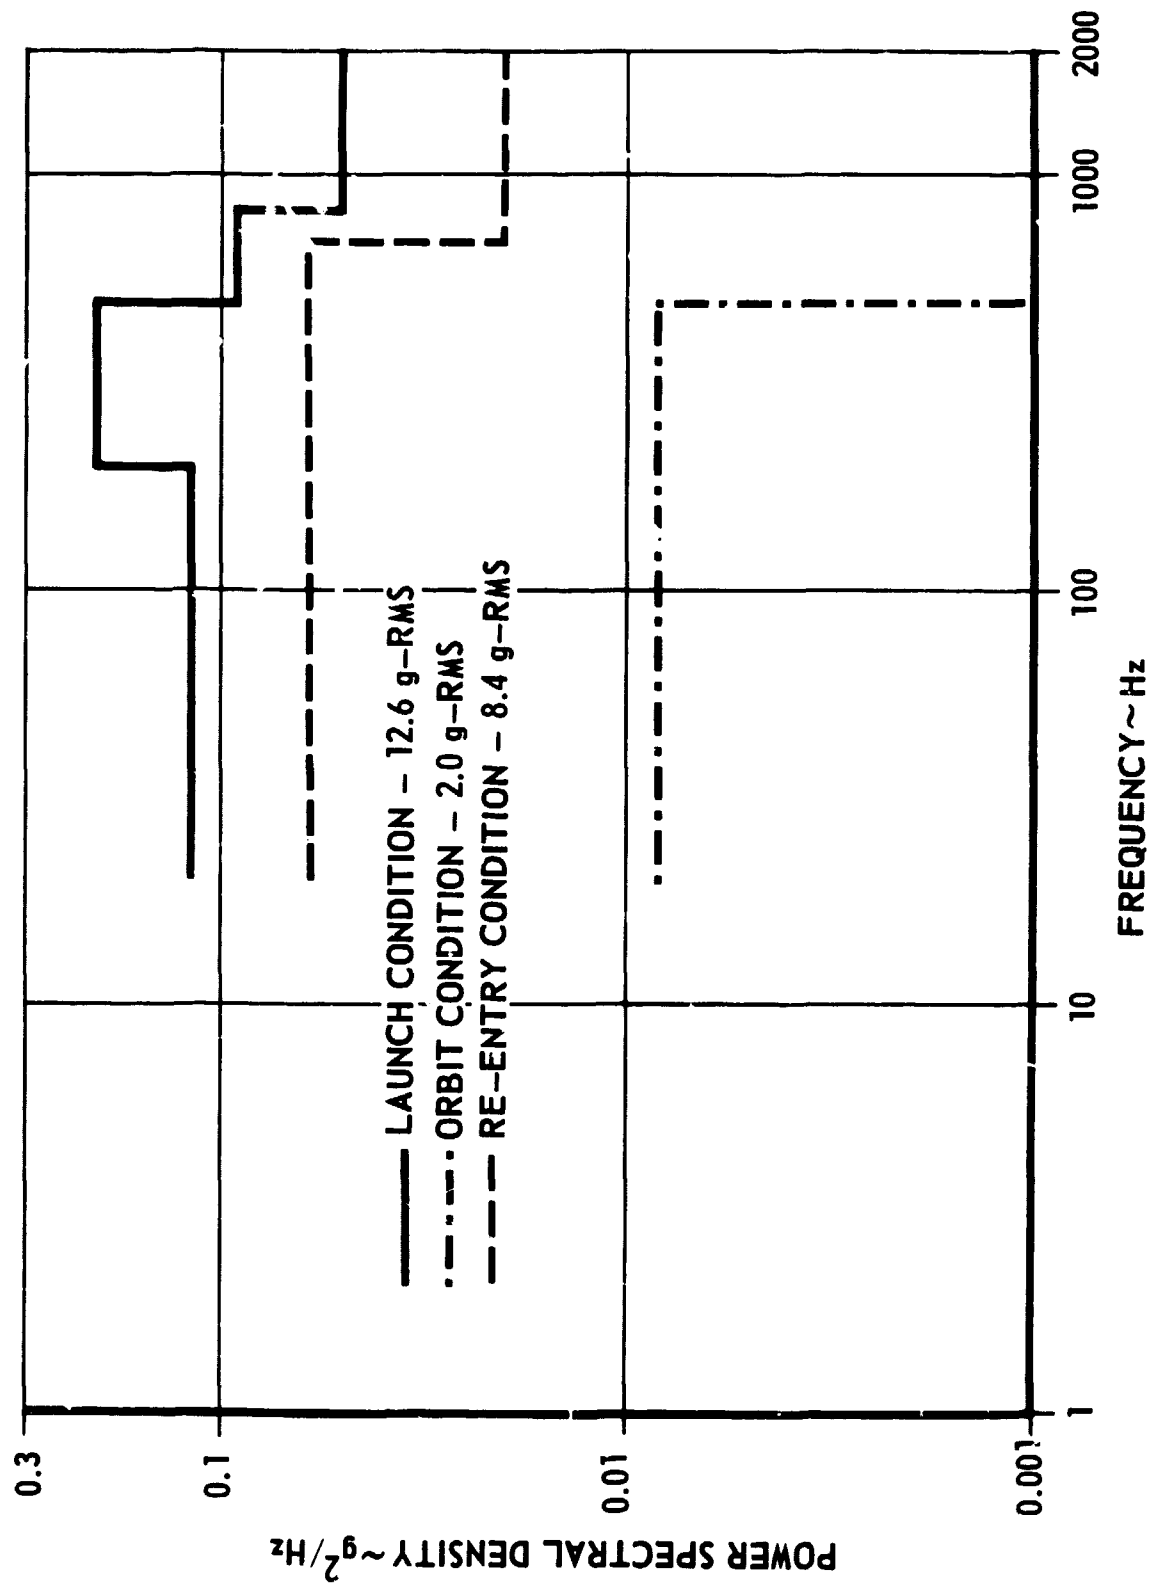
Figure 6-10: COMPONENT QUALIFICATION TEST, RANDOM VIBRATION
