**APOLLO TIE
WASHINGTON, D. C.**

DOCUMENT NO. D2-120001-2

TITLE SUMMARY OF VIBRATION AND ACOUSTIC TESTS ON
FOUR SPACECRAFT PROGRAMS

This document summarizes the vibration and acoustic test programs for four spacecraft: Mariner, Lunar Orbiter, Gemini and Surveyor. Information is presented on laboratory test programs and results, flight results, derivation of test levels, identification of test factors, and spacecraft contractor conclusions and recommendations.

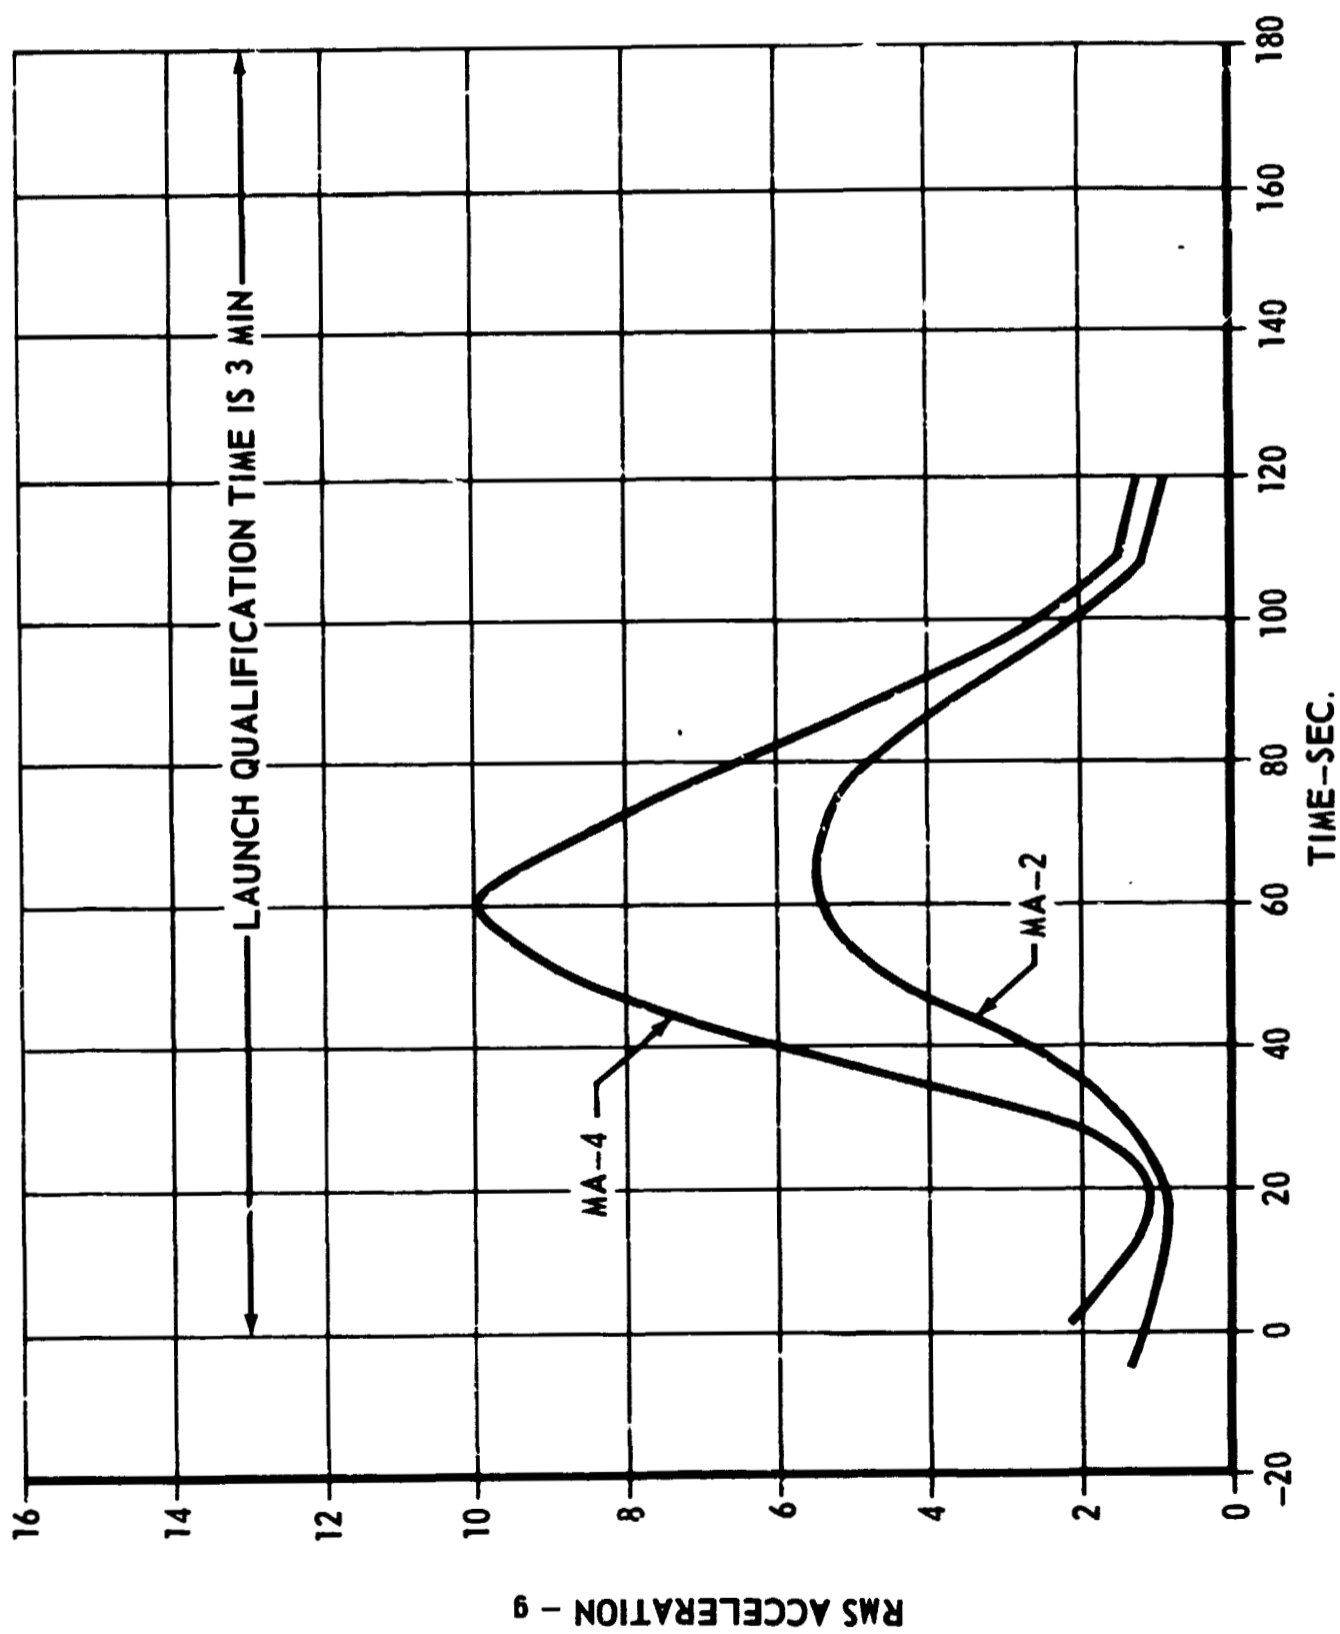
Figure 6-14: COMPARISON OF TIME HISTORIES OF ADJUSTED MERCURY LAUNCH VIBRATION WITH ORIGINAL GEMINI QUALIFICATION TEST TIMES

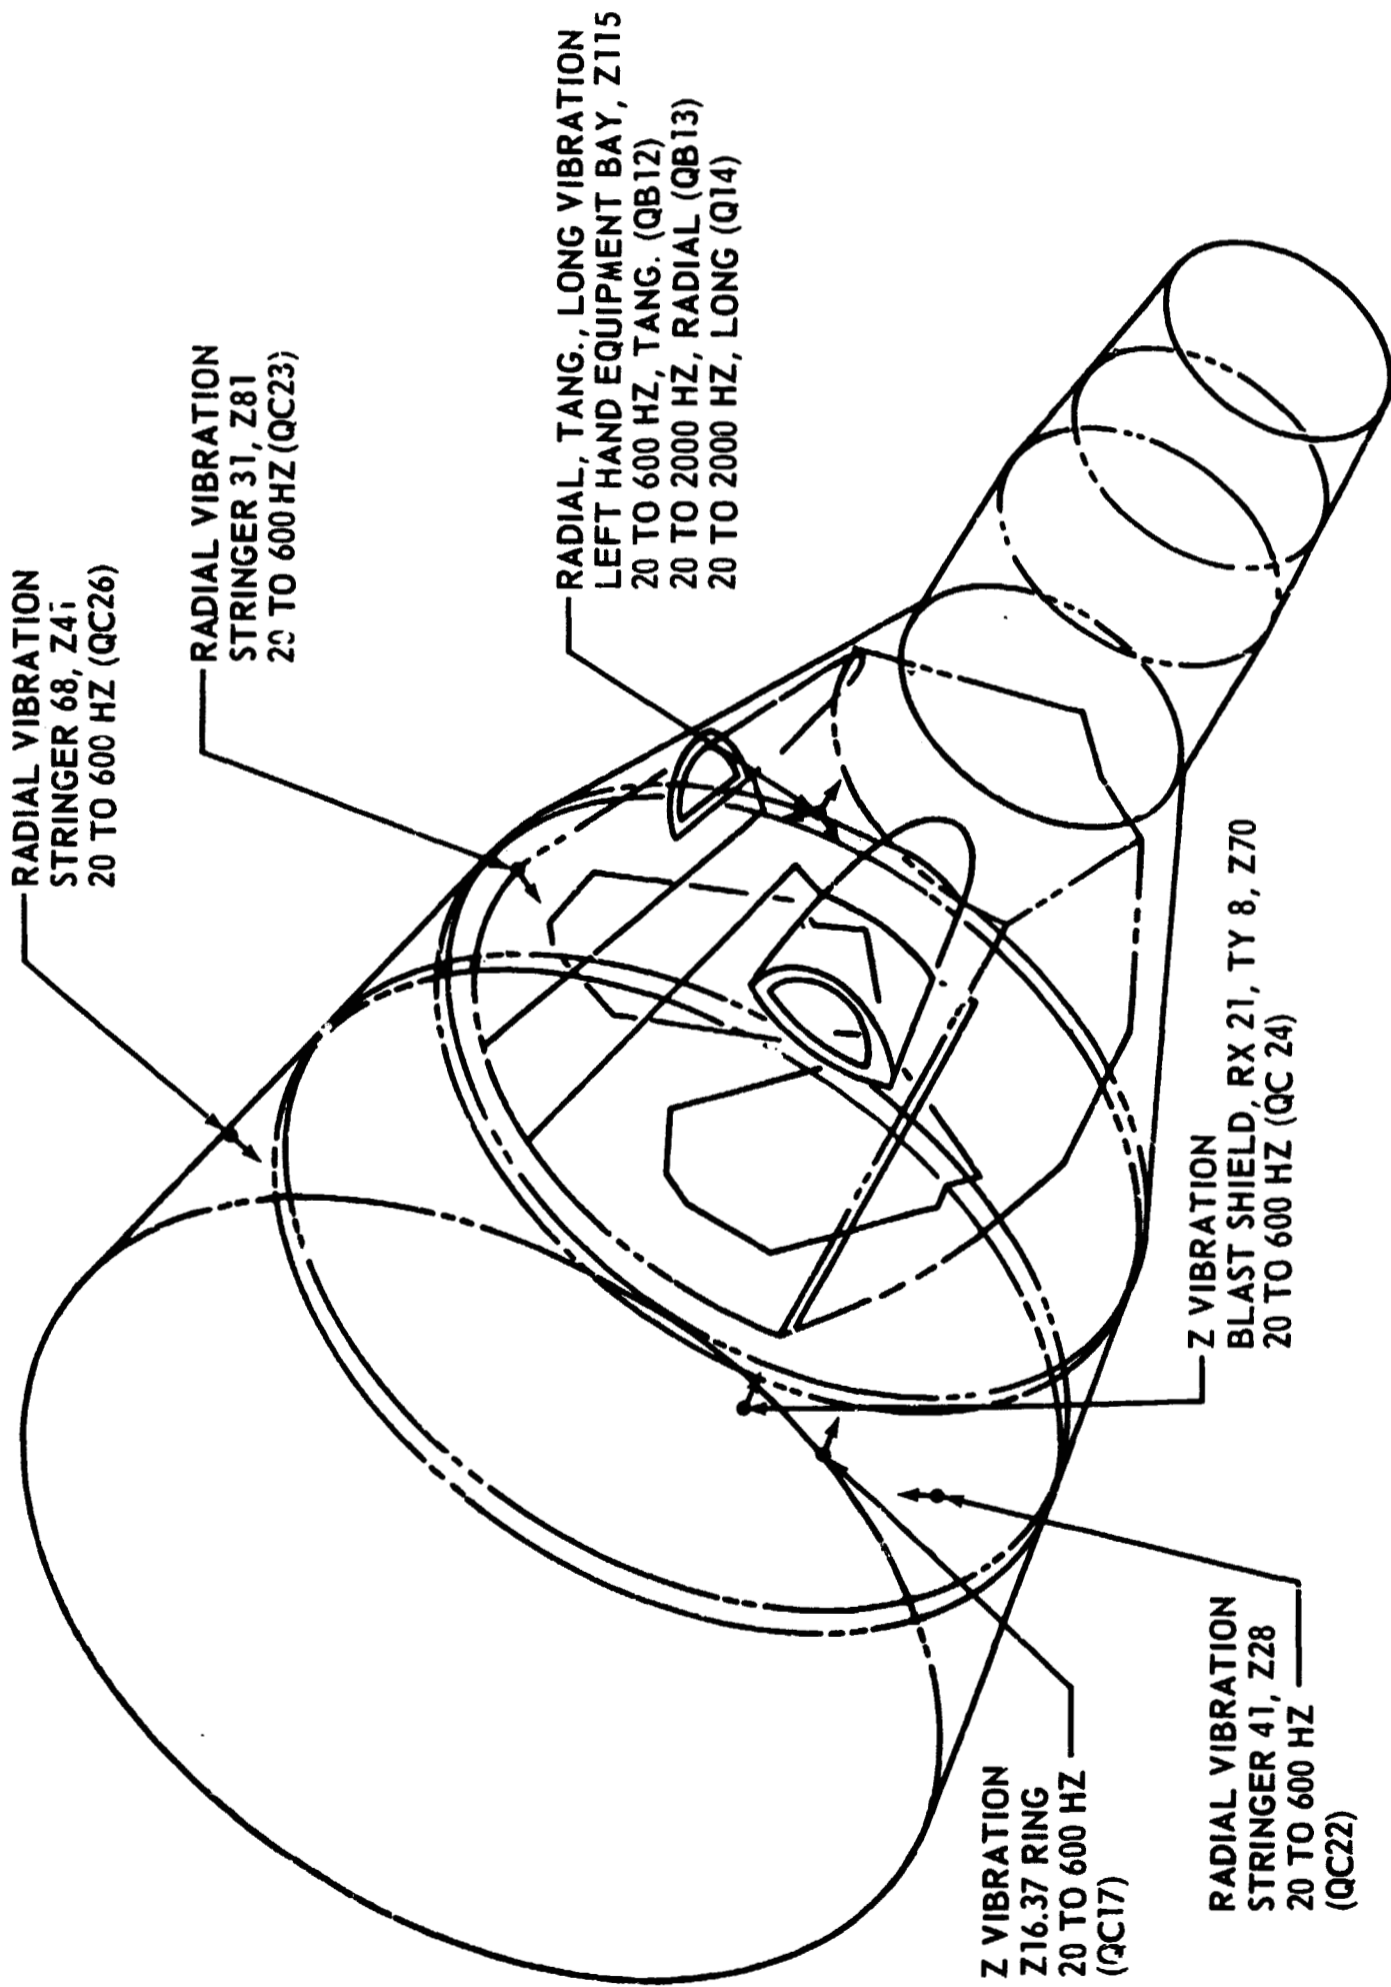
Figure 6--18: GEMINI SPACECRAFT NO. 1 VIBRATION PICKUP LOCATIONS

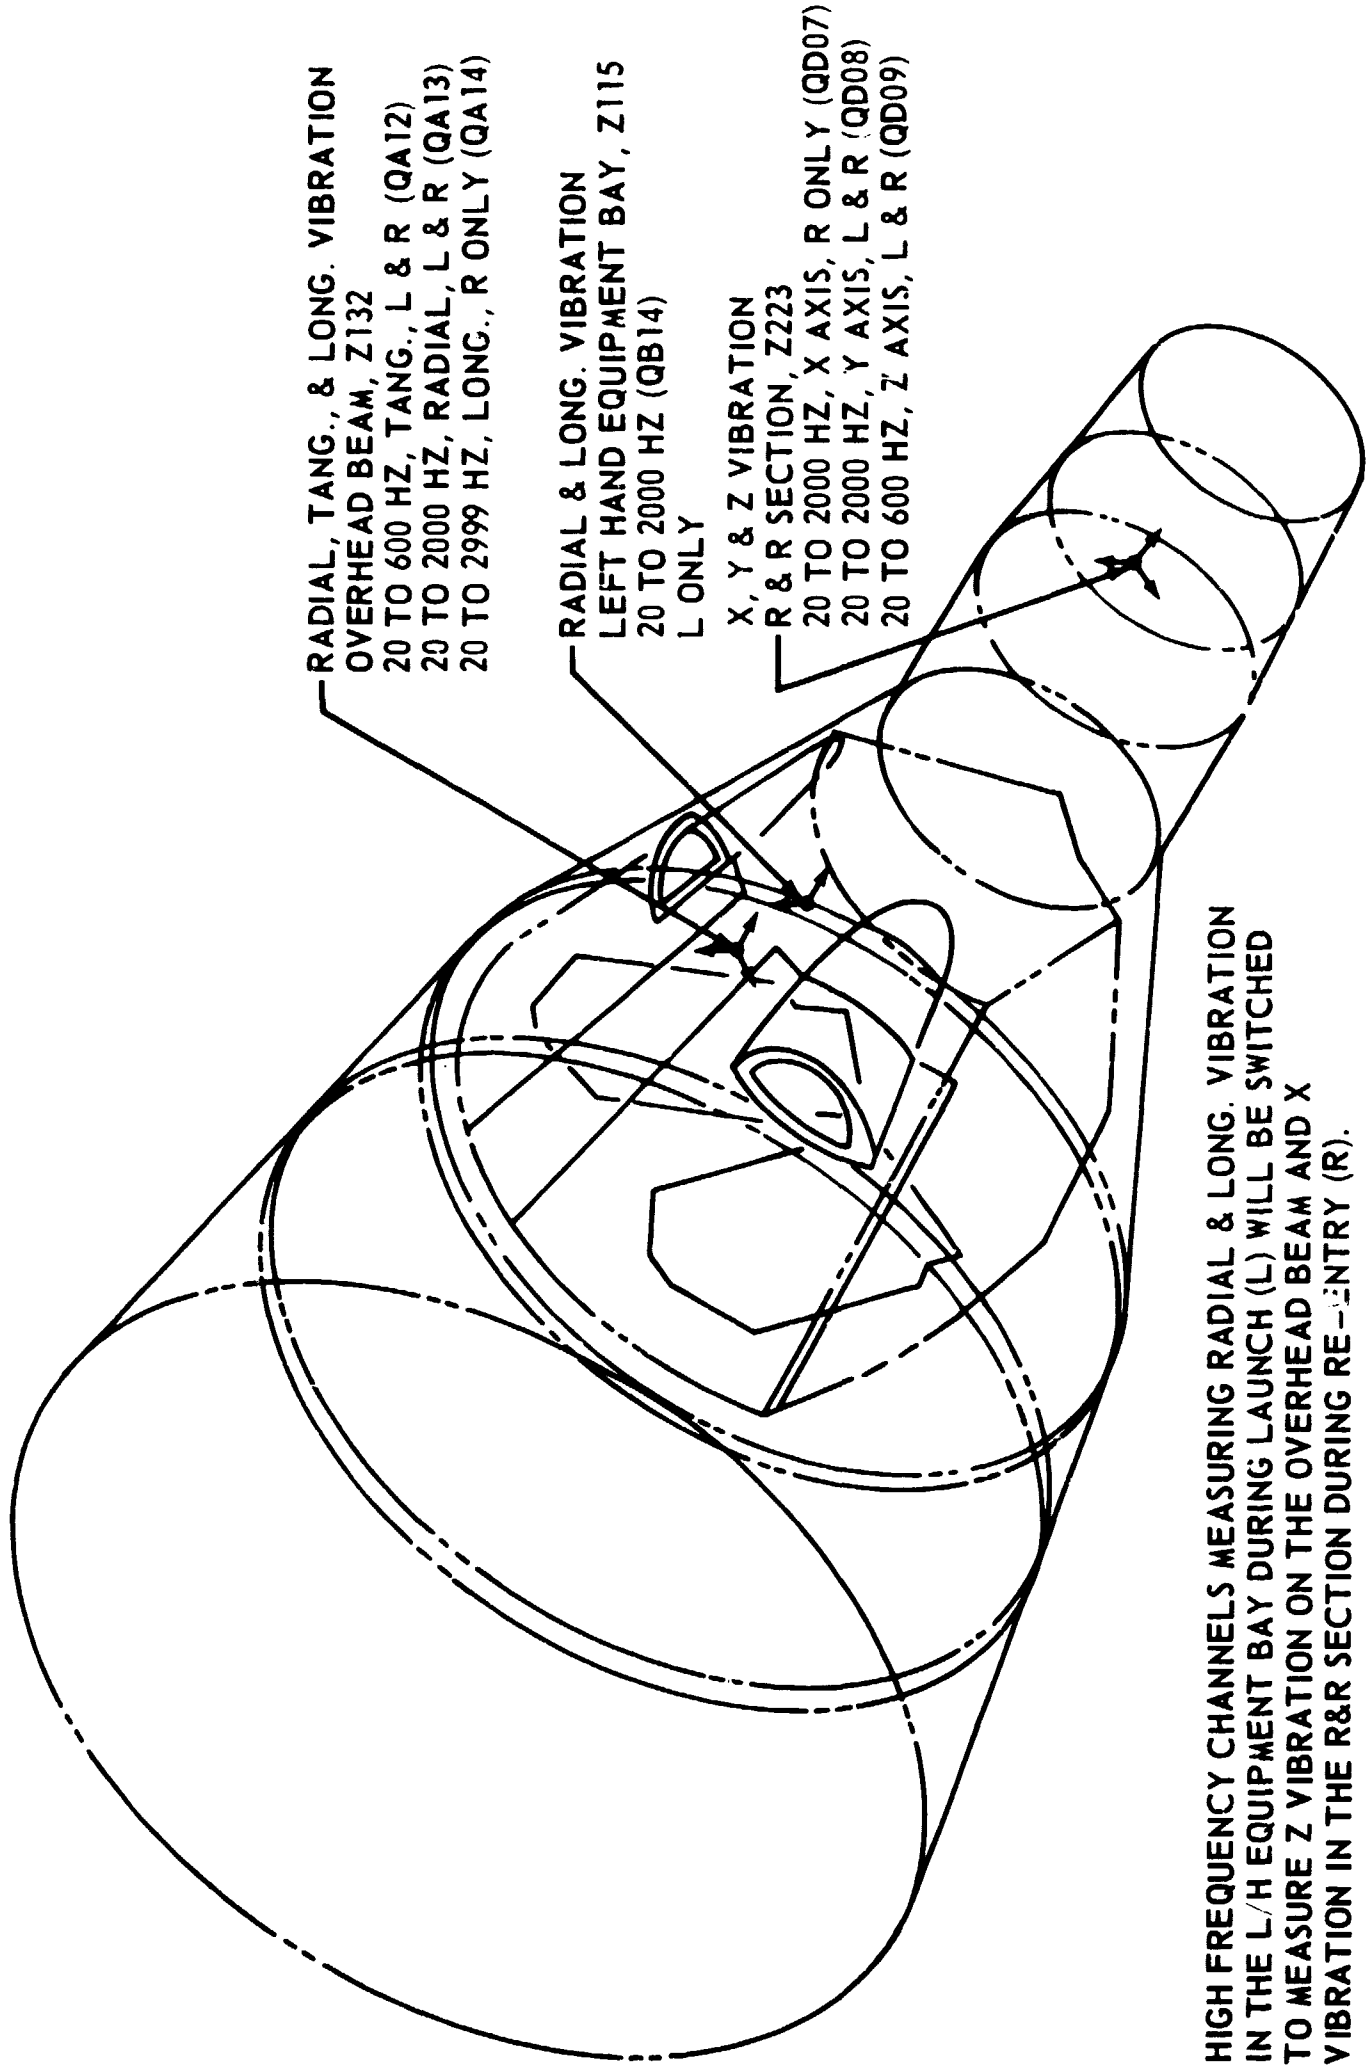
HIGH FREQUENCY CHANNELS MEASURING RADIAL & LONG. VIBRATION IN THE L/H EQUIPMENT BAY DURING LAUNCH (L) WILL BE SWITCHED TO MEASURE Z VIBRATION ON THE OVERHEAD BEAM AND X VIBRATION IN THE R&R SECTION DURING RE-ENTRY (R).

Figure 6-19: GEMINI SPACECRAFT NO. 2 VIBRATION PICKUP LOCATIONS

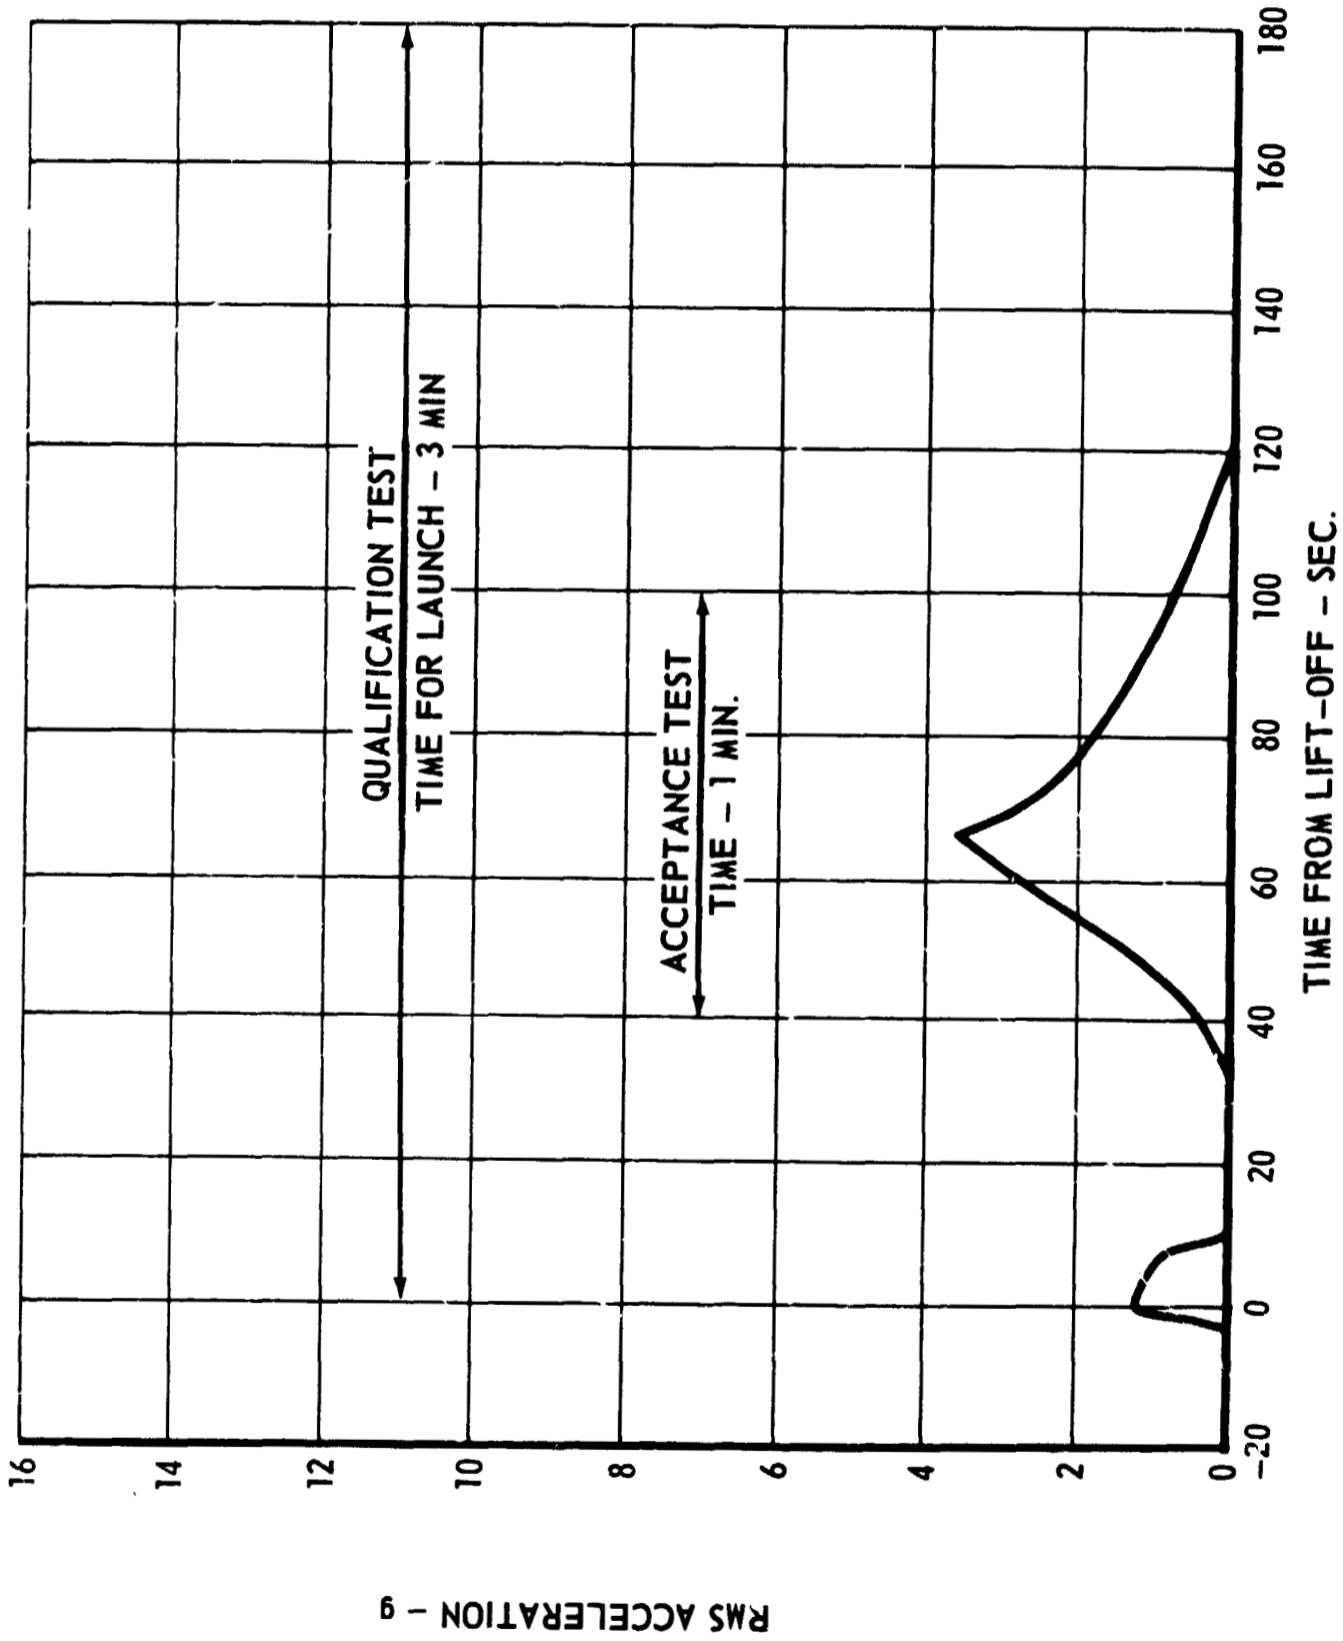
Figure 6-20: COMPARISON OF TIME HISTORY OF GT-1 MEASURED RE-ENTRY VEHICLE VIBRATION WITH QUALIFICATION AND ACCEPTANCE TEST DURATIONS

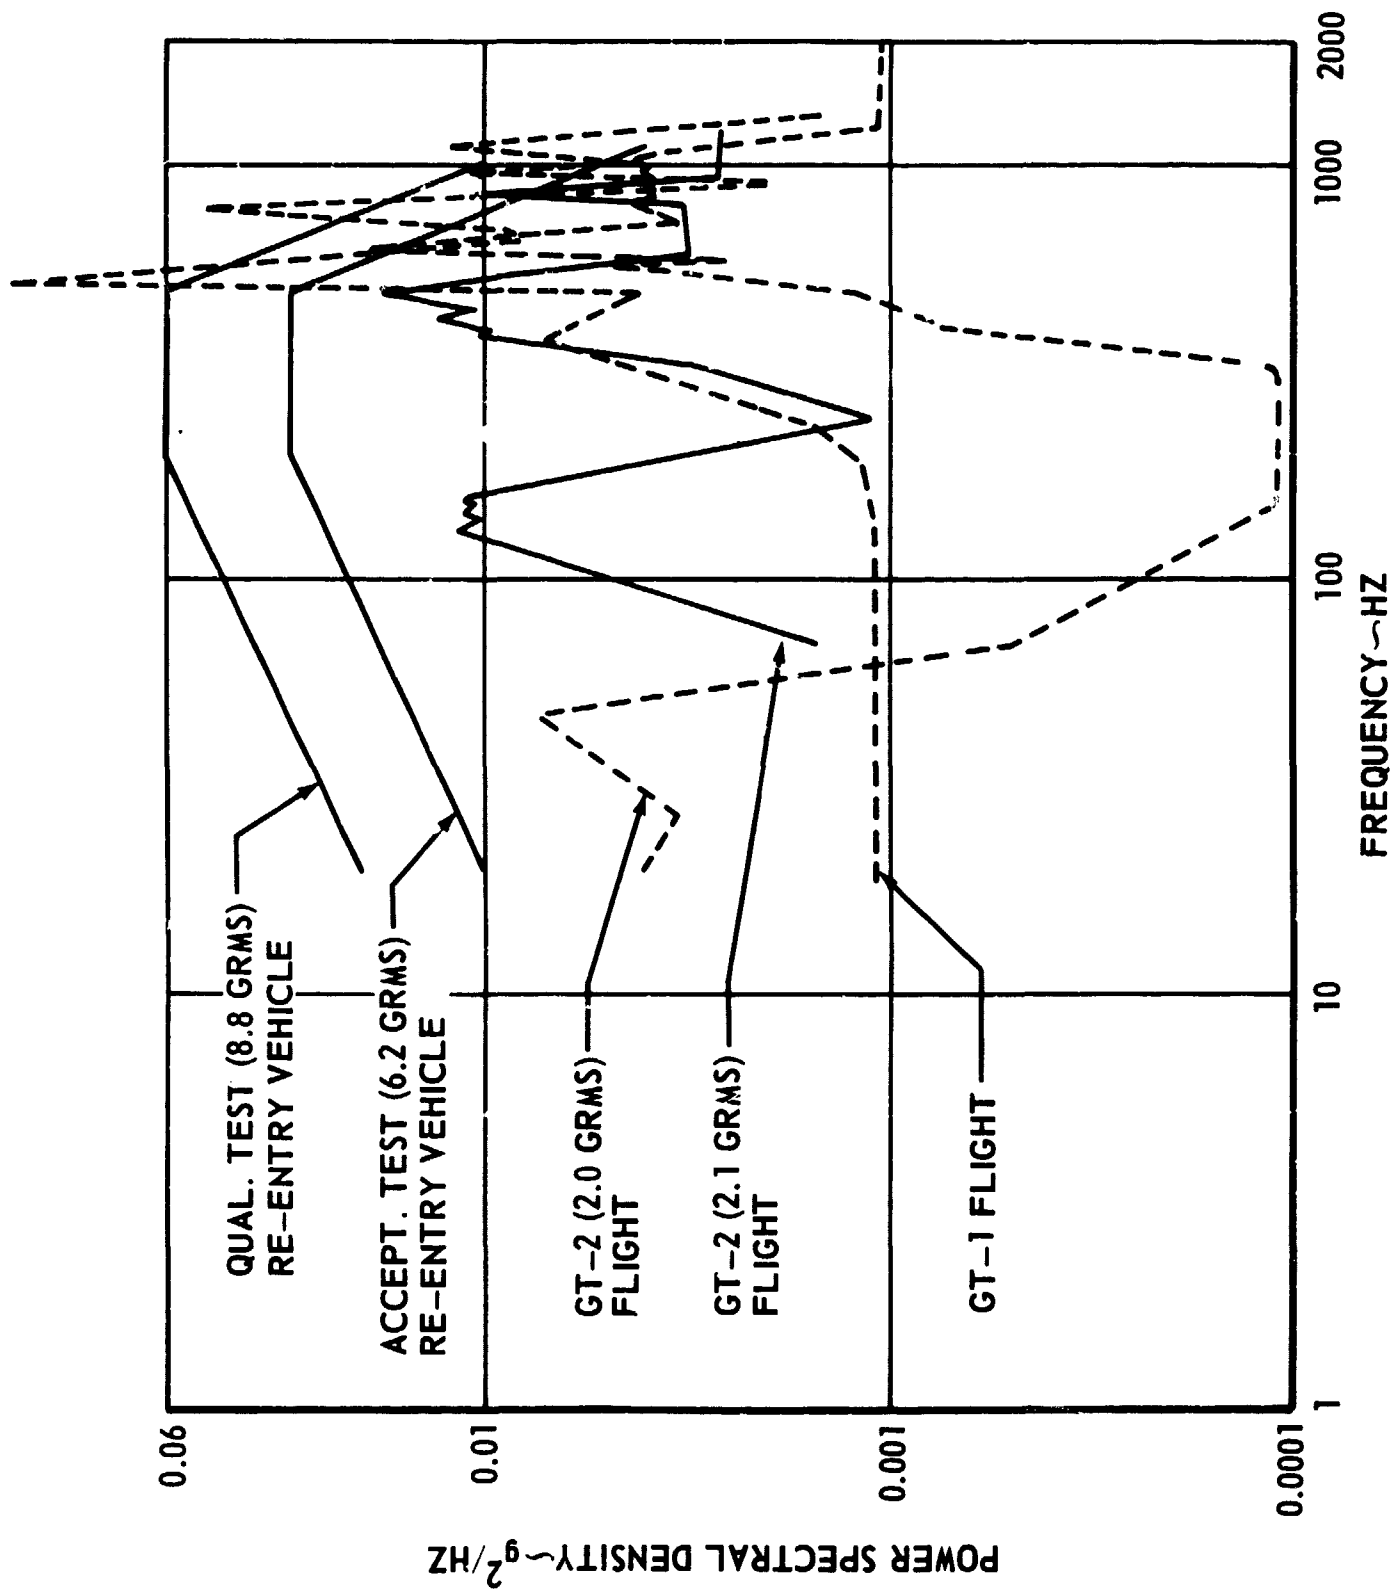
Figure 6-21: COMPARISON OF MEASURED FLIGHT LEVELS TO TEST LEVELS

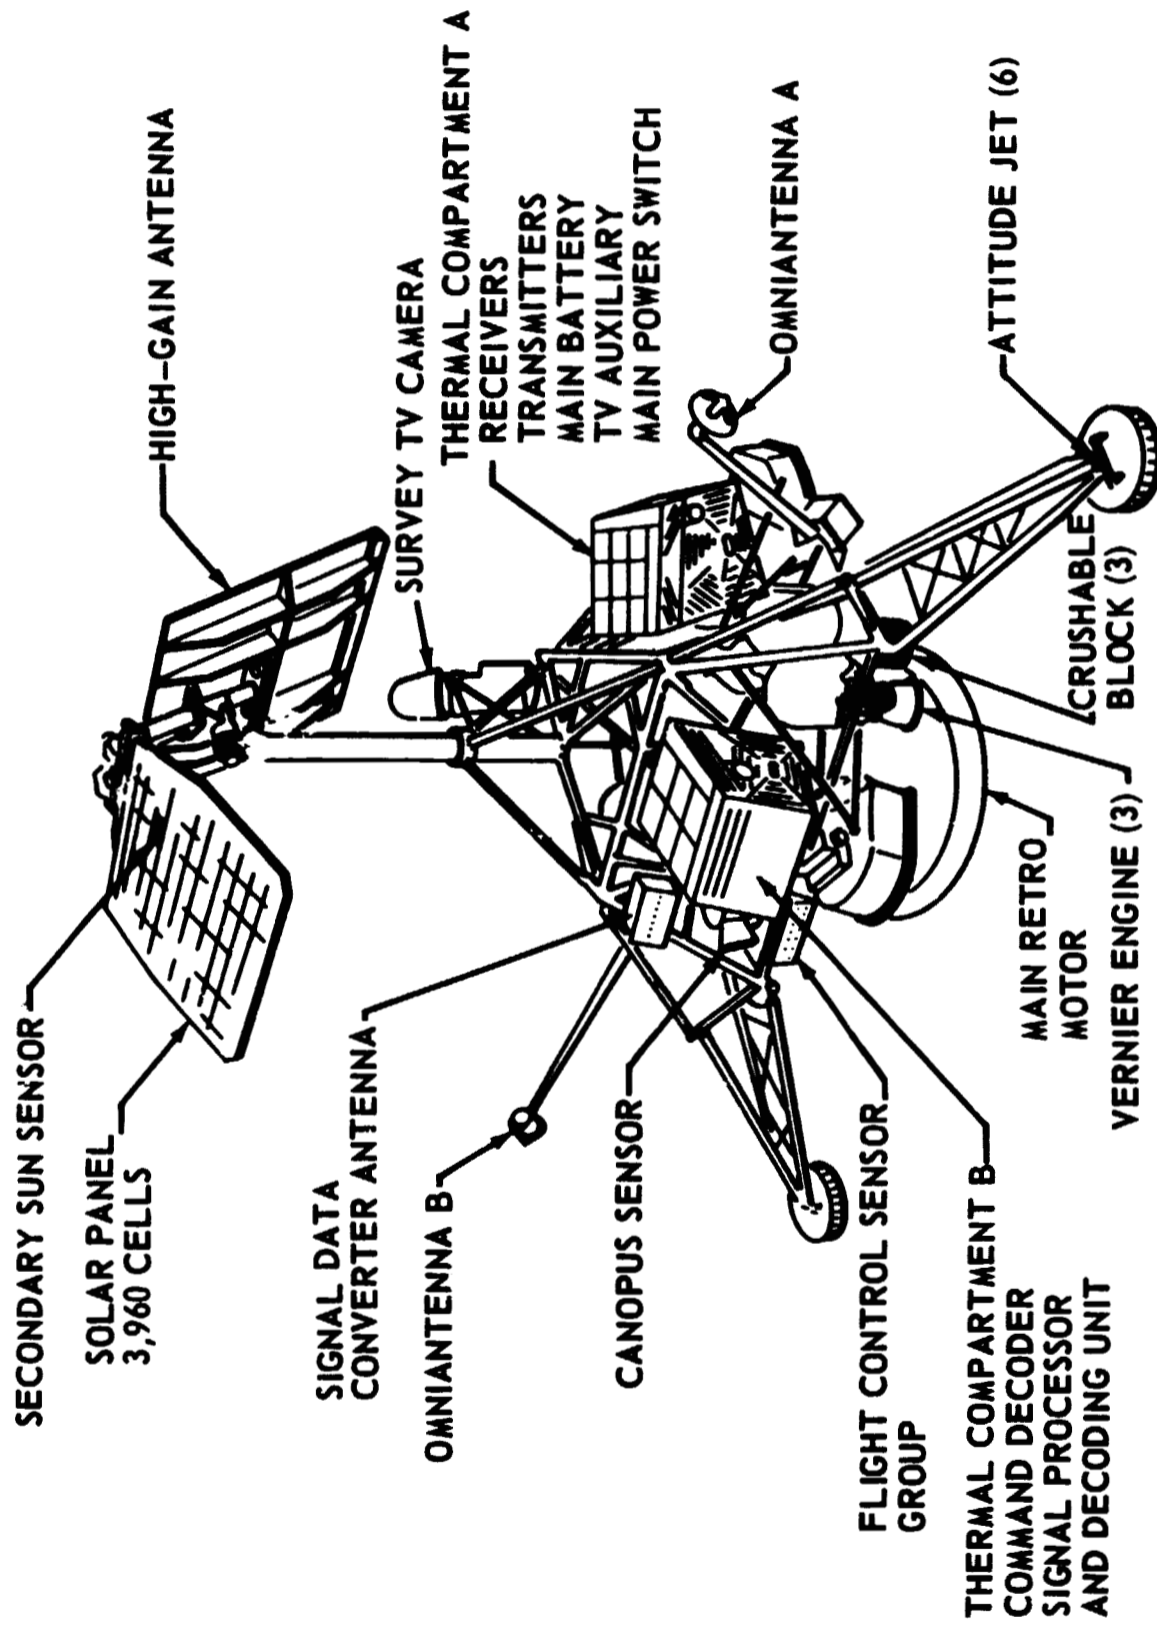
Figure 7-1: SURVEYOR 1 SPACECRAFT CONFIGURATION

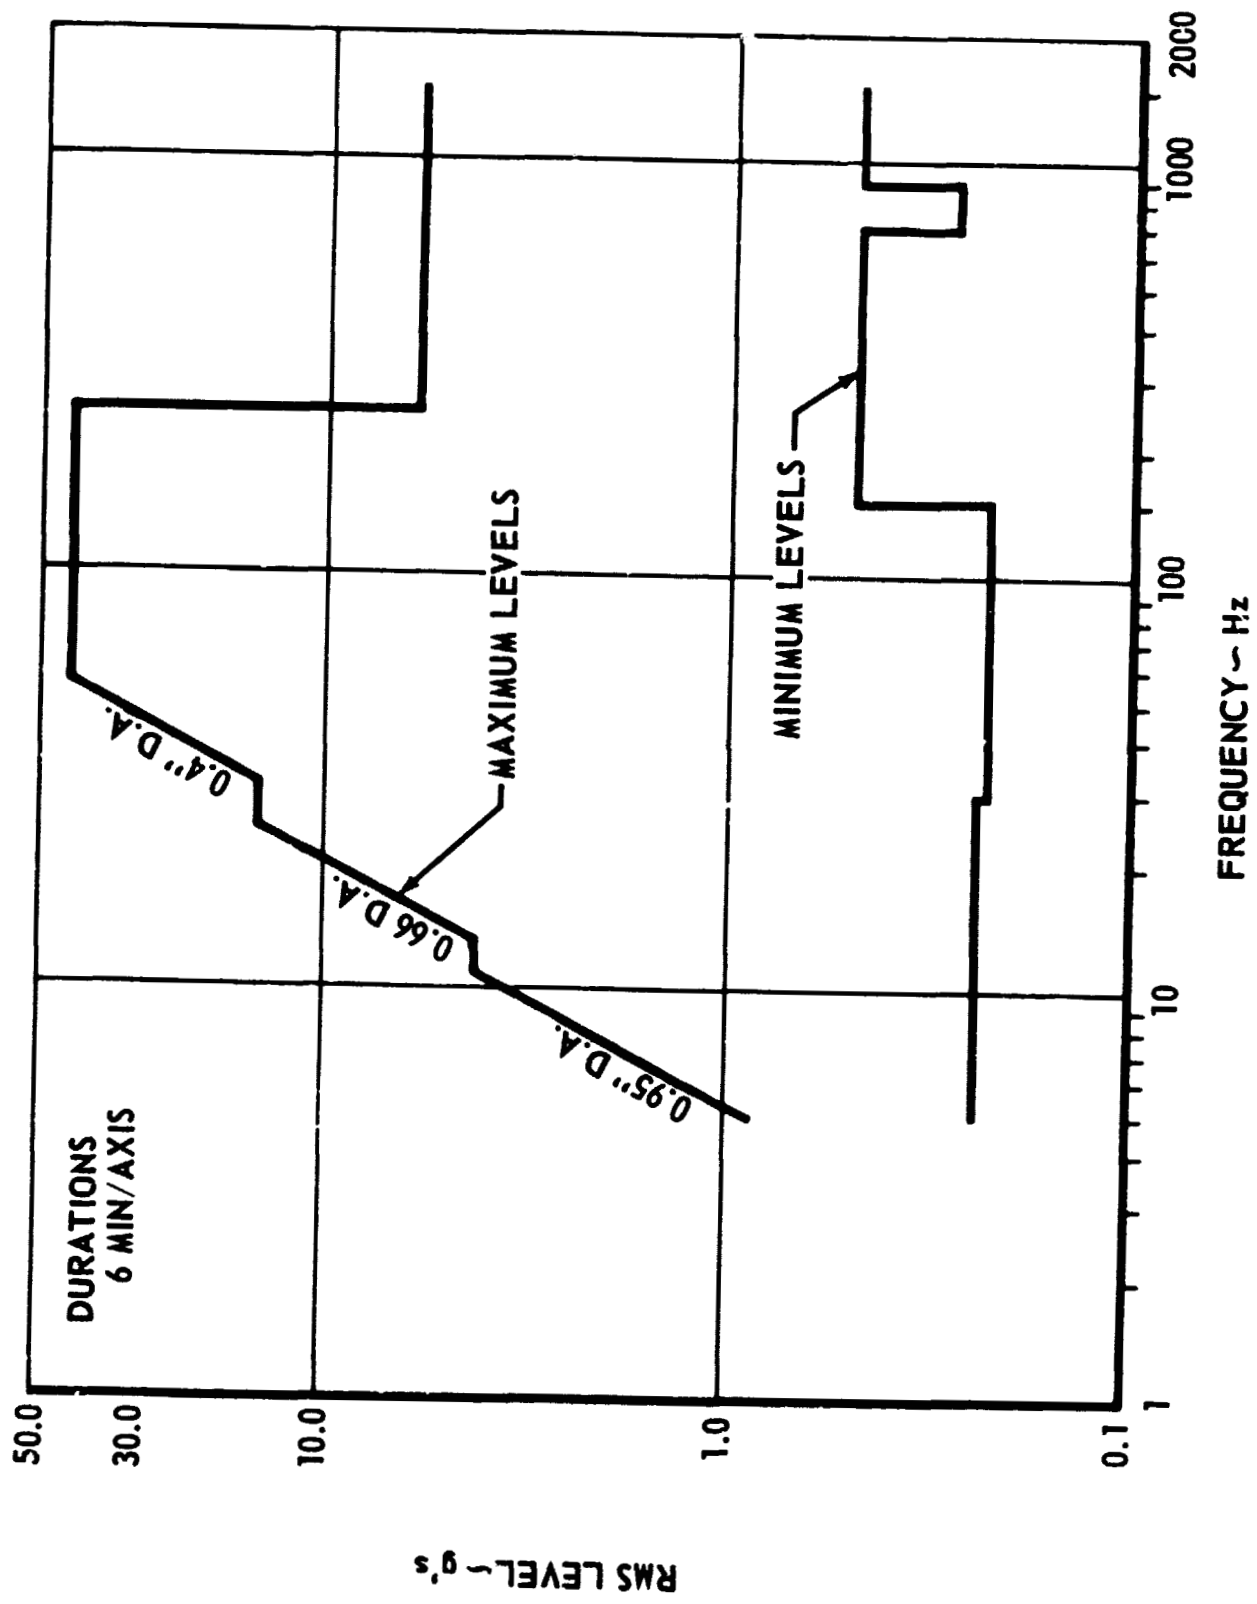
Figure 7-3: ENVELOPE OF SUBSYSTEM ACCEPTANCE TEST LEVELS, SINUSOIDAL VIBRATION

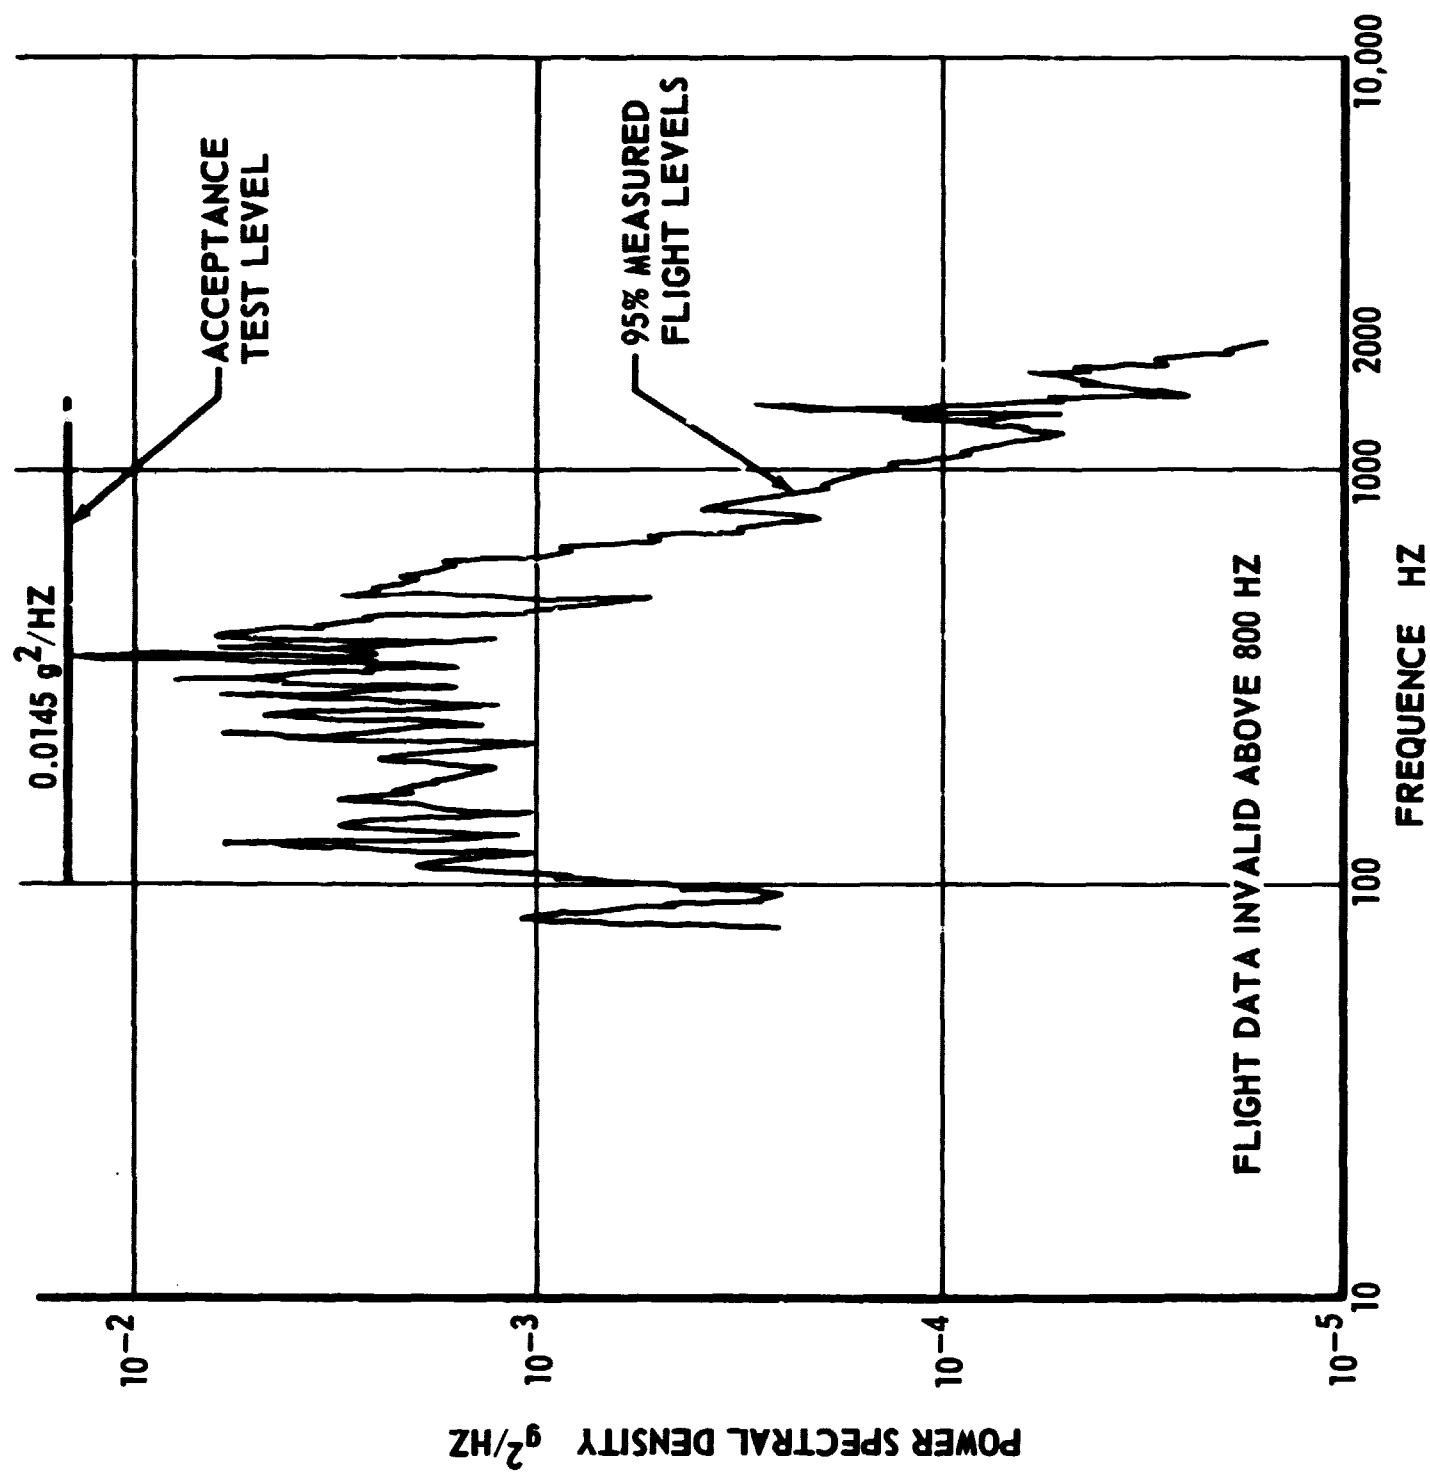
Figure 7-11: COMPARISON OF FLIGHT ENVIRONMENT TO TEST LEVELS, RANDOM VIBRATION

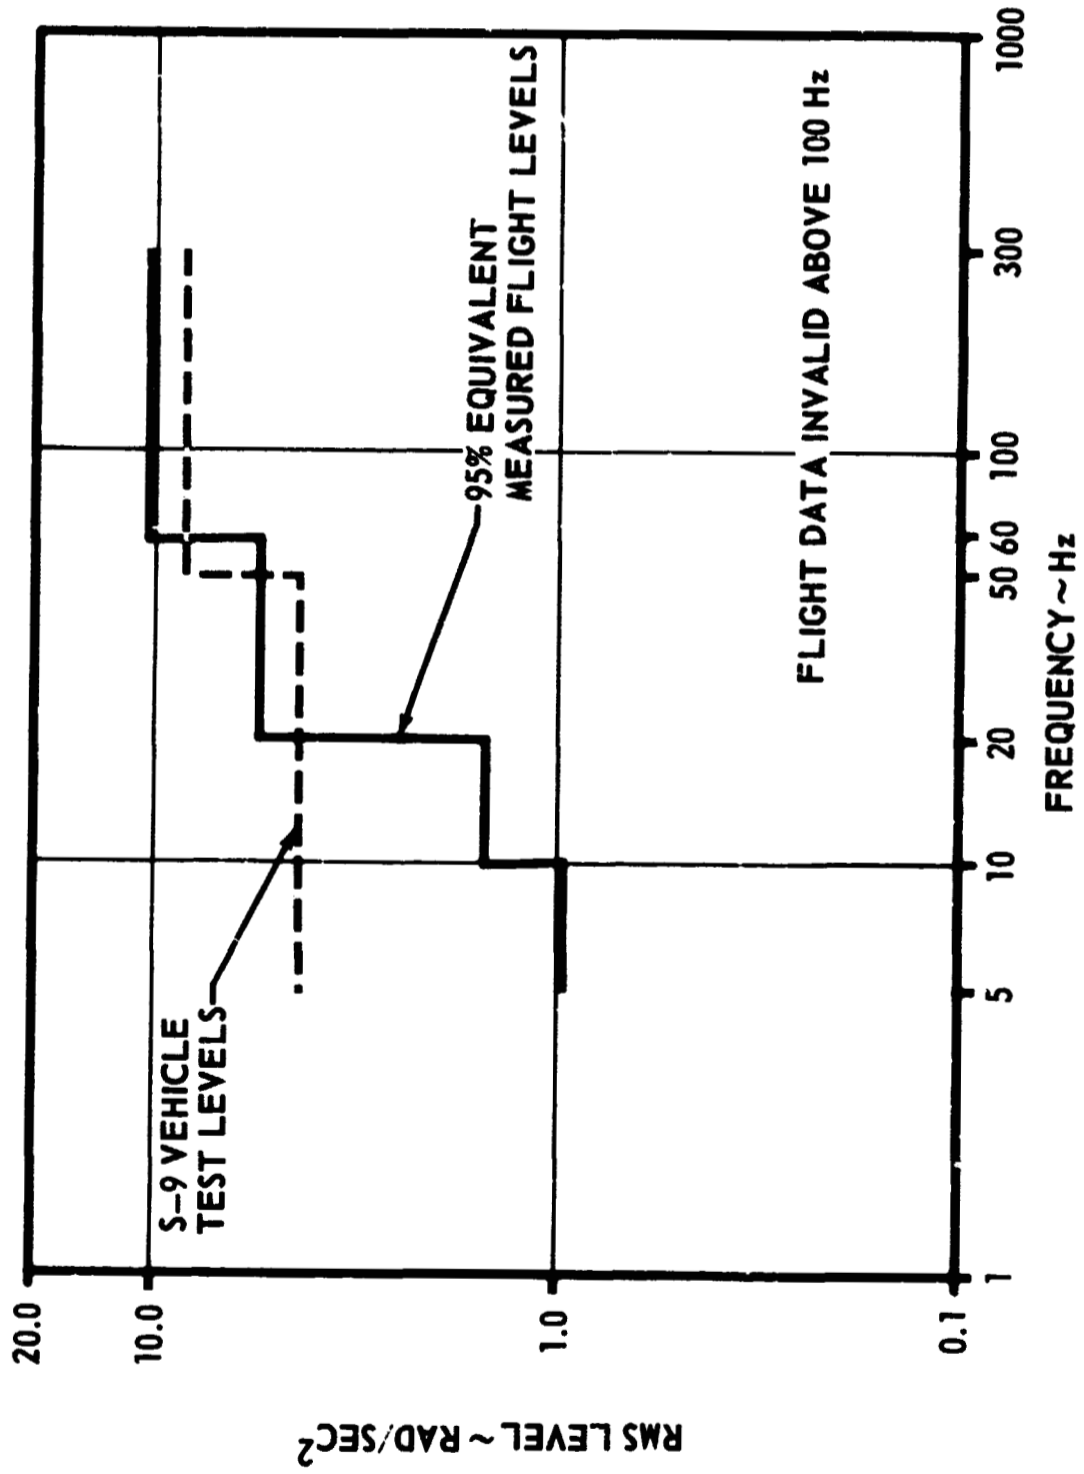
Figure 7-14: COMPARISON OF FLIGHT ENVIRONMENT TO TEST LEVELS, TORSIONAL SINUSOIDAL VIBRATION

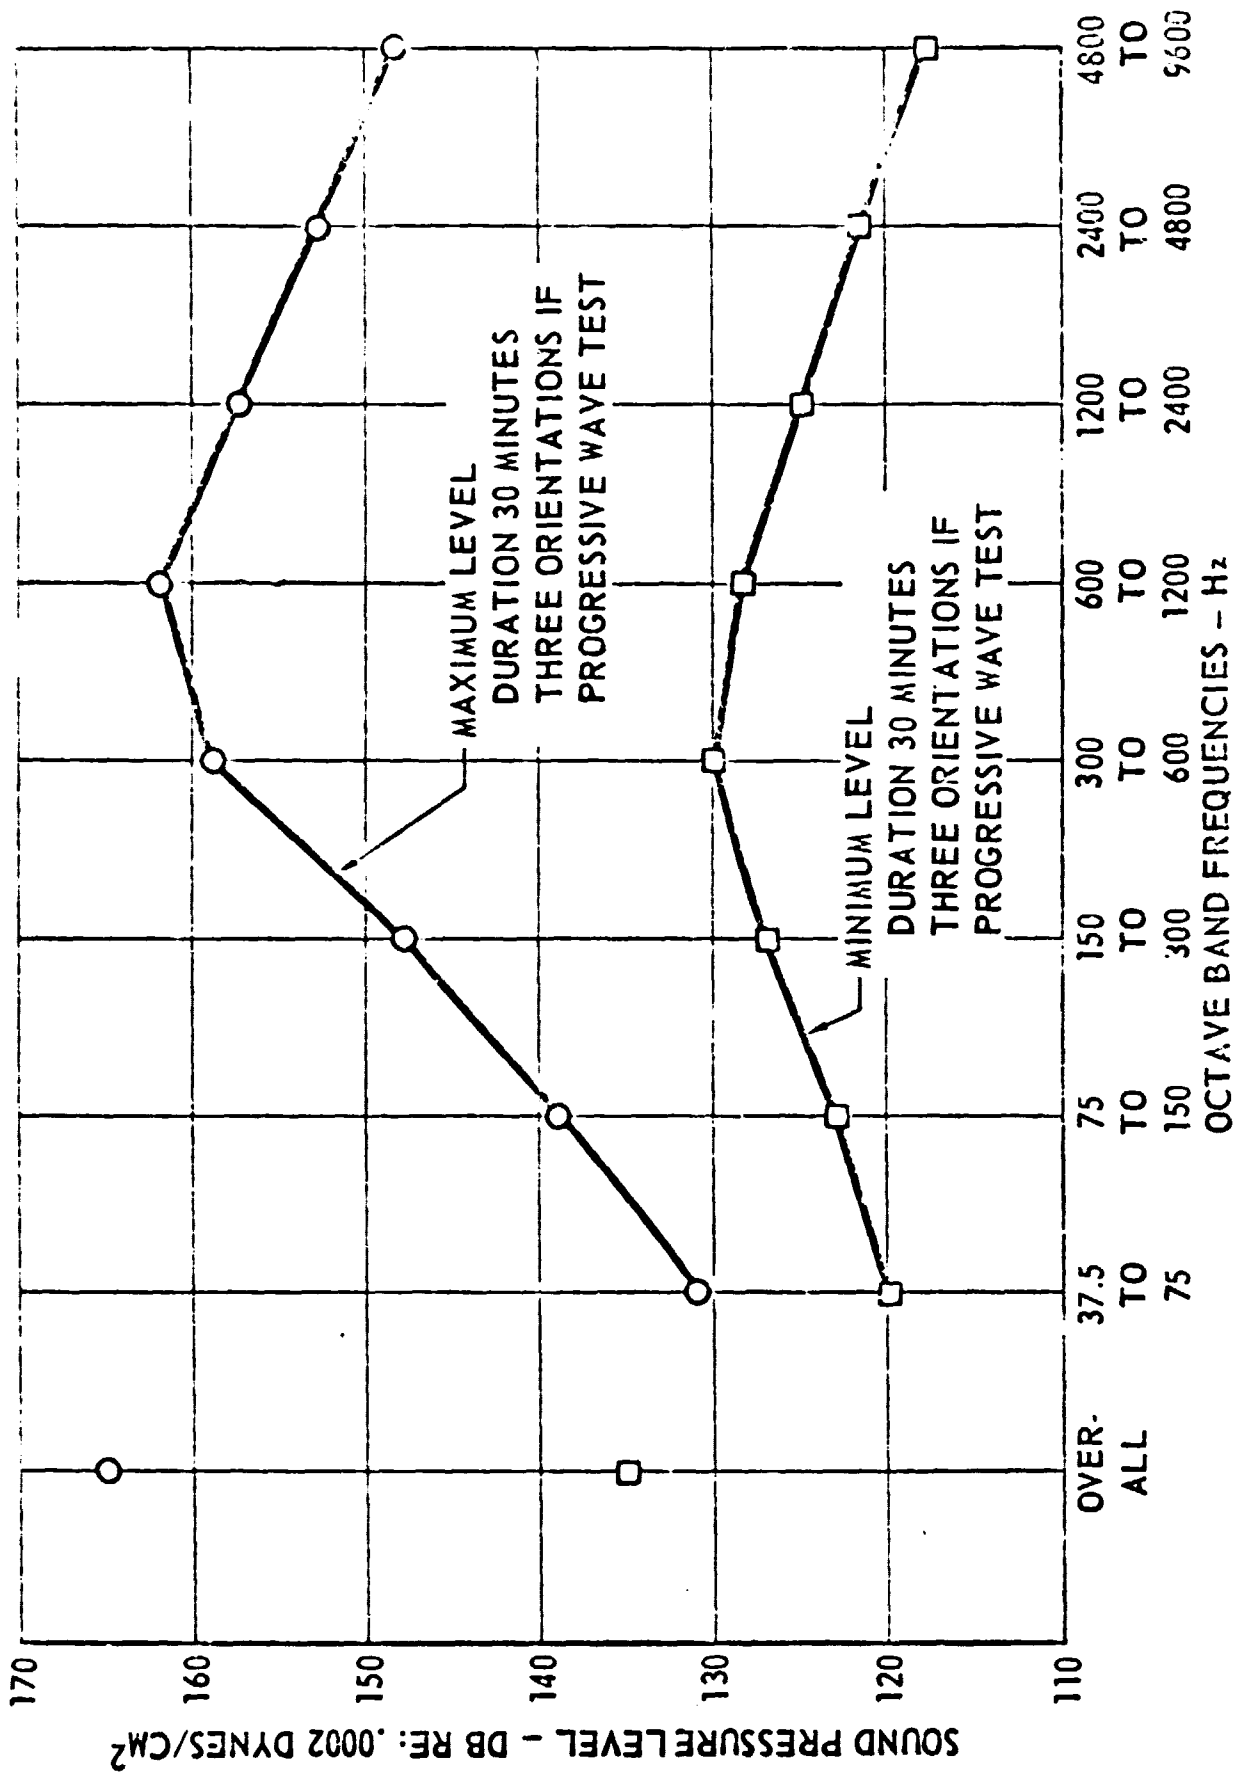
FIGURE 1-2 ENVELOPE OF ACOUSTIC QUALIFICATION TEST LEVELS.
