**APOLLO TIE
WASHINGTON, D. C.**

DOCUMENT NO. D2-120001-2

TITLE SUMMARY OF VIBRATION AND ACOUSTIC TESTS ON
FOUR SPACECRAFT PROGRAMS

This document summarizes the vibration and acoustic test programs for four spacecraft: Mariner, Lunar Orbiter, Gemini and Surveyor. Information is presented on laboratory test programs and results, flight results, derivation of test levels, identification of test factors, and spacecraft contractor conclusions and recommendations.

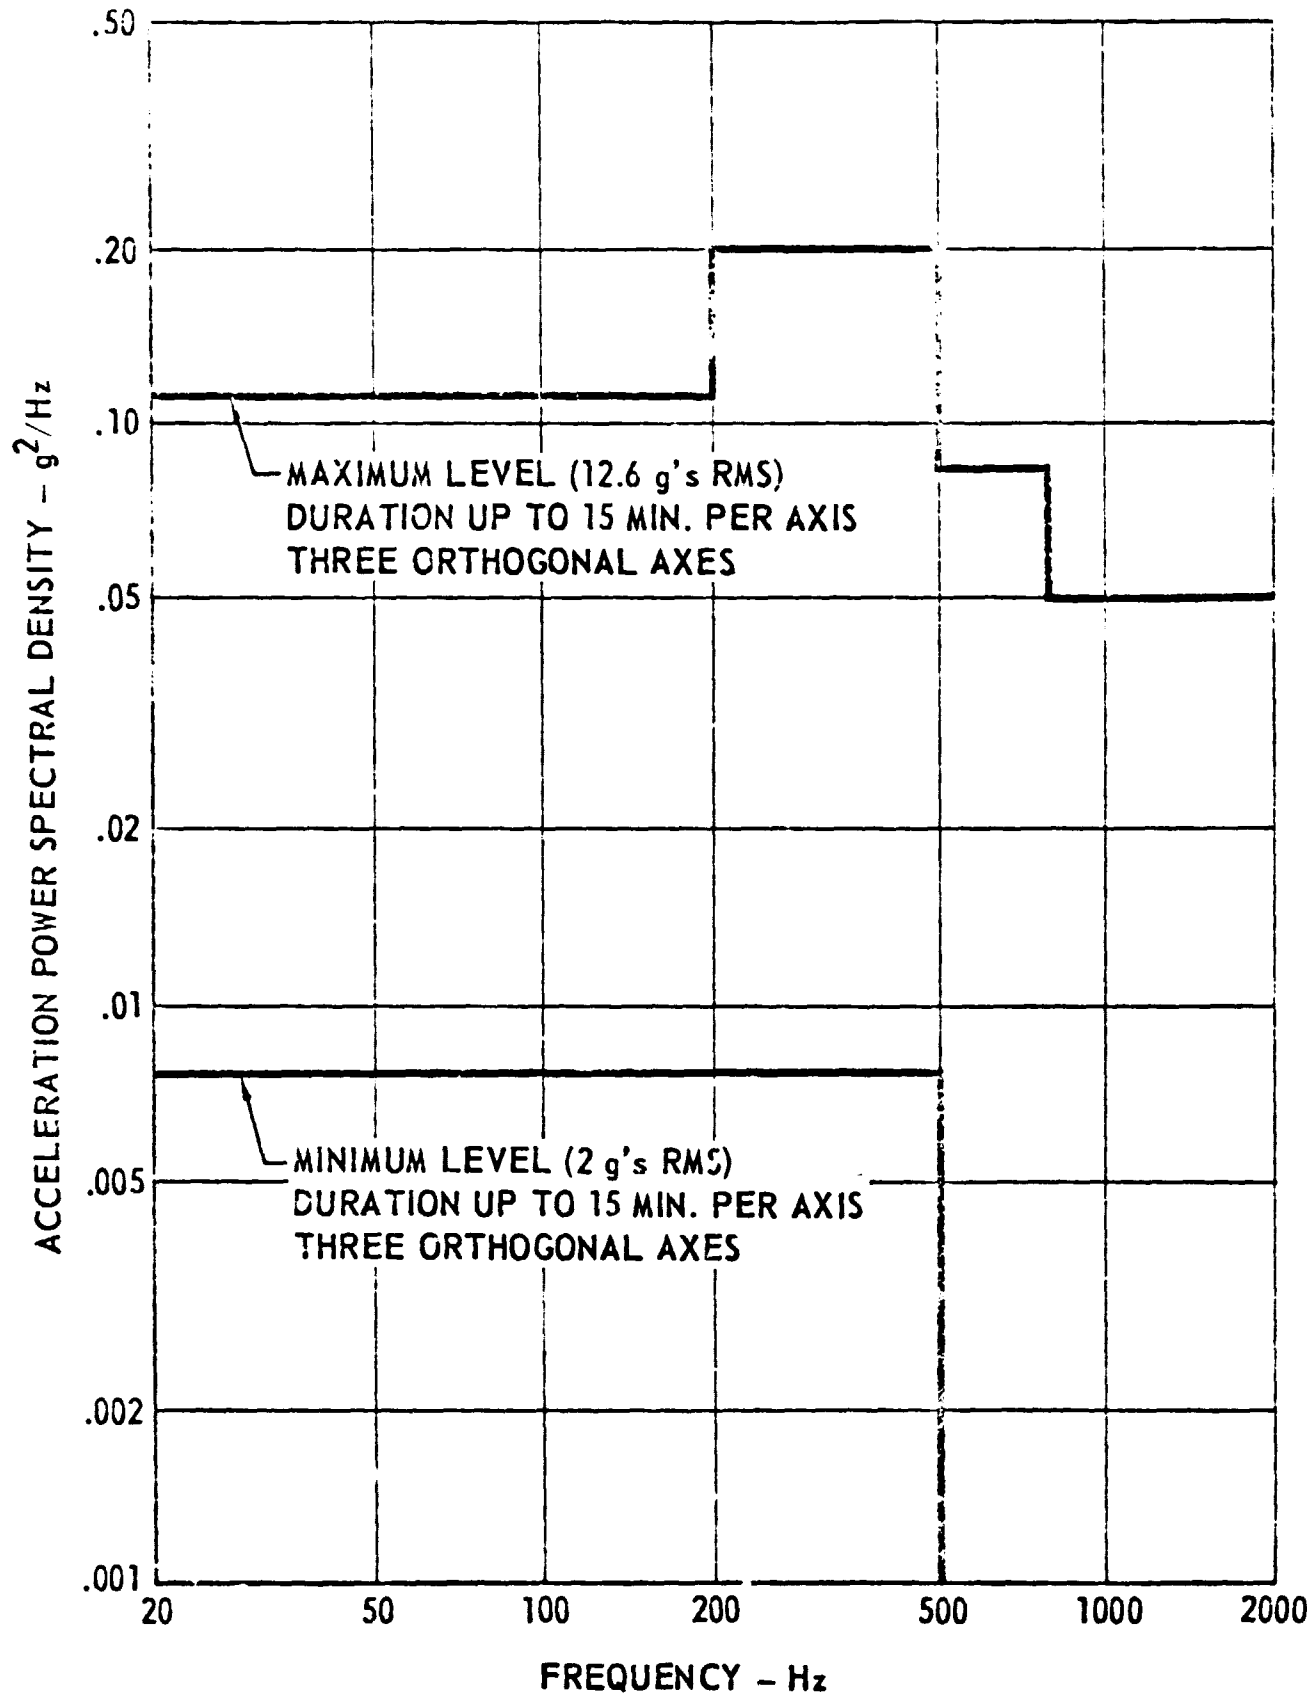
FIGURE 1-3 ENVELOPE OF RANDOM VIBRATION
QUALIFICATION TEST LEVELS

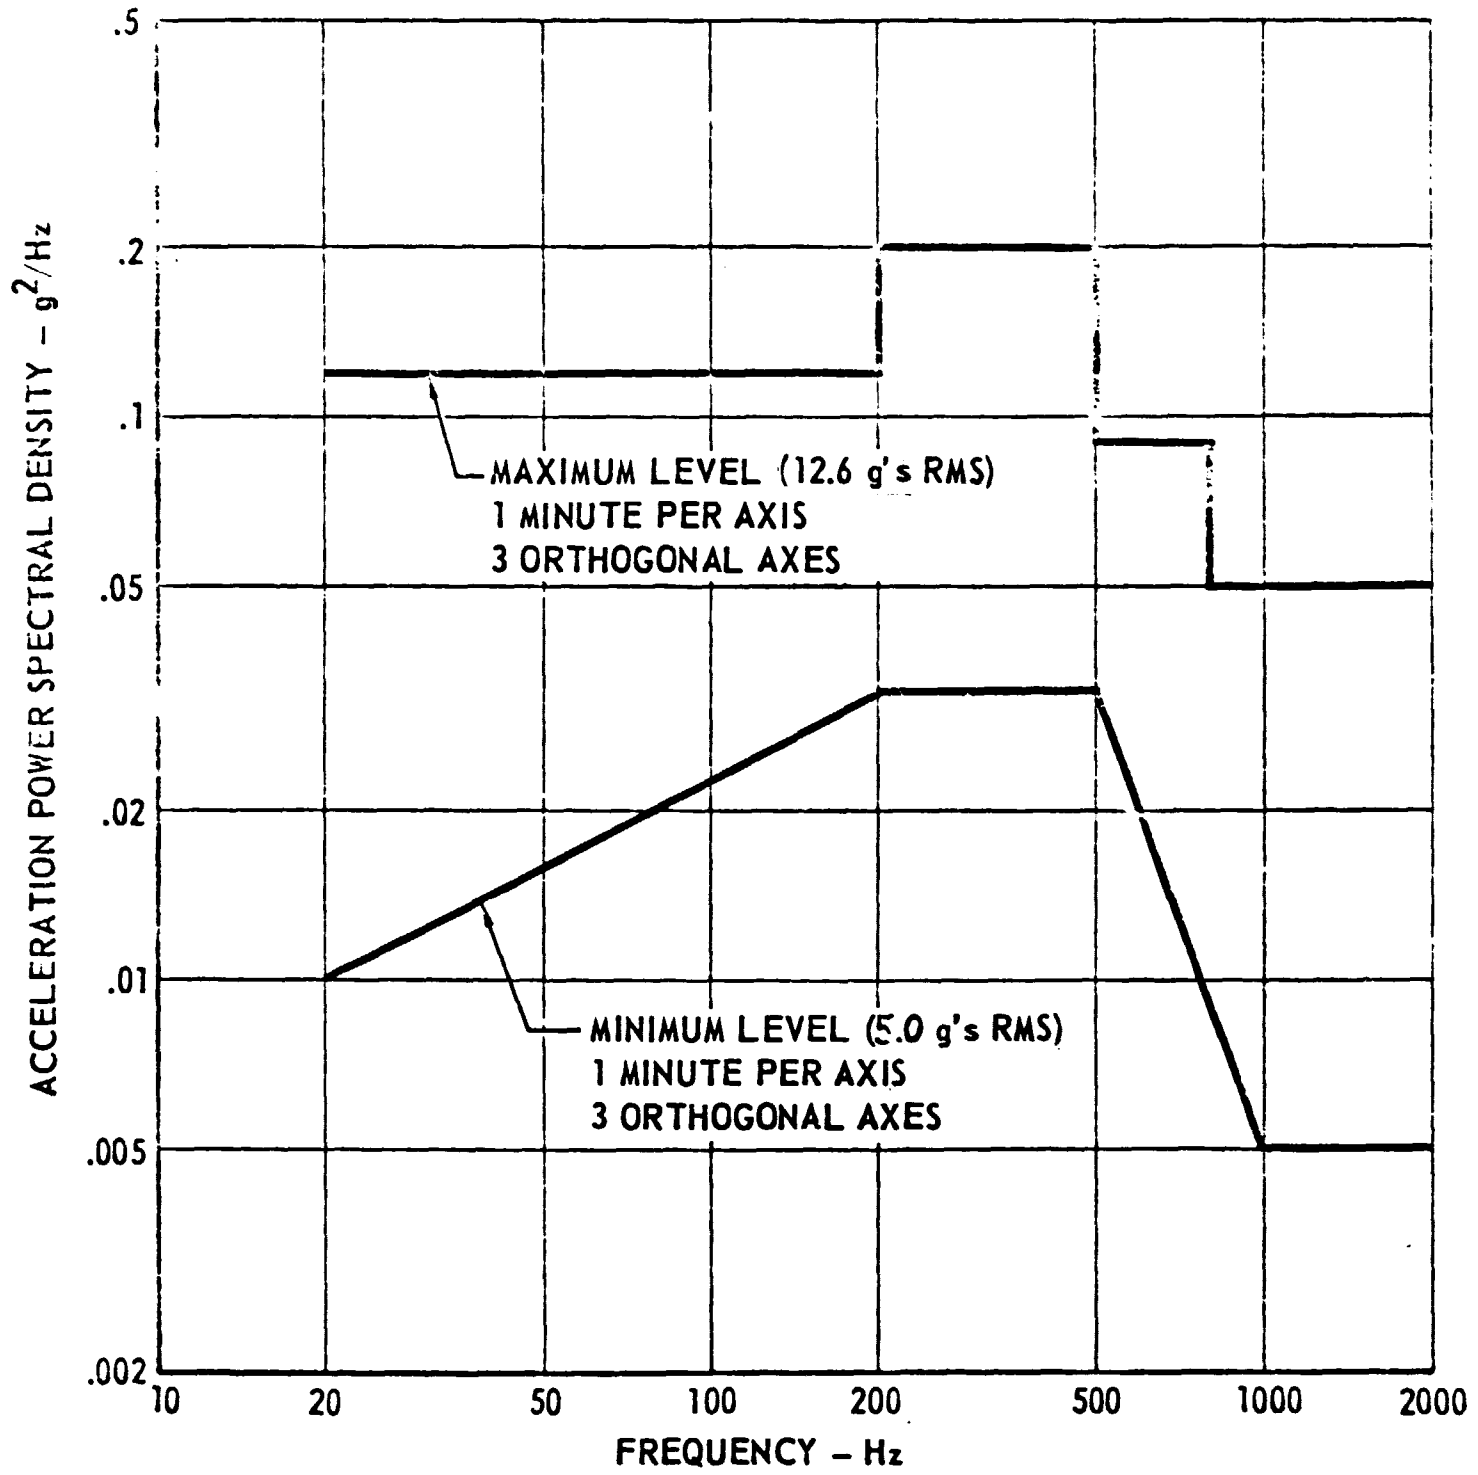
**FIGURE 1-5 ENVELOPE OF RANDOM VIBRATION
ACCEPTANCE TEST LEVELS**

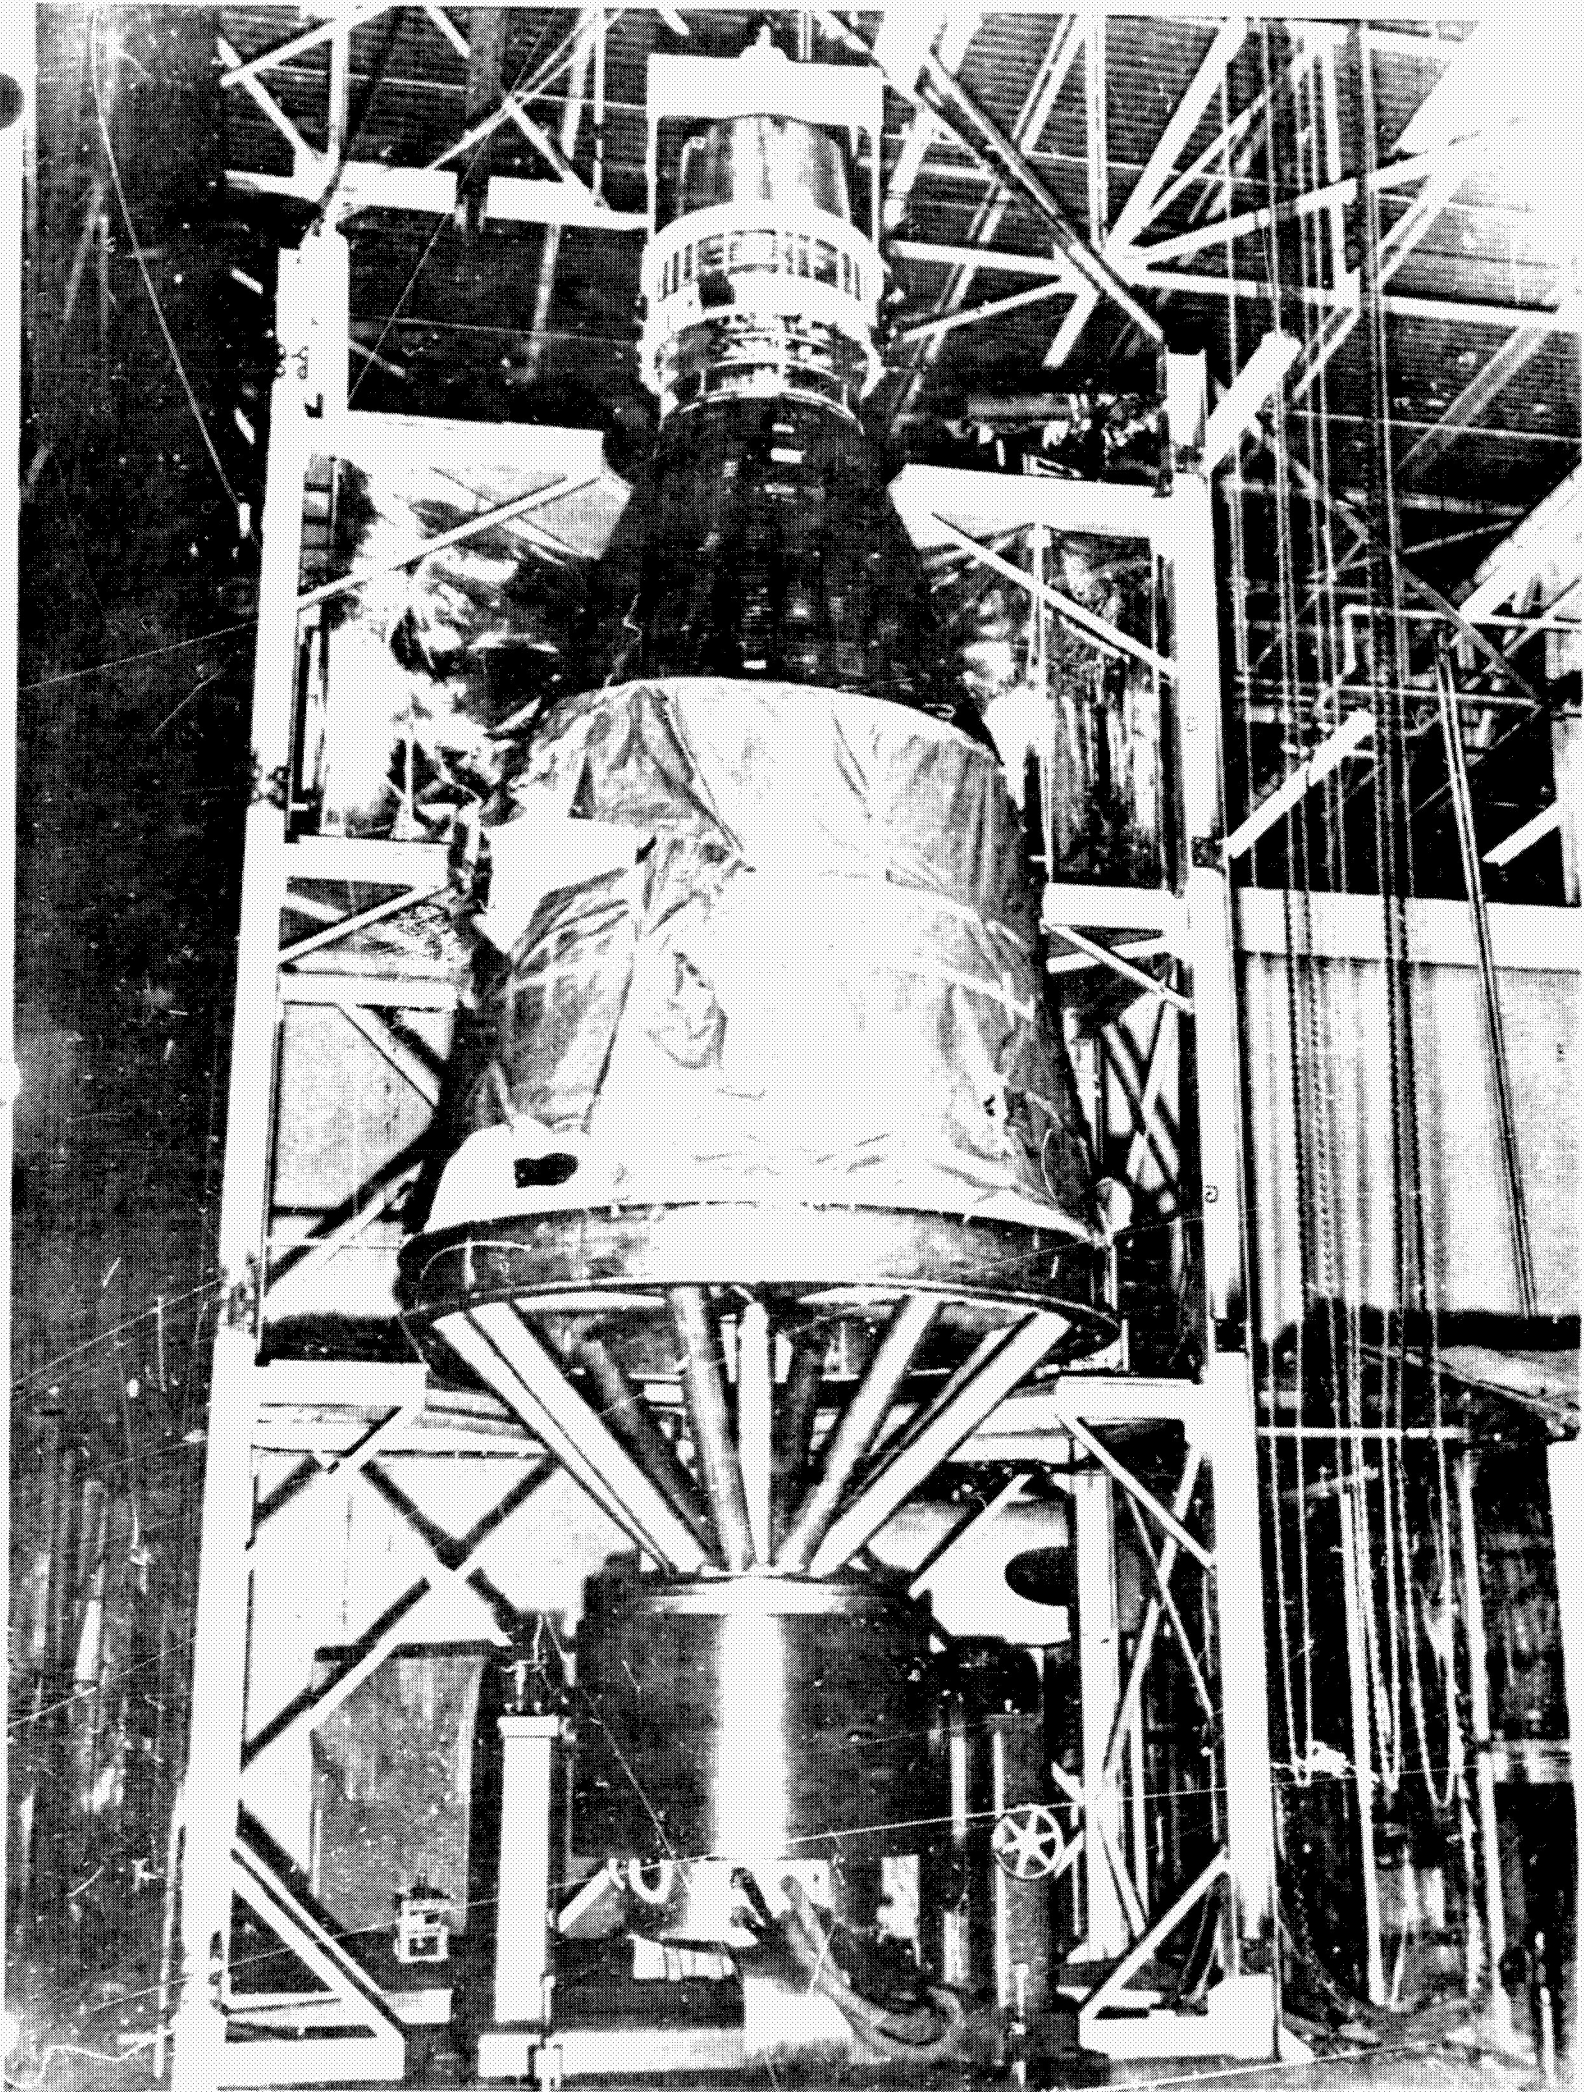
FIGURE i-7 VIBRATION TEST OF SPACECRAFT 1

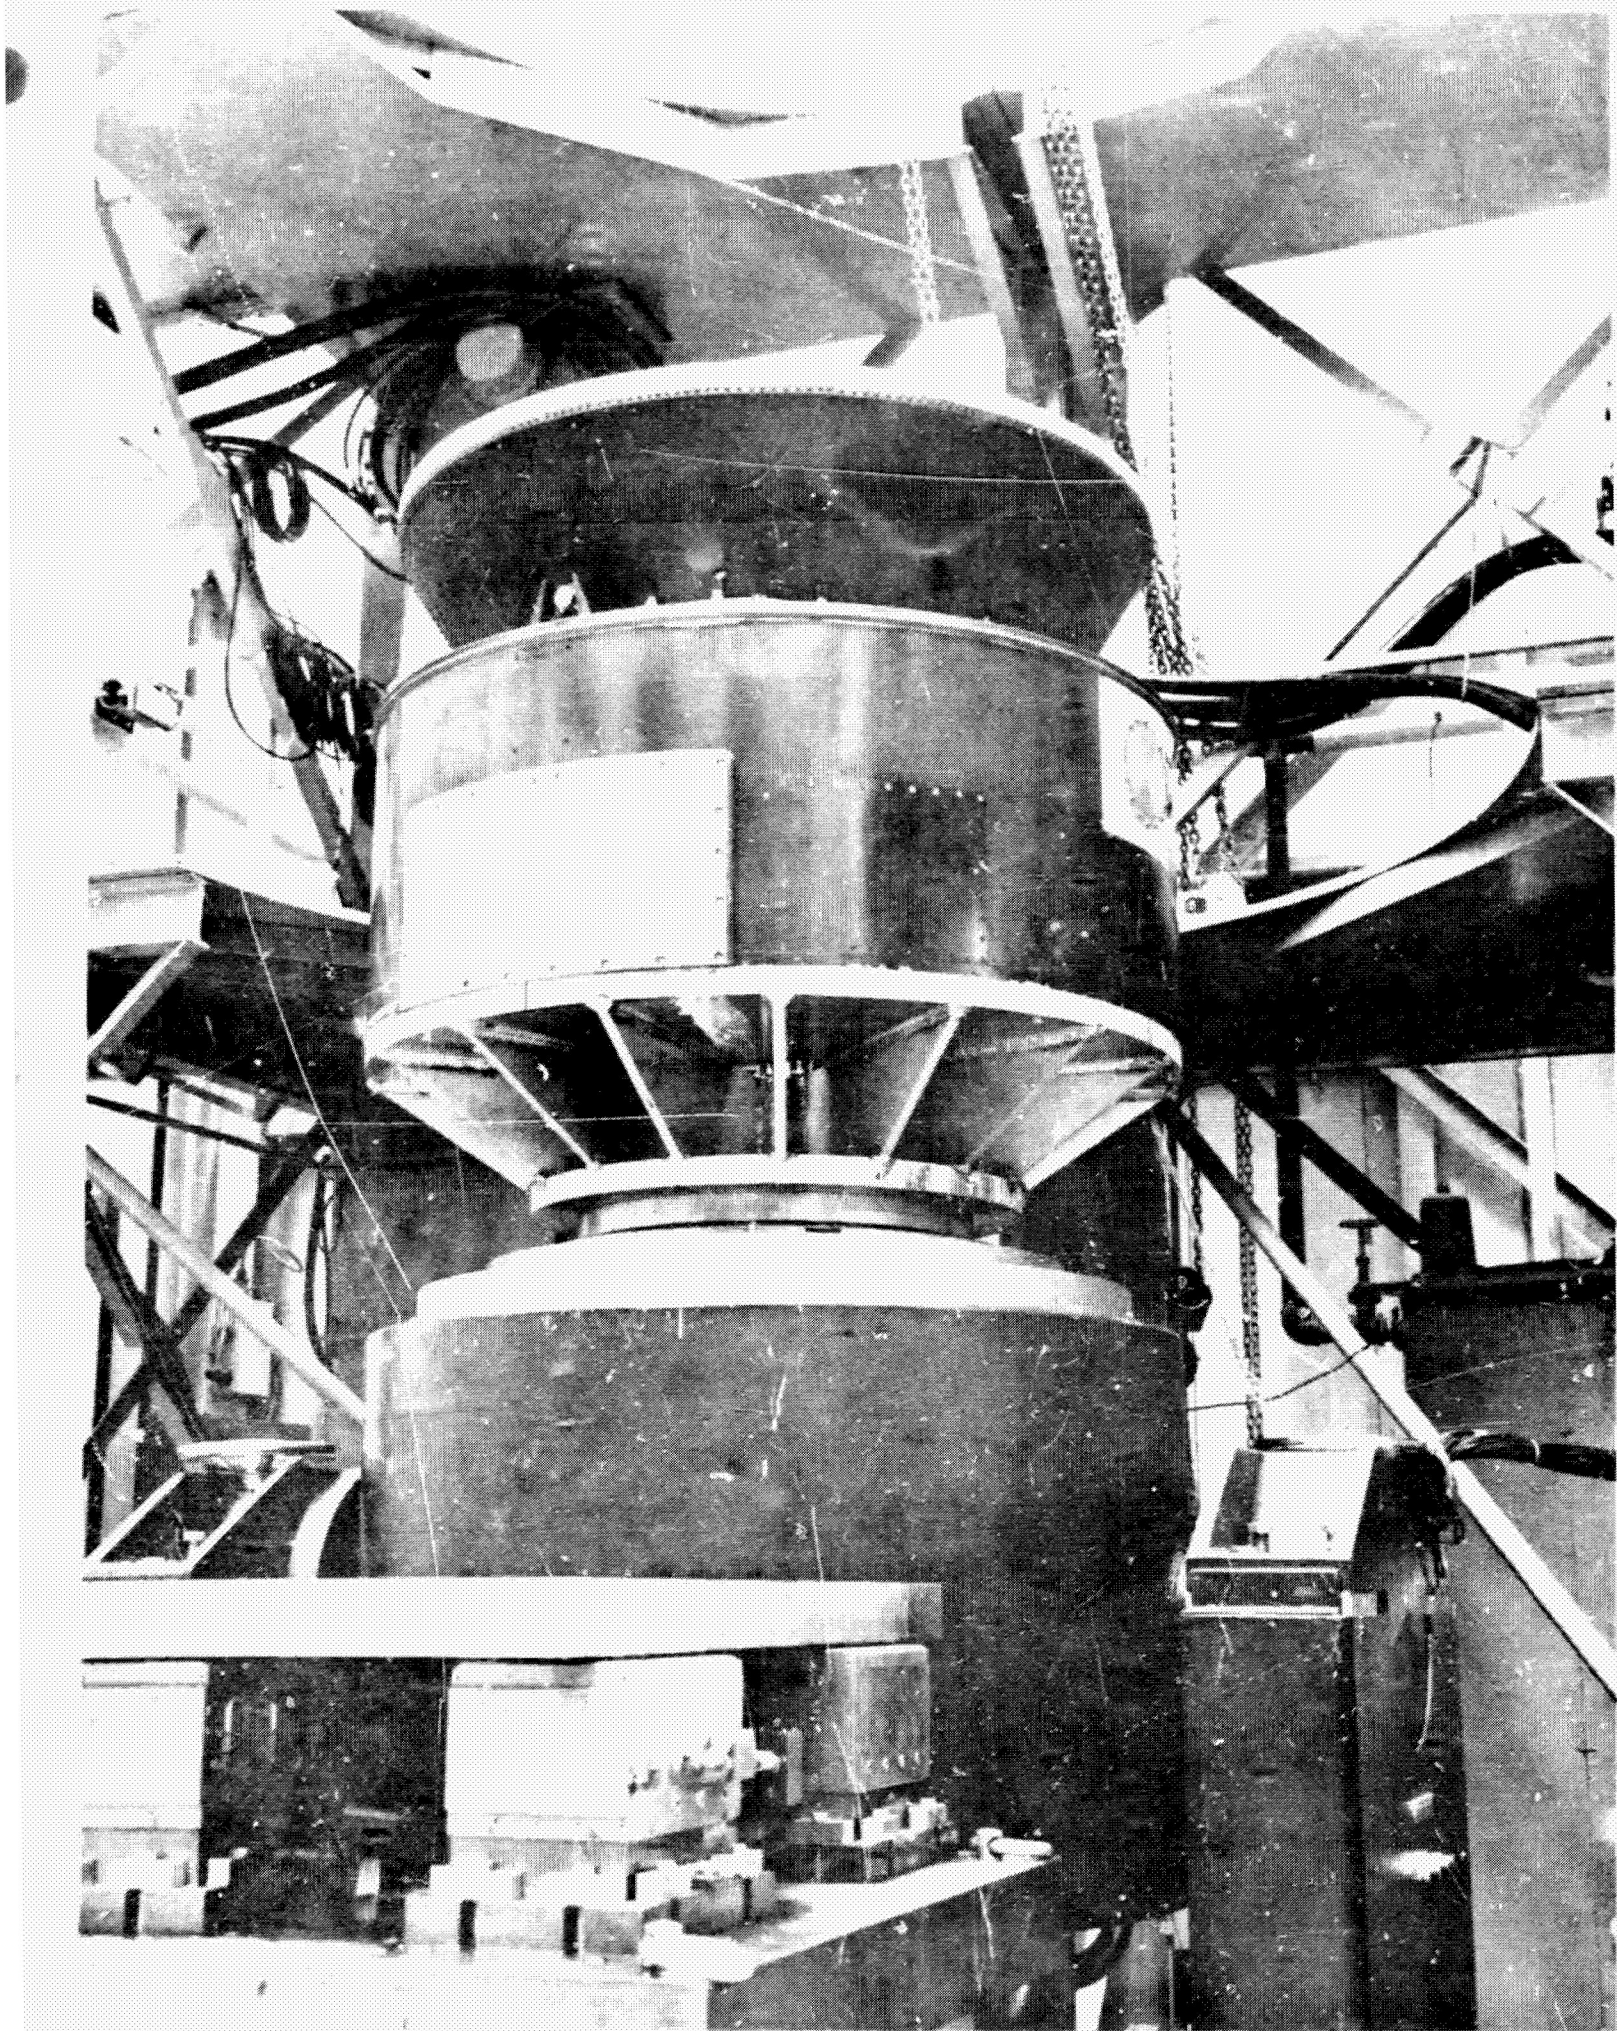
**FIGURE 1-8 VIBRATION TEST OF THE FIRST FLIGHT
TARGET DOCKING ADAPTER.**

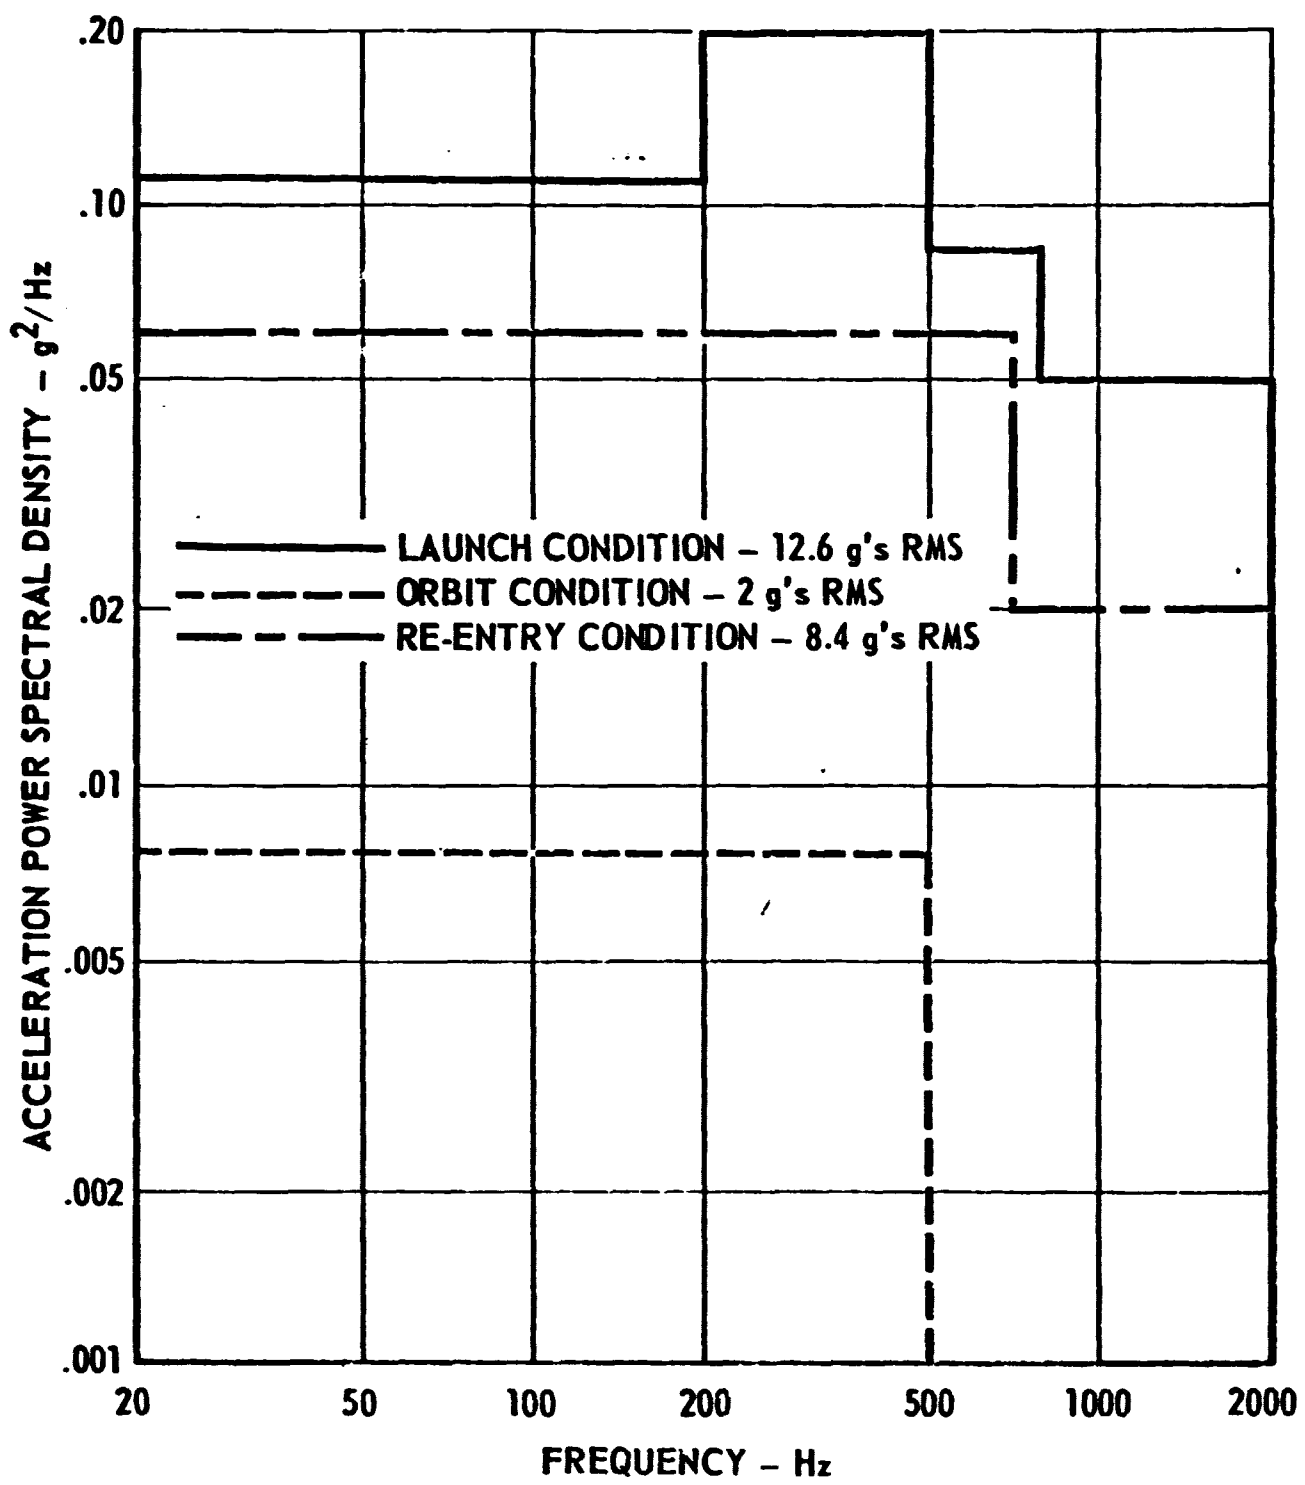
**FIGURE 4-1 GEMINI SPACECRAFT
RANDOM VIBRATION QUALIFICATION SPECTRA -
ORIGINAL REQUIREMENTS**

The ratio of power spectral densities of the qualification tests to those of the corresponding acceptance test was two to one. The ratio resulted as a convenient specification of levels which would provide qualification tests in excess of the predicted mean plus 2σ vibration levels and acceptance tests near the mean plus 1σ vibration levels. The test durations for qualification included a 5 minute test period which was intended to demonstrate the capability of the design to withstand expected flight vibrations plus ground test vibrations, including re-tests if necessary. The time relation is really not so simple since the levels are not one-to-one for the time period, but more detailed comparison was not made.

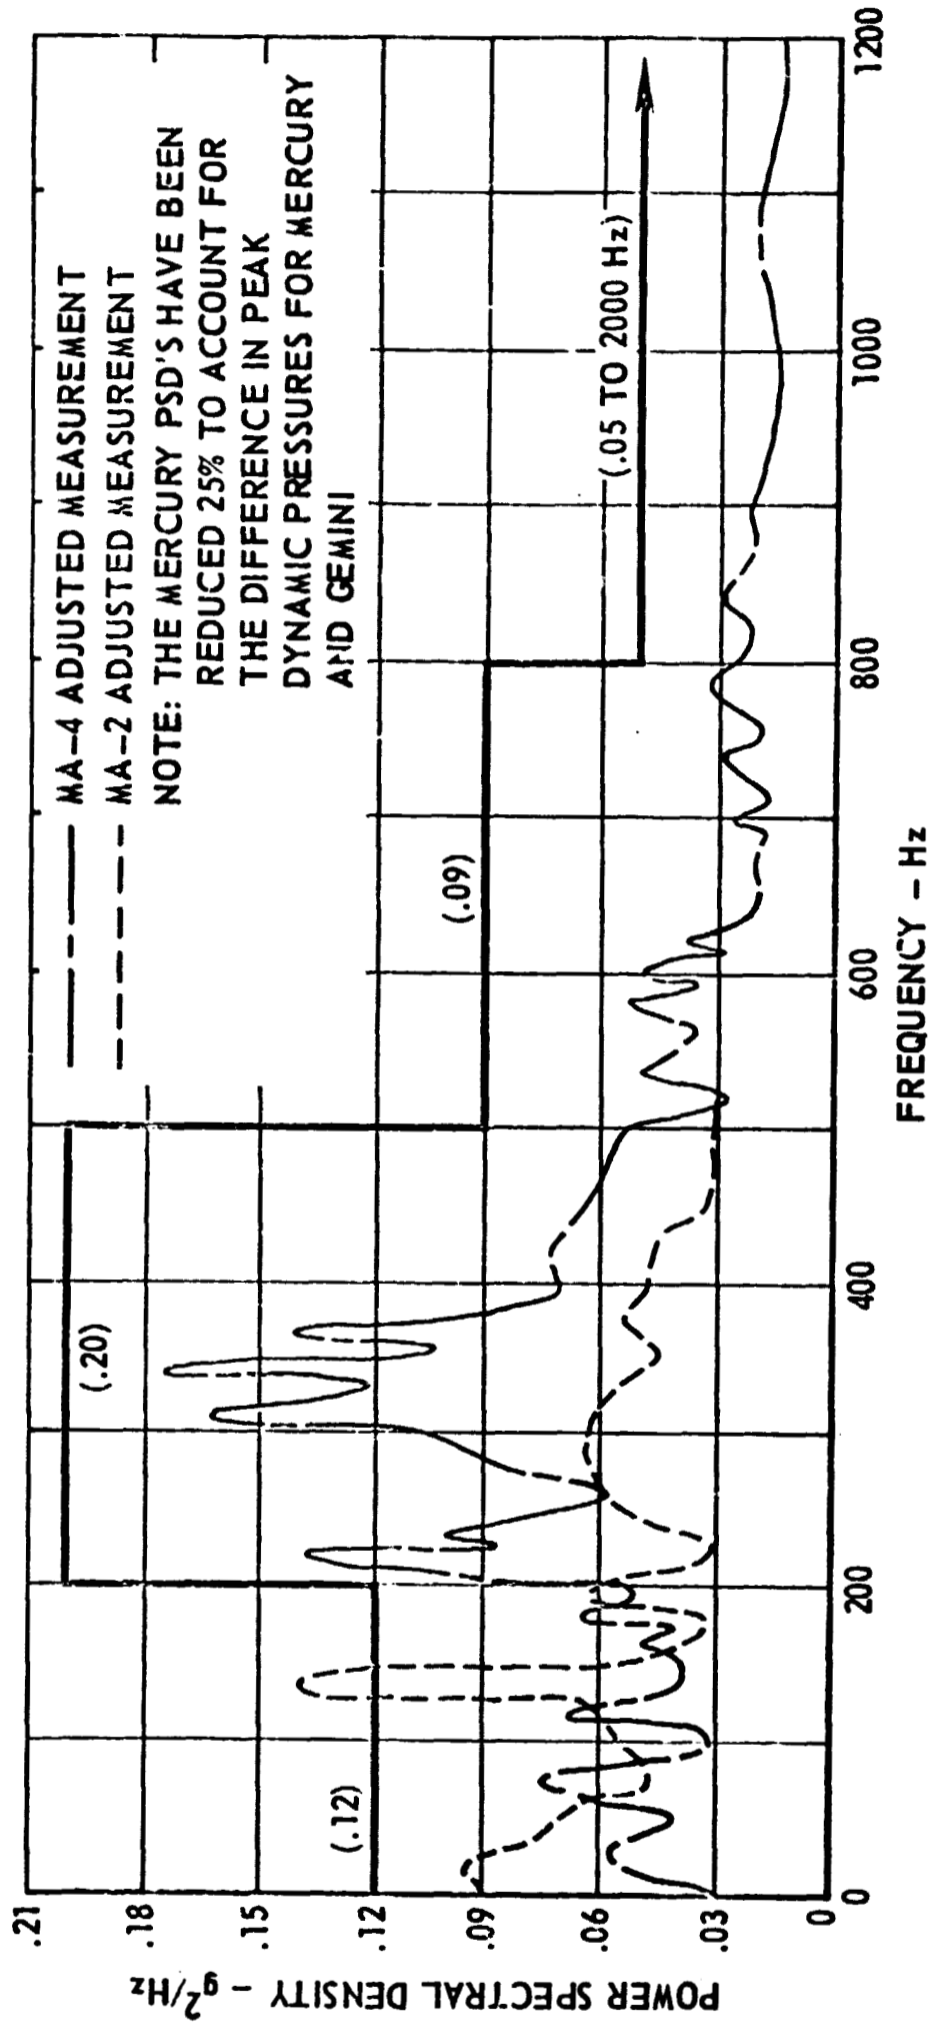
FIGURE 4-3 COMPARISON OF SPECIFIED TEST LEVEL WITH ADJUSTED MERCURY DATA

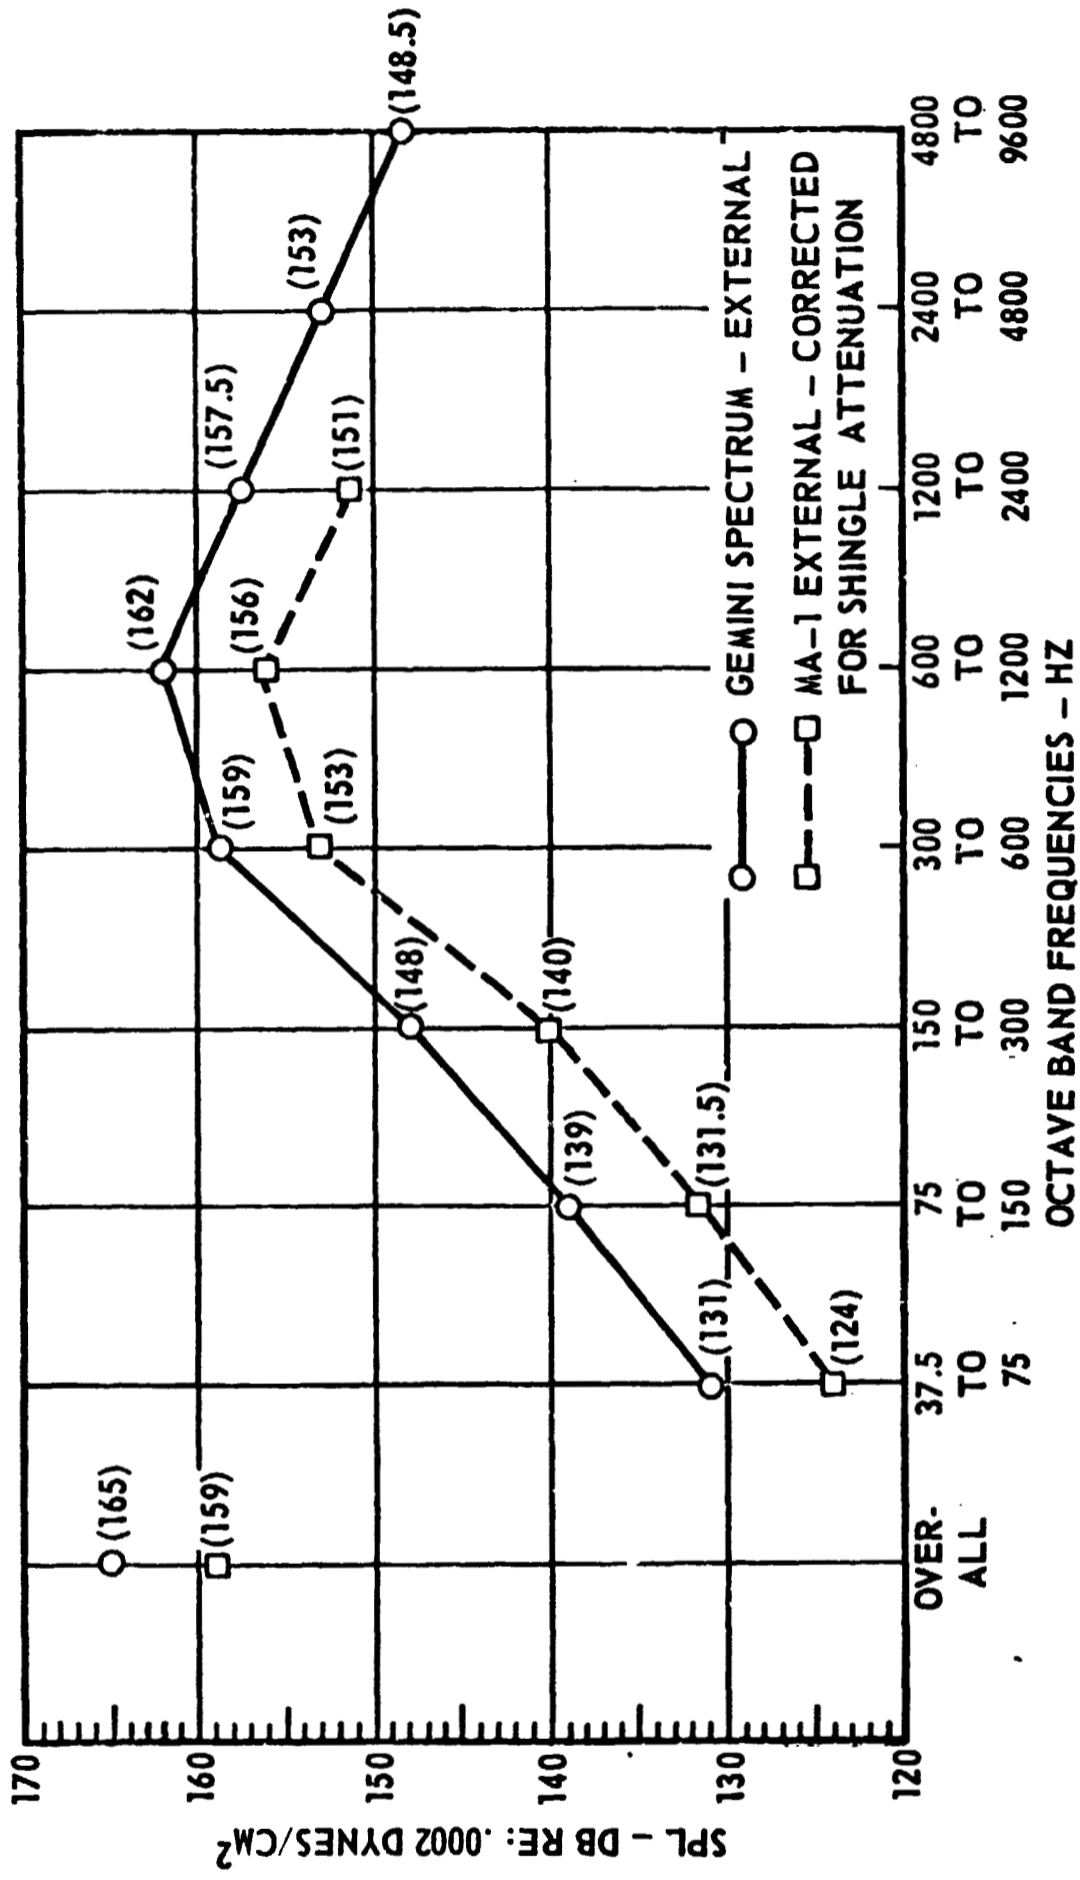
FIGURE 4-4 GEMINI EXTERNAL ACOUSTIC SPECTRA

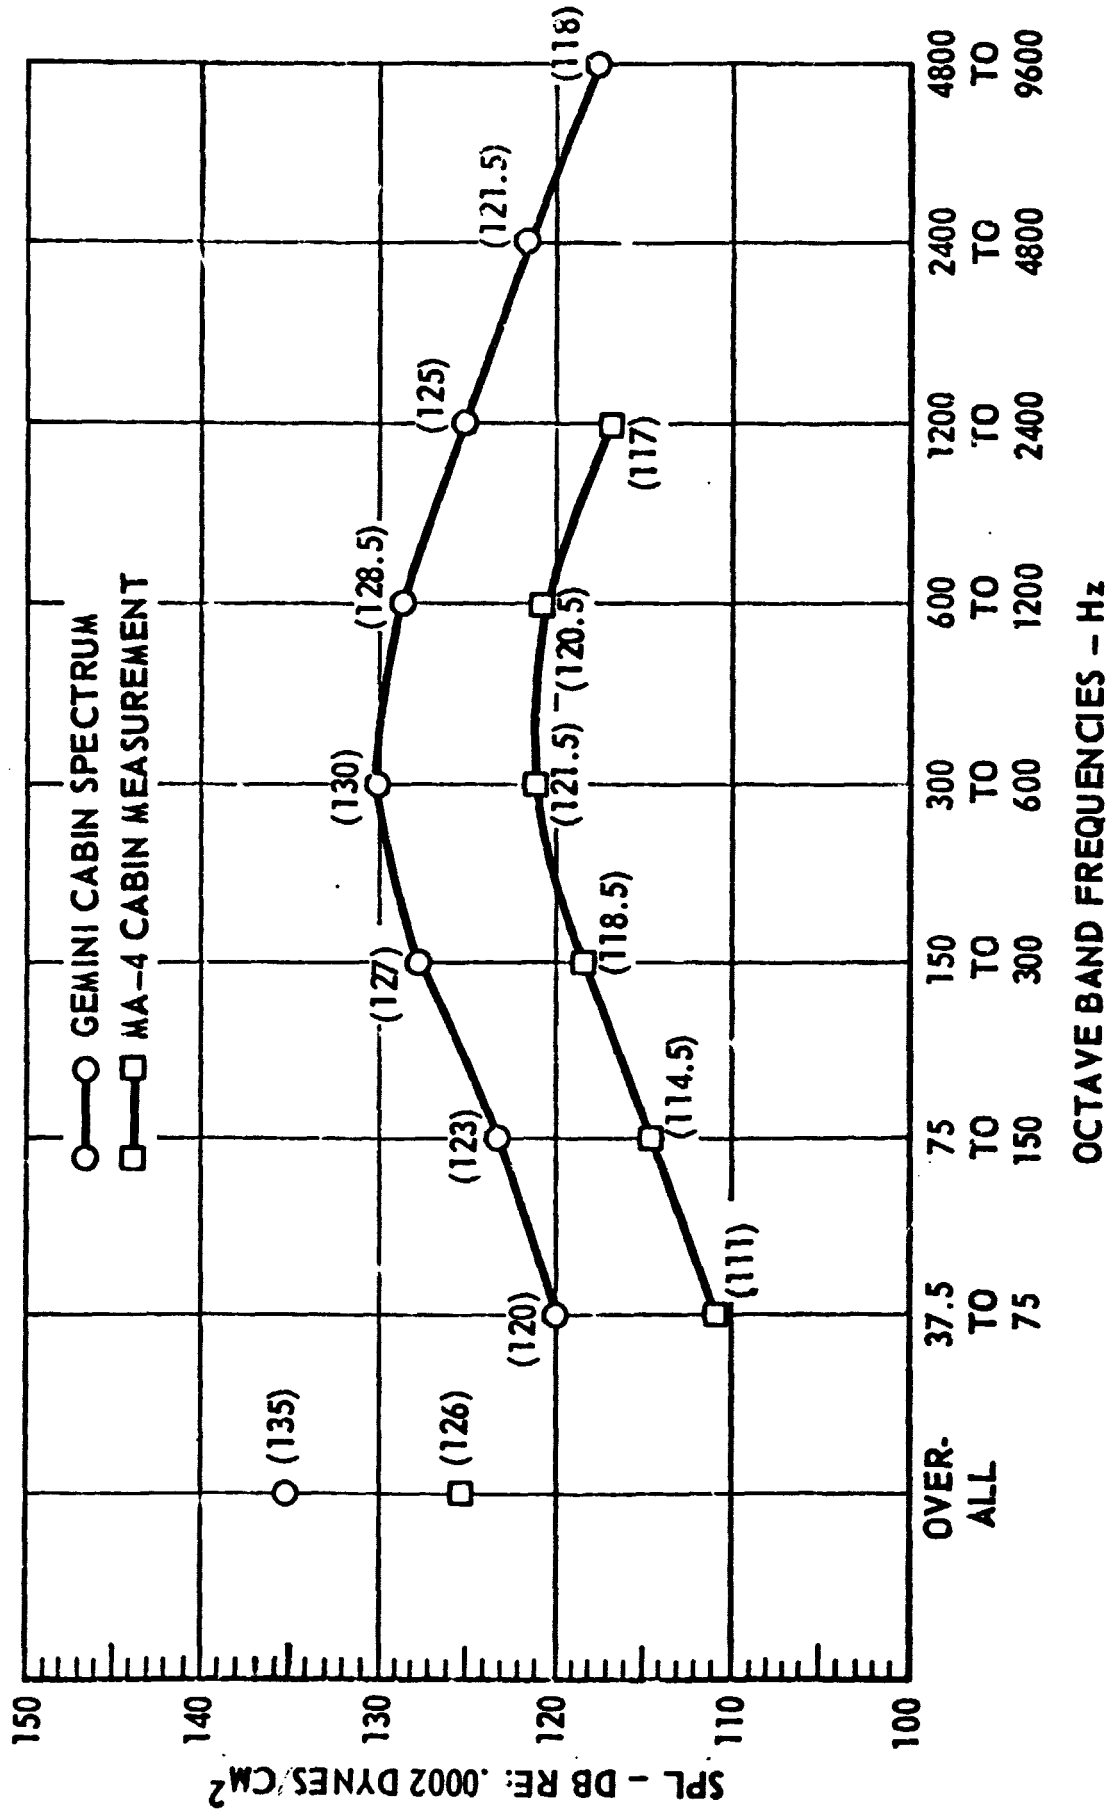
FIGURE 4-5 ACOUSTIC SPECTRA FOR GEMINI CABIN AREA

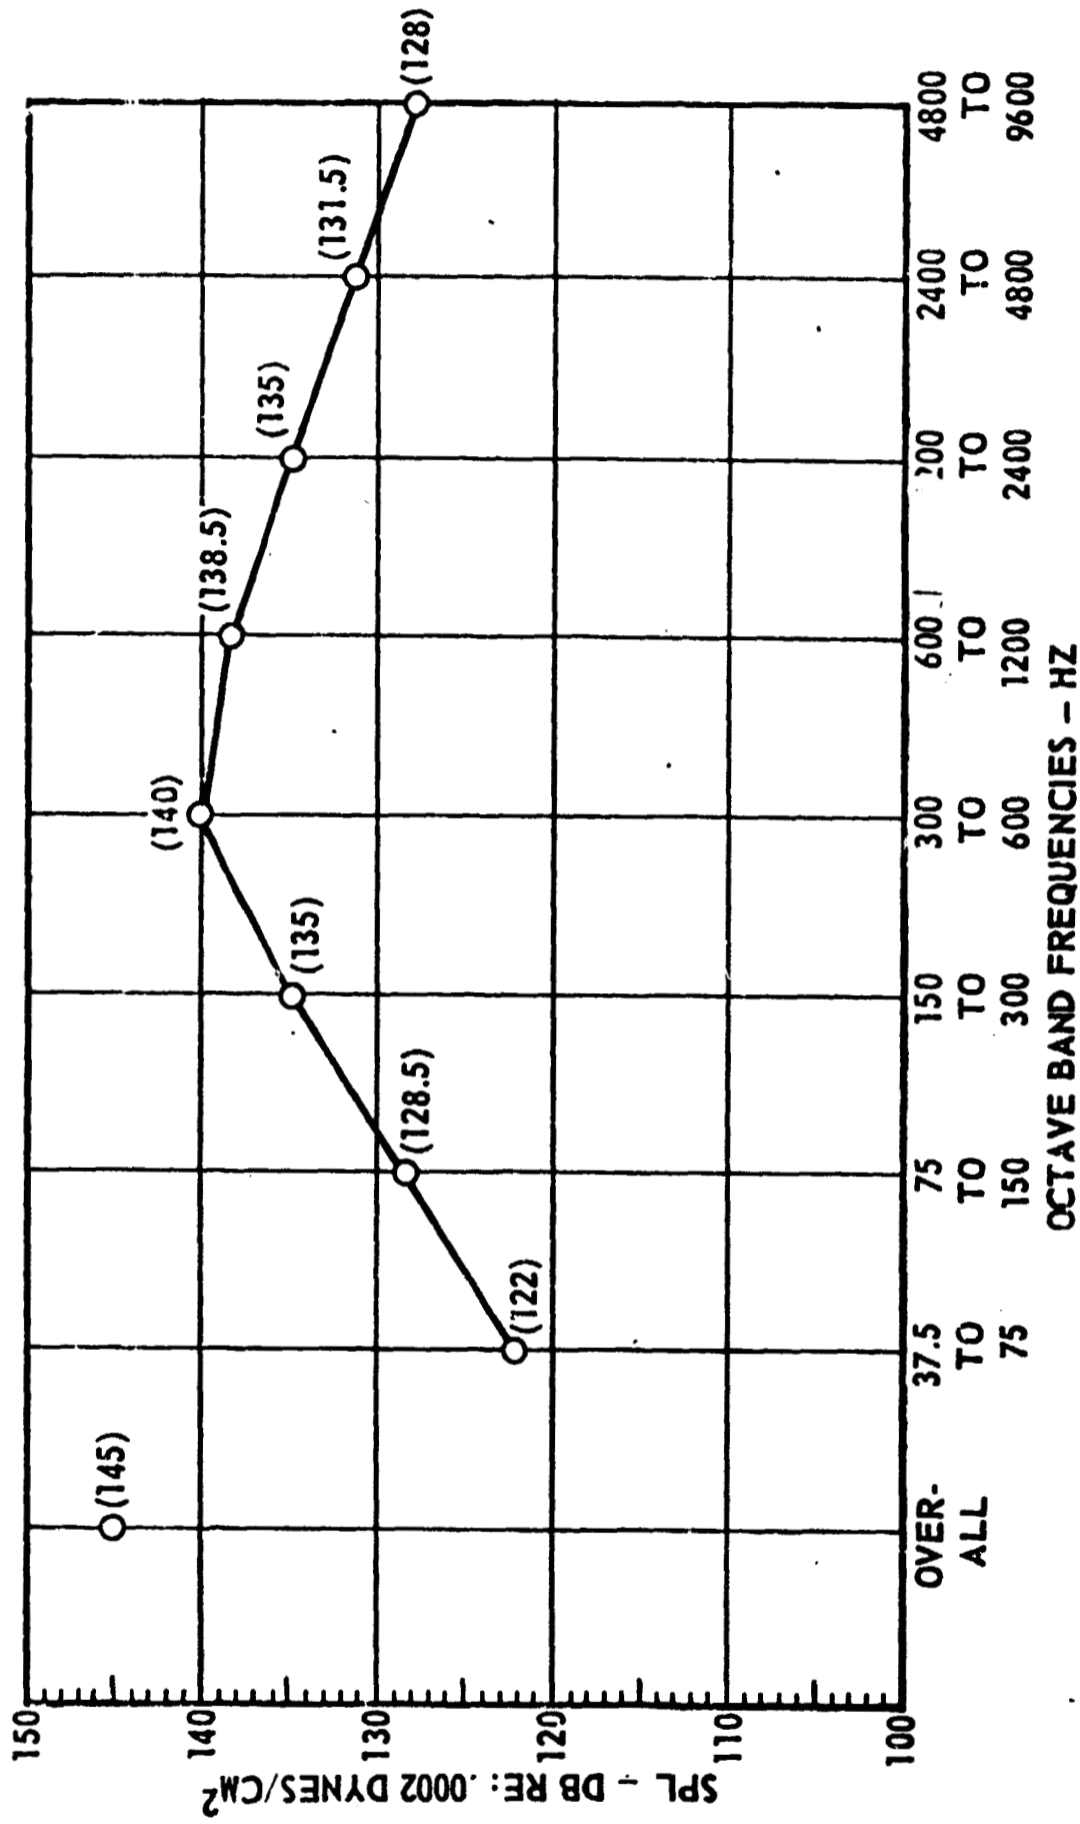
FIGURE 4-6 ACOUSTIC SPECTRA FOR GEMINI EQUIPMENT BAY AREAS
