**APOLLO TIE
WASHINGTON, D. C.**

DOCUMENT NO. D2-120001-2

TITLE SUMMARY OF VIBRATION AND ACOUSTIC TESTS ON
FOUR SPACECRAFT PROGRAMS

This document summarizes the vibration and acoustic test programs for four spacecraft: Mariner, Lunar Orbiter, Gemini and Surveyor. Information is presented on laboratory test programs and results, flight results, derivation of test levels, identification of test factors, and spacecraft contractor conclusions and recommendations.

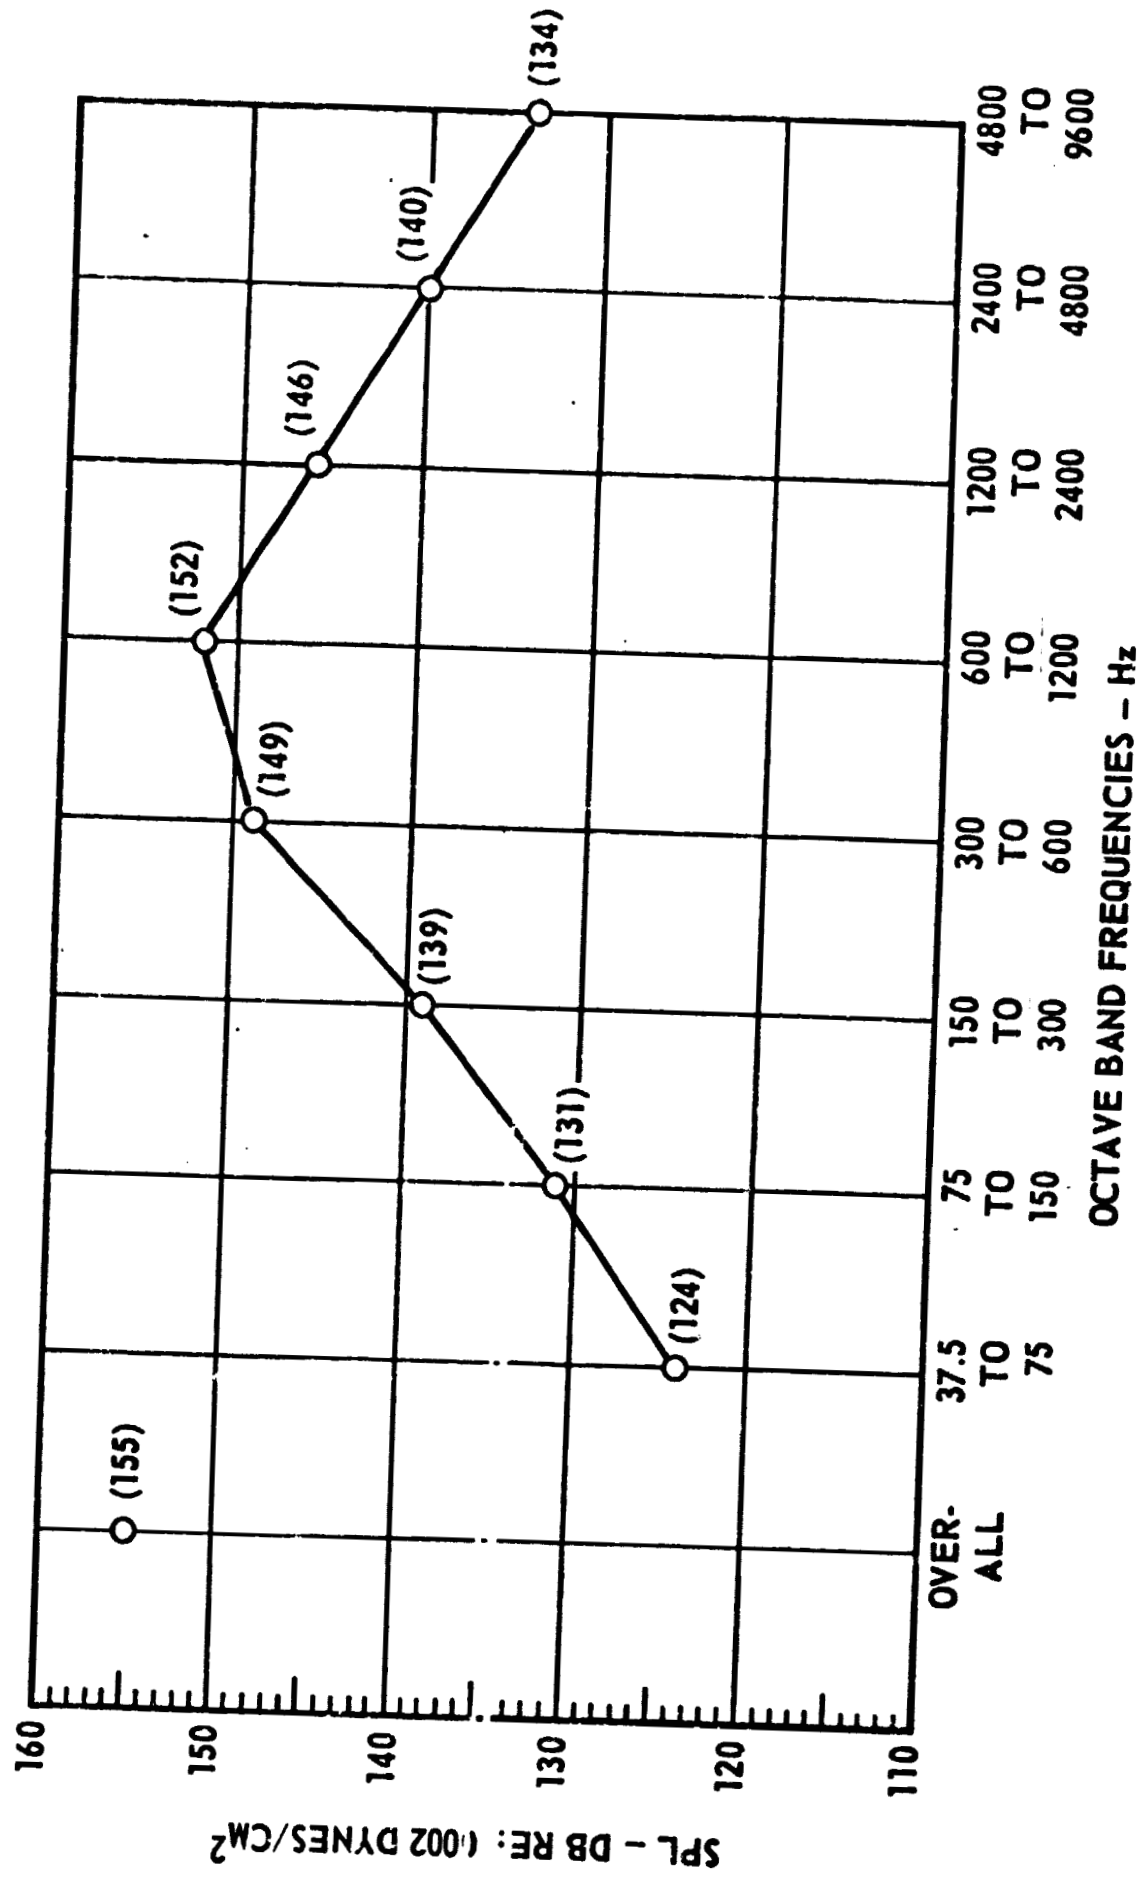
FIGURE 4-7 ACOUSTIC SPECTRA FOR GEMINI ADAPTER AREA

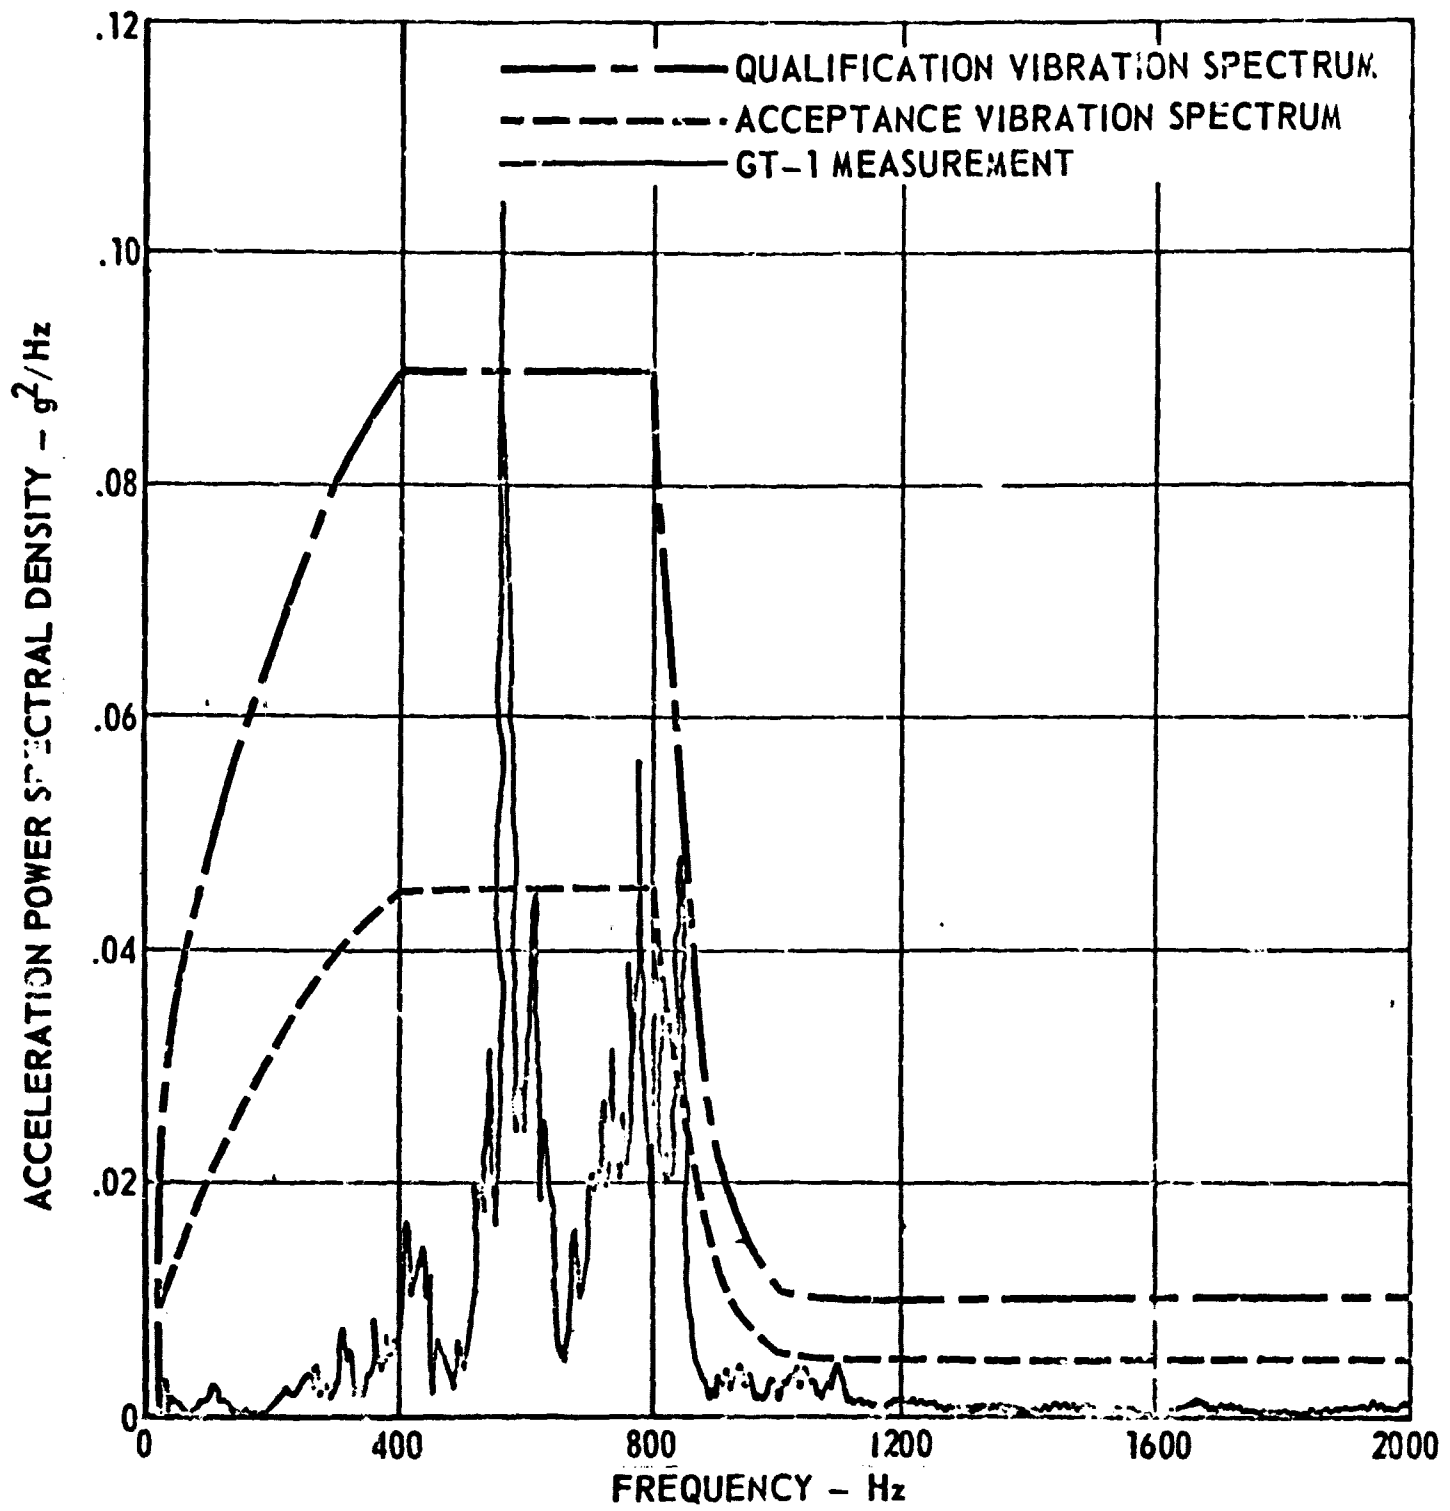
**FIGURE 4-8 GT-1 EQUIPMENT BAY VIBRATION MEASUREMENT
COMPARED WITH QUALIFICATION AND ACCEPTANCE
VIBRATION SPECTRA**

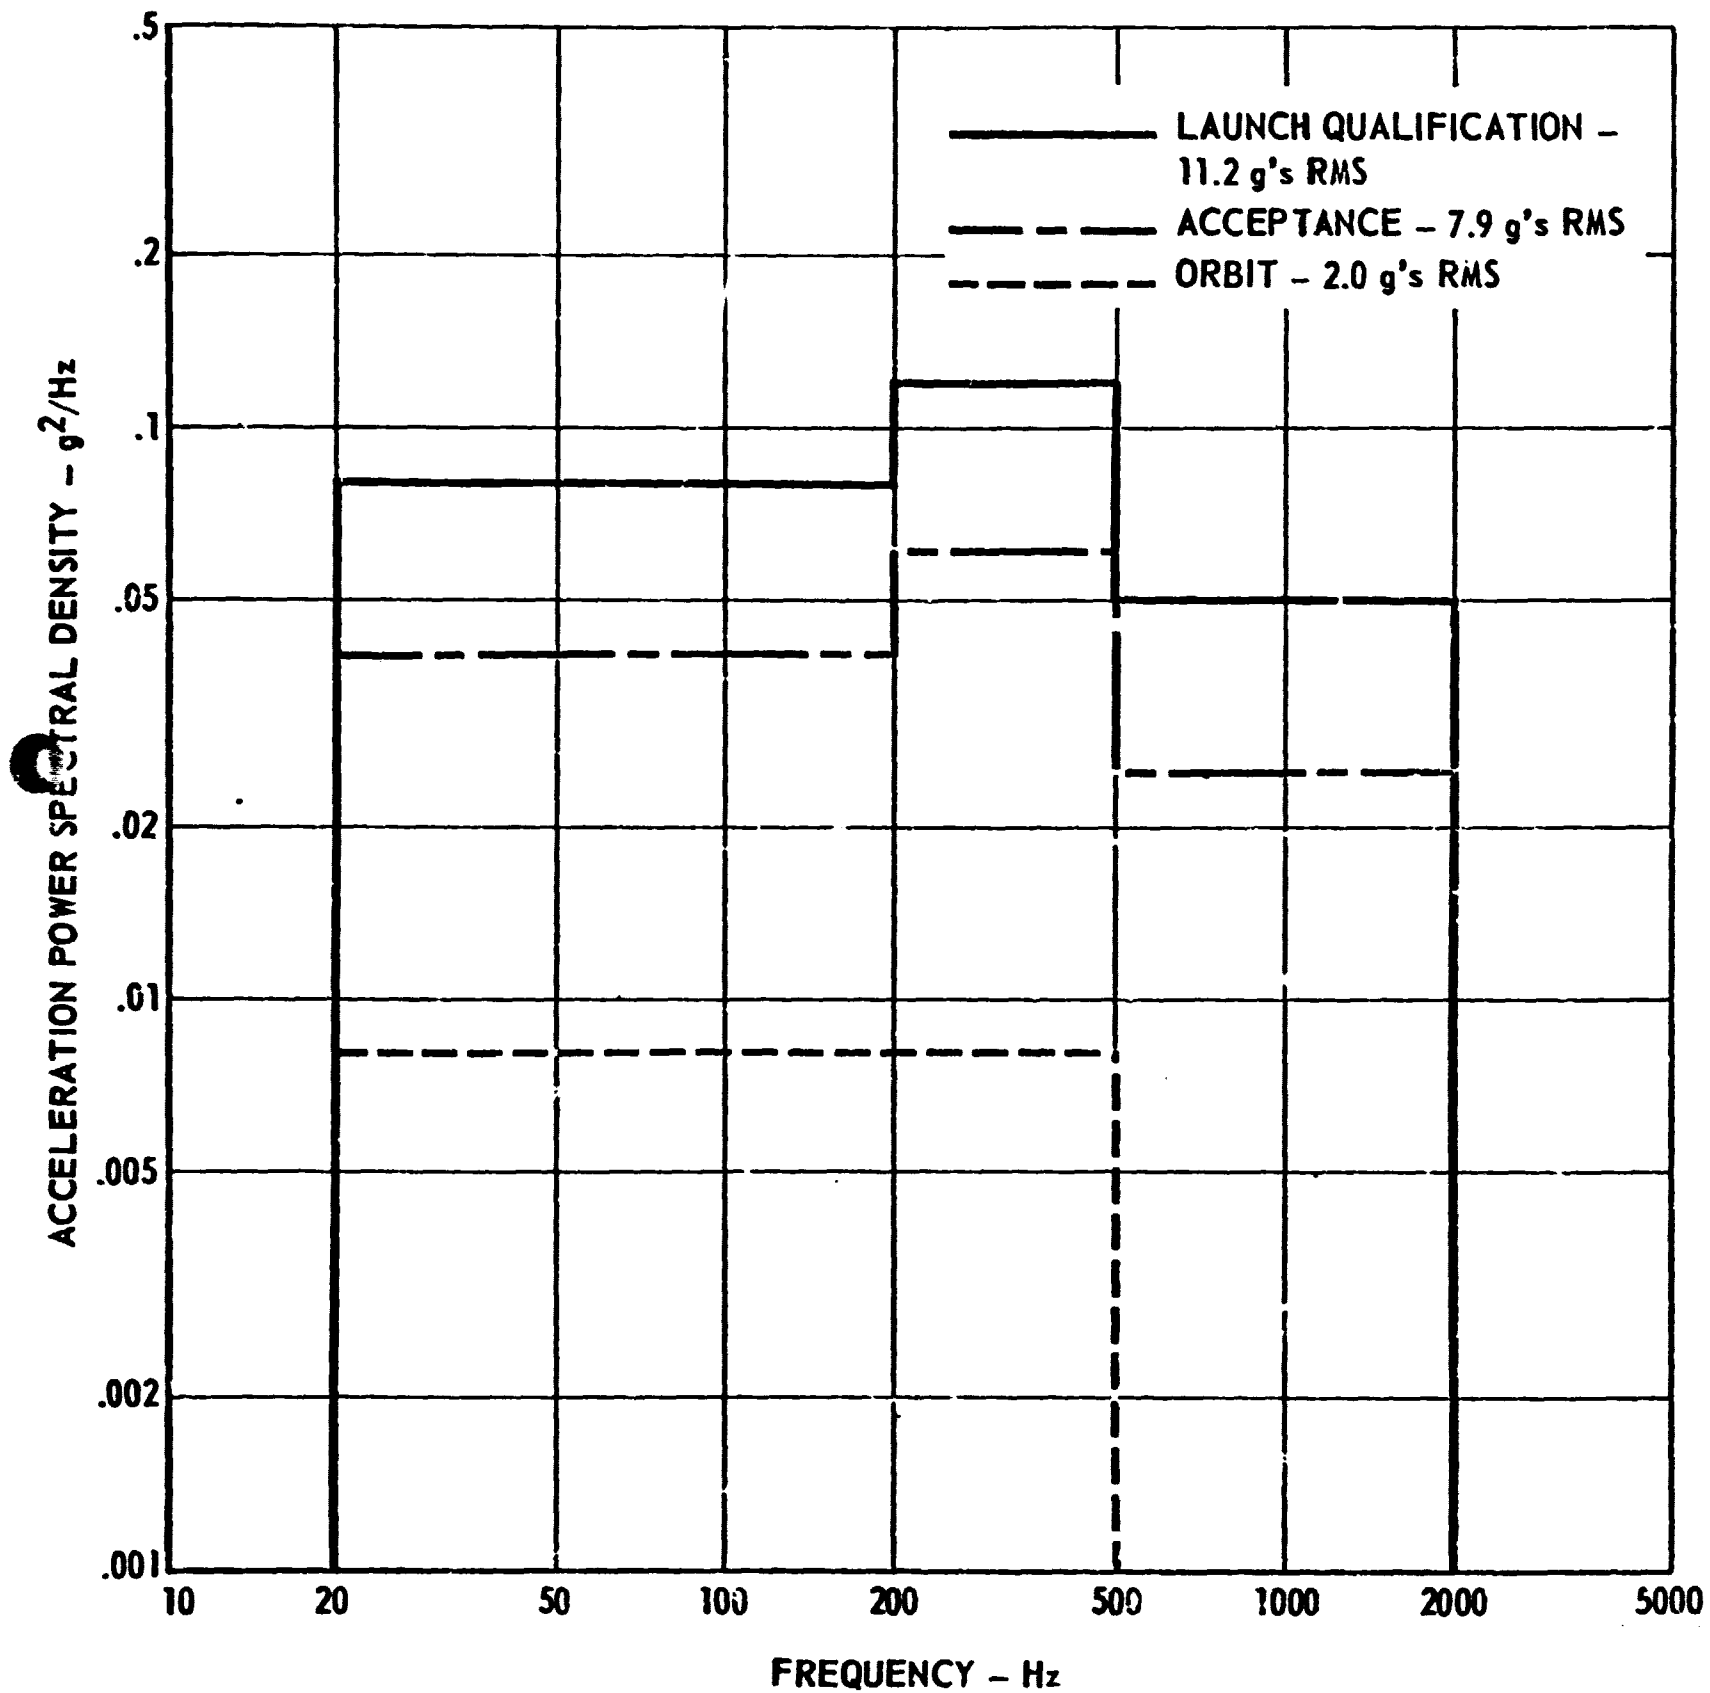
**FIGURE 4-10 GEMINI TARGET DOCKING
ADAPTER RANDOM VIBRATION SPECTRA**

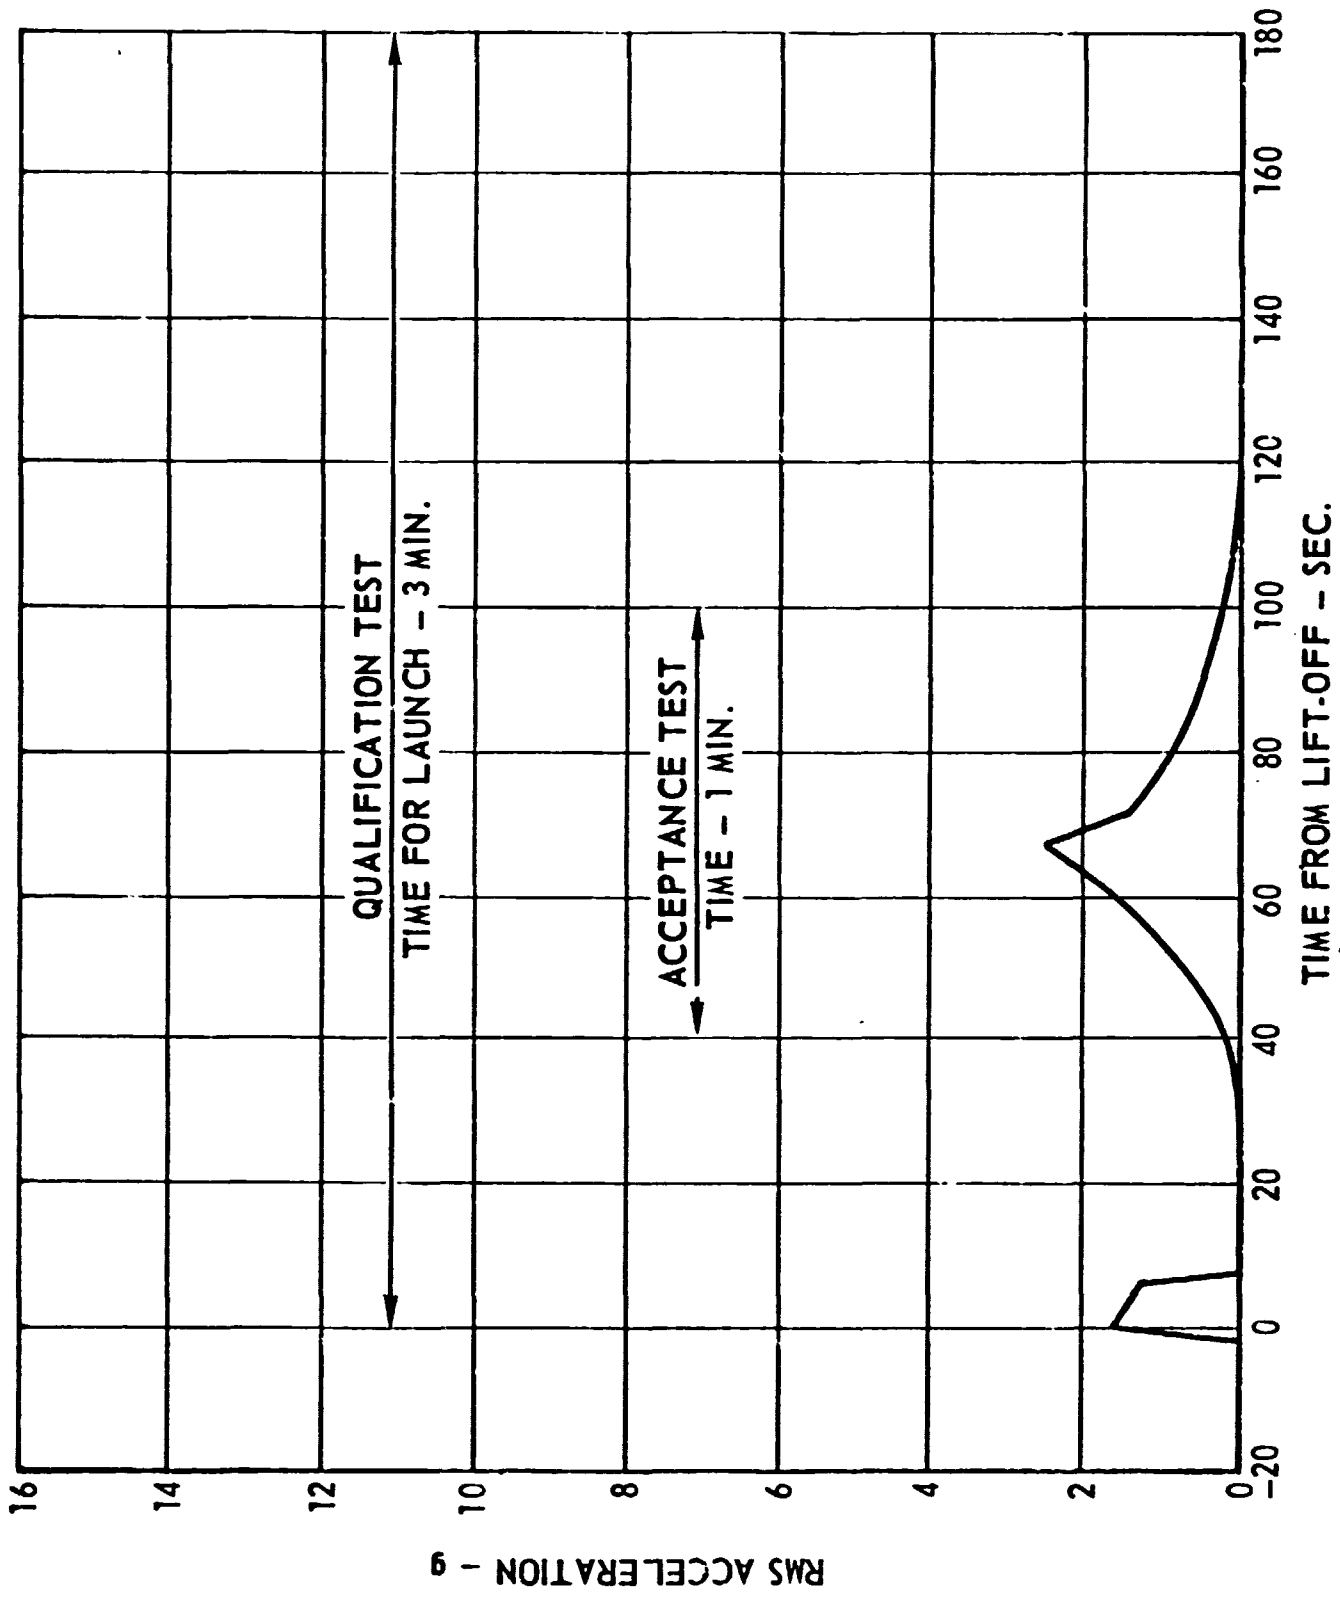
FIGURE 4-15 COMPARISON OF TIME HISTORY OF GT-1 MEASURED ADAPTER BLAST SHIELD VIBRATION WITH QUALIFICATION AND ACCEPTANCE TEST DURATIONS

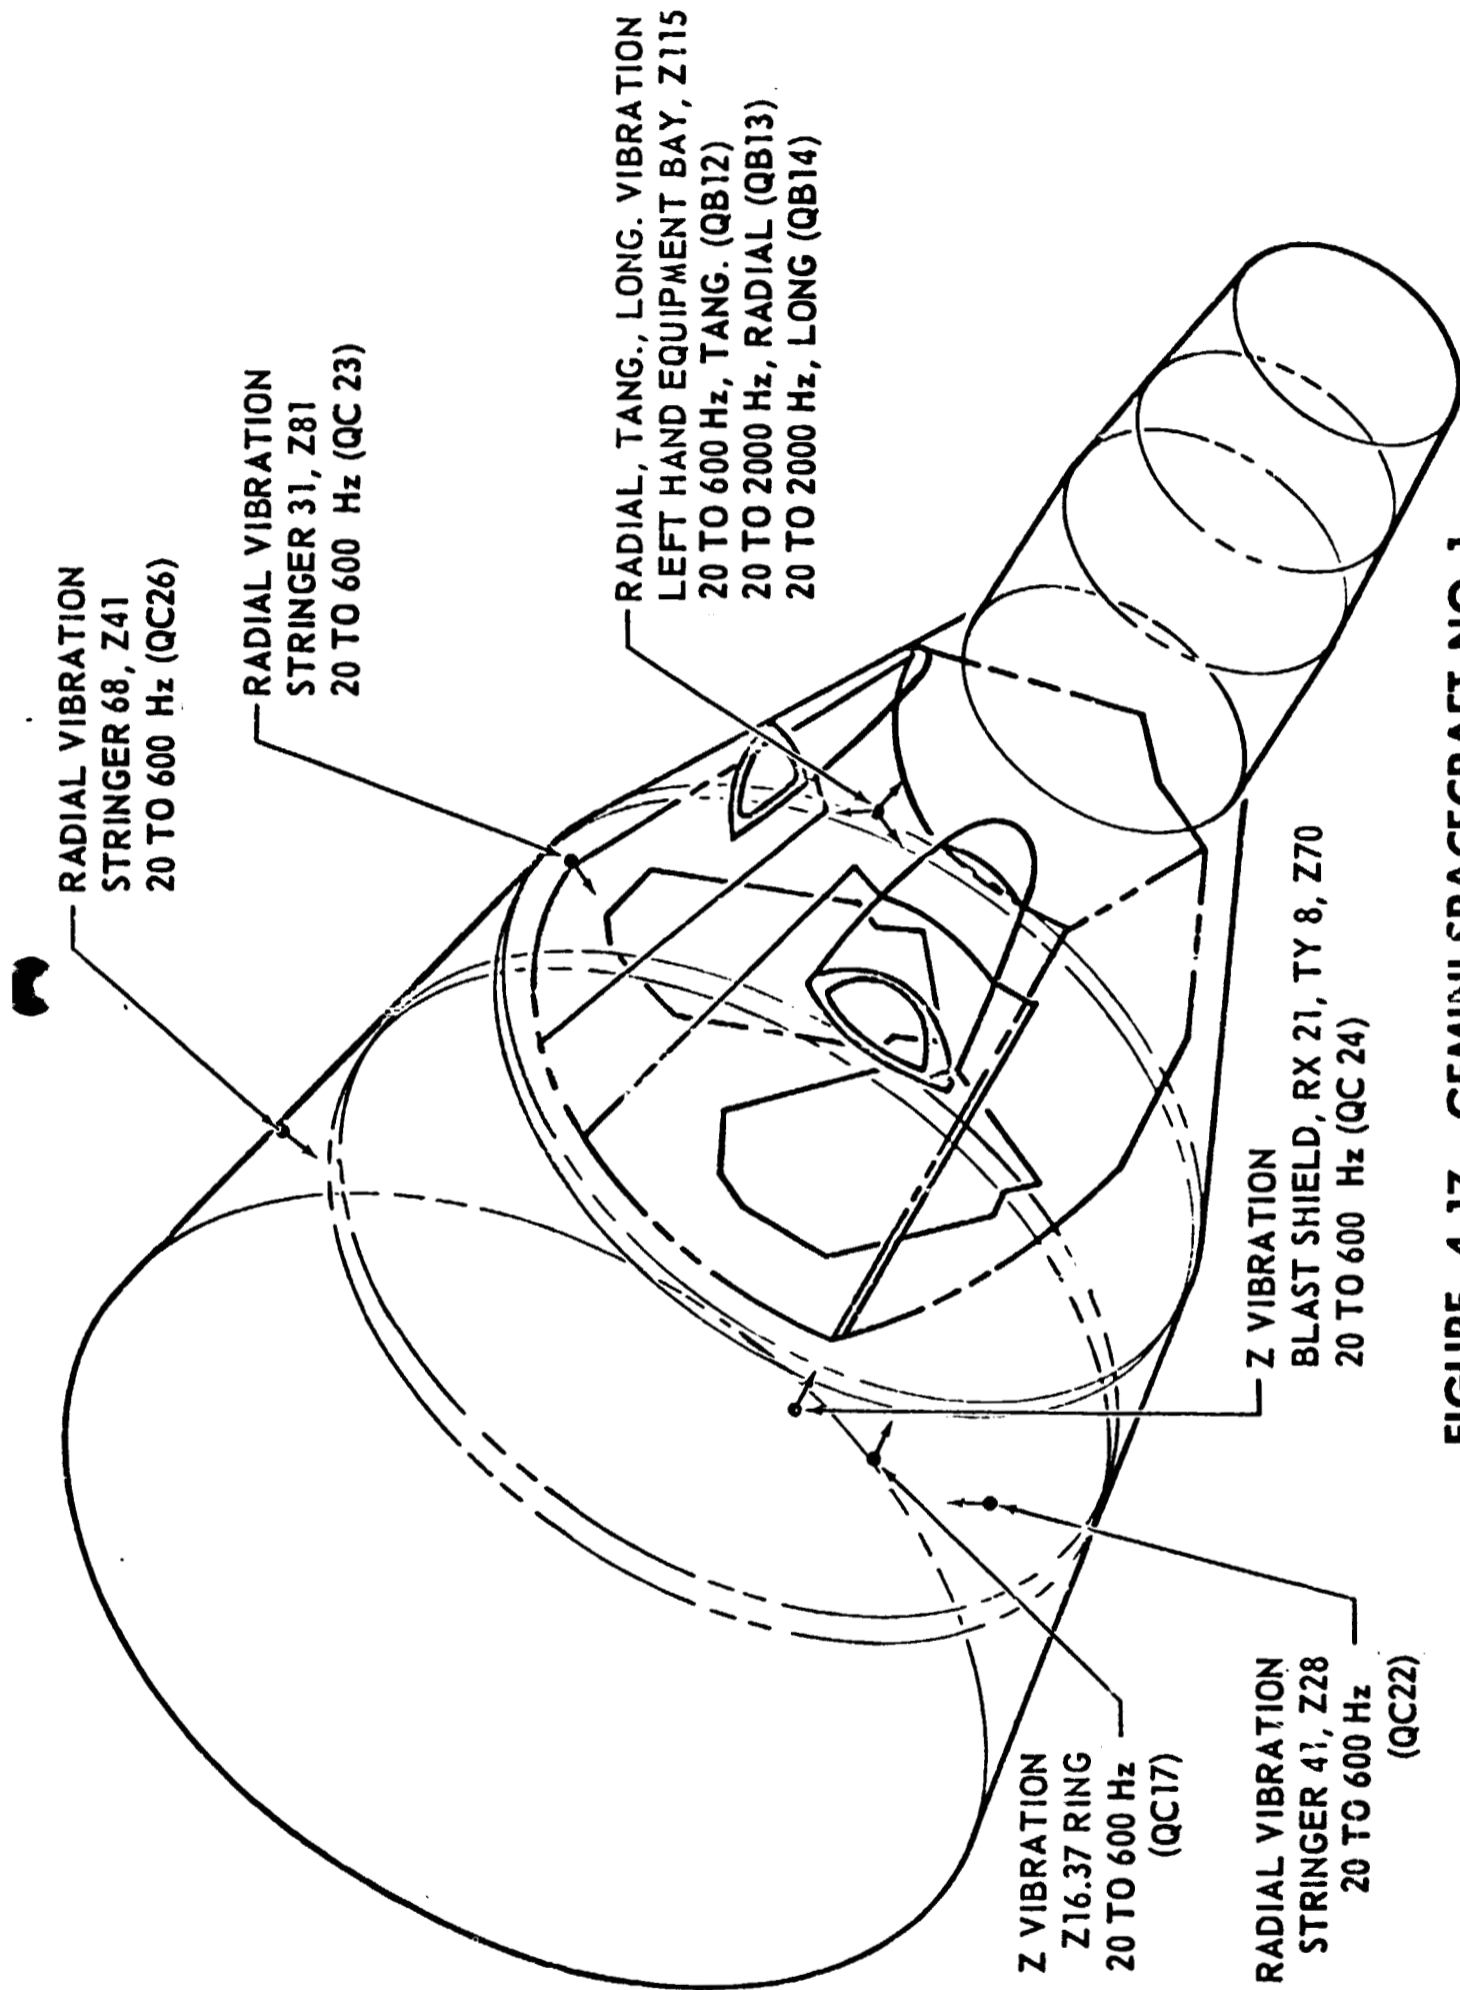
**FIGURE 4-17 - GEMINI SPACECRAFT NO. 1
(VIBRATION PICKUP LOCATIONS)**

As mentioned in paragraph 4.0, GT-1 flight data were used in the derivation of test requirements. A sketch showing instrument locations for the GT-1 spacecraft is shown in Figure 5-1. Plots of GT-1 re-entry vehicle vibration data are included as Figures 5-2 and 5-3, showing the comparisons of level versus frequency and level versus time, respectively. Figures 5-4 and 5-5 are the comparable plots for the adapter measurement. A single cabin acoustic measurement was also taken, and the comparison plots are shown in Figures 5-6 and 5-7. Figures 5-1 through 5-5 are identical to figures given in paragraph 4.0 but are repeated for convenience.

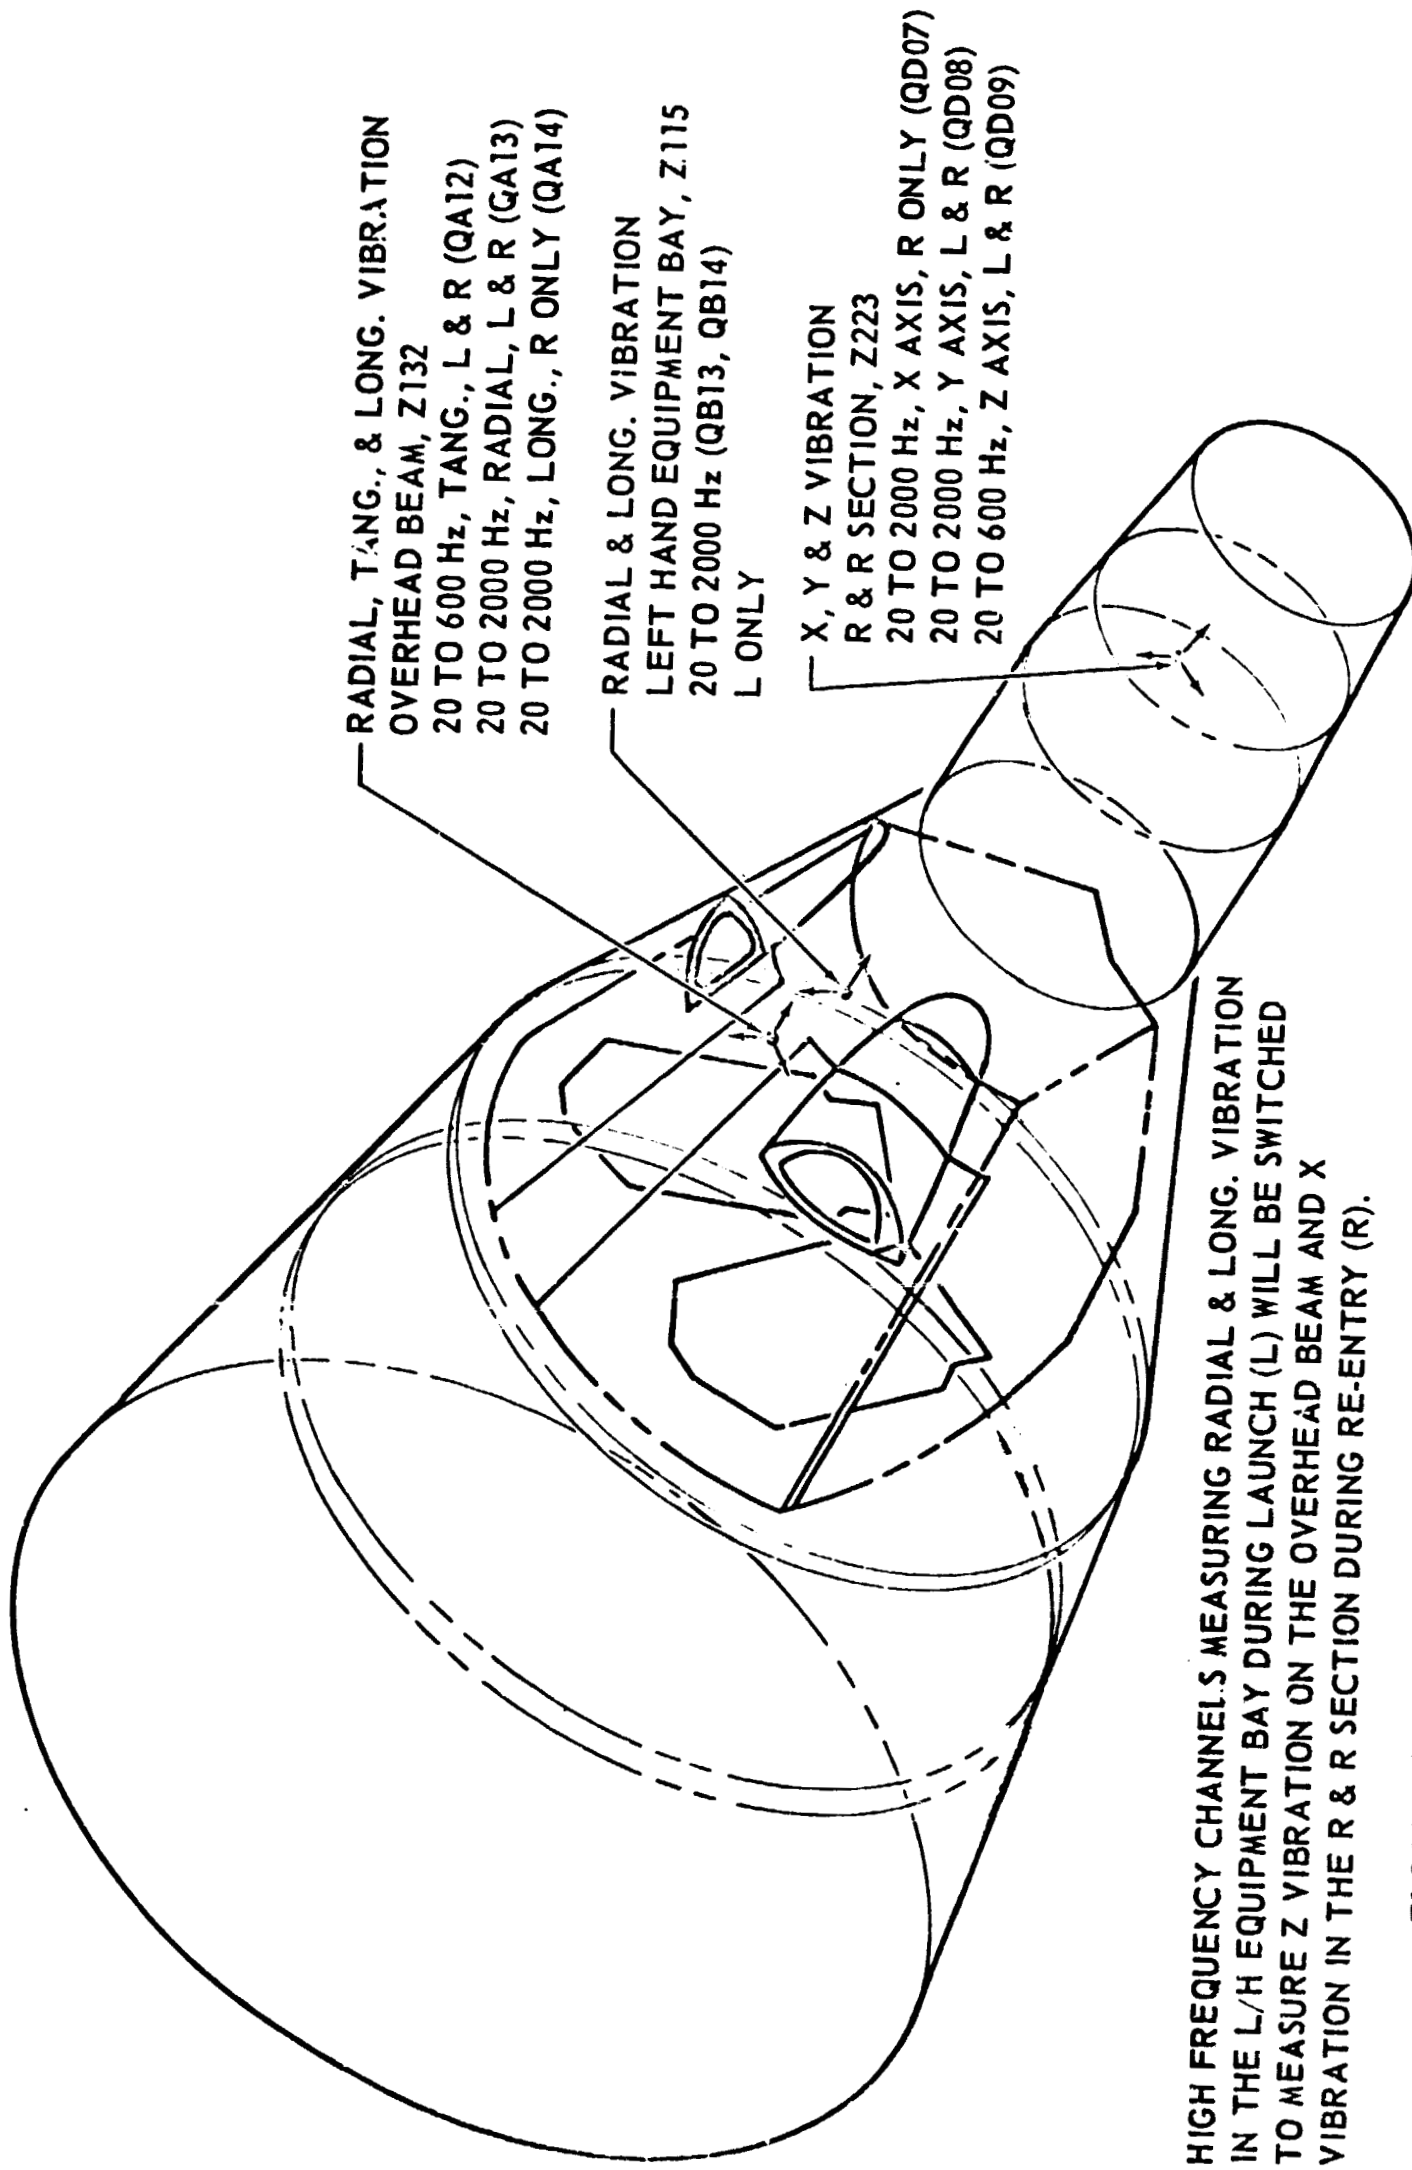
FIGURE 4-18 GEMINI SPACECRAFT NO. 2 VIBRATION PICKUP LOCATIONS

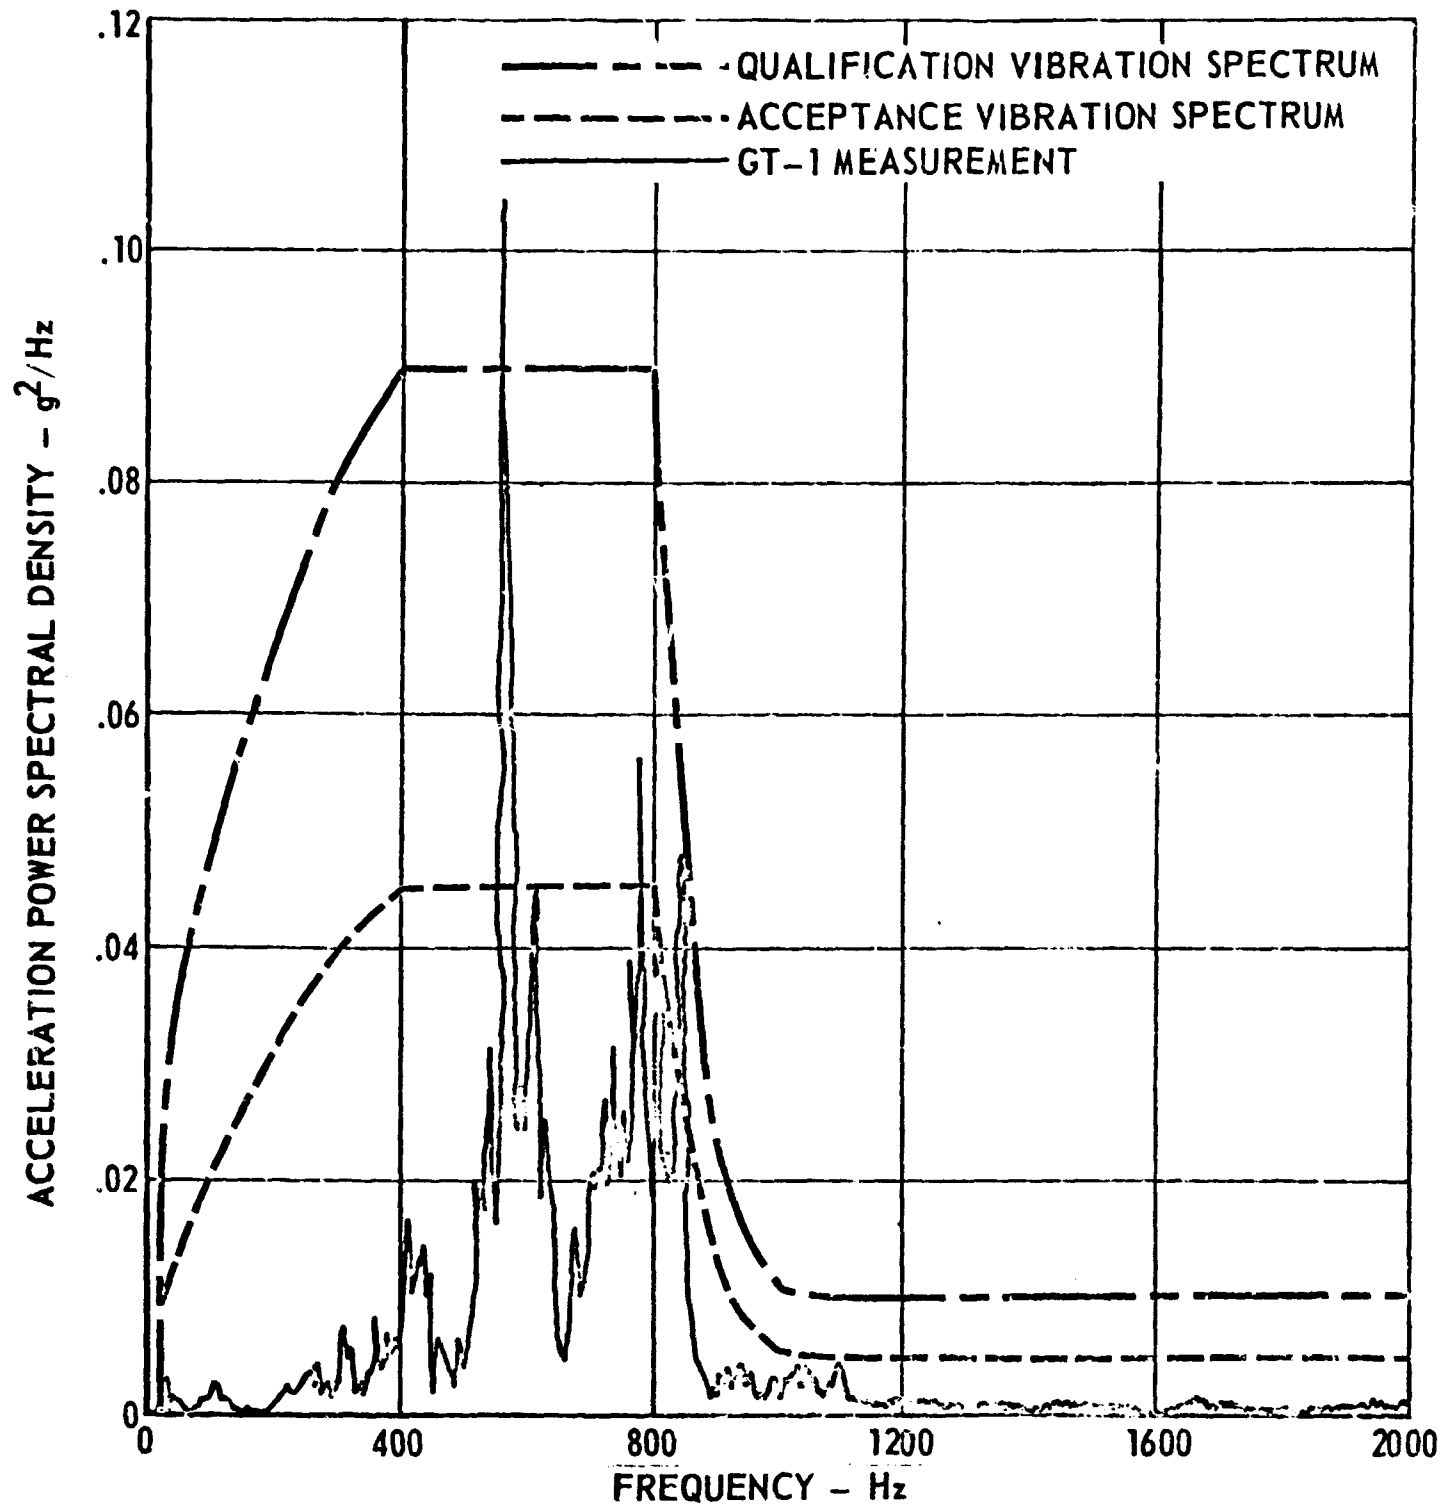
FIGURE 5-2 GT-1 EQUIPMENT BAY VIBRATION MEASUREMENT
COMPARED WITH QUALIFICATION AND ACCEPTANCE
VIBRATION SPECTRA

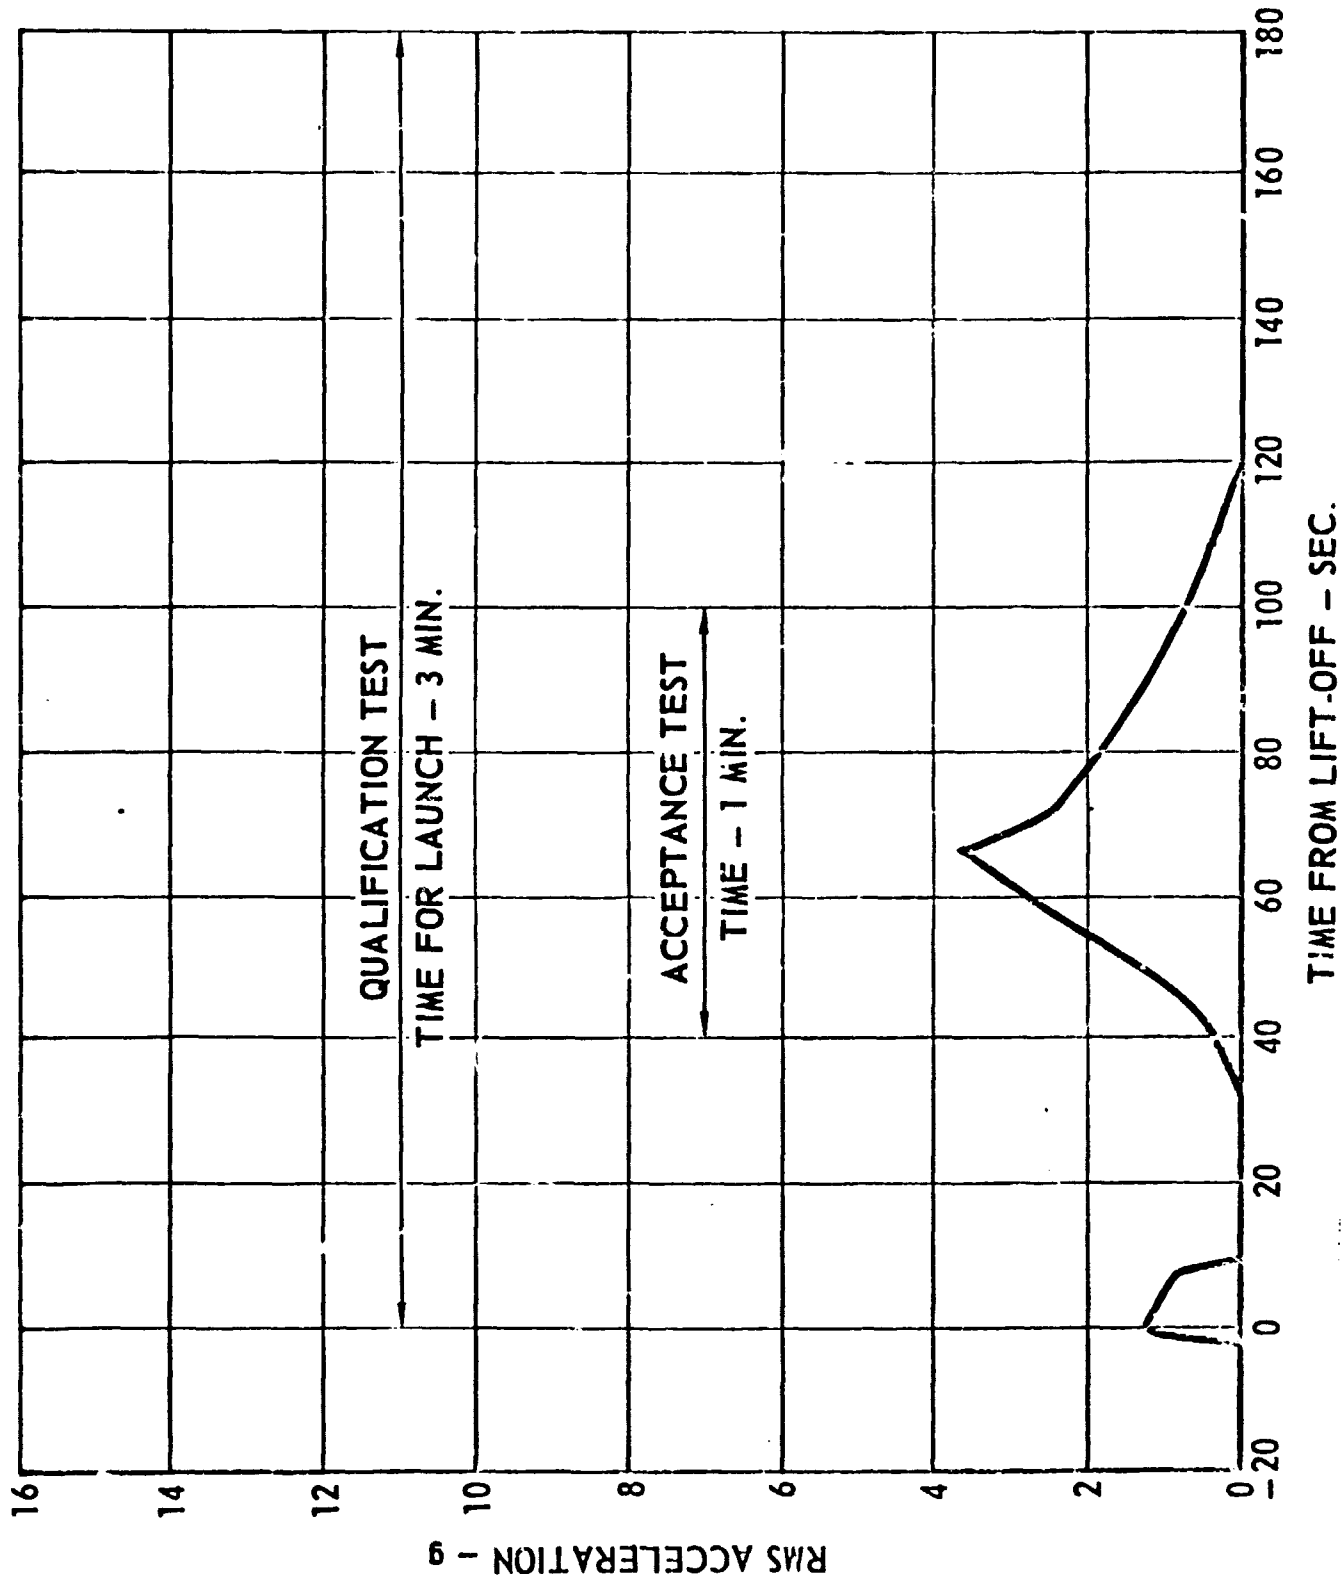
FIGURE 5-3 COMPARISON OF TIME HISTORY OF GT-1 MEASURED RE-ENTRY VEHICLE VIBRATION WITH QUALIFICATION AND ACCEPTANCE TEST DURATIONS

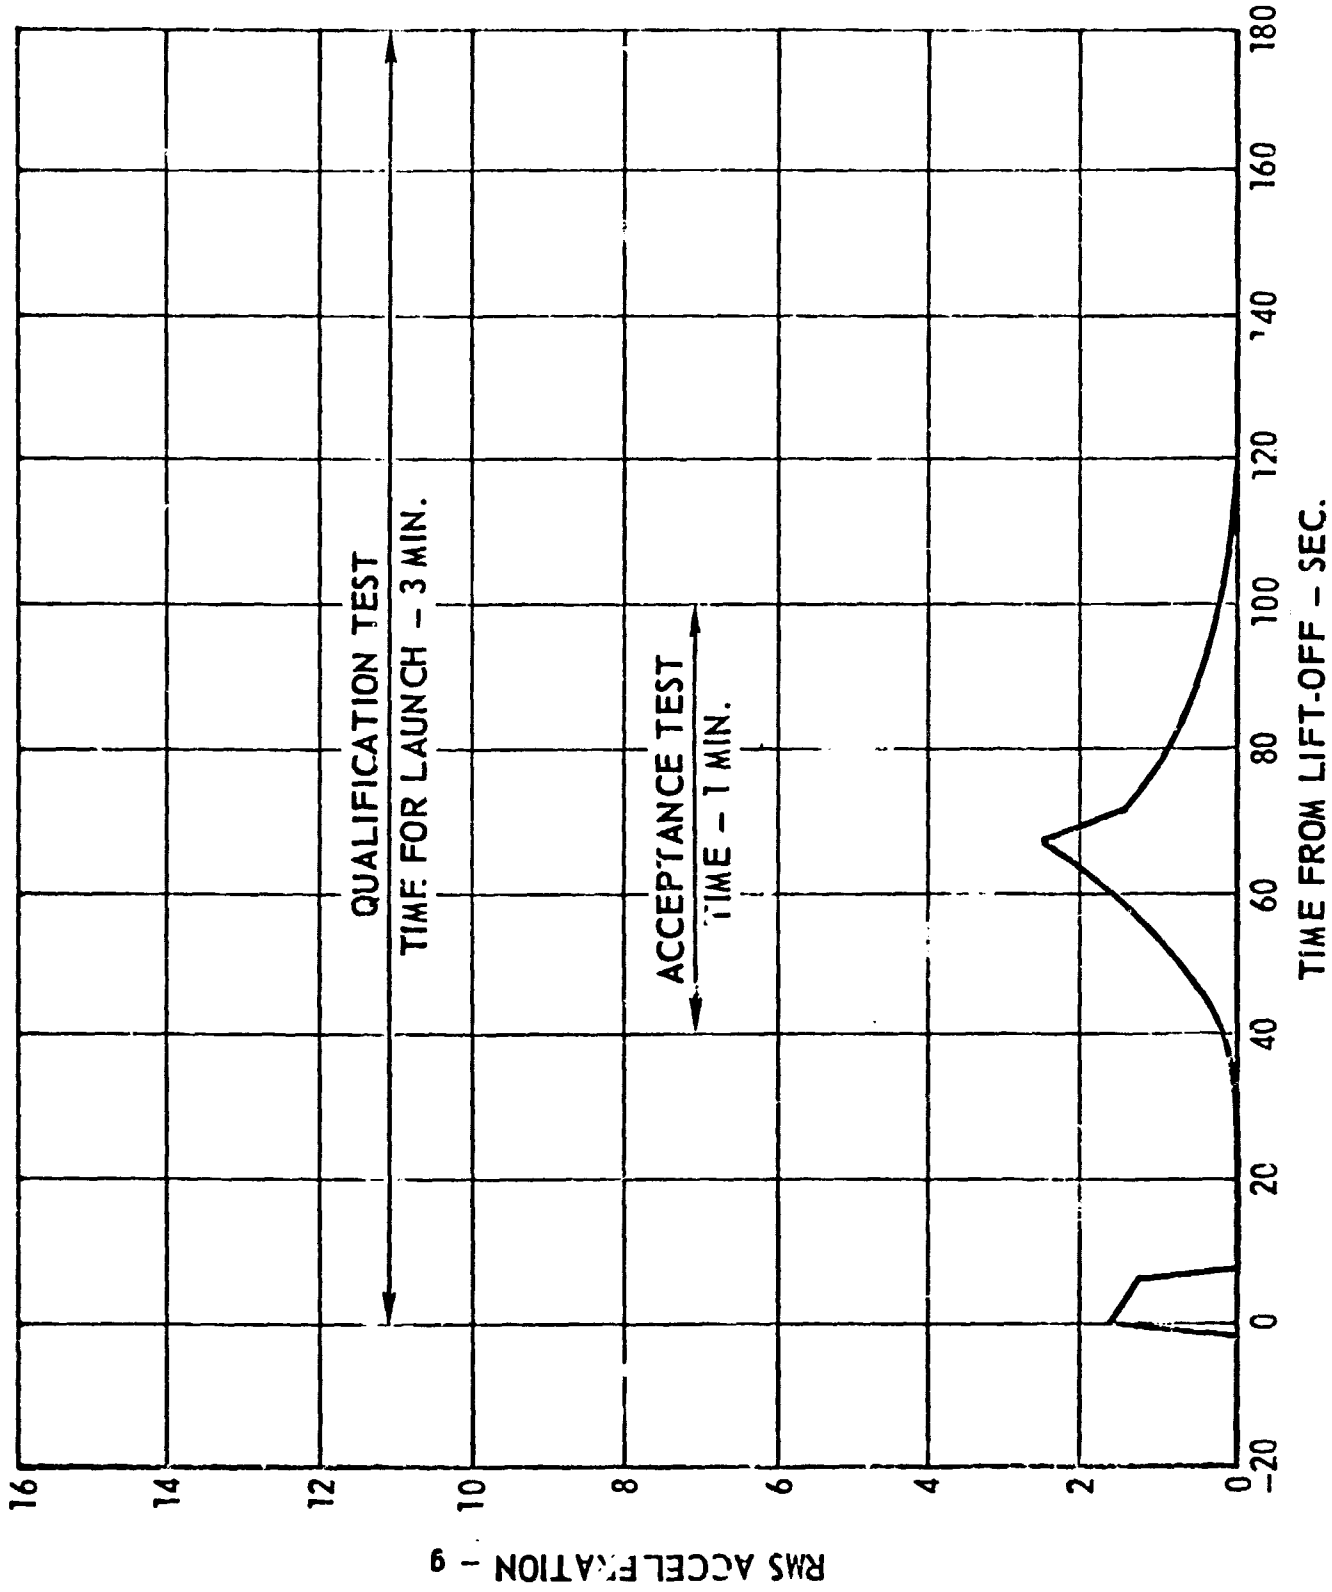
FIGURE 5-5 COMPARISON OF TIME HISTORY OF GT-1, MEASURED ADAPTER BLAST SHIELD VIBRATION WITH QUALIFICATION AND ACCEPTANCE TEST DURATIONS
