**APOLLO TIE
WASHINGTON, D. C.**

DOCUMENT NO. D2-120001-2

TITLE SUMMARY OF VIBRATION AND ACOUSTIC TESTS ON
FOUR SPACECRAFT PROGRAMS

This document summarizes the vibration and acoustic test programs for four spacecraft: Mariner, Lunar Orbiter, Gemini and Surveyor. Information is presented on laboratory test programs and results, flight results, derivation of test levels, identification of test factors, and spacecraft contractor conclusions and recommendations.

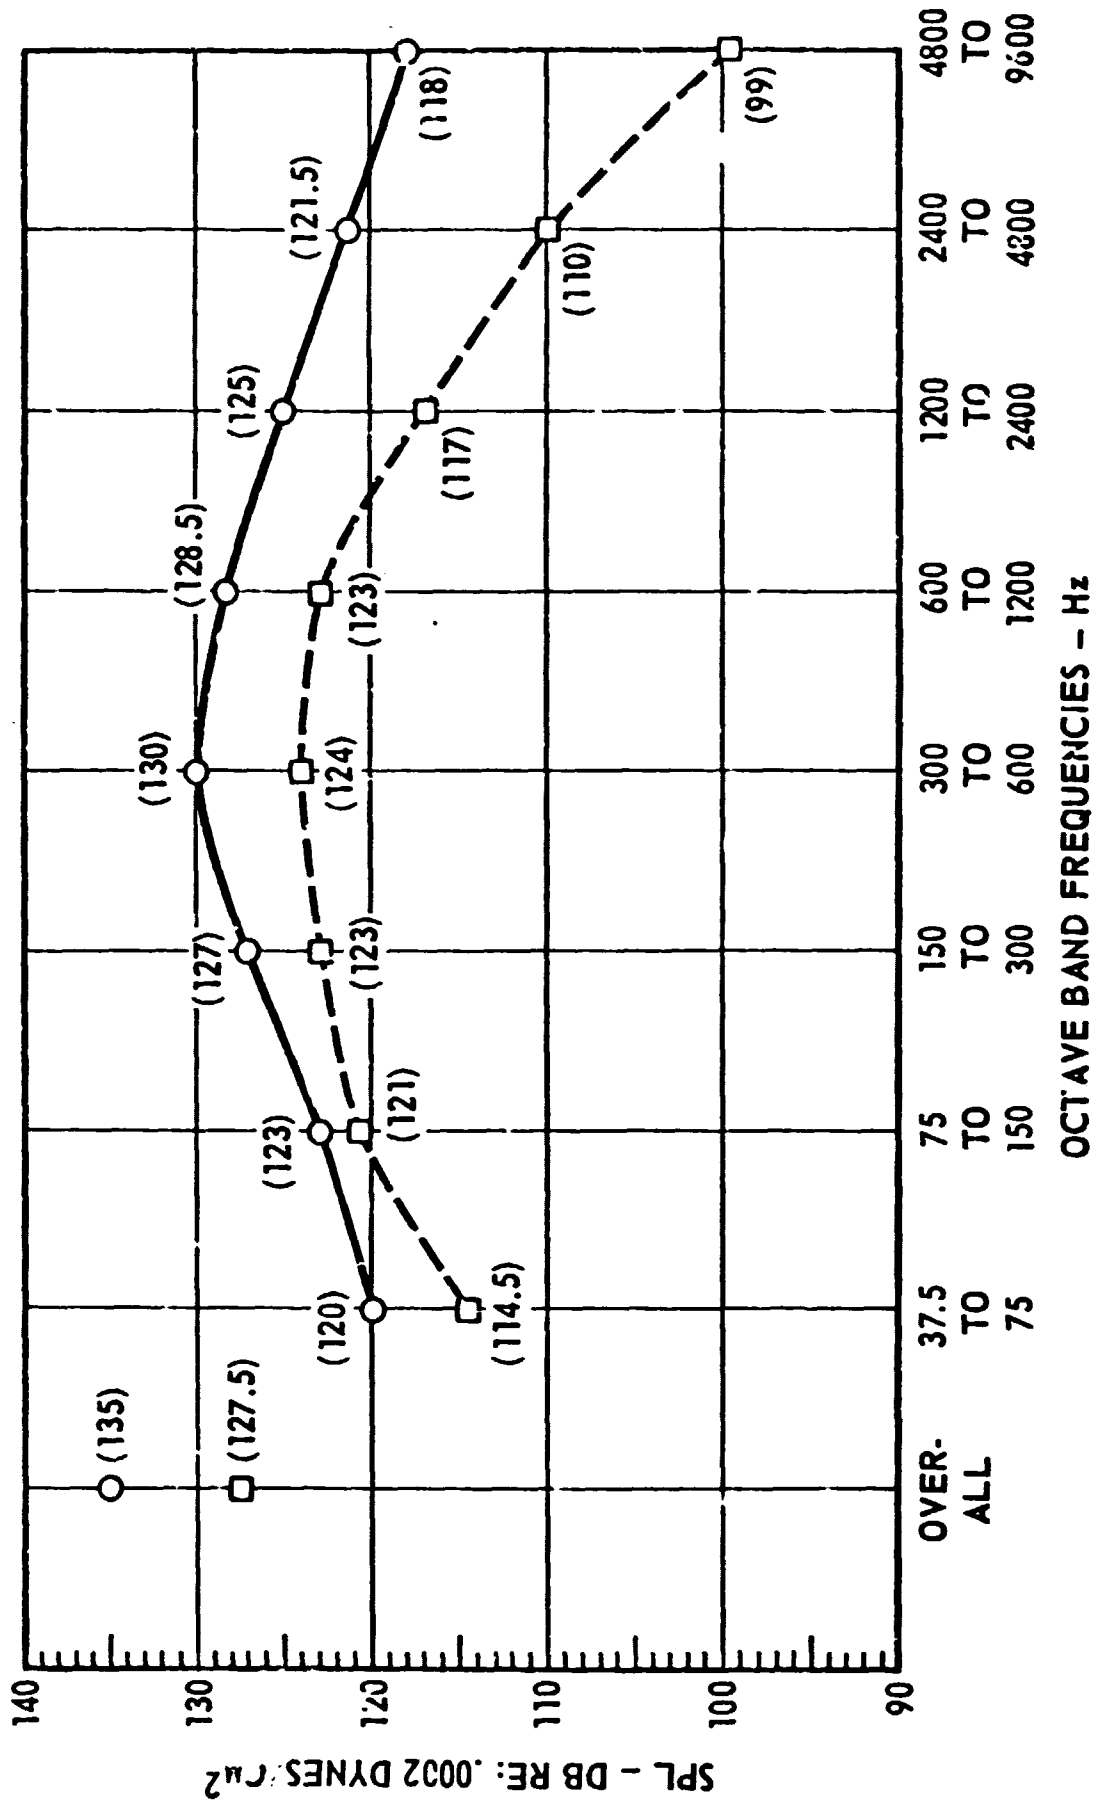
**FIGURE 5-6 COMPARISON OF PEAK GT-1 CABIN
ACOUSTIC MEASUREMENT WITH QUALIFICATION LEVELS**

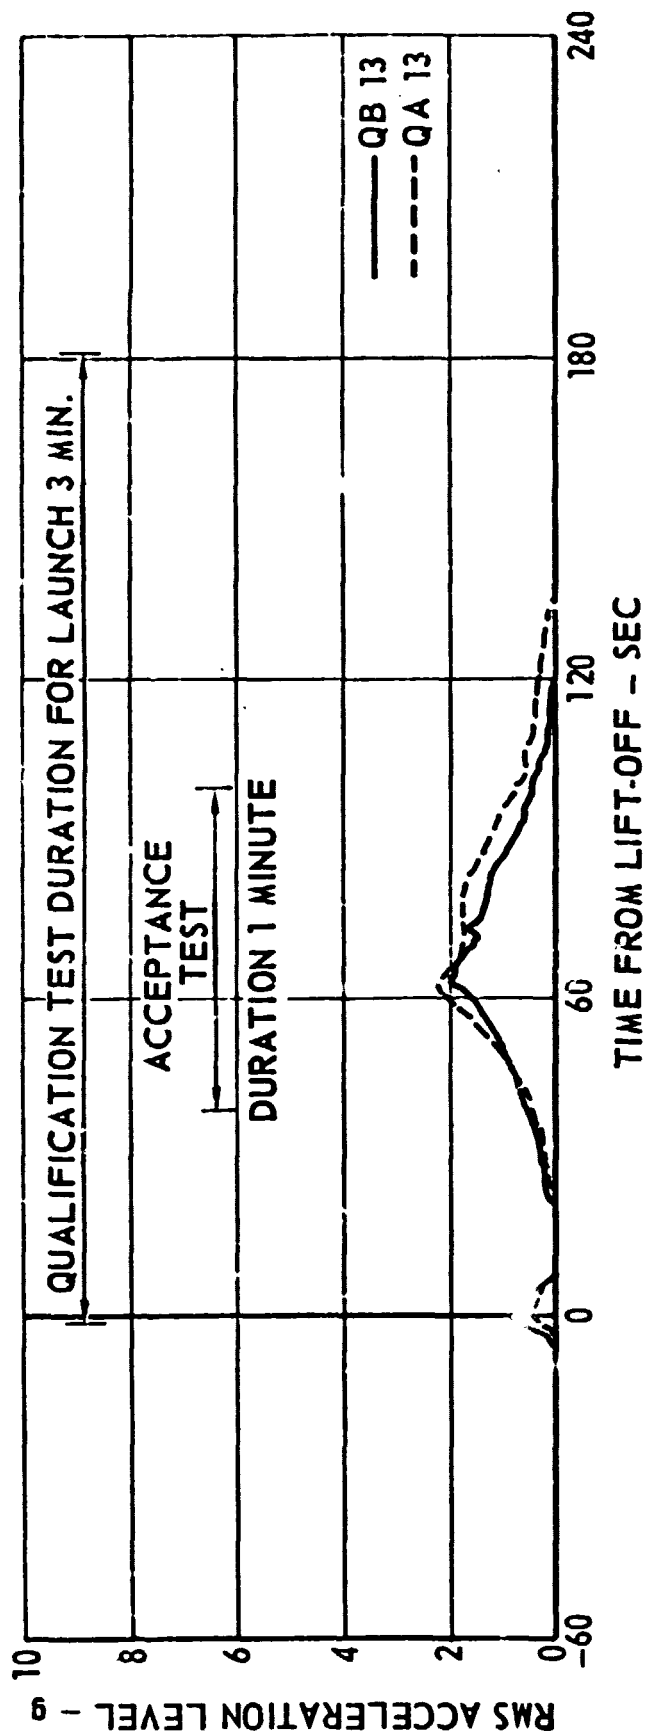
FIGURE 5-10 COMPARISON OF GT-2 MEASURED VIBRATION RMS LEVELS WITH QUALIFICATION AND ACCEPTANCE TEST DURATIONS

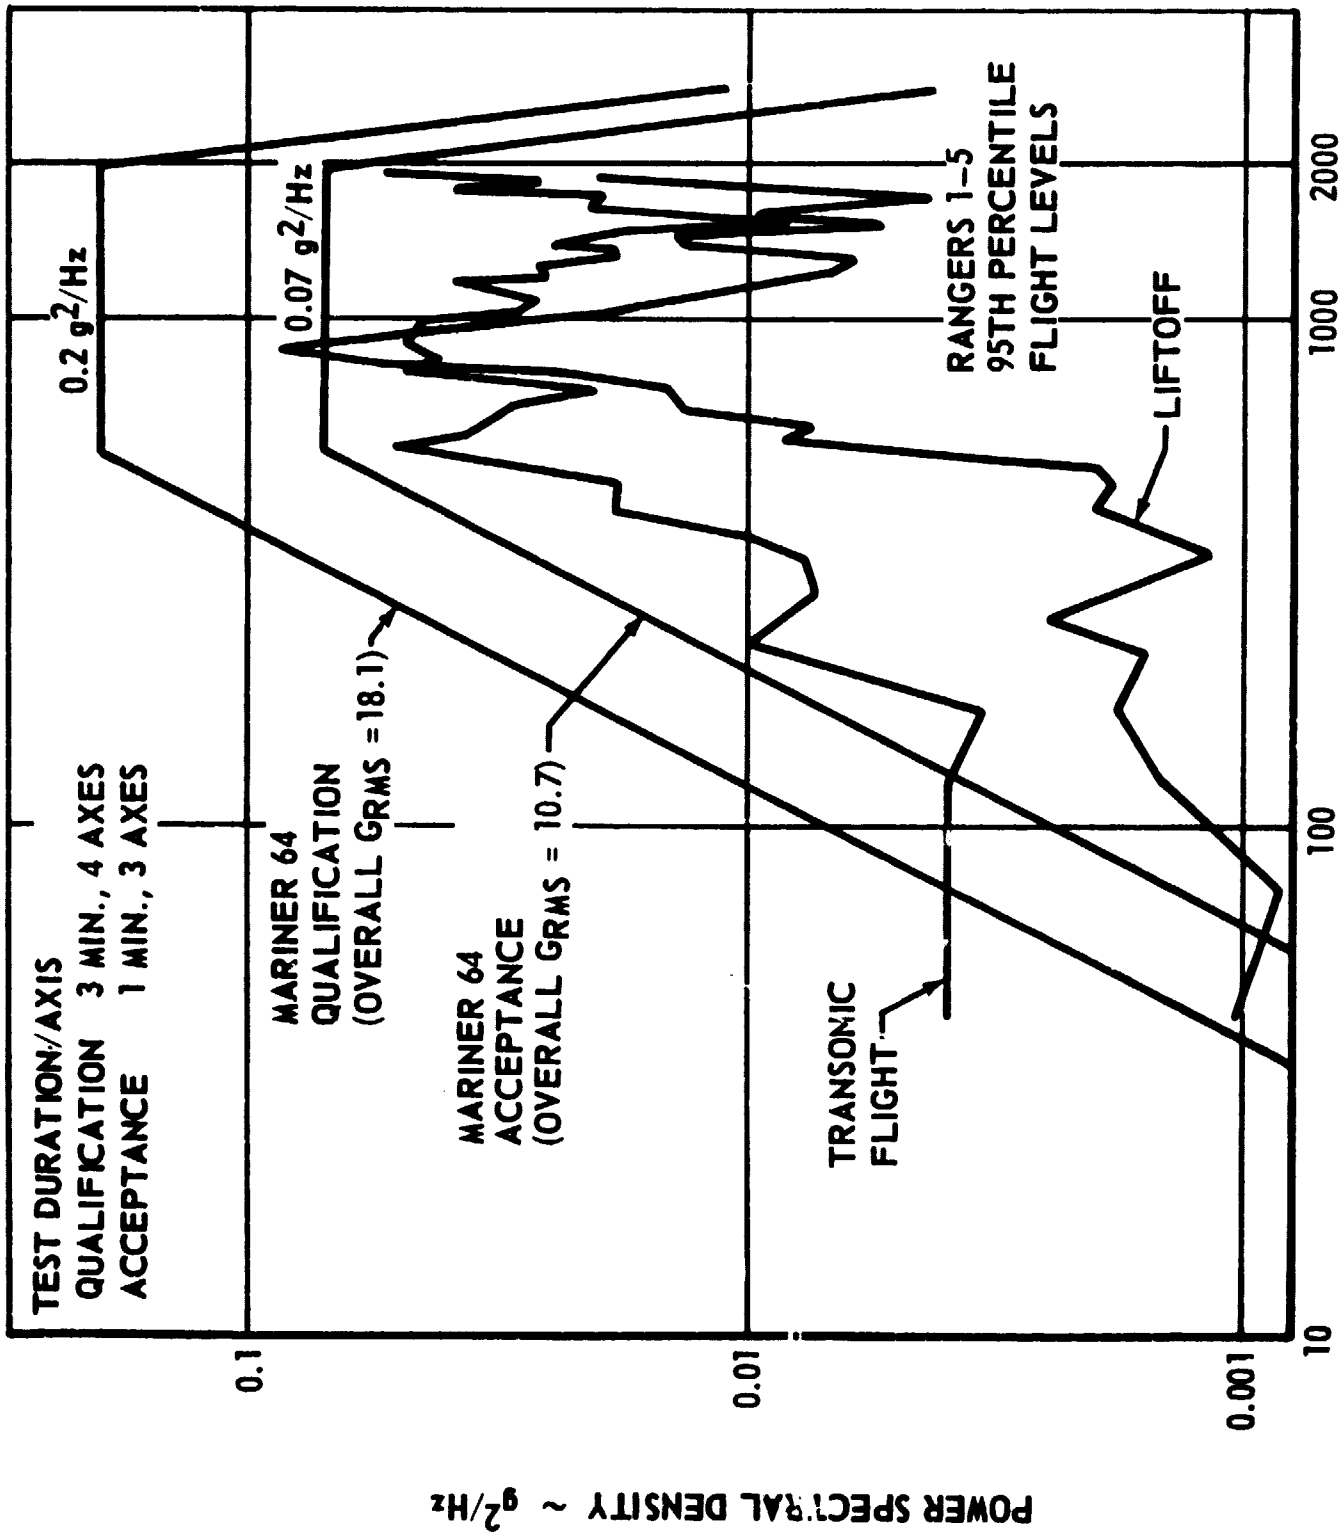
DERIVATION OF SYSTEM VIBRATION LEVELS

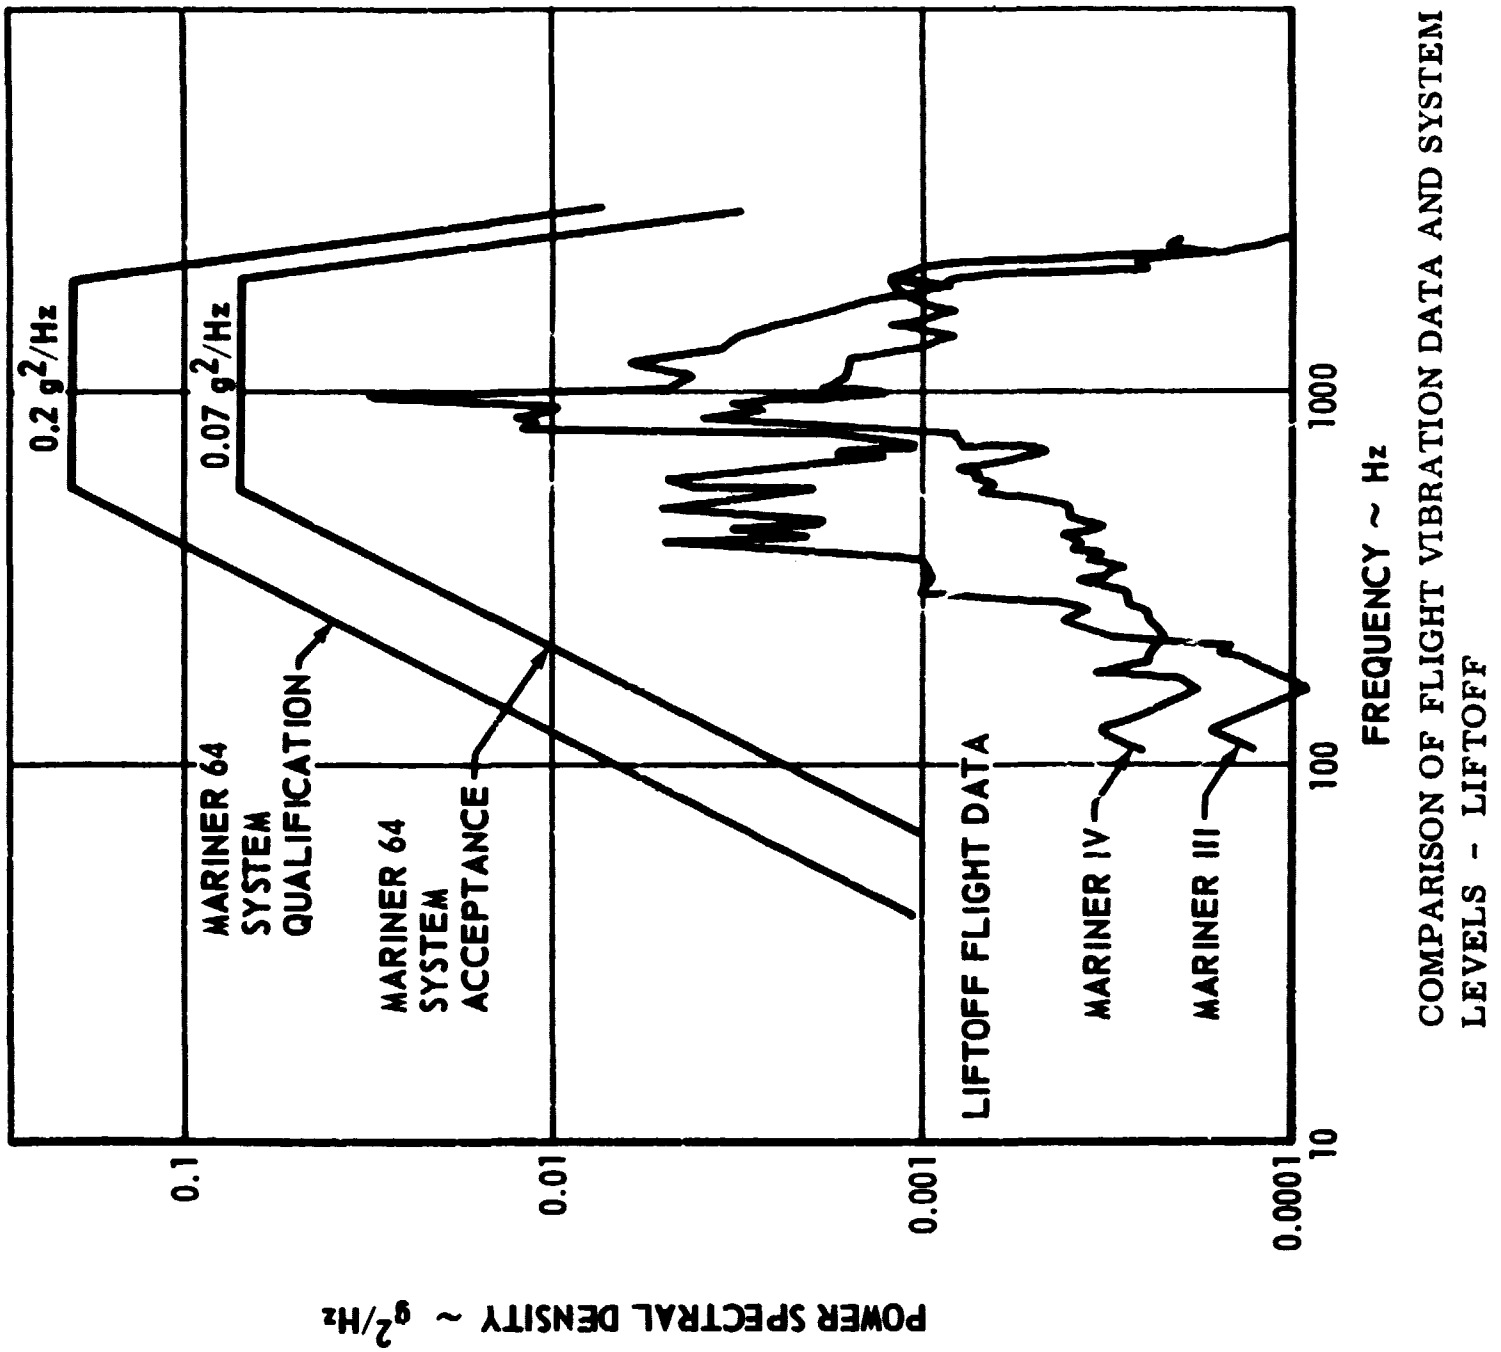
COMPARISON OF FLIGHT VIBRATION DATA AND SYSTEM TEST LEVELS - LIFTOFF

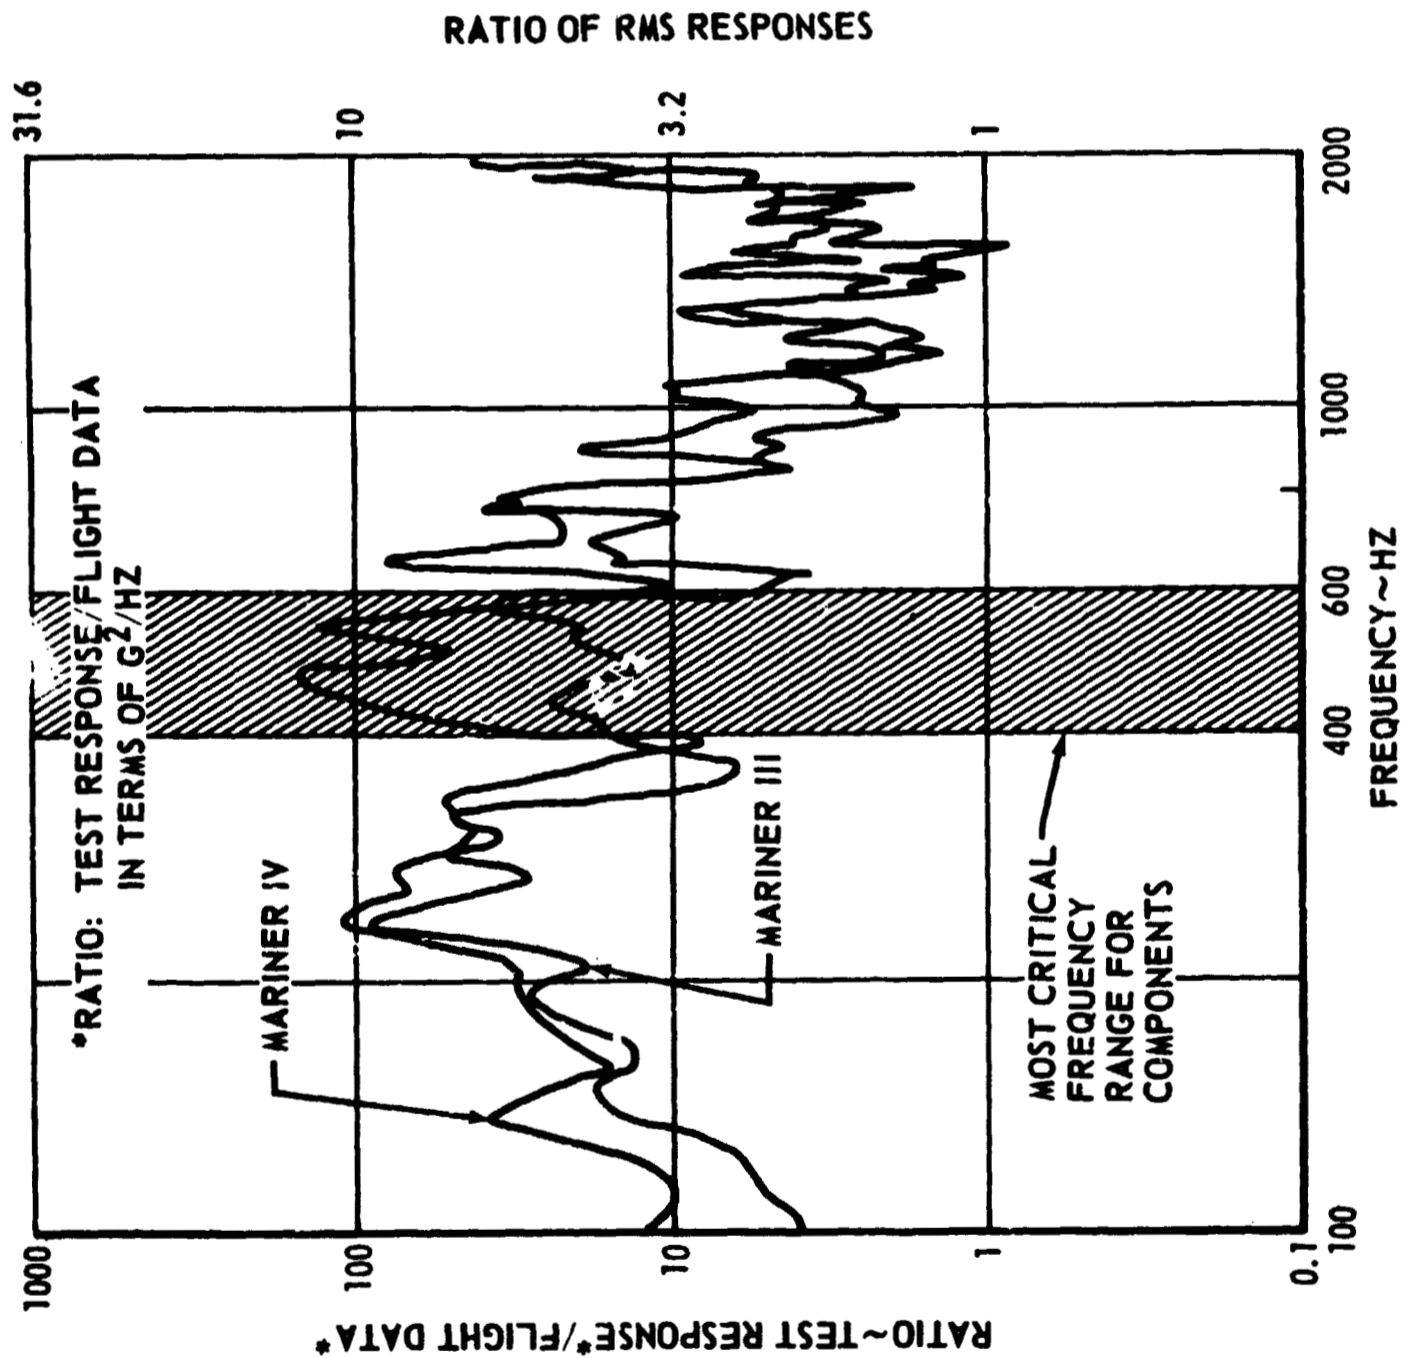
COMPARISON OF LAB TEST VIBRATION RESPONSE TO MEASURED FLIGHT RESPONSE ON SPACECRAFT ADAPTER

MARINER 64	LEVEL	DURATION
SYSTEM ACCEPTANCE TEST	10.7 GRMS	1 MIN/AXIS, 3 AXES
SYSTEM QUALIFICATION TEST	18.1 GRMS	3 MIN/AXIS, 4 AXES

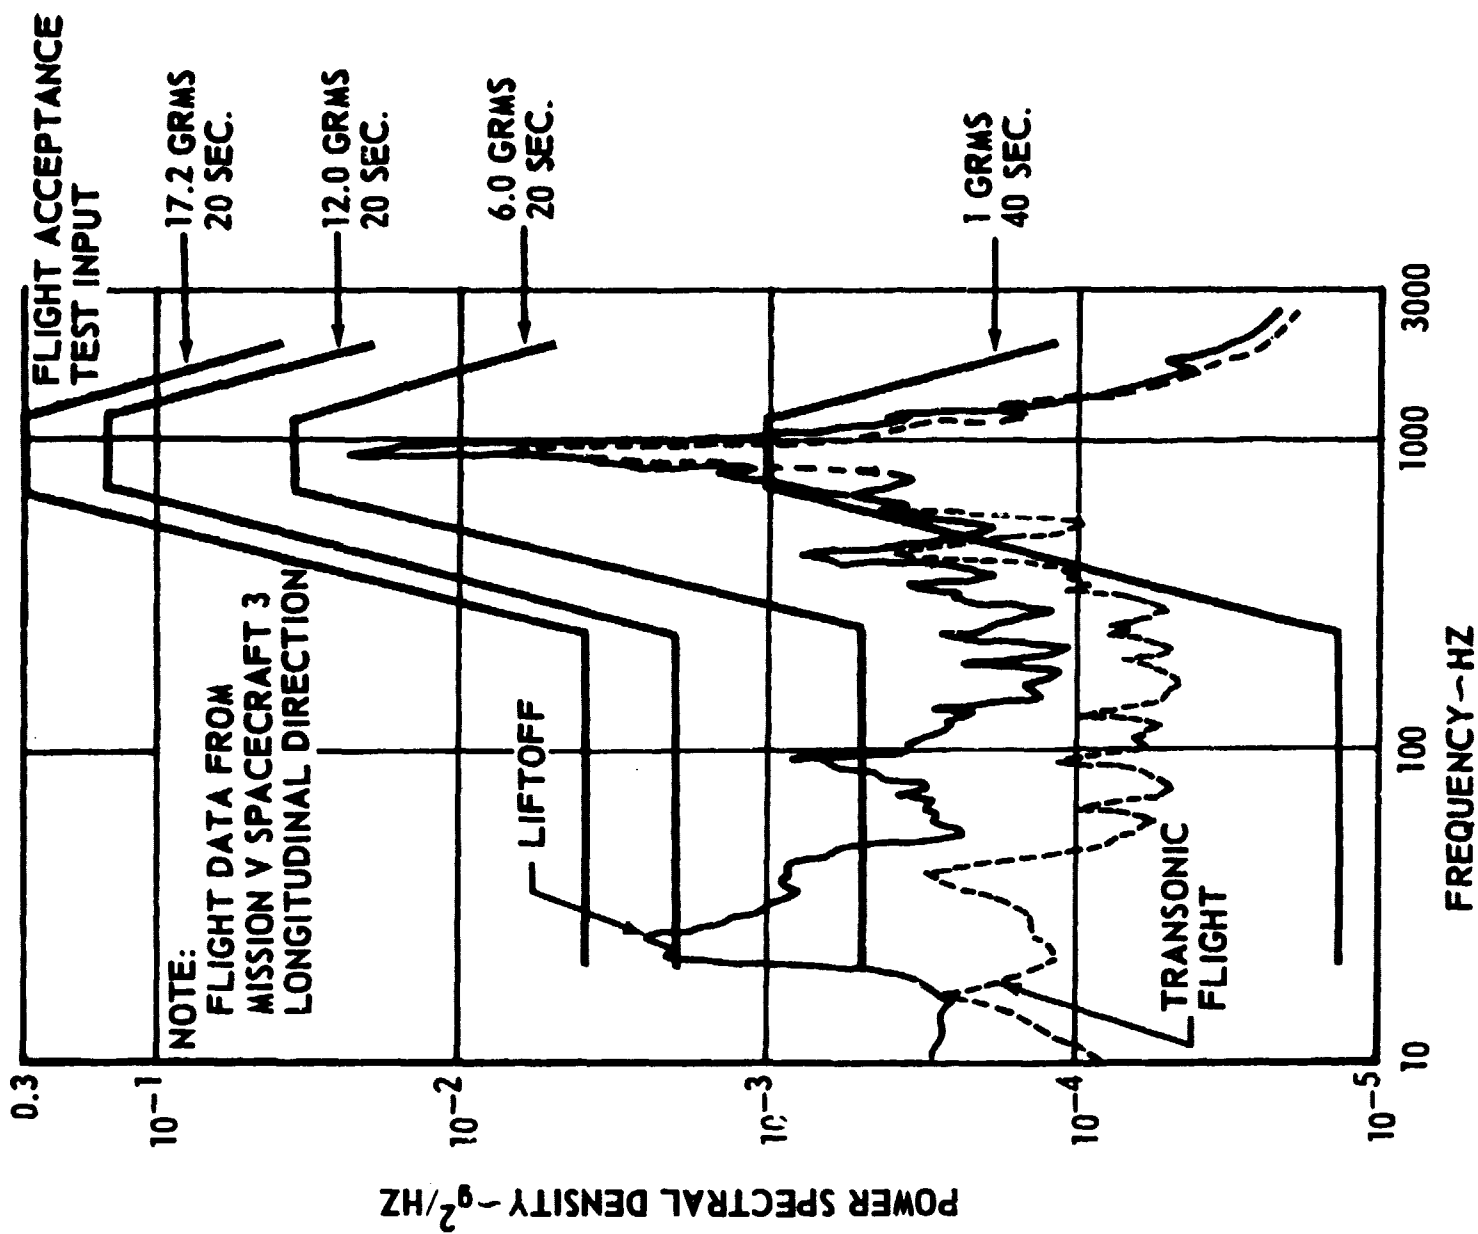
COMPARISON OF ACCEPTANCE TEST LEVELS WITH MEASURED FLIGHT RESPONSE LEVELS, RANDOM VIBRATION, LUNAR ORBITER

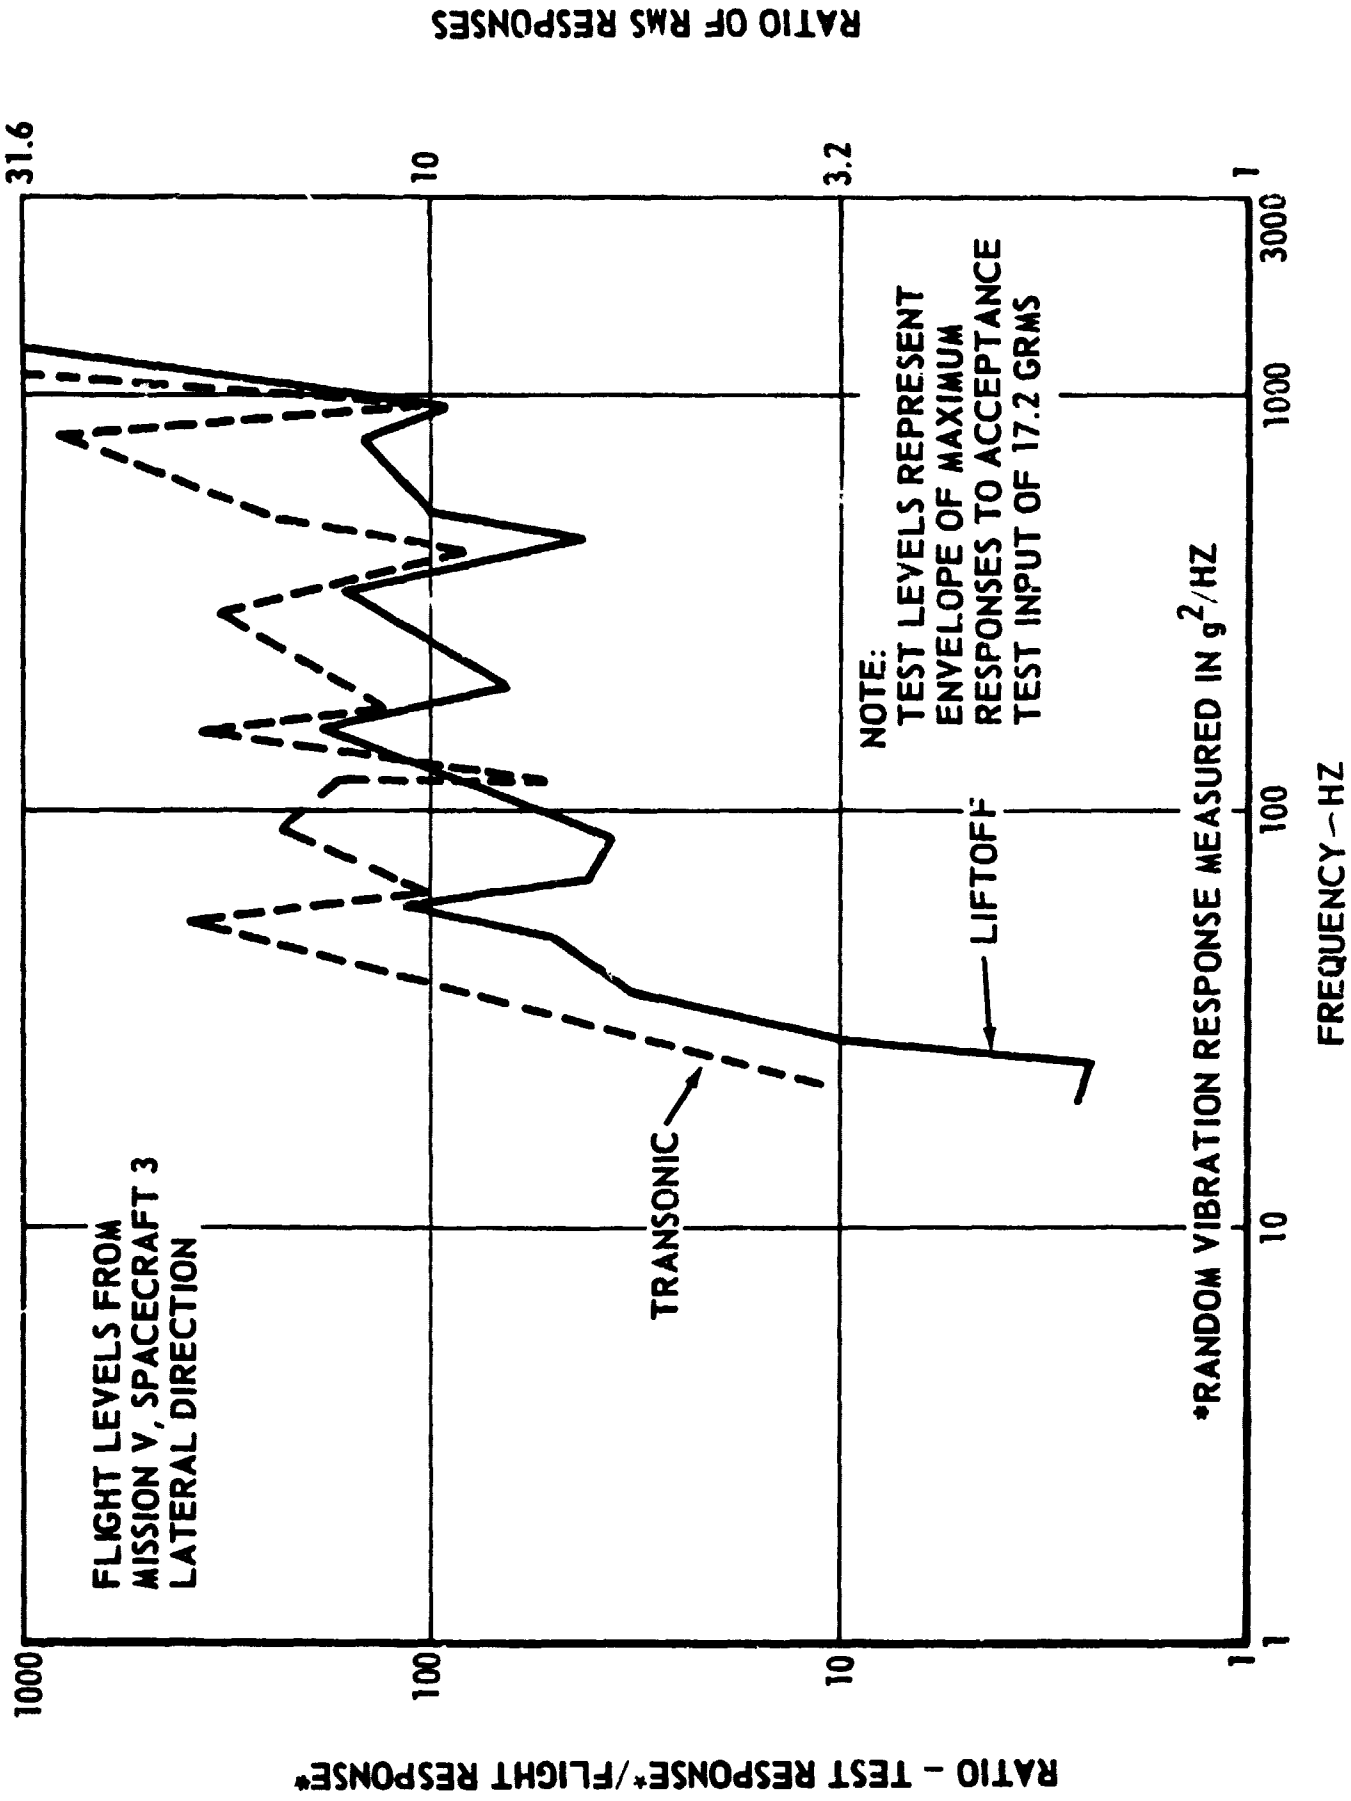
COMPARISON OF LAB TEST VIBRATION RESPONSE TO MEASURED FLIGHT RESPONSE IN LATERAL DIRECTION - LUNAR ORBITER

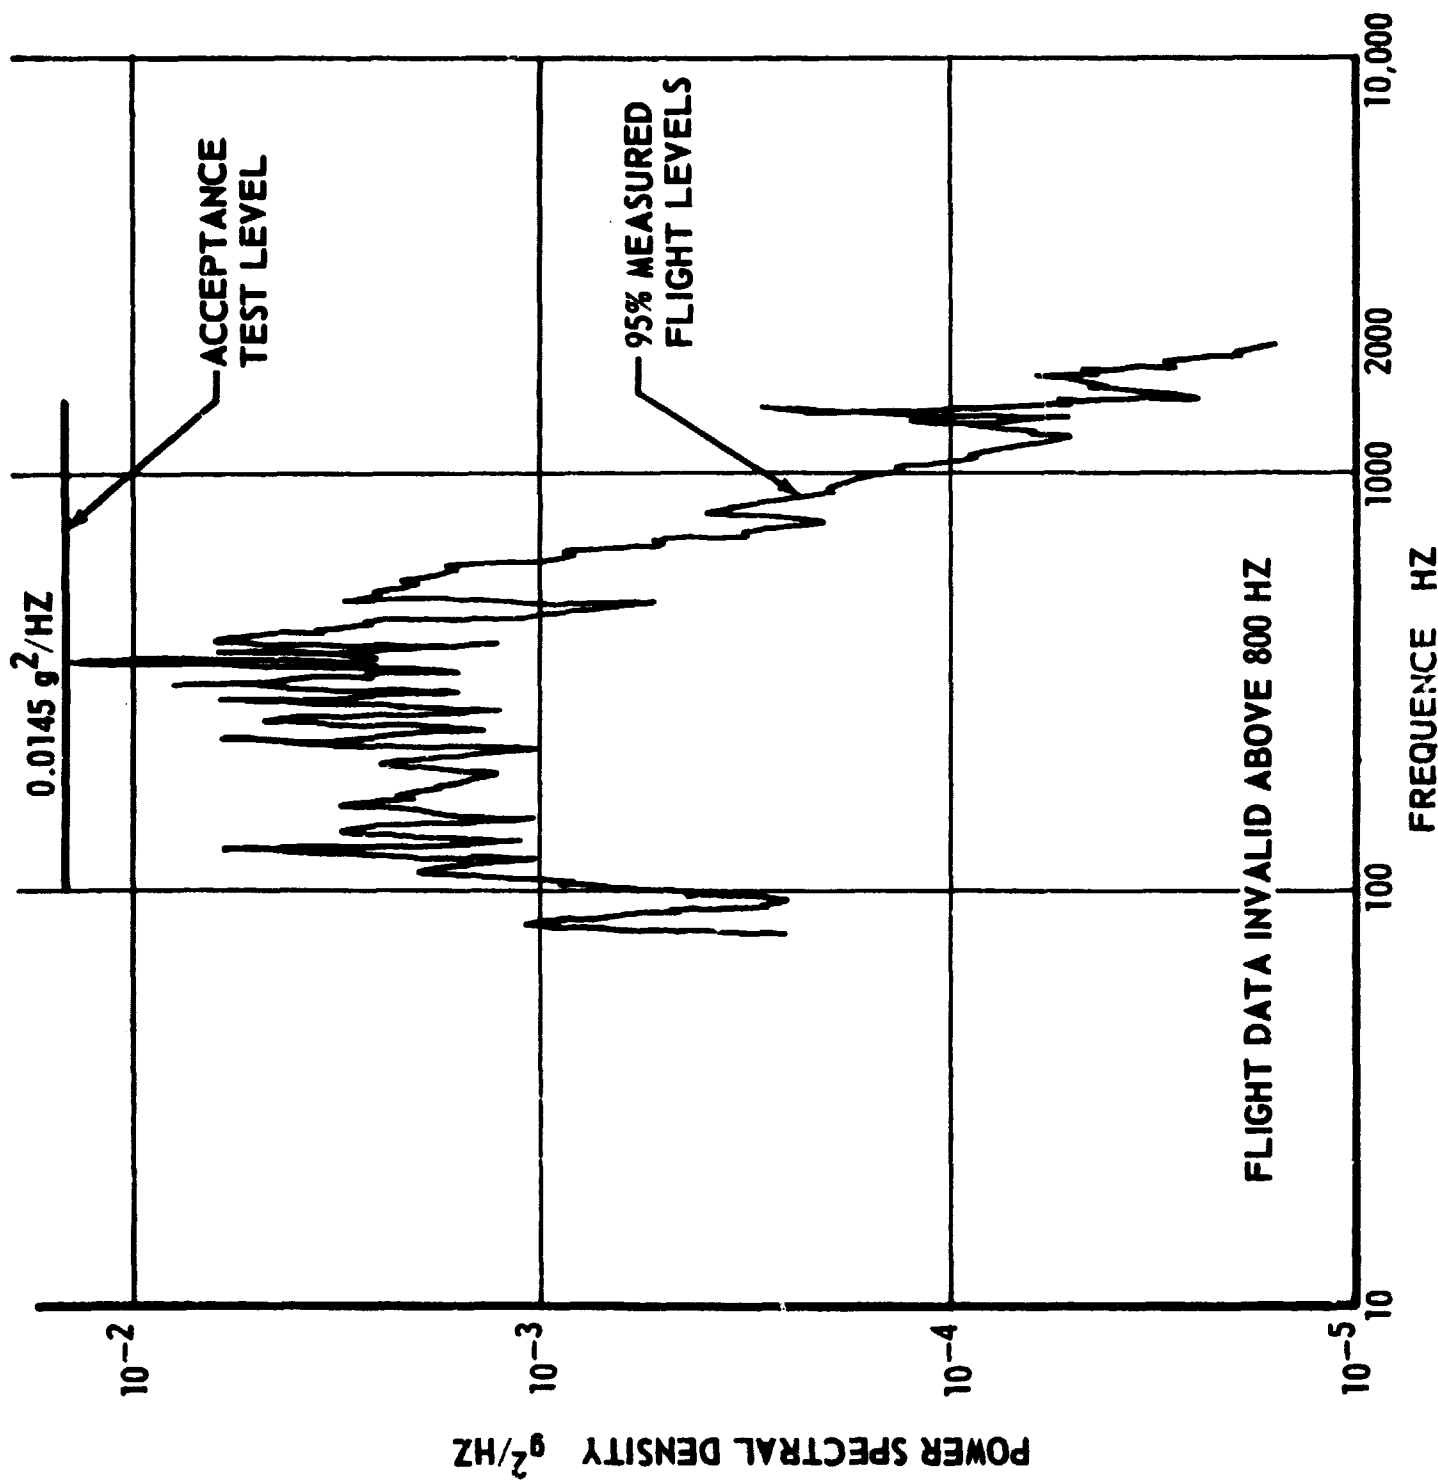
COMPARISON OF FLIGHT ENVIRONMENT TO TEST LEVELS,
RANDOM VIBRATION -SURVEYOR

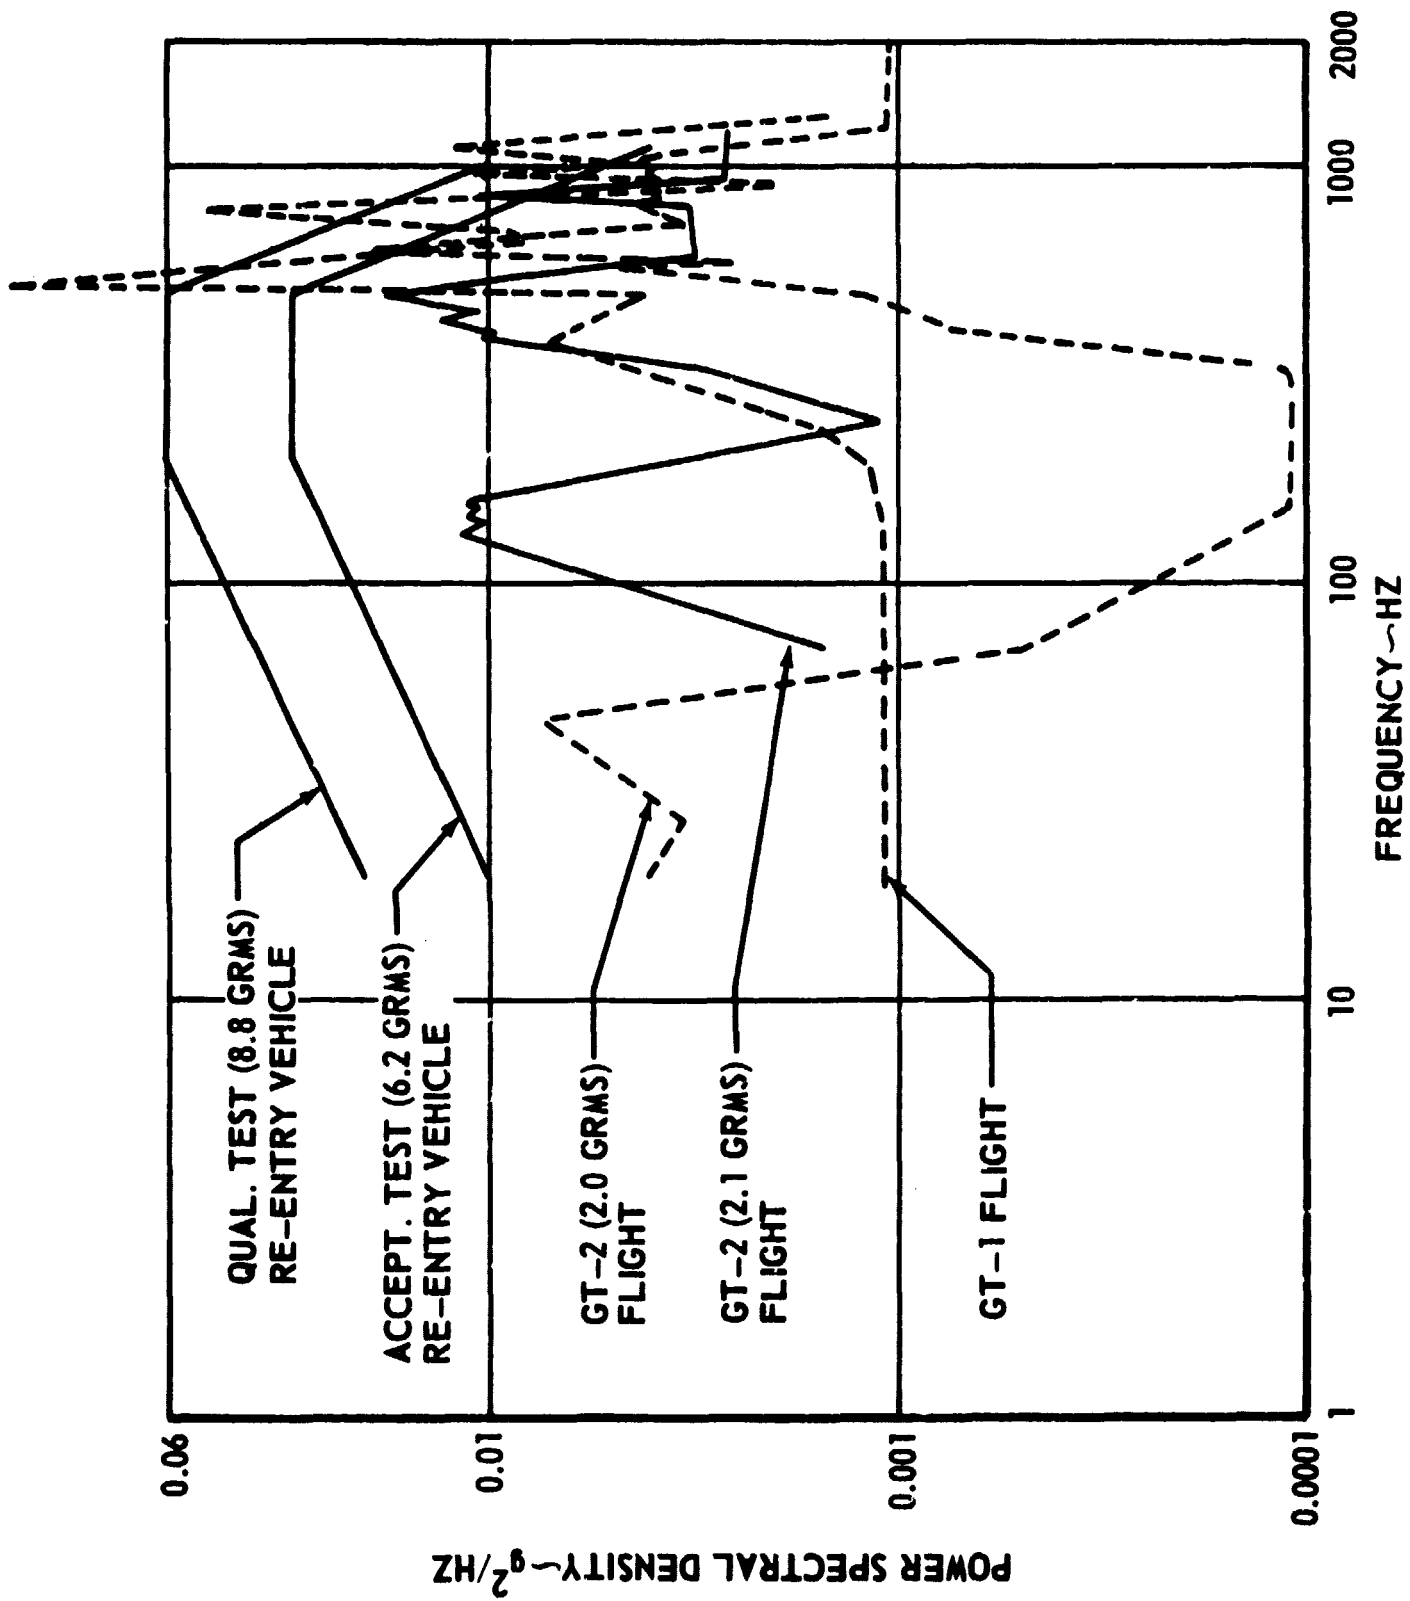
COMPARISON OF MEASURED FLIGHT LEVELS TO TEST LEVELS -GEMINI
