EVALUATION OF MIG AND TIG WELDING PROCESSES FOR JOINING 2014-T6 ALUMINUM ALLOY - PHASE II

DOUGLAS REPORT DAC 62130  
DATE:

Prepared For:  
National Aeronautics and  
Space Administration  
Huntsville, Alabama  
Contract NAS 7-101

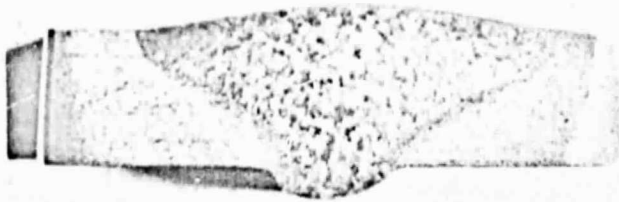
Photo Number: M21594

MIG Weld  
(1-pass)

Stainless Steel  
Back-up Bar

Magn. 3X

Keller's Etchant

Transverse weld specimens cut from each of the test weld panels were polished and etched with Keller's reagent. A typical cross-section of each weld is shown in Figures 1 and 2. The MIG welds were considerably wider than the TIG welds but no other significant differences were observed. Note: the

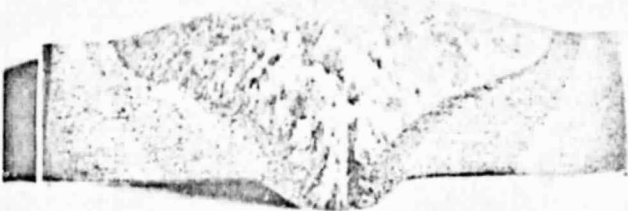
Photo Number: M21595

MIG Weld  
(1-pass + double repair)

Stainless Steel  
Back-up Bar

Magn. 3X

Keller's Etchant

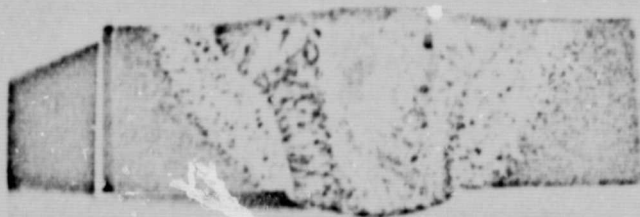
Photo Number: M21596

TIG Weld  
(1-pass)

Copper Back-up Bar

Magn. 3X

Keller's Etchant

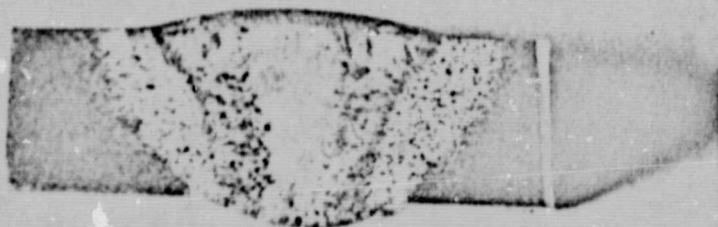
Photo Number: M21591

TIG Weld  
(1-pass + double repair)

Copper Back-up Bar

Magn. 3X

Keller's Etchant

Cross Section of TIG Welds in  
.250" Thick 2014-T6 Aluminum Alloy
