*Technical Report 32-1480*

*Solar Electric Propulsion System  
Tests*

*E. V. Pawlik  
E. N. Costogue  
J. D. Ferrera  
T. W. Macie*

**JET PROPULSION LABORATORY  
CALIFORNIA INSTITUTE OF TECHNOLOGY  
PASADENA, CALIFORNIA**

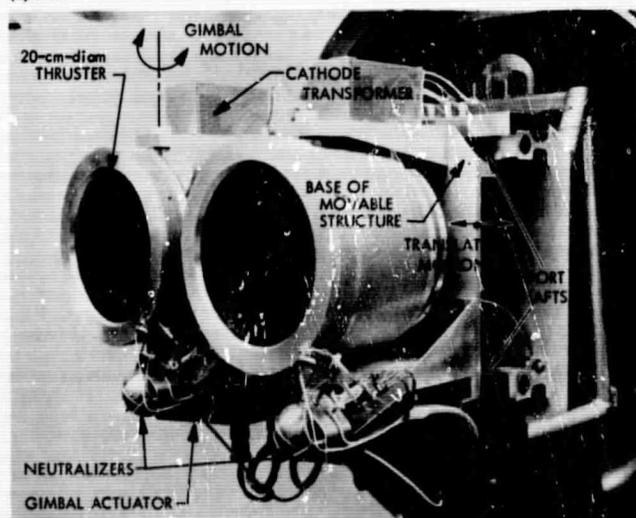
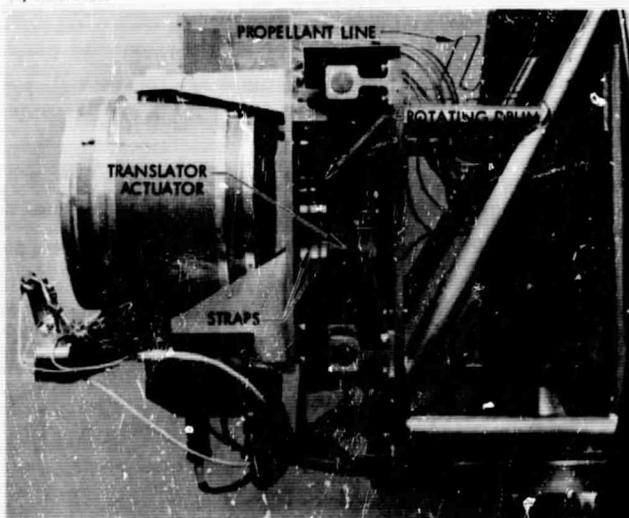
Fig. 1. In-tank portion of the propulsion system

(a) FRONT VIEW

(b) SIDE VIEW

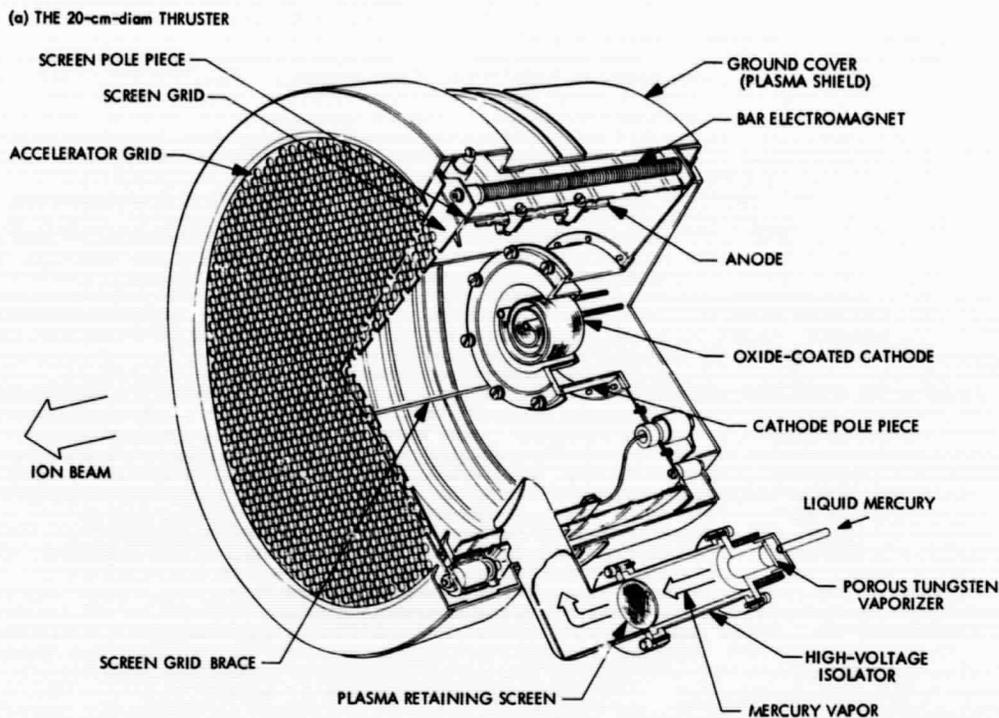
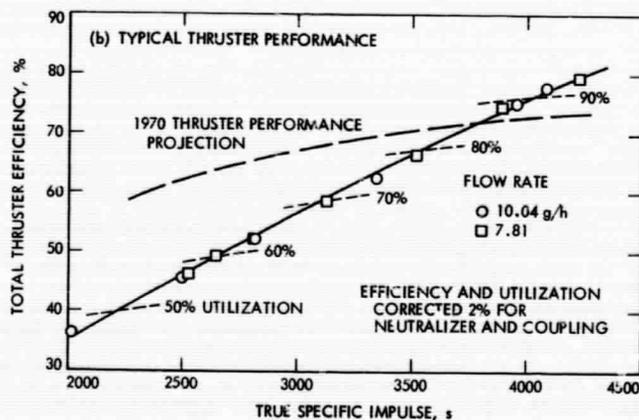
Fig. 3. The 20-cm-diam thruster

In an attempt to reduce the grid geometry variations, with their attendant effects on ion chamber performance, thrusters using screen grid sets 1 and 3 were modified to include braces to restrict the screen grid movement (see Fig. 3). The braces were thin nonmagnetic stainless steel rods that tied the screen grid to the cathode pole piece. The results of bench tests, with the thruster using grids braced at one and at two locations, are included in Table 2. When a third brace was added, the screen grid exhibited little or no movement during bench thermal tests (less than 0.002 cm). This configuration, with three

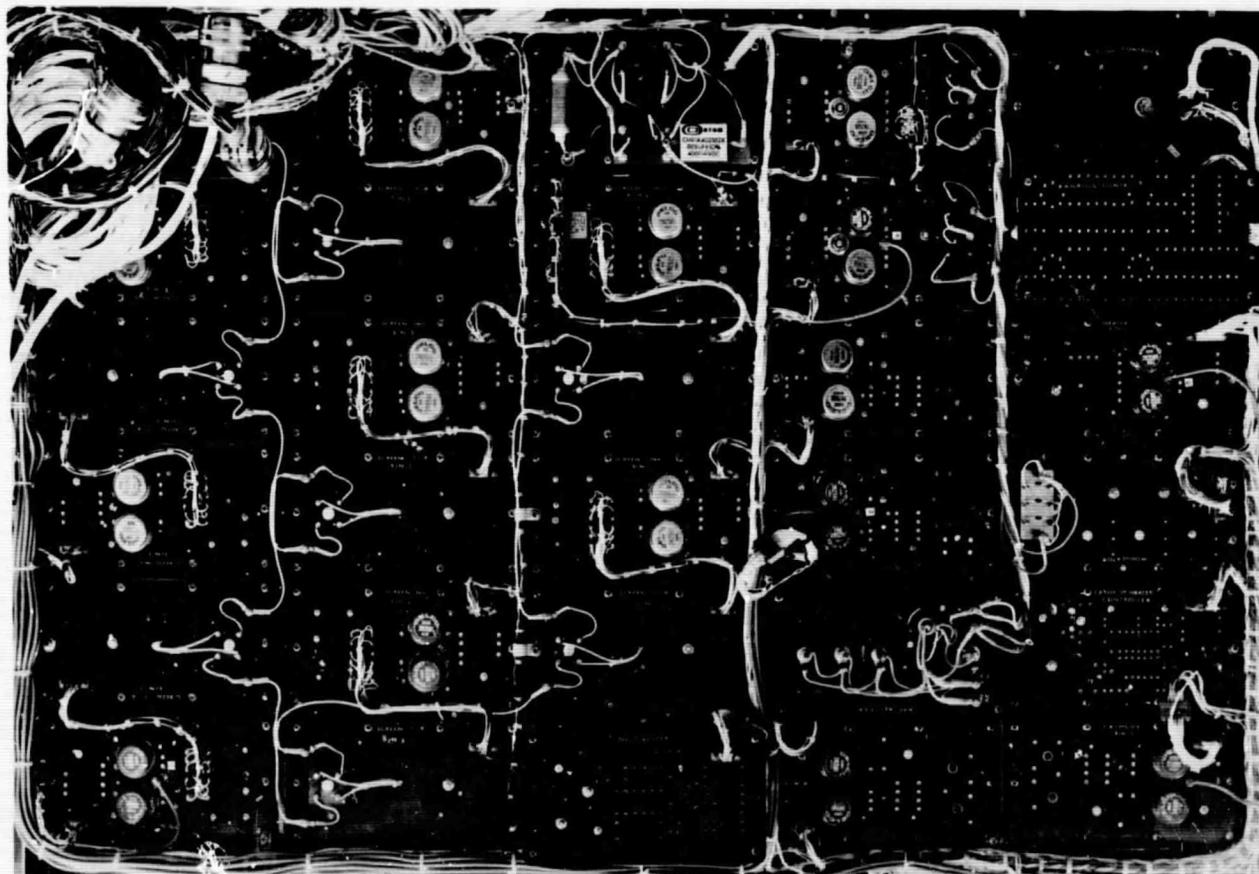
Fig. 5. Power conditioner, radiating side

high efficiency, and high-reliability operation. A power conditioner that was felt to be capable of meeting these criteria was procured from the Hughes Aircraft Company. This unit was modified from the unit reported in Ref. 17 and is shown in Fig. 5. Modifications included: (1) an increase in the total power level, (2) different control loops, (3) regulation of arc and magnet supplies, (4) incorporation of neutralizer power supplies, and (5) a redistribution of the power levels.

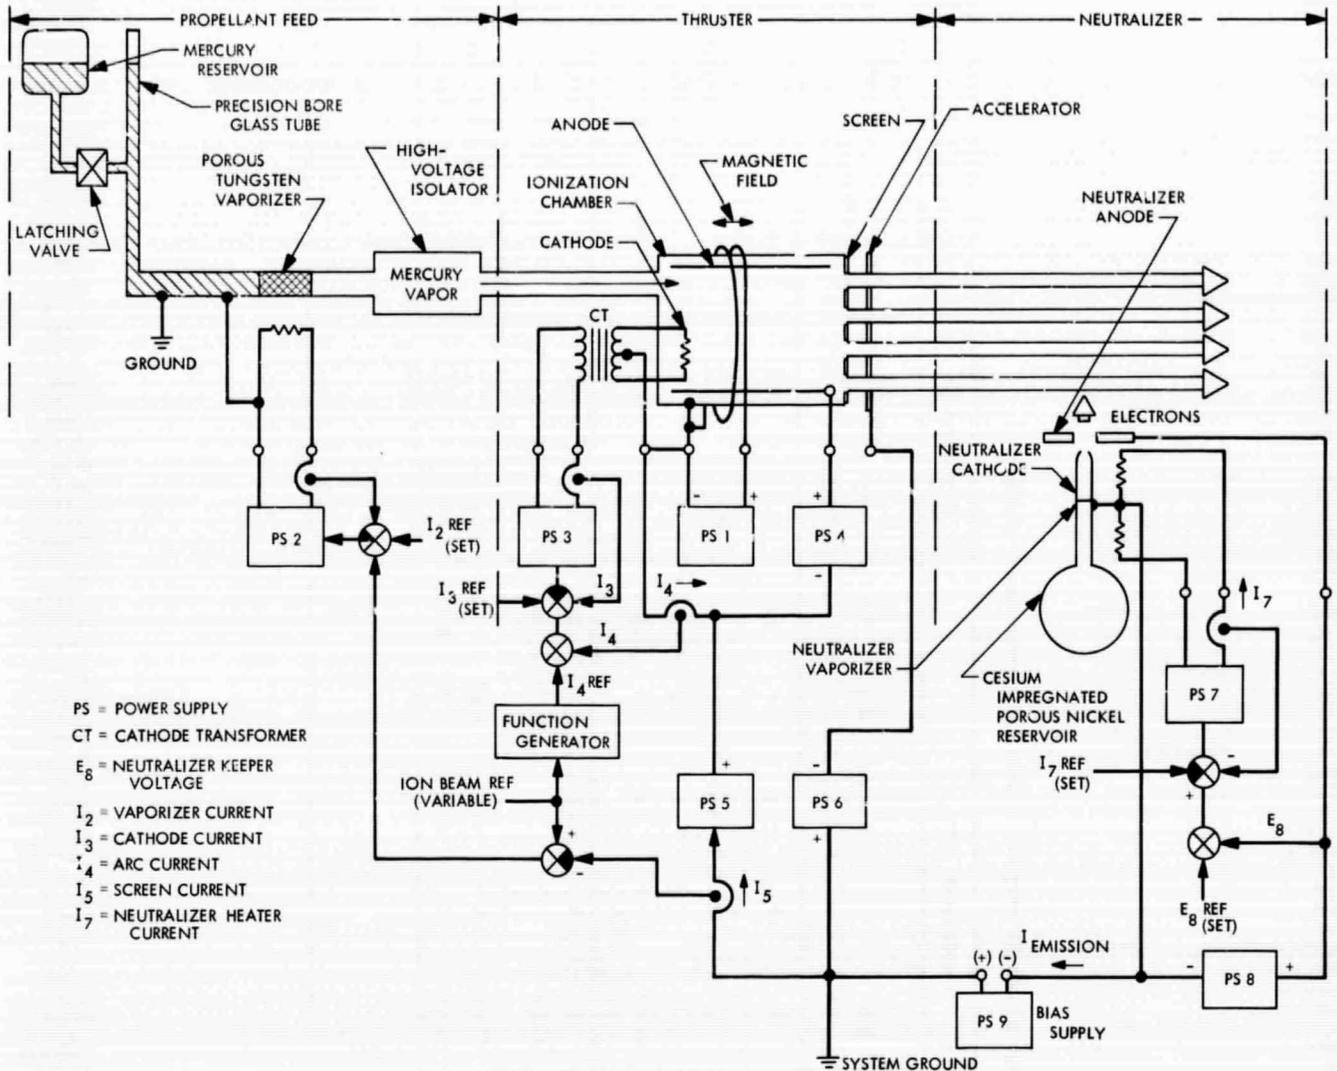
Fig. 6. Electrical connections for the power conditioner and thruster

The interconnections between the ion thruster and the power conditioning unit are shown in Fig. 6. The outputs of the individual power supplies are listed in Table 3 and are broken into two groups to aid in identifying the turn-on sequence. The power conditioner delivered a nominal power of approximately 2450 W, while the maximum power handling capacity was 2800 W. The input power was delivered at a voltage that could range from 72 to 80 Vdc. The unit weighed 38 lb (includ-

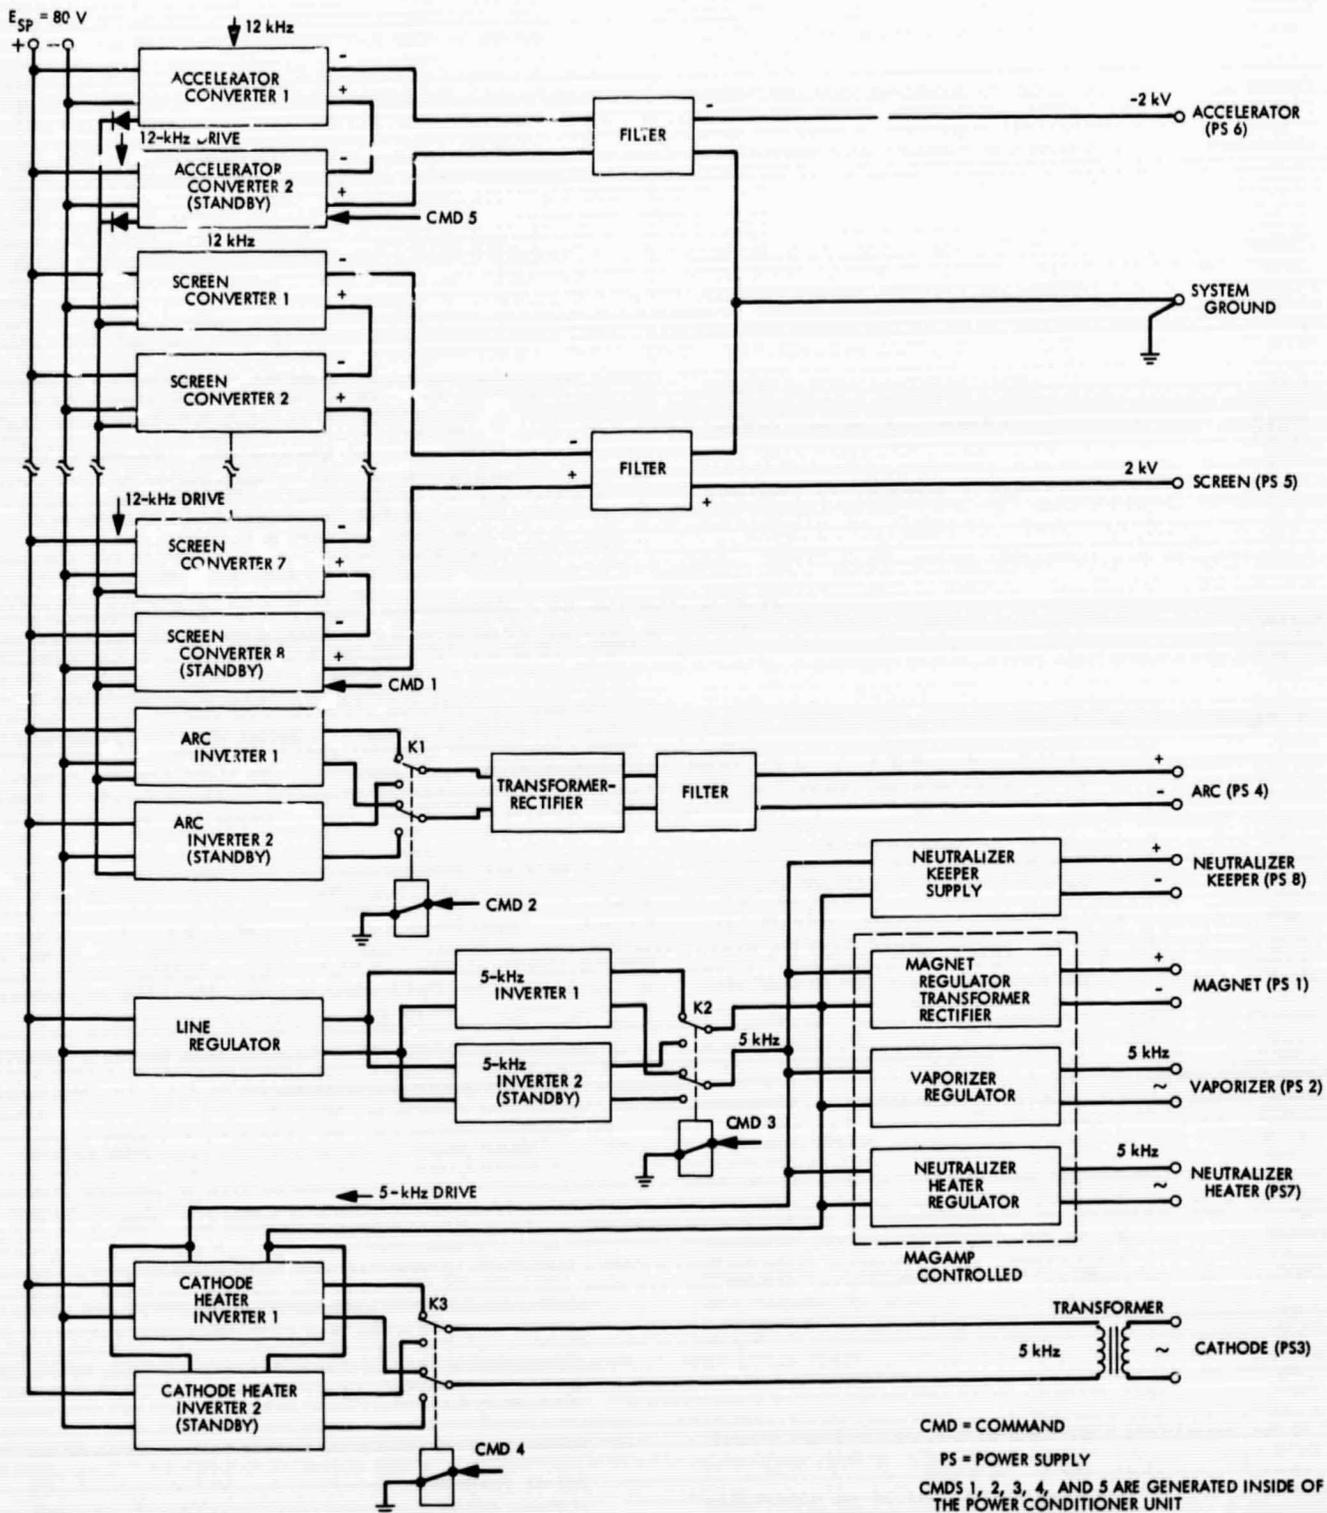
Fig. 7. Block diagram of power conditioner

Table 4 lists both the working and spare modules. Changeover from the working to spare module was performed electronically by means of a command generated by an internal failure logic. No significant interruption in the thruster operation was observed to result. The main building blocks are shown in the diagram presented in Fig. 7. Each power supply will be described in turn.

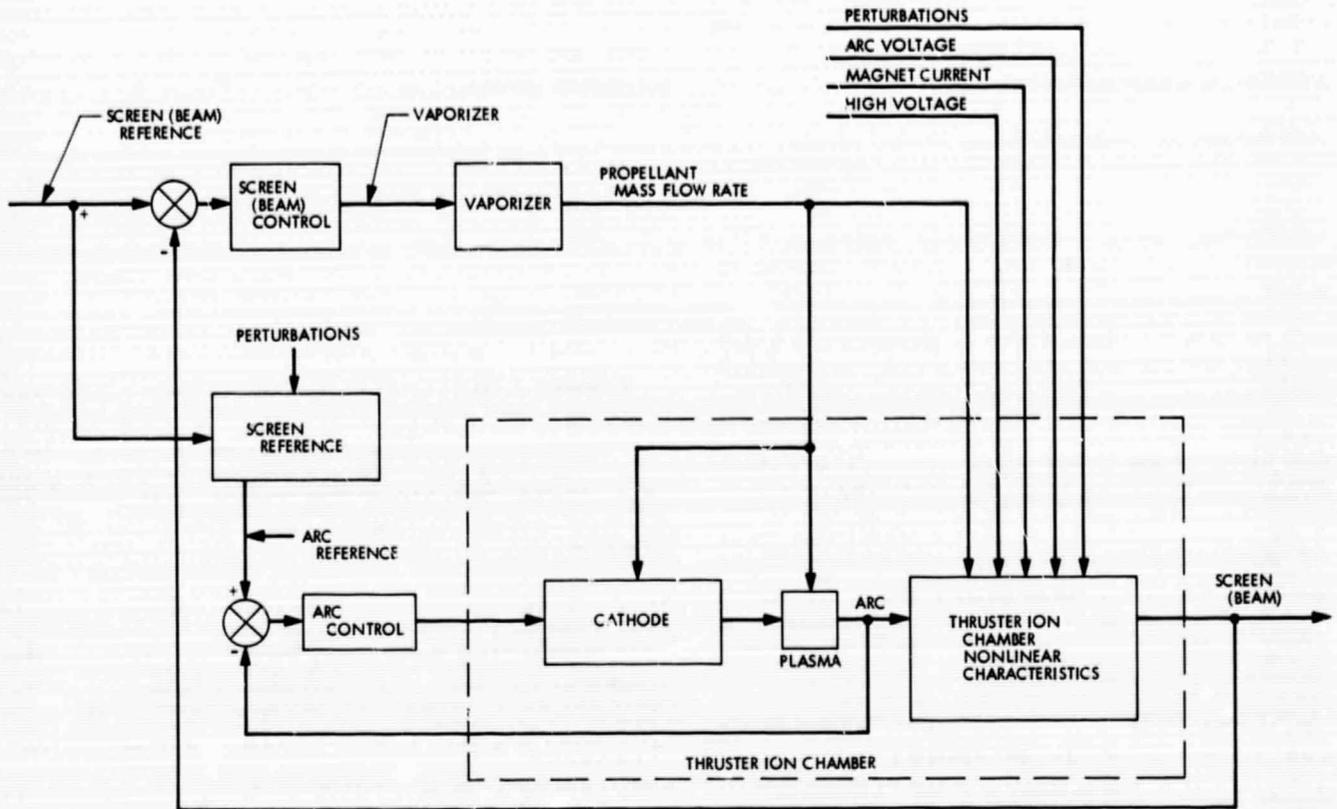
Fig. 8. Block diagram of thruster control loops

The first loop was closed as soon as the neutralizer was started. The second and third loops were closed only after the plasma in an operating thruster was established. A block diagram of the control loops for the ion thruster is presented in Fig. 8. These control loops have been analyzed and are discussed in Ref. 21. The main conclusions for the analytical model used are that the loops are stable under most operating conditions. The need to control the propellant utilization accurately imposes tight (1% or better) output regulation requirements on the power conditioner. It was also found that operation at high propellant utilization (90% or better) eased this requirement slightly.

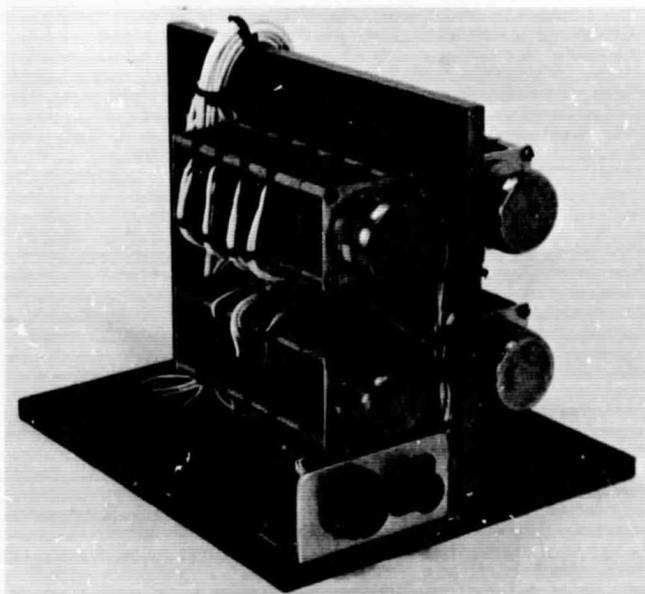
Fig. 9. Switchgear

The power conditioning unit could be linked to either of the two ion thrusters by means of multiple-contact, multiple-deck selector switches. A photograph of the four switches used is shown in Fig. 9. These switches were intended for laboratory use in atmosphere only. Lightweight, sealed units would be necessary for flight applications. Each switch contained four decks with two poles per deck and six positions per pole. Each pole was

capable of carrying 8 A. Voltages up to 4 kV could be applied between contacts. The design permitted switching only when the power conditioner was turned off. Two such switches were required per power conditioning unit. The four switches that were used in the system also permitted the laboratory power supplies to be connected to either thruster. Excess capacity existed within this system for connections to as many as four additional ion thrusters.

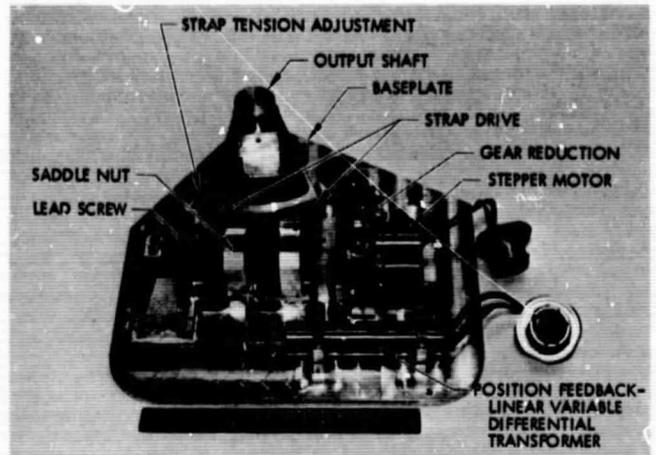
**Fig. 10. Internal view of gimbal actuator**

The drive motors in both actuators were size 11, 90-deg, permanent-magnet stepper motors. The nominal input stepping rate for the gimbal actuators was 50 steps/s although, in actual flight use, the rate could be as low as one step over a period of hours. The gear train ratio provided 0.1 mrad output rotation per stepper motor input step. Aside from the backlash problem, one of the main areas of concern in designing the actuator was the thermal environment that the actuator components would see. This concern arose because of their proximity to the thrusters whose maximum operating temperature was on the order of 250°C. A detailed thermal analysis was performed that resulted in making an intermediate

shaft connecting the actuator to the ion thruster of stainless steel, rather than aluminum, to minimize heat transfer to the actuators. With the exception of the straps, all parts of the actuator were made of aluminum. The lead screw itself was a hollow aluminum shaft, hard-anodized after machining. For the system testing of the actuator, six thermistors were attached internally to monitor temperature during thruster operation. The actuator case was a sealed unit and is pressurized to 5 psia using a 90% N<sub>2</sub>, 10% He mixture. Static seals were provided by a single O-ring. The dynamic output shaft seal was accomplished by using two O-rings separated by a lubrication groove. The output shaft was supported prior to its attachment to the thruster by a bronze sleeve bushing. Mechanical stops were provided inside the actuator to limit mechanical travel to ±12 deg.

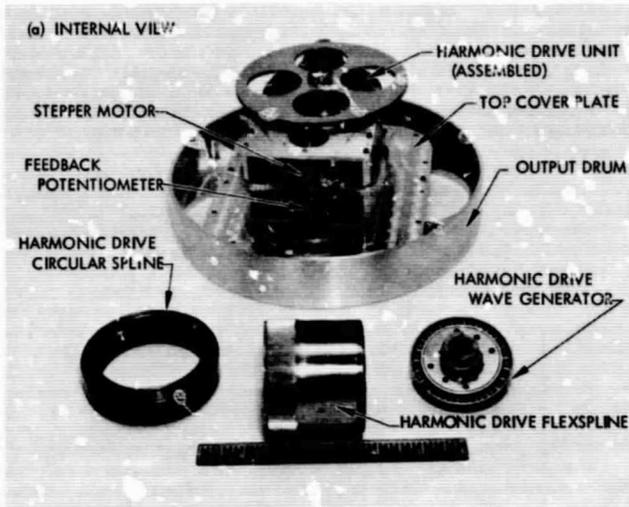
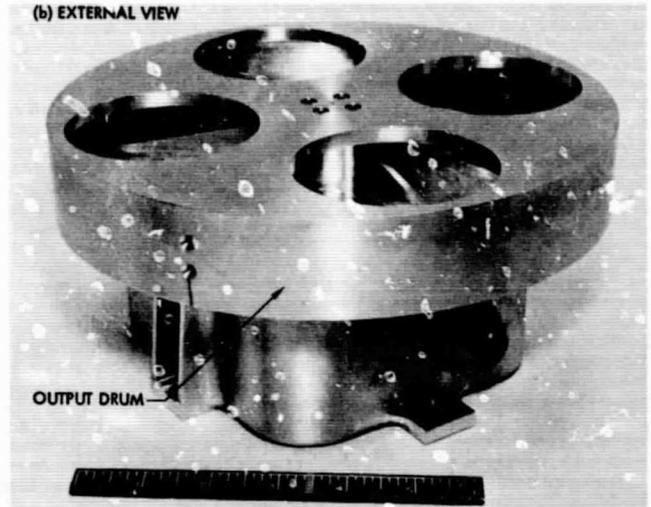
Fig. 11. Translator actuator

**2. Translator actuator.** The characteristics of the translator actuator are also listed in Table 6, and the actuator is shown in Fig. 11. Two features are particularly noteworthy. The first is the application of a harmonic drive gear train to obtain very low values of backlash (less than 5 arc s) and high output torsional stiffness. This item can be purchased as off-the-shelf hardware with the low level of backlash specified. This low backlash is obtained by the vendor through careful selection and matching of component parts. The second noteworthy feature is the platform drive external to the actuator. This motion was accomplished by the use of a flat-strap type of drive that connects the output drum to stainless steel roller bearings that ride on parallel stainless steel shafts. Fatigue cracks that might develop in the strap drive are self-healing in a space vacuum. It is anticipated that ceramic balls will be used in the roller bearings to eliminate the possibility of cold welding of similar metals

in a space vacuum. Mechanical stops on the stainless steel rods limited mechanical travel to  $\pm 7.5$  cm for the system tested. The system was capable of 33 cm of travel when removed from the vacuum chamber. As mentioned previously, a size 11 stepper motor was used. The gear ratio provides 0.0064 cm (0.0025 in.) of output translation per stepper motor step. A rotary infinite resolution potentiometer was used for position feedback. Mechanical feedback gain is approximately 1. As mentioned for the gimbal actuator, similar metals were used here also to minimize thermal expansion problems. This actuator was also instrumented with thermistors to provide temperature feedback information during system testing.

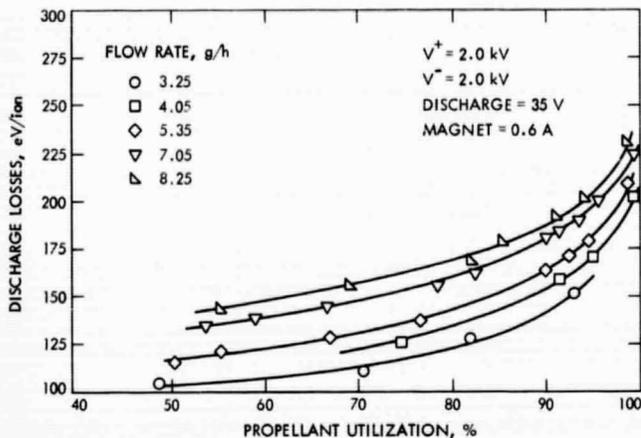
**Fig. 13. Ion chamber losses as a function of utilization for various flow rates**

where the ion chamber losses (ion chamber power/ion beam current) are presented as a function of propellant utilization (ion beam current/equivalent currents of mercury propellant flow rate) for several values of flow rate. These data, therefore, include the effects of a high-frequency cathode heating current. No unusual operational behavior was observed.

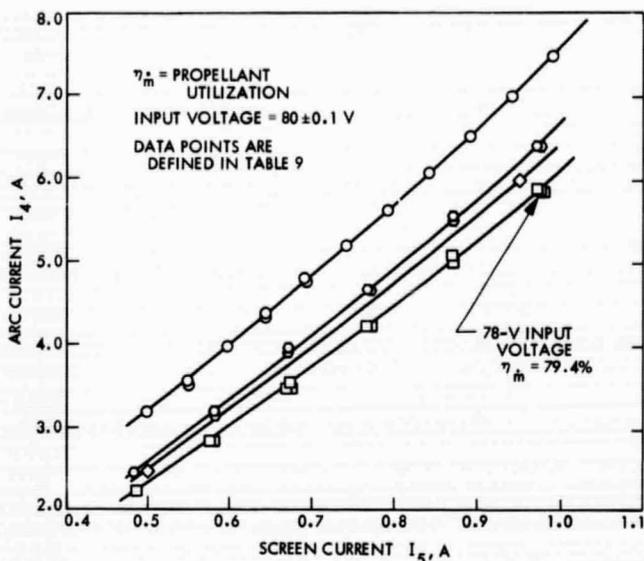
Fig. 15. Curve matching of two thrusters

The differences in performance between thrusters 1 and 2 were initially found to be quite large (~15% at full power to 25% at ½ power). This difference was attributed to an inadvertently large gap (0.233 cm) that existed on the axis of thruster 1, compared to a nominal 0.178-cm gap spacing at the grid periphery. Attention was focused on the requirement for uniformity of grid separation over the entire grid area. Thruster 1 was therefore modified to approach the thruster 2 spacing. In adjusting the spacing by changing the lengths of the braces, attempts were also made to decrease the overall spacing tolerance. This was difficult because of the construction and tolerances of the thruster part. Best results were obtained by machining a 0.25-cm-deep seat for the screen grid to minimize screen pole-piece distortions.

After these modifications, the gap spacing better approximated that of thruster 2 and the performance was checked. A 9.9% variation in ion chamber performance was recorded, with thruster 1 showing the better performance. Variations in the gap spacing still existed between the two thrusters. Instead of striving for identical spacing on each unit, however, the nominal spacing on thruster 2 was reduced. This resulted in smaller variation between the two thrusters (about 6.0%). Since this difference did not significantly affect the system performance, no further refinements were made. The test operation satisfactorily demonstrated that the thruster performance can be trimmed to match a power conditioning unit by adjusting grid spacing.

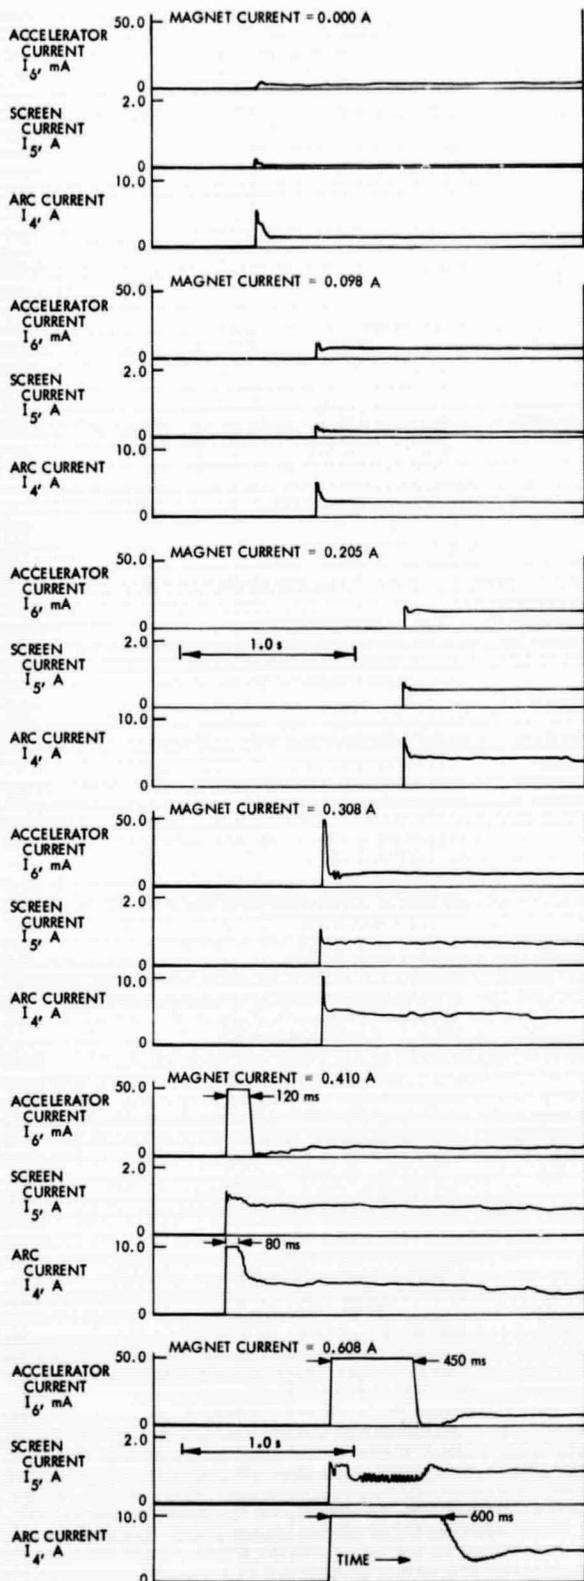
Fig. 16. Accelerator, screen, and arc currents

The ion chamber plasma density is a function of the magnetic field. Figure 16 shows how the intensity of the

magnetic field (or plasma density) affects the amplitude and duration of the overshoots of the three currents from circuits that have trip limits. It became evident that the most desirable way to restart thruster operation was to do so without any magnetic field.

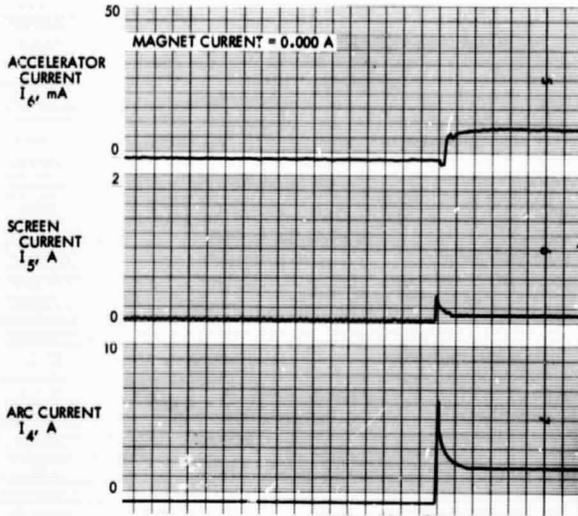
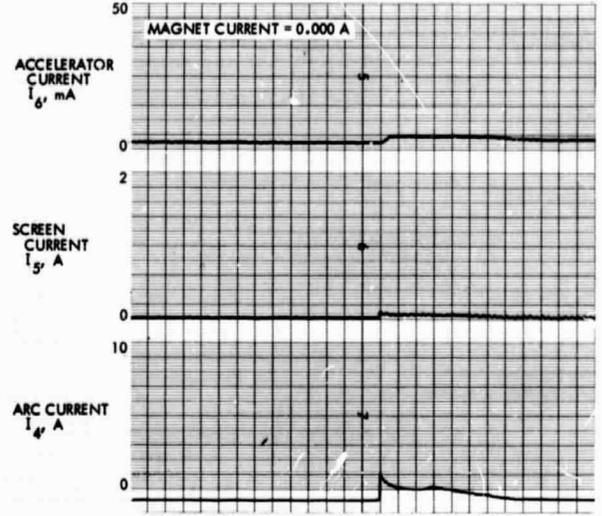
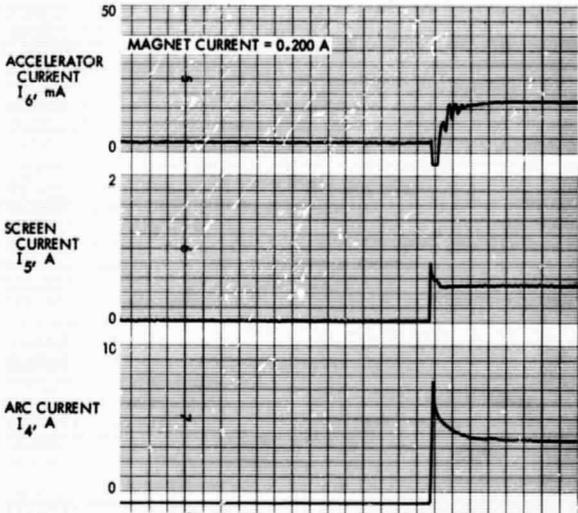
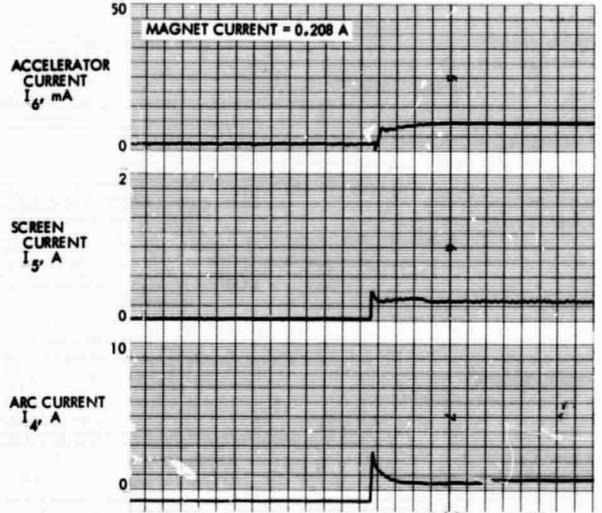
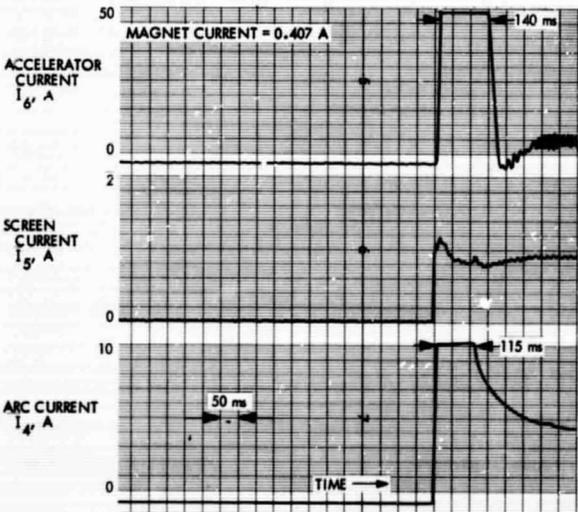
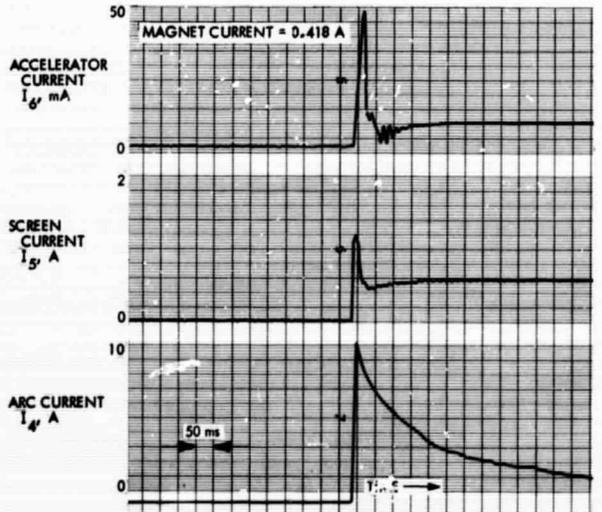
Fig. 17. Discharge initiation at high cathode power

Fig. 18. Discharge initiation at low mercury flow

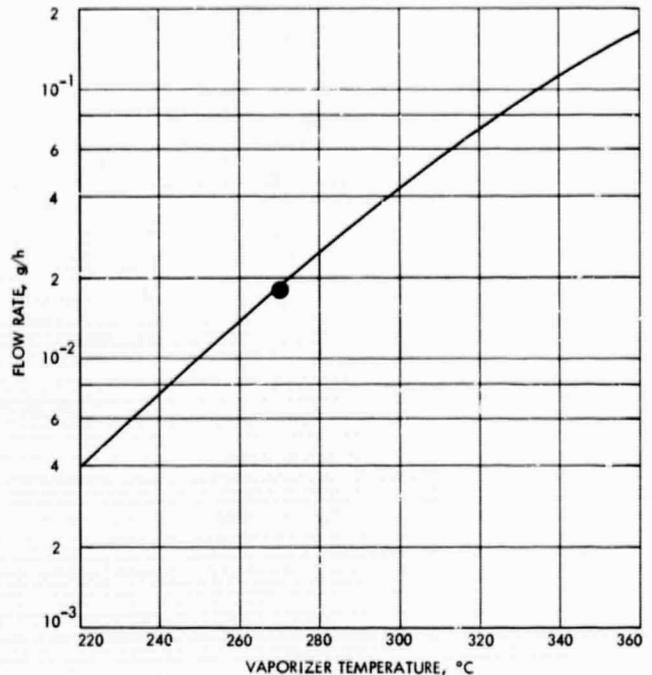
Fig. 21. Neutralizer calibration curve

The keeper voltage was maintained at a set point of 5.2 V. The cesium flow for this set point was derived from an extrapolation as presented in Fig. 21. The solid data point represents the flow rate as measured during an endurance test on this type of neutralizer at Electro-Optical Systems, Inc.\* A curve was fitted through this point with the flow proportional to the vapor pressure divided by the square root of the vaporizer temperature. Flow rates derived on this basis were on the order of 0.09 g/h. The bias voltage necessary to maintain the neutralizer emission equal to the beam current as the thruster was gimbaled is presented in Fig. 22 for two values of beam current. The data point values for Fig. 22 are defined in Table 10. Low voltage levels of neutralizer to beam coupling were found to exist for all values of gimbal position. These voltages were considerably below the 30-V level where detrimental wear has been observed (Ref. 16). The cesium flow was calculated to be 1.2 to 2.2% of the ion beam. No changes in the neutralizer set

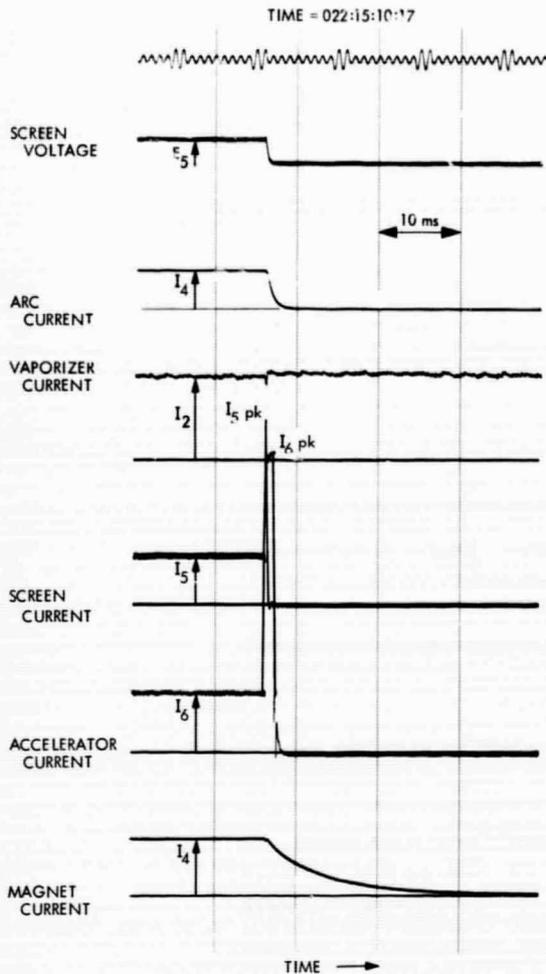
Fig. 24. Overcurrent shutdown of the system

In Fig. 24, the arcing between screens caused a temporary shutdown. Magnet, arc, screen, and accelerator currents and screen voltage are shown to decay to zero, whereas the vaporizer current  $I_2$  remains on. The amplitude and duration of the overcurrents in the accelerator and screen grid supplies can be identified as belonging to the nuisance category that should not trip off the system. As the blanking time was extended from the original 2 to 5 ms, the number of nuisance overcurrent trips was greatly reduced.

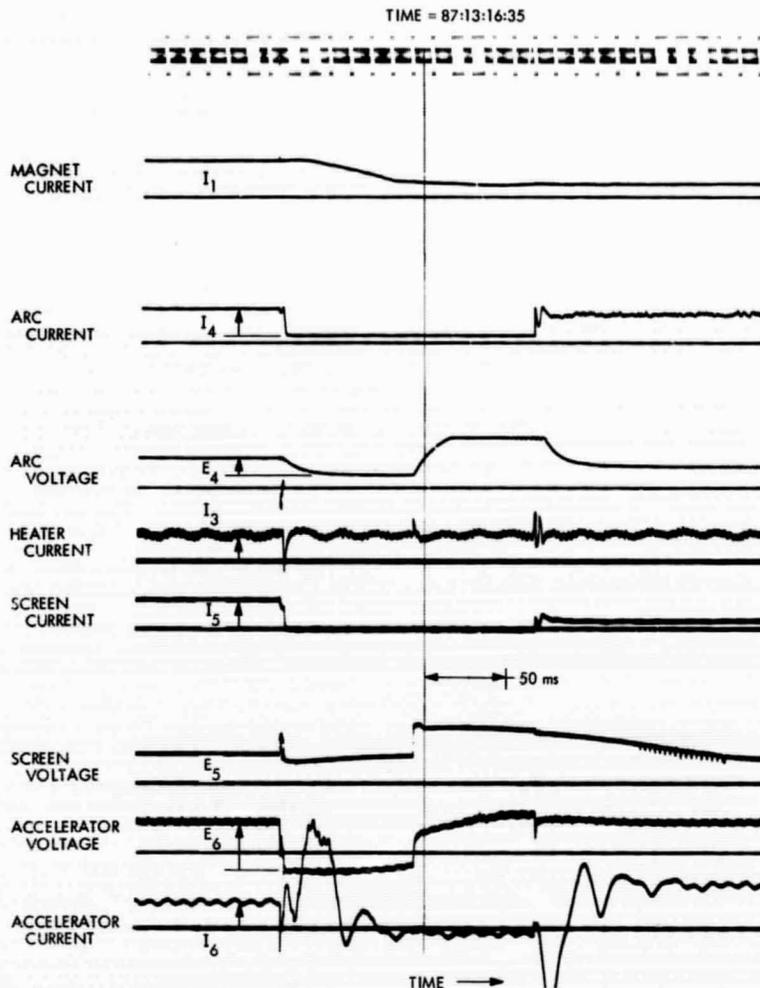
**Fig. 25. System recovery from an arc**

Figure 25 traces a recycle during initial stages of recovery from arcing and indicates a large accelerator current flow during deionization of the thruster, after the power conditioner had been shut down. It also records the negative accelerator current  $I_6$  at the time of the thruster restrike. Note the delay in striking from the time the voltages are applied. The arc, screen, and accelerator voltages ( $E_4$ ,  $E_5$ , and  $E_6$ ) are off for 90 ms only. In view of the fact that the magnet current requires nearly 60 ms to decay, this downtime was considered insufficient.
