TECHNICAL LETTER NASA-61

HYDROLOGIC INTERPRETATION OF

NIMBUS VIDICON IMAGE -- GREAT SALT LAKE, UTAH\*

November 1966

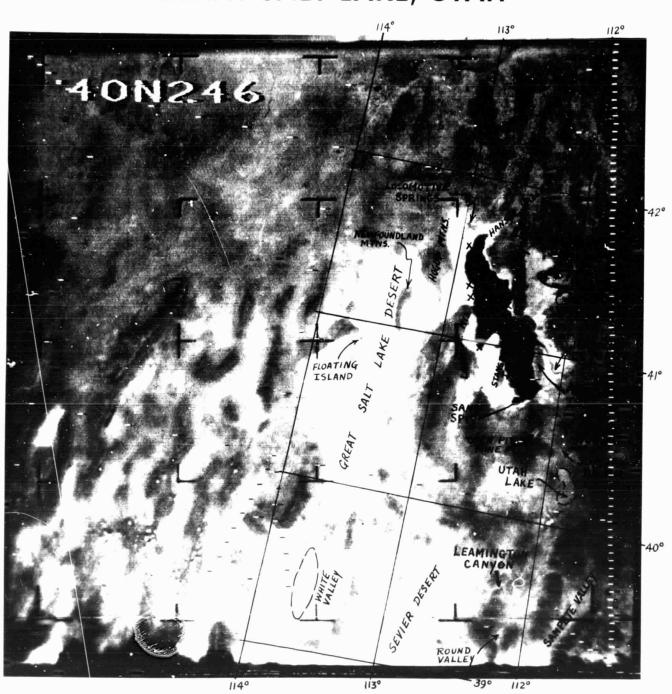
# NIMBUS SATELLITE AVCS IMAGERY GREAT SALT LAKE, UTAH

A Nimbus Advanced Vidicon Camera System (AVCS) image of Great Salt Lake and adjacent areas recorded in September 1964 was examined to determine if features of hydrologic significance were visible and identifiable. An annotated copy of the image is shown in figure 1.

Evidently several factors are required to produce an image. Features such as Willard Bay Reservoir and Utah Lake do not show on the image, yet Great Salt Lake, which is of comparable depth shows clearly. Adjoining Willard Bay Reservoir is Bear River Bay Migratory Bird Refuge, which is discernible. The dikes, land areas, and water areas in the refuge match those on recent aerial photographs. Depth does not seem to be a factor in producing an image because the brackish water of the refuge that is less than two feet deep shows black; whereas, subaqueous features ("X's" offshore of Great Salt Lake, figure 1) of comparable depth in Great Salt Lake show through the brine.

Vegetation and geology may be responsible for the delineation or lack of delineation of some features. An example is a comparison between White Valley and Floating Island. White Valley is surrounded by mountains of about equal height (4,500 feet above the valley floor), yet only the eastern mountains are visible. Floating Island is a small feature (800 feet above the desert floor) and it shows clearly in the image.

The only man-made features discernible are the Bear River Bay
Migratory Bird Refuge and the open pit copper mine of Kennecott Copper
Corporation at Bingham.
