FINAL REPORT
BEARING RETAINER MATERIALS DEVELOPMENT

NERVA Program

NUCLEAR ROCKET OPERATIONS

October 1960

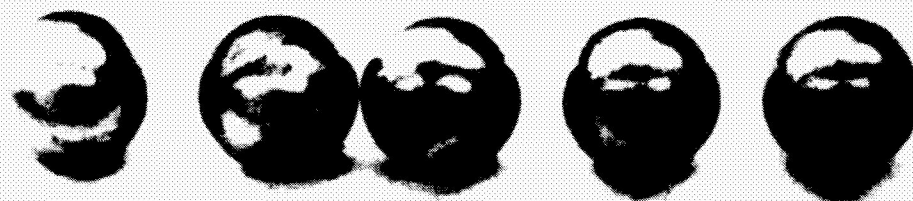
Figure 20 - Frosted Surface Condition of Balls Caused by Abrasive Glass Debris from Retainer

(i.e., the balls, the outer race, and the loaded half of the inner race) had lost their pretest finish and had a finely frosted surface condition (see Figure 20). Closer examination revealed small dents and gouges in several balls and in the outer race track. The cause of the surface degradation (i.e., abrasive debris from the ball retainer) was evident from examination of the retainer. As shown in Figures 21 and 22, each ball pocket contained wear scars at both driven and trailing walls, resulting in the generation of considerable debris. Table 7 shows that a total of more than 0.69 gm of material (solid lubricant and retainer material) was lost during the test.

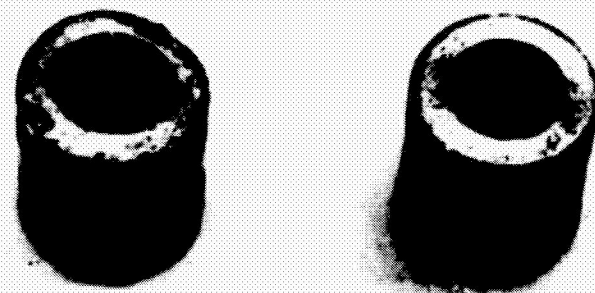
Figure 53 - Posttest Appearance of Motor Roller-Bearing Rollers Showing Effects of Extreme End-Wear and Bearing Failure, Upstream Faces

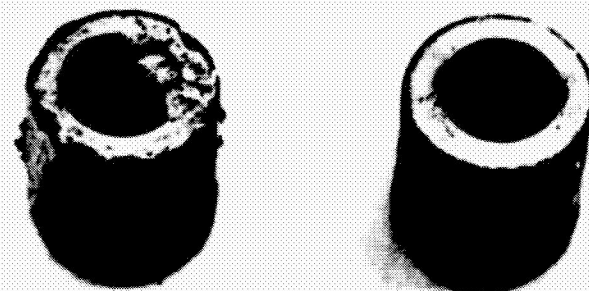
Figure 54 - Posttest Appearance of Motor Roller-Bearing Roller Downstream Faces

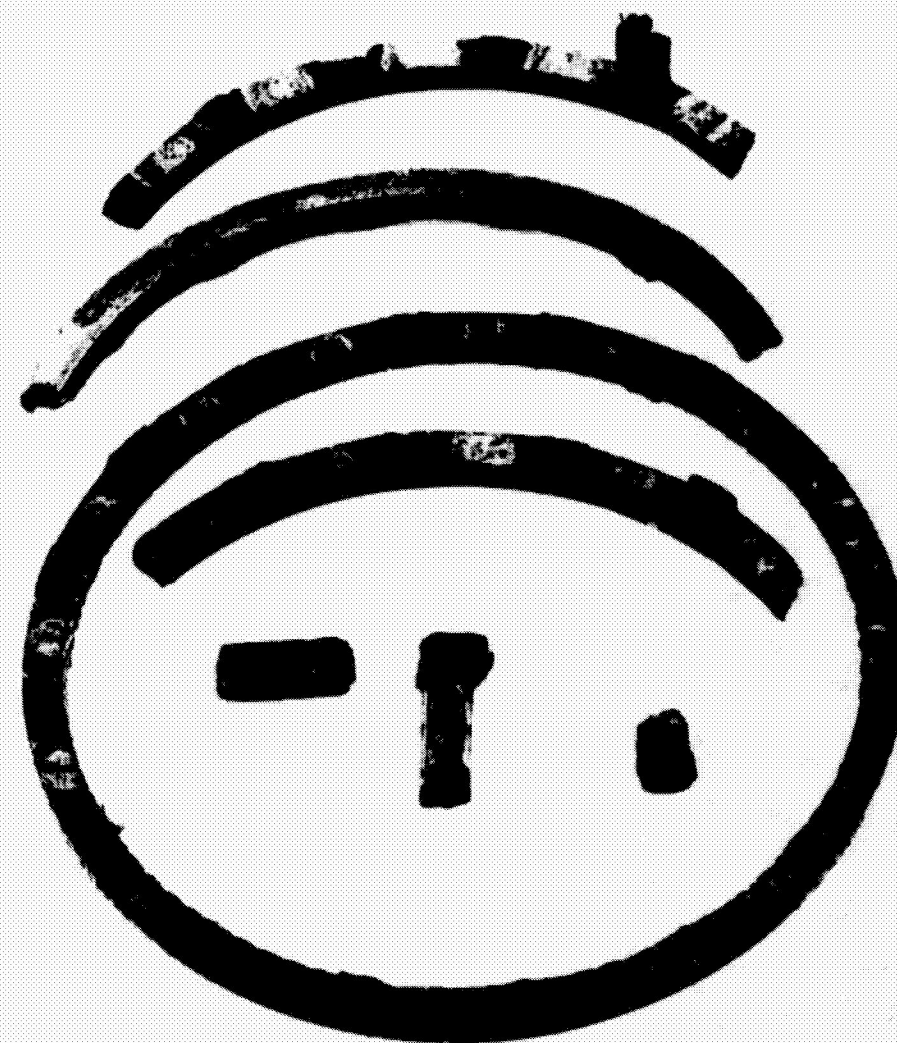
Figure 56 - Posttest Appearance of PBI-Graphite Roller Retainer S/N 880008, Destroyed by Extreme End-Wear and Roller Skewing
