**A REVIEW OF THERMAL CONTROL COATING
DEGRADATION BY THE SERVICE MODULE
REACTION CONTROL SYSTEM ROCKET EXHAUST
AND ESTIMATED EFFECTS ON SKYLAB**

TM- 70-1022-12

DATE- September 21, 1970

AUTHOR(S)- G. M. Yanizeski

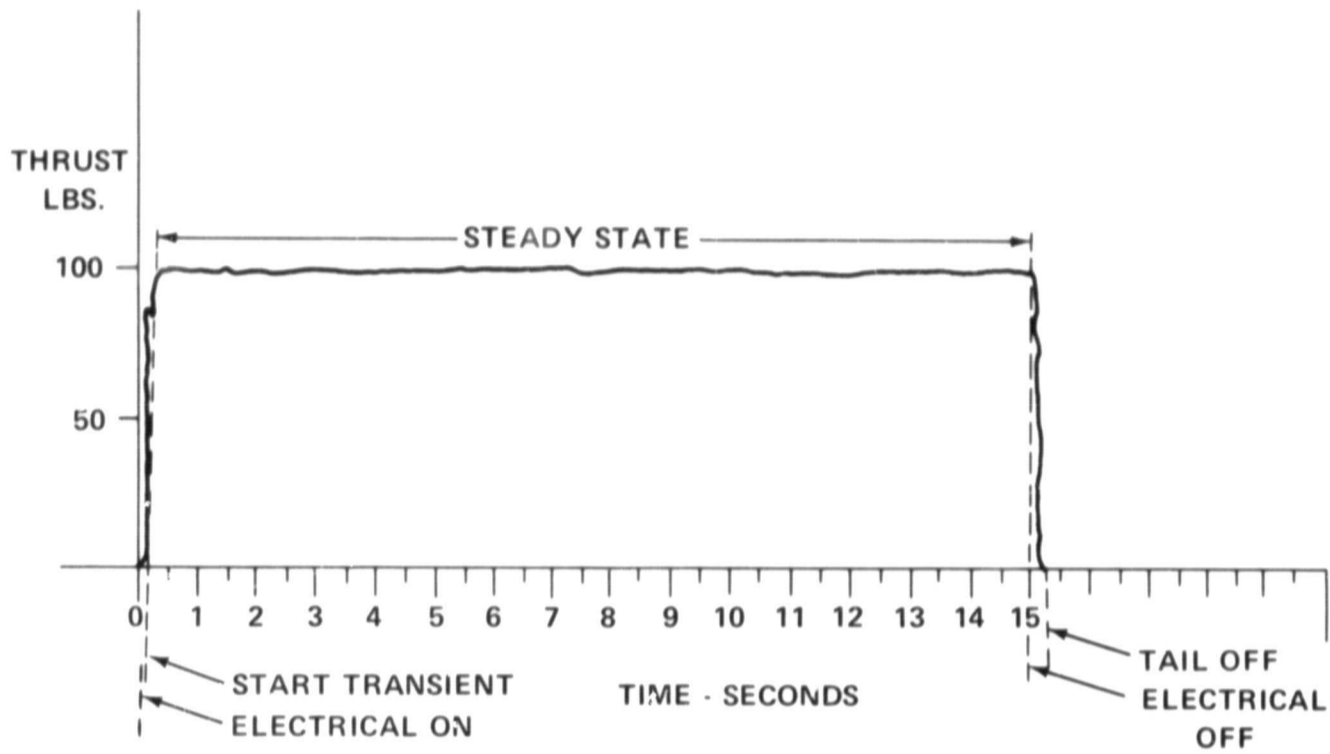
FIGURE 5A - SM RCS STEADY STATE OPERATION-TYPICAL
(FROM REFERENCE 26)

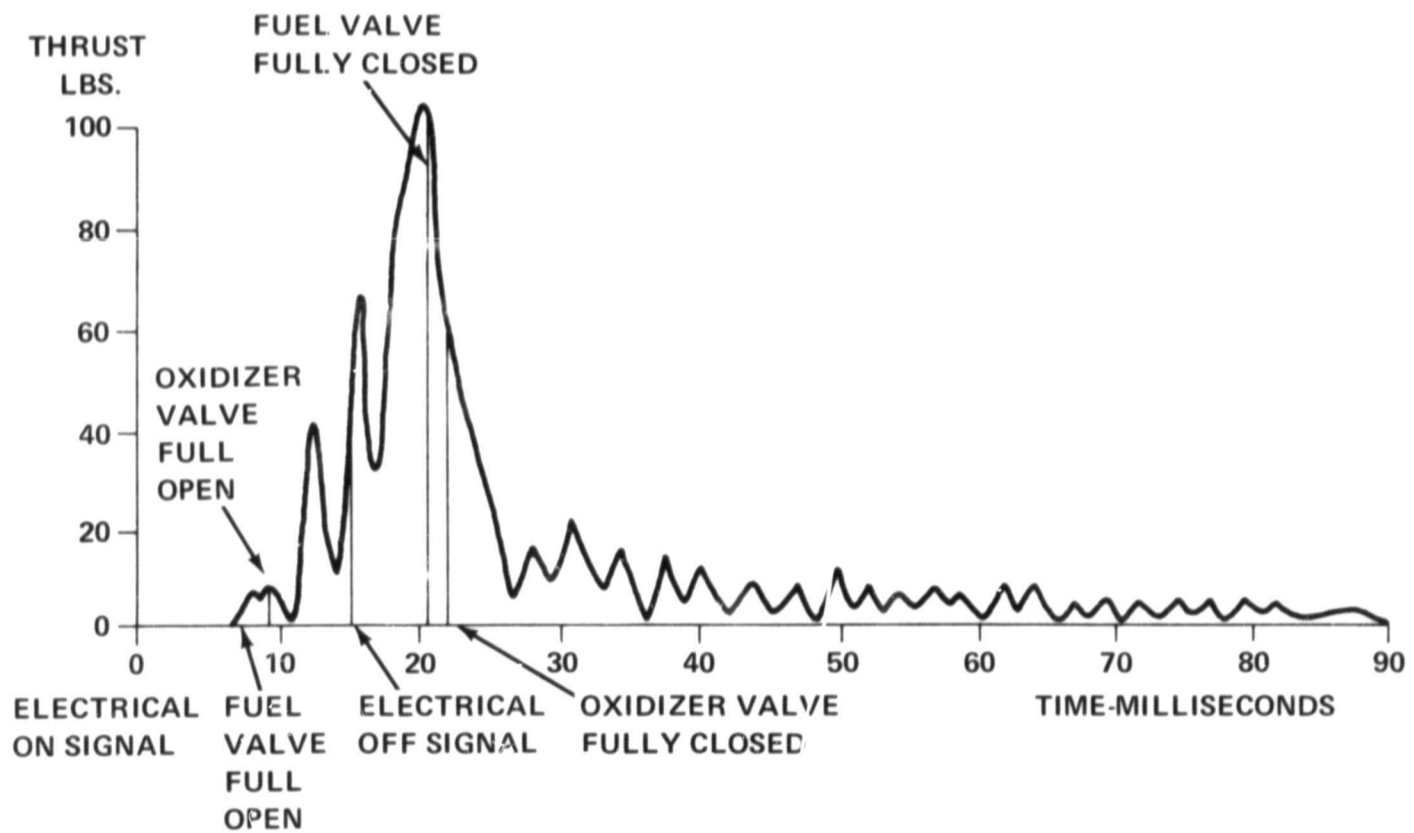
FIGURE 5B - SM RCS ENGINE MINIMUM TOTAL PULSE (FROM MARQUARDT COMPANY QUALIFICATION TEST CONDUCTED NOVEMBER 23, 1965)
